Structural Assessment

Muscle Shoals Reservation
adaptive re-use study

Conditions/Market/Planning/Implementation

July 31, 2009
Revised August 25, 2009

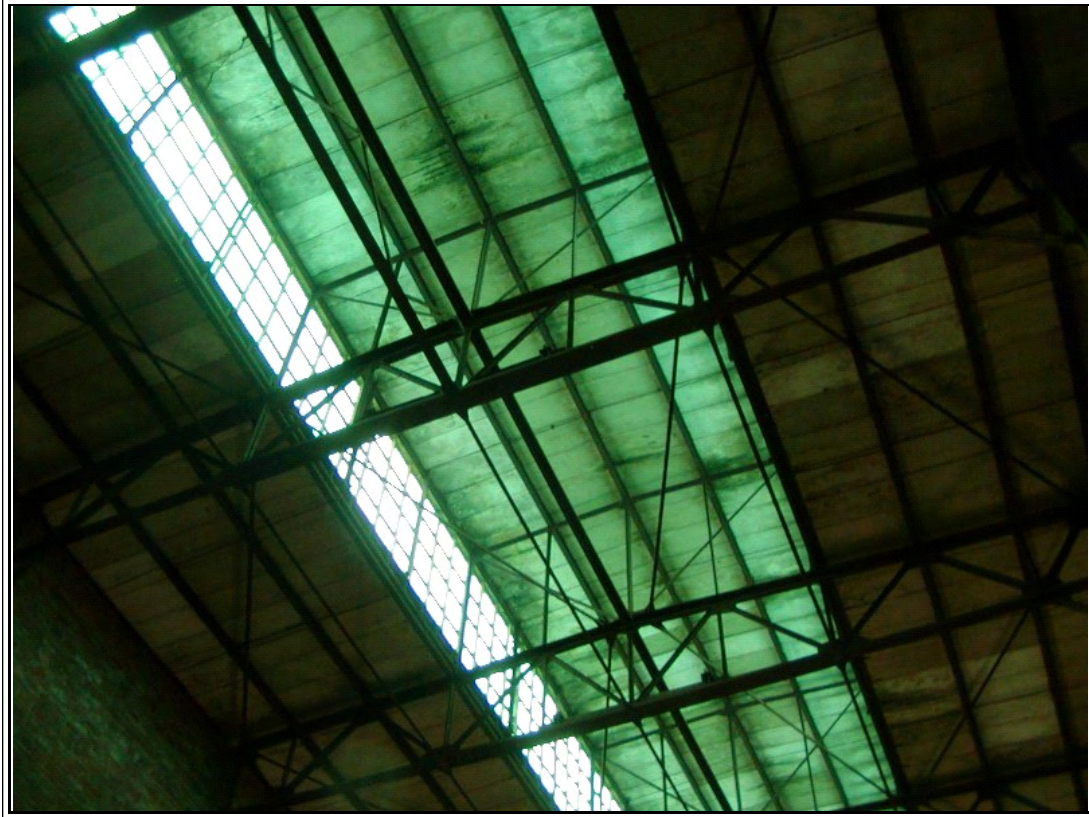
Photograph #: 14

Deteriorated concrete roof planks

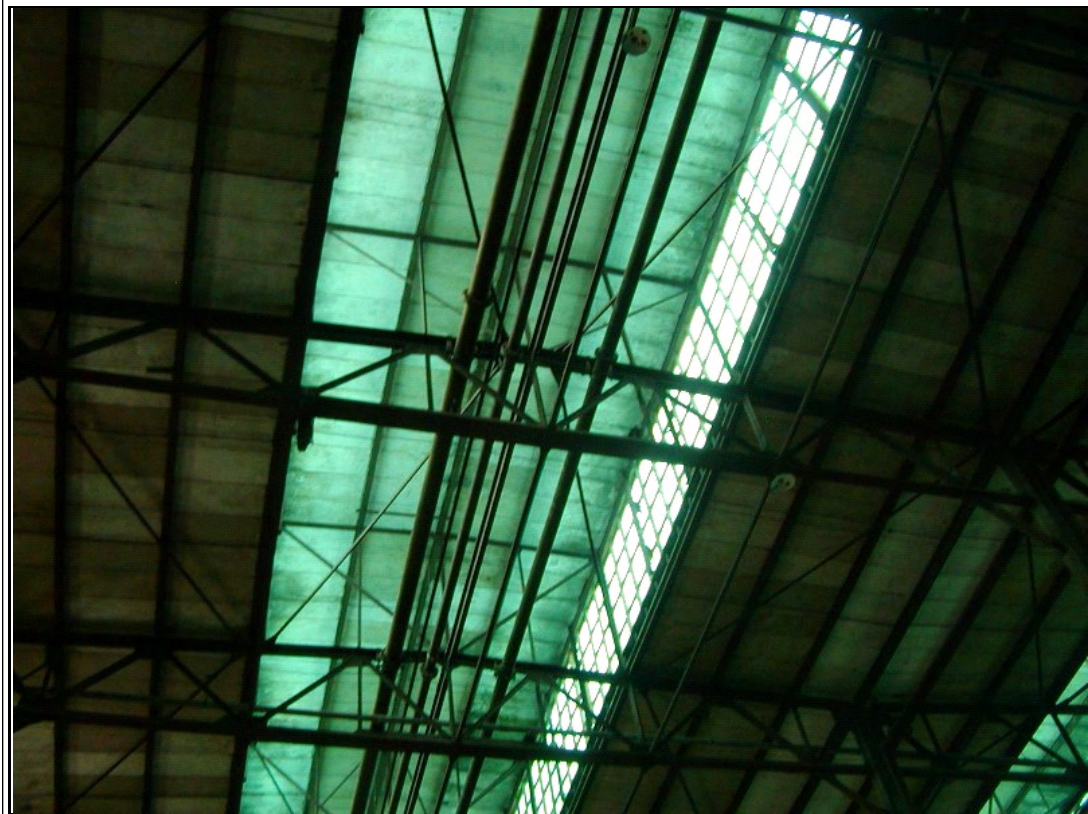
Photograph #: 15

Deteriorated concrete roof planks

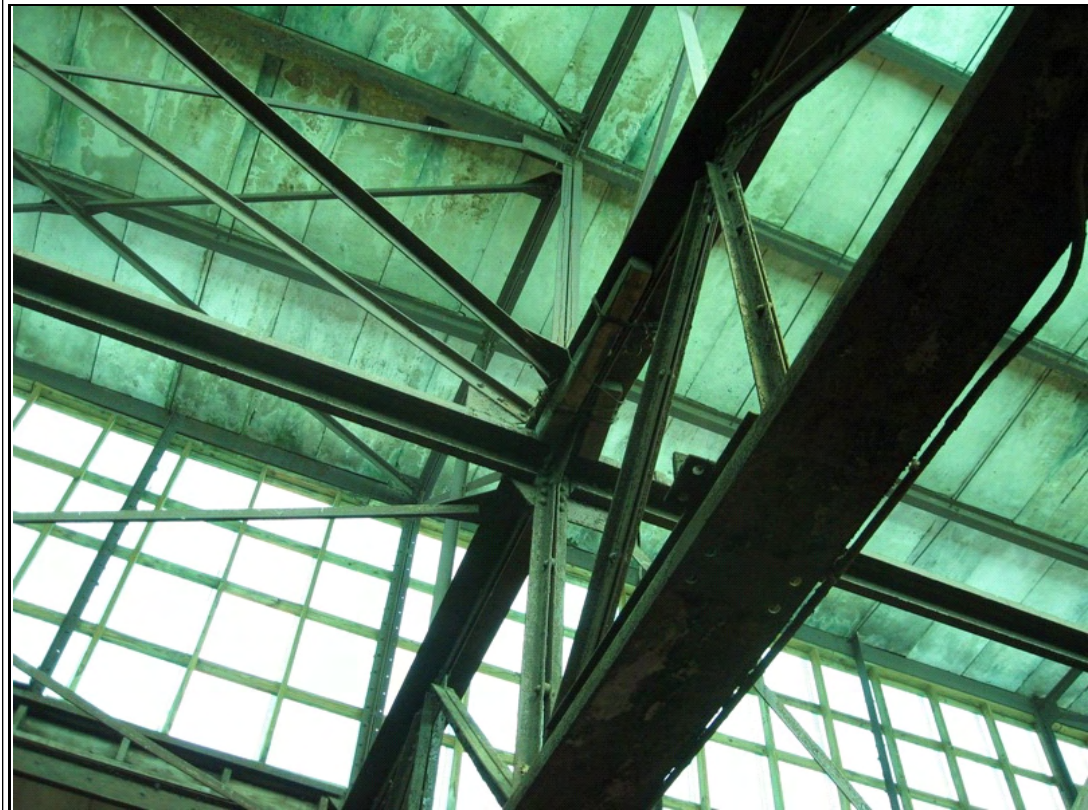
Photograph #: 16

Deteriorated concrete roof planks

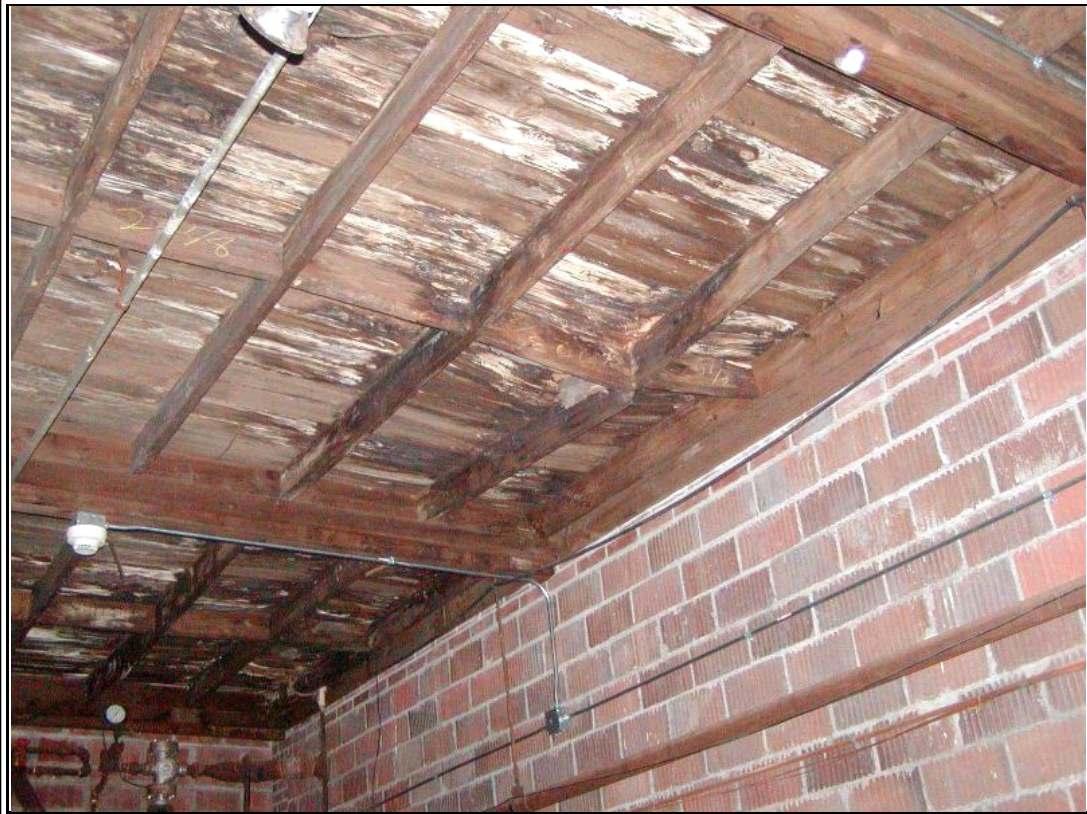
Photograph #: 19

Ruined roof deck of interior enclosure

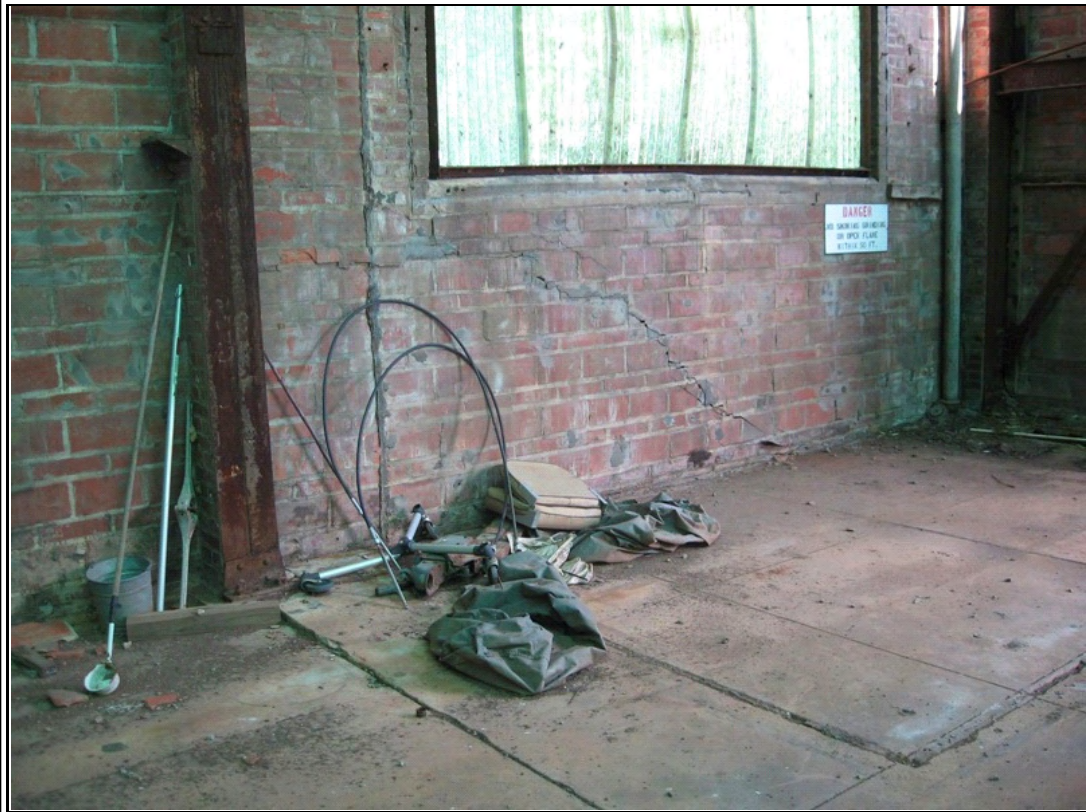
Photograph #: 21

Cracked masonry at outside wall

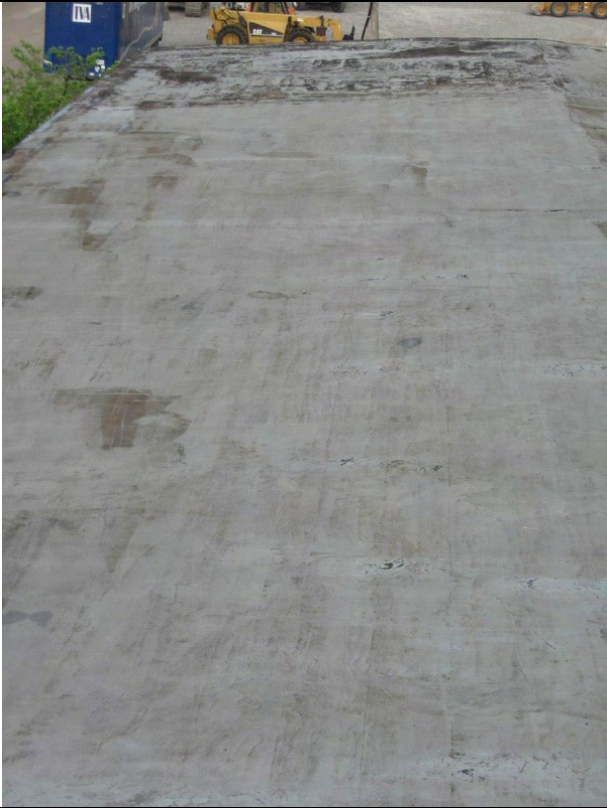
<p>Photograph #: 7</p> <p>View of building roof membrane in fair condition</p>
 	<p>Photograph #: 8</p> <p>View of deteriorated awning roof from above</p>

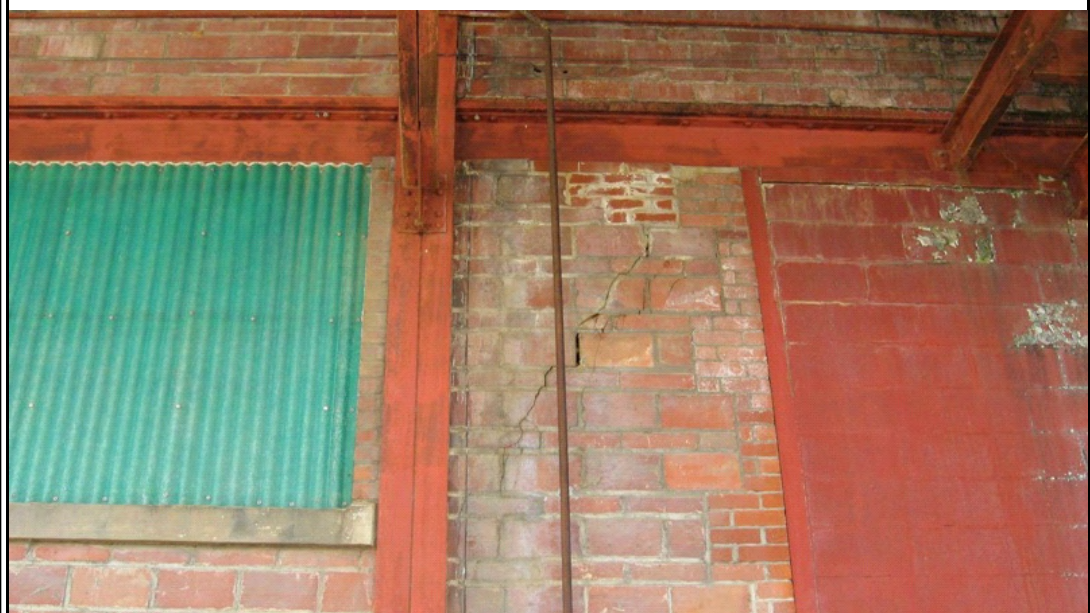
Building 33 Shipping and Receiving Office,34 Instrumentation - Electric Shop,35 Chemical Plant Warehouse & 36 Projects Operations Storage Warehouse				
38	Voids in south wall - east end on lower level of Bldgs 33 - 36		R-M-1	27
39	General condition South wall, east end on lower level of Bldgs 33 - 36			29
40	Crack in floor +/- 1/8" by ?? Door, east end on lower level of Bldgs 33 - 36		R-C-1	28
41	General condition looking south, east end on lower level of Bldgs 33 - 36			30
42	Vertical crack at southeast corner & context of exterior walls		R-M-2	21,22
43	Wood awnings (2) - fair condition for age			
44	Context photo northeast corner			1
45	Wall above cantilevered canopy, north side - rusted steel columns. Stained clay masonry		R-S-1	2,3
46	North canopy steel mildly corroded/heavily stained. Concrete planks are in fair to poor condition		R-S-1	4,5,7,8
47	Cracks in masonry north wall, east end	18 LF	R-M-2	6

<p>Photograph #: 6</p> <p>Crack in exterior masonry below north canopy.</p>

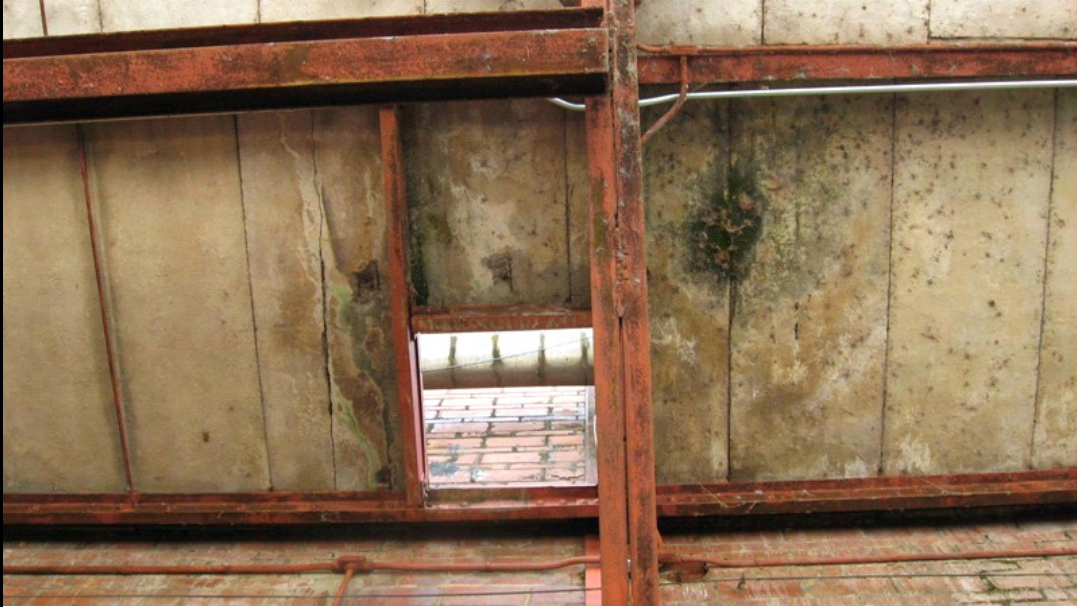
A photograph showing a close-up view of a concrete roof structure. The concrete planks are heavily deteriorated, showing significant cracking, discoloration, and areas of missing material. A wooden frame or support structure is visible behind the concrete.	<p>Photograph #: 7</p> <p>Deteriorated concrete roof planks at north canopy.</p>

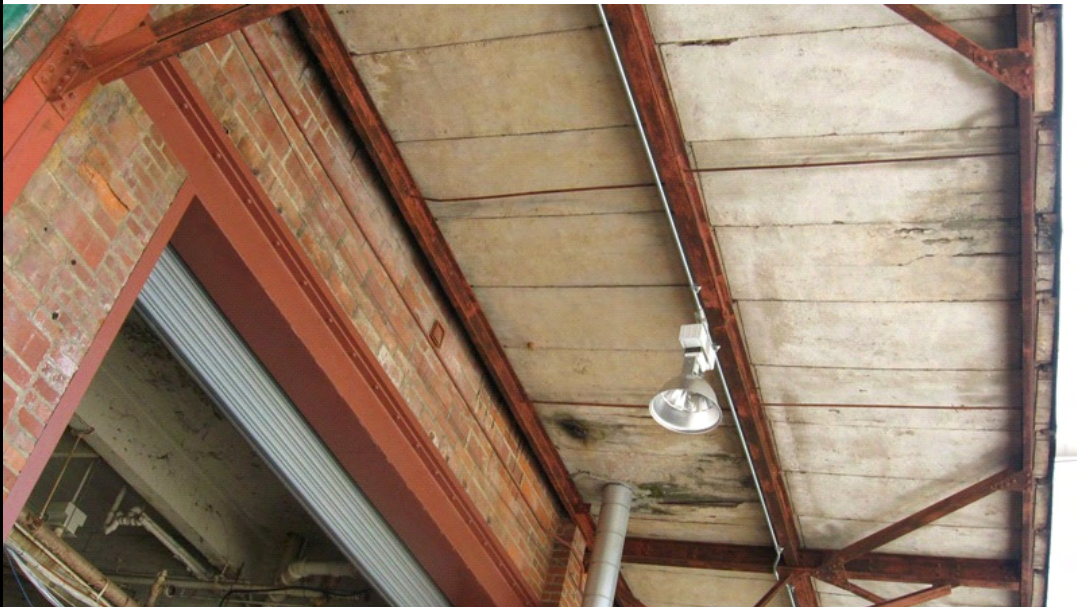
A photograph showing a wider view of the deteriorated concrete roof planks. The structure is supported by a wooden frame. A light fixture is visible hanging from the ceiling. The concrete shows extensive cracking and peeling.	<p>Photograph #: 8</p> <p>Deteriorated concrete roof planks at north canopy.</p>

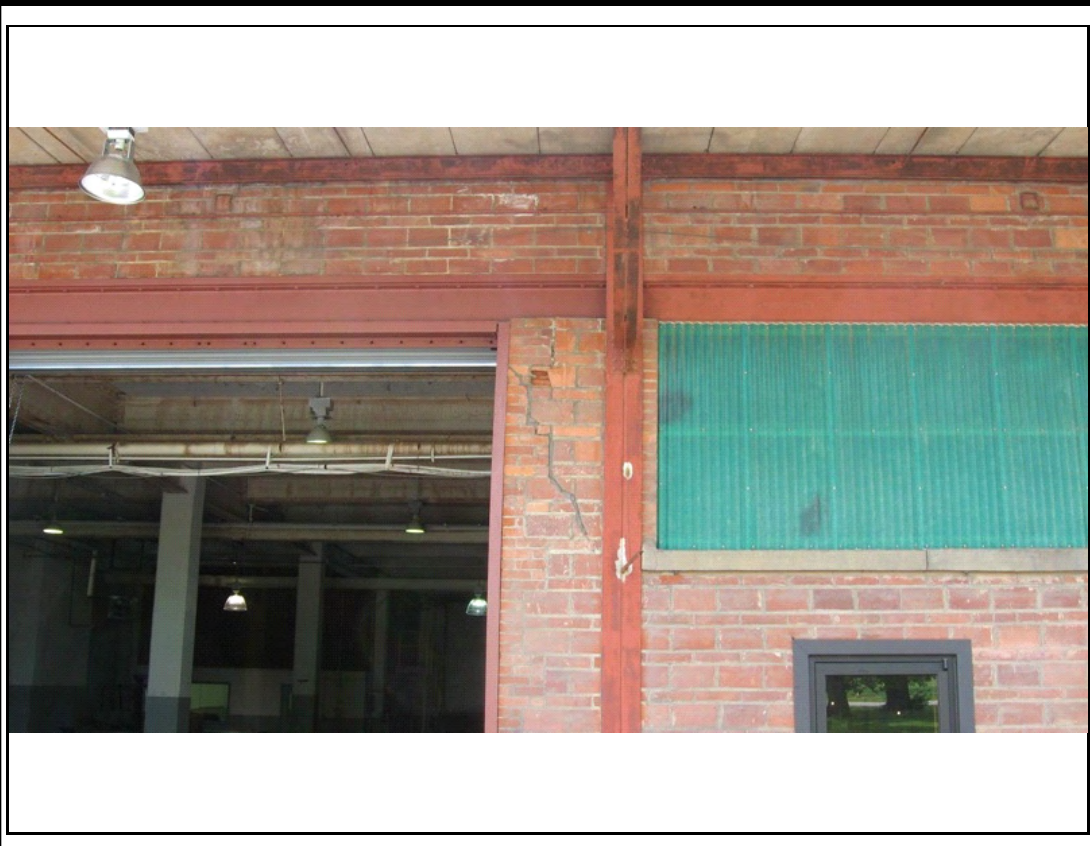
A photograph showing a close-up of a brick wall. A vertical crack is visible in the masonry, extending downwards from a horizontal concrete lintel. To the left, a doorway leads into a dark interior space. To the right, there is a green corrugated metal panel and a small window.	<p>Photograph #: 9</p> <p>Crack in exterior masonry below north canopy.</p>

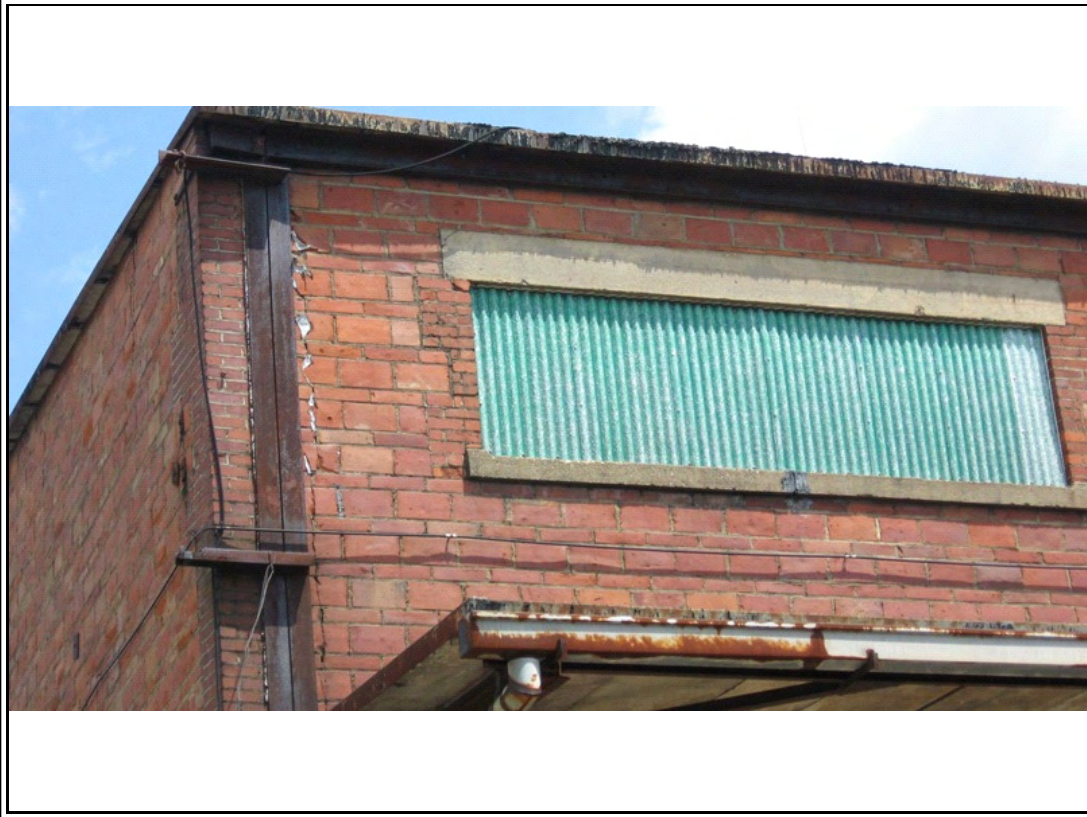
Photograph #: 14

Crack in exterior masonry on south side southwest corner.

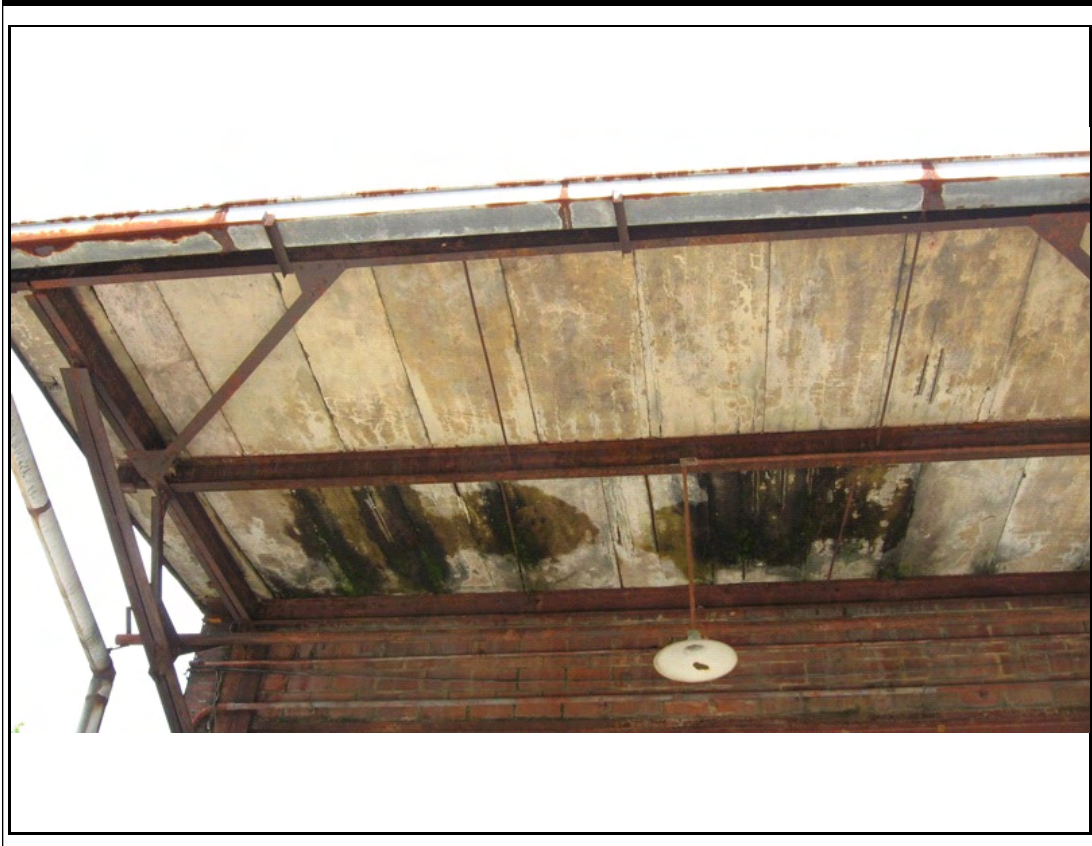
A photograph showing the interior of a building's south canopy. The view is looking up at the underside of the roof, which consists of several horizontal concrete planks. The concrete is heavily deteriorated, with large areas of peeling and crumbling, revealing a dark, possibly moldy or stained surface underneath. A single, small, white, circular light fixture is hanging from the center of the roof structure. The steel support beams are visible, showing signs of rust and wear.	<p>Photograph #: 15</p> <p>Deteriorated concrete roof planks at west end of south canopy.</p>
  A photograph showing another section of the south canopy's interior. The concrete planks are in a state of severe disrepair, with significant portions missing or crumbling away, exposing the underlying structure. The remaining concrete is discolored and stained. The steel beams supporting the roof are heavily rusted and show signs of structural wear. The overall condition appears to be one of significant neglect and decay.	<p>Photograph #: 16</p> <p>Ruined concrete roof planks at south canopy.</p>

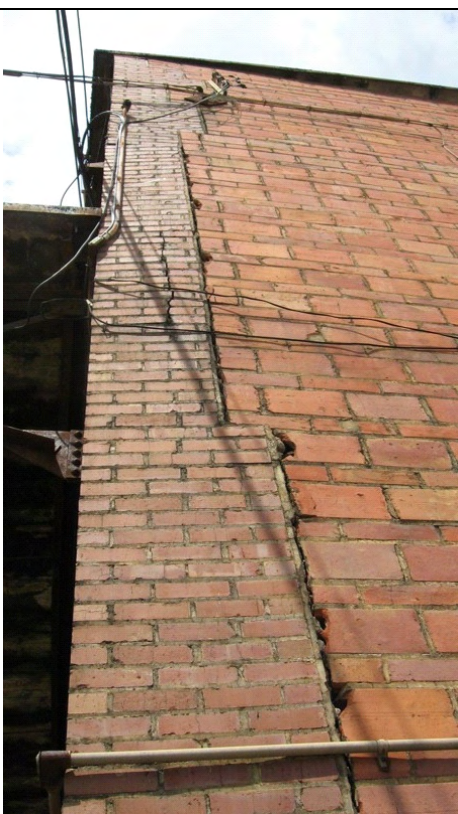
A close-up photograph of a brick wall. A prominent vertical crack runs down the center of the frame, passing through several courses of bricks. The bricks are reddish-brown and show signs of weathering. A metal railing is visible at the bottom of the frame.	<p>Photograph #: 22</p> <p>Vertical crack in masonry on east side of southeast corner.</p>

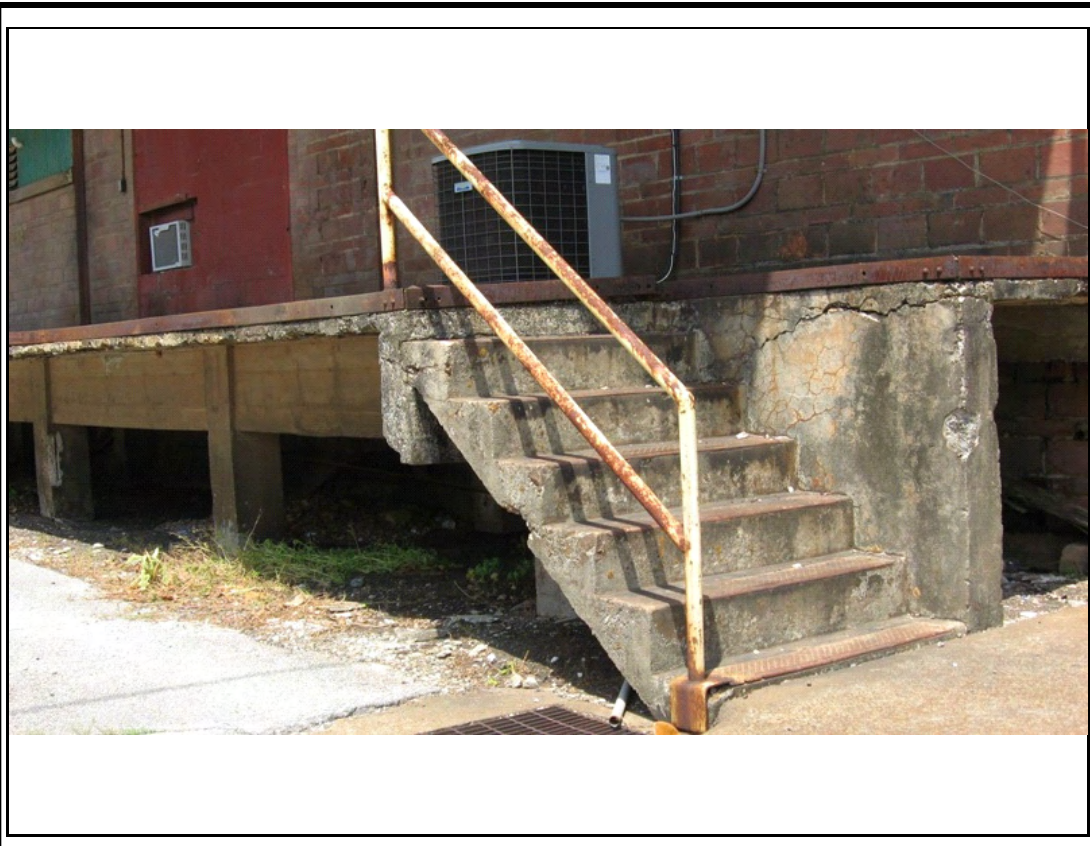
A photograph showing a set of concrete stairs leading up to a loading dock. The stairs are made of concrete and have a rusty metal handrail. The concrete appears aged and somewhat deteriorated. The loading dock is supported by a concrete wall. In the background, there is a brick building with a red door and some electrical equipment.	<p>Photograph #: 23</p> <p>Deteriorated concrete steps and support at east and south loading dock.</p>

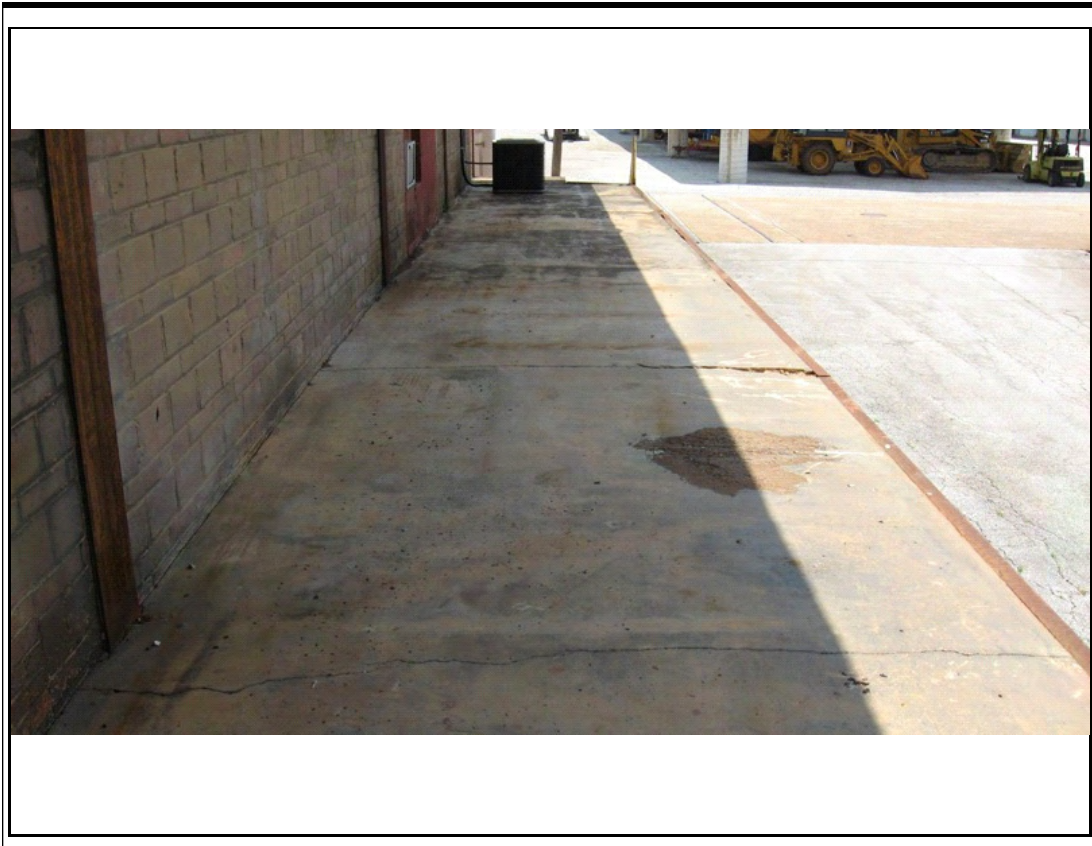
<p>Photograph #: 25</p> <p>Cracks in south loading deck slab.</p>

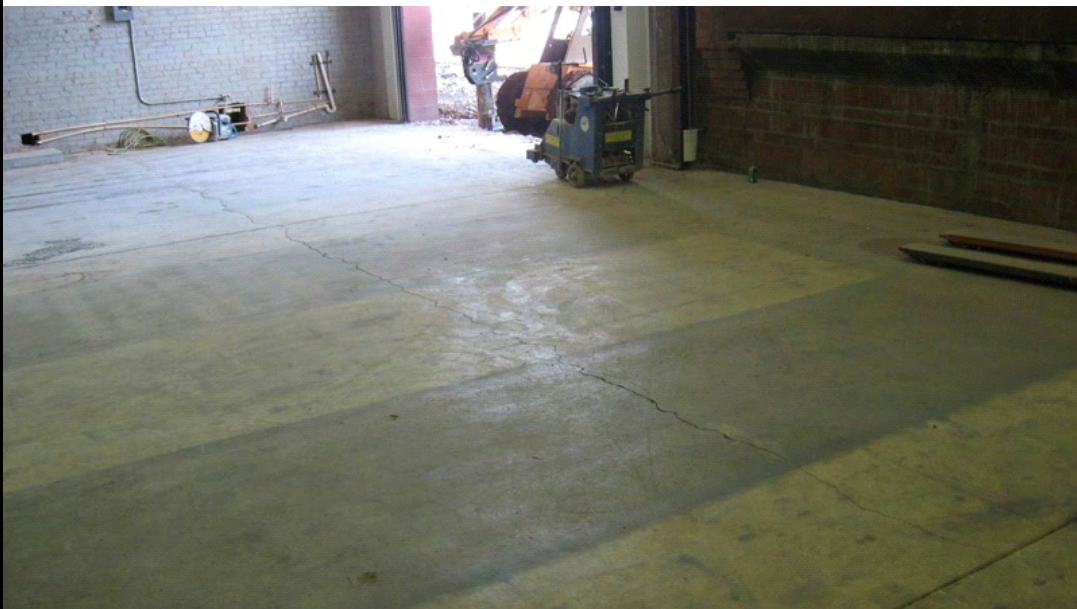
A photograph of a large, open interior space, likely a warehouse or workshop. The floor is made of concrete and shows a prominent crack running across the middle. In the background, there is a large open bay door, some construction equipment, and a brick wall.	<p>Photograph #: 28</p> <p>Crack in floor in northwest area of first level.</p>

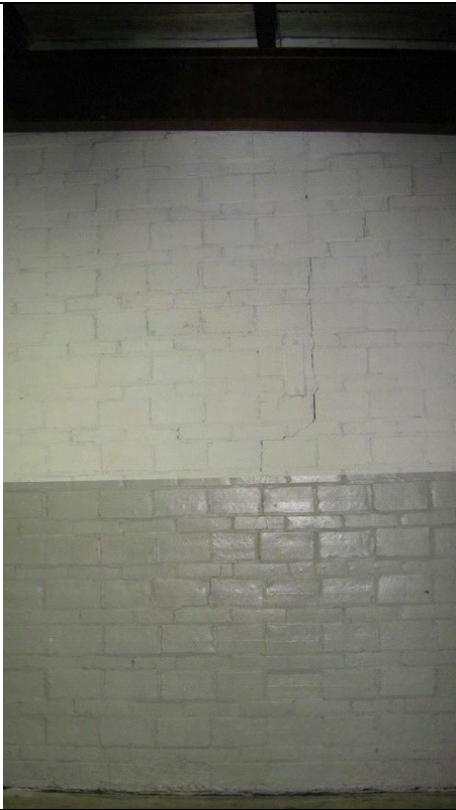
A photograph showing a vertical crack in a light-colored, textured interior wall. The crack runs from the ceiling down to the base of the wall. The wall has a masonry-like appearance with some horizontal lines.	<p>Photograph #: 37</p> <p>Interior crack in east wall.</p>

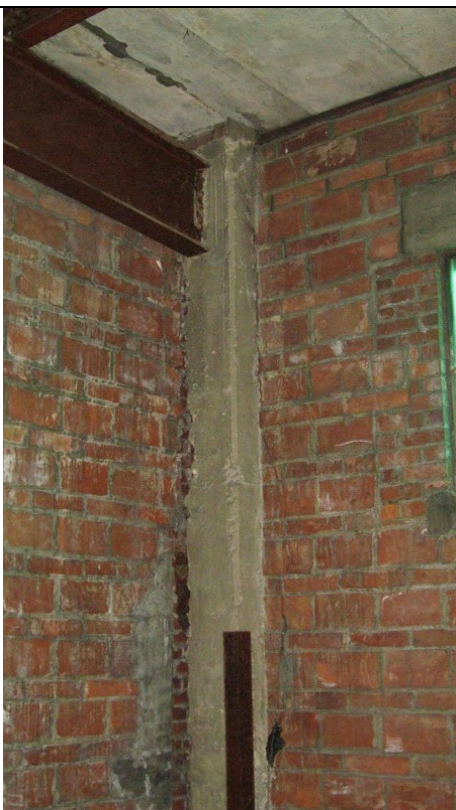
A photograph showing a corner of a room with red brick walls. A vertical concrete column is visible, and there is a significant crack or void at the top of the column where it meets the ceiling. The ceiling is made of concrete with some exposed rebar.	<p>Photograph #: 38</p> <p>Interior crack/void at column and wall at northwest corner.</p>

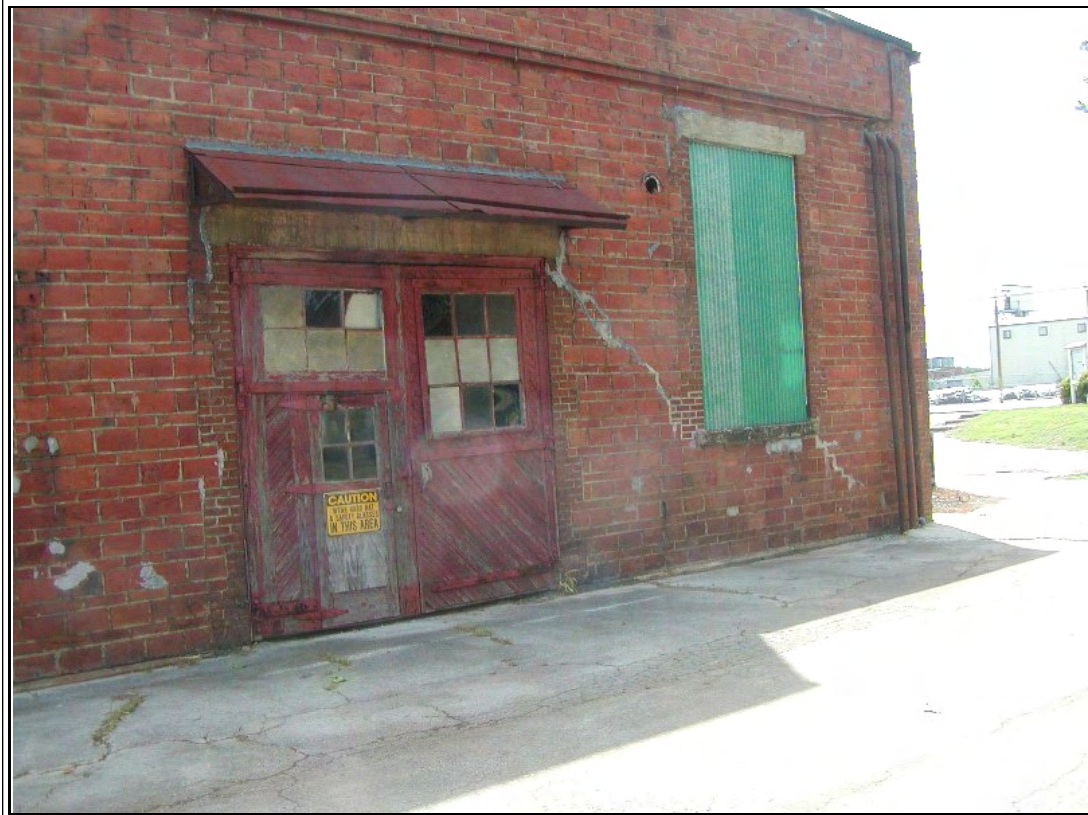
Photograph #: 4
Cracks in masonry south end of west wall

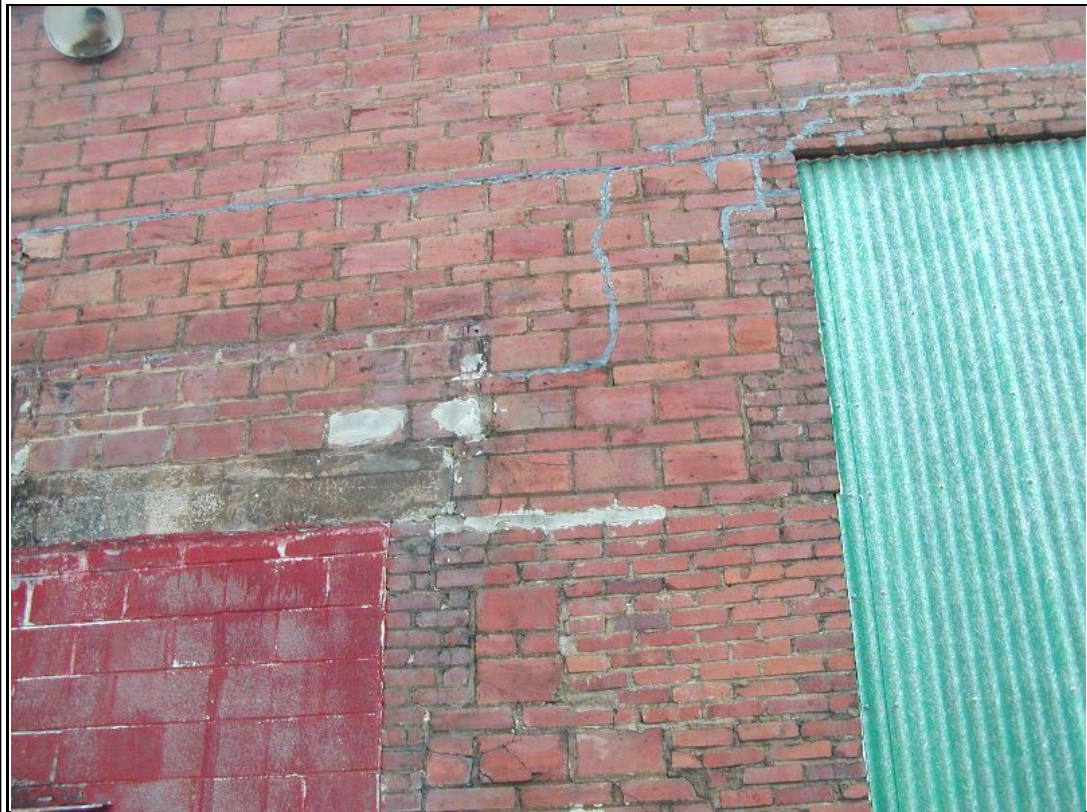
Photograph #: 7

Cracks in masonry in south wall

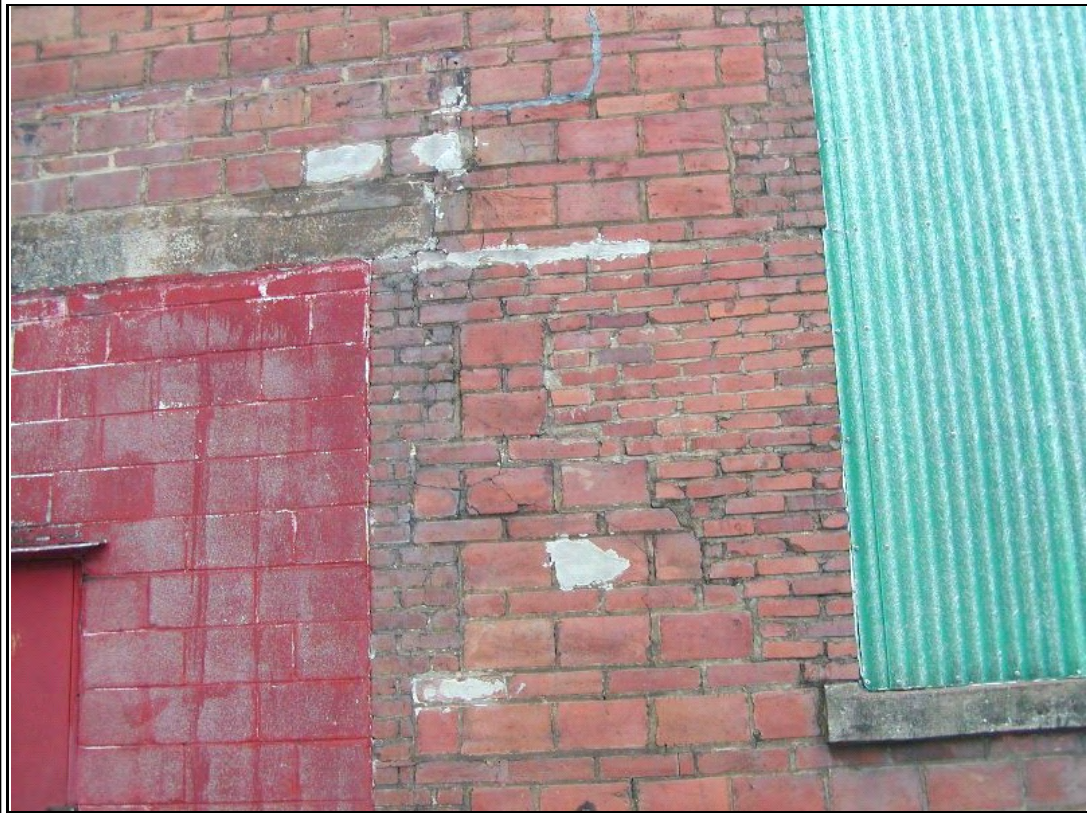
Photograph #: 8

Cracks in masonry (same location as Photo No. 7)

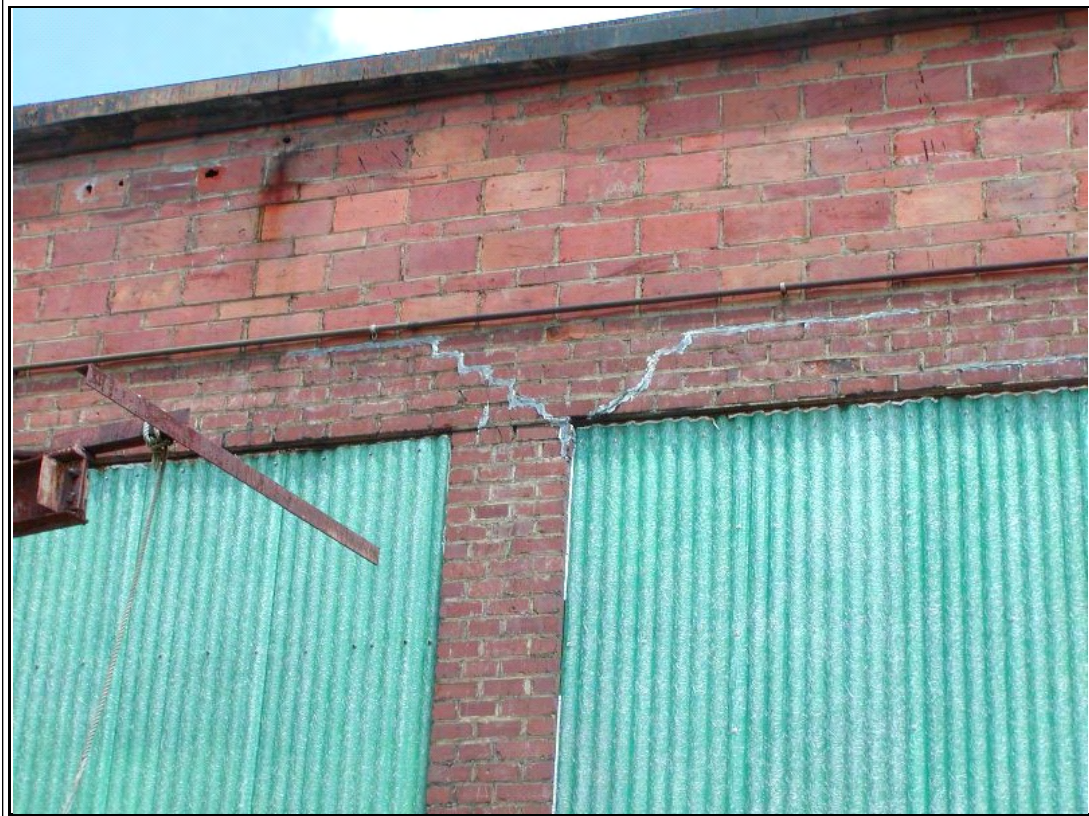
Photograph #: 9

Cracks in masonry lintels
at south wall

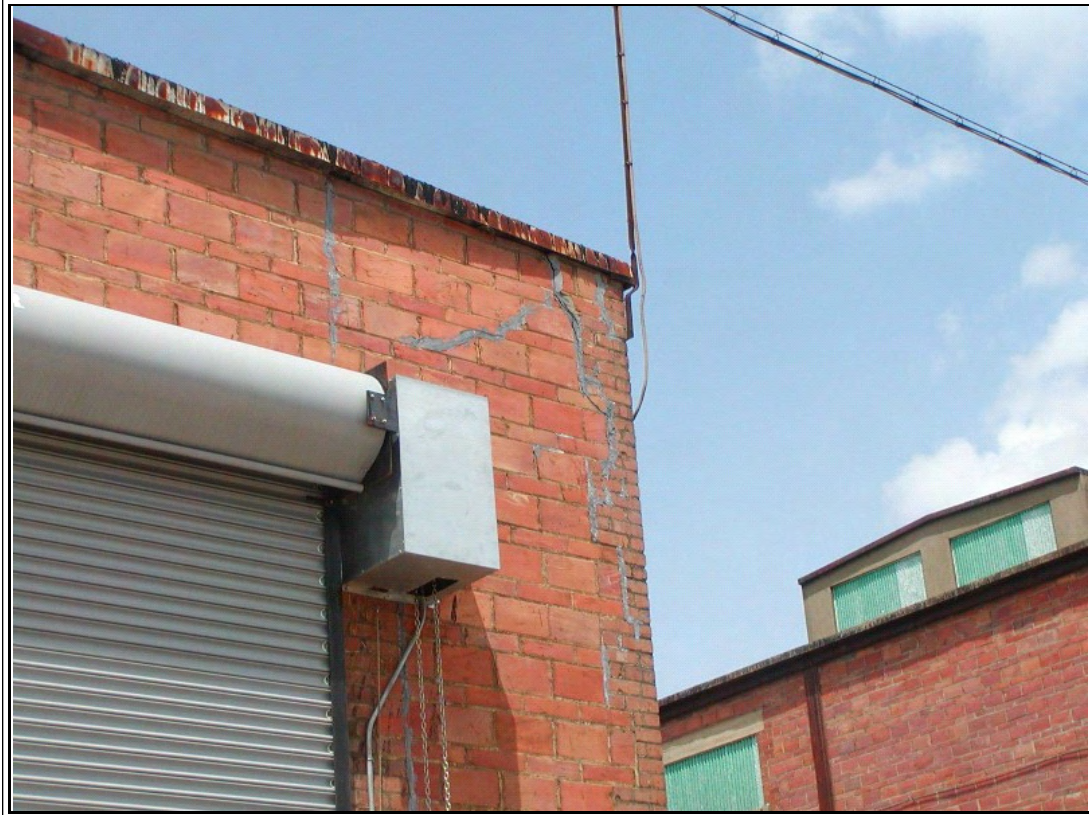
Photograph #: 10

Cracks in masonry north
end of east wall

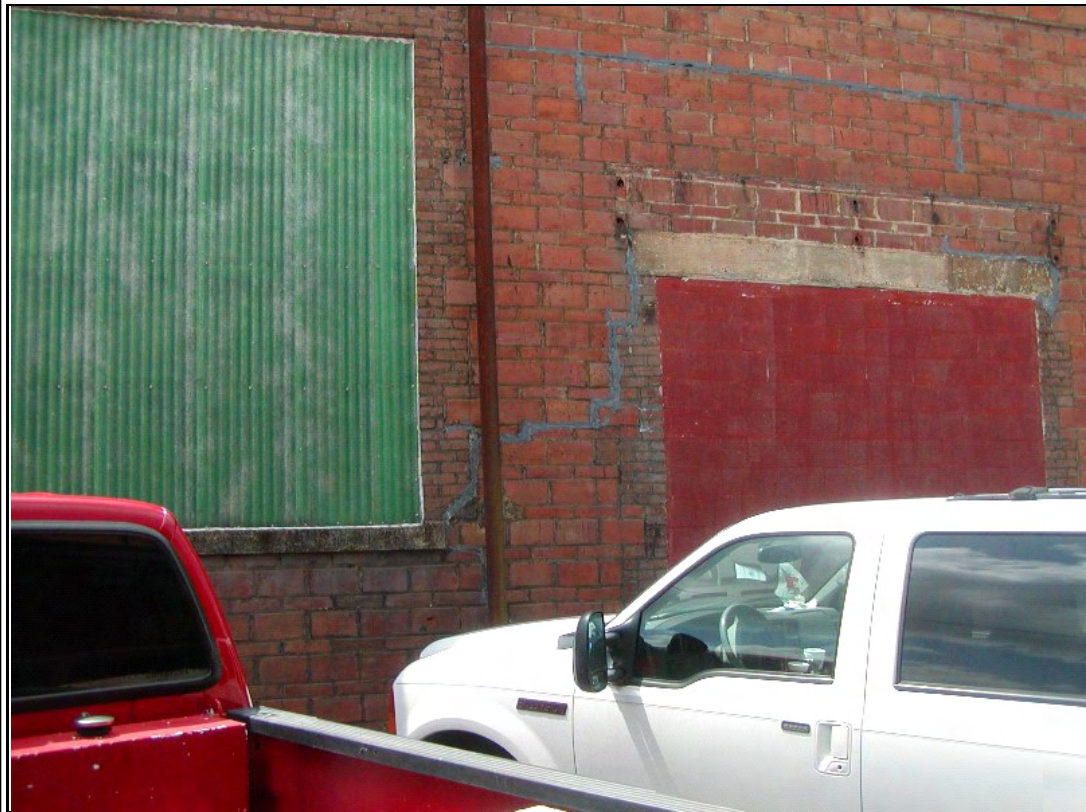
Photograph #: 11

Cracks in masonry at north wall

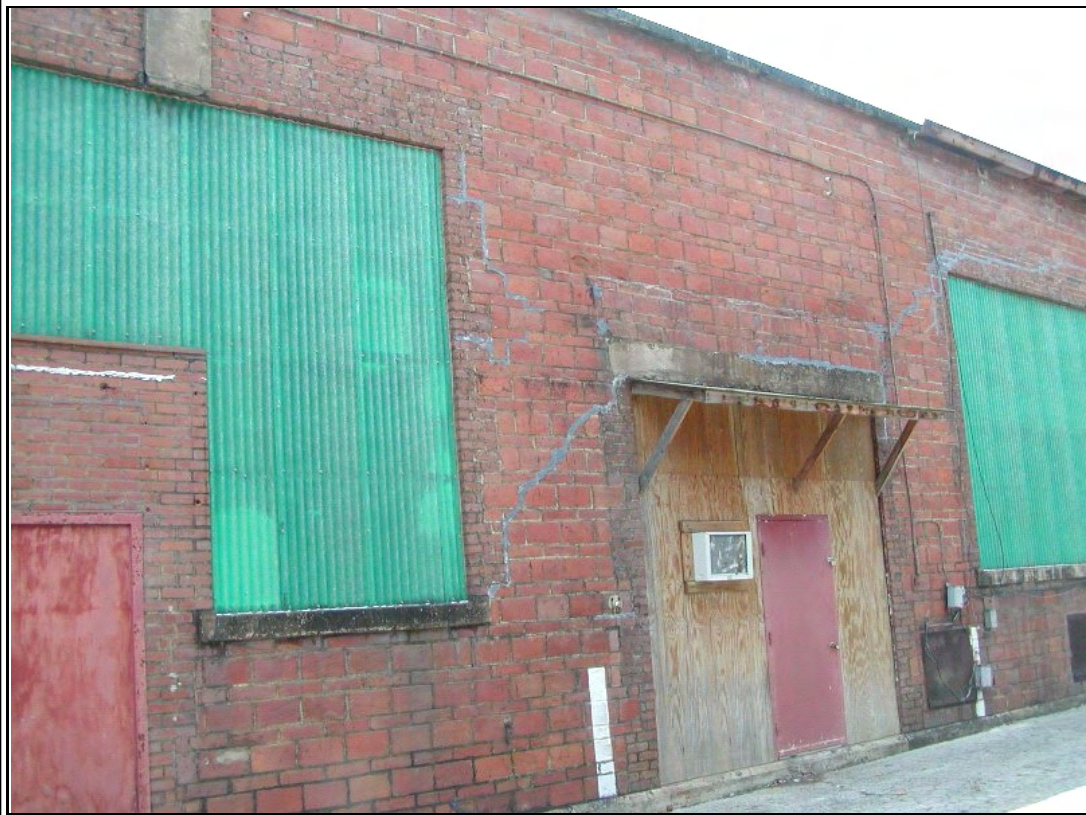
Photograph #: 12

Cracks in masonry at north wall

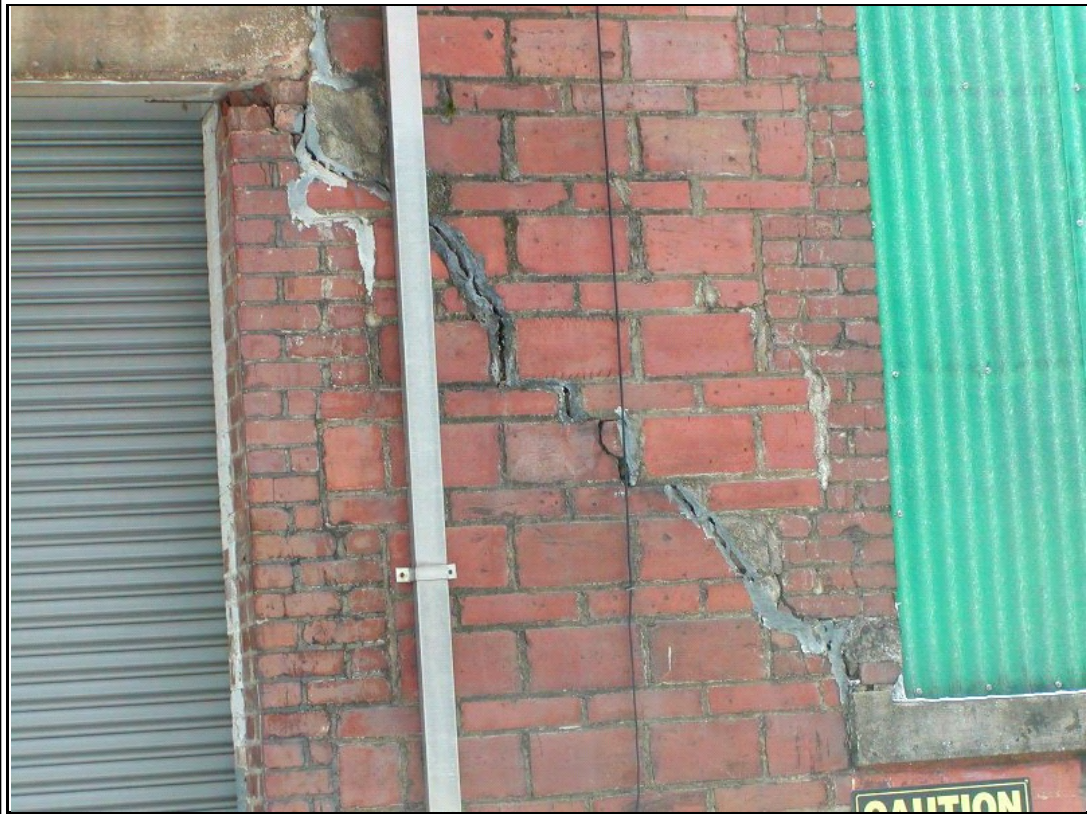
Photograph #: 13

Crack in masonry at north wall

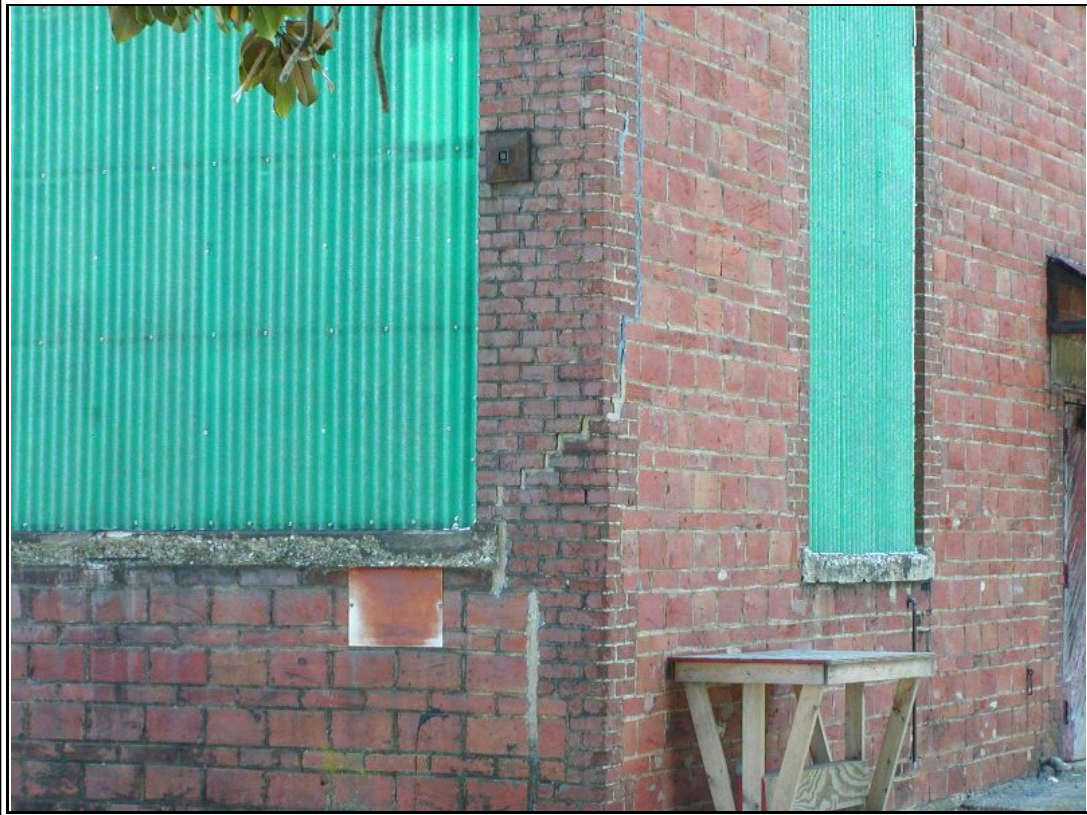
Photograph #: 14

Cracks in masonry at northwest corner
