Structural Assessment

Muscle Shoals Reservation
adaptive re-use study

Conditions/Market/Planning/Implementation

July 31, 2009
Revised August 25, 2009

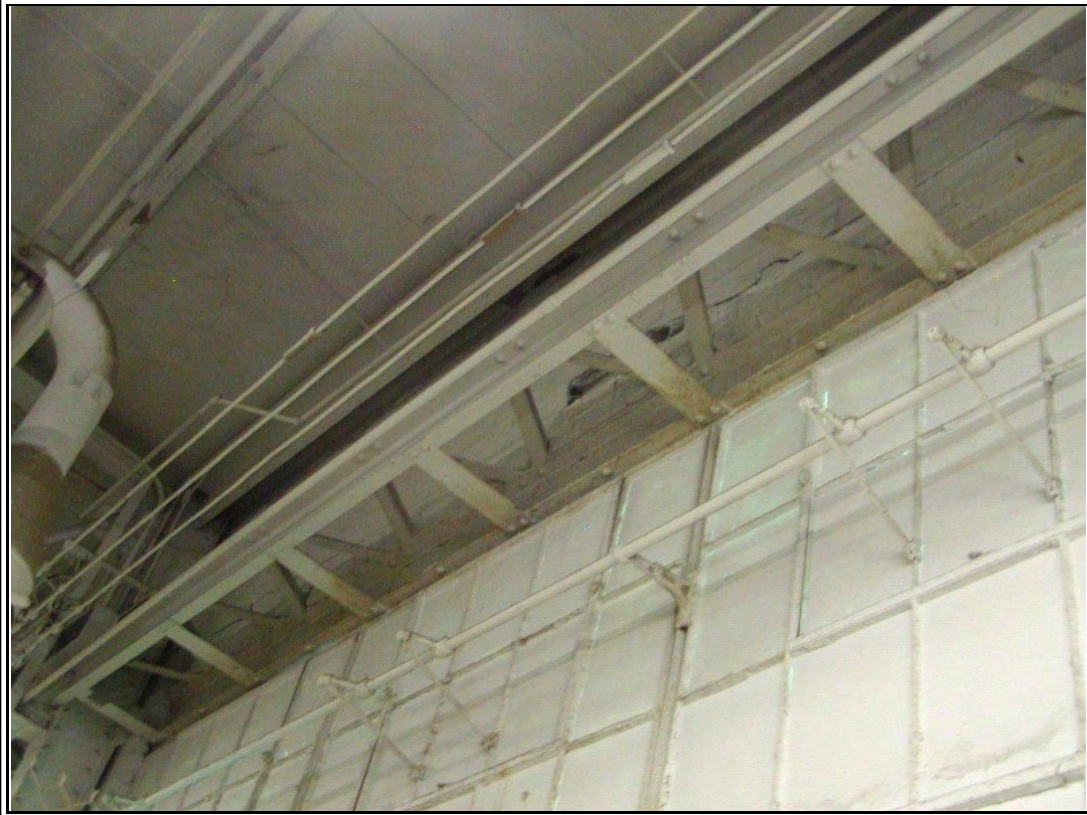
Photograph #: 18

Crack and spall in concrete plank roof deck

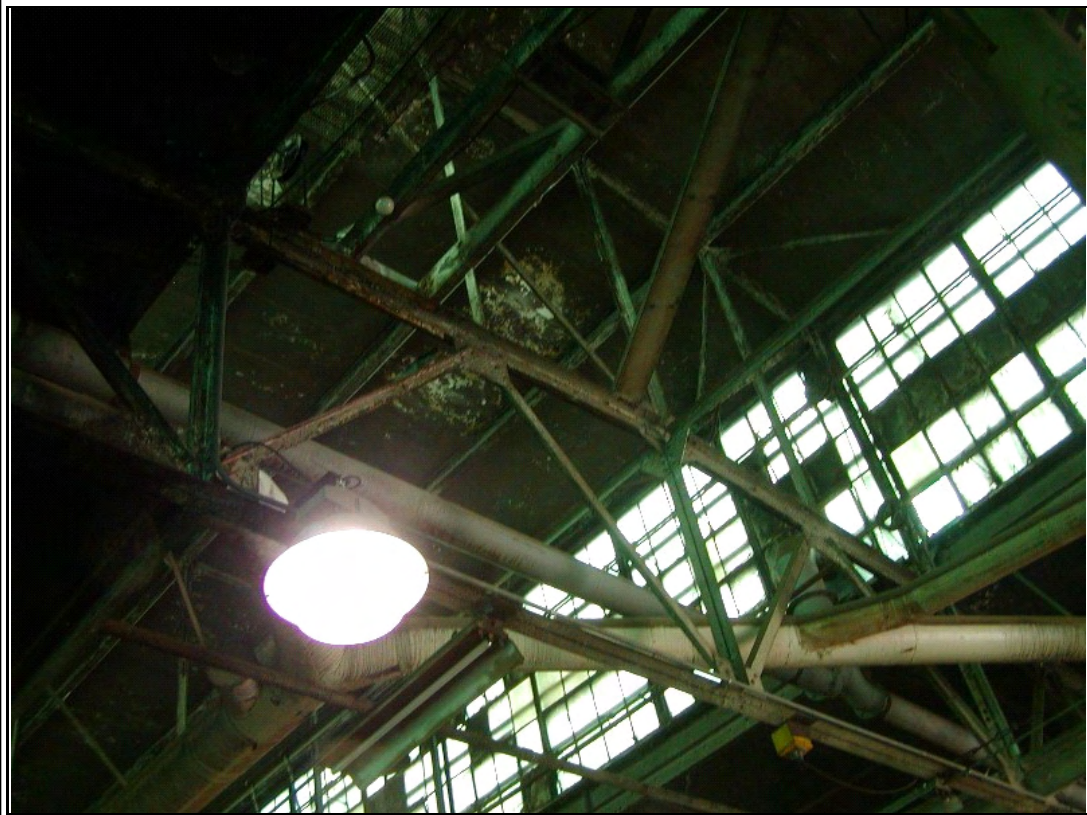
Photograph #: 20

Deteriorated concrete plank roof deck at monitor

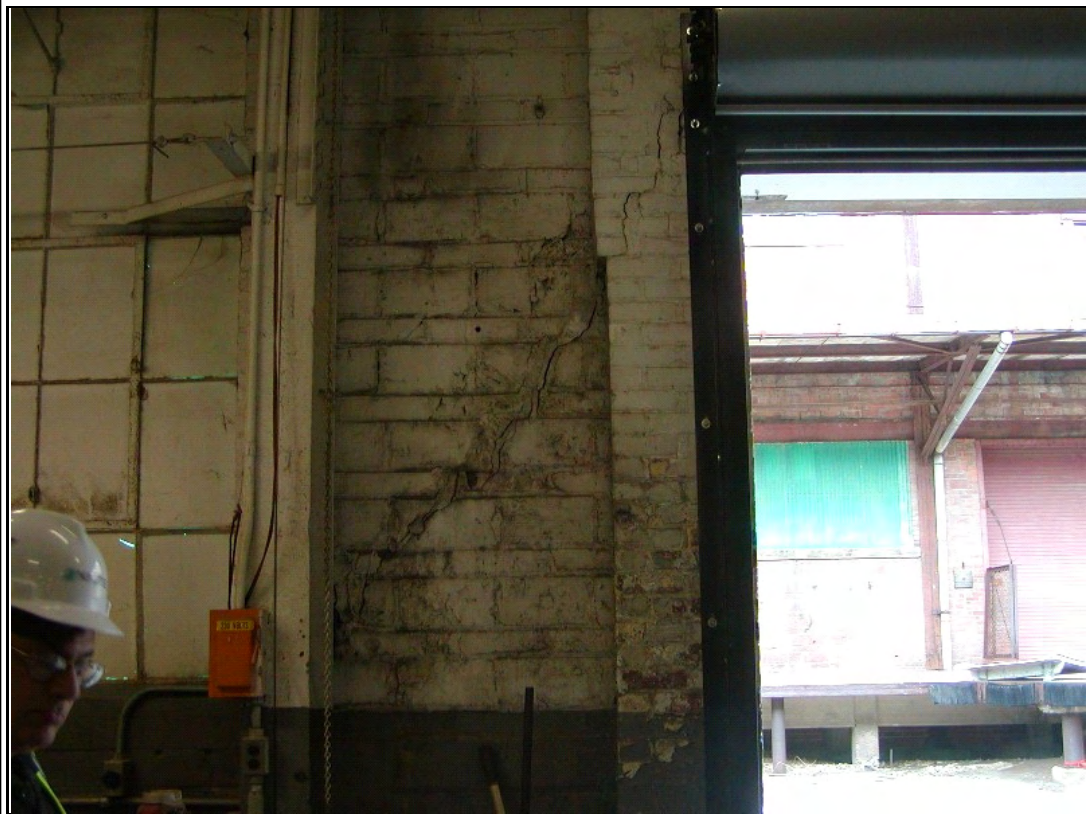
Photograph #: 21

Diagonal crack in masonry
at north wall

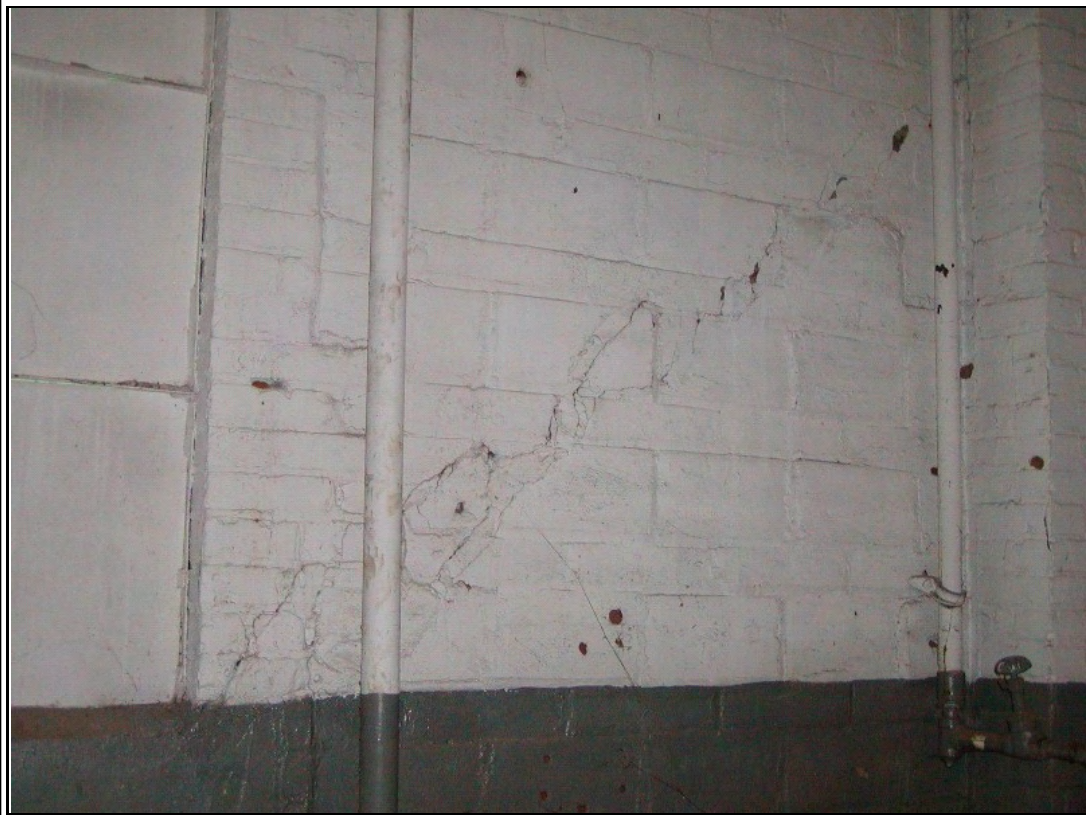
Photograph #: 22

Diagonal crack in masonry
at west wall

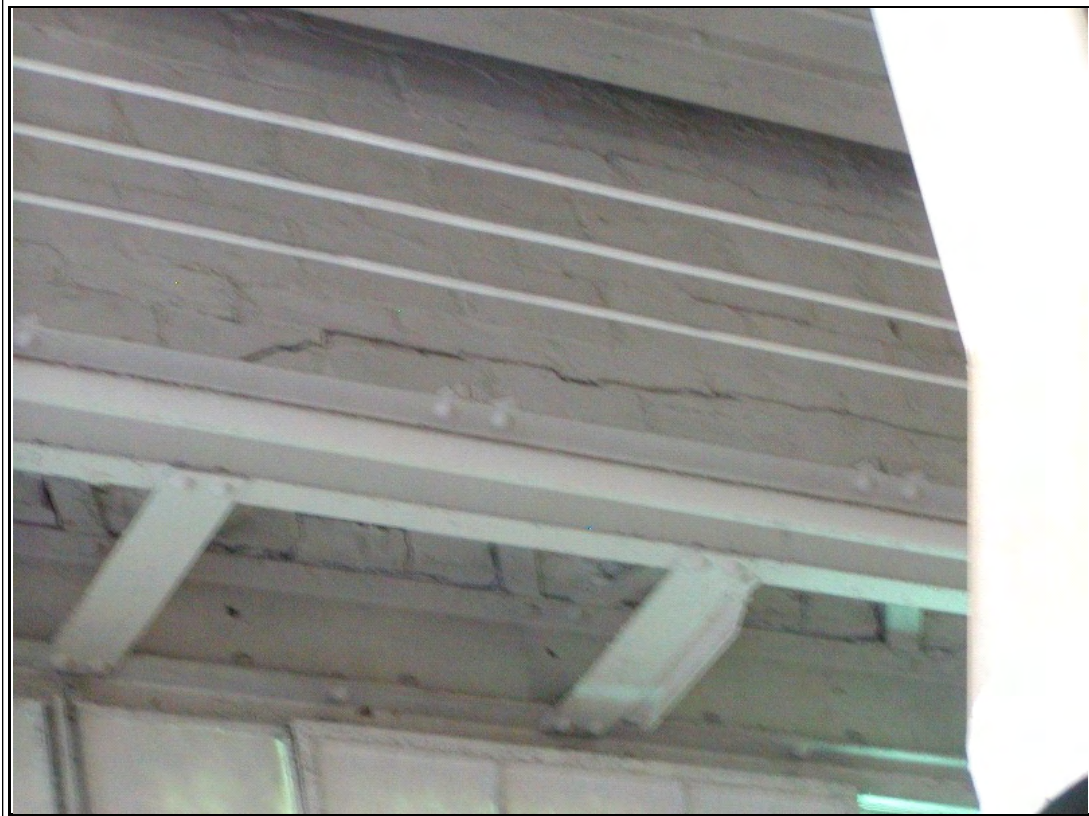
Photograph #: 25

Horizontal crack in masonry at south wall

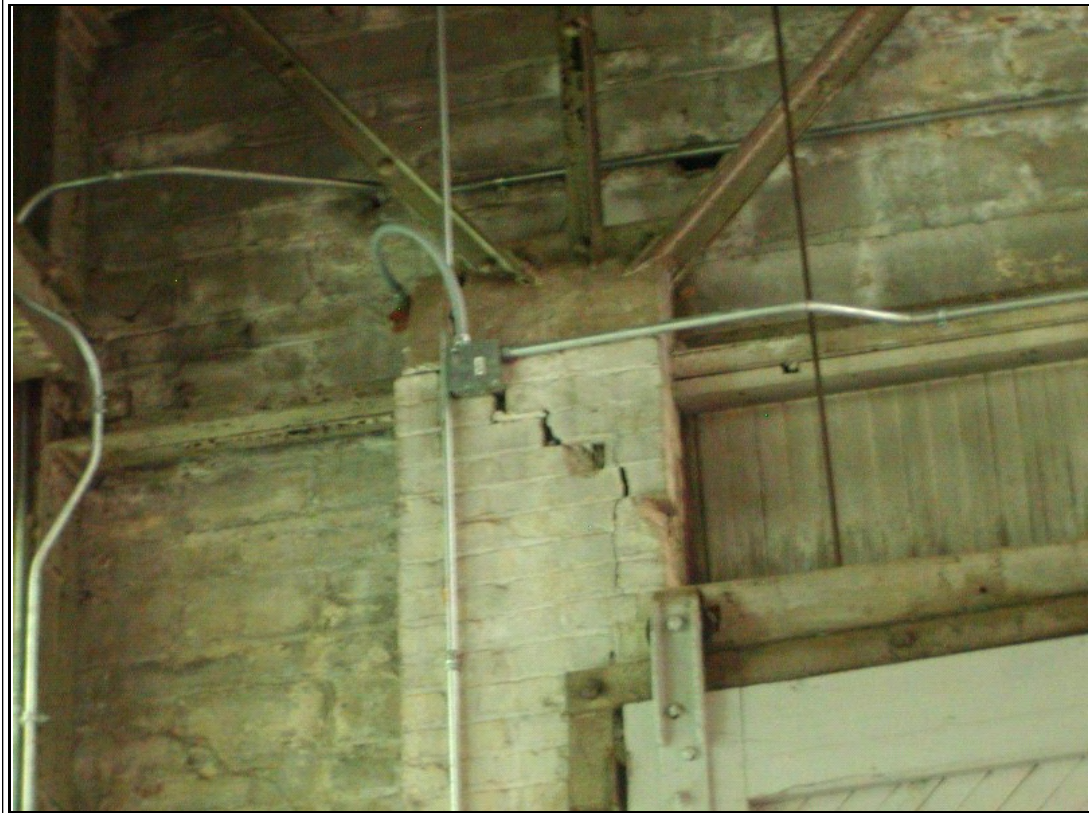
Photograph #: 26

Cracked and partially dislodged masonry at northeast corner

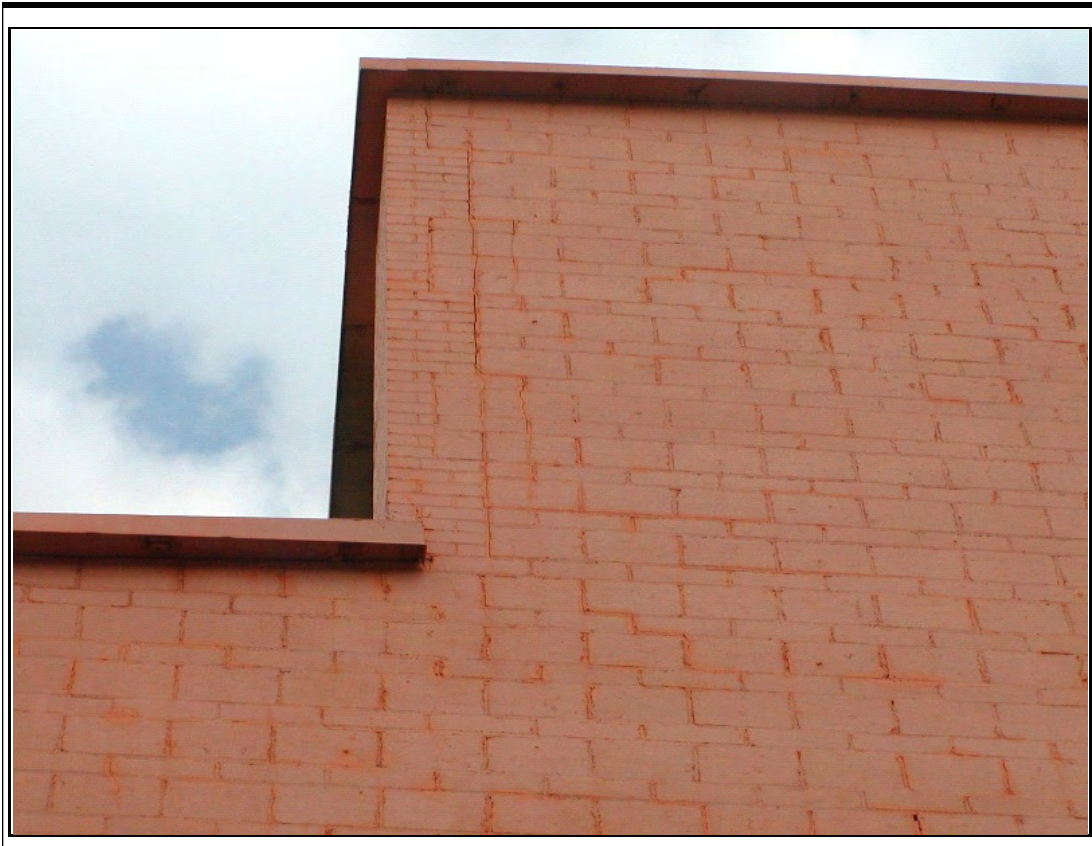
<p>Photograph #: 5</p> <p>Crack in masonry at end wall east side</p>

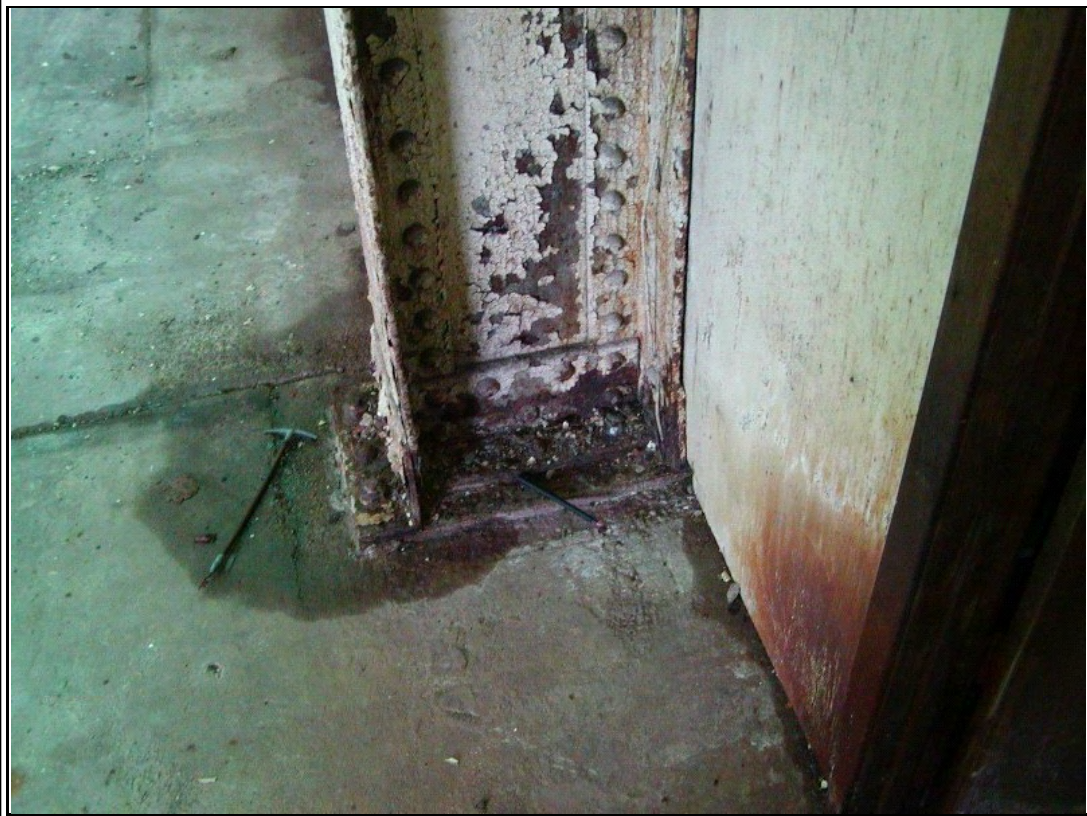
Photograph #: 13

Corroded steel column
north side of main building

Summary of Recommended Structural Repairs:	The steel framing must be sandblasted and painted. Cracks on the masonry walls must be repaired. The second floor structure must be repaired.
Additional Recommendations:	A detailed evaluation of the second floor deck will be required to determine the extent of repairs and/or replacement required.

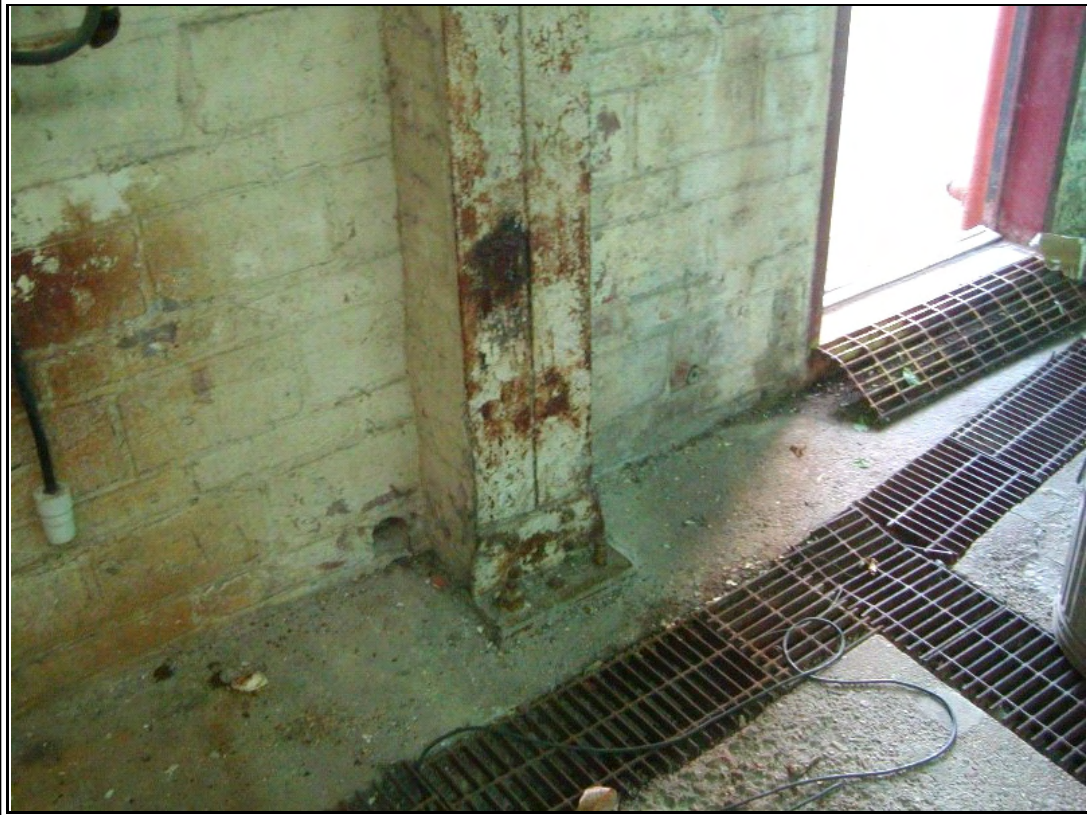
Photograph #: 14

Corroded steel column and
deteriorated steel trench
grates at south side of main
building

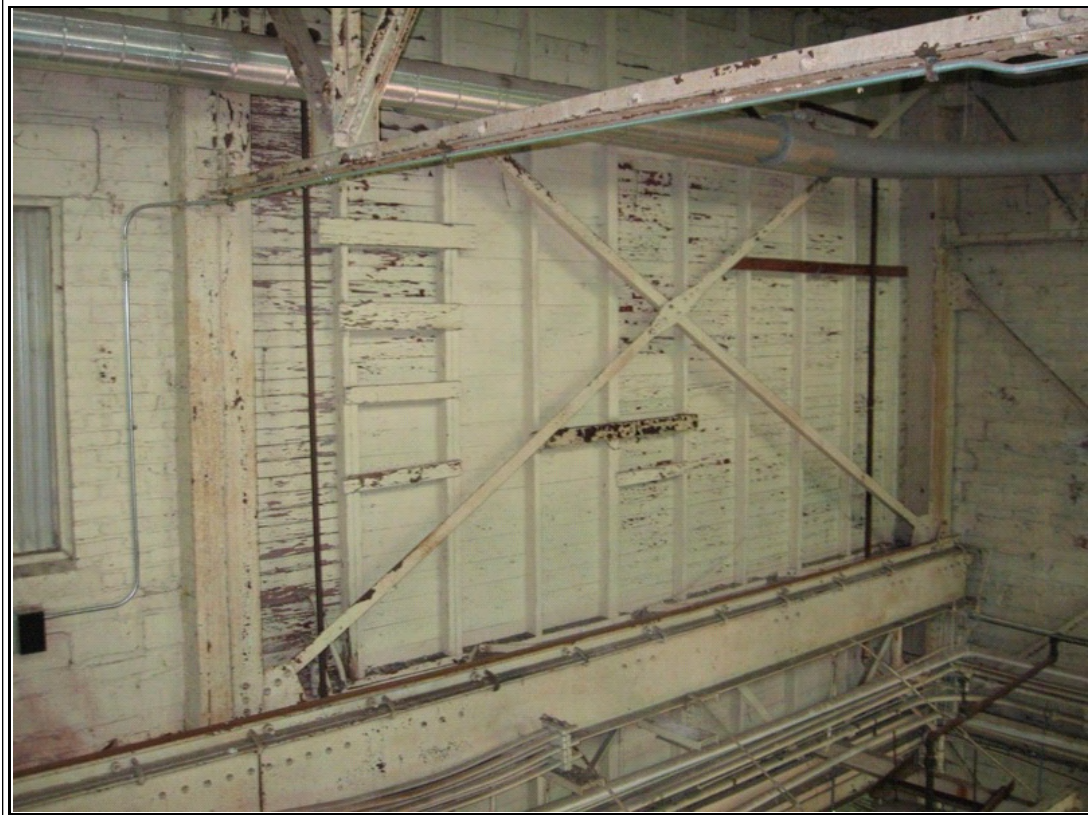
Photograph #: 18

Wood frame interior wall at second floor

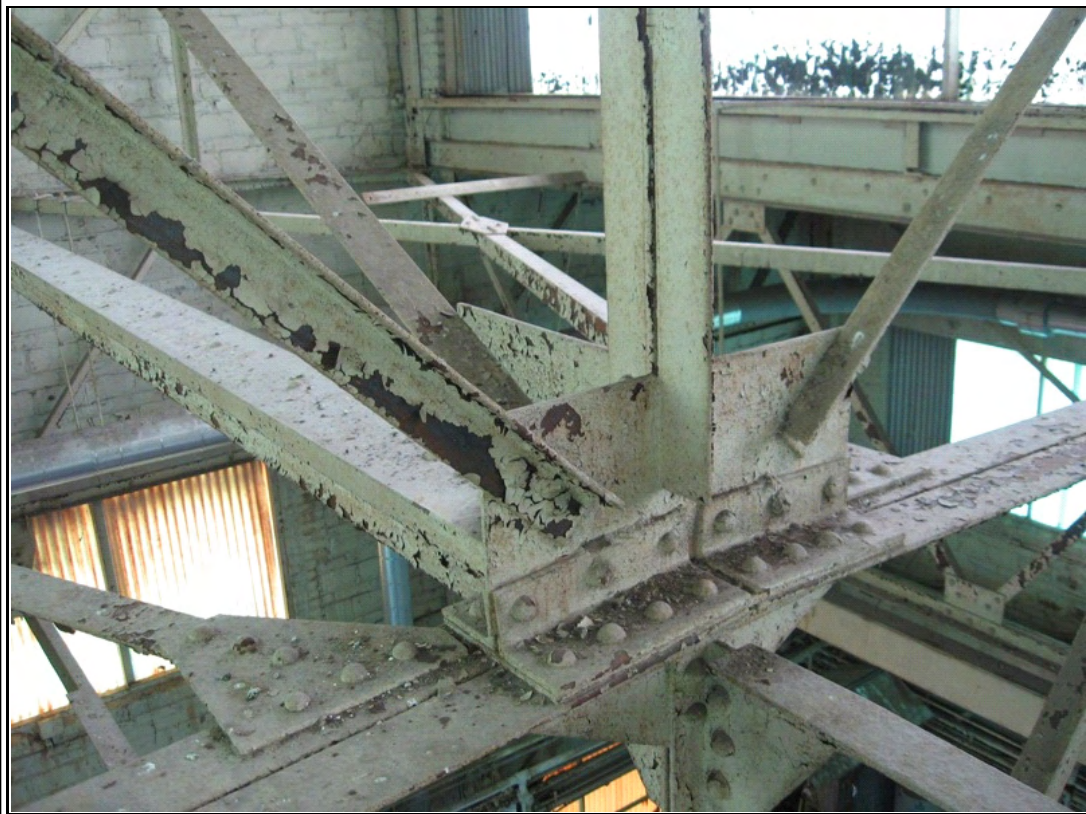
Photograph #: 19

Flaking paint at corroded steel roof framing

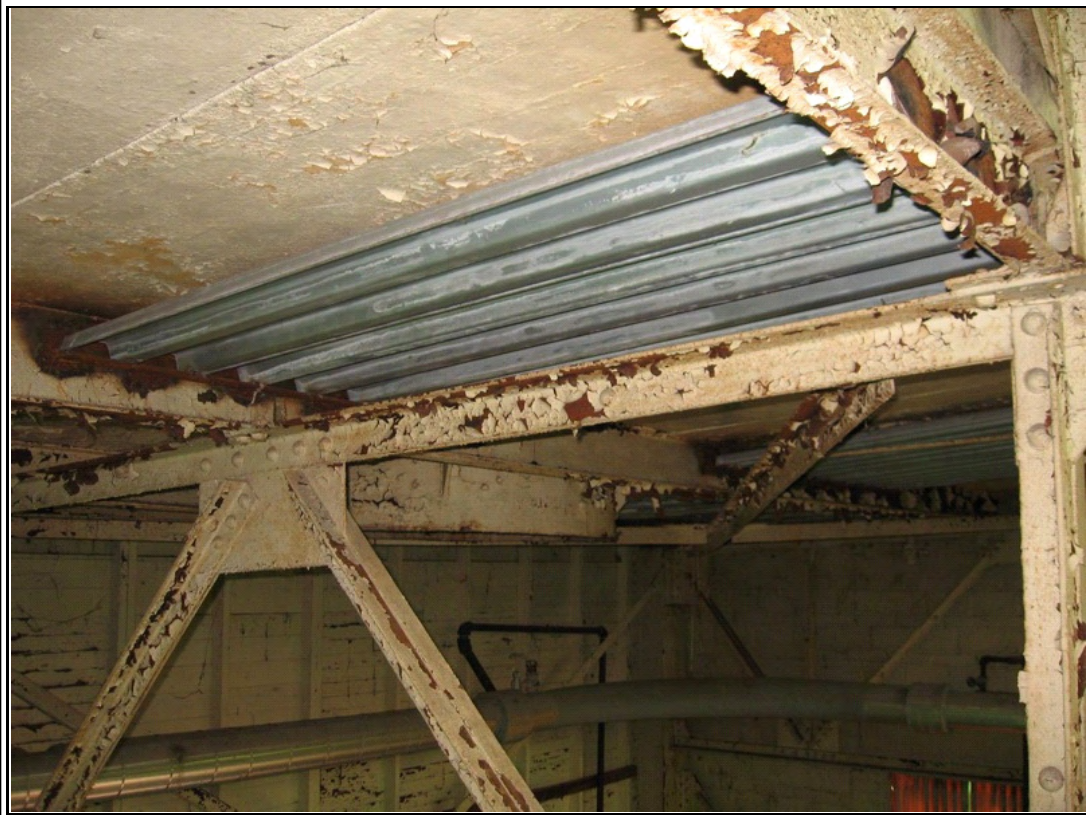
Photograph #: 20

Flaking paint at corroded steel roof framing

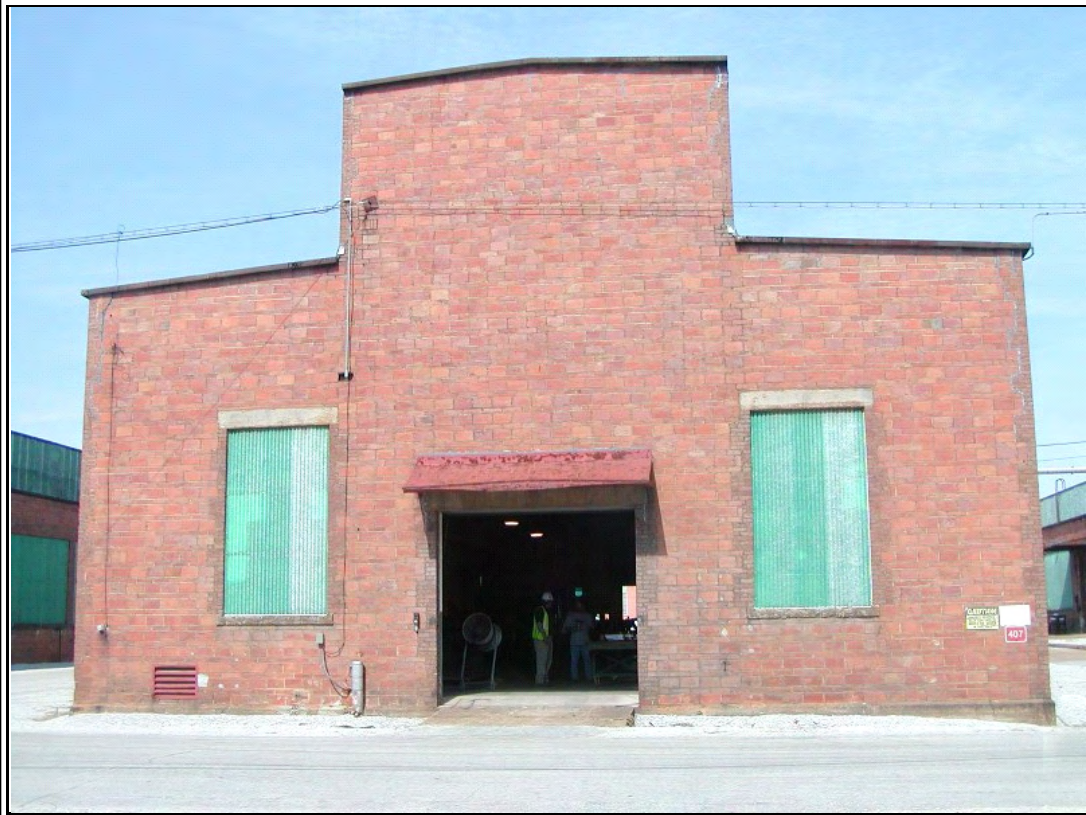
Photograph #: 1

Exterior of building - east elevation

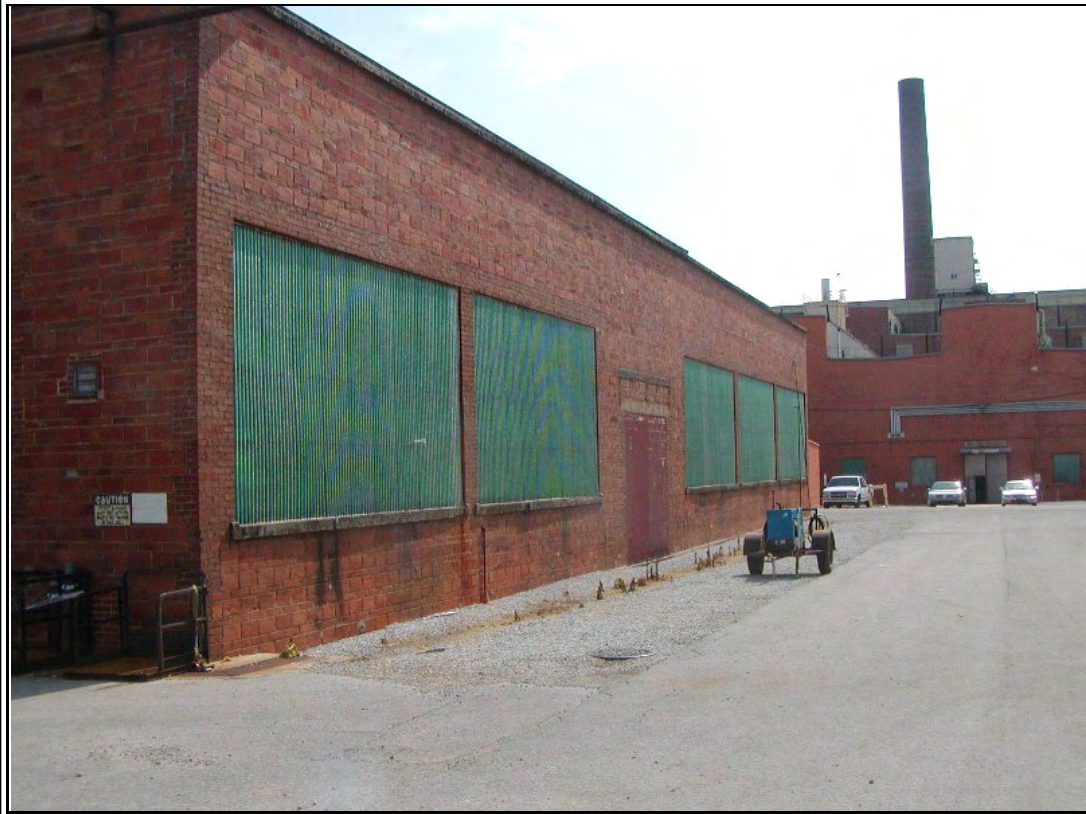
Photograph #: 2

Exterior of building - south elevation

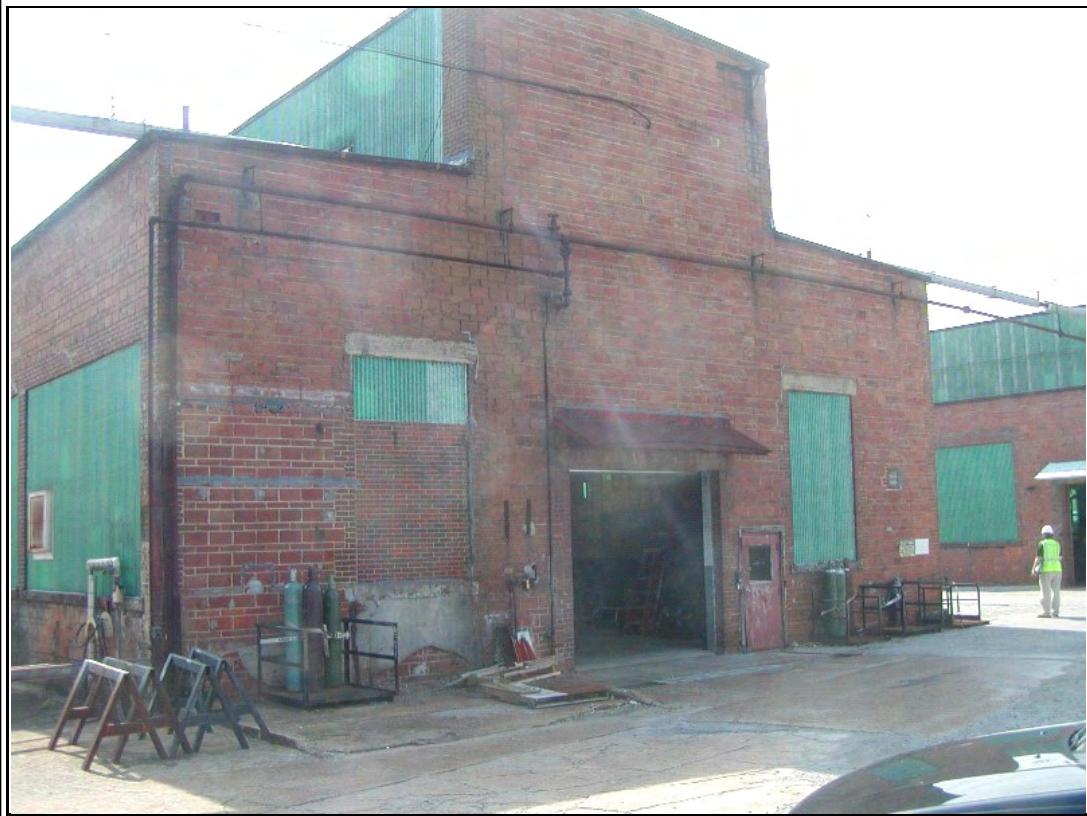
Photograph #: 3

Exterior of building - west elevation

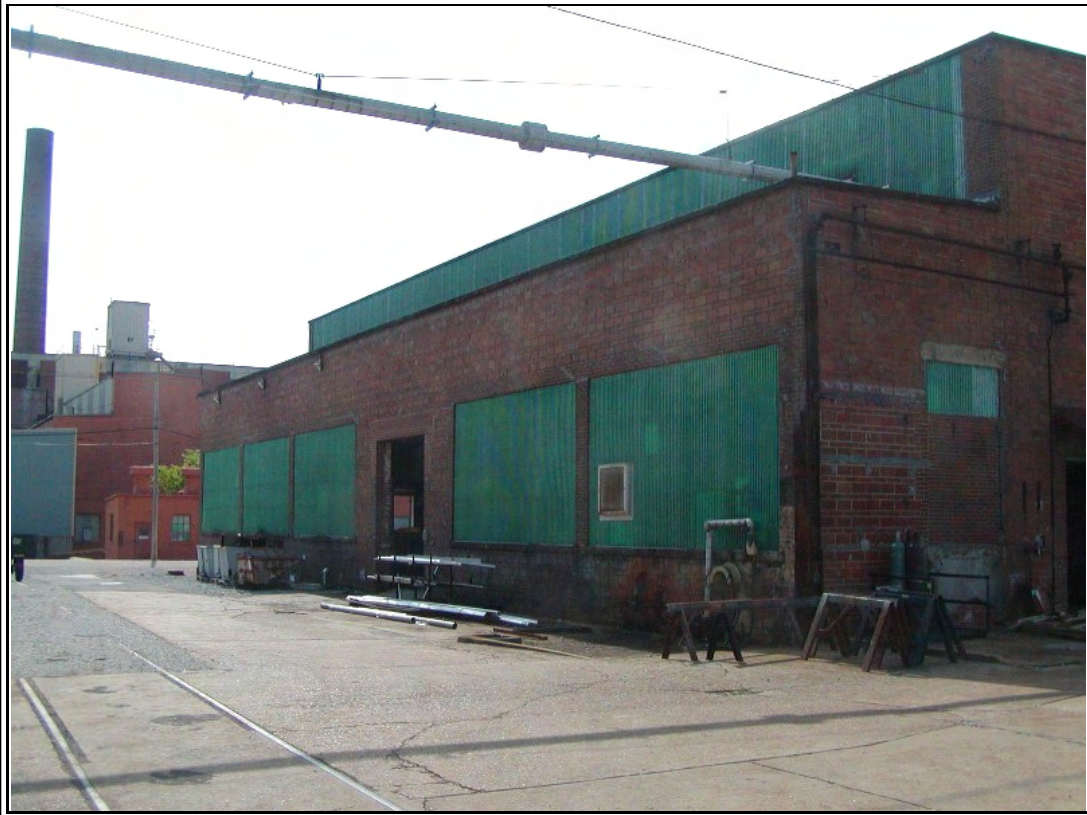
Photograph #: 4

Exterior of building looking at north elevation

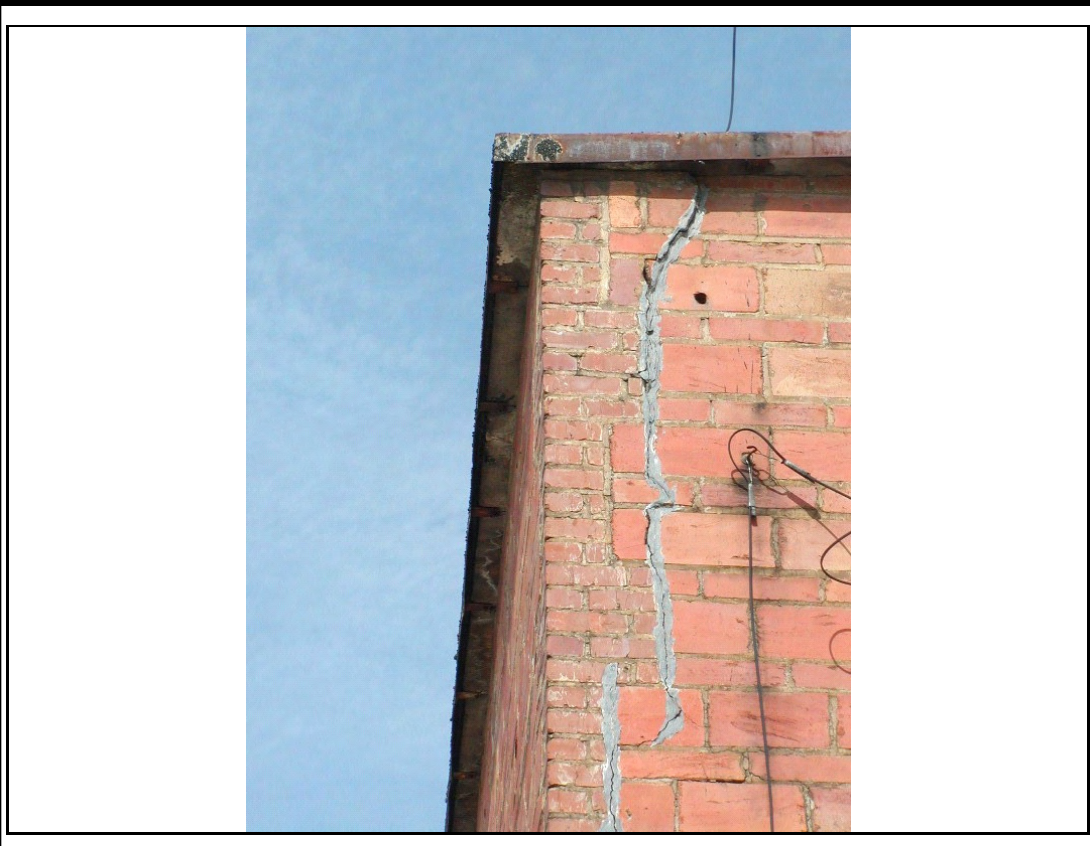
<p>Photograph #: 5</p> <p>Cracked and partially dislodged masonry at southeast corner</p>

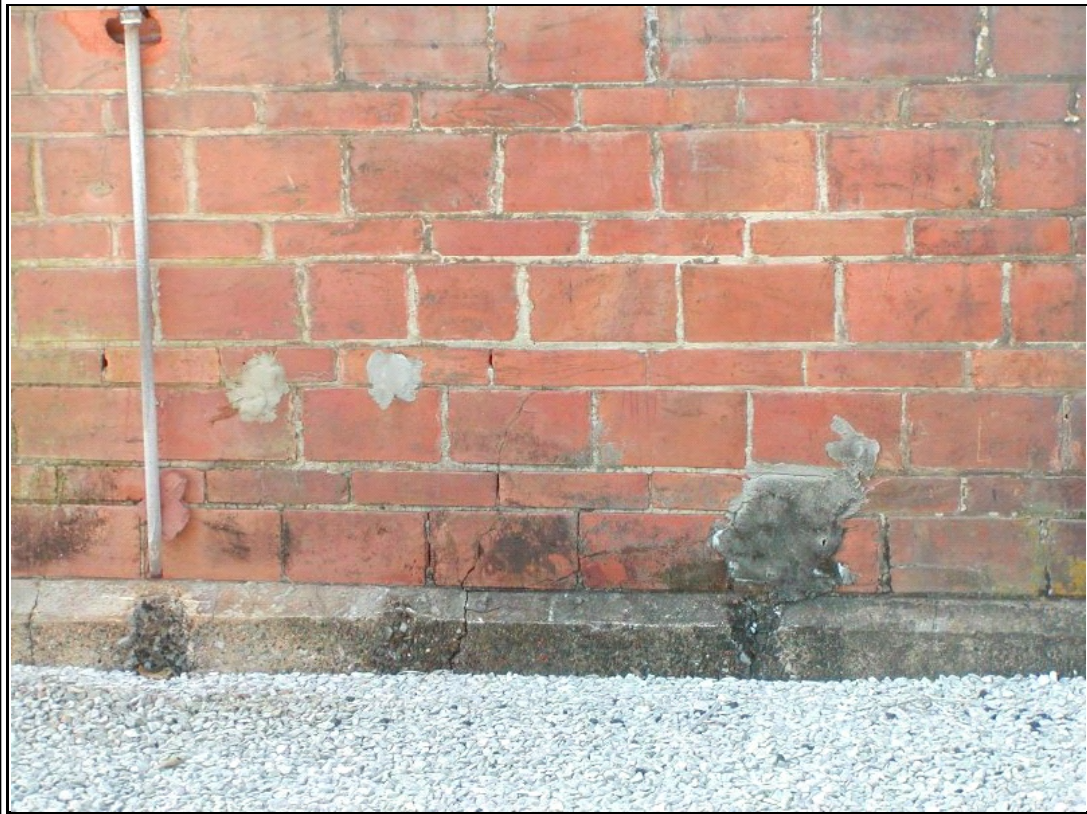
Photograph #: 9

Cracks in masonry and exposed slab edge on north side

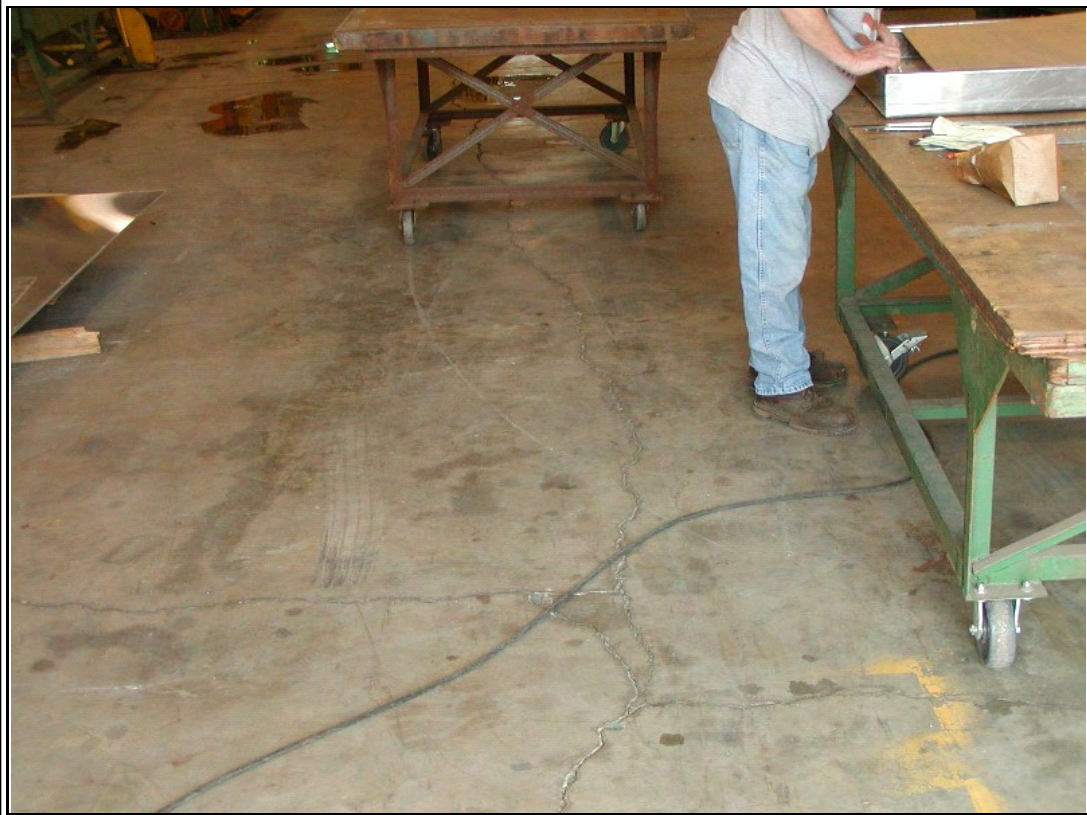
Photograph #: 10

Large cracks in concrete floor slab

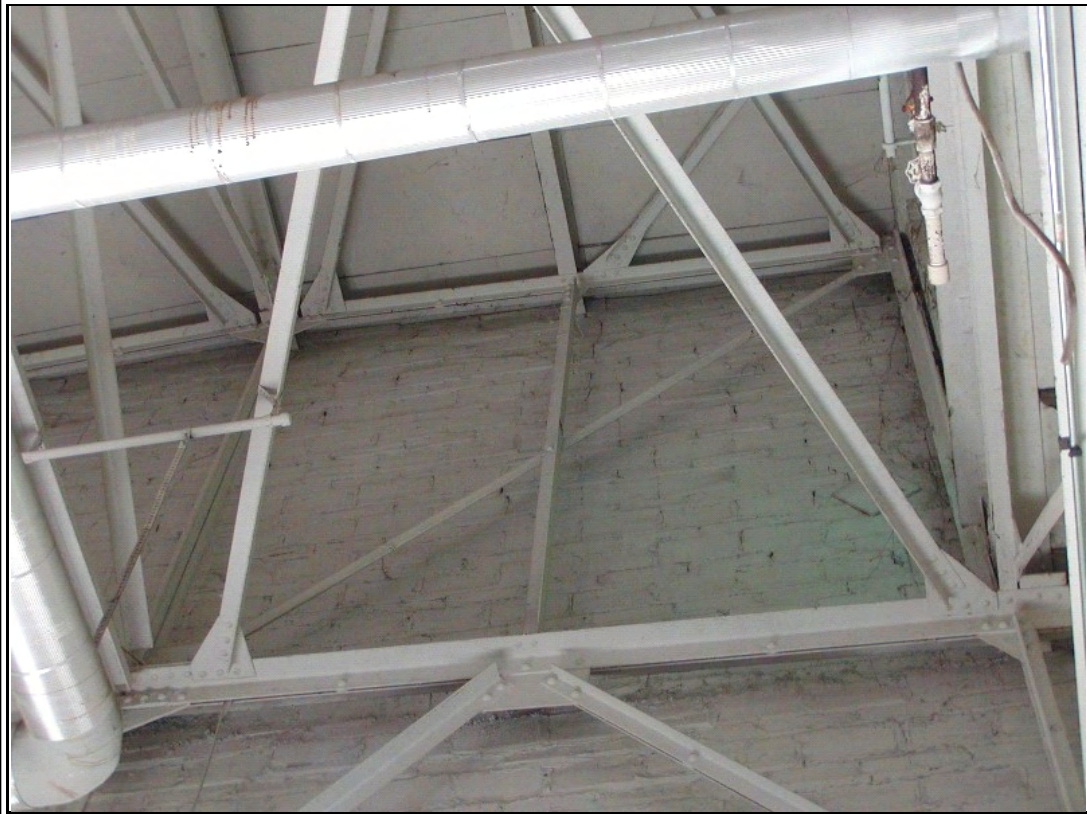
Photograph #: 11

Roof framing at east end wall

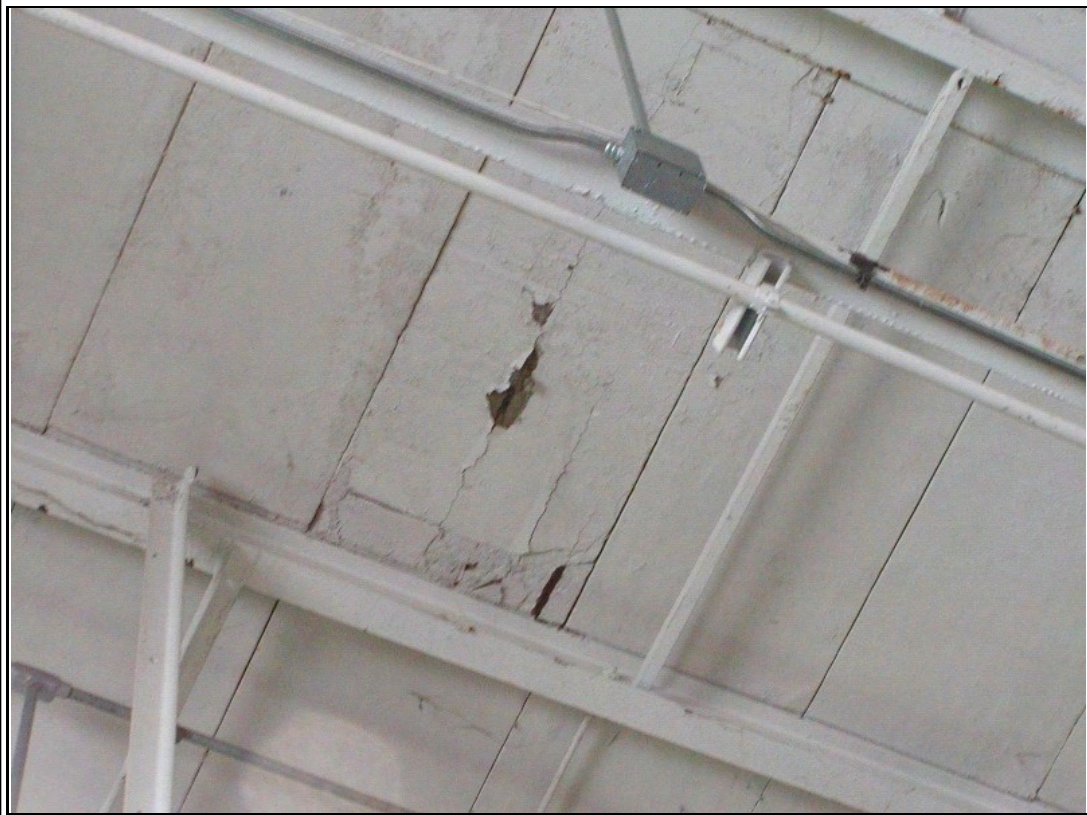
Photograph #: 12

Structurally defective concrete roof deck panel

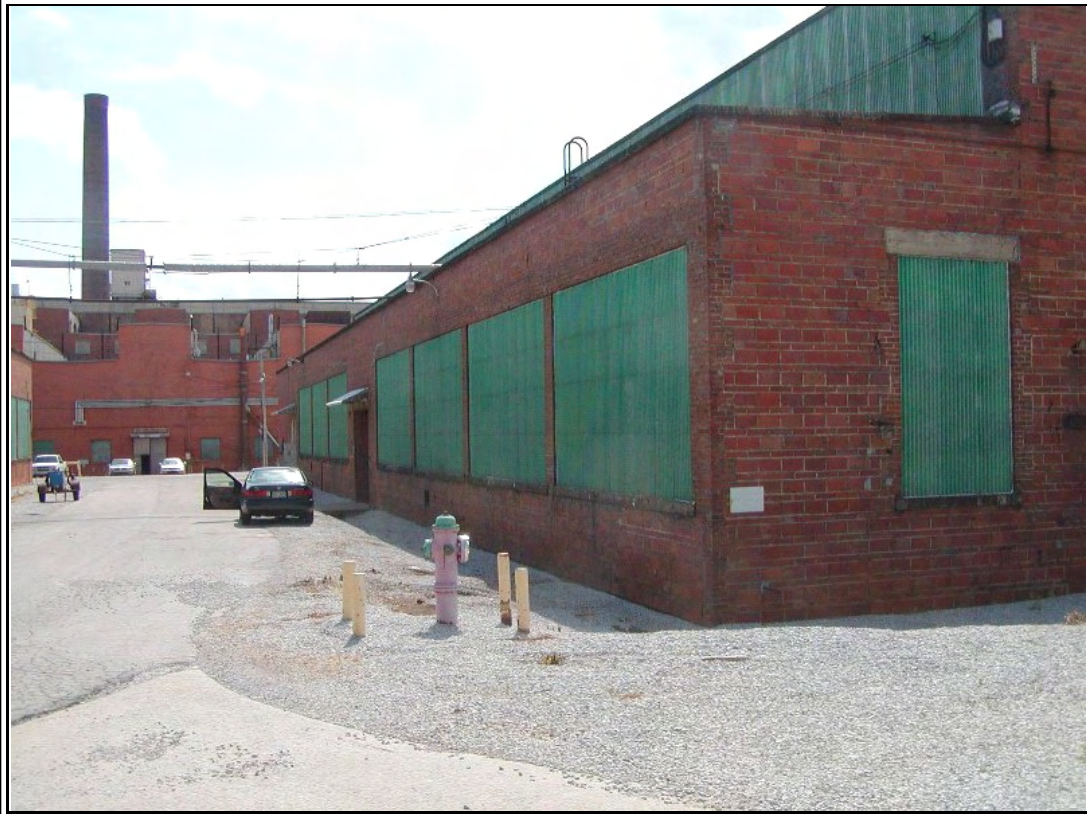
Photograph #: 2
Exterior of building on north side

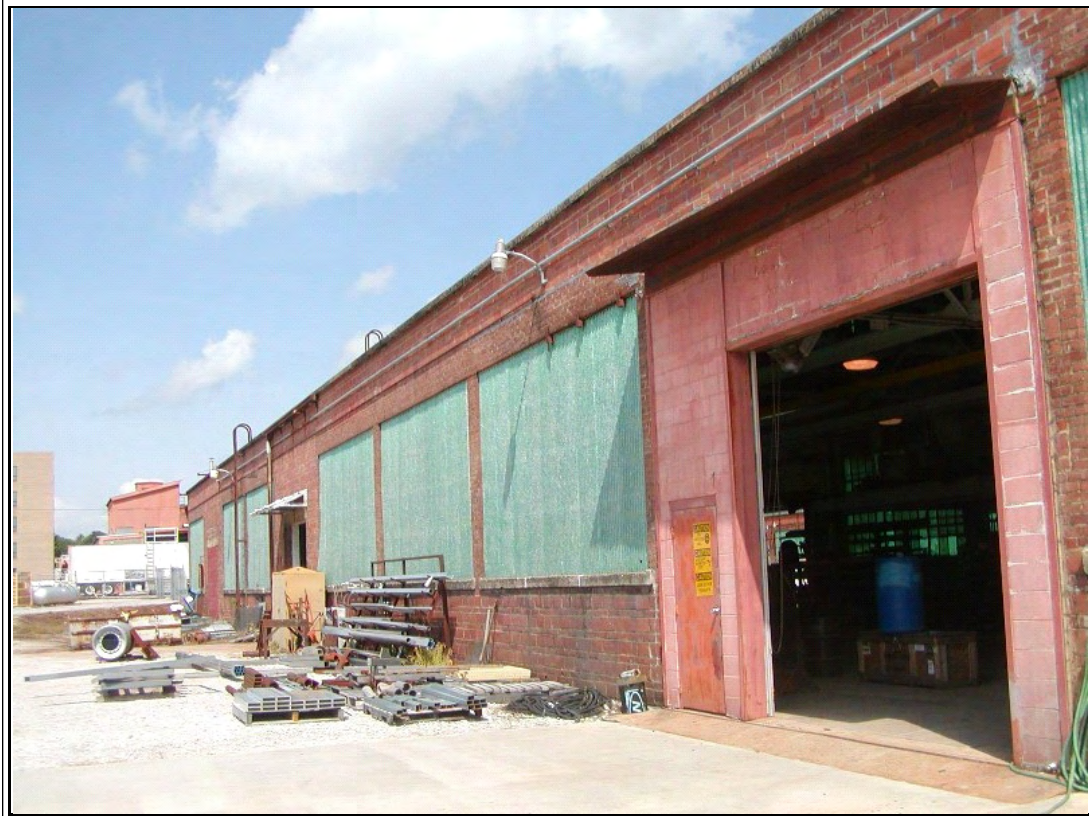
Photograph #: 3

Exterior of building on south side

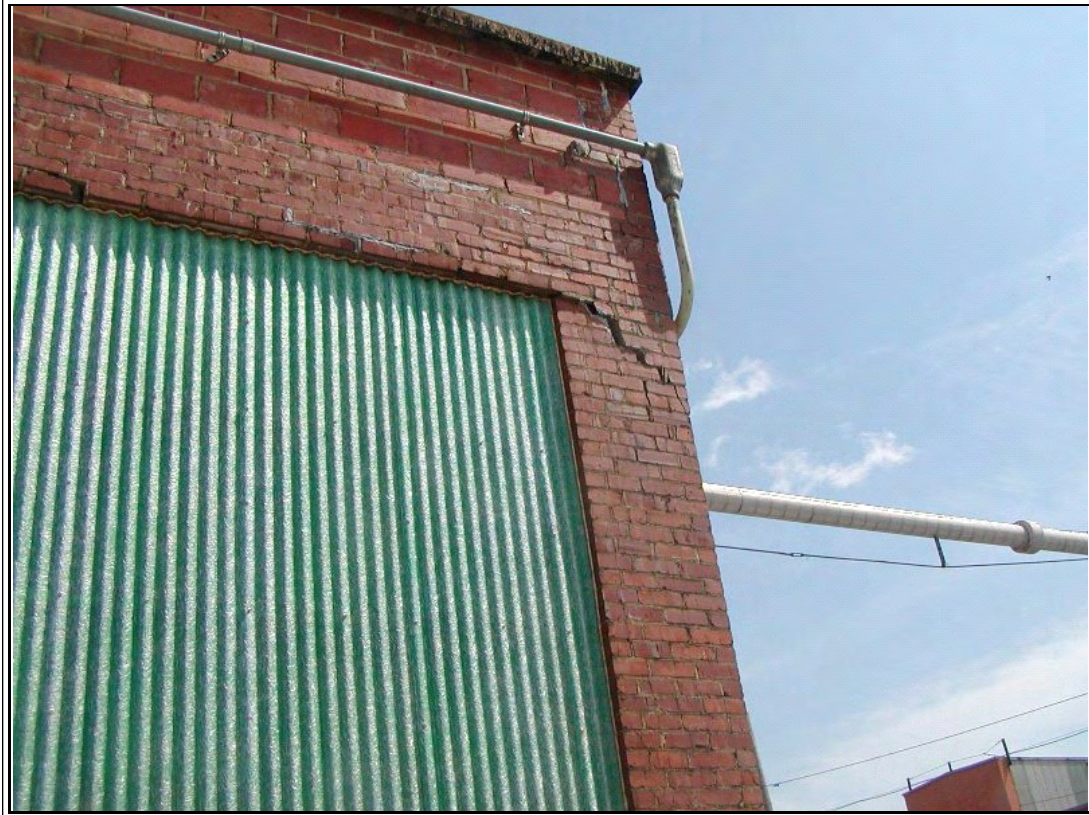
Photograph #: 4

Crack and partially dislodged masonry at southeast corner

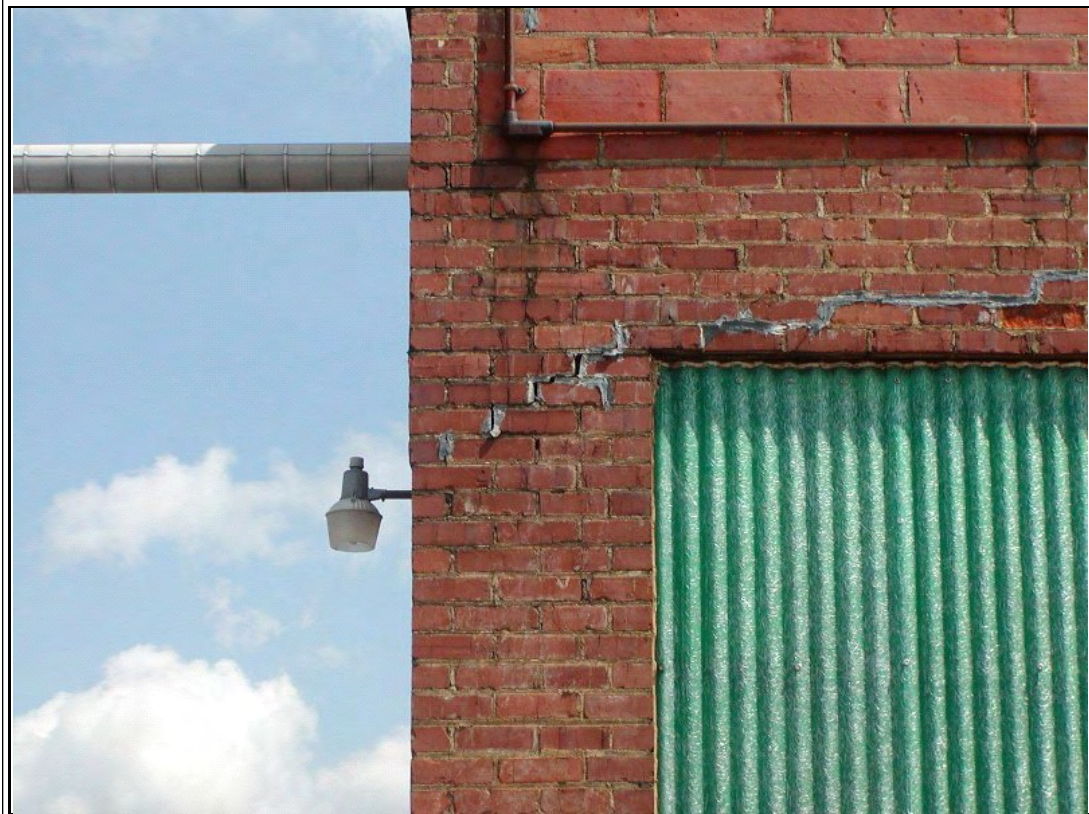
Photograph #: 5

Horizontal crack in masonry at southwest corner
