Structural Assessment

Muscle Shoals Reservation
adaptive re-use study

Conditions/Market/Planning/Implementation

July 31, 2009
Revised August 25, 2009

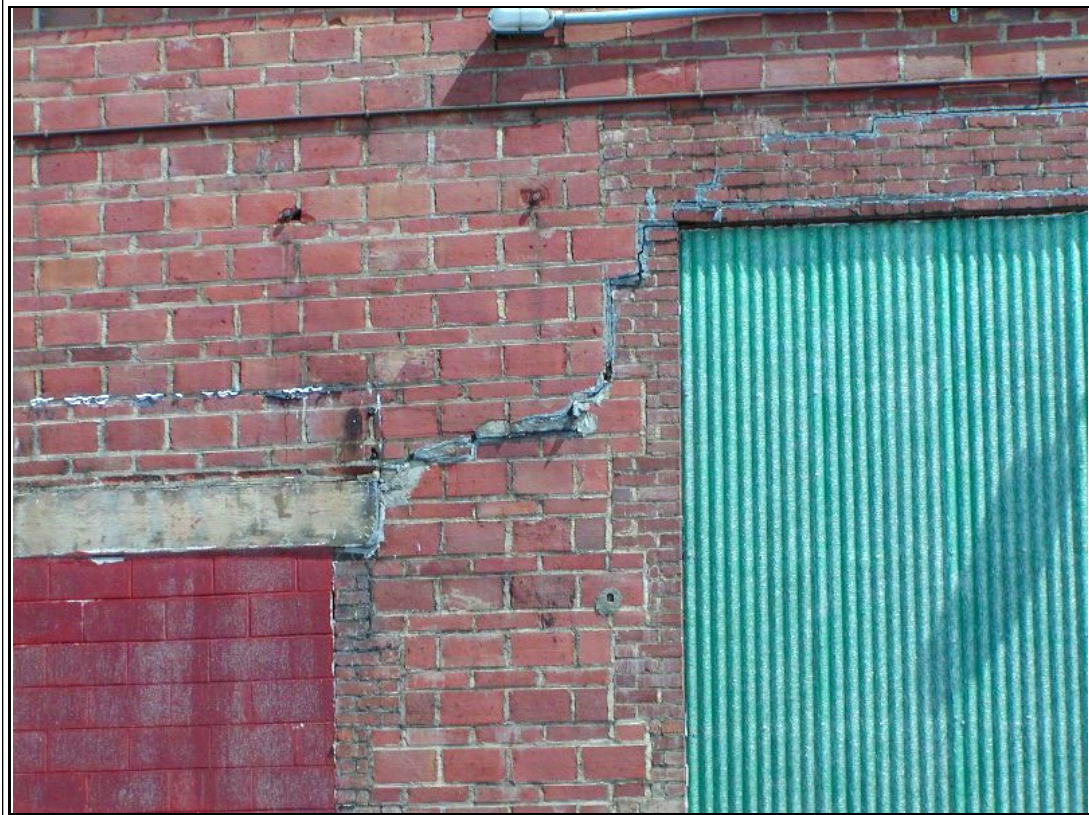
Photograph #: 6

Cracks in masonry on south side

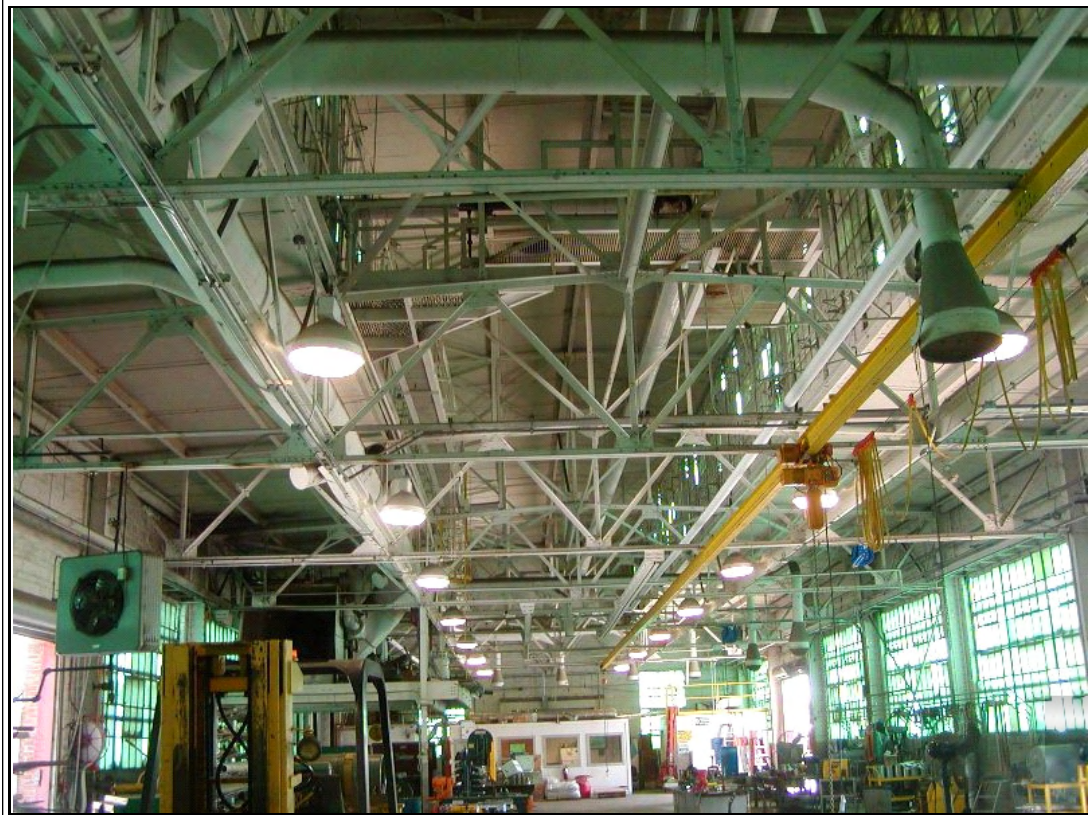
Photograph #: 8

Interior building looking east

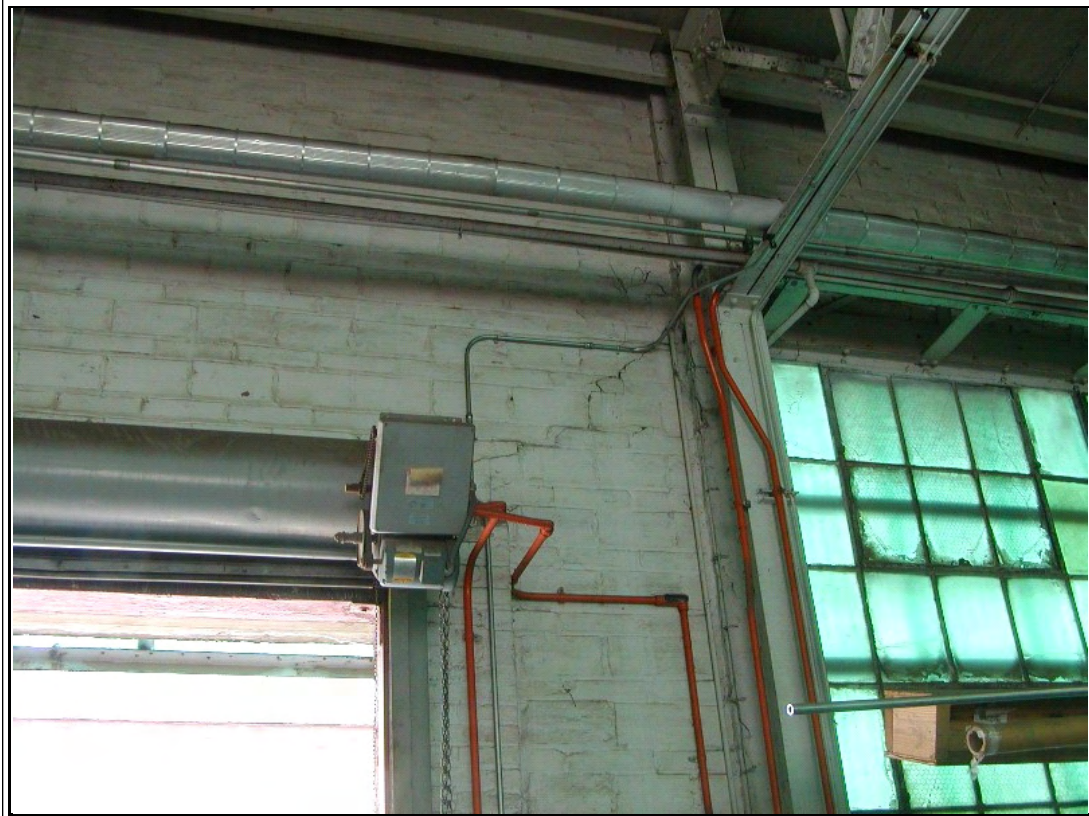
Photograph #: 9

Example of diagonal crack
in masonry at overhead
doors

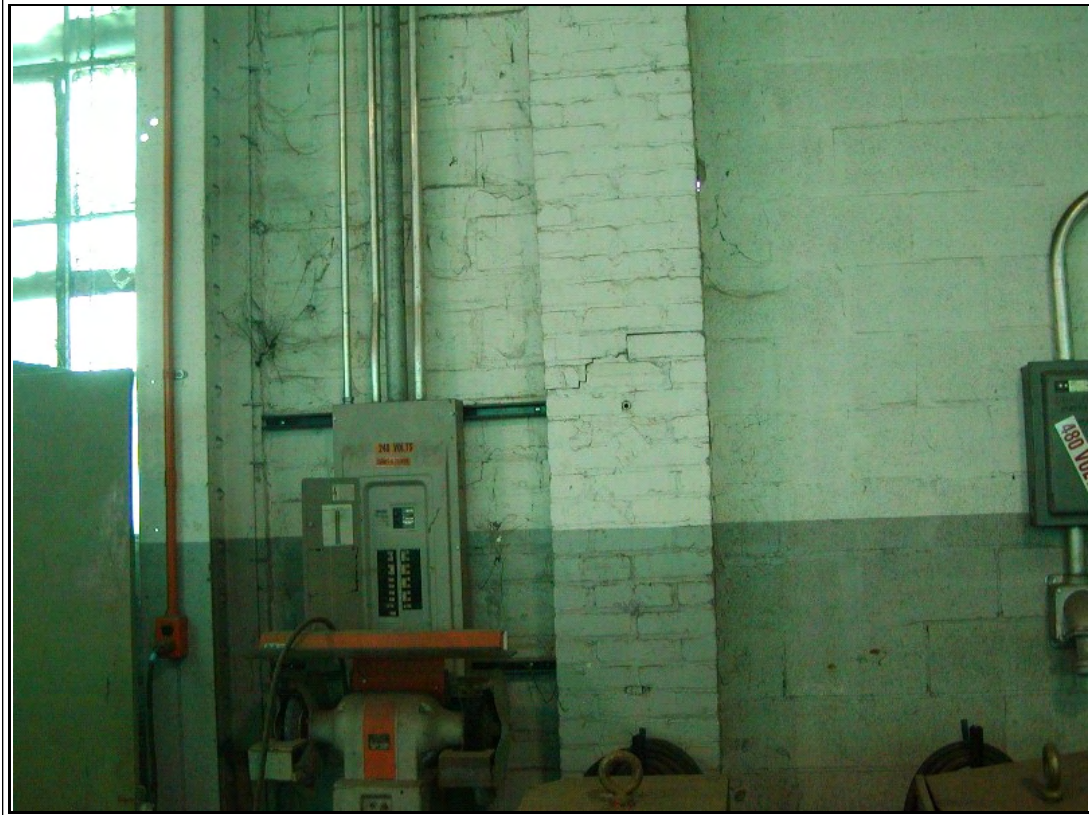
Photograph #: 10

Horizontal crack in brick
pier

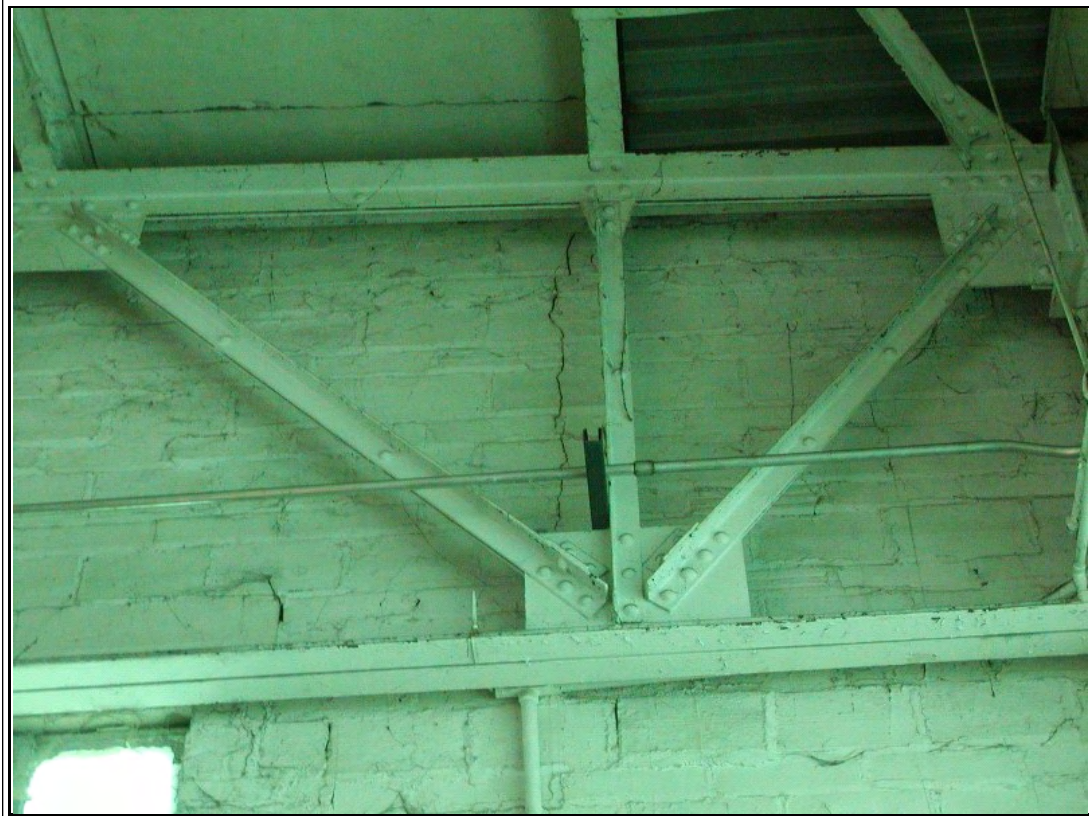
Photograph #: 11

Crack in masonry at end wall

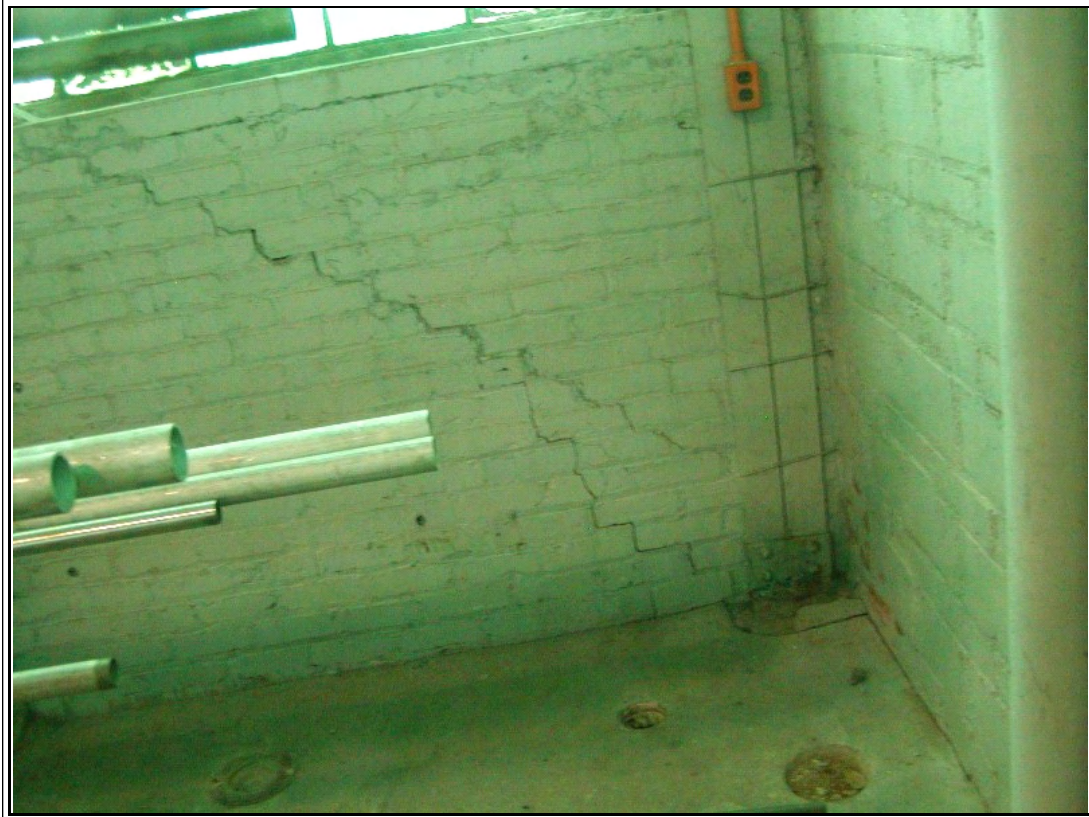
Photograph #: 12

Diagonal crack in masonry at corner of building below window

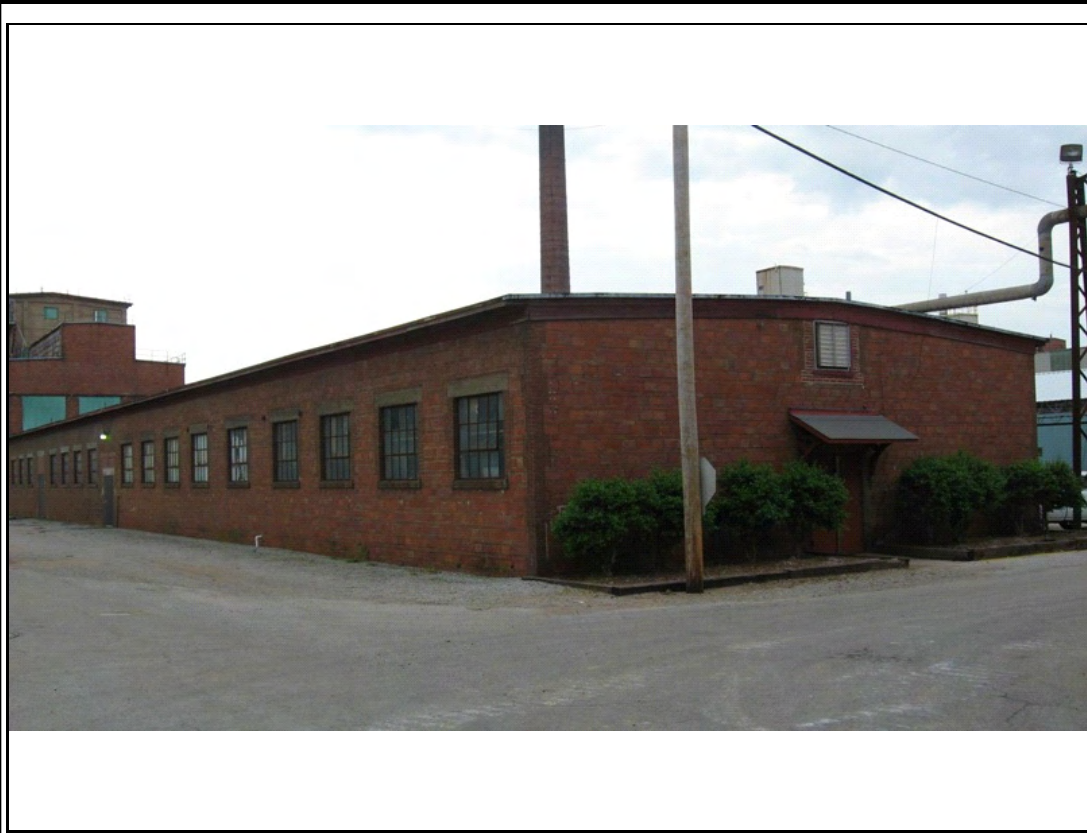
Photograph #: 1

Exterior building looking at northwest corner.

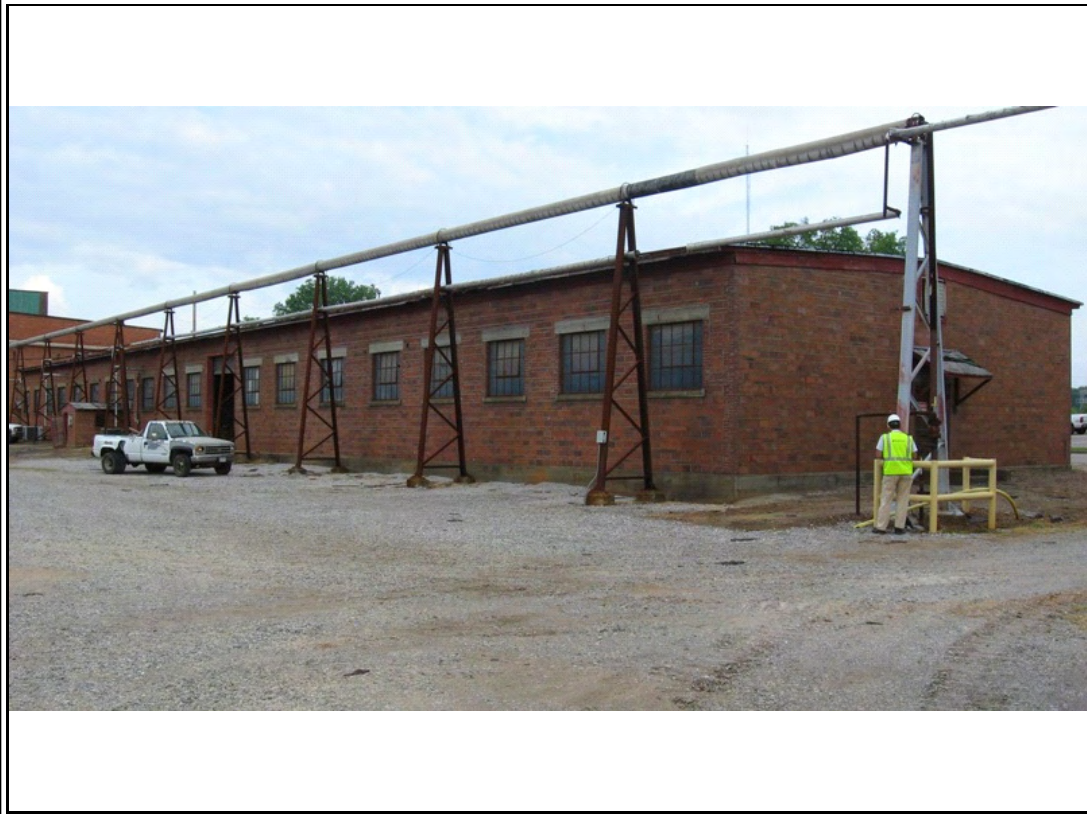
Photograph #: 2

Exterior building looking at southeast corner

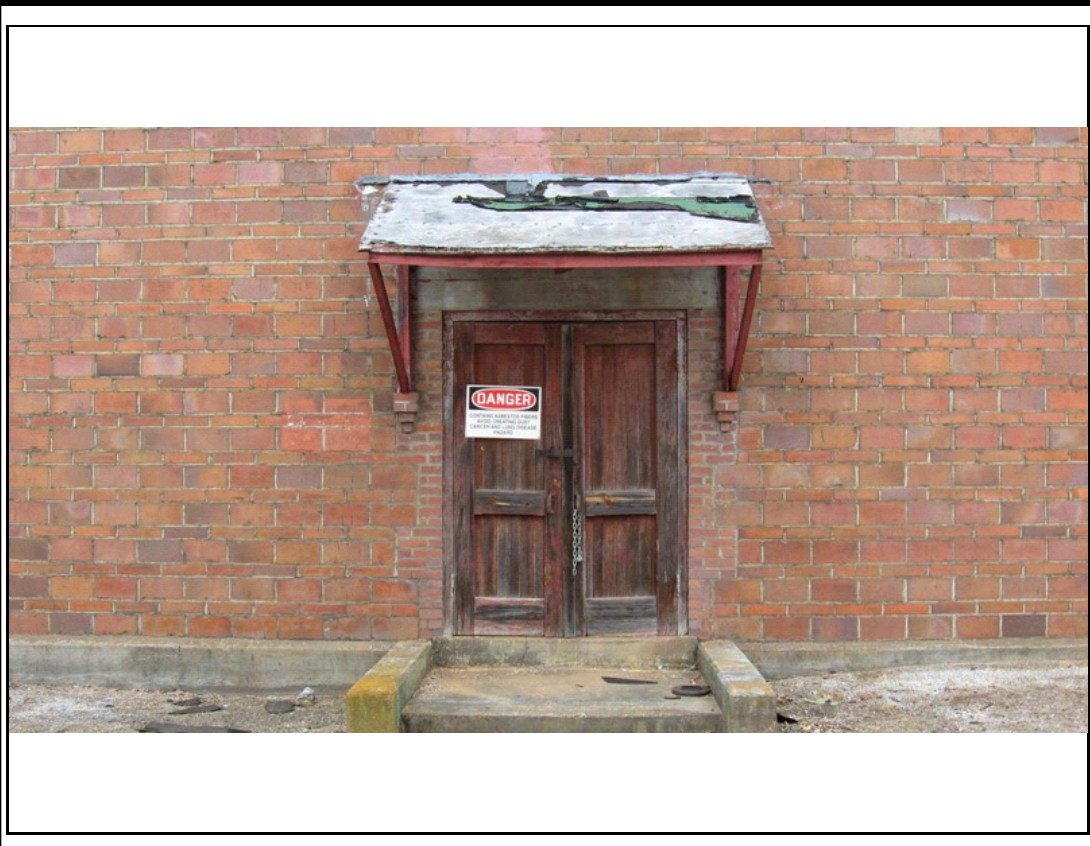
A photograph of a brick building's exterior. A wooden double door is centered, with a small concrete step leading up to it. Above the door is a small, flat, wooden awning supported by two red-painted wooden brackets. A white sign with the word "DANGER" in red letters is posted on the left door panel. The wall is made of red brick.	<p>Photograph #: 3</p> <p>Wood frame exterior awning at east end.</p>

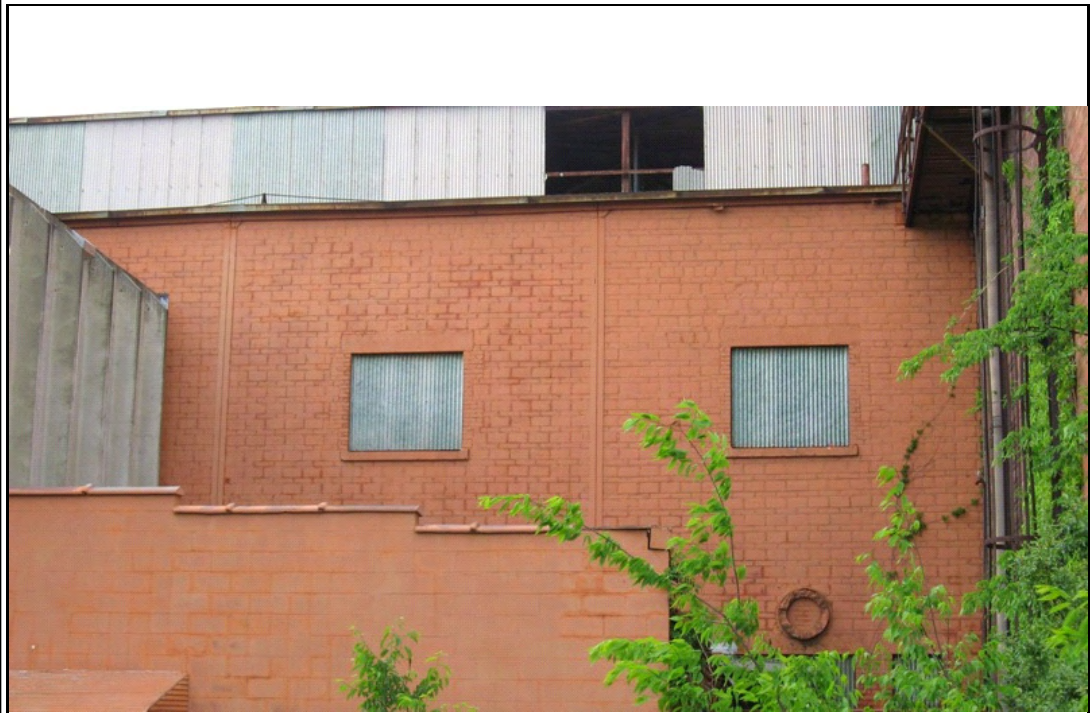
<p>Photograph #: 7</p> <p>South wall at intersection with Building 50. Buildings 51 and 49 are partially visible at left and center of photograph.</p>

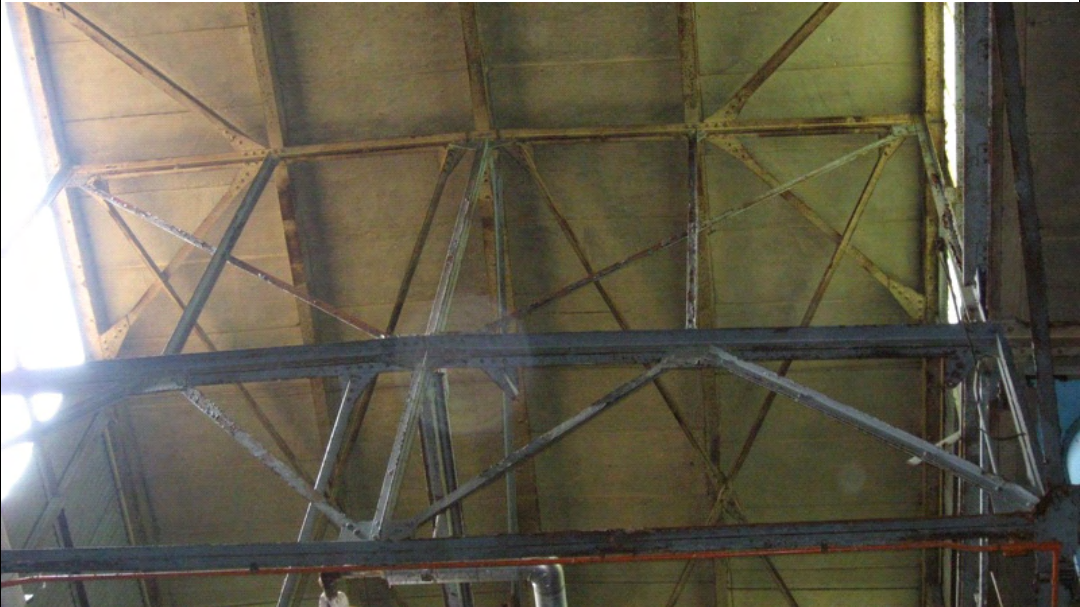
<p>Photograph #: 10</p> <p>Mildly corroded steel roof framing.</p>

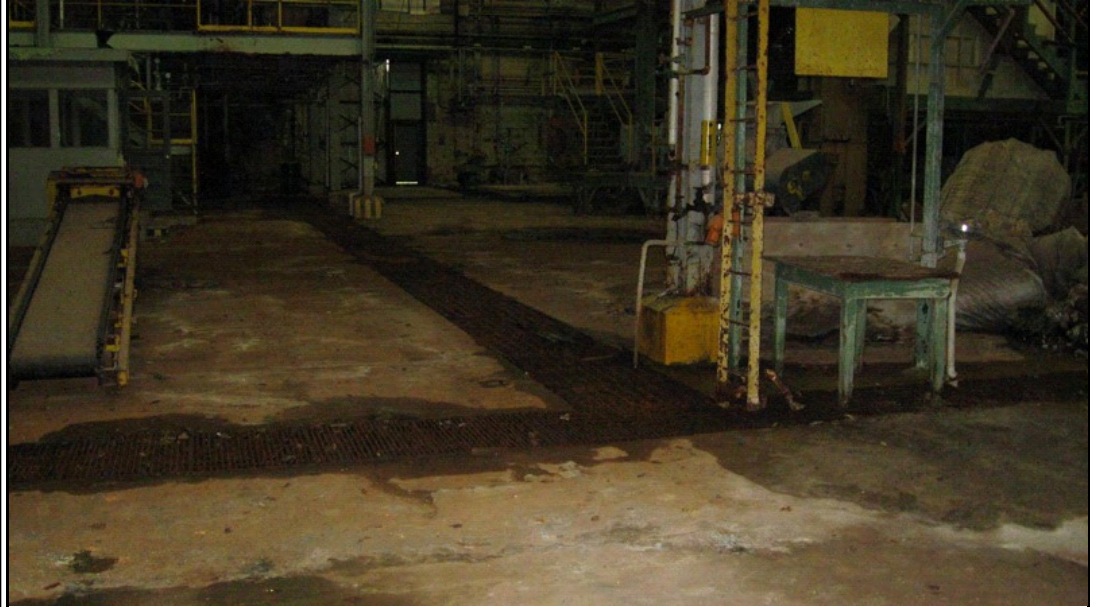
<p>Photograph #: 15</p> <p>Deteriorated concrete floor and steel grate.</p>

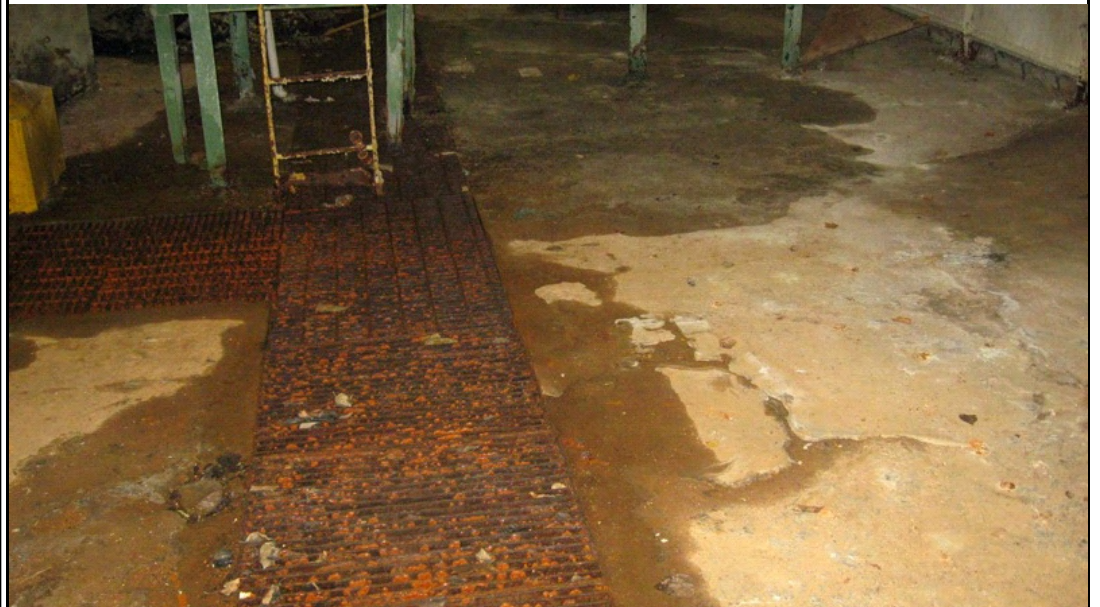
<p>Photograph #: 16</p> <p>Deteriorated concrete floor and steel grate.</p>

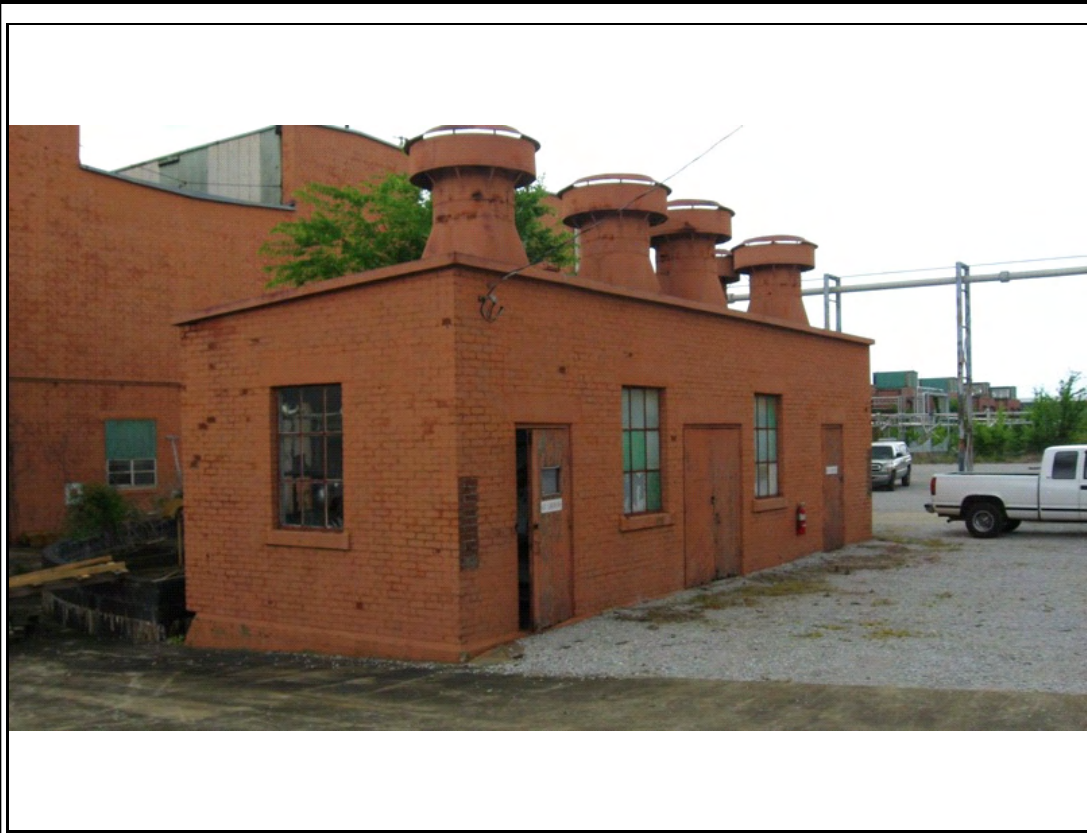
Photograph #: 1

Exterior building looking at northwest corner.

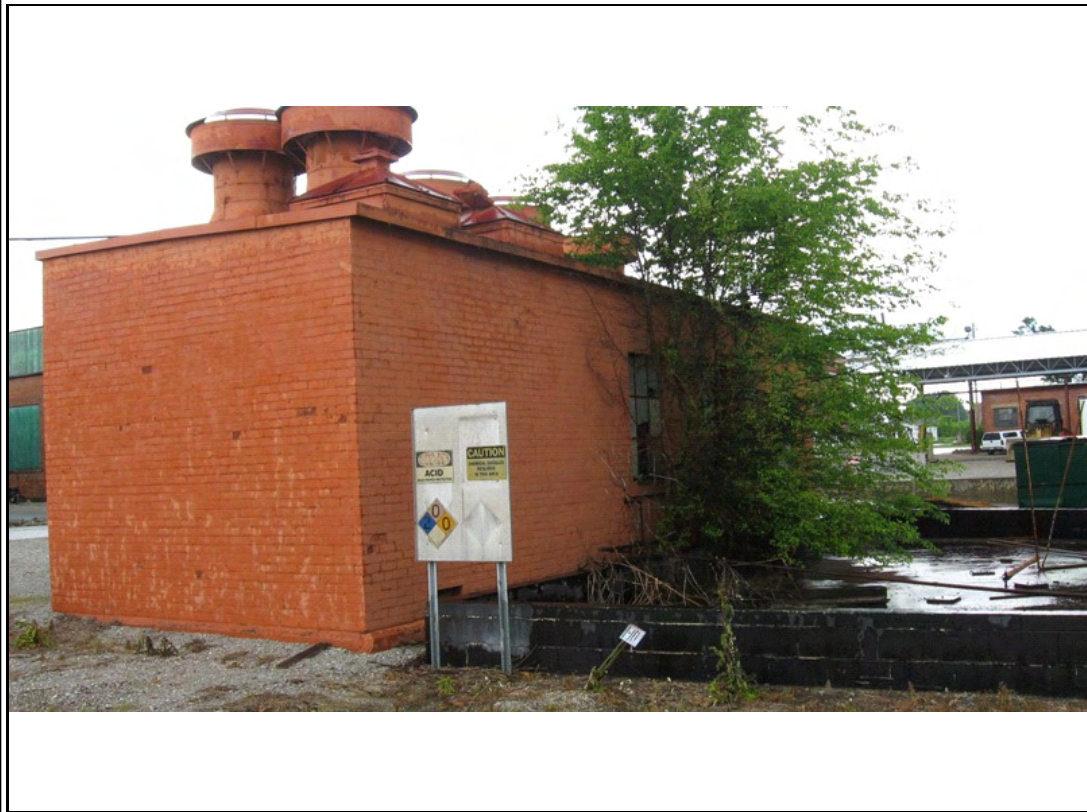
Photograph #: 2

Exterior building looking at southeast corner.

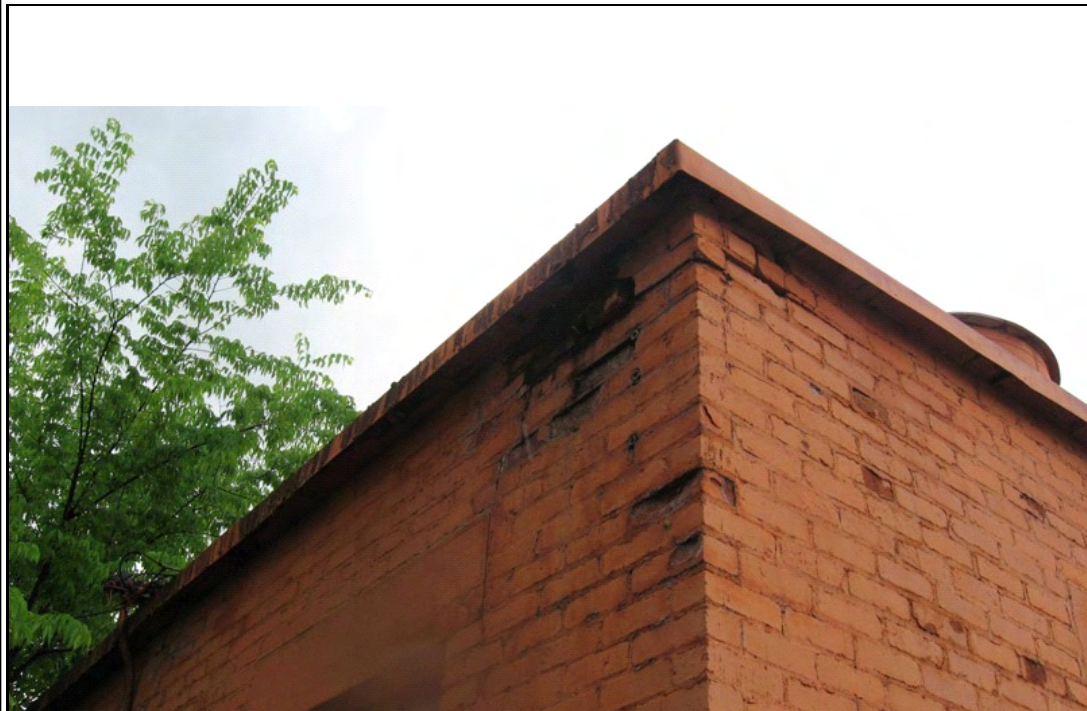
Photograph #: 3

Deteriorated masonry wall at northeast corner with water intrusion damage - see Photograph # 5.

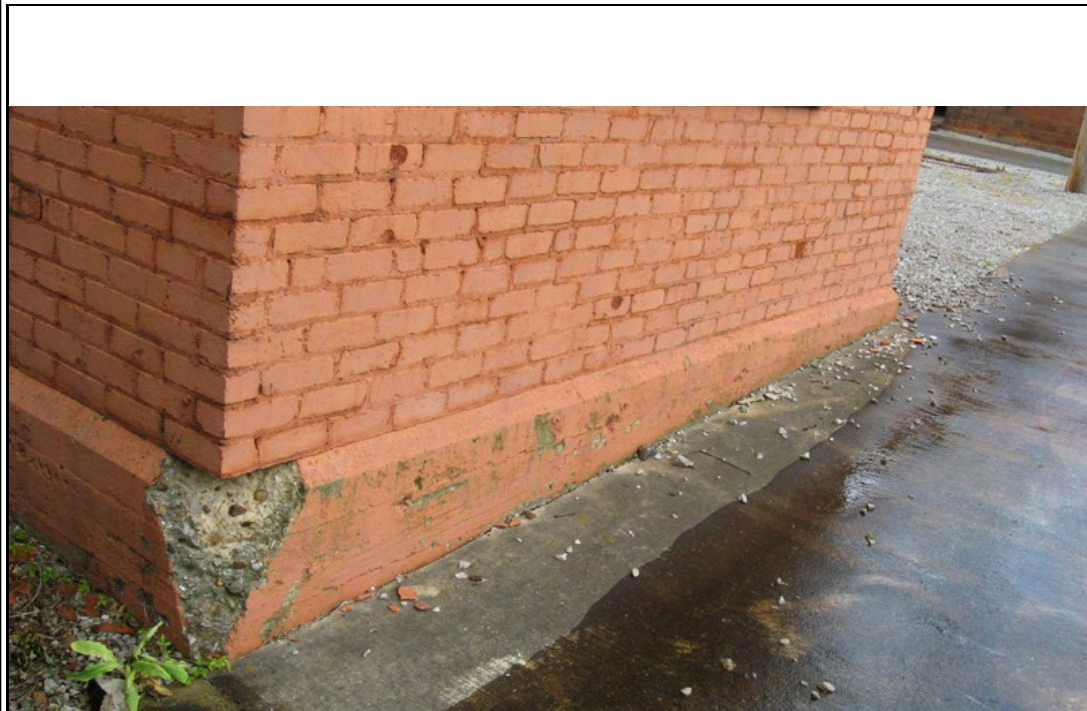
Photograph #: 4

Spalled concrete foundation at northeast corner.

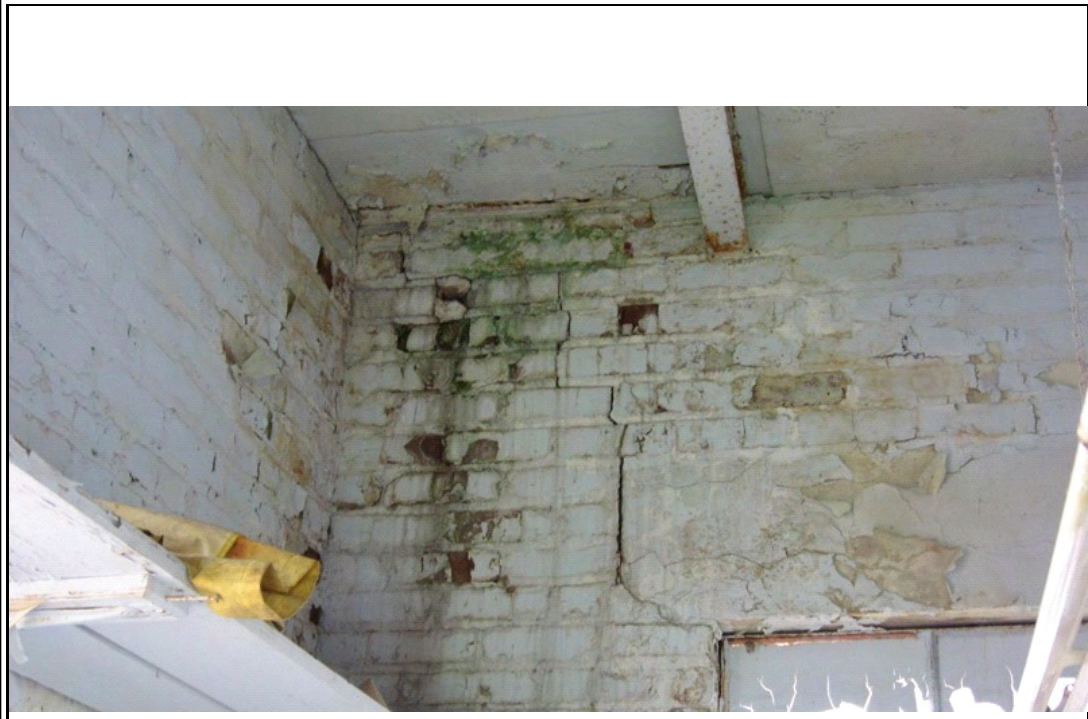
A photograph showing a corner of a masonry wall. The wall is made of light-colored bricks or blocks, many of which are missing or crumbling. There is significant water intrusion damage, with dark, wet areas and some greenish mold or algae growth. A yellow object, possibly a bag or container, is visible in the lower left corner of the frame.	<p>Photograph #: 5</p> <p>Crack in masonry wall at northeast corner with water intrusion damage - see Photograph #3.</p>

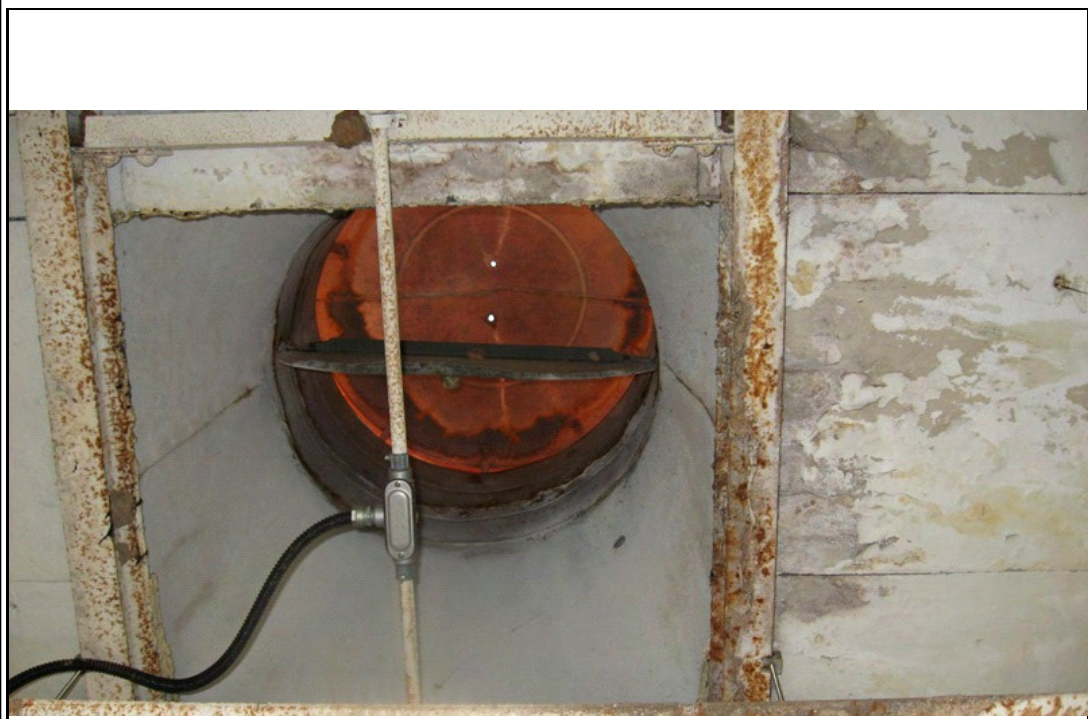
A photograph showing a close-up of a roof structure. A large, circular, rusted metal object, possibly a vent or a pipe, is mounted on a concrete plank roof deck. The surrounding steel frame is heavily corroded and rusted. The concrete deck appears deteriorated and stained.	<p>Photograph #: 6</p> <p>Corroded steel frame at roof; deteriorated concrete plank roof deck.</p>

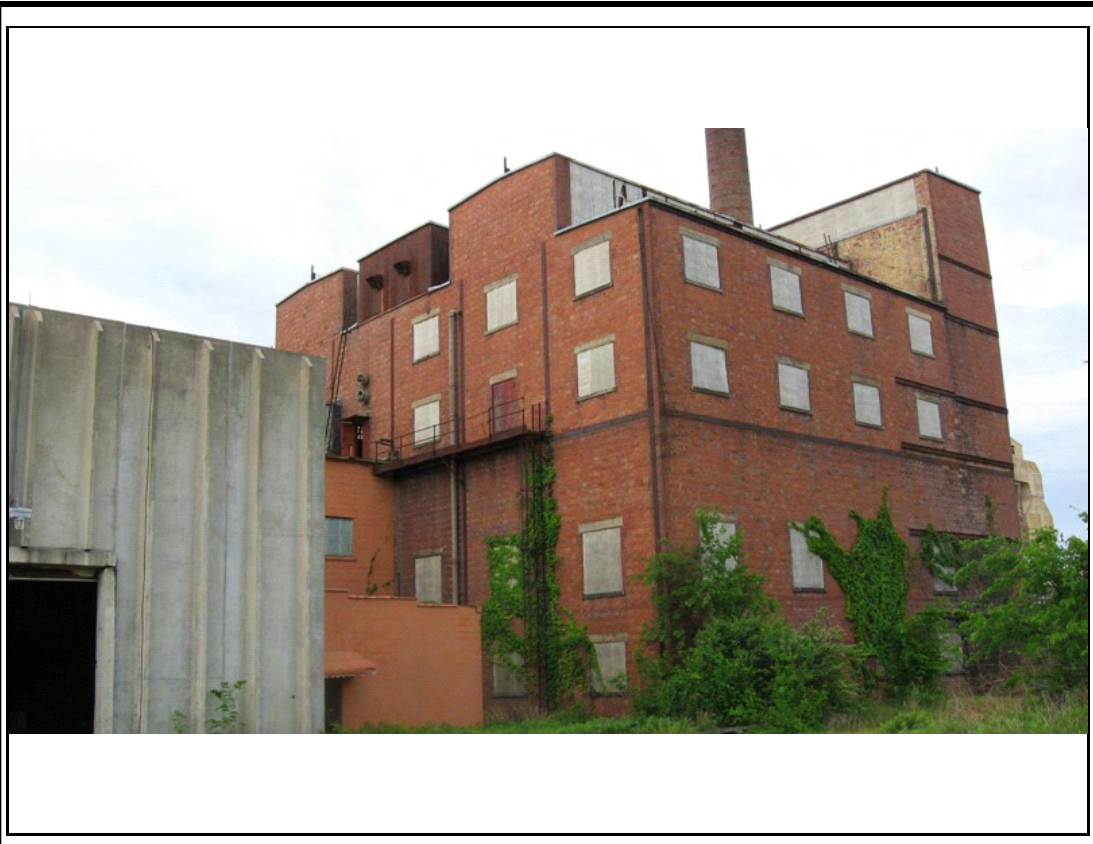
<p>Photograph #: 1</p> <p>Exterior building looking at southwest corner.</p>

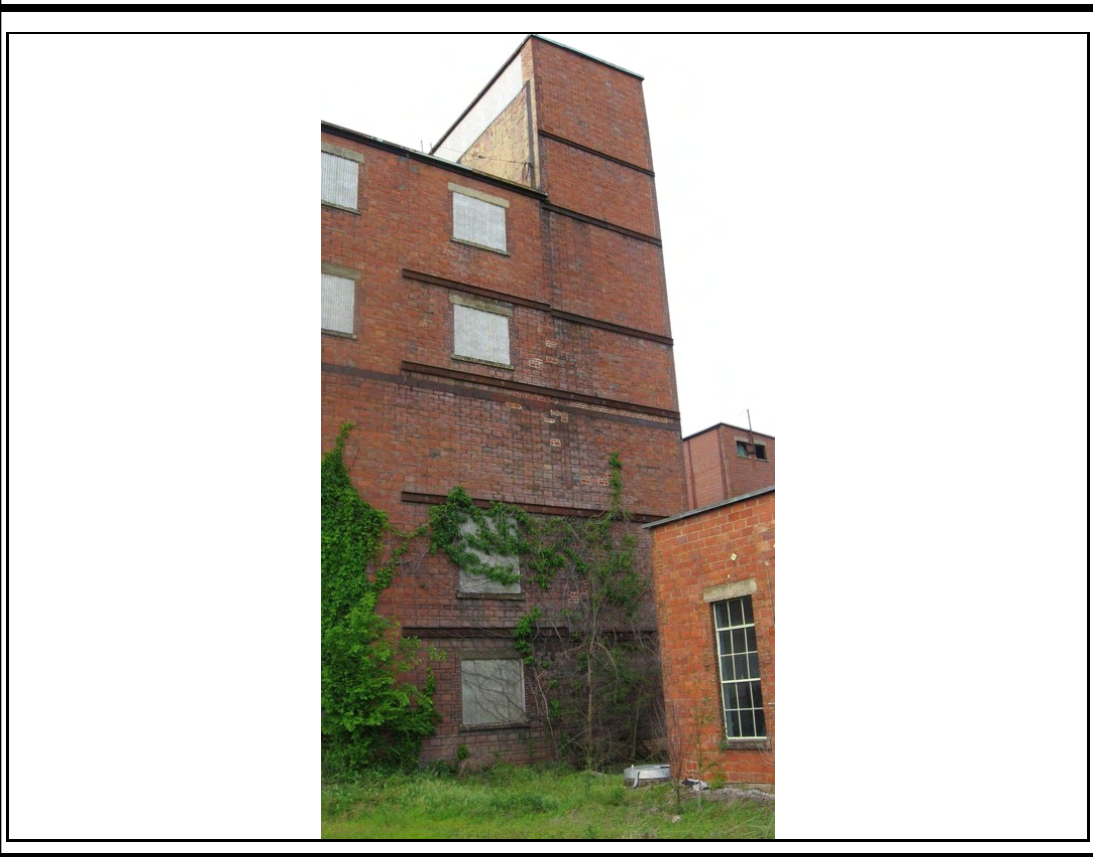
<p>Photograph #: 2</p> <p>Exterior building looking at south side - east end.</p>

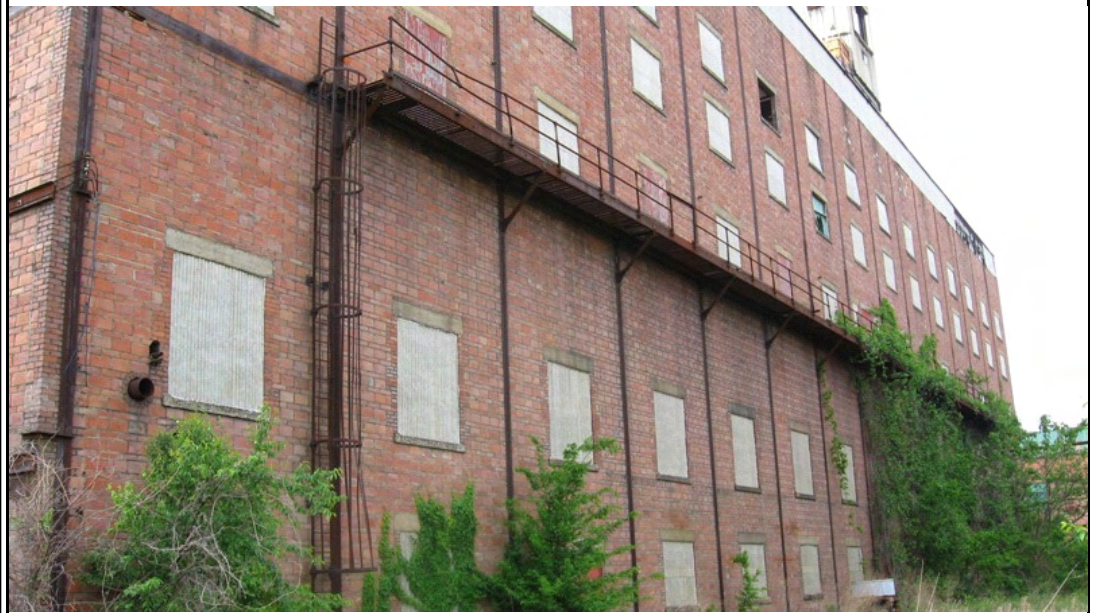
<p>Photograph #: 5</p> <p>Deteriorated fire escape east side</p>

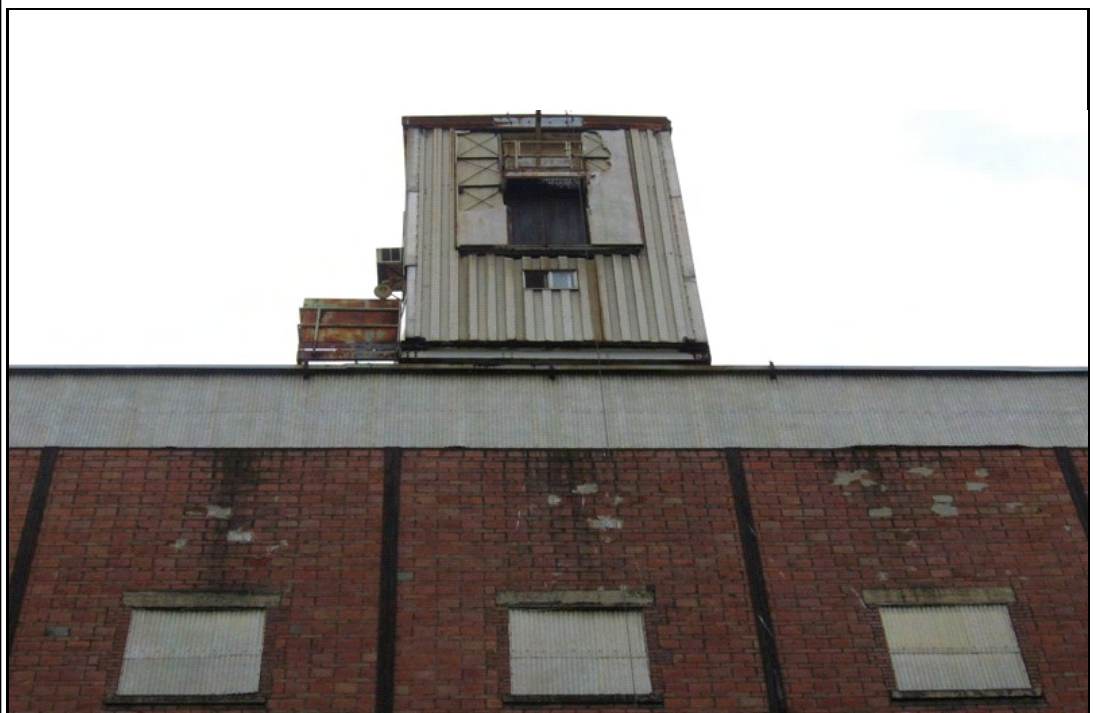
<p>Photograph #: 6</p> <p>View of penthouse with repaired spalls in masonry below east side</p>

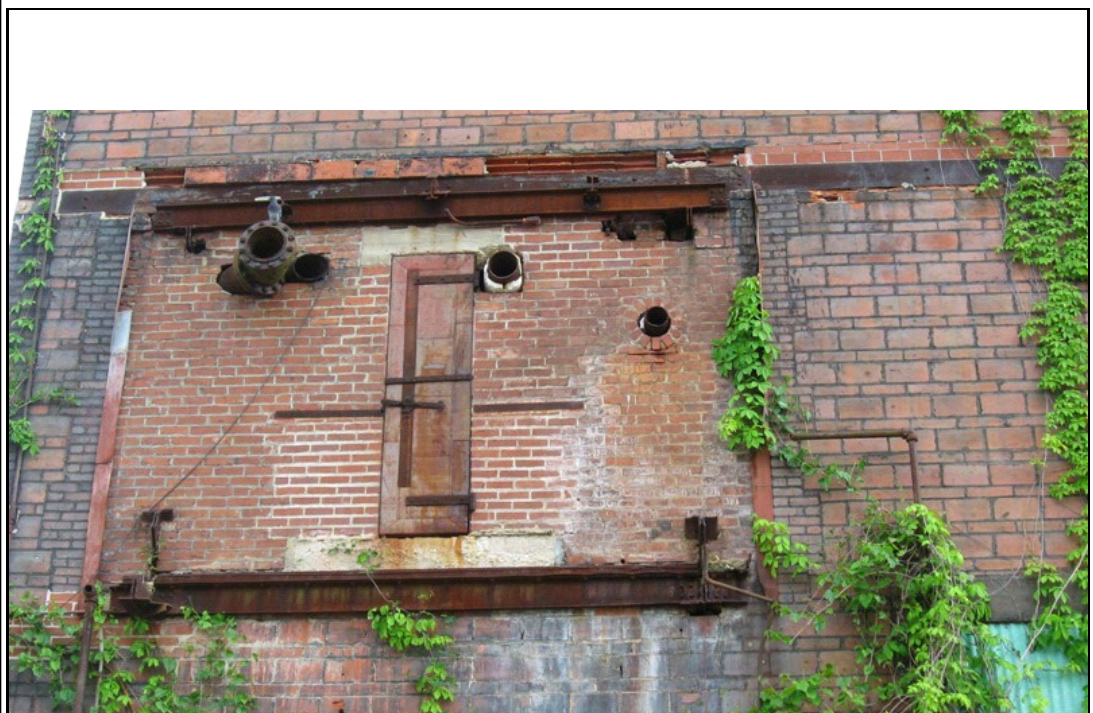
<p>Photograph #: 8</p> <p>Spalled and deteriorated masonry, north side - east end.</p>

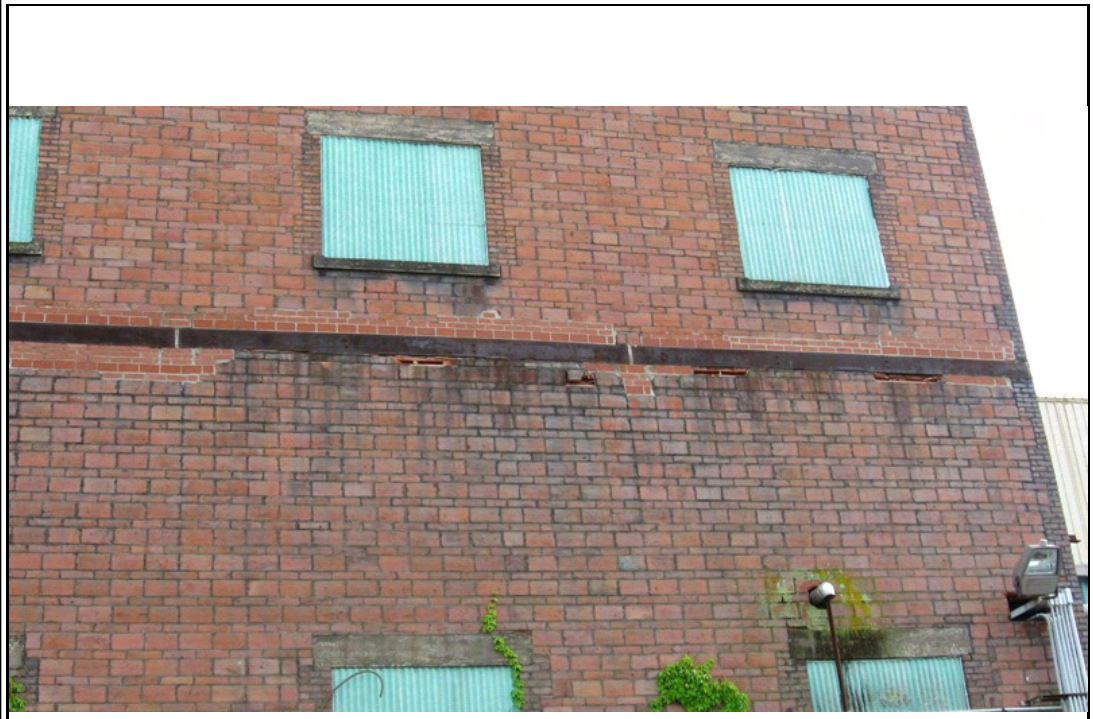
<p>Photograph #: 9</p> <p>Spalled masonry - north side - west end.</p>

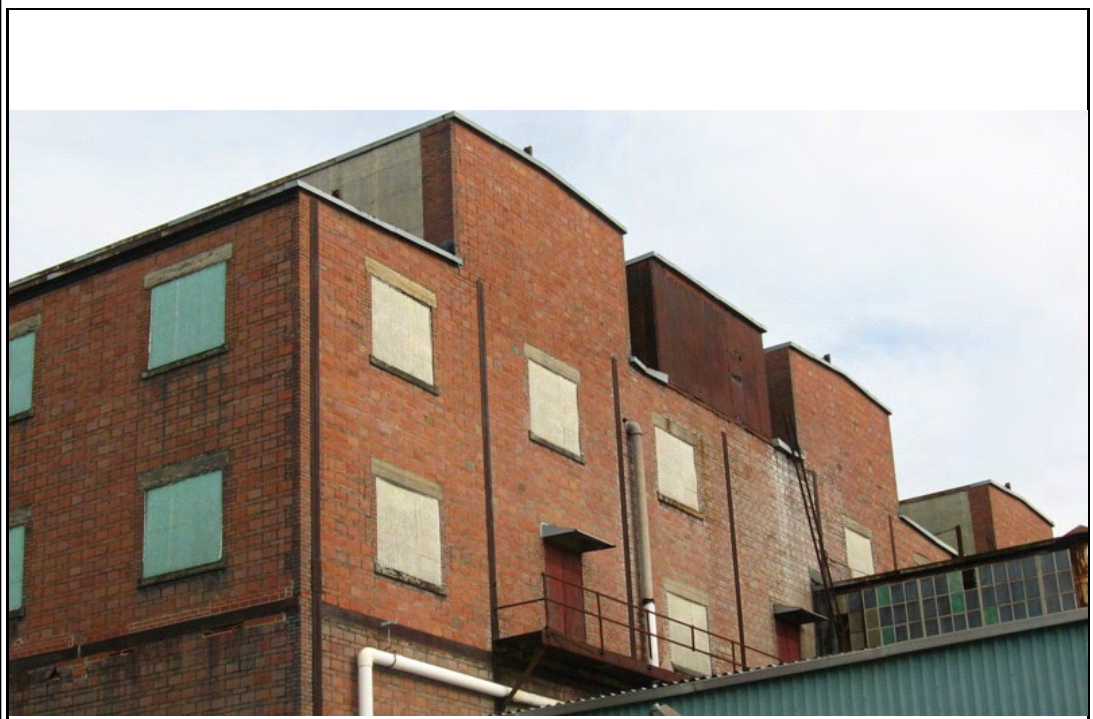
<p>Photograph #: 10</p> <p>Exterior building looking at northwest corner.</p>

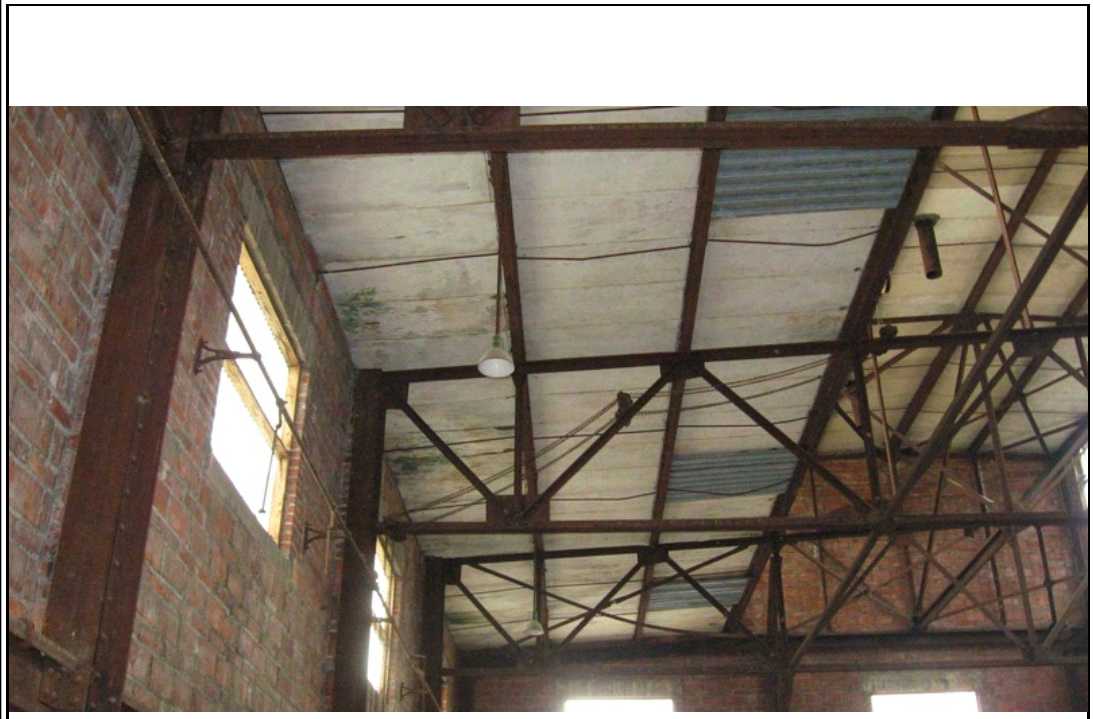
<p>Photograph #: 11</p> <p>Corroded steel framing and surface deterioration at concrete plank roof deck, south end.</p>
 	<p>Photograph #: 12</p> <p>Corroded steel framing and surface deterioration at concrete plank roof deck at clerestory monitor (typical of 5).</p>
