Structural Assessment

Muscle Shoals Reservation
adaptive re-use study

Conditions/Market/Planning/Implementation

July 31, 2009
Revised August 25, 2009

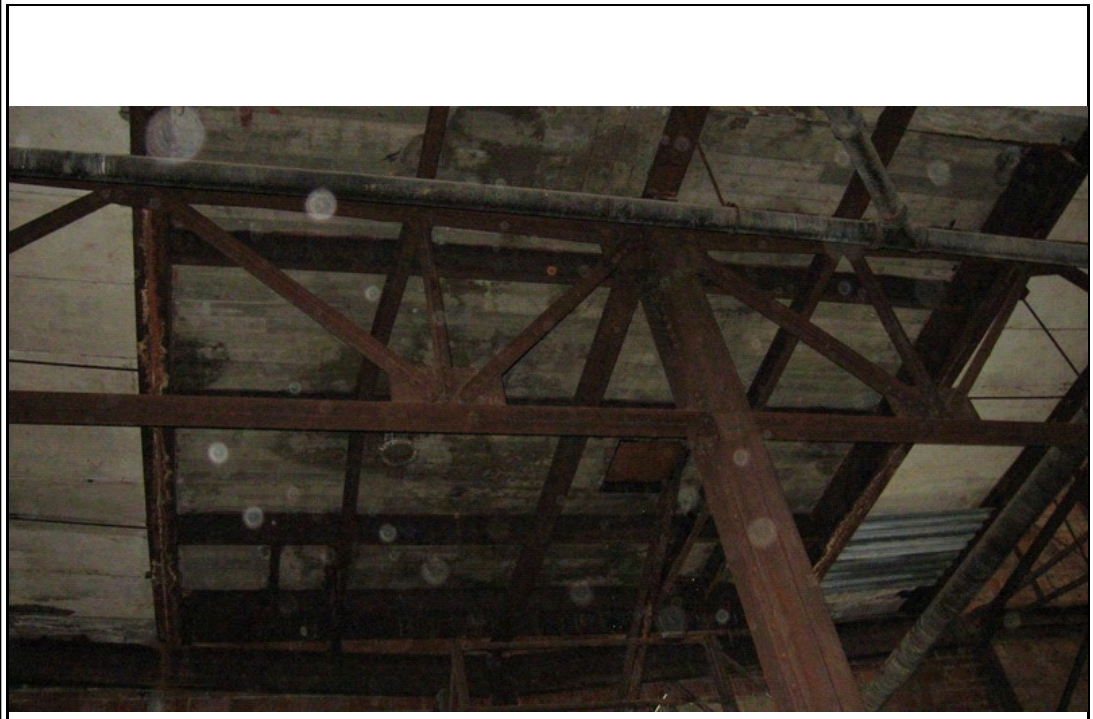
<p>Photograph #: 13</p> <p>Water intrusion damage at cast-in-place portion of roof deck, east side</p>

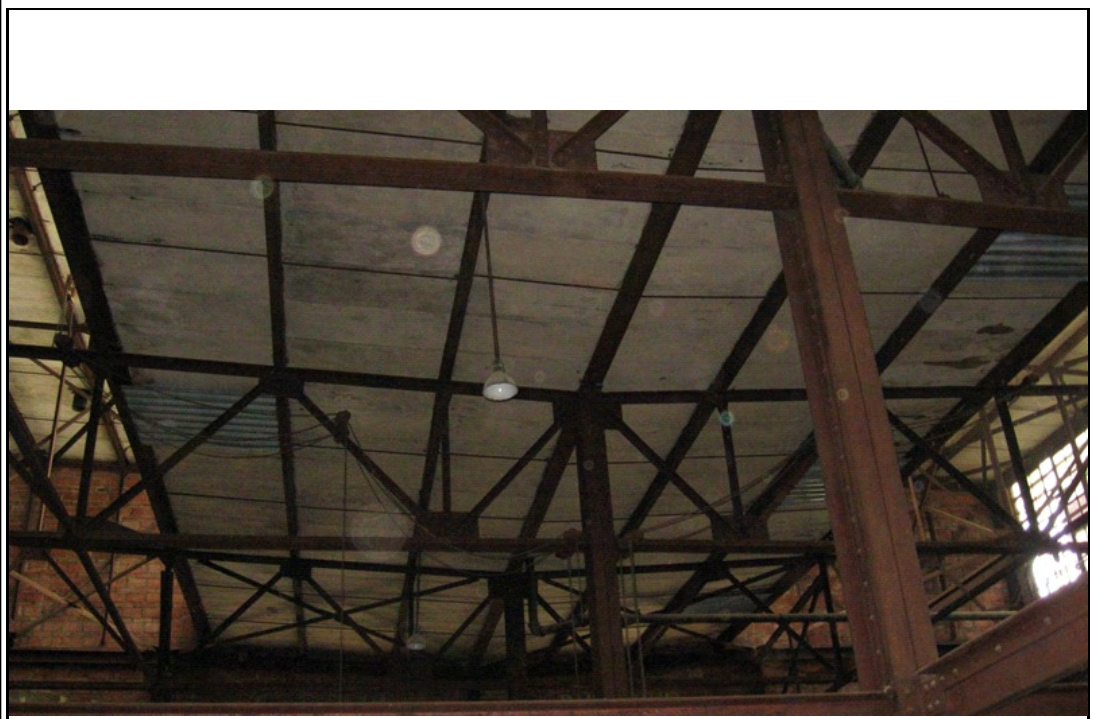
<p>Photograph #: 14</p> <p>Concrete plank roof deck with surface deterioration</p>

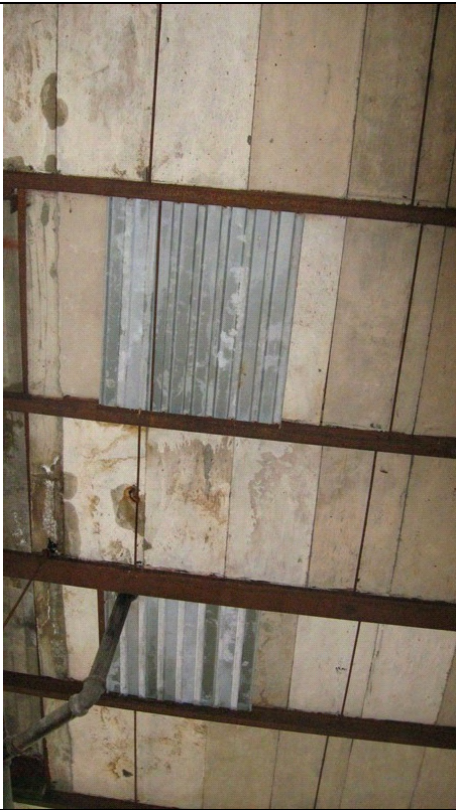
<p>Photograph #: 15</p> <p>Concrete plank roof deck with surface deterioration</p>

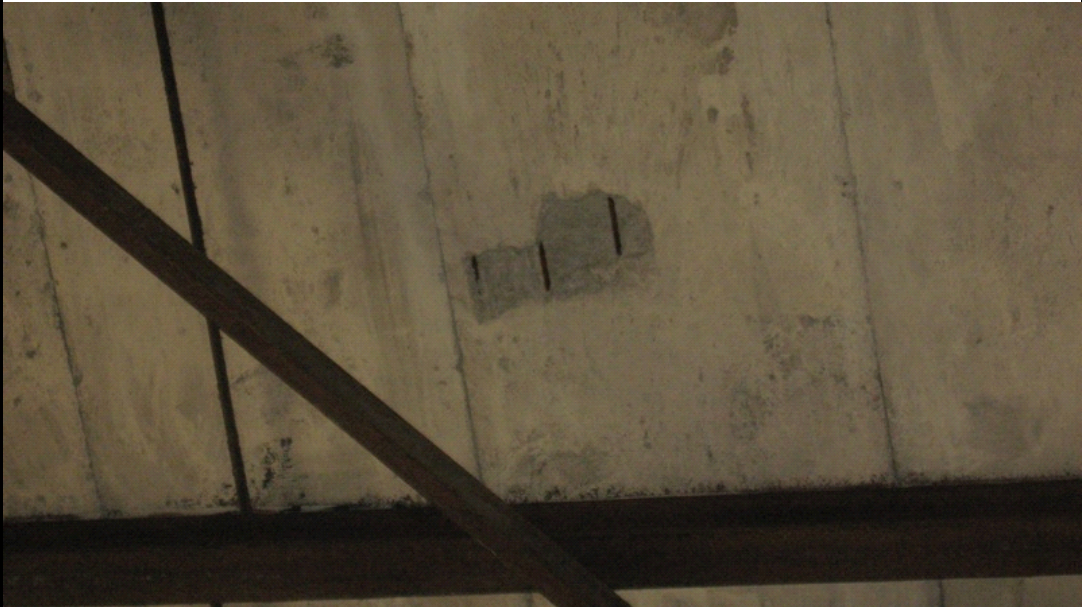
<p>Photograph #: 16</p> <p>Structurally deteriorated concrete roof plank.</p>

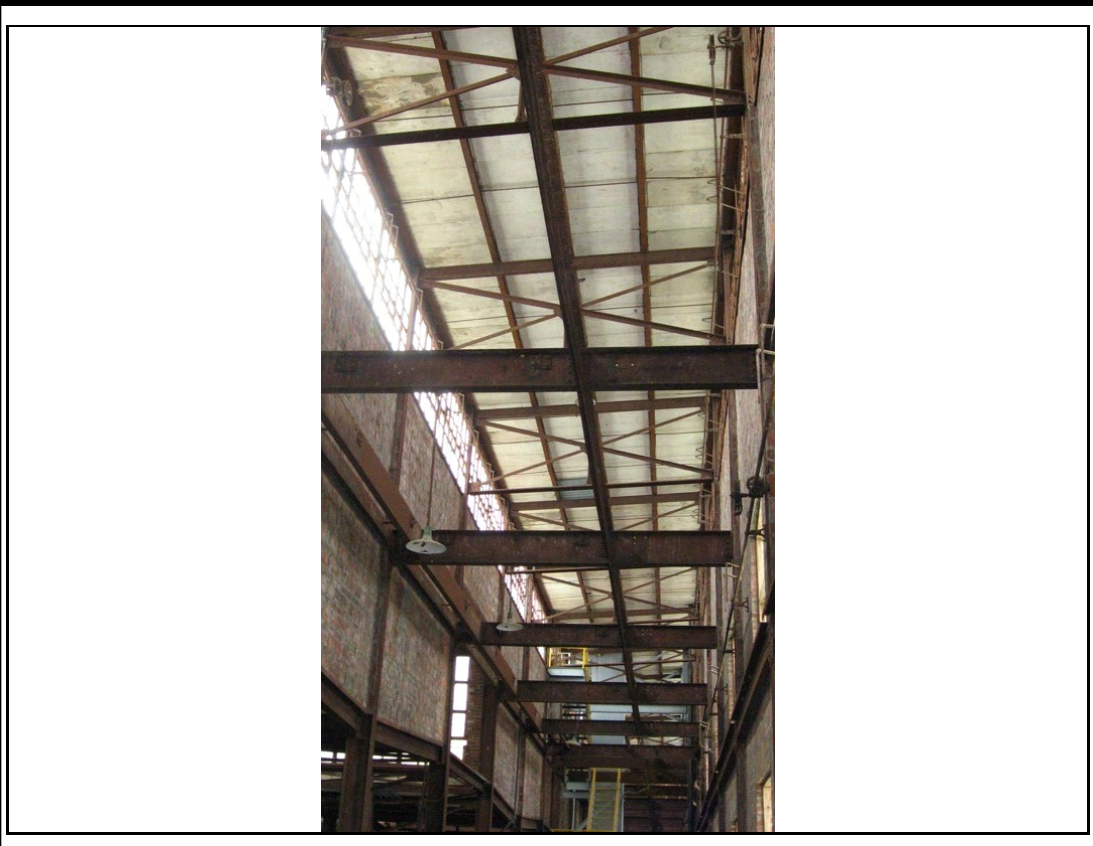
A vertical photograph showing the interior of a large industrial building. The view is looking up at a complex network of dark steel beams and trusses that support a high ceiling. Light enters from windows on the left side, creating a bright area near the top of the frame.	<p>Photograph #: 19</p> <p>View of high bay monitor on north side.</p>

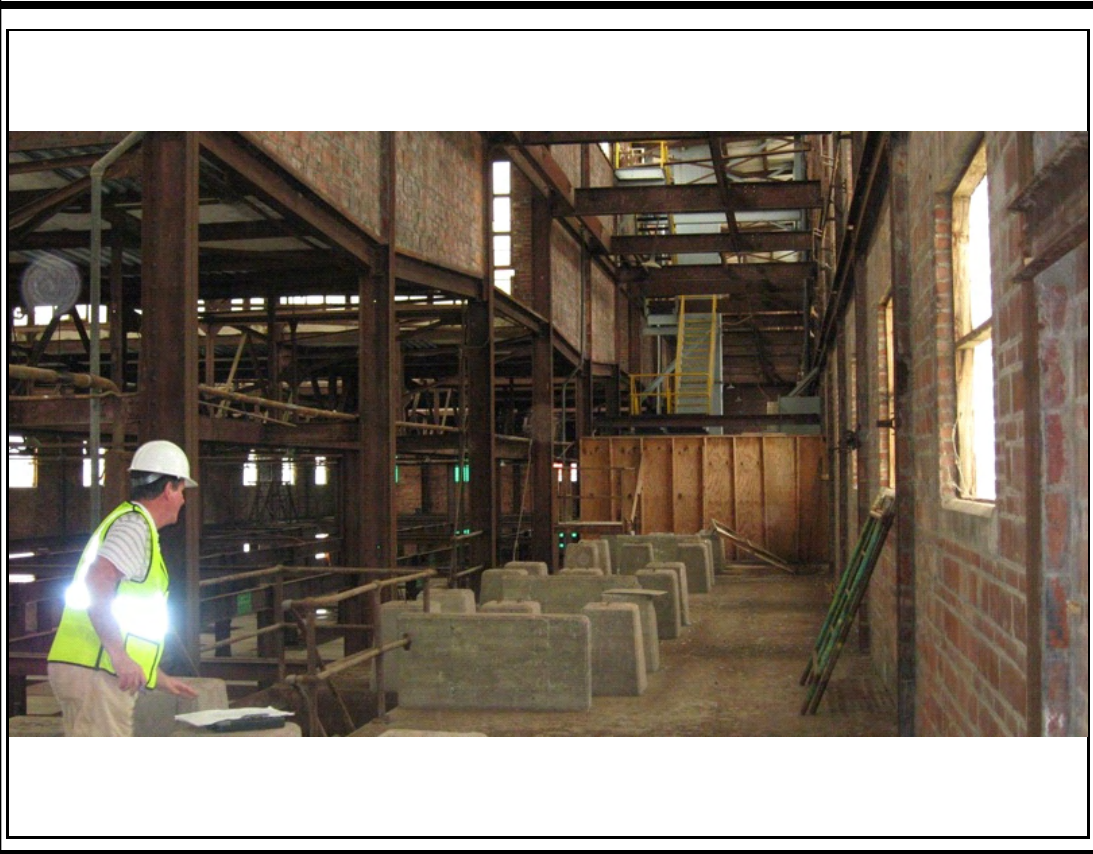
A horizontal photograph of an industrial interior. In the foreground, a worker wearing a white hard hat and a high-visibility yellow vest stands on the left, looking towards the right. The floor is concrete and has several large, rectangular concrete blocks or forms arranged in a row. In the background, there are multiple levels of steel framing, including a mezzanine. A yellow staircase is visible on an upper level. The right wall is made of red brick with a window.	<p>Photograph #: 20</p> <p>View of mezzanine above 3rd floor at high bay on north side.</p>

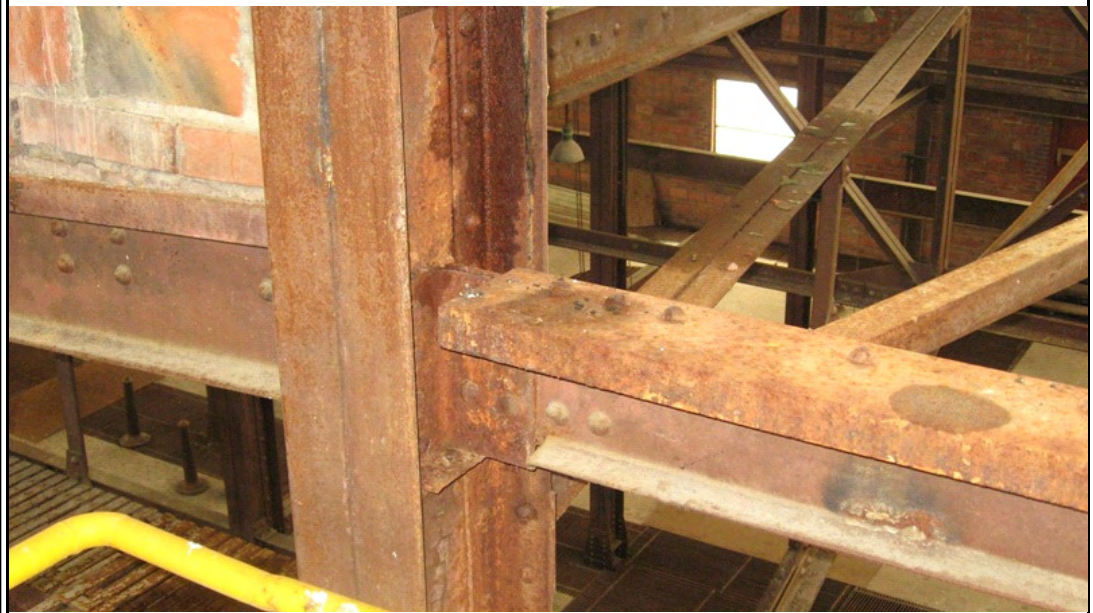
<p>Photograph #: 21</p> <p>Corroded steel framing at high bay adjacent to stair to penthouse.</p>

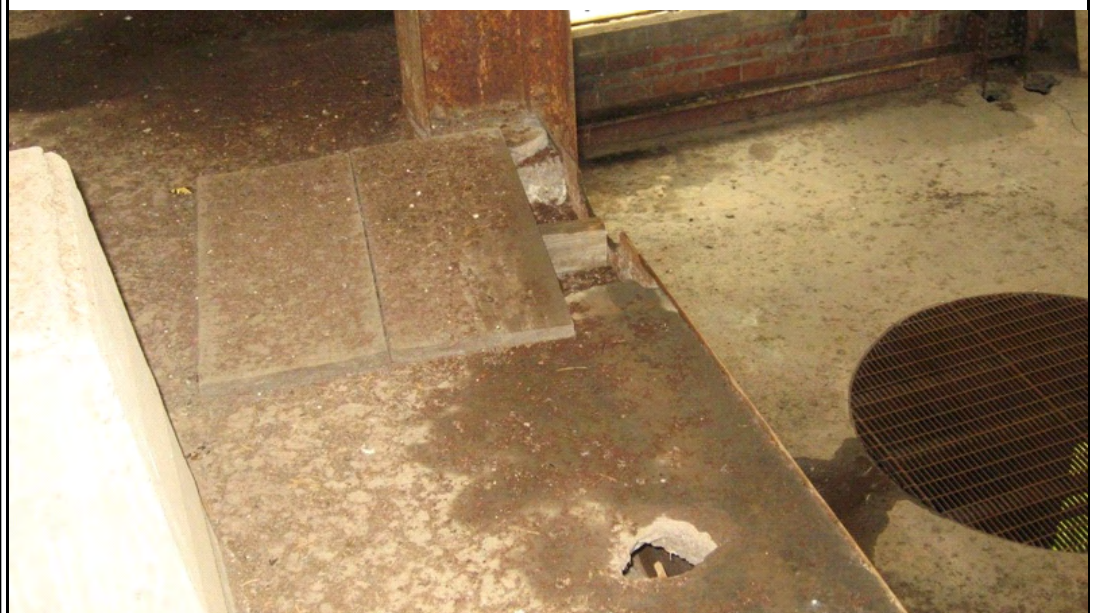
<p>Photograph #: 22</p> <p>Structural damage at mezzanine slab above 3rd floor.</p>

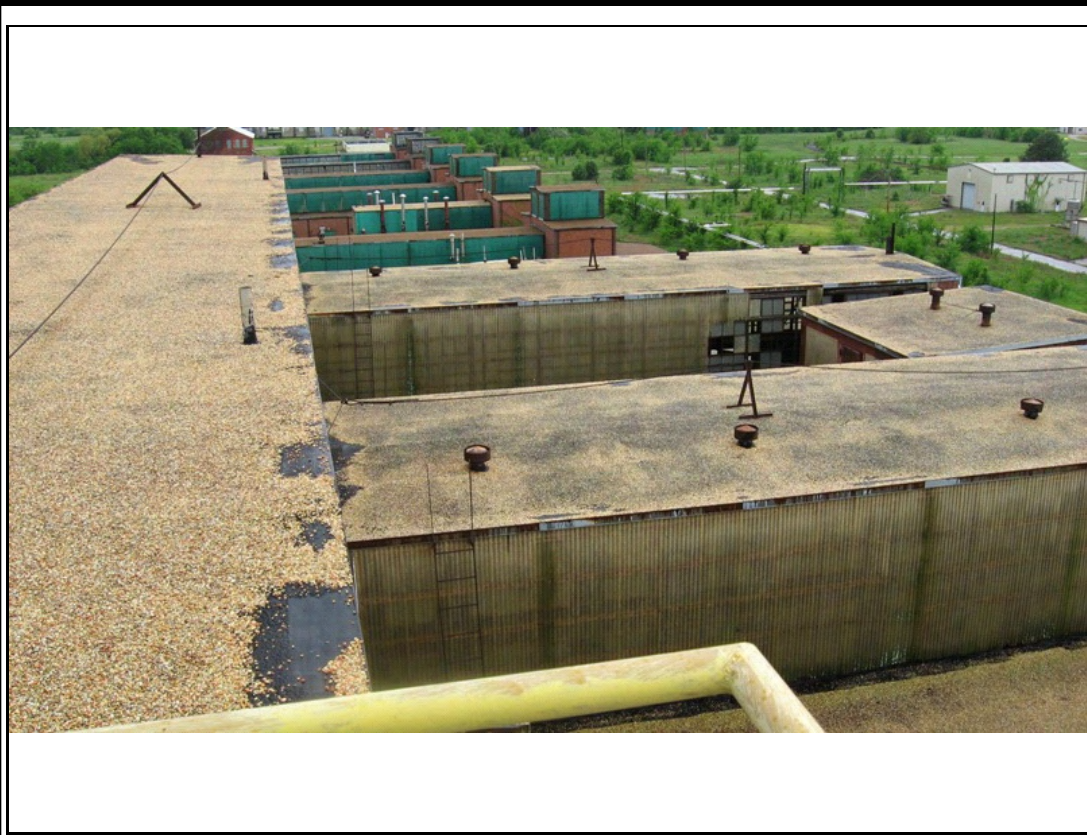
Photograph #: 23

View of roof from
penthouse stair looking
south.

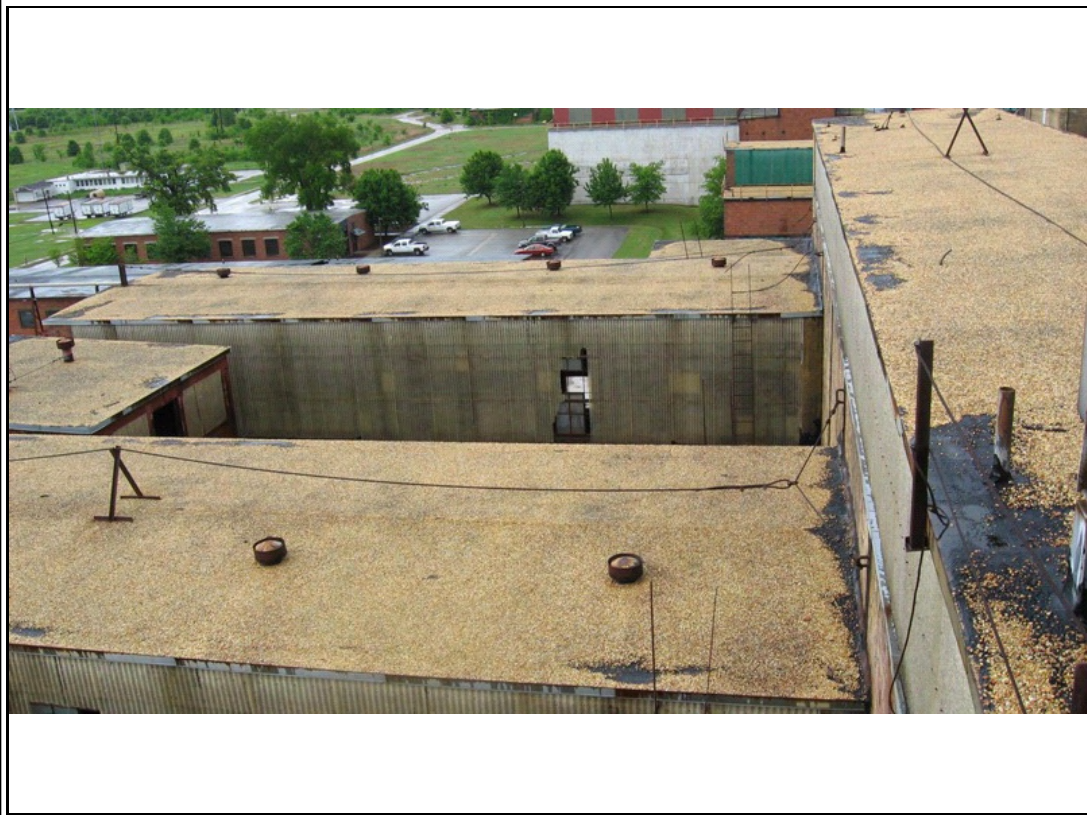
Photograph #: 24

View of roof from
penthouse stair looking
north

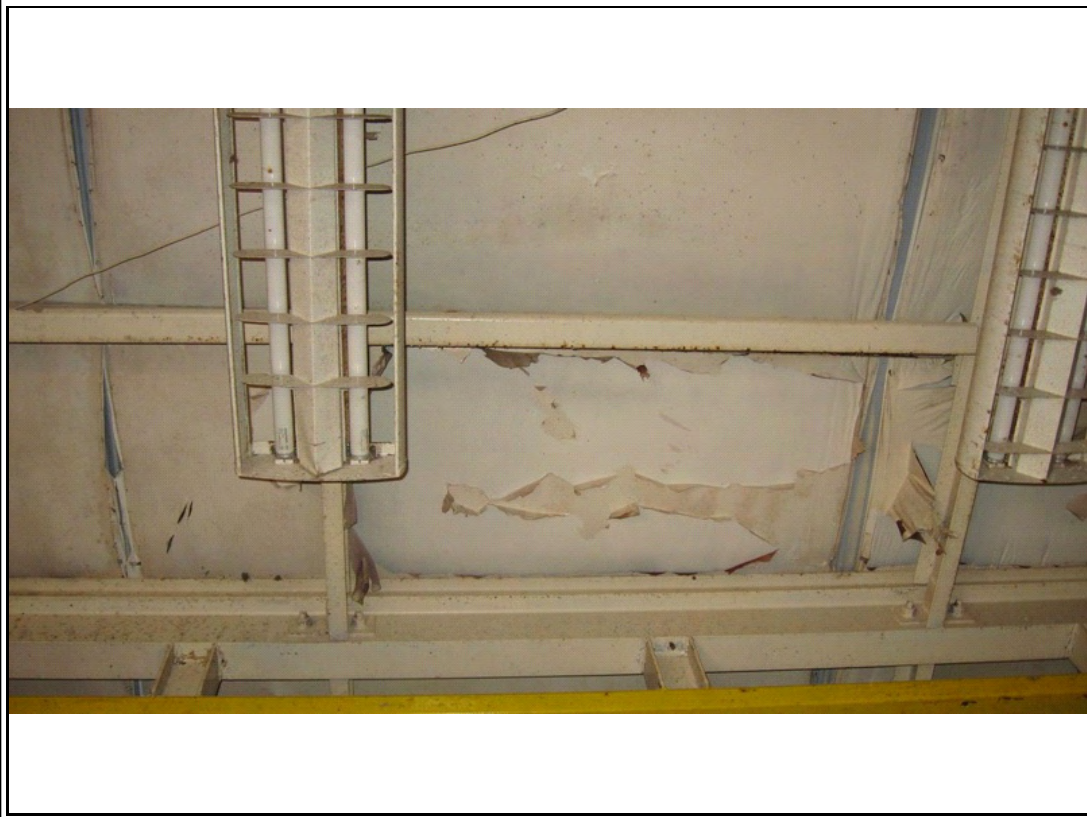
Photograph #: 26

Interior view of penthouse
roof.

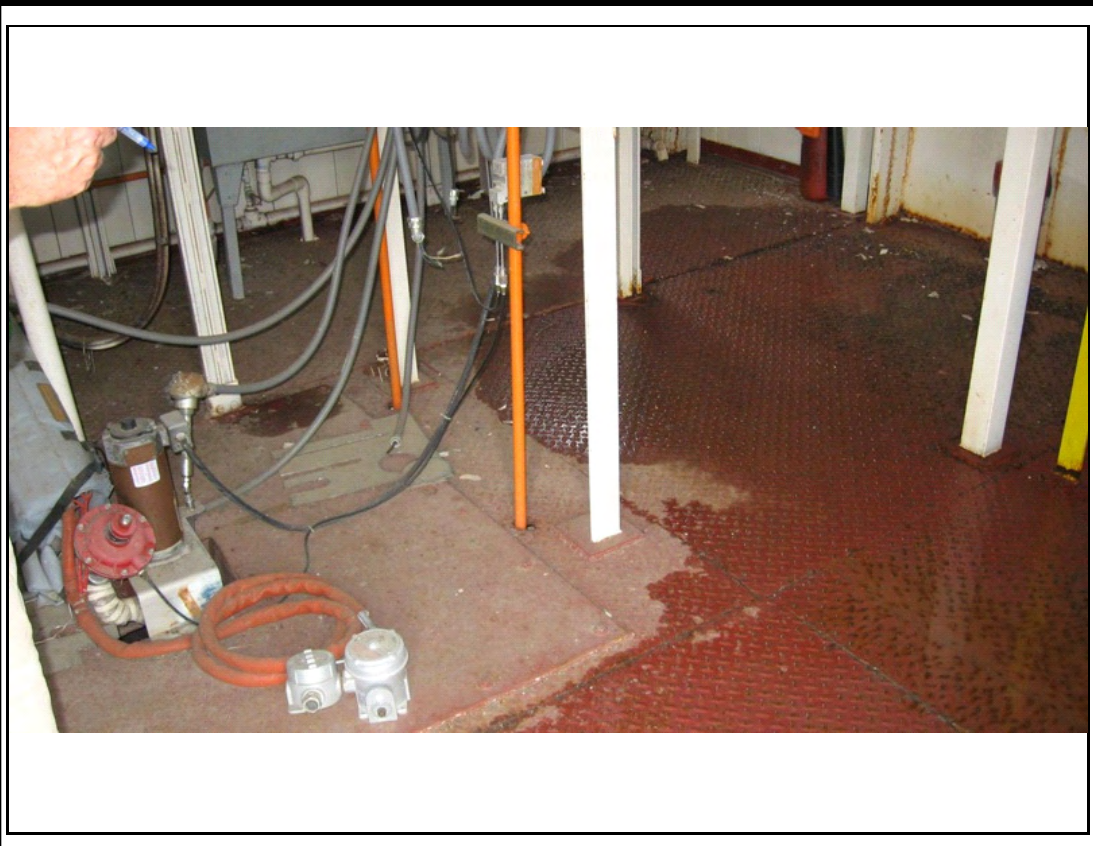
A photograph showing the topside of the upper penthouse floor. The floor is covered with a reddish-brown, textured material, possibly a safety mat or a type of flooring. There are several white vertical support columns. A bundle of orange and grey cables runs across the floor. In the foreground, there is a red fire extinguisher and some electrical equipment.	<p>Photograph #: 27</p> <p>Interior view of upper penthouse floor (topside).</p>

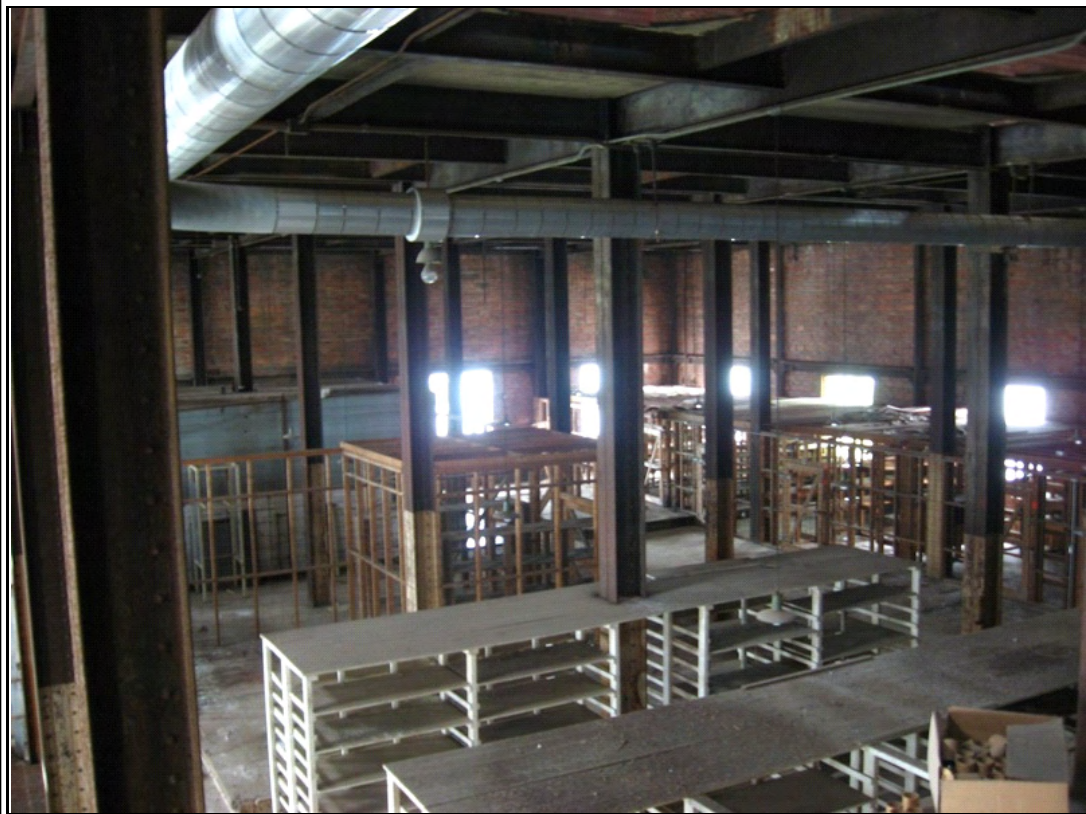
Photograph #: 29

Interior view of 2nd floor
looking south.

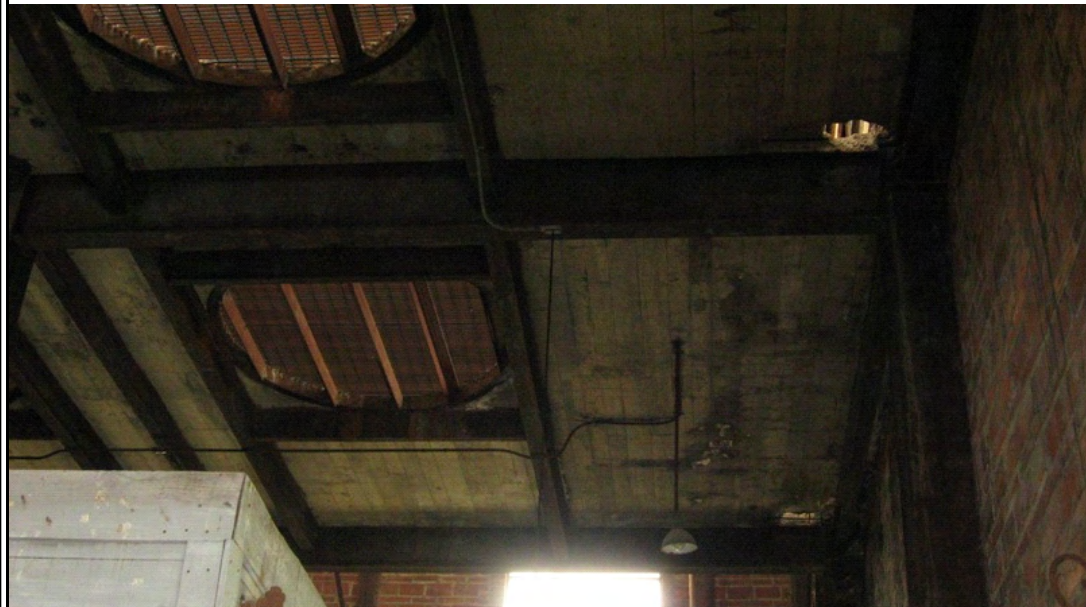
Photograph #: 30

View of voids in 3rd floor
slab from below.

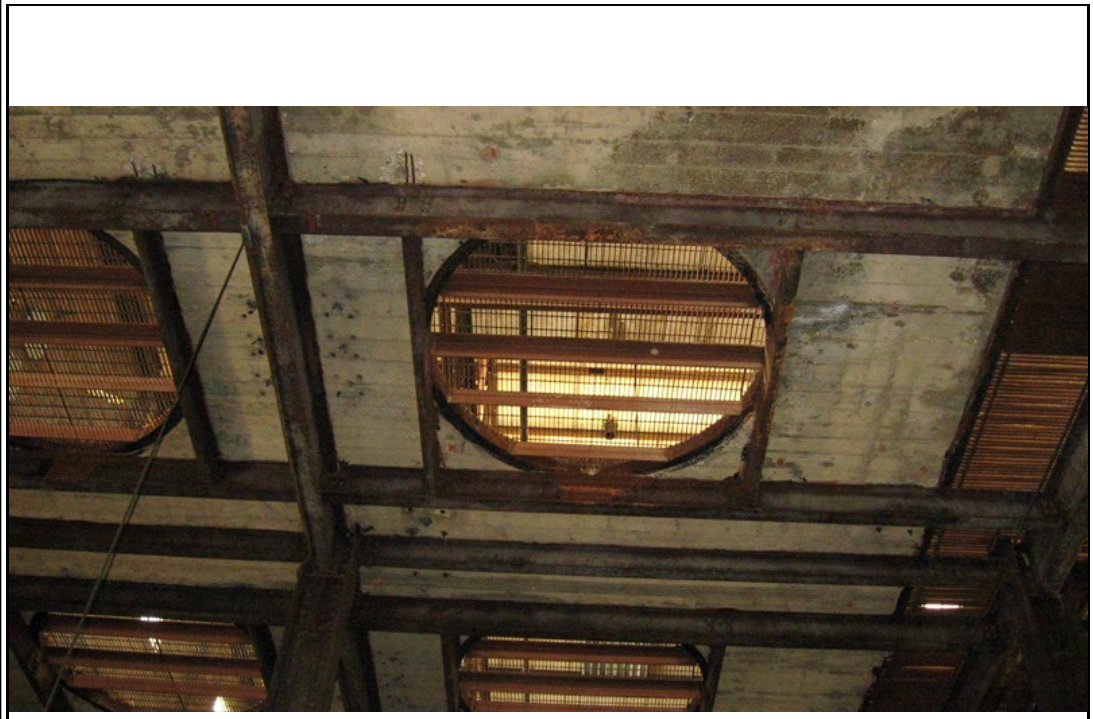
<p>Photograph #: 31</p> <p>Deteriorated steel and concrete at 3rd floor slab from below.</p>

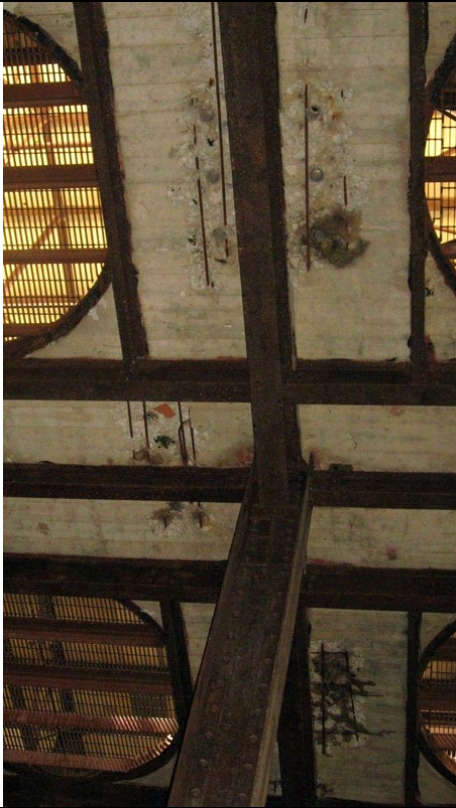
A photograph showing the underside of a third floor, featuring a network of dark, heavy steel beams. The concrete ceiling is heavily deteriorated, with large areas of missing material and exposed aggregate. Two large, arched openings with metal grates are visible on the left and right sides, through which bright light is streaming.	<p>Photograph #: 33</p> <p>Structural damage at underside of 3rd floor.</p>

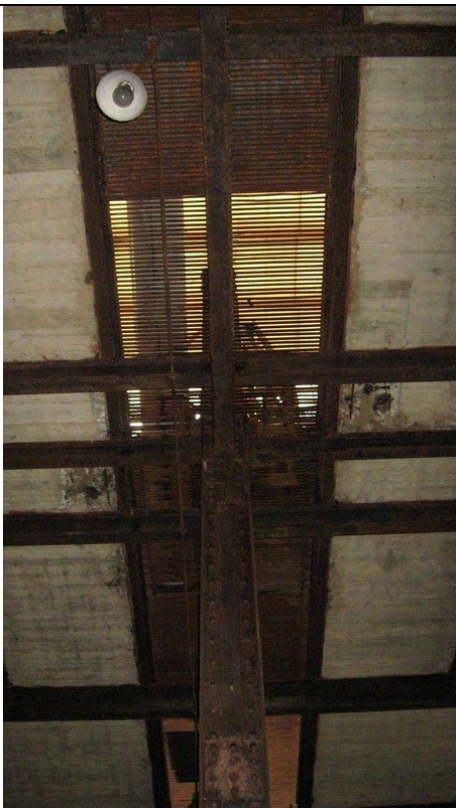
A photograph showing another section of the underside of the third floor. It features a similar steel beam structure and a damaged concrete ceiling. A single, round, white light fixture is mounted on a beam in the upper left. Large, rectangular openings with metal grates are visible in the background, with light shining through them.	<p>Photograph #: 34</p> <p>Structural damage at underside of 3rd floor.</p>

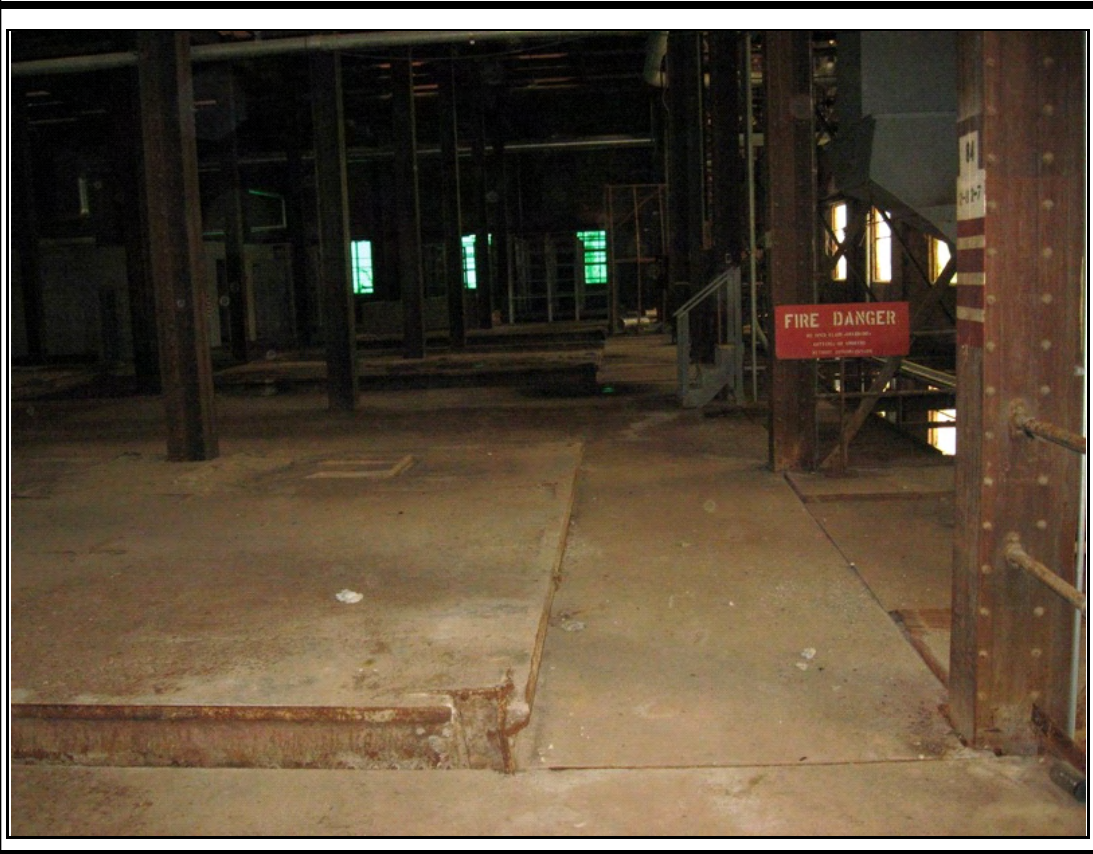
A photograph showing a view of the second floor of the same building from the top. The floor is made of concrete and appears somewhat worn. In the background, there are several vertical steel columns supporting the structure. To the right, there is a set of stairs and a red sign that reads "FIRE DANGER". The lighting is brighter here, possibly from windows or overhead lights.	<p>Photograph #: 36</p> <p>View of 2nd floor from topside.</p>

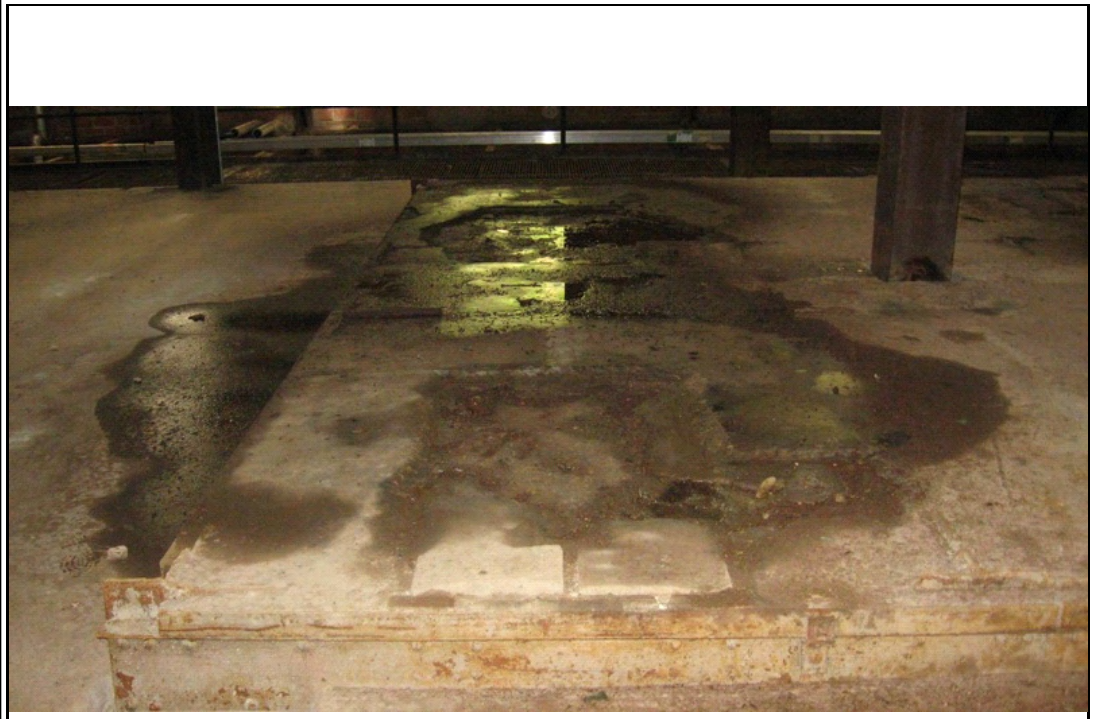
A photograph showing a concrete floor slab with significant deterioration. The surface is uneven, with large areas of discoloration and exposed aggregate. A rectangular section of the slab is missing, revealing a rough, pitted interior. The surrounding area is also stained and shows signs of wear.	<p>Photograph #: 37</p> <p>Deterioration at raised slab - topside of 2nd floor.</p>

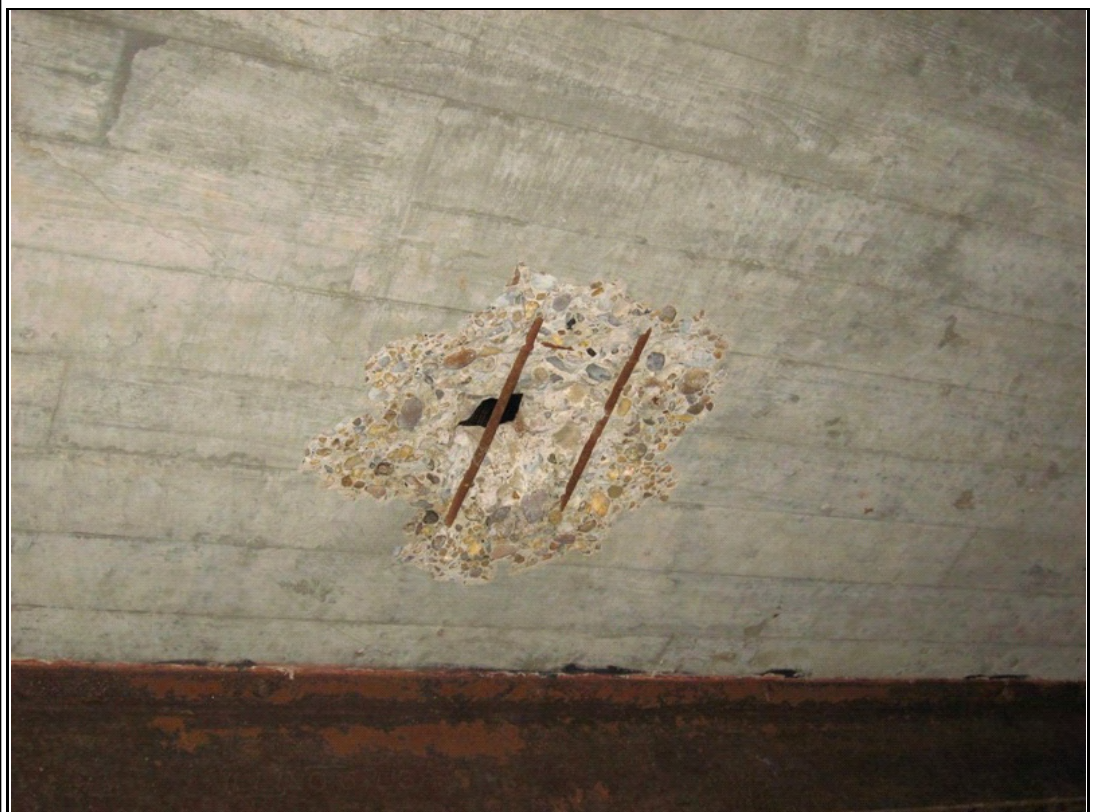
A photograph showing structural damage on the underside of a concrete slab. Two vertical rebar rods are visible, protruding from a large, irregular hole in the concrete. The surrounding concrete is cracked and crumbling. The bottom edge of the image shows a dark, possibly rusted, metal beam.	<p>Photograph #: 38</p> <p>Structural damage at underside of 2nd floor.</p>

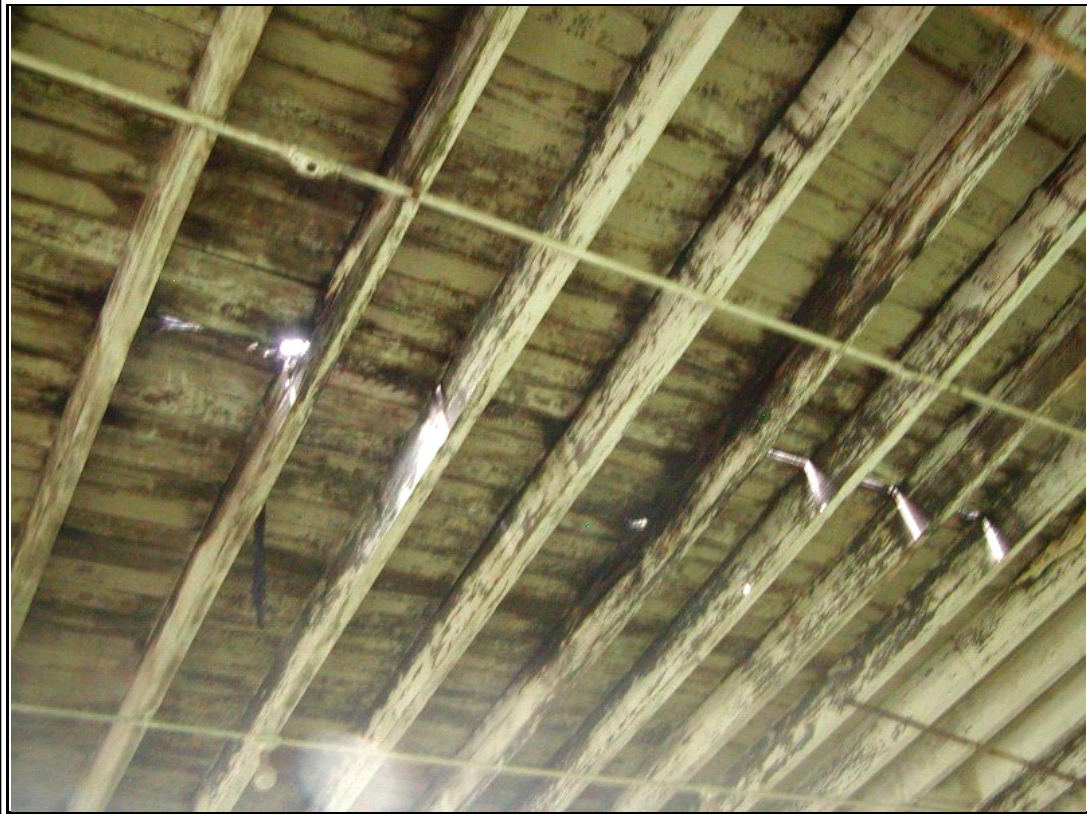
Photograph #: 3

Severely decayed wood roof structure with daylight visible through voids in wood plank deck.

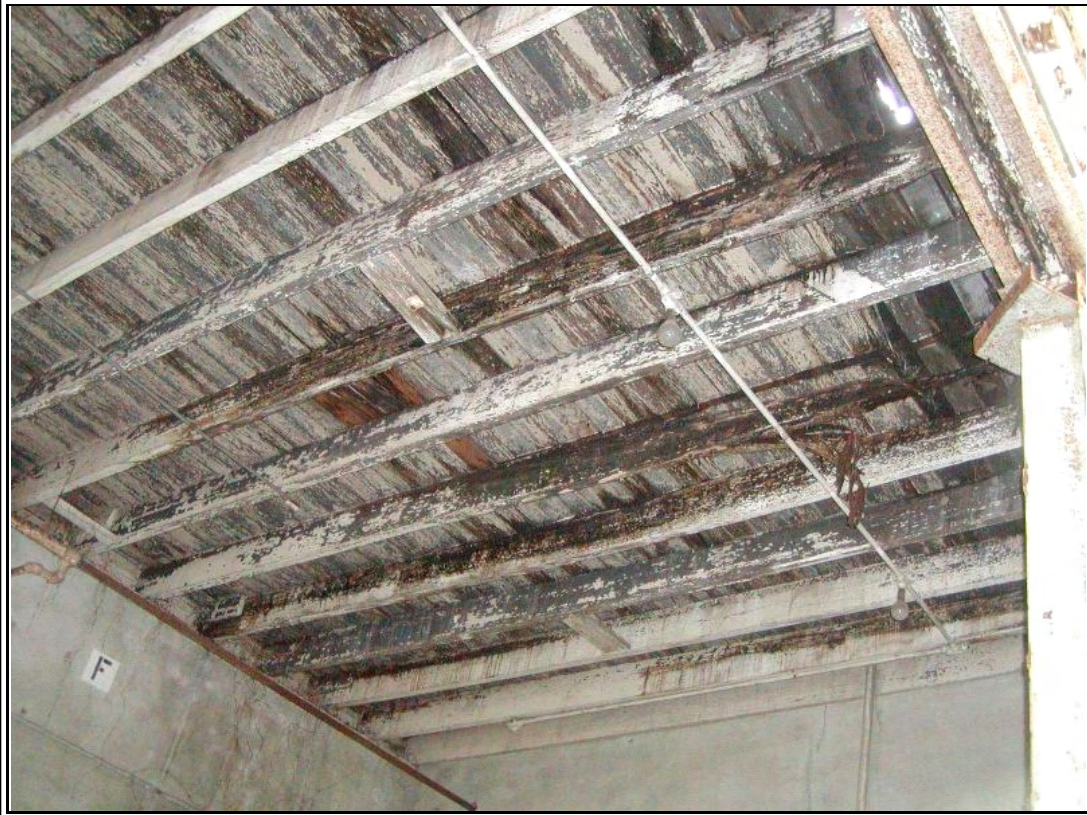
Photograph #: 4

Severely deteriorated wood roof structure.

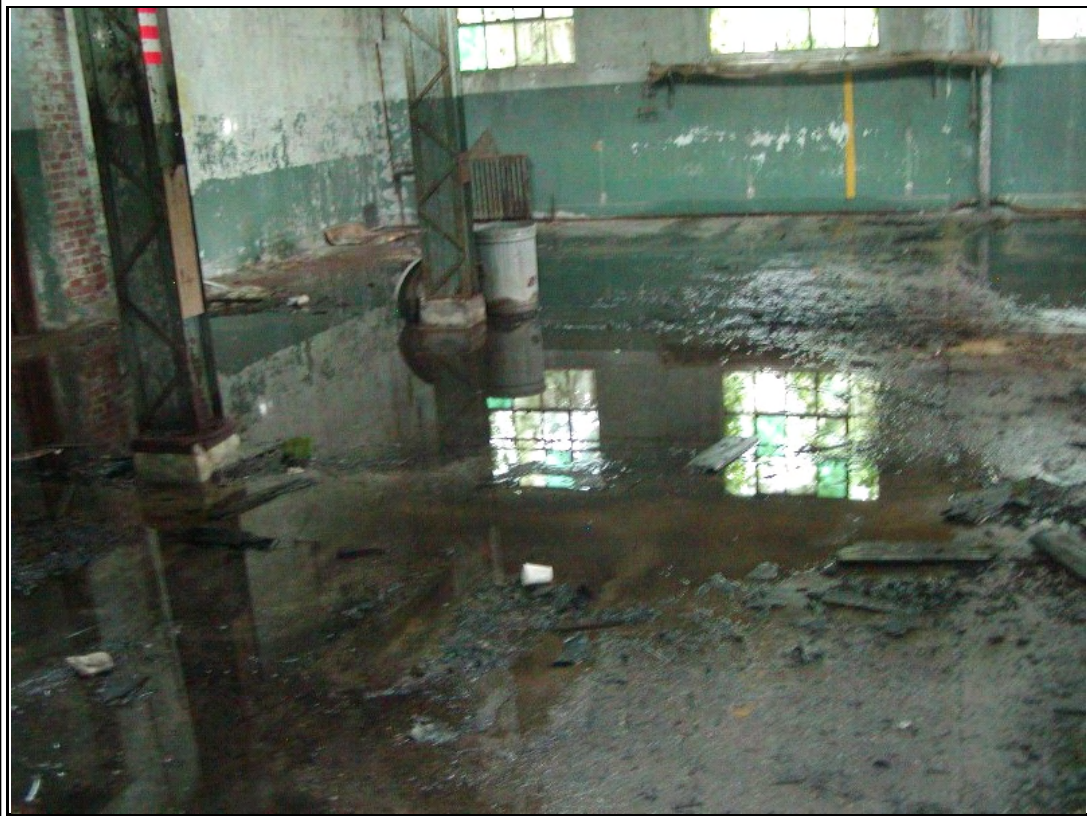
Photograph #: 5

Standing water on floor inside building; corroded steel columns.

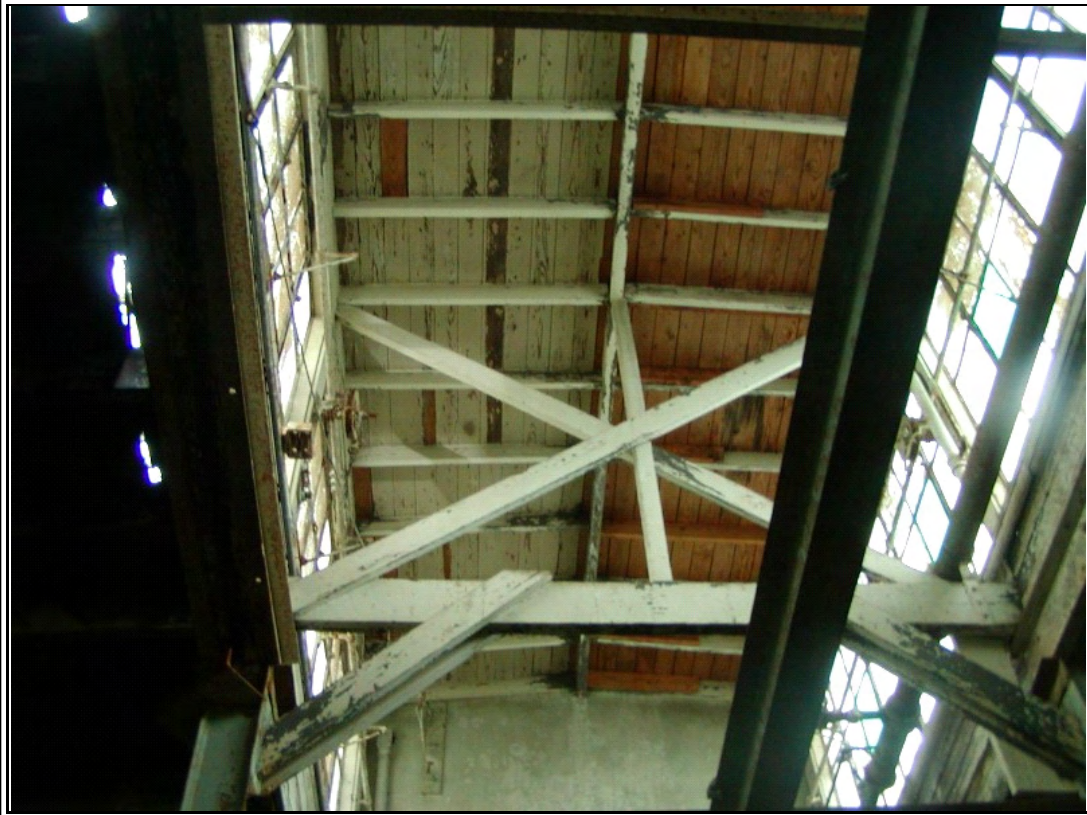
Photograph #: 6

Partially repaired roof deck at clerestory monitor.

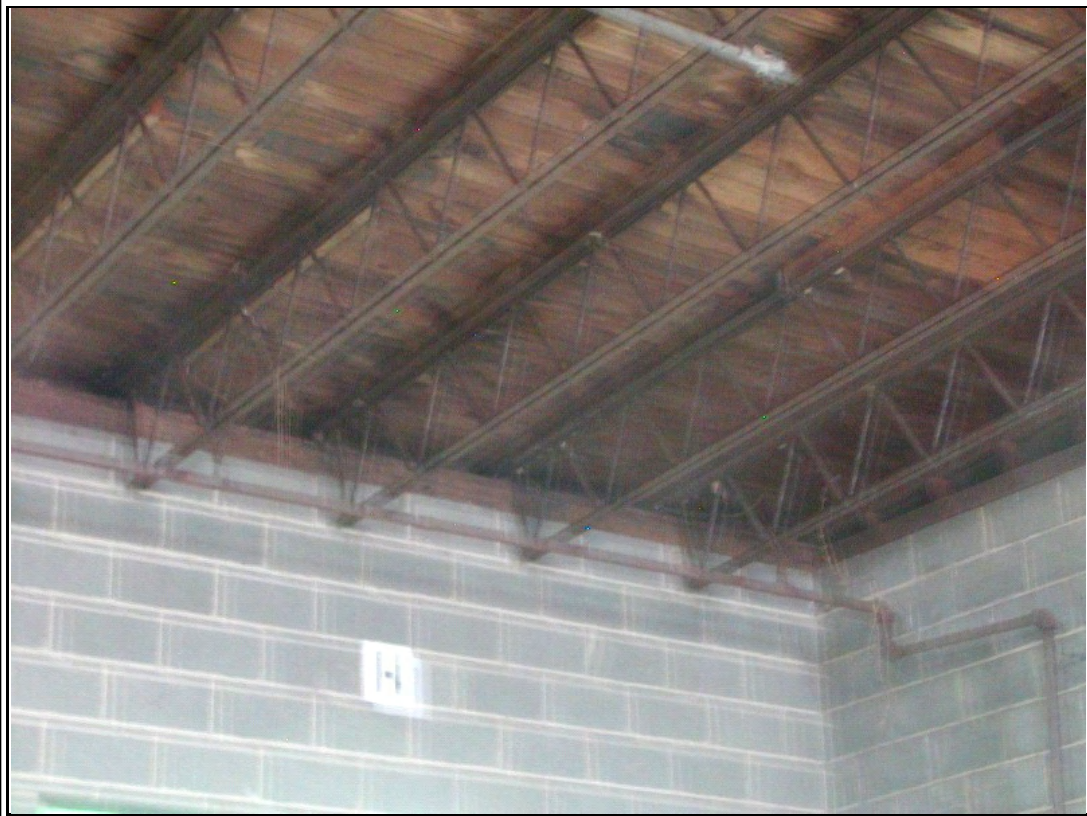
Photograph #: 7

Wood plank roof deck at east addition is damaged by water intrusion.

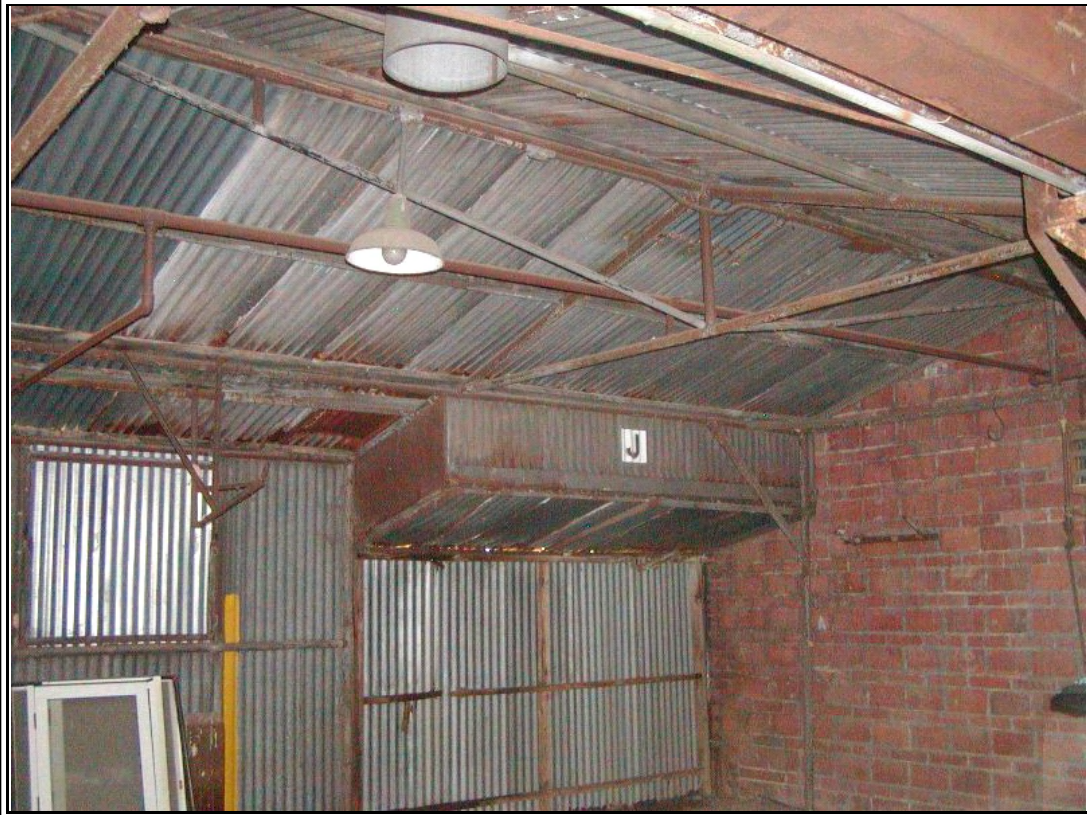
Photograph #: 8

Corroded metal roof deck and steel framing at east addition.

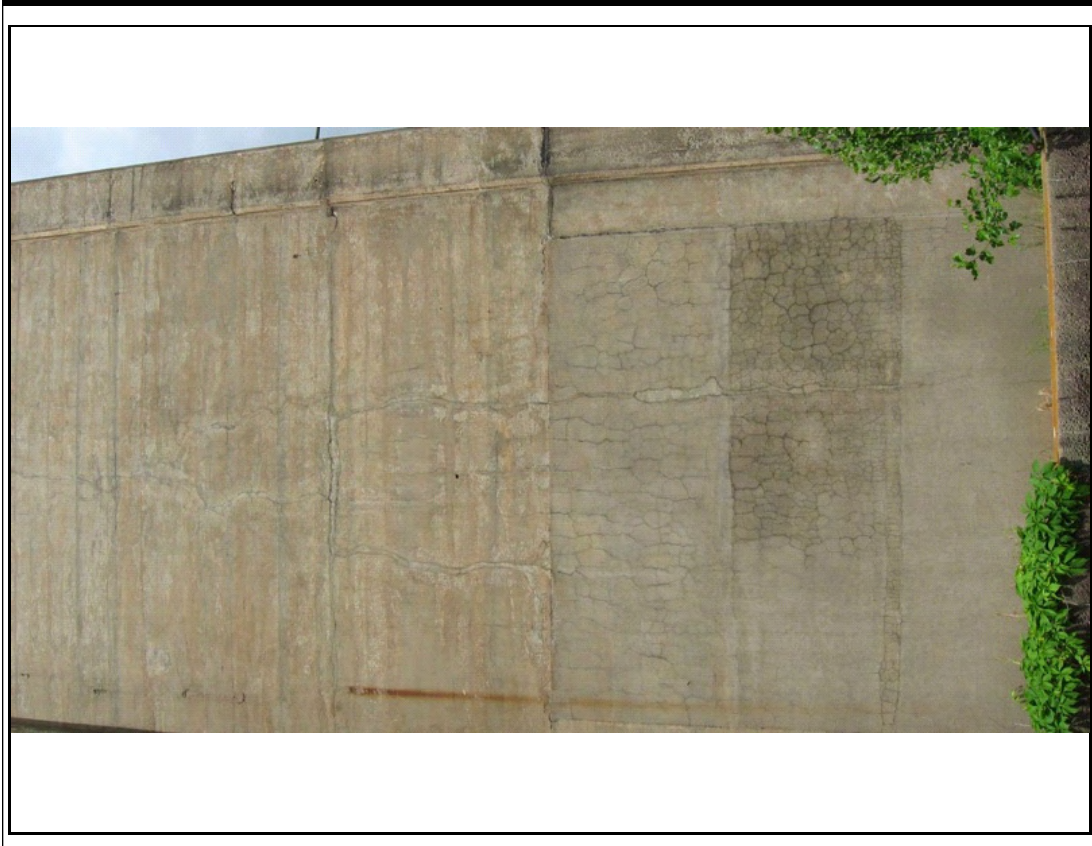
<p>Photograph #: 3</p> <p>Surface cracks at concrete building - east side.</p>
