Structural Assessment

Muscle Shoals Reservation
adaptive re-use study

Conditions/Market/Planning/Implementation

July 31, 2009
Revised August 25, 2009

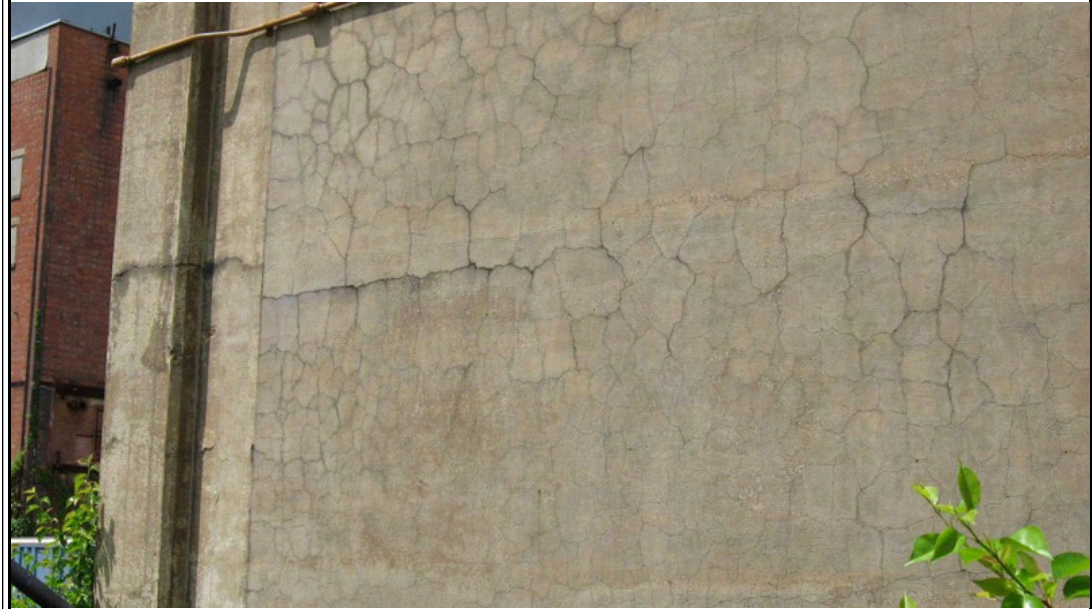
<p>Photograph #: 5</p> <p>Concrete building - surface cracks and horizontal crack at southeast corner column.</p>

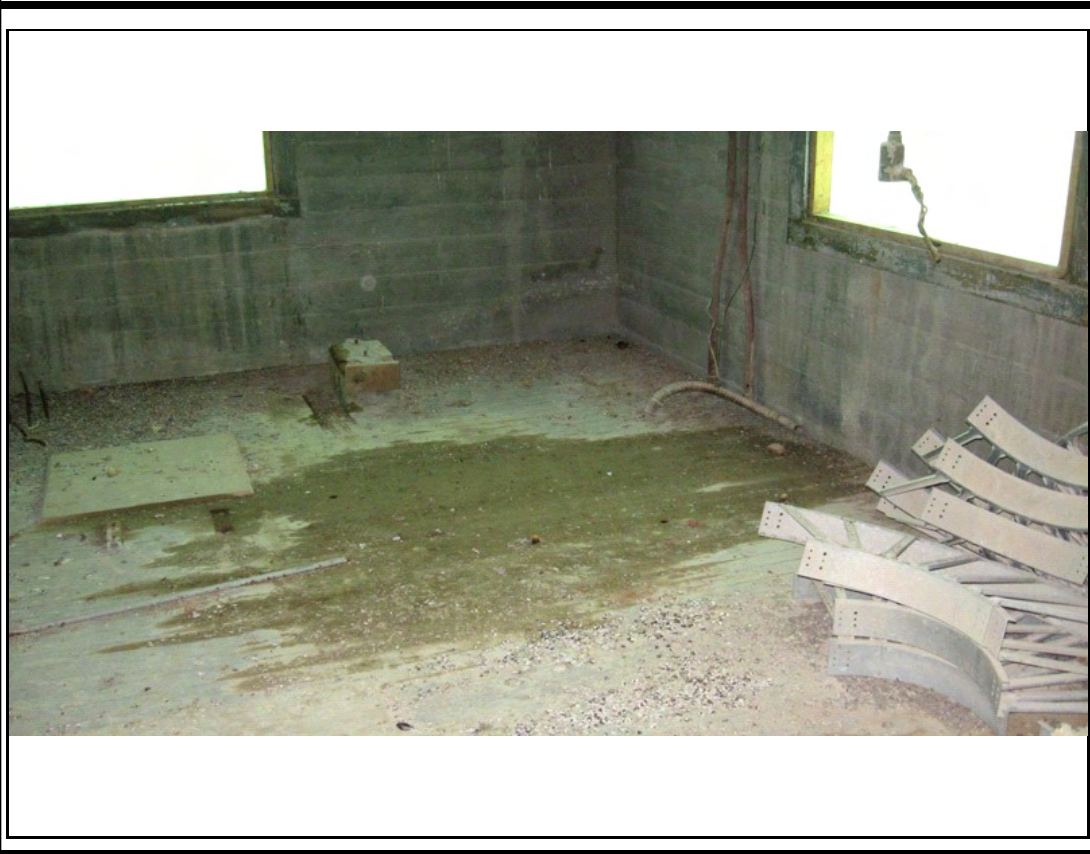
<p>Photograph #: 10</p> <p>Concrete building - water intrusion evident on penthouse floor.</p>

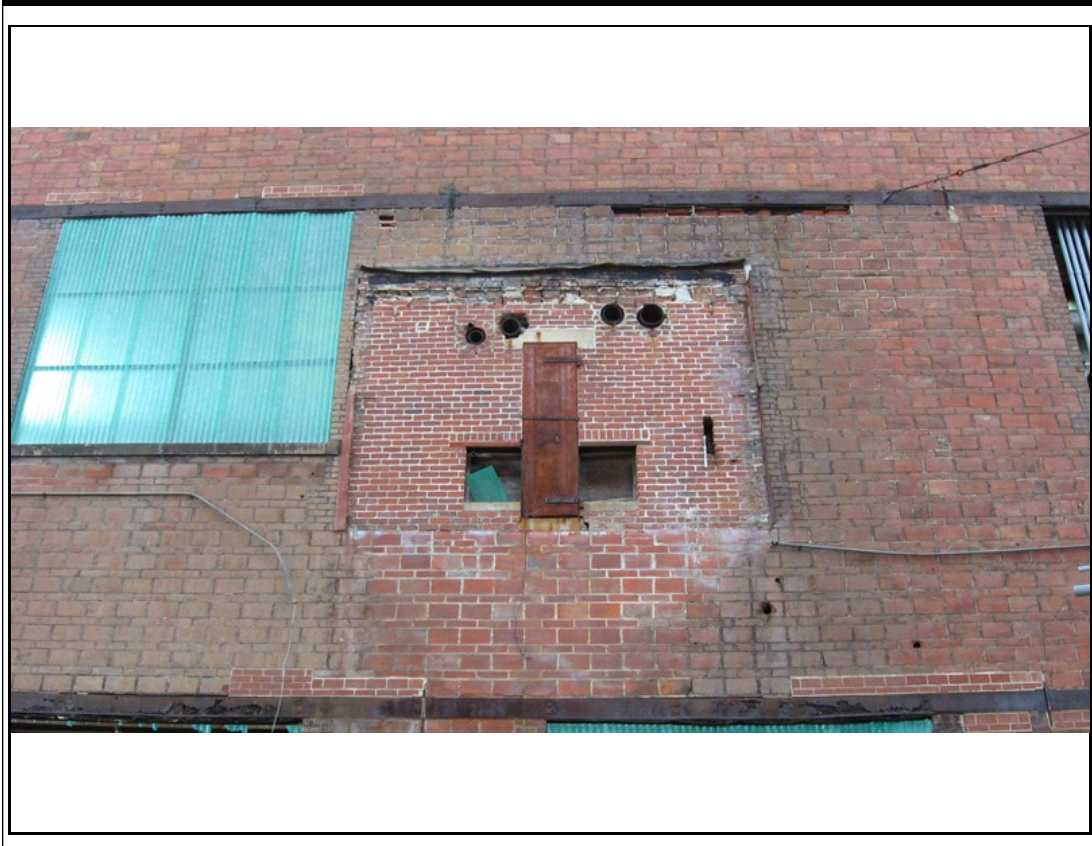
A photograph showing a section of a brick wall with significant deterioration. A large rectangular area of the brickwork is missing, revealing a wooden door frame and three small circular openings above it. To the left of this opening is a section of green corrugated metal siding. The surrounding brickwork is weathered and discolored.	<p>Photograph #: 13</p> <p>Spalled masonry and corroded steel lintel beams - south side.</p>

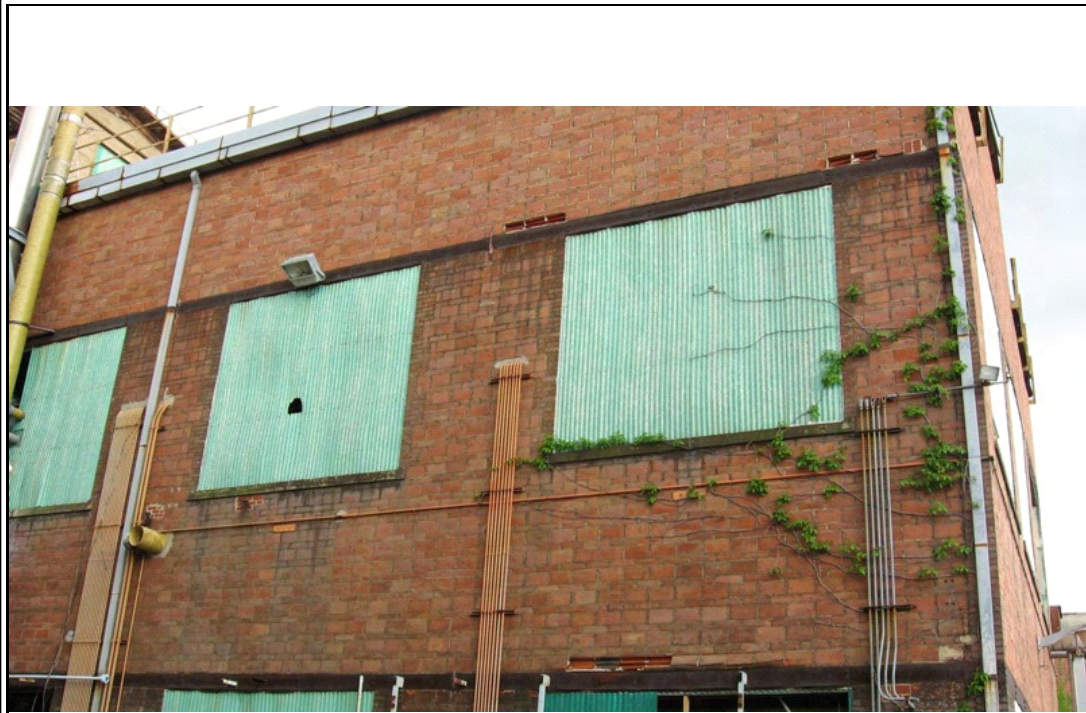
Photograph #: 15

Spalled masonry and corroded steel lintel beams - north side.

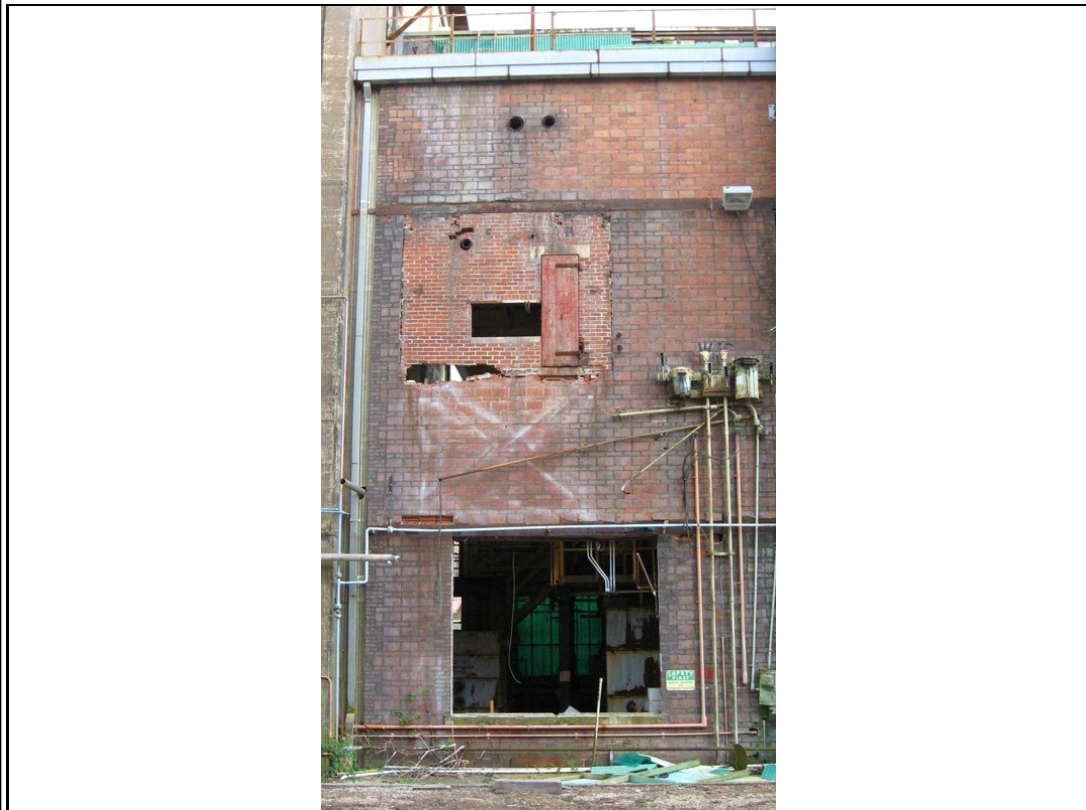
Photograph #: 16

Defective exterior masonry, including partially collapsed brick infill - north side.

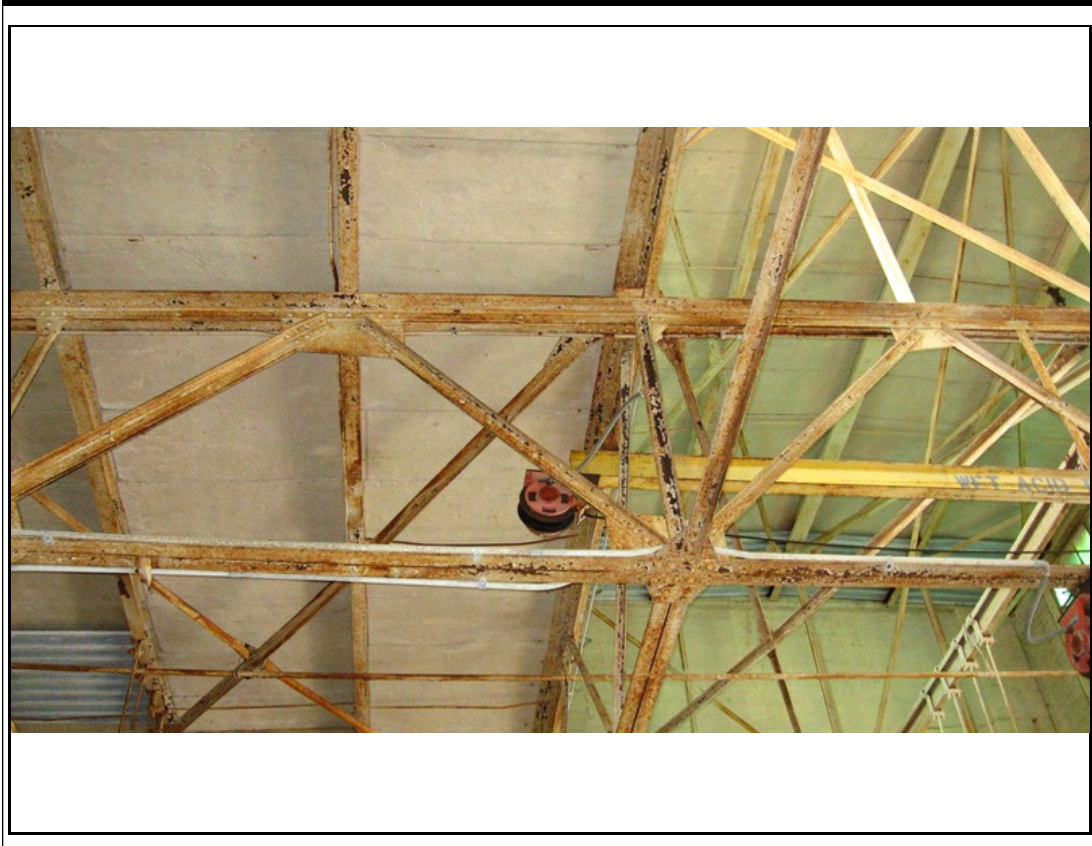
<p>Photograph #: 17</p> <p>Moderately corroded steel framing in masonry building.</p>

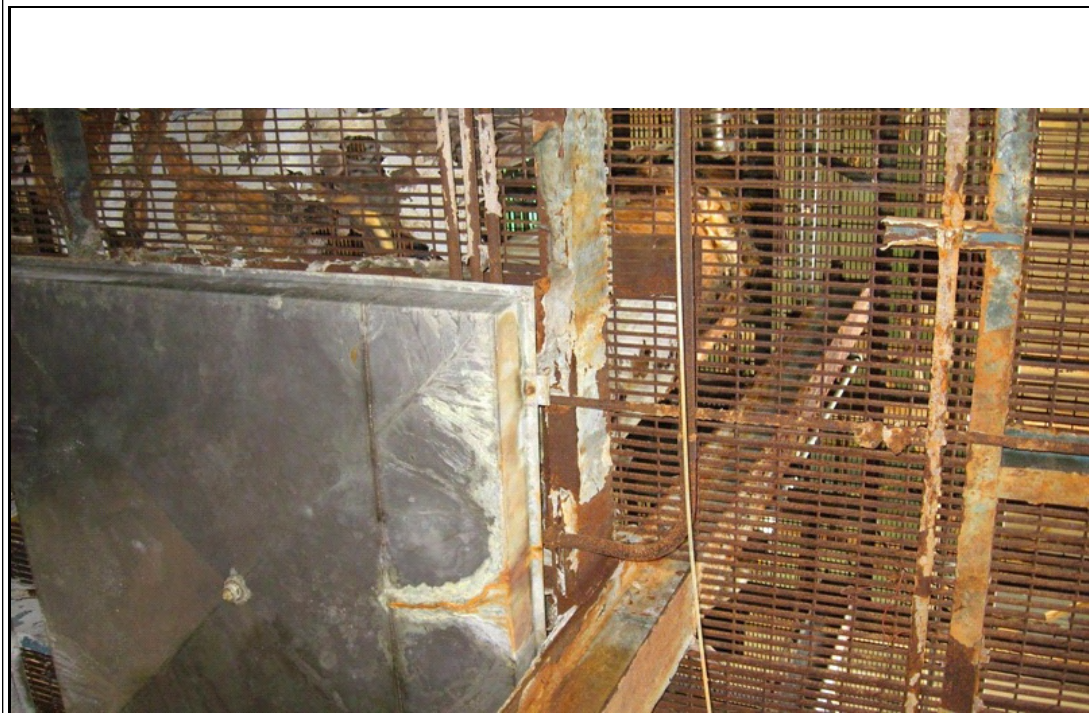
Photograph #: 22

Building 54 Grinding Building				
Defect Item No.	Defect Description	Quantity/ Unit of Measure	Repair Code/ Remarks	Photo Log Reference No.
1	Loose railing on top level.	15 LF		
2	Severe corrosion of steel at multi-level mezzanine.	70 %	R-S-2	22
3	Large hole in masonry wall.	40 SF	R-M-4	21
4	Mild corrosion of vertical trusses.	50 %	R-S-1	
5	Moderate corrosion of vertical trusses.	50 %	R-S-1	
6	Mild corrosion of horizontal trusses.	50 %	R-S-1	
7	Moderate corrosion of horizontal trusses.	50 %	R-S-1	17,18
8	Minor spalls in low roof deck.	20 SF	R-D-1	20
9	Spalls in masonry wall	98 SF	R-M-3	
10	Crack in masonry wall	70 LF	R-M-2	
11	Corroded steel lintels or girders across 2 openings	40 LF	R-S-3	
12	Cracks in monitor	10 LF	R-C-1	
13	Minor spalls in exterior wall	85 SF	R-M-1	
14	Vertical and horizontal narrow cracks in exterior wall	50 LF	R-M-2	
15	Horizontal and vein cracks in exterior wall	50 LF	R-M-2	
Repair Code - Description

Severely corroded steel at multi-level interior mezzanine.

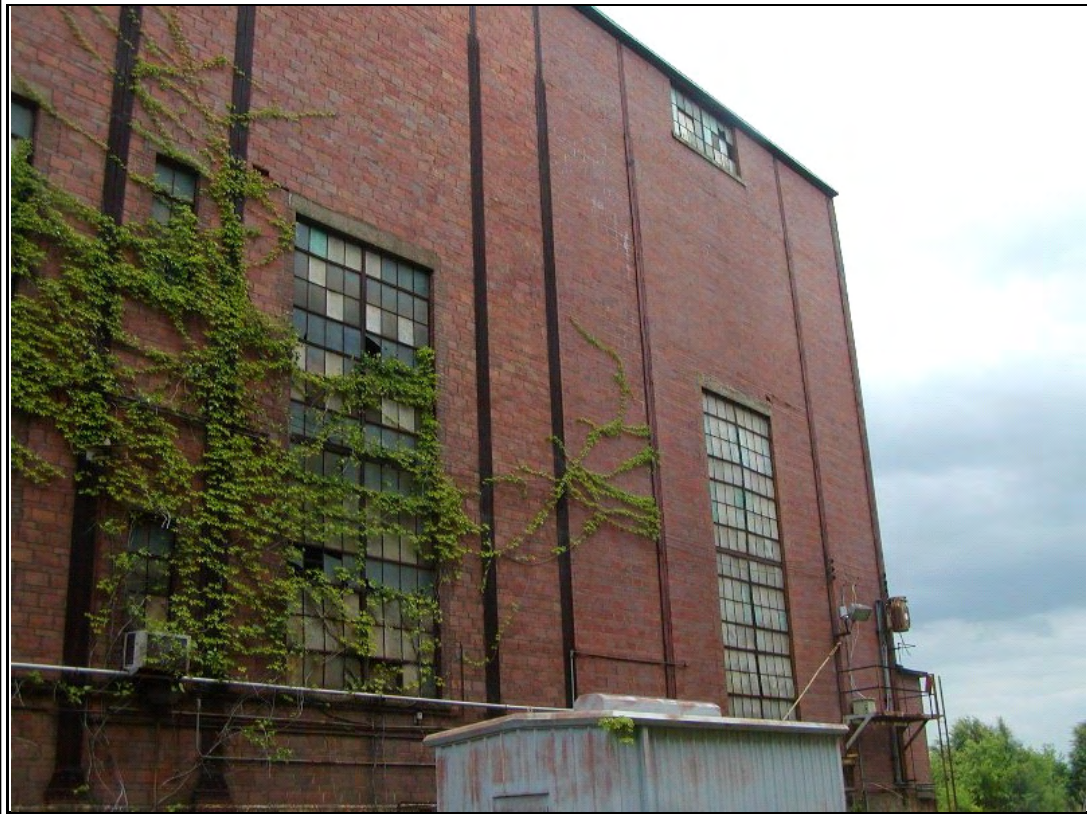
Photograph #: 7

Exterior building - west wall

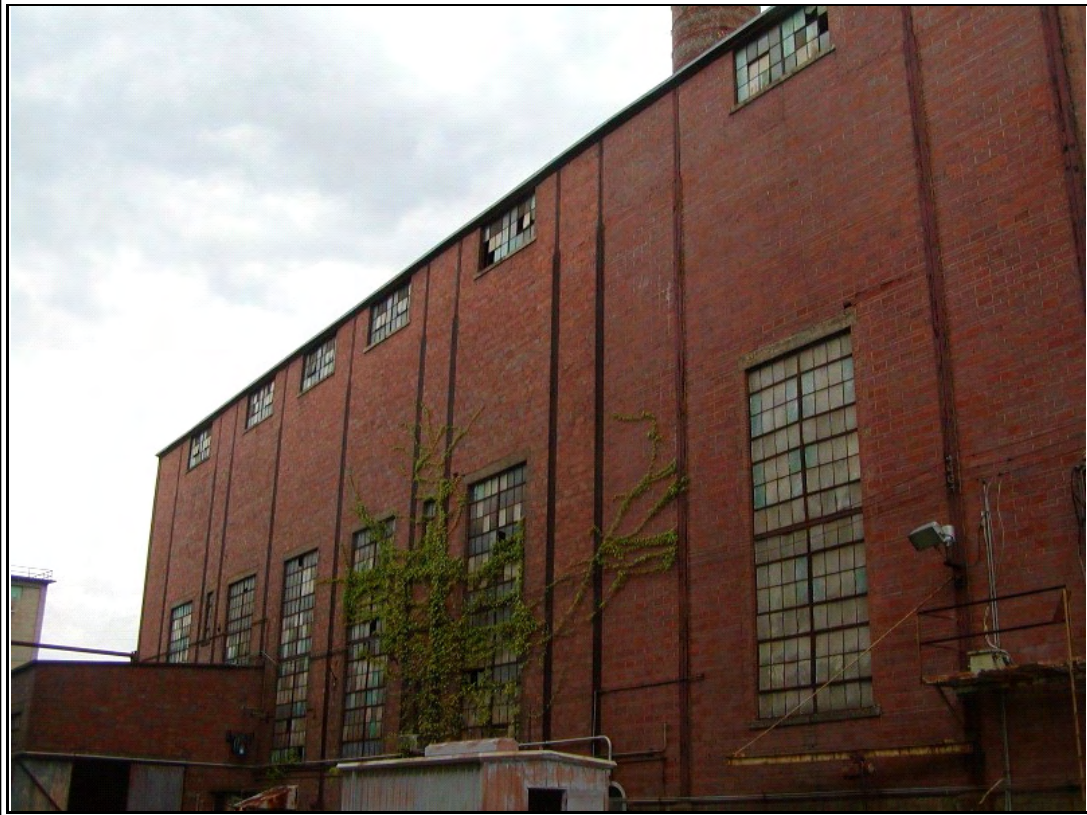
Photograph #: 8

Exterior building - west wall

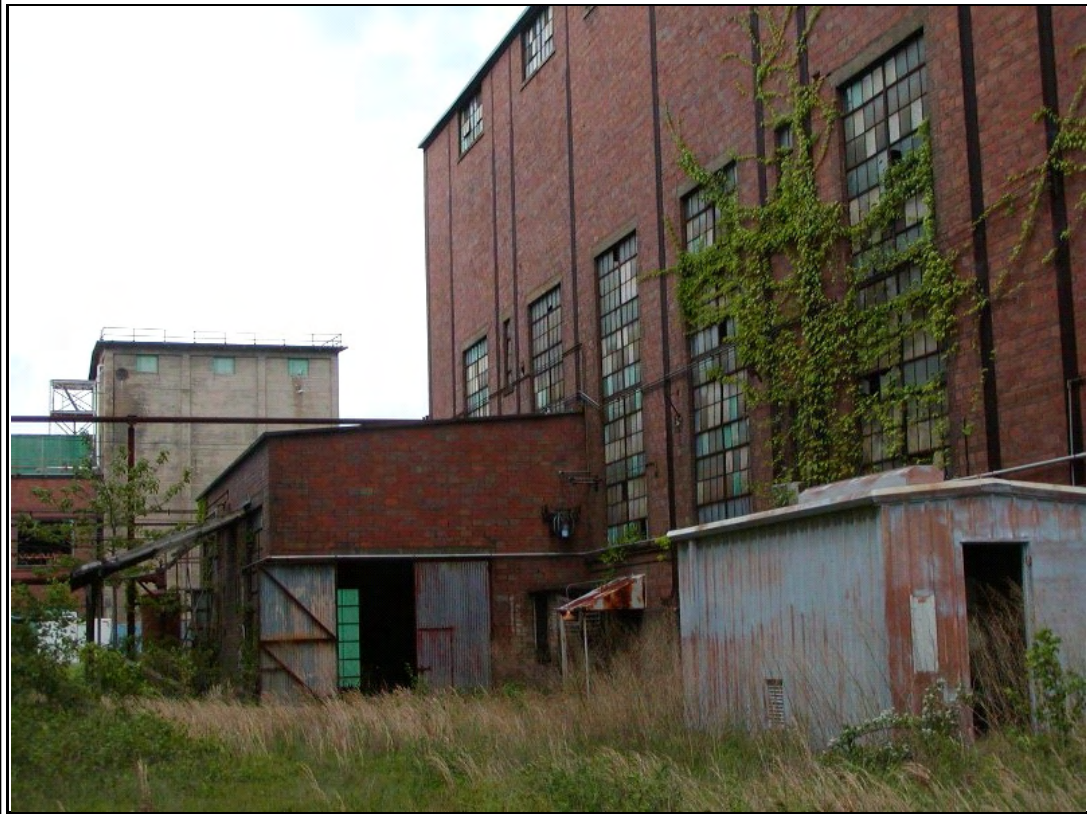
Photograph #: 9

Exterior building looking at west addition

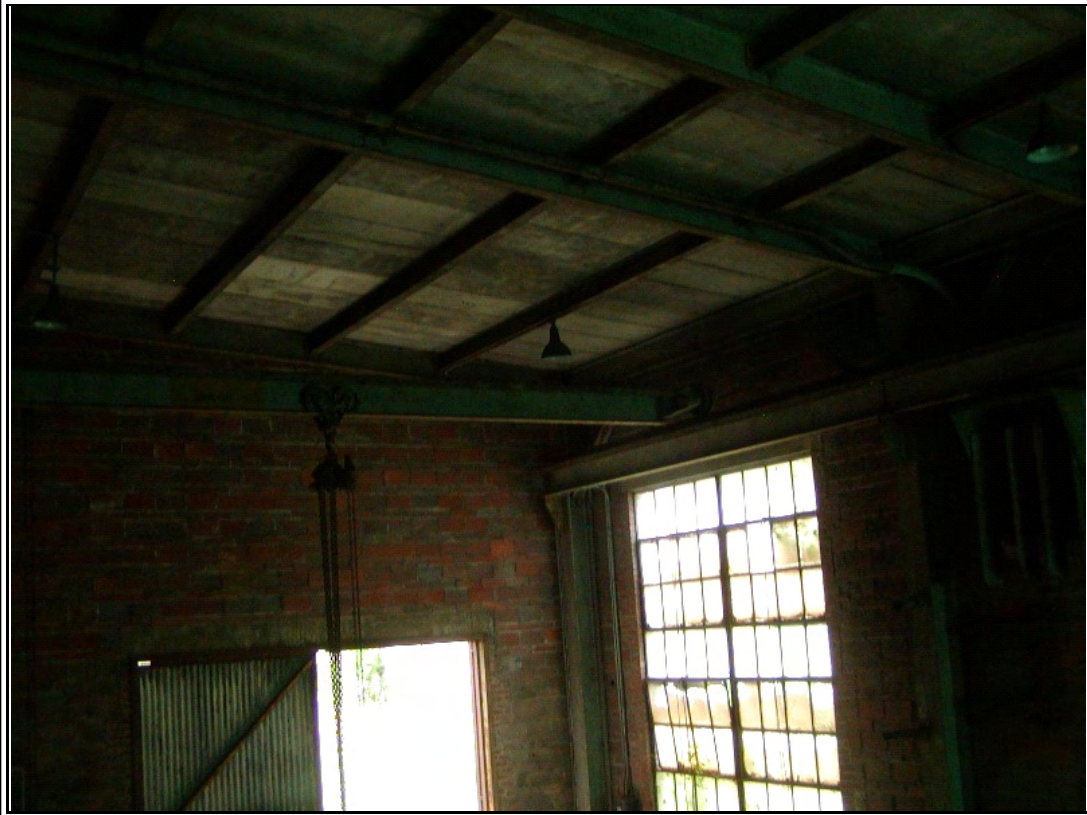
Photograph #: 10

Deteriorated wood roof at west addition

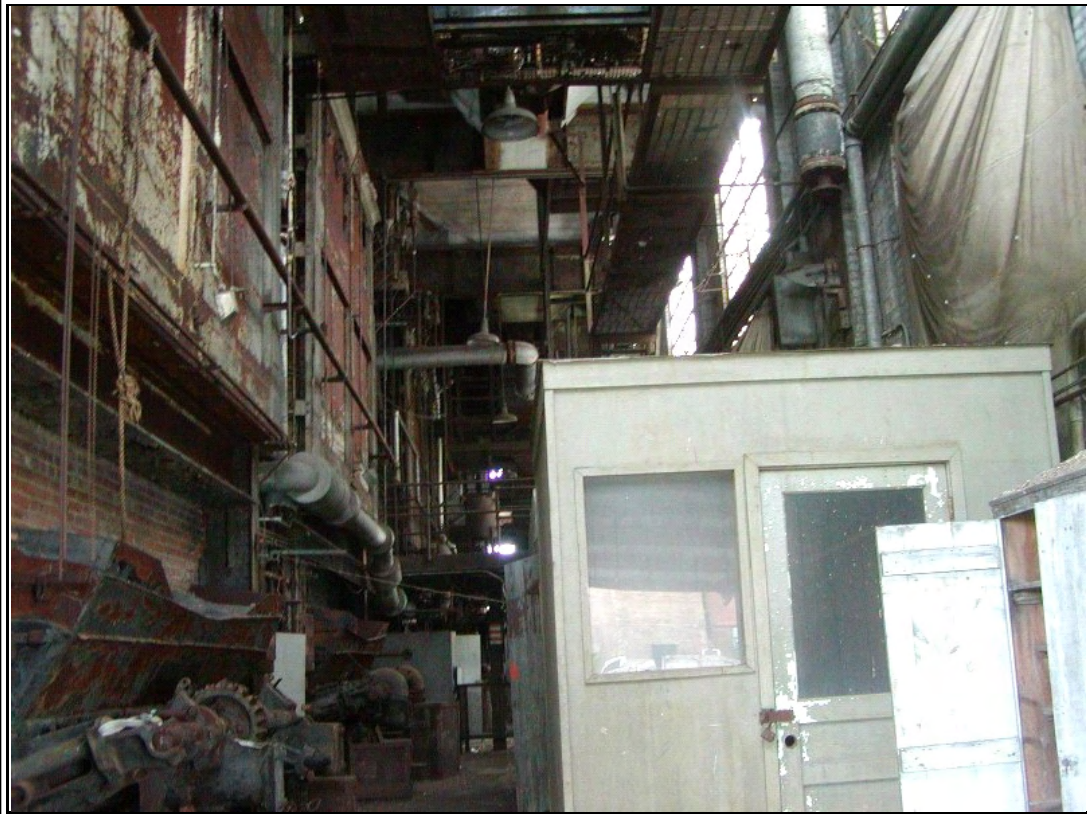
Photograph #: 11

View of interior building with limited access

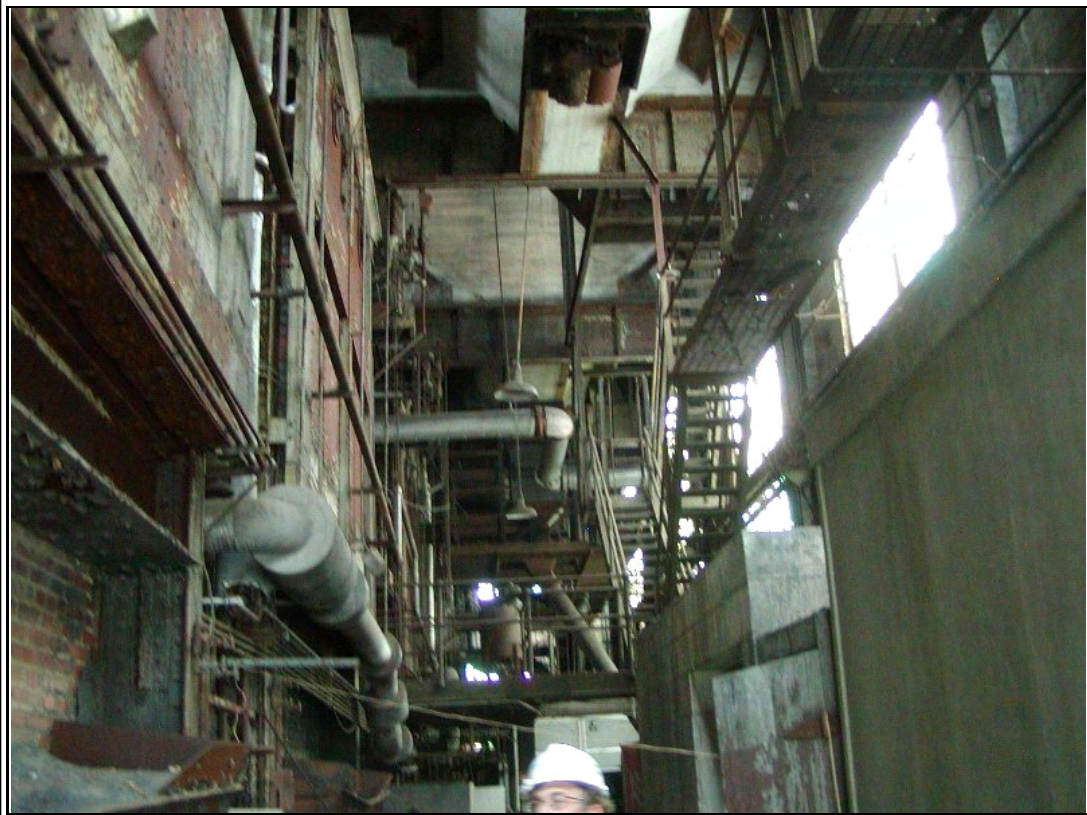
Photograph #: 12

View of interior building with limited access

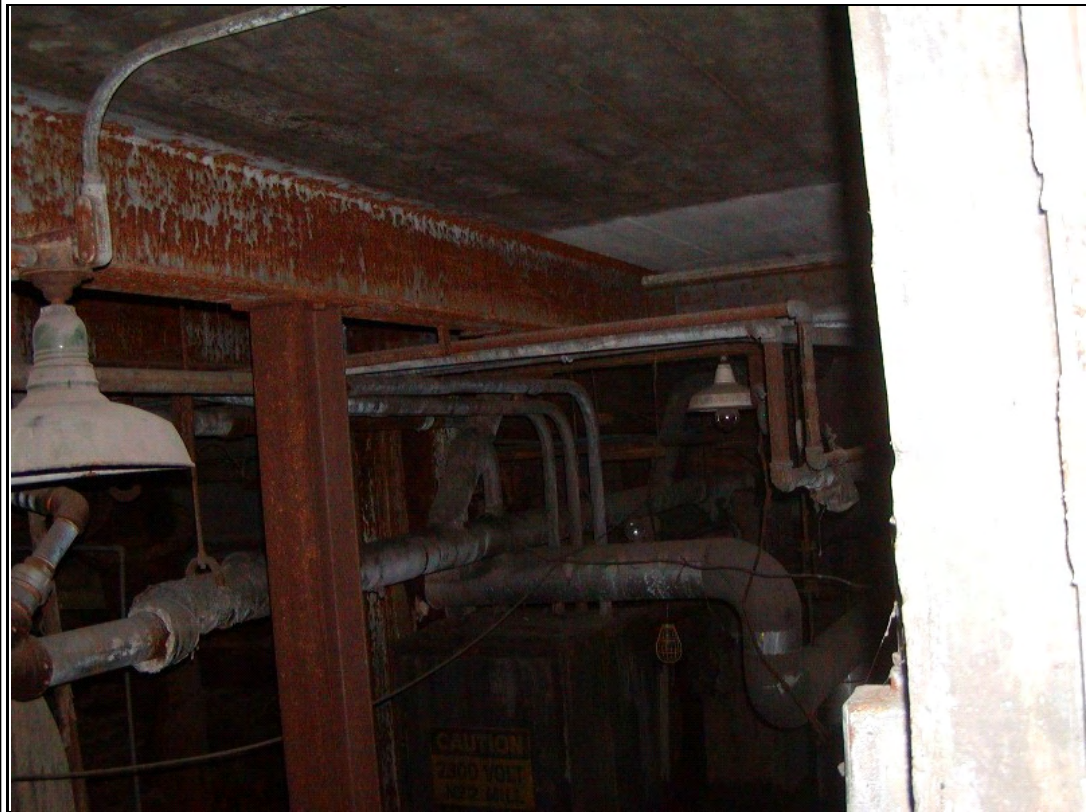
Photograph #: 13

Building 56 Boiler House				
Defect Item No.	Defect Description	Quantity/ Unit of Measure	Repair Code/ Remarks	Photo Log Reference No.
1	Basement steel framing is heavily corroded - very limited access		R-S-3	13,14
2	Wood awning is deteriorated		R-A-1	9
3	Cracking in the exterior brick masonry wall at southwest, southeast, northeast, and northwest corners of the building	120 LF	R-M-8	
Repair Code - Description				
R-A-1	Repair damaged awning			
R-M-8	Repair voids in masonry with appropriate filler. Repair cracks in masonry with appropriate sealant. Repair spalls in masonry with matching material.			
R-S-3	Replace structural steel framing

Corroded steel framing in basement

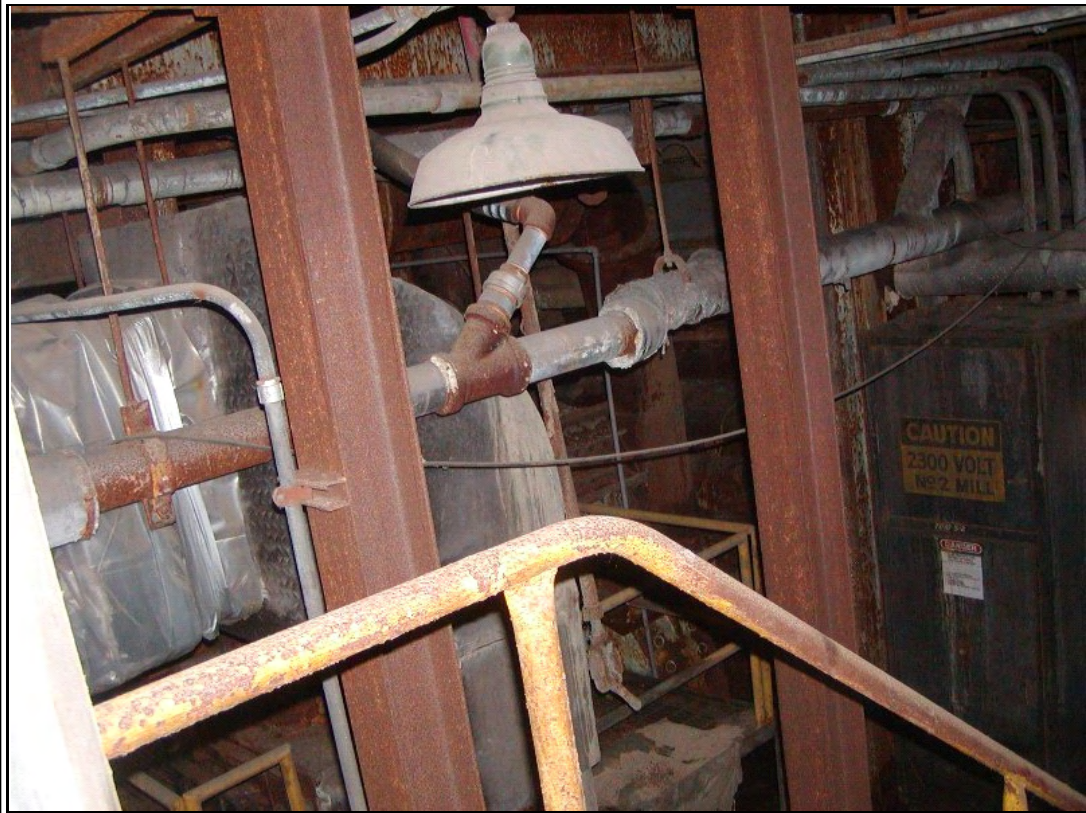
Photograph #: 14

Corroded steel framing in basement

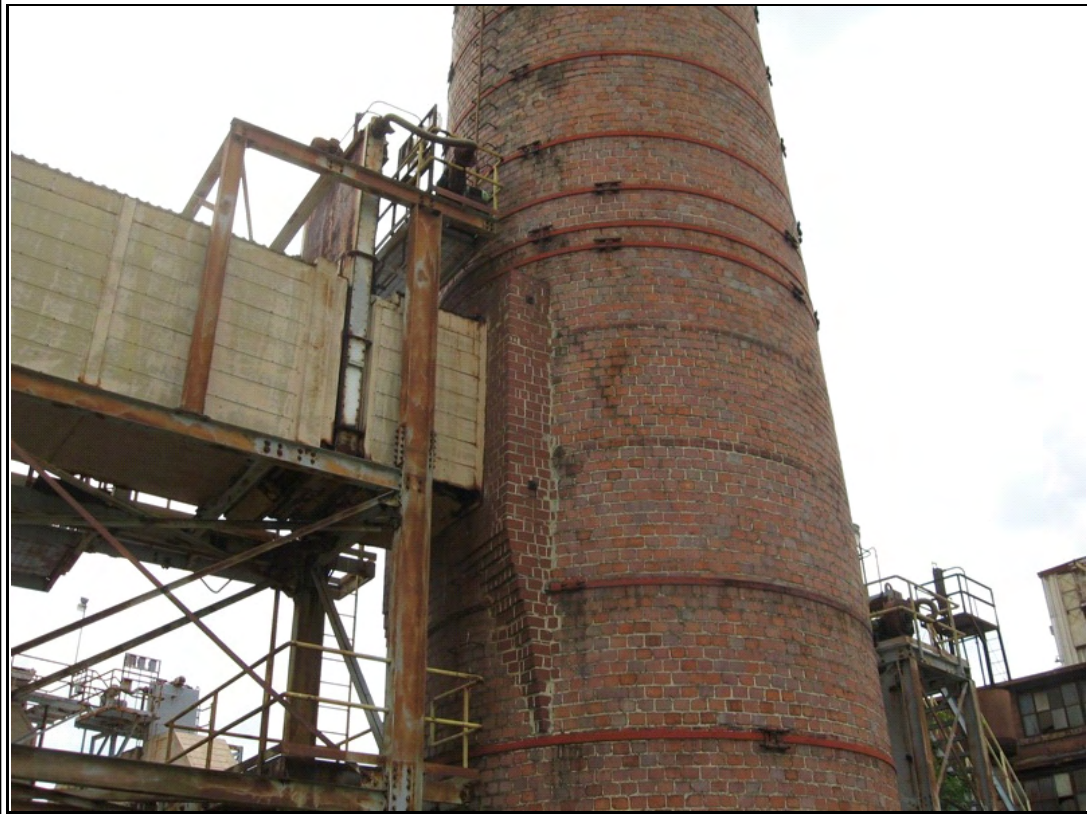
Photograph #: 15

Smokestack on east side of Building 56

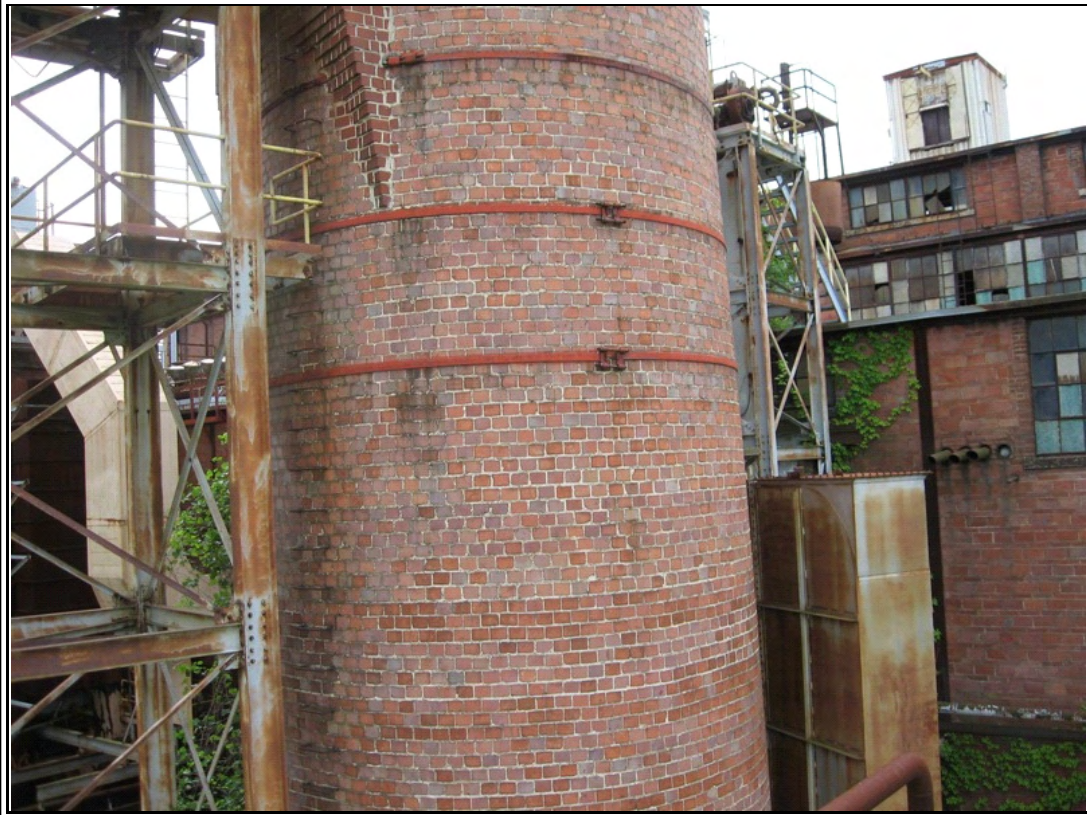
Photograph #: 16

Smokestack on east side of Building 56

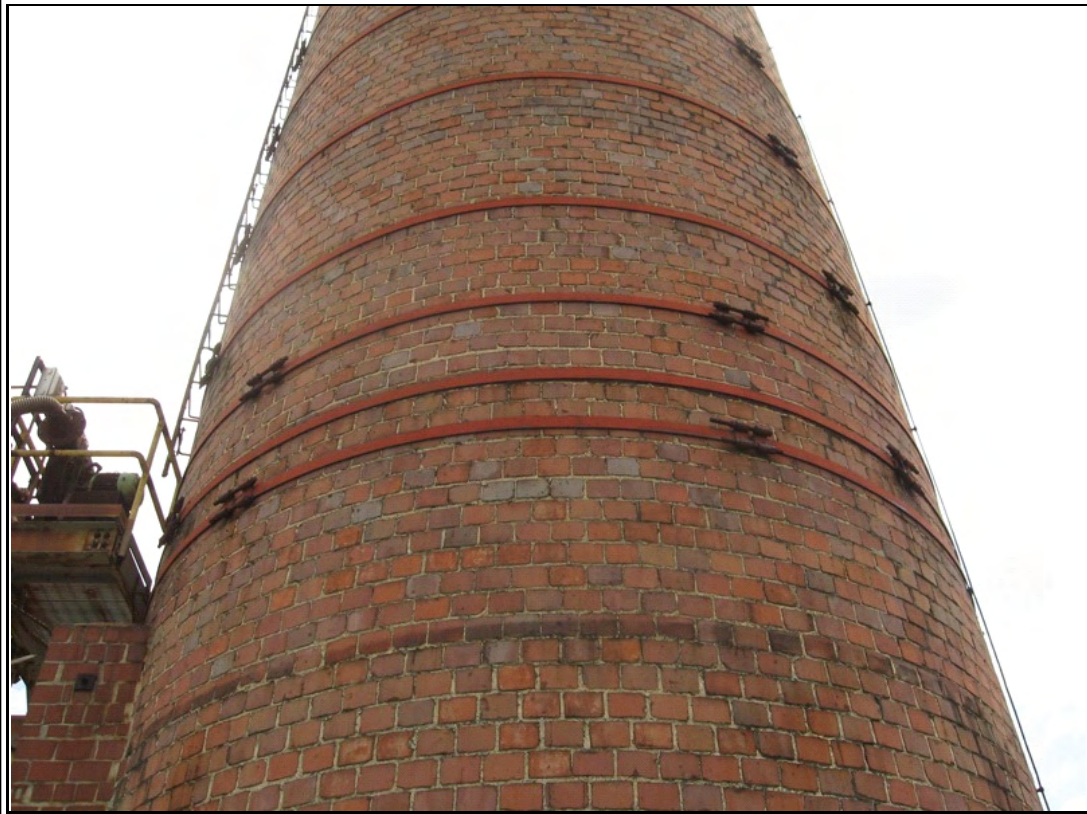
Photograph #: 17

Steel banding at smokestack

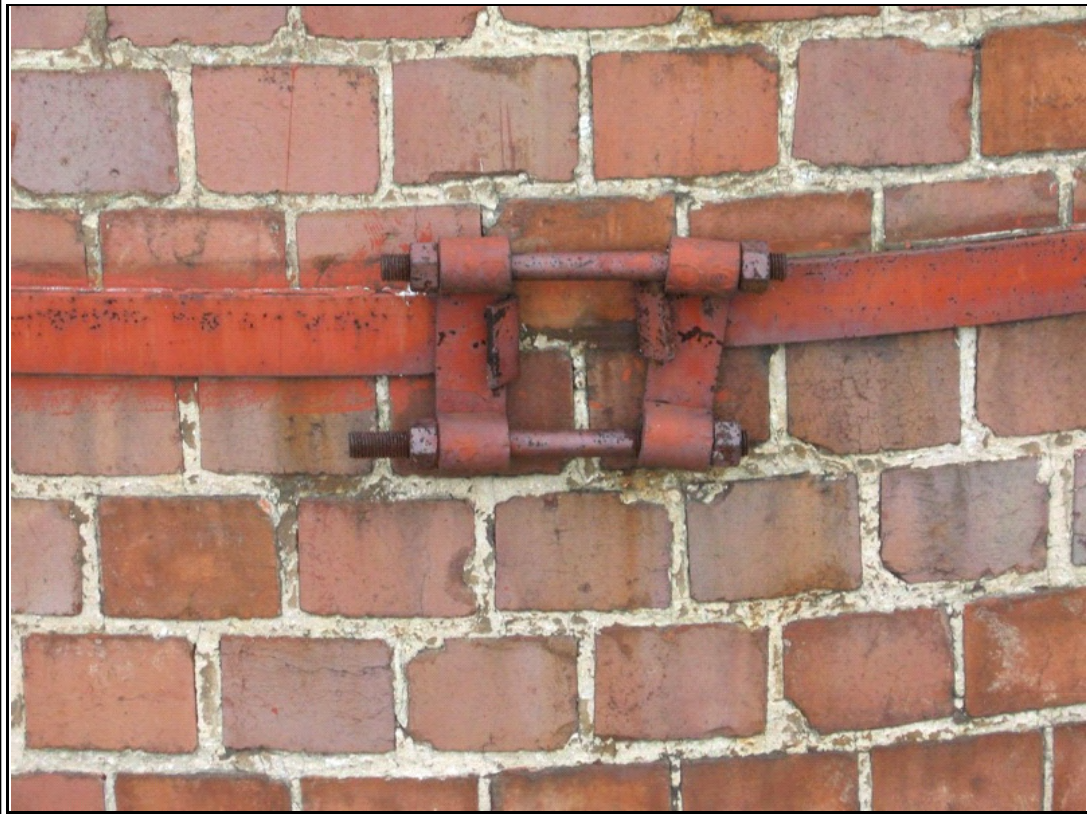
Photograph #: 19

Deteriorated steel coupling
at smokestack

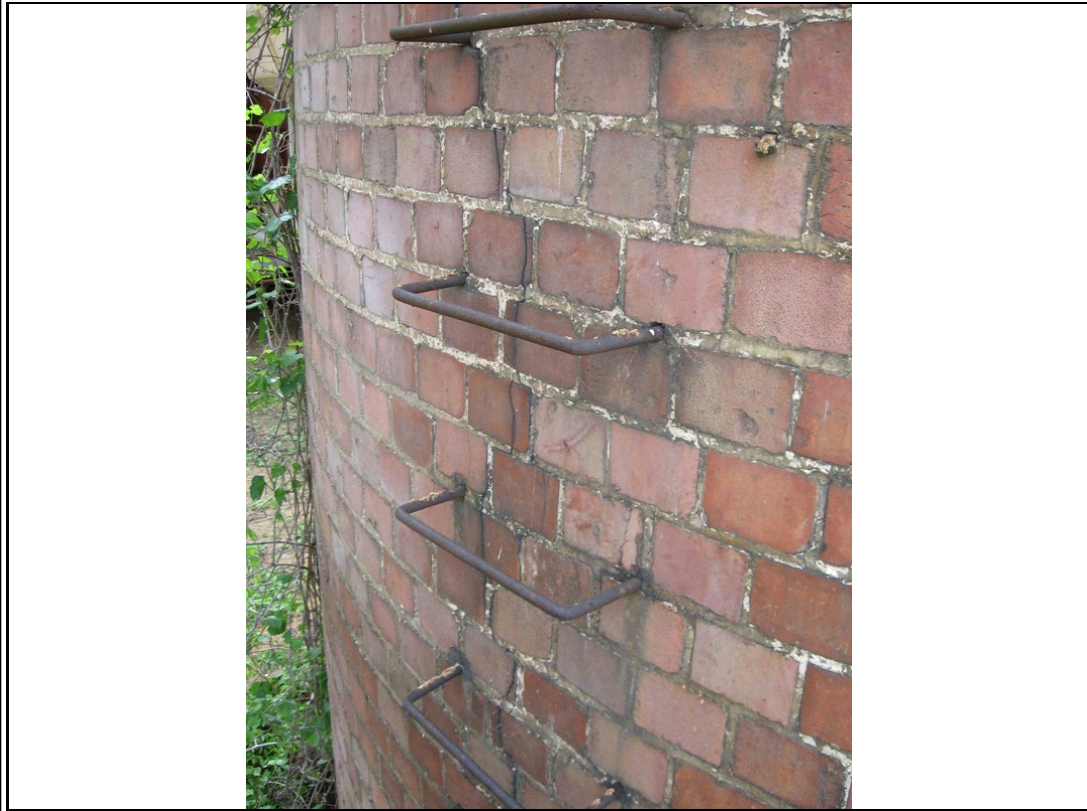
Photograph #: 20

Cracked masonry at
smokestack

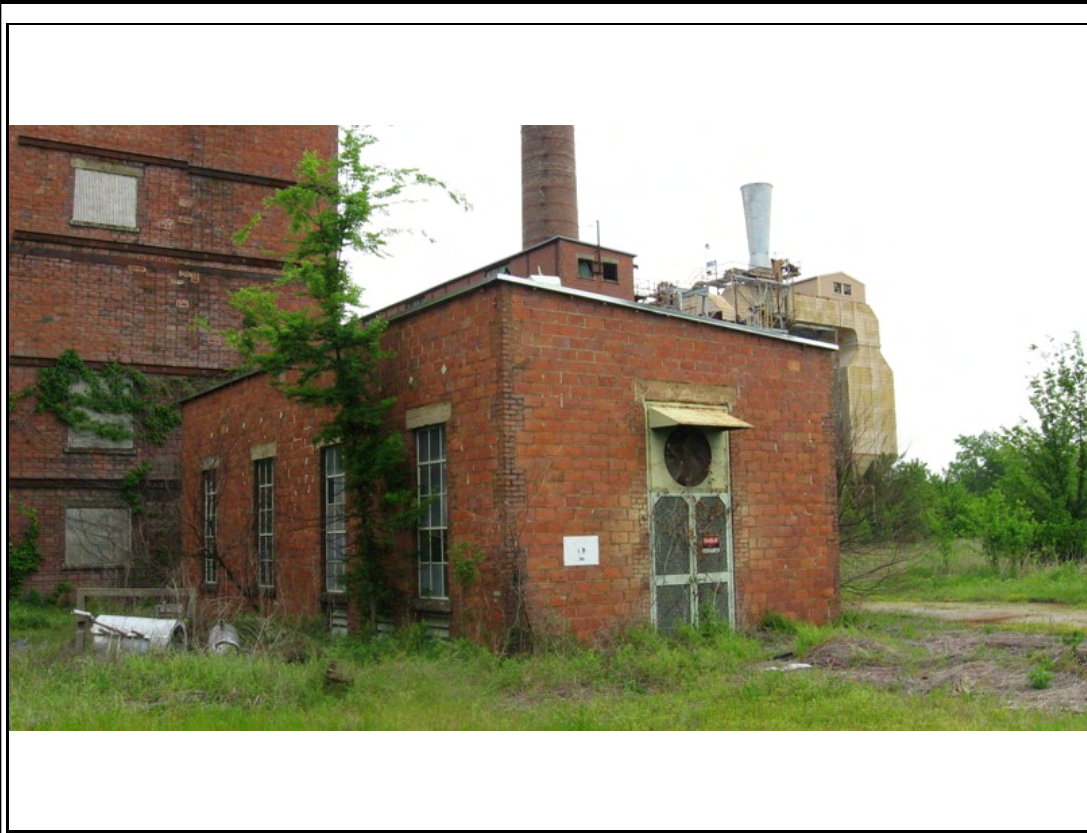
Photograph #: 1

Exterior building looking at southwest corner.

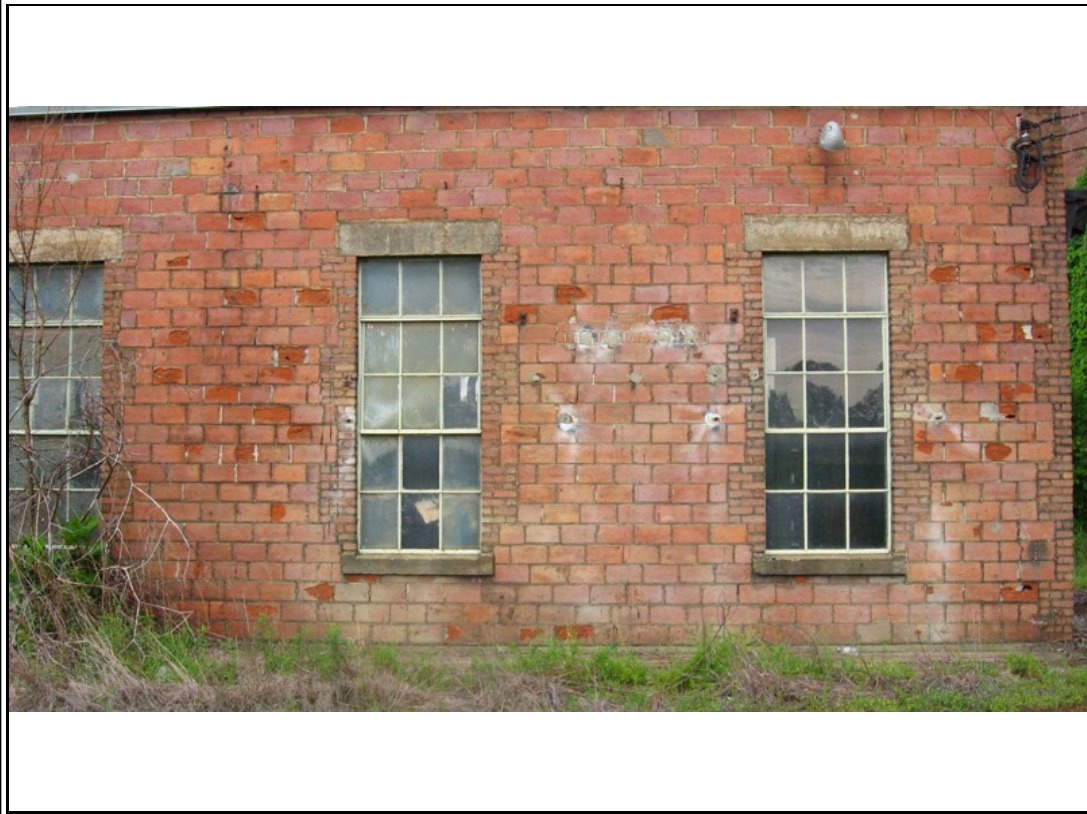
Photograph #: 2

Multiple surface spalls in exterior masonry - east side.

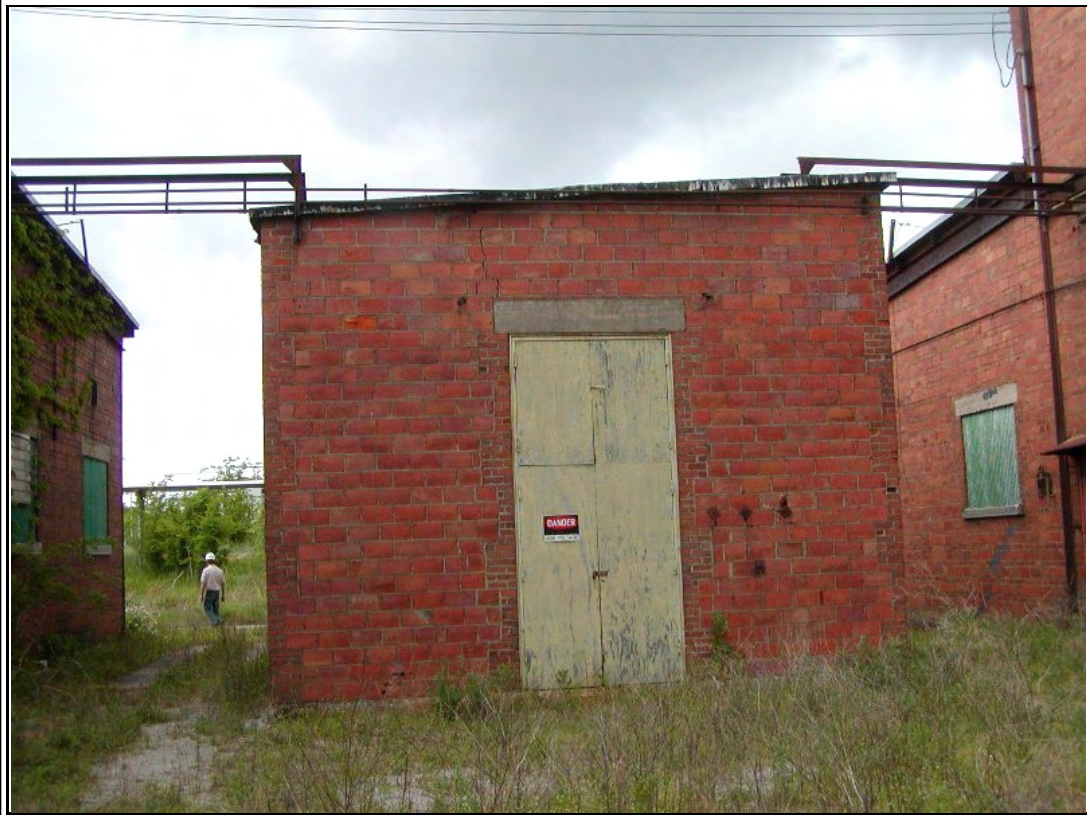
Photograph #: 1

East wall of substation

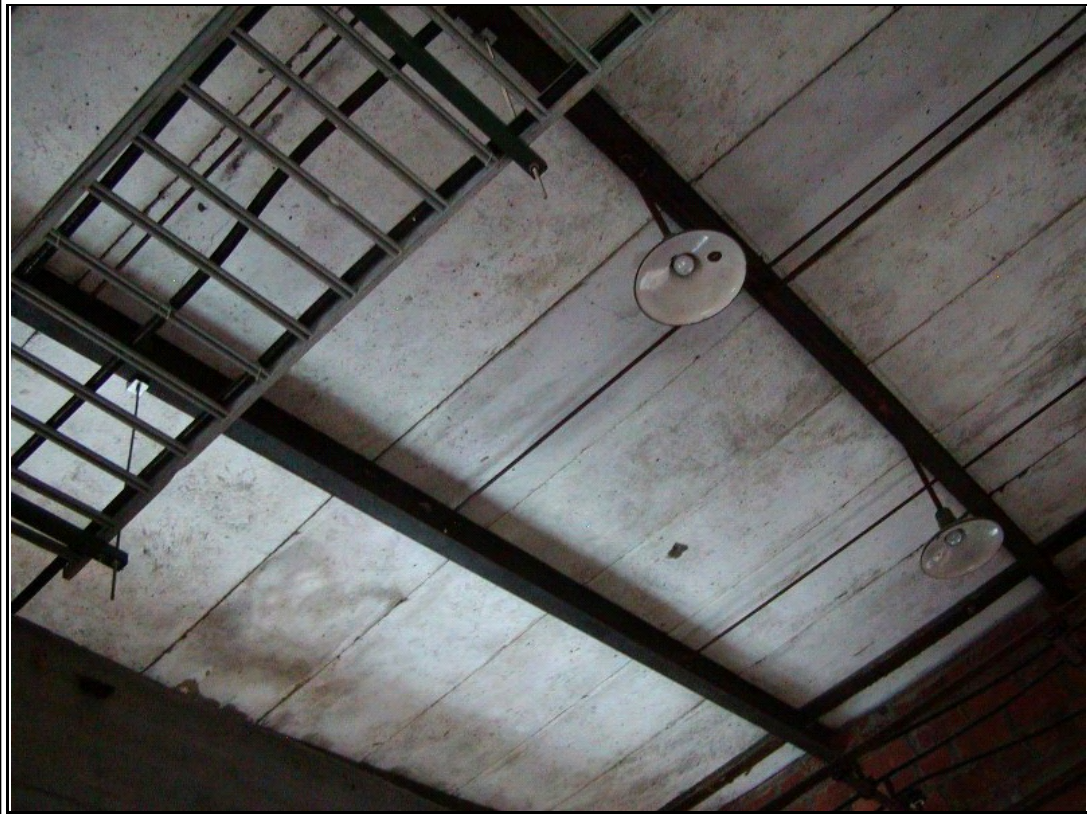
Photograph #: 2

Building 68 Substation No. 4				
Defect Item No.	Defect Description	Quantity/ Unit of Measure	Repair Code/ Remarks	Photo Log Reference No.
1	Cracked and spalled masonry at east wall	10 LF	R-M-2	3
2	Cracked masonry at lintel	3 LF	R-M-2	4
3	Roof beams are moderately corroded		R-S-1	2
Repair Code - Description				
R-M-2	Repair cracks in masonry with appropriate sealant			
R-S-1	Sandblast, prime, and paint structural steel

Roof deck at substation

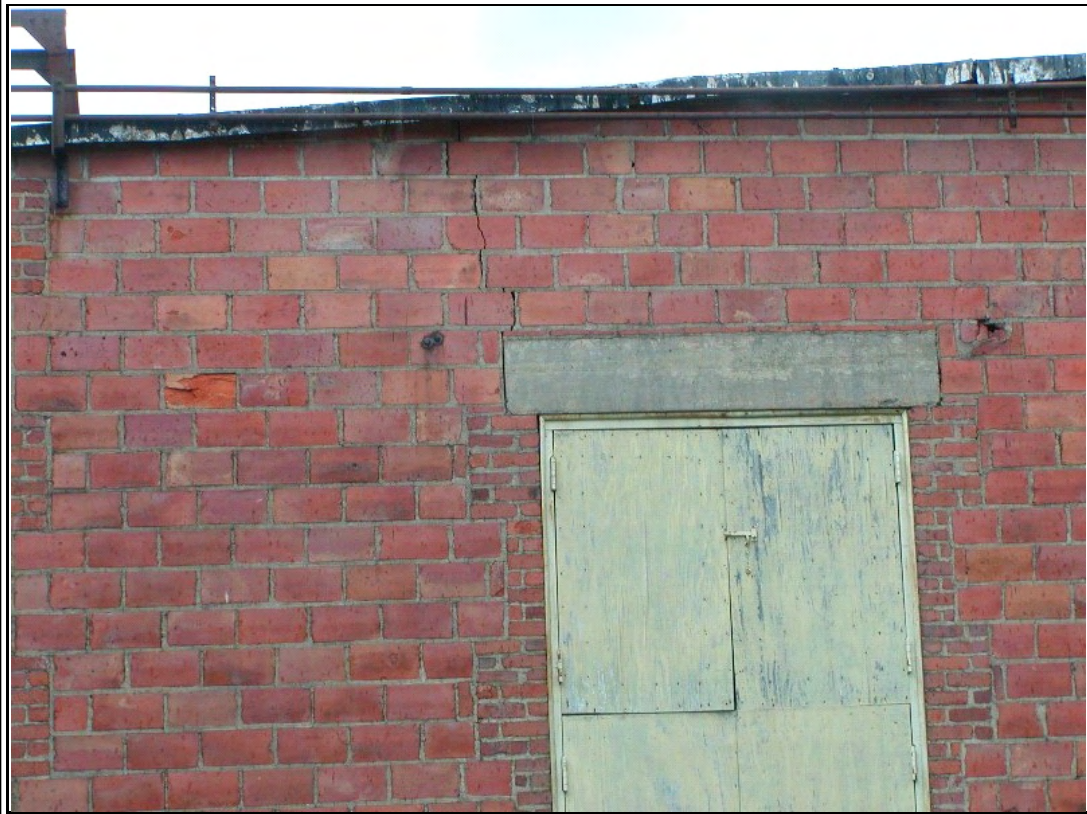
Photograph #: 3

Cracked and spalled masonry at substation
