Structural Assessment

Muscle Shoals Reservation
adaptive re-use study

Conditions/Market/Planning/Implementation

July 31, 2009
Revised August 25, 2009

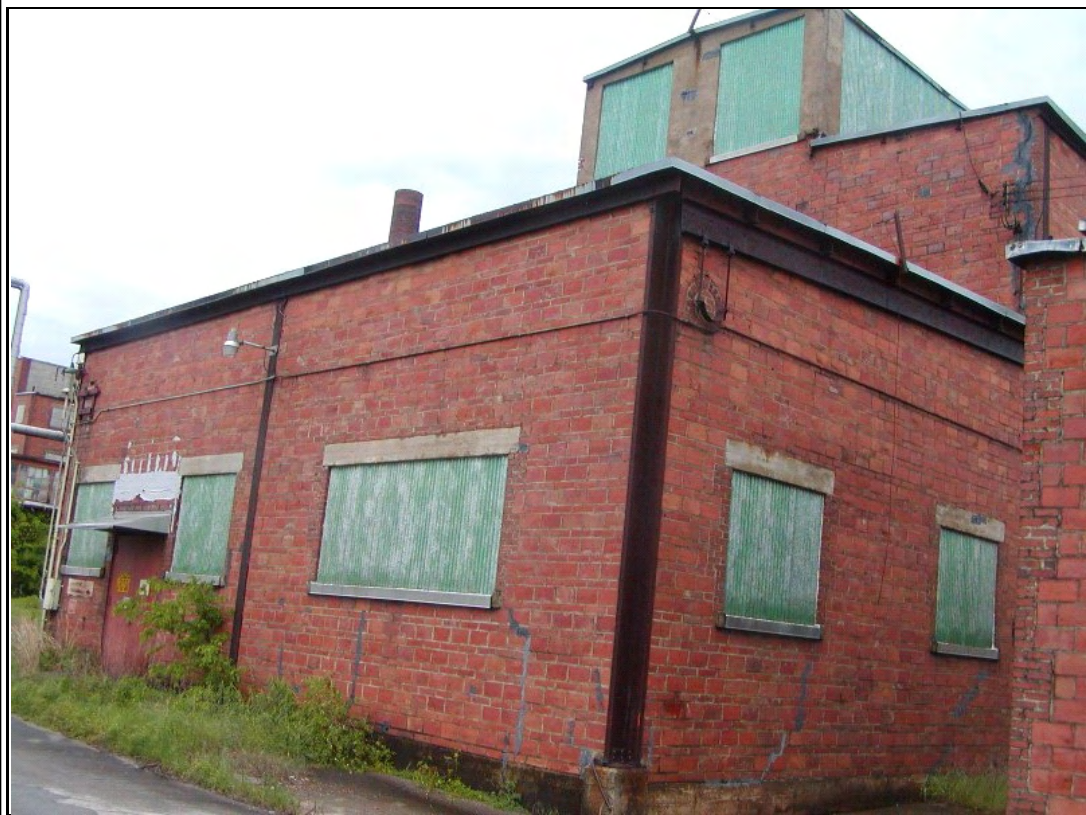
Photograph #: 1

Exterior building looking at southwest corner - note multiple cracks in masonry

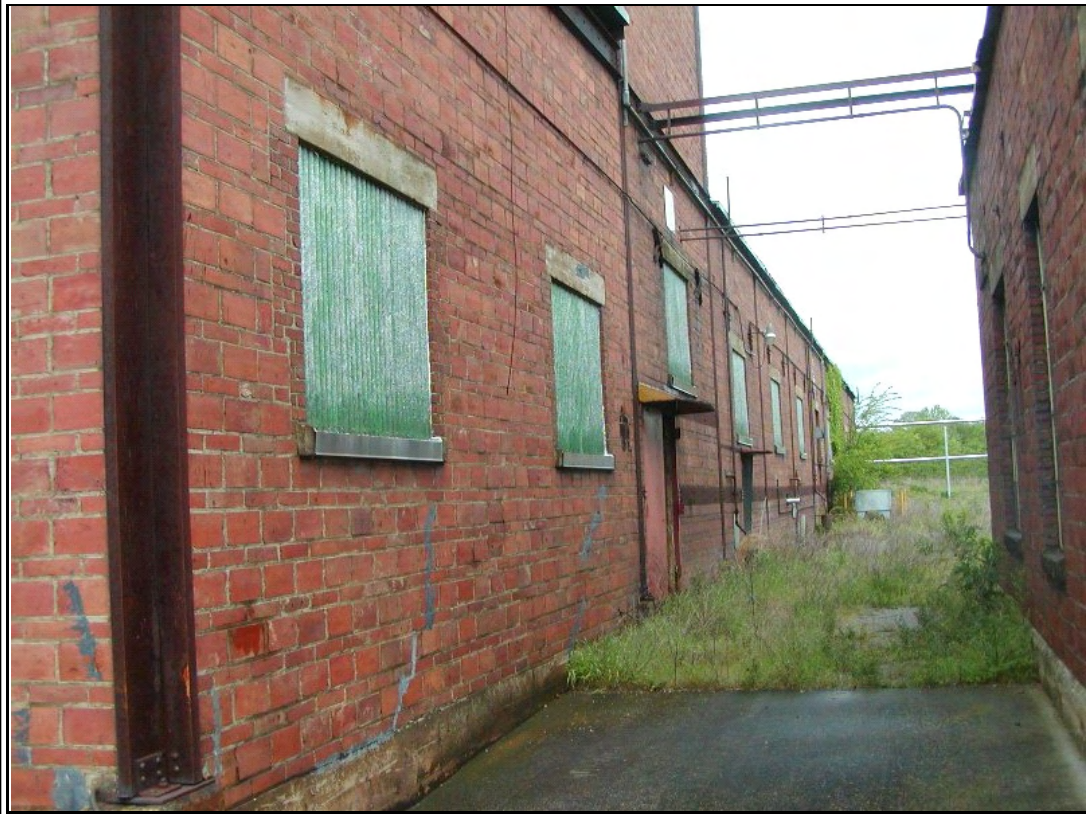
Photograph #: 2

Exterior building looking at south wall - note cracks in masonry above foundation wall

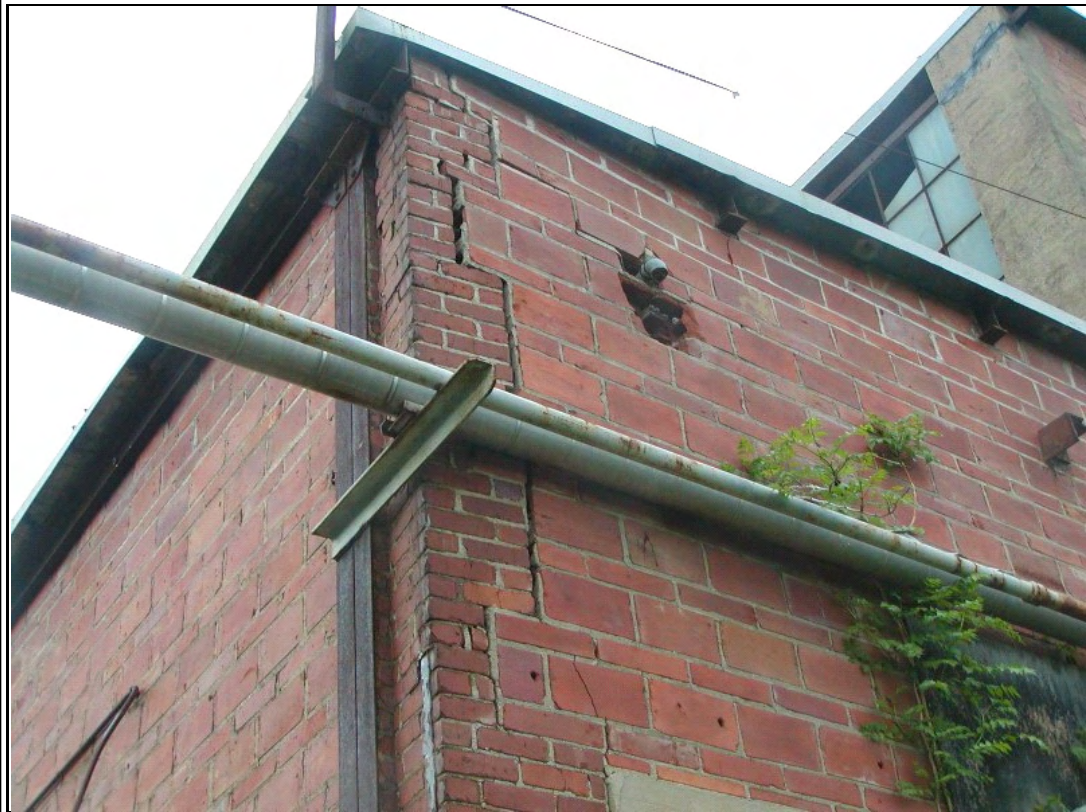
Photograph #: 3

Cracked and partially dislodged masonry at southeast corner

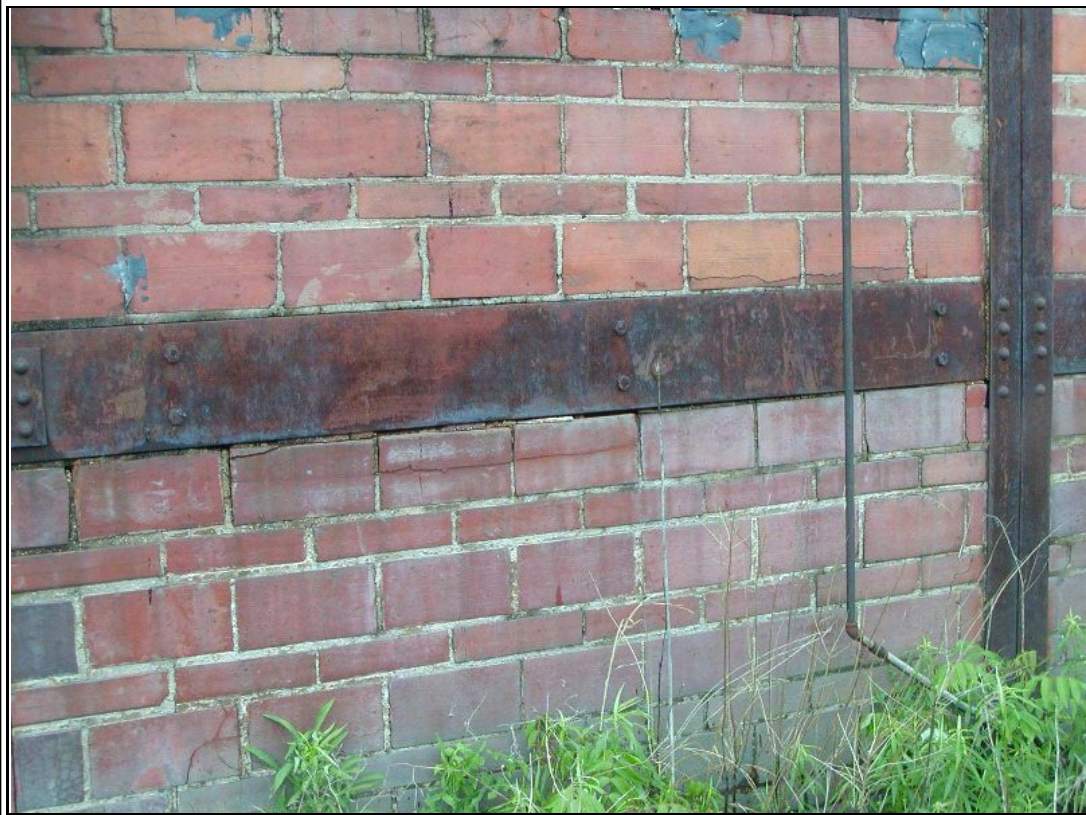
Photograph #: 4

Corroded exterior steel framing at south wall

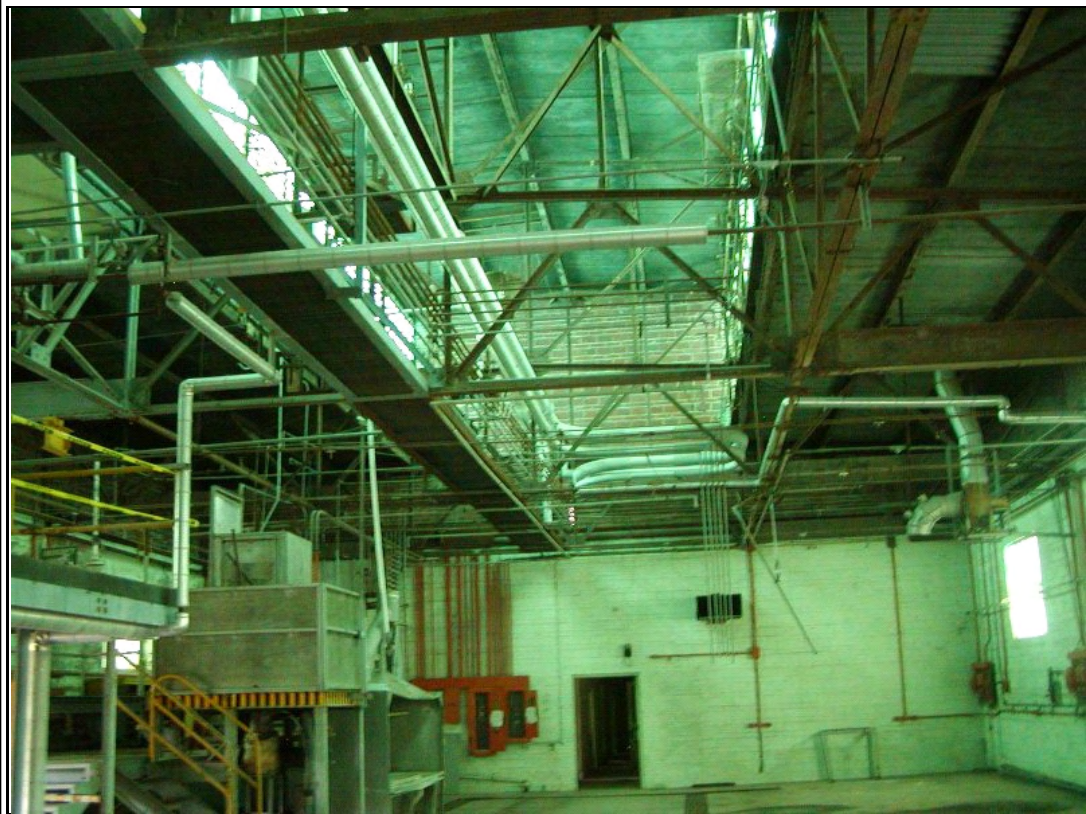
Photograph #: 5

Interior building looking east

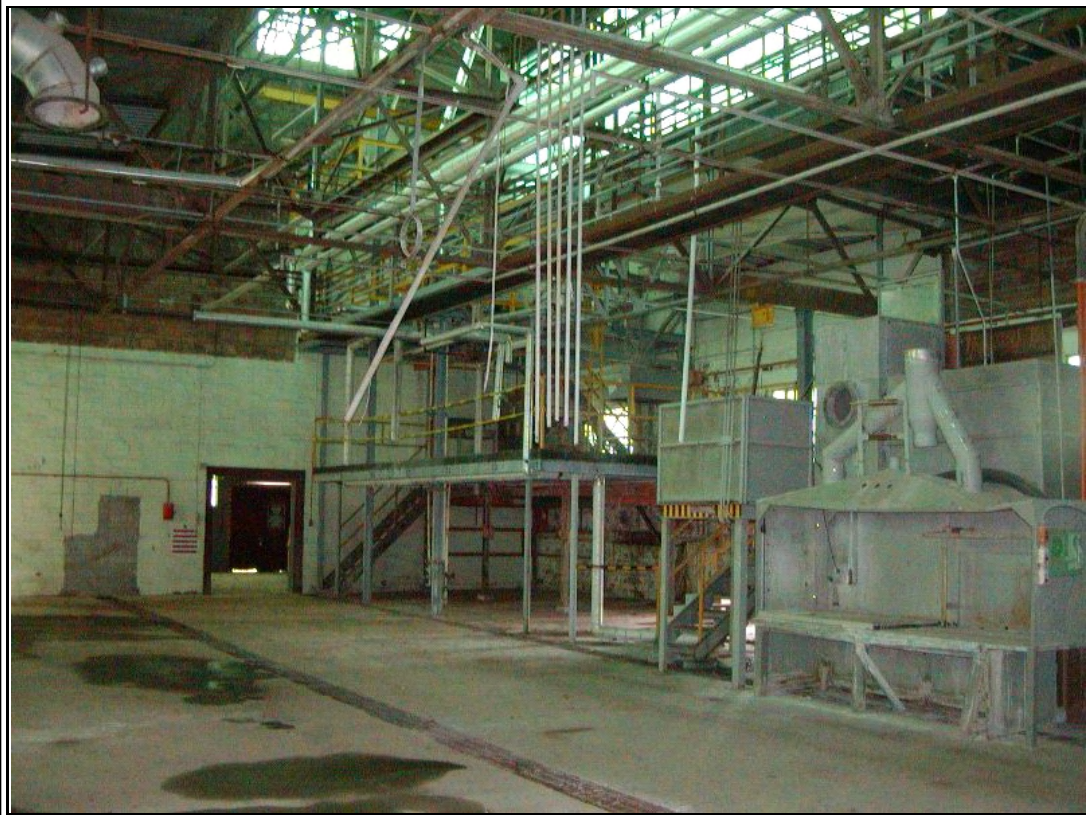
Photograph #: 6

Interior building looking west

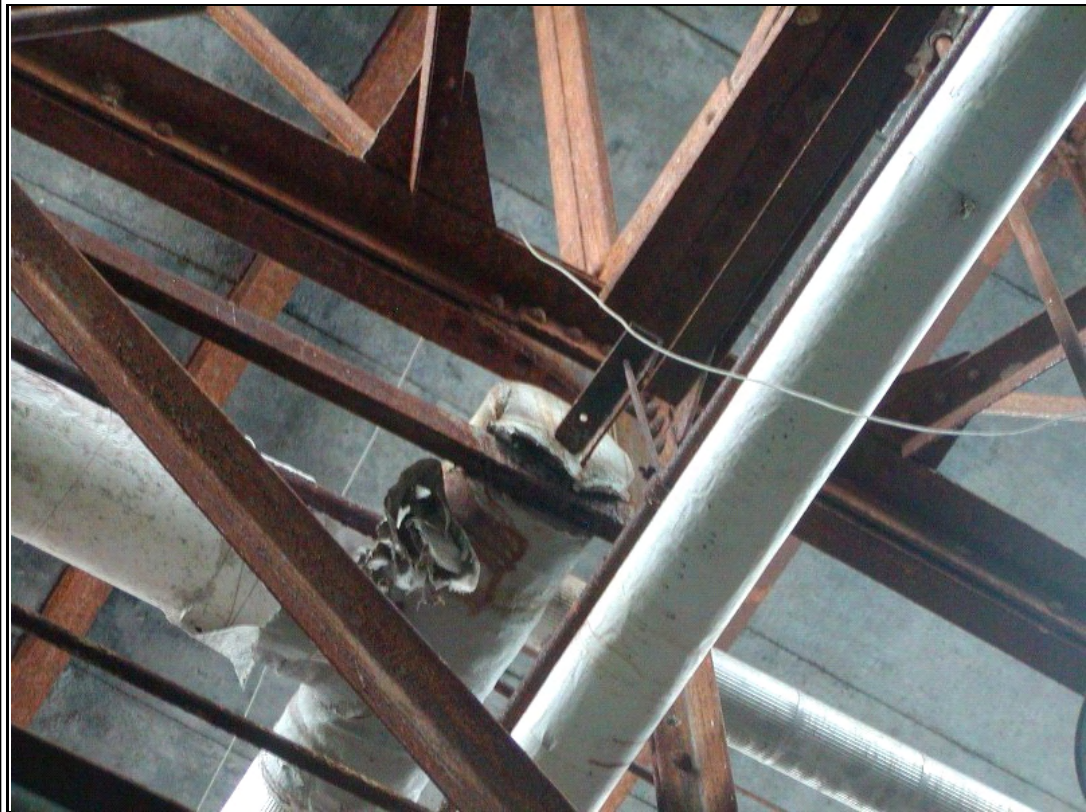
Photograph #: 7

Moderately corroded steel roof framing

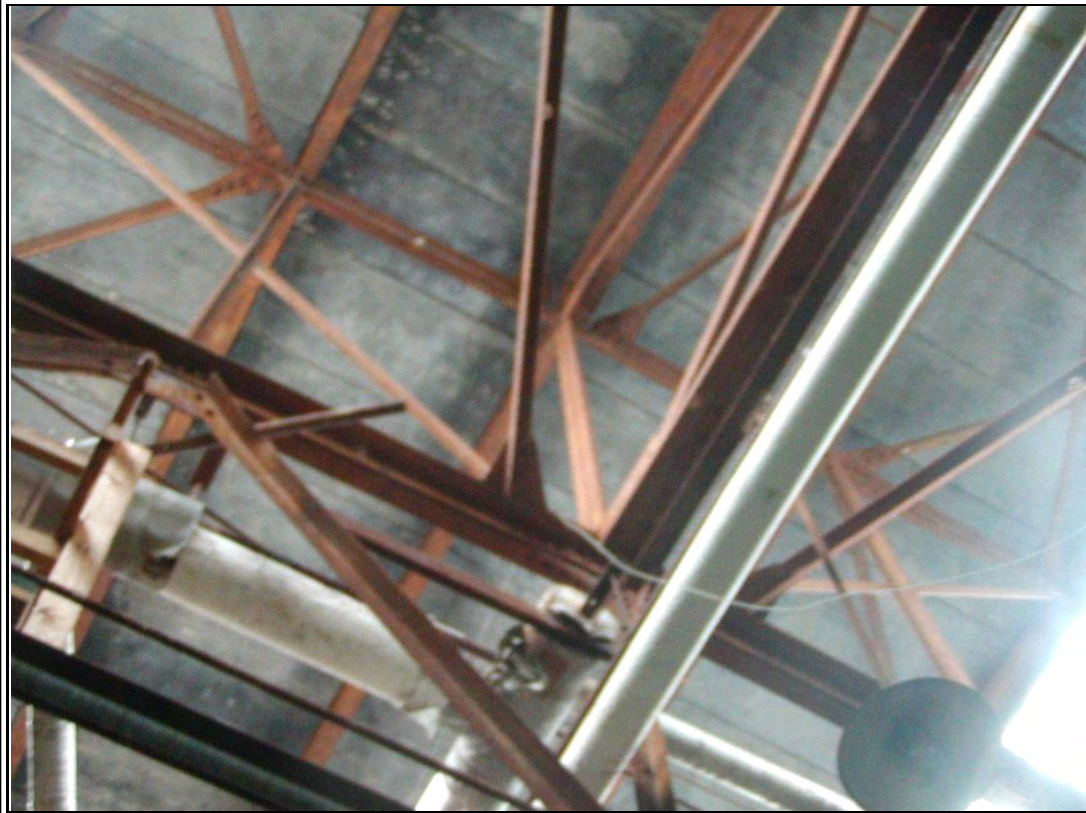
Photograph #: 8

Moderately corroded steel roof framing and surface deterioration on concrete plank roof deck

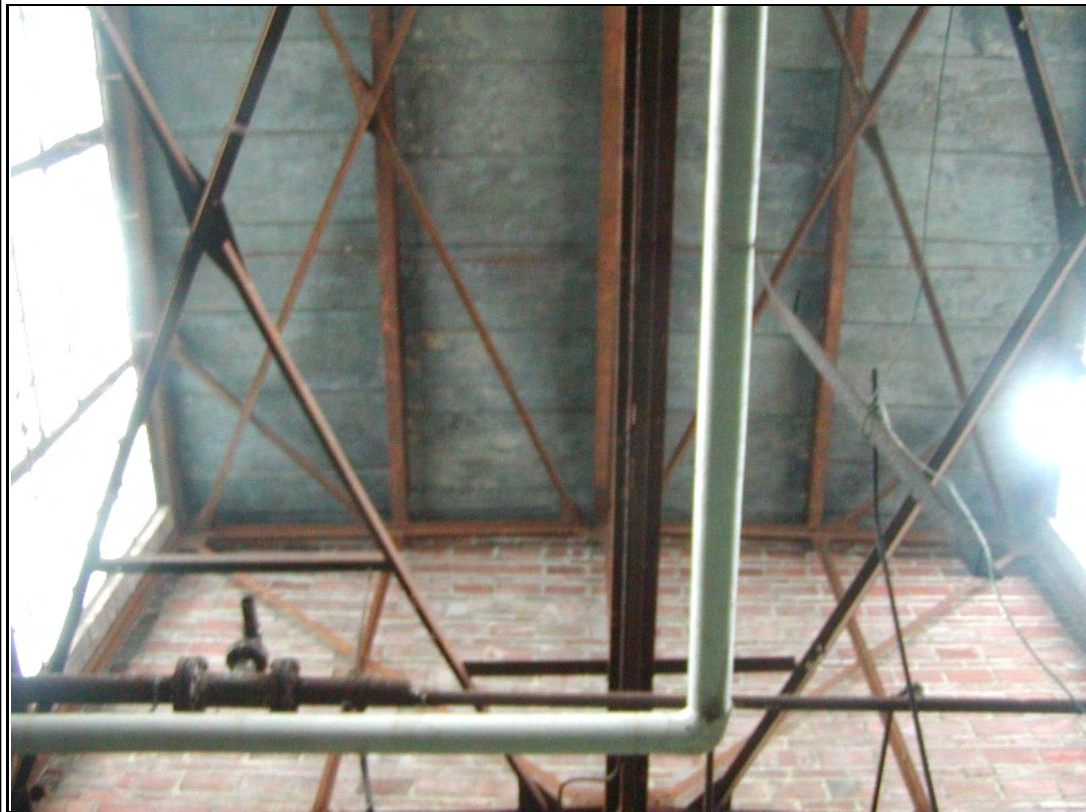
Photograph #: 9

Monitor roof with corroded steel framing and surface deterioration on concrete plank roof deck

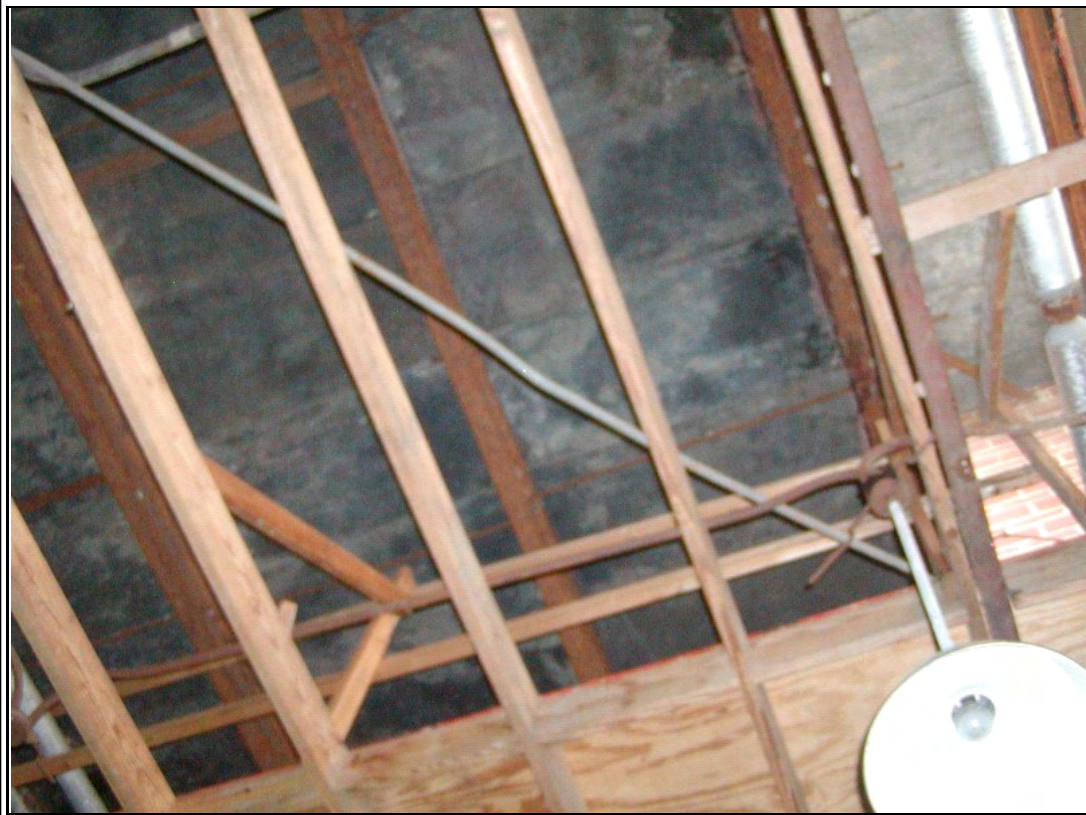
Photograph #: 10

Corroded steel framing and deteriorated roof deck at low roof

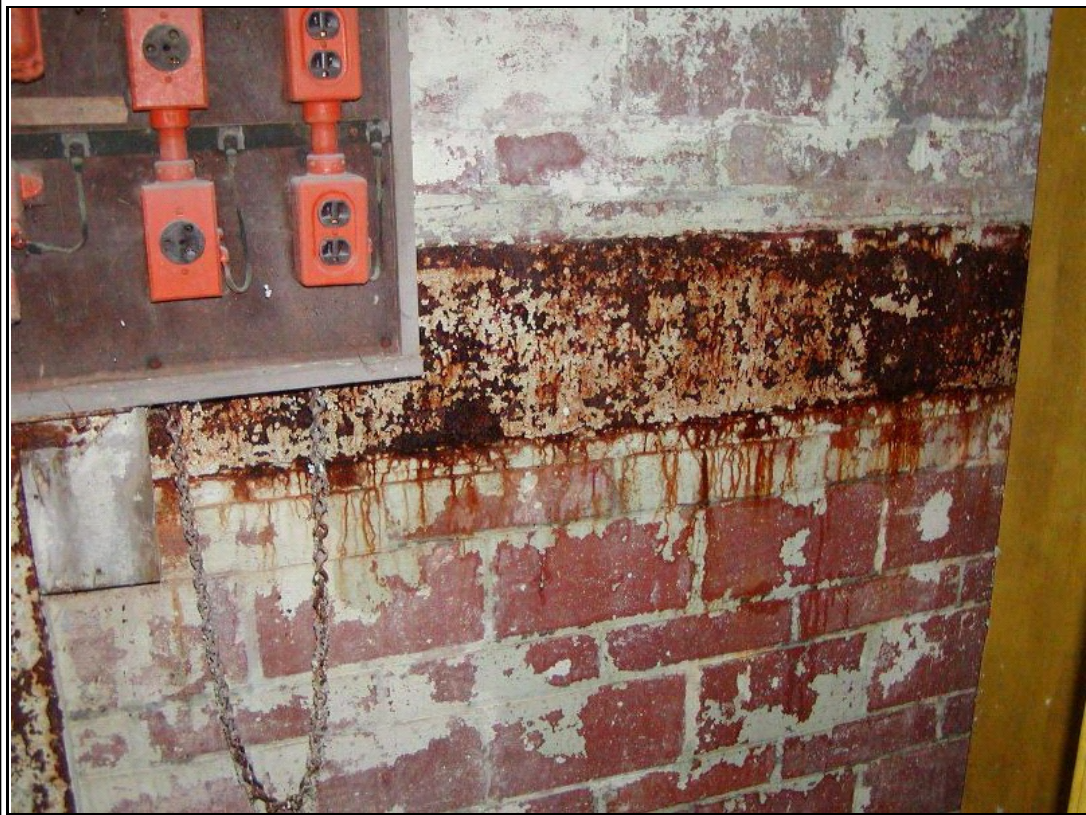
Photograph #: 12

Building 69 Catalyzer #1				
Defect Item No.	Defect Description	Quantity/ Unit of Measure	Repair Code/ Remarks	Photo Log Reference No.
1	Severe corrosion of masonry support beam on north wall	150 LF	R-S-1	11,12
2	Moderate corrosion of steel column at north wall and column line 5	20 LF	R-S-1	
3	Moderate corrosion of steel column at north wall and column line 5	15 LF	R-S-1	
4	Moderate corrosion of roof framing in the southeast corner	200 LF	R-S-1	7,8
5	Surface corrosion of concrete planks at roof deck and discoloration of roof deck planks		R-D-2	9,10
6	Settlement cracks in the masonry wall in northeast, southeast and southwest corners	50 LF	R-M-2,R-M-3	3,14
7	Thermal crack in masonry wall in high bay at the south wall	20 LF	R-M-1	
8	Buckling of wall in the southeast corner	20 LF	R-M-4	3
Repair Code - Description				
R-D-2	Replace roof deck			
R-M-1	Repair voids in masonry with appropriate filler			
R-M-4	Reconstruct damaged and/or unstable masonry

Heavily corroded steel framing at north wall

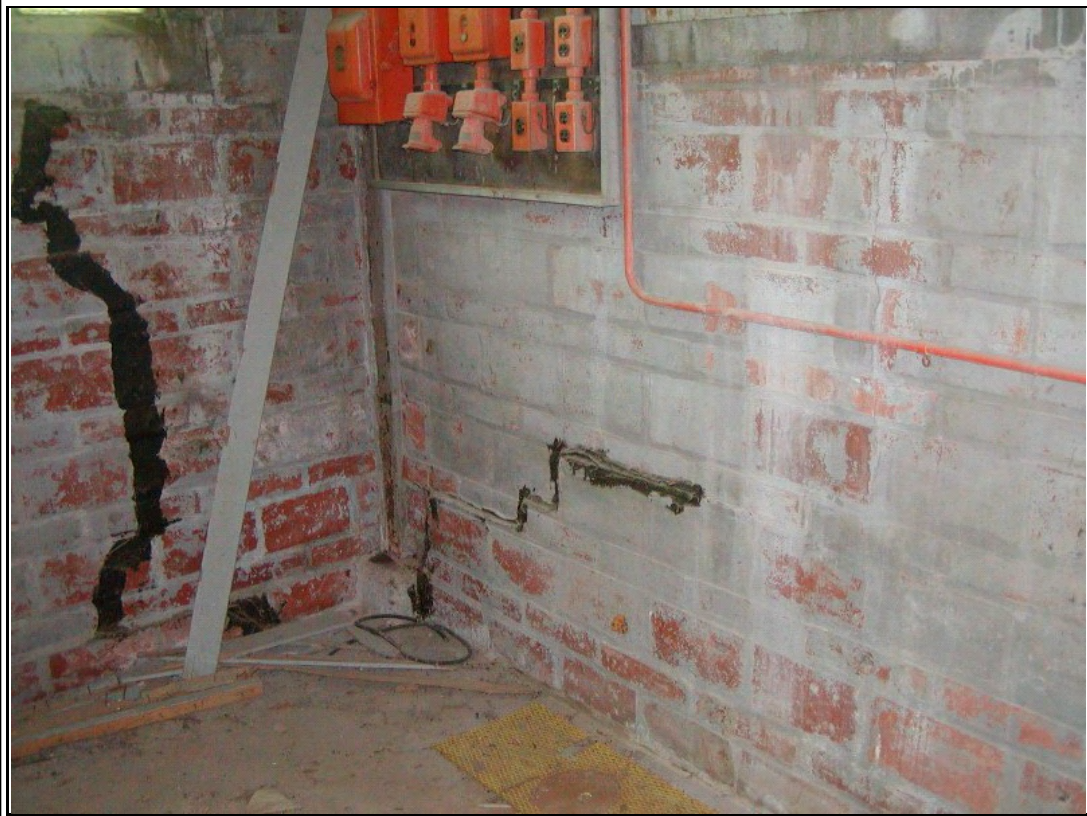
Photograph #: 13

Previously repaired cracks
in wall at northwest corner

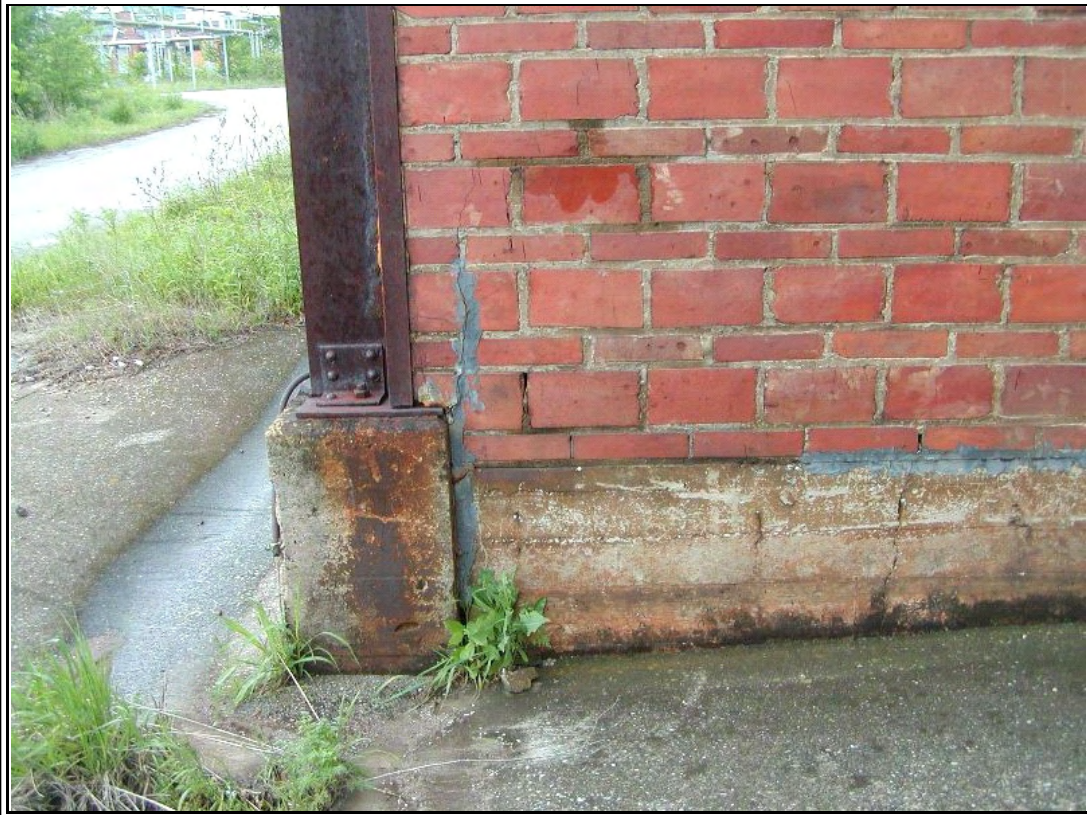
Photograph #: 14

Cracks in masonry and
foundation wall at
southwest corner

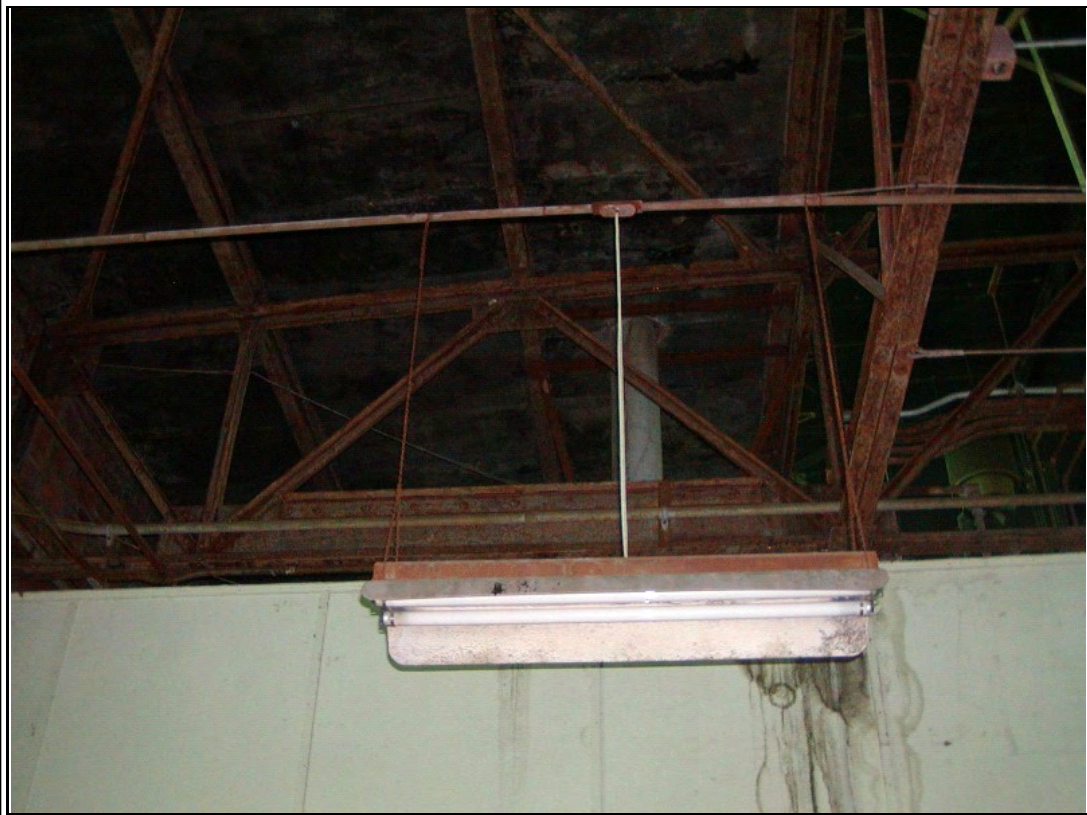
Photograph #: 10

Corroded steel framing and deteriorated roof deck

Summary of Recommended Structural Repairs:	The structural steel framing must be cleaned and repainted. Remediation of the concrete plank roof deck in the main building will be required, and repair or replacement of the roof deck at the west end will be required. Cracks in the exterior masonry walls must be repaired, and deteriorated concrete piers at column attachments must be repaired.
Additional Recommendations:	A detailed evaluation of the concrete plank roof deck will be required to determine the type of remediation and the extent of repairs and/or replacement required.

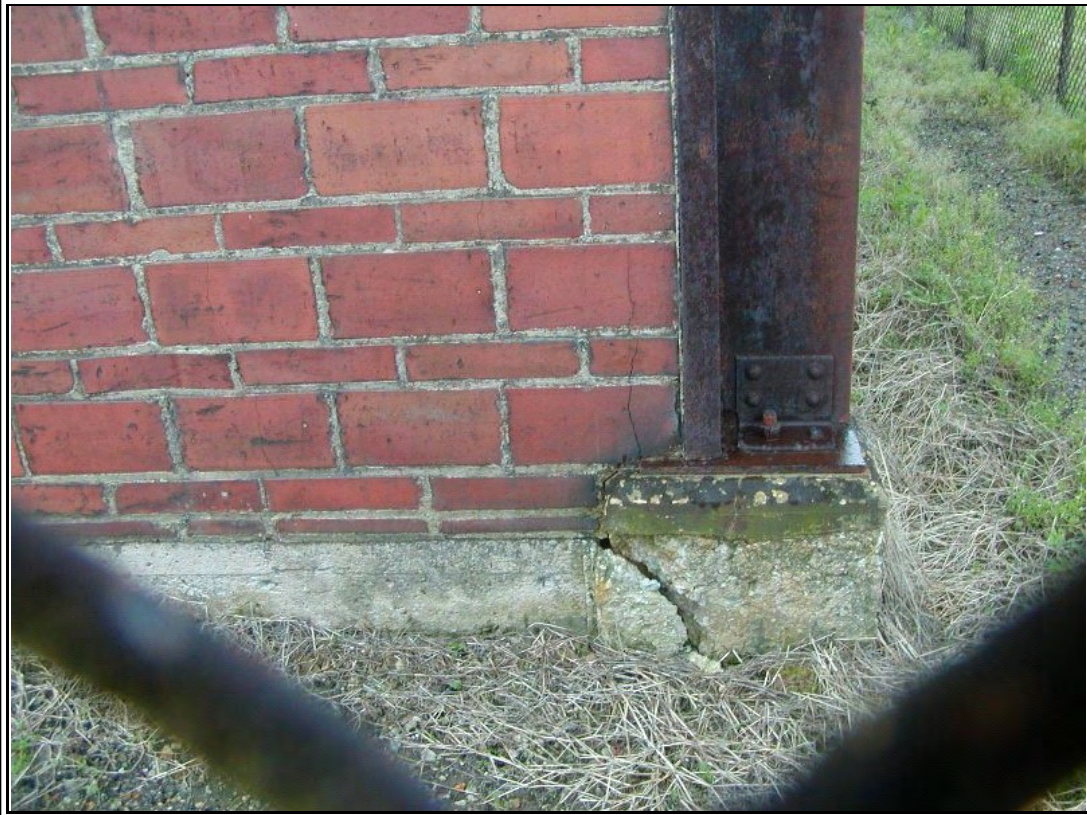
Photograph #: 4

Cracked concrete pier and masonry at northwest corner

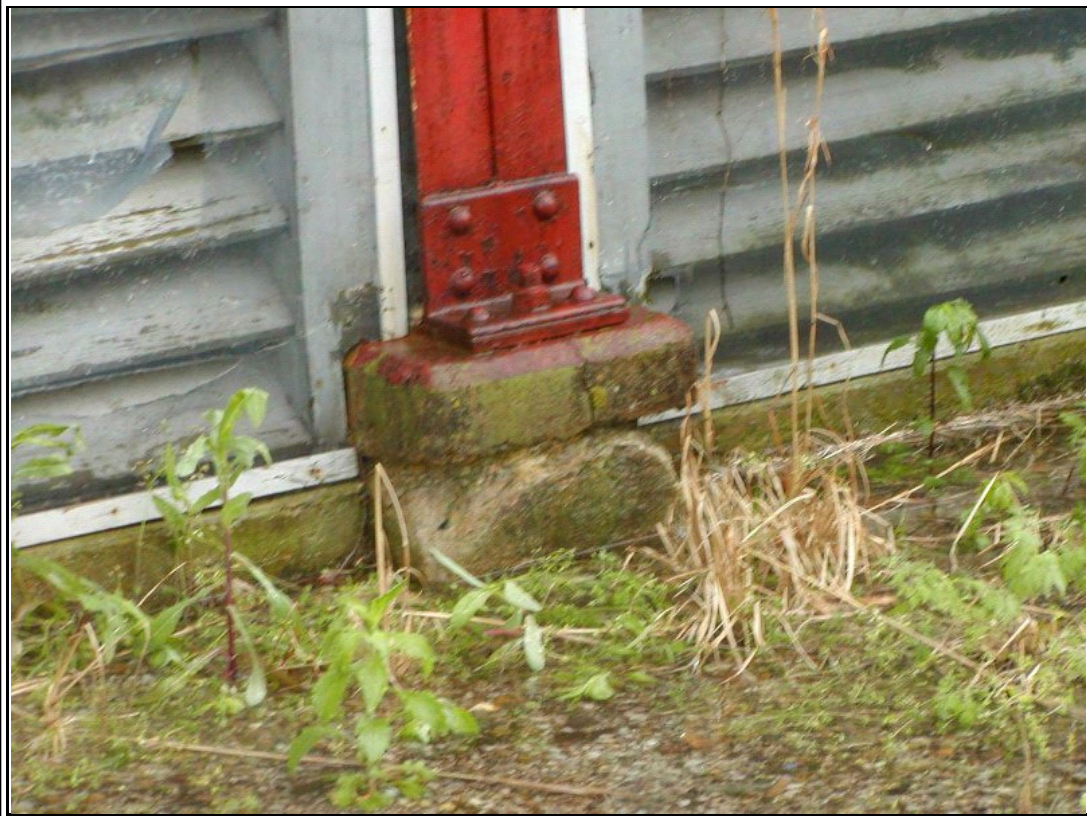
Photograph #: 5

Deteriorated concrete pier
at column

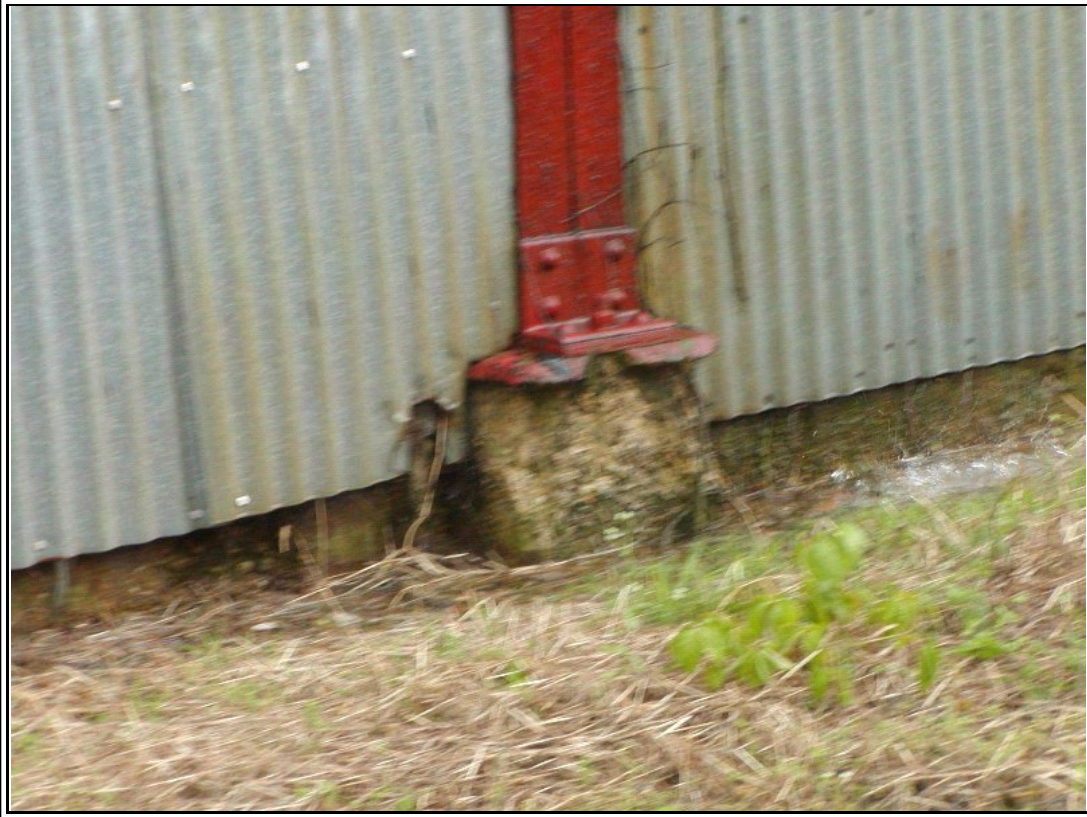
Photograph #: 6

Deteriorated concrete pier
at column

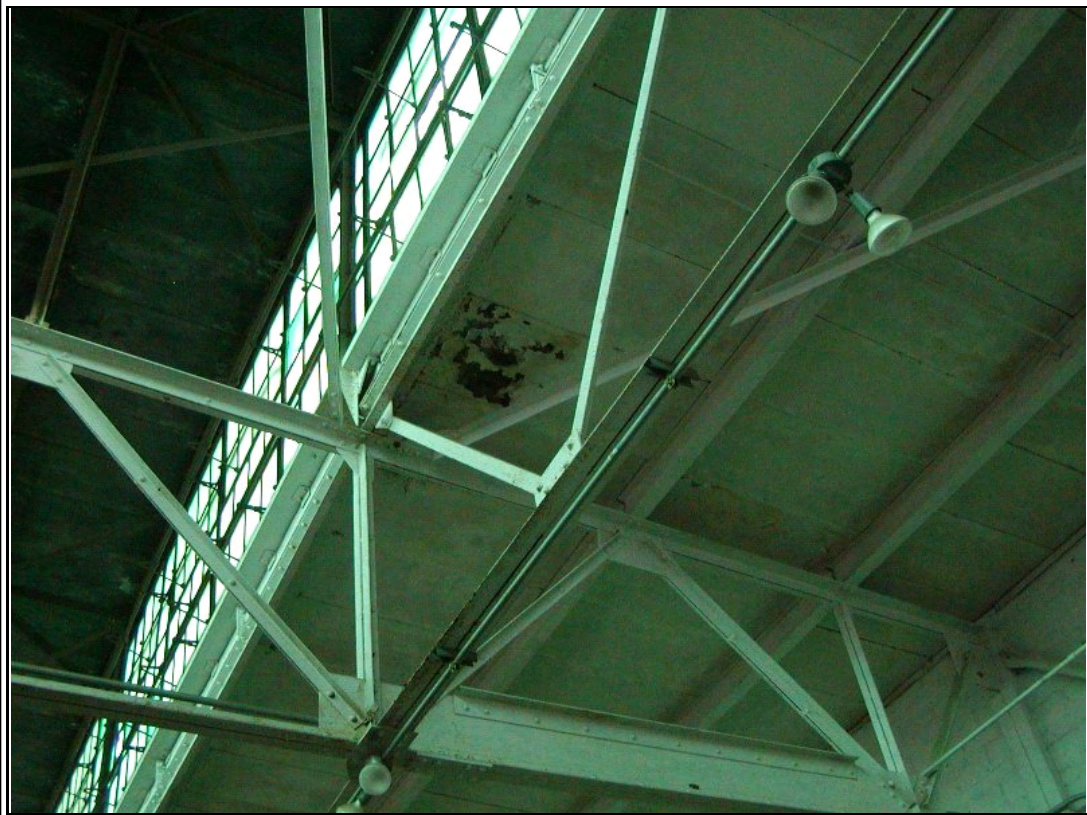
Photograph #: 10

Deteriorated concrete plank at roof deck

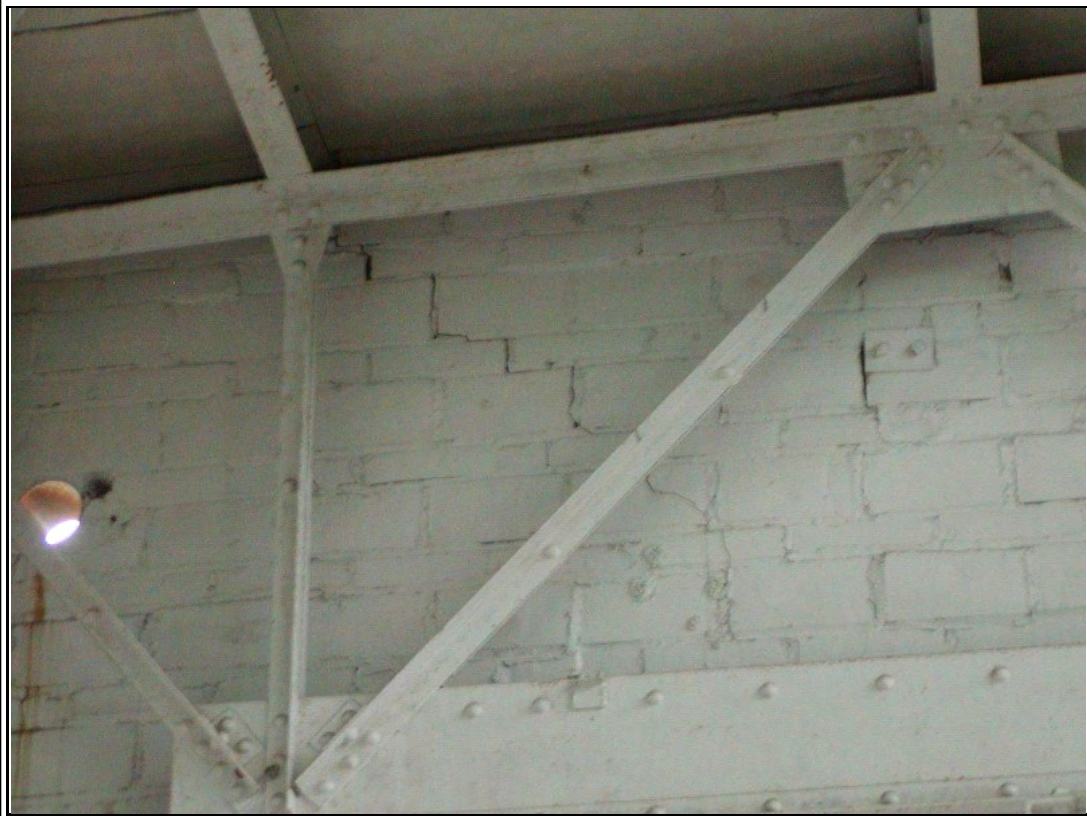
Photograph #: 11

Interior crack in masonry
at east wall

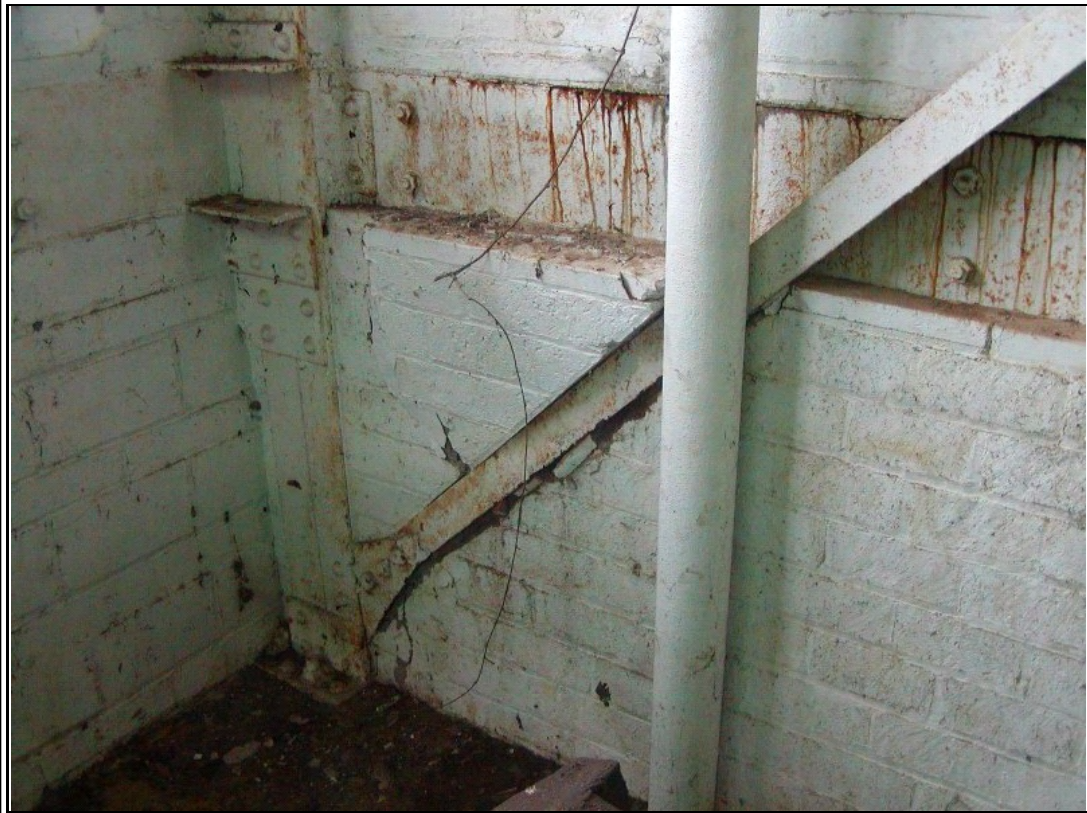
Photograph #: 12

Building 71 Catalyzer #3				
Defect Item No.	Defect Description	Quantity/ Unit of Measure	Repair Code/ Remarks	Photo Log Reference No.
1	Minor infill cracking at northeast corner	10 LF	R-M-2	
2	Infill cracking and displacement at southeast corner	10 LF	R-M-2	12
3	Minor cracking due sag at door opening	10 LF	R-M-4	
4	Step cracking at northeast corner	20 LF	R-M-2	11
5	Northwest corner cracking	30 LF	R-M-2,R-M-3	
6	Footing pier cracked and spalled	2 EA	R-C-2,R-C-3	5,6
Repair Code - Description R-M-2 Repair cracks in masonry with appropriate sealant R-M-4 Reconstruct damaged and/or unstable masonry

Infill cracking and
displacement at southeast
corner

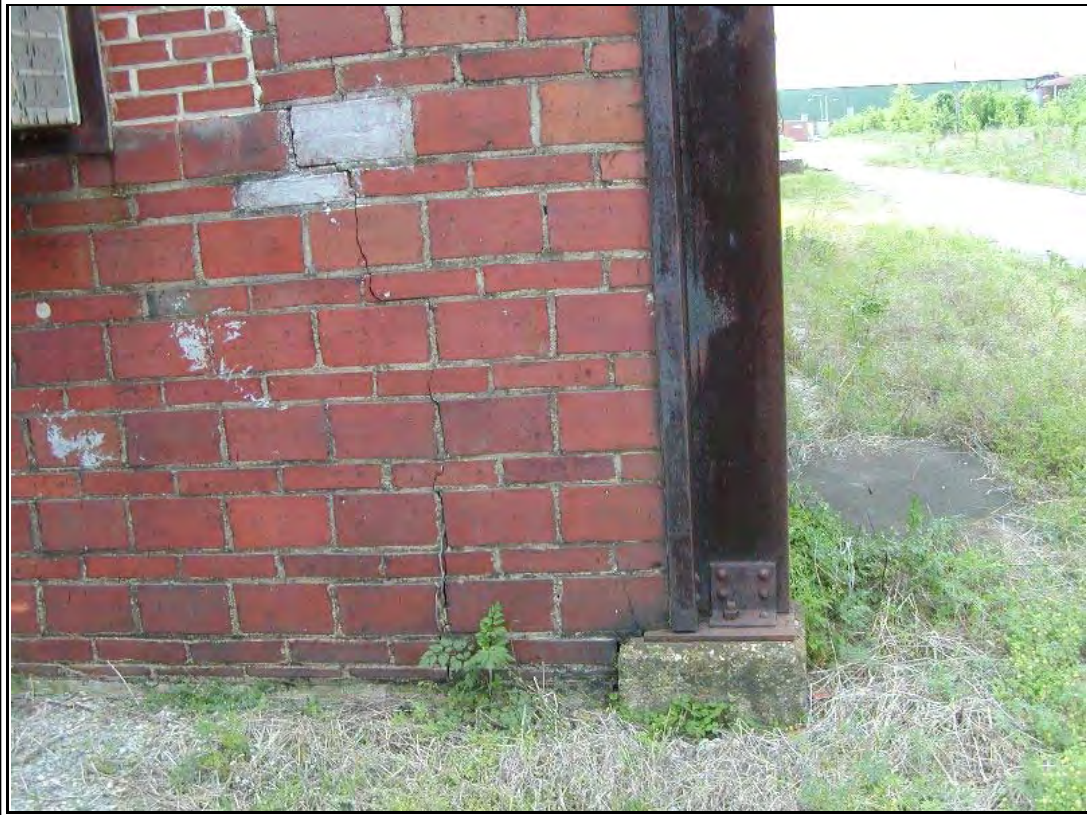
Photograph #: 4

Crack in wall at northwest corner

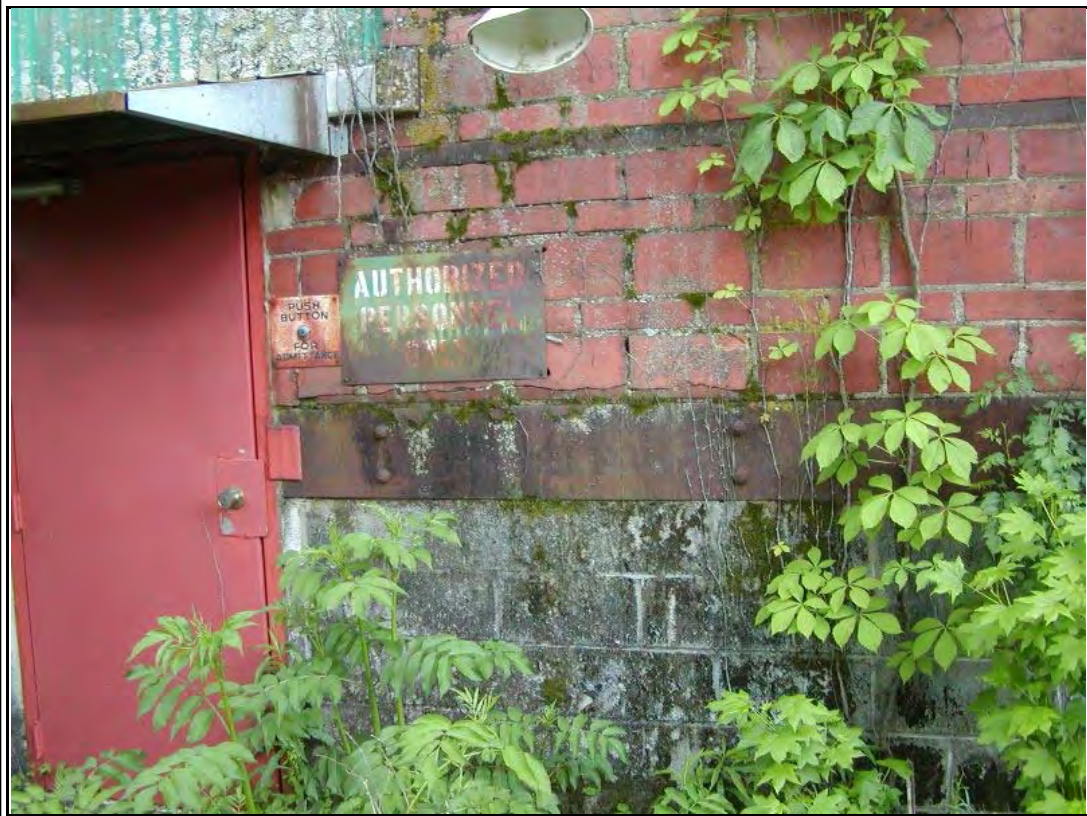
Photograph #: 5

General deterioration on north side of building

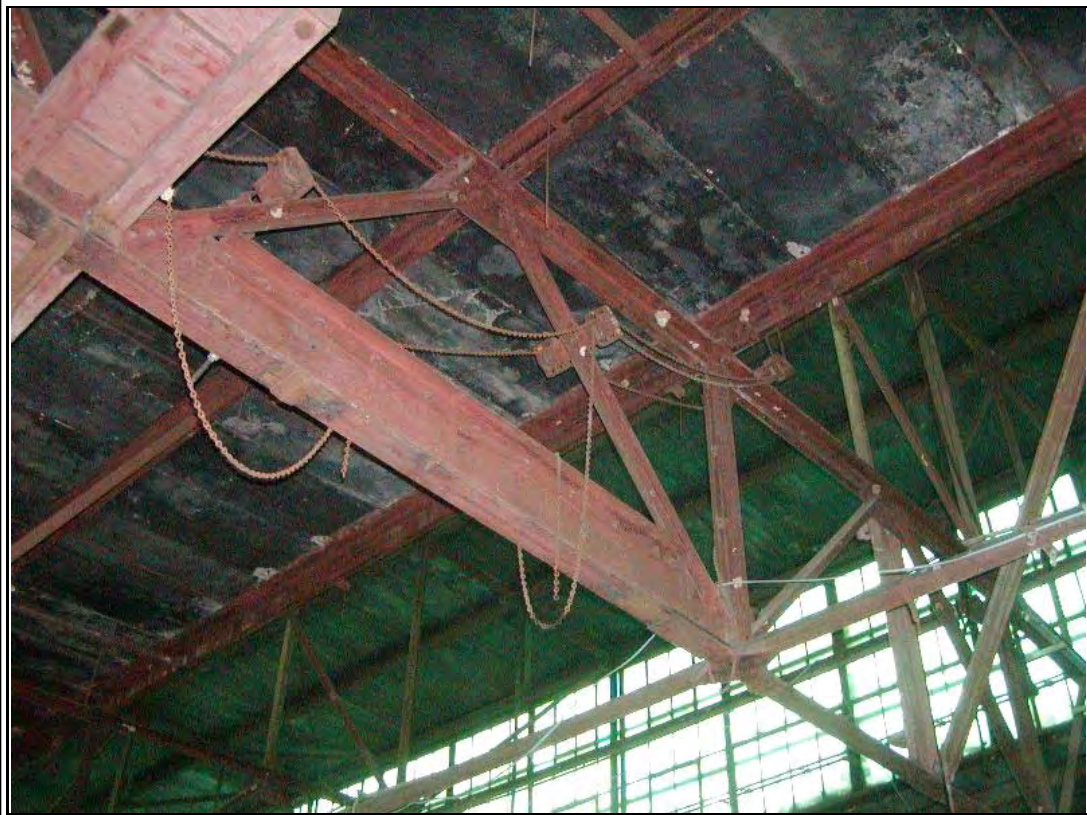
Photograph #: 8

Corroded steel roof framing and deteriorated concrete roof planks

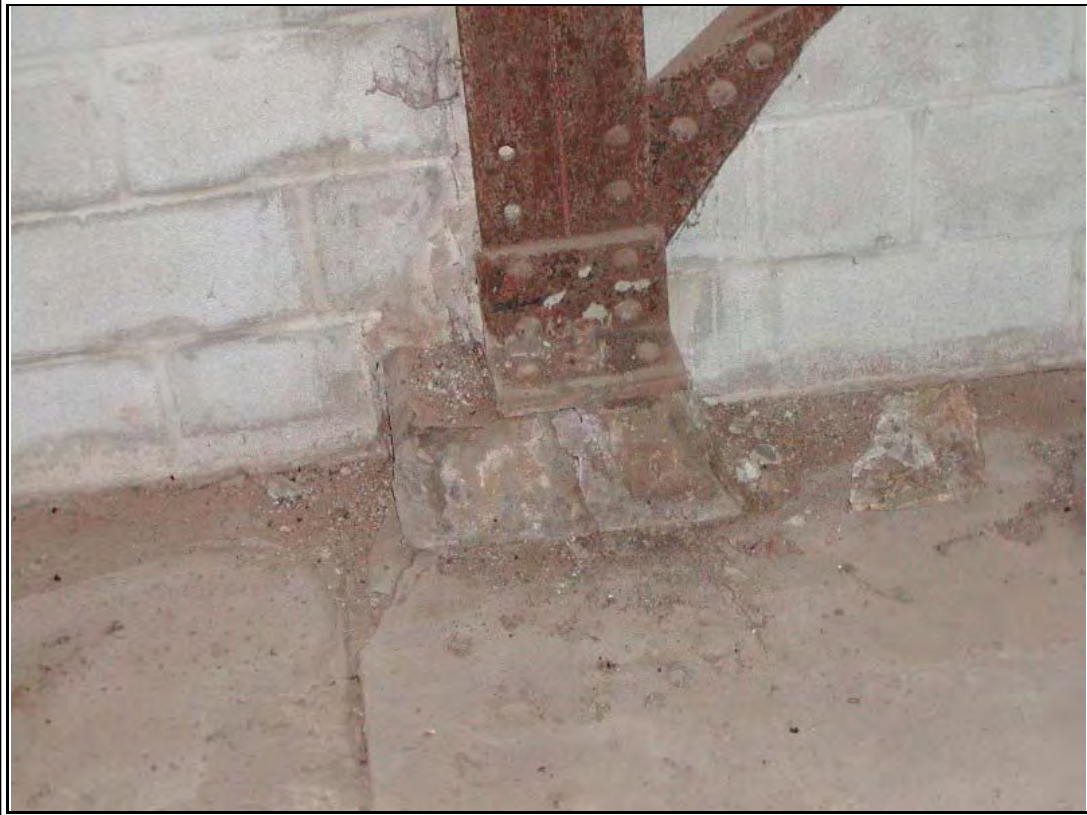
Photograph #: 10

Deteriorated concrete pier at column

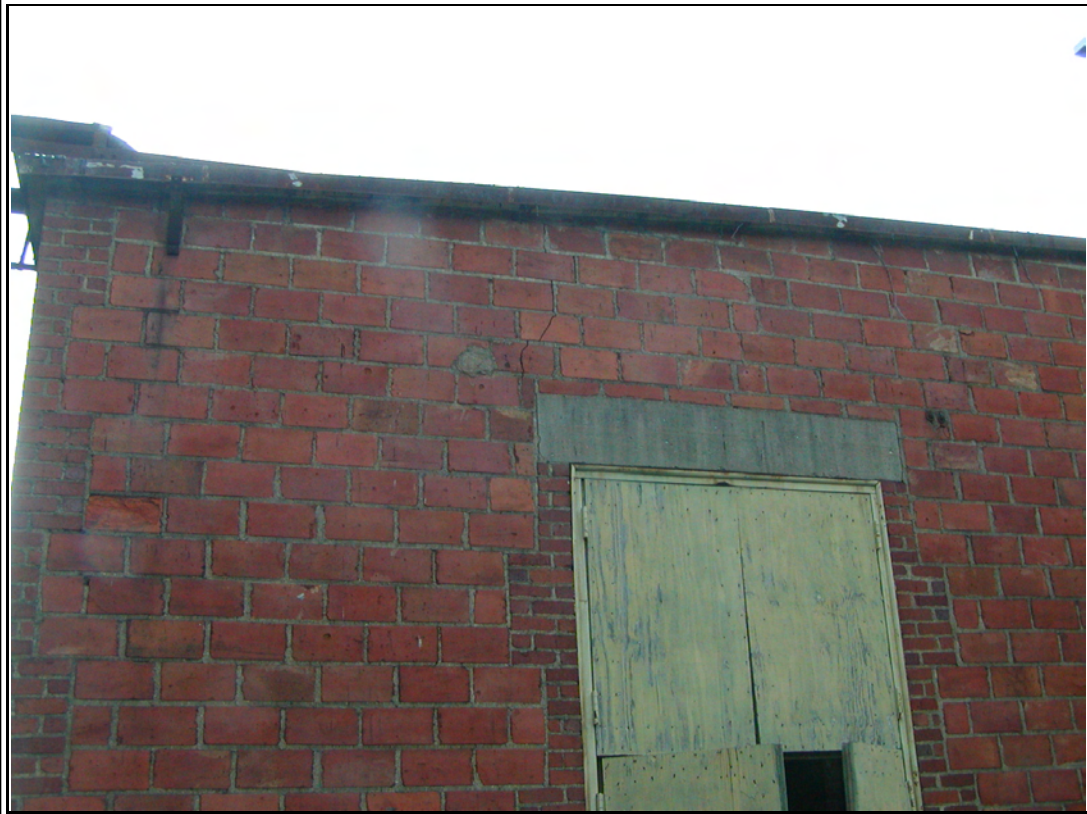
Photograph #: 2

Building 72a - Substation				
Defect Item No.	Defect Description	Quantity/ Unit of Measure	Repair Code/ Remarks	Photo Log Reference No.
1	Cracked masonry at east wall	10 LF	R-M-2	2
2	Spalled masonry at south wall	3 SF	R-M-3	3
Repair Code - Description				
R-M-2	Repair cracks in masonry with appropriate sealant			
R-M-3	Repair spalls in masonry with matching material

Minor cracks in masonry at east wall of substation
