Structural Assessment

Muscle Shoals Reservation
adaptive re-use study

Conditions/Market/Planning/Implementation

July 31, 2009
Revised August 25, 2009

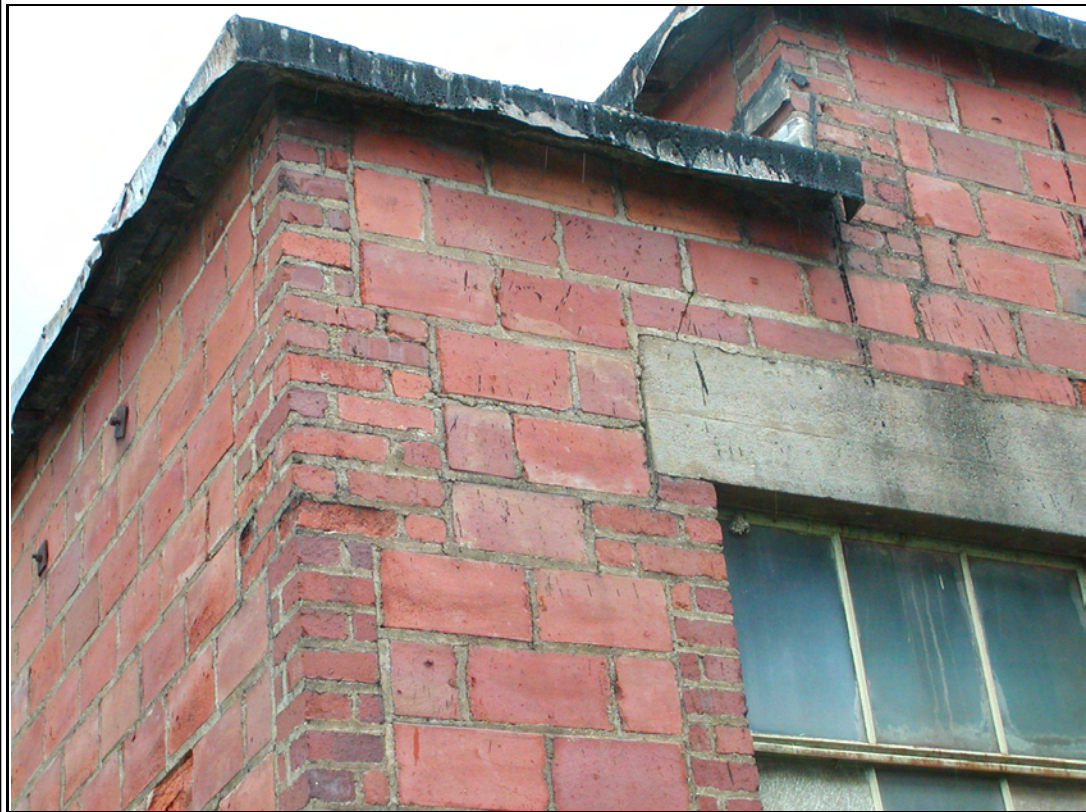
Photograph #: 3

Building 72a - Substation				
Defect Item No.	Defect Description	Quantity/ Unit of Measure	Repair Code/ Remarks	Photo Log Reference No.
1	Cracked masonry at east wall	10 LF	R-M-2	2
2	Spalled masonry at south wall	3 SF	R-M-3	3
Repair Code - Description				
R-M-2	Repair cracks in masonry with appropriate sealant			
R-M-3	Repair spalls in masonry with matching material

Minor spalls in exterior masonry

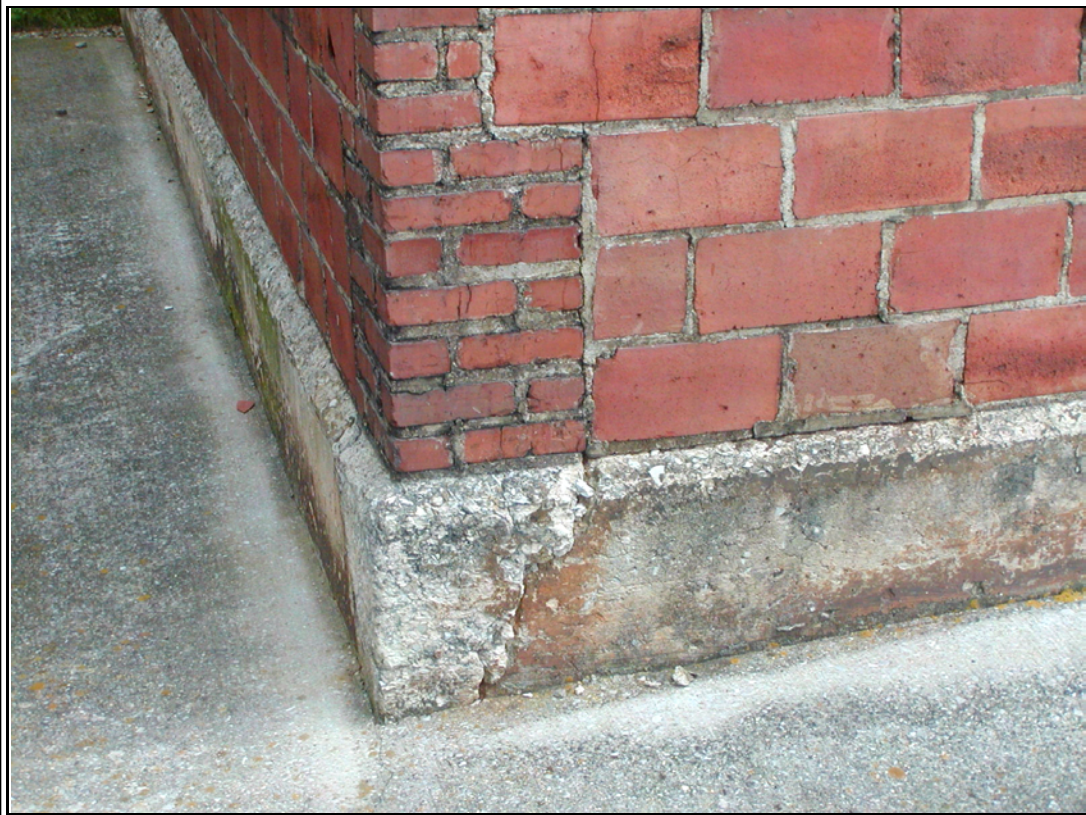
Photograph #: 4

Minor crack on turned down slab

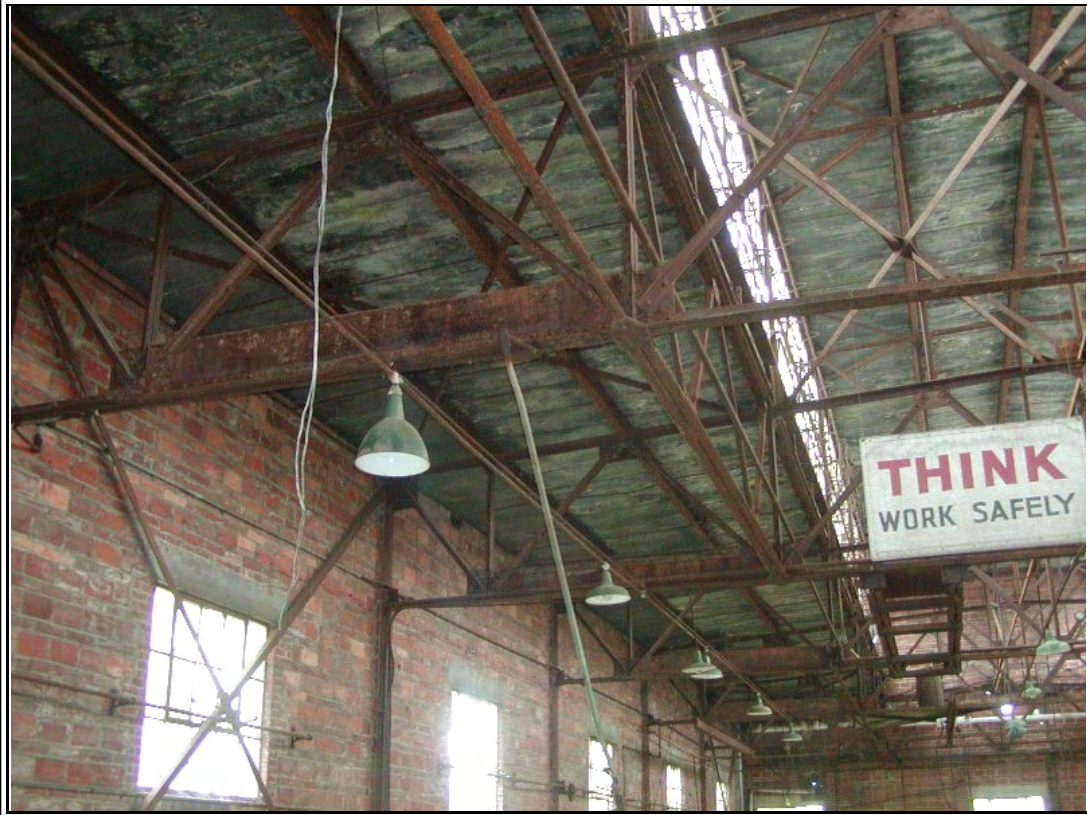
Photograph #: 6

Corroded steel framing and deteriorated concrete plank roof deck.

R-C-1	Route and seal cracks in concrete			
R-D-1	Replace defective concrete planks at roof deck			
R-M-2	Repair cracks in masonry with appropriate sealant			
R-M-4	Reconstruct damaged and/or unstable masonry			
R-S-1	Sandblast, prime, and paint structural steel			
R-S-3	Replace structural steel framing

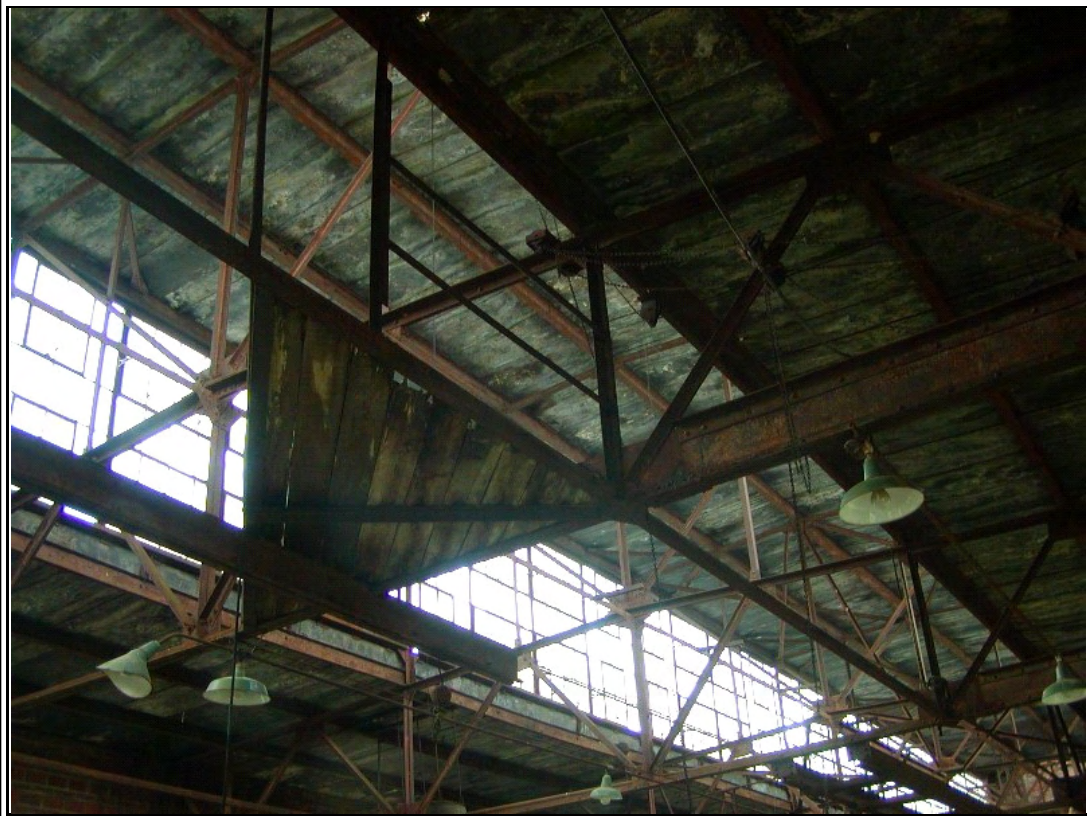
Photograph #: 7

Corroded steel framing and deteriorated concrete plank roof deck.

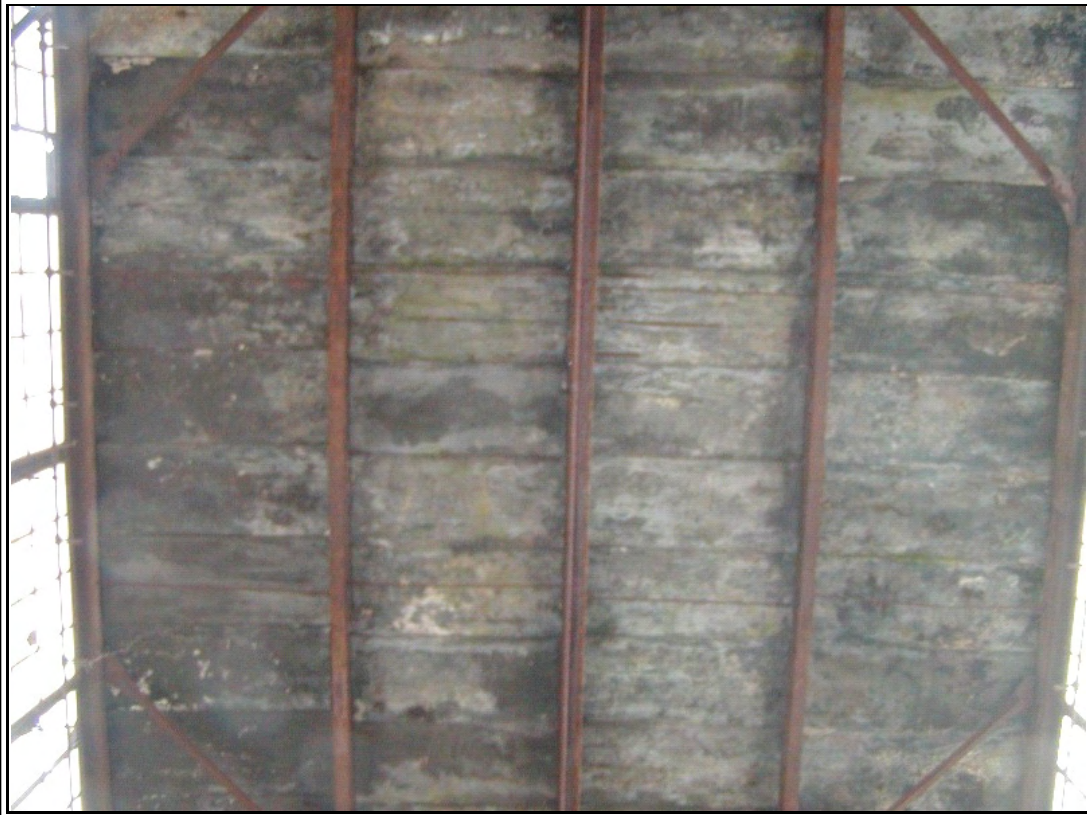
Photograph #: 8

Deteriorated concrete plank roof deck at monitor. Exposed reinforcing steel is visible.

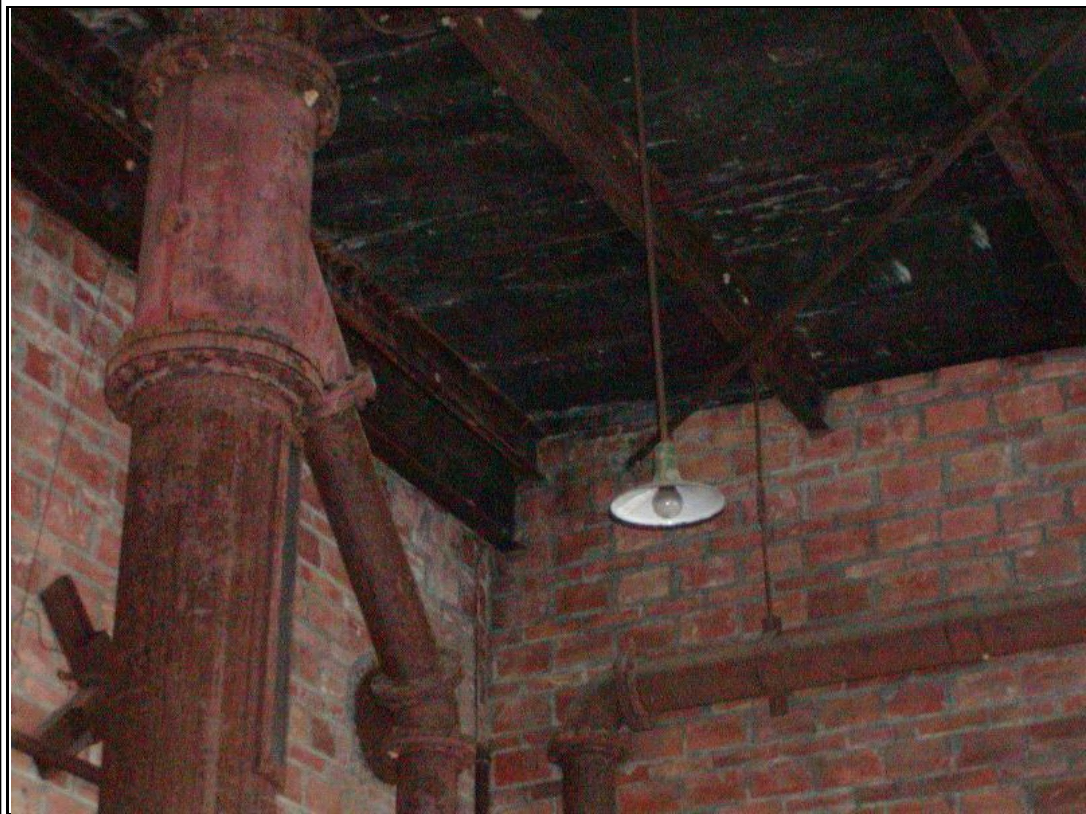
Photograph #: 9

Severely deteriorated roof structure at west end of building.

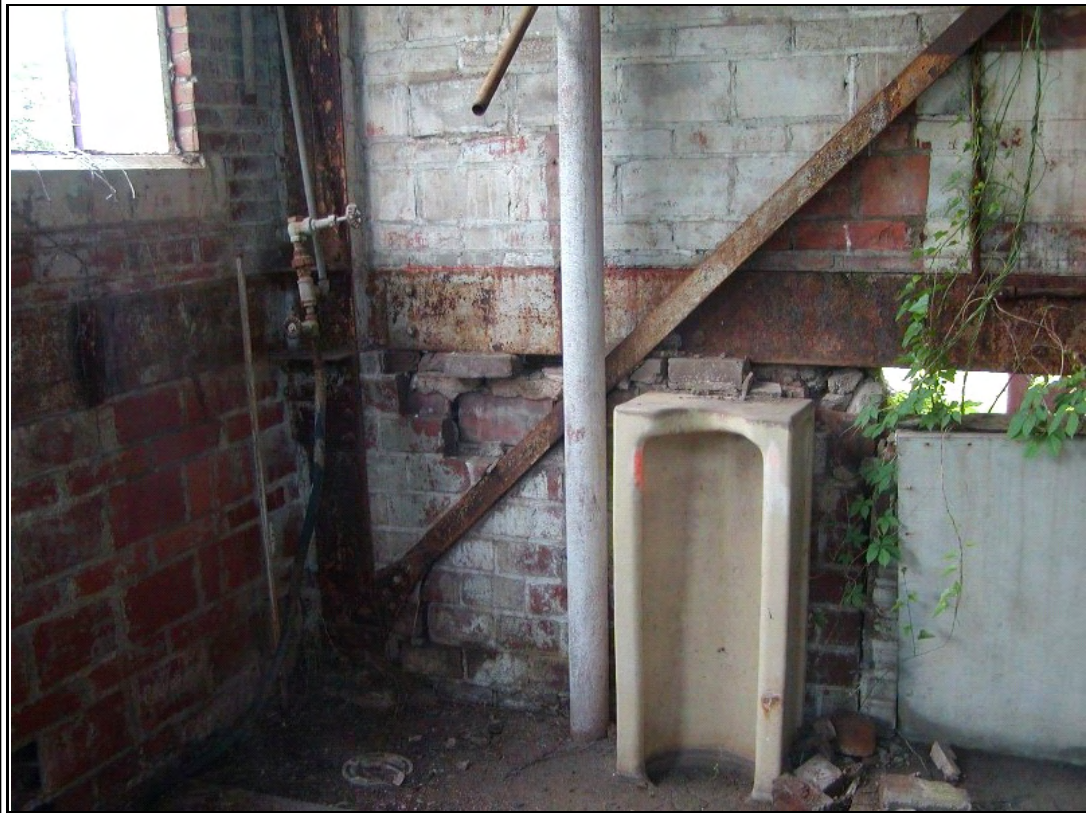
Photograph #: 10

Damaged masonry infill at southeast corner.

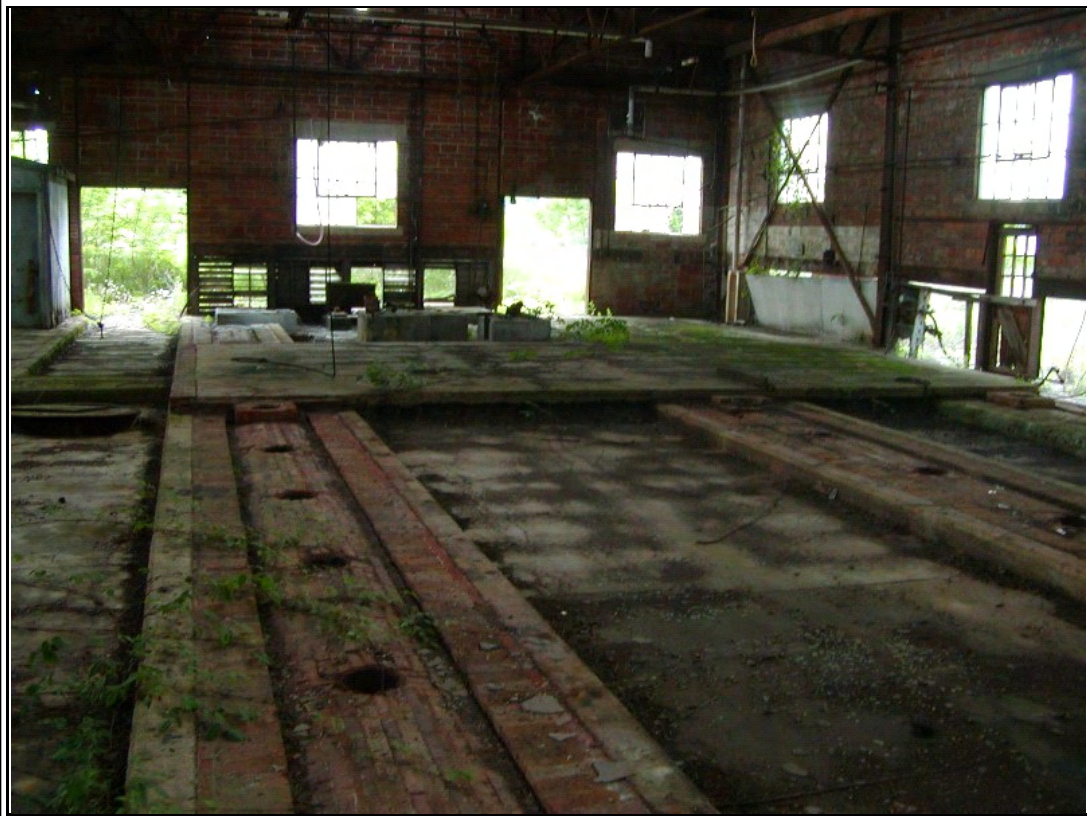
Photograph #: 11

Irregular, deteriorated floor system in main building.

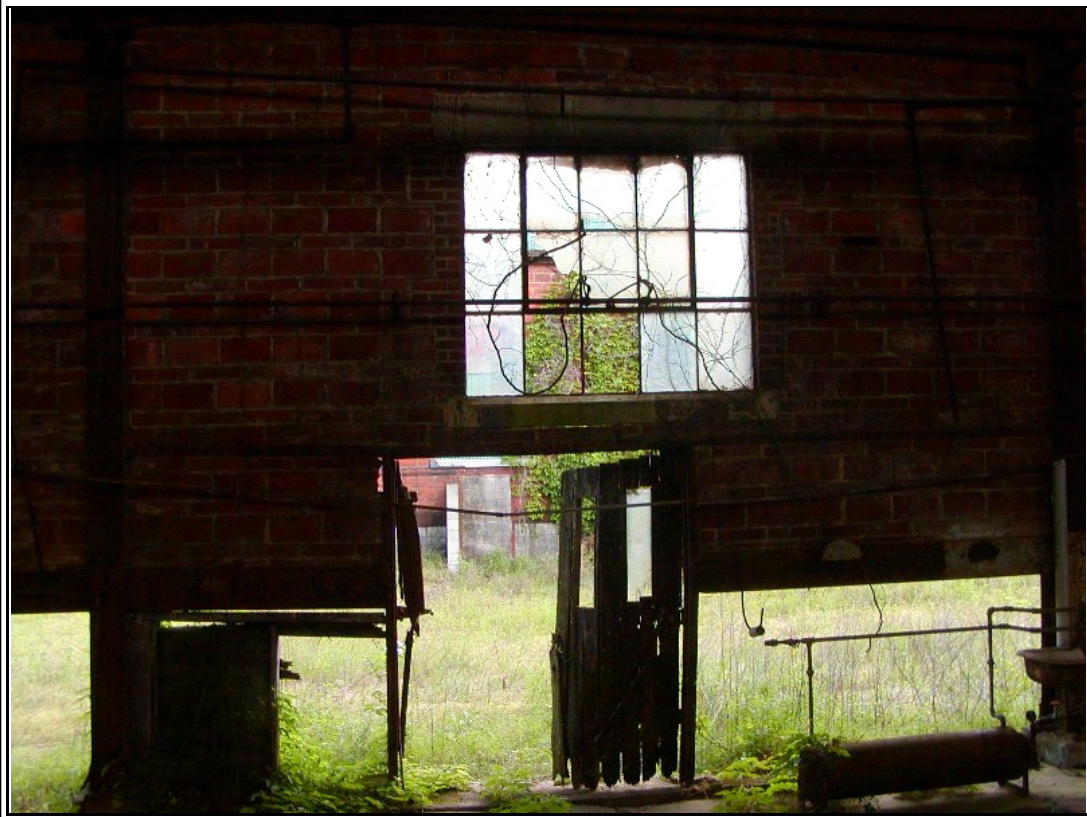
Photograph #: 12

Structurally unstable masonry infill and supporting steel framing.

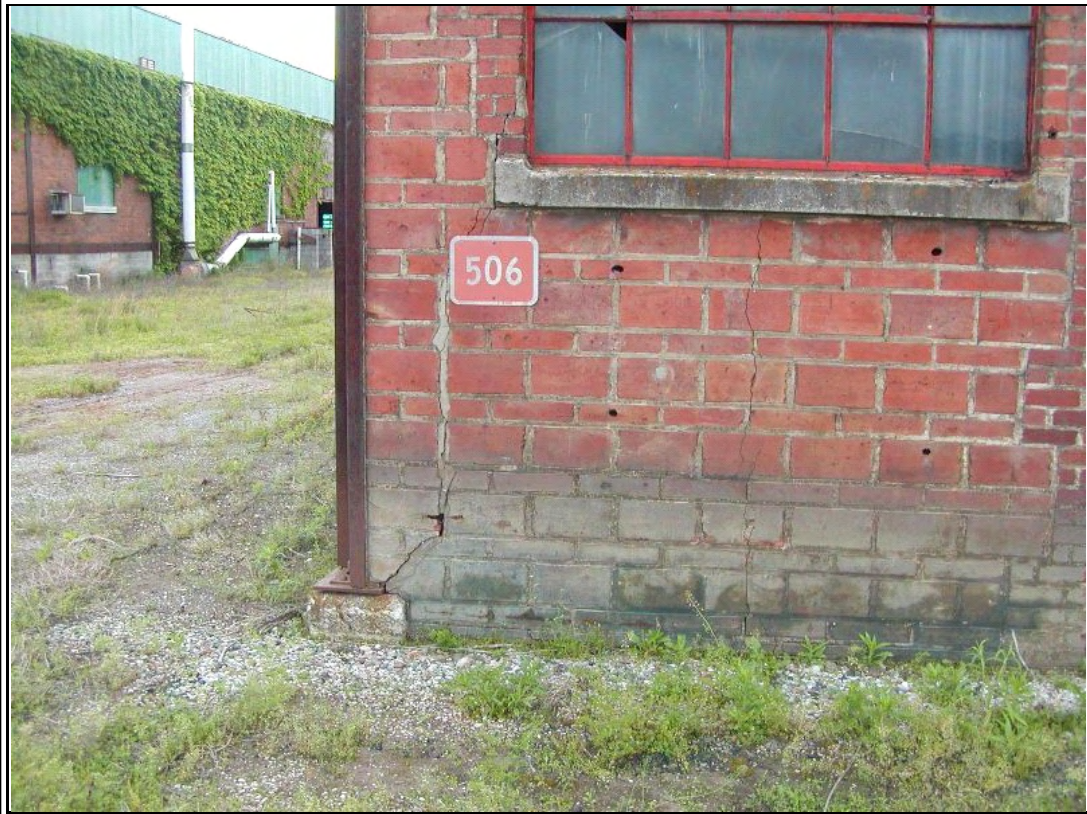
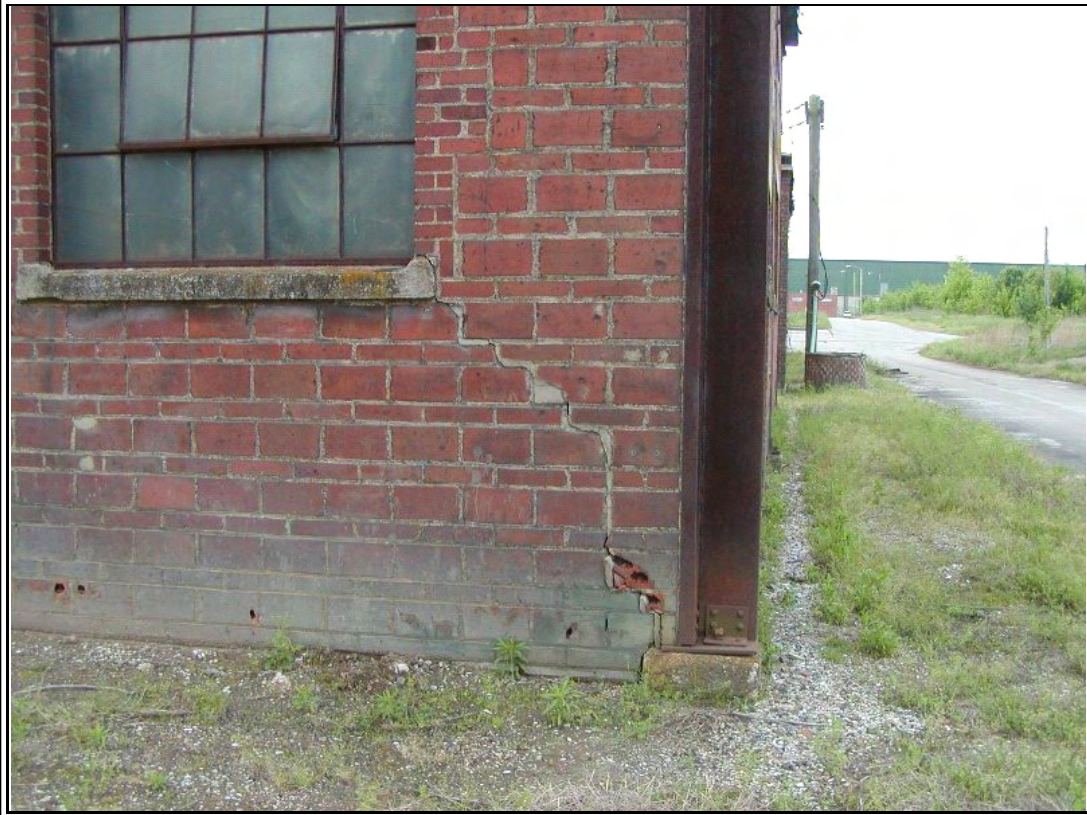
Building 73 Catalyzer #5				
Defect Item No.	Defect Description	Quantity/ Unit of Measure	Repair Code/ Remarks	Photo Log Reference No.
1	Foundation settlement cracks on northwest corner	20 LF	R-M-2	13,14
2	Foundation settlement cracks on southwest corner	20 LF	R-M-2	
3	Foundation settlement cracks on north wall	30 LF	R-M-2	
4	Sagging support beam for north wall masonry.	10 LF	R-M-4	12
4	Sagging support beam for north wall masonry	10 LF	R-S-3	12
5	Deteriorated masonry at southeast corner.	10 LF	R-M-4	10
6	Cracking in exterior masonry at southeast corner.	18 LF	R-M-2	
7	Cracking in masonry at northeast corner	10 LF	R-M-2	
8	Corrosion of steel framing	95 %	R-S-1	6,7
9	Spalling and deteriorated concrete roof deck.	20 %	R-D-1	6,7,8,9
10	Cracks in floor slab.	30 LF	R-C-1	
11	Door lintel severely deformed on north wall.	20 LF	R-M-4	
11	Door lintel severely deformed on north wall.	20 LF	R-S-3	
Repair Code - Description

Settlement cracks in masonry at northwest corner.

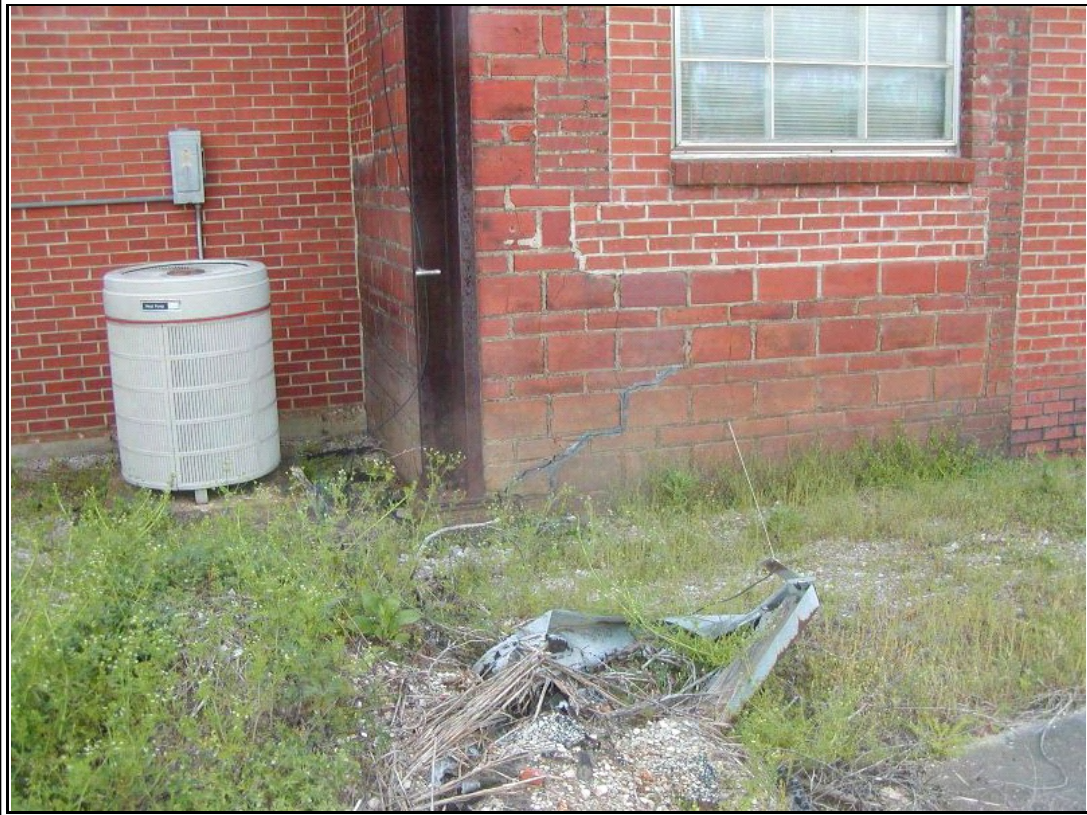
Photograph #: 4

Crack in masonry at northwest corner where north addition adjoins original building

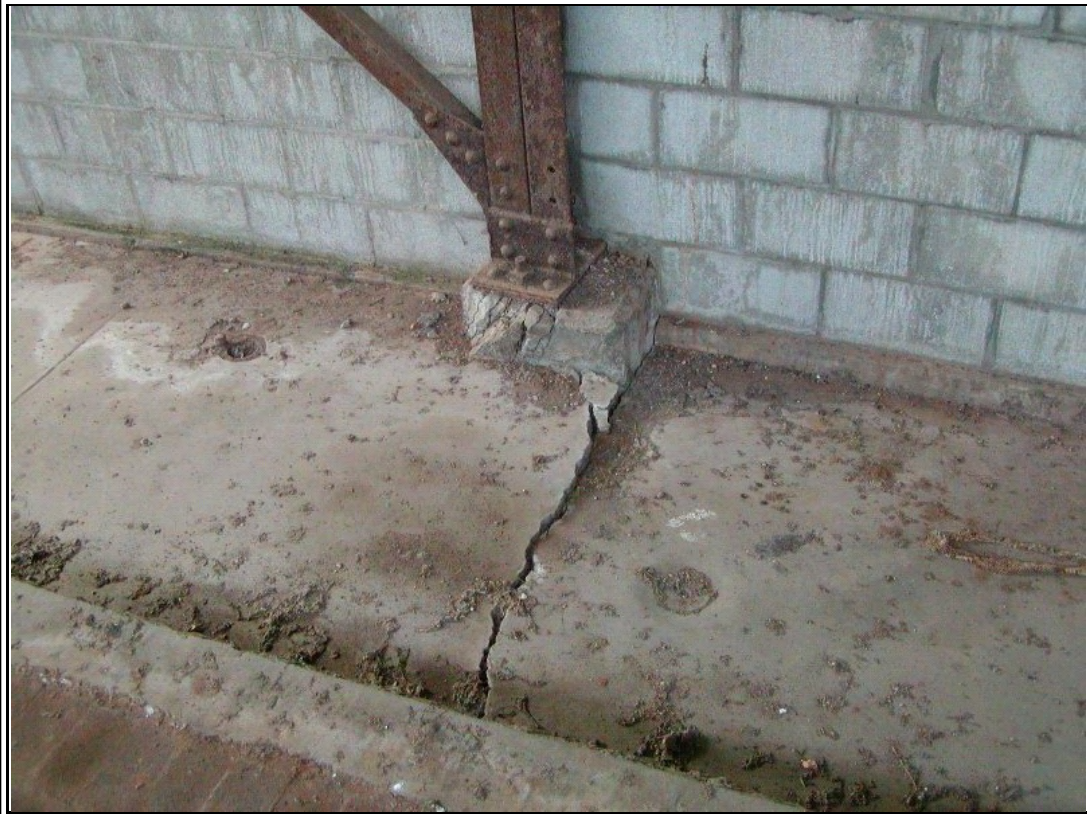
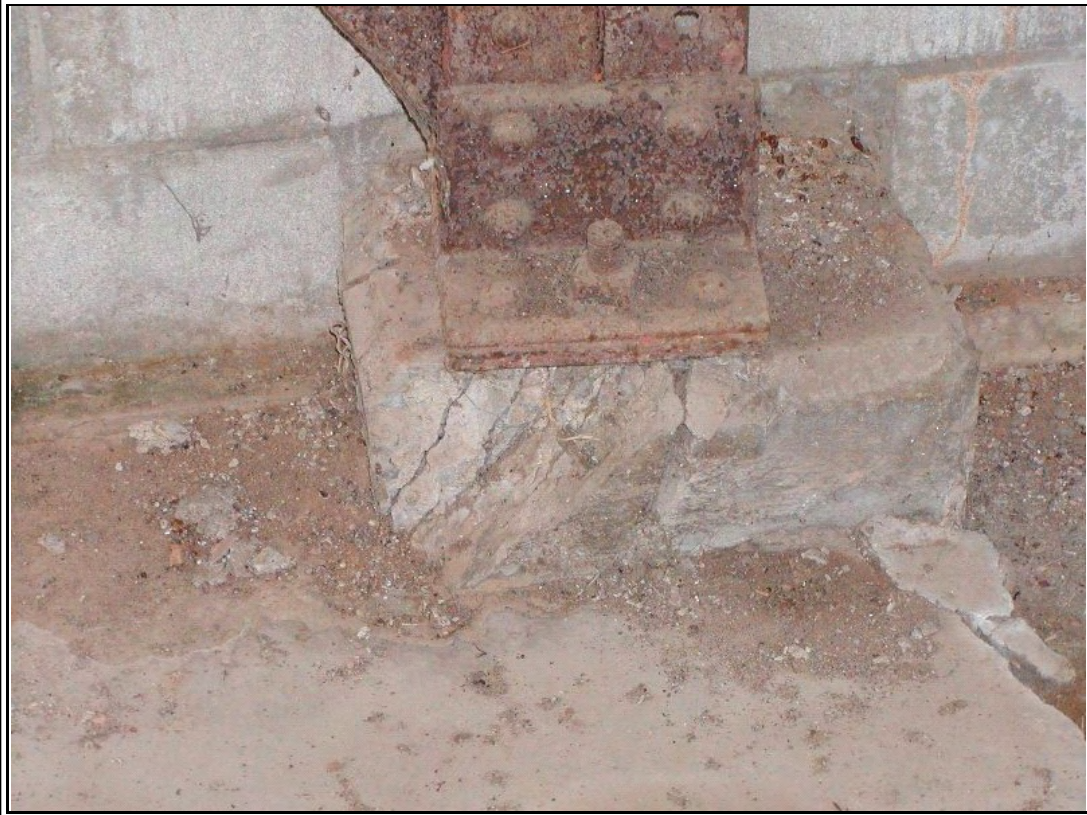
Building 74 Catalyzer #6				
Defect Item No.	Defect Description	Quantity/ Unit of Measure	Repair Code/ Remarks	Photo Log Reference No.
1	Minor stair step crack at northeast corner interior	20 LF	R-M-2	
2	Footing pier cracking at southeast corner		R-C-2	7,8
3	Wall cracking at southeast corner	20 LF	R-M-2	9
4	Cracking at northeast corner of high wall	30 LF	R-M-2	
5	Small 1 story building (20' x 30') between Bldg 74 and Bldg 73. No access. No cracking noted in masonry walls			
6	Cracking at northwest corner	20 LF	R-M-2	4
7	Cracking at center of west wall	10 LF	R-M-2	
8	Cracking at southwest corner	20 LF	R-M-2	
9	Crack at south sides of high bay	30 LF	R-M-2	
10	Crack under lintel at southwest corner	20 LF	R-C-2	
11	Crack at southeast corner	20 LF	R-M-2	10
Repair Code - Description				
R-C-2	Inject sealant to seal cracks in concrete			
R-M-2	Repair cracks in masonry with appropriate sealant

Deteriorated concrete pier and slab at column

Close-up of deteriorated column attachment at concrete pier

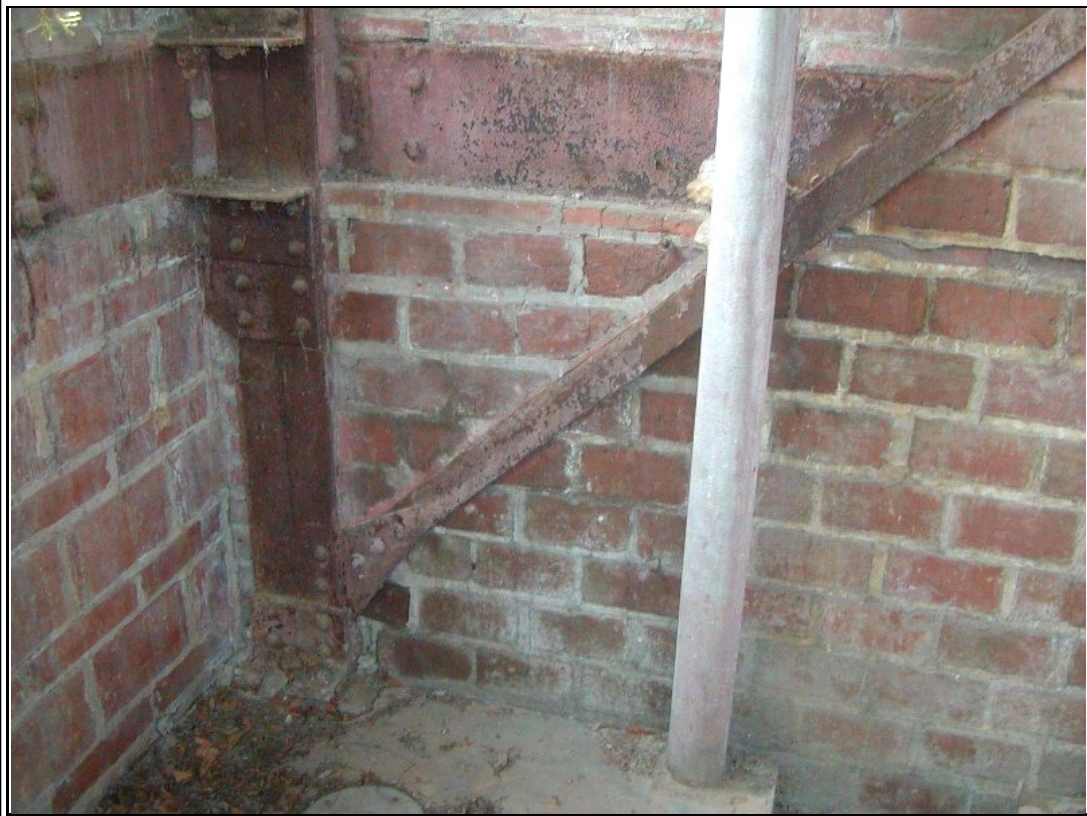
Photograph #: 9

Deteriorated steel column and wall framing

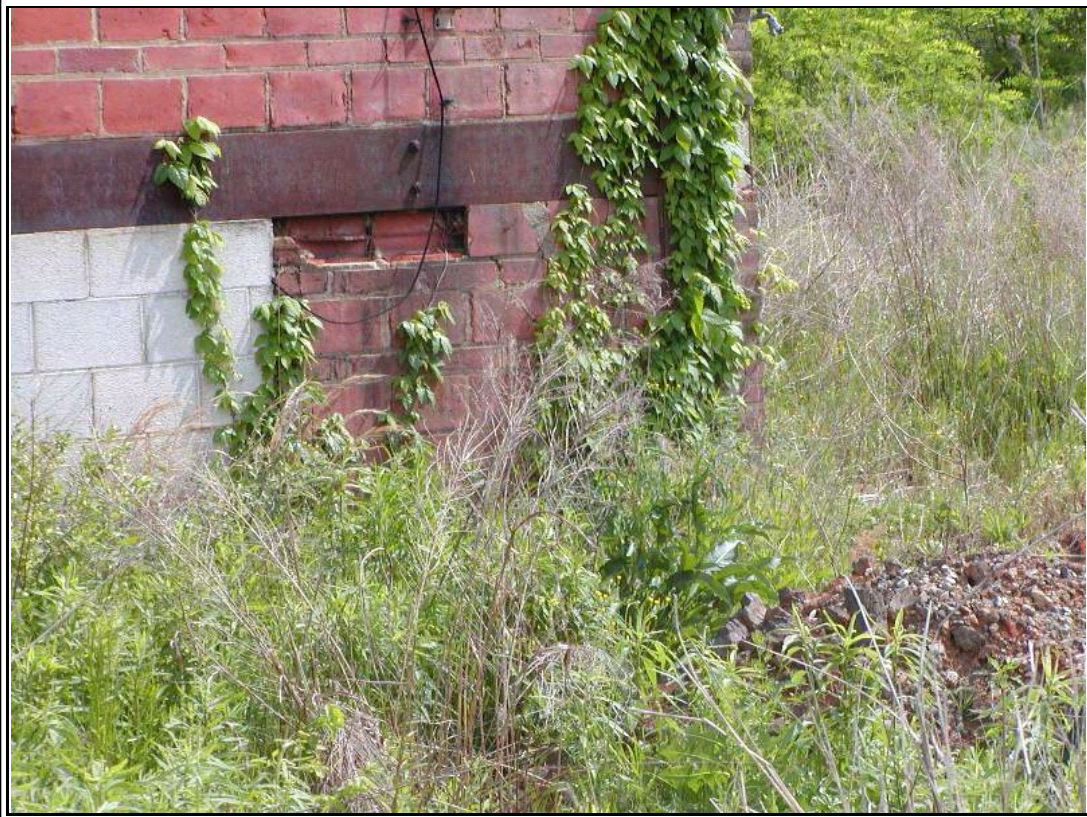
Photograph #: 10

Exterior view of wall and wall framing shown in Photo No. 9

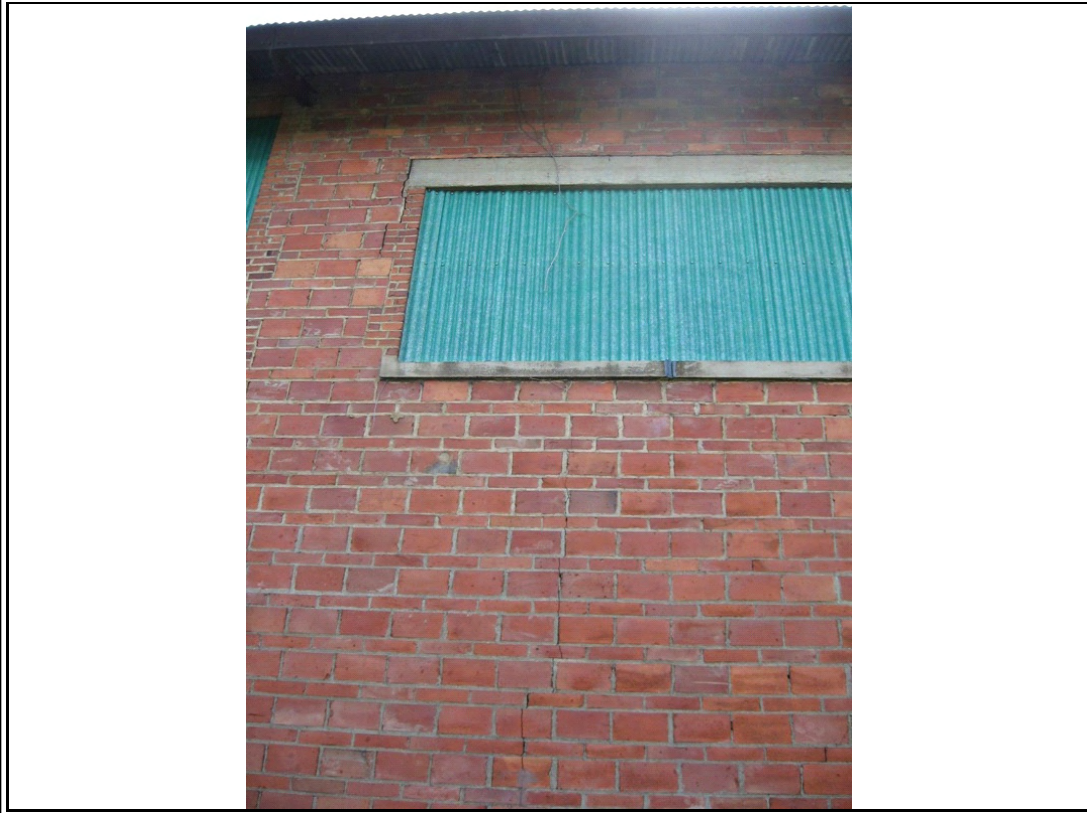
Photograph #: 4

Building 79 3A Building				
Defect Item No.	Defect Description	Quantity/ Unit of Measure	Repair Code/ Remarks	Photo Log Reference No.
1	Vertical masonry crack 1 inch wide in southwest corner	20 LF		2
2	Cracks at lintel on west elevation at south window	20 LF		4
3	Vertical cracks at columns on exposed mezzanine concrete frame on west elevation	15 SF		10
4	Spalls in west elevation	20 SF	R-C-3	
5	Badly rusted exterior metal stars on west elevation		R-S-3	3
6	Masonry exterior wall at north elevation - fair condition			
7	Crack at columns in exposed mezzanine concrete frame on east elevation			
8	Surface spalls on east elevation		R-C-3	
9	Lots of spalls (impact damage) of concrete columns supporting concrete mezzanine	12 ea	R-C-3	21,22
10	Impact damage at concrete mezzanine beams; serious chunk missing in 3 locations		R-C-3	23,24,25,26
11	Voids in masonry wall below both mezzanines at closed end		R-M-1, R-M-3

Vertical cracks in masonry

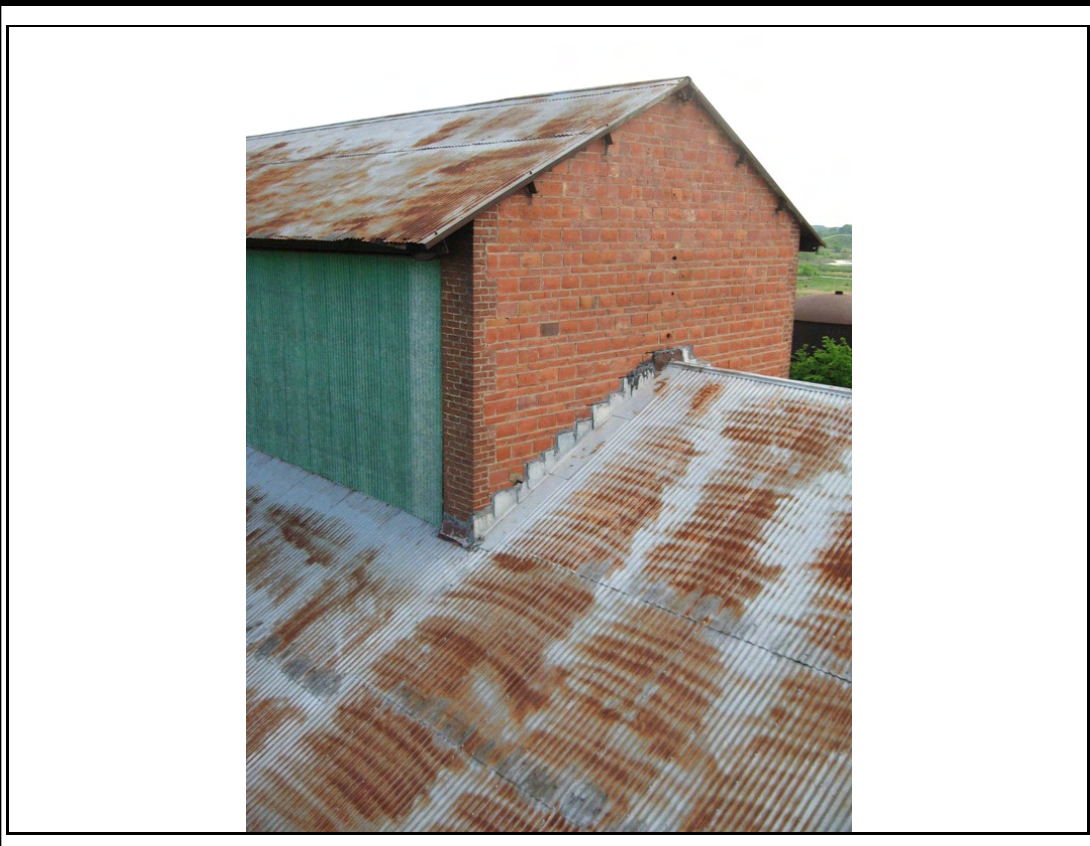
12	Roof diaphragm - corrugated metal deck or signs of rusting		R-D-2	7,8
Repair Code - Description				
R-C-3	Remove unsound concrete, remediate corroded reinforcing steel (if applicable) and repair spalls with appropriate filler			
R-D-2	Replace roof deck			
R-S-3	Replace structural steel framing

<p>Photograph #: 7</p> <p>Deteriorated metal roof at south end</p>

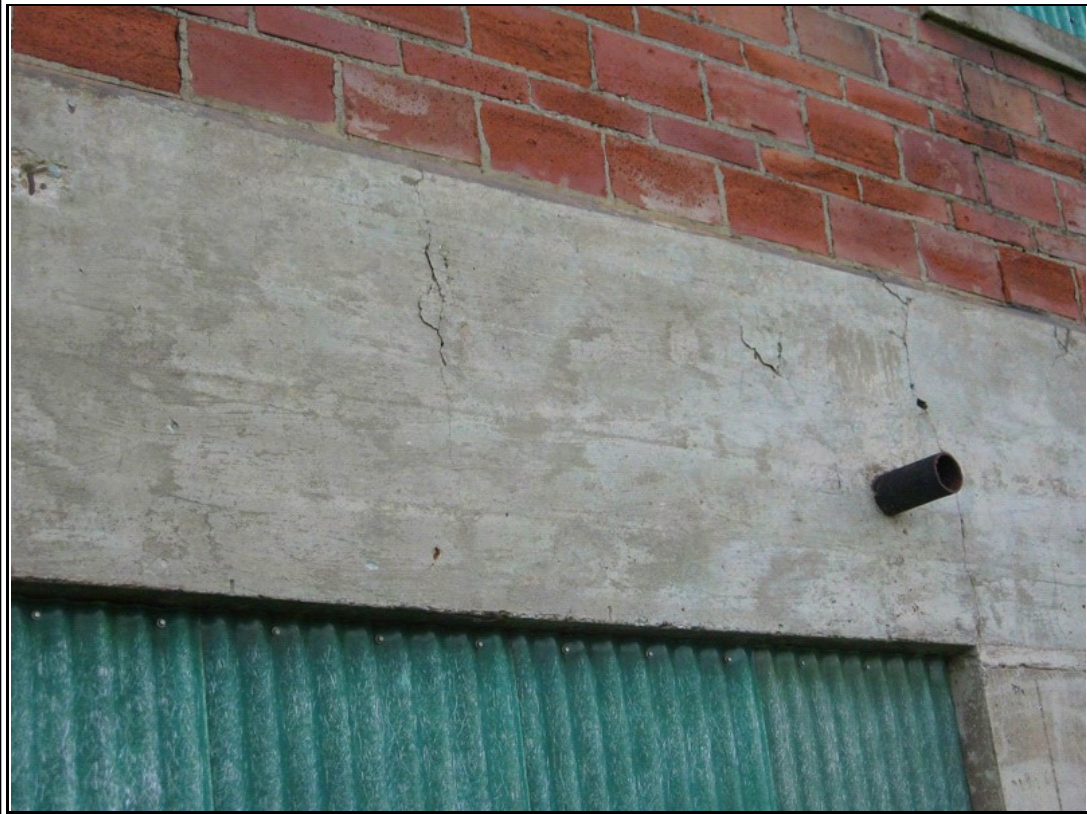
Photograph #: 9

Minor cracks and spalls in exterior face of mezzanine concrete frame

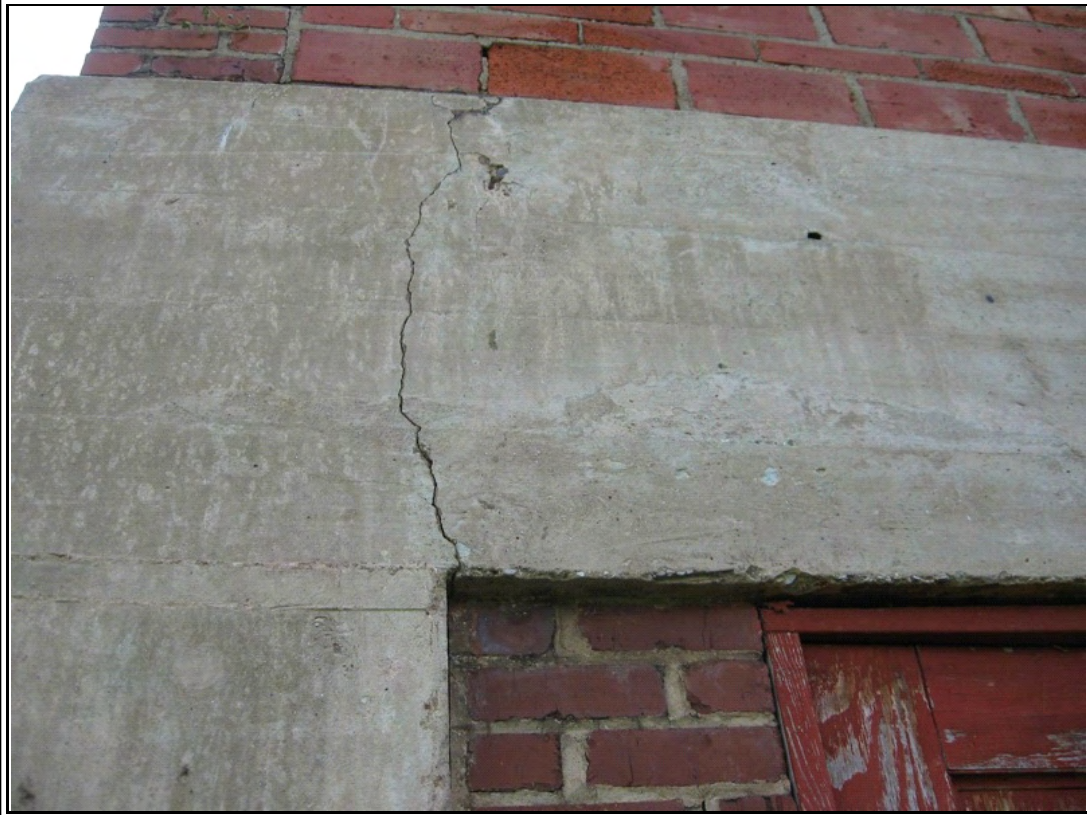
Photograph #: 10

Substantial crack in exterior mezzanine concrete frame

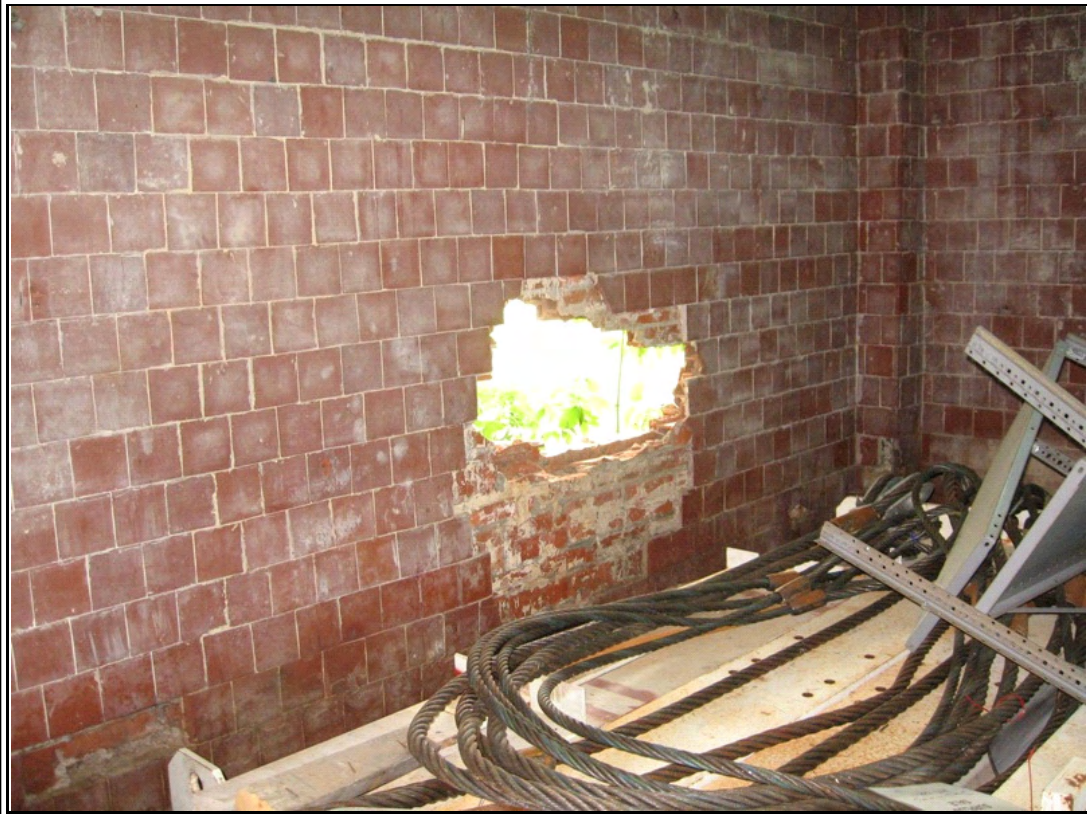
Photograph #: 19

Large hole in exterior masonry wall

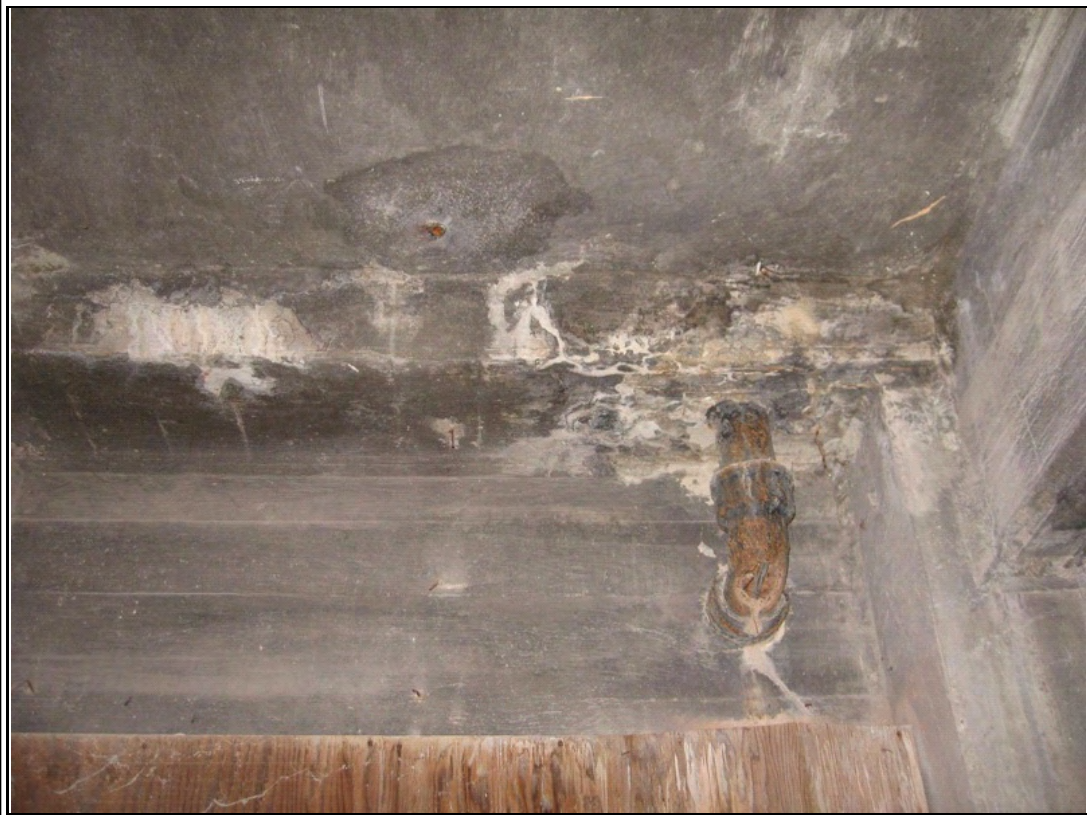
Photograph #: 20

Deterioration from water intrusion at mezzanine concrete frame

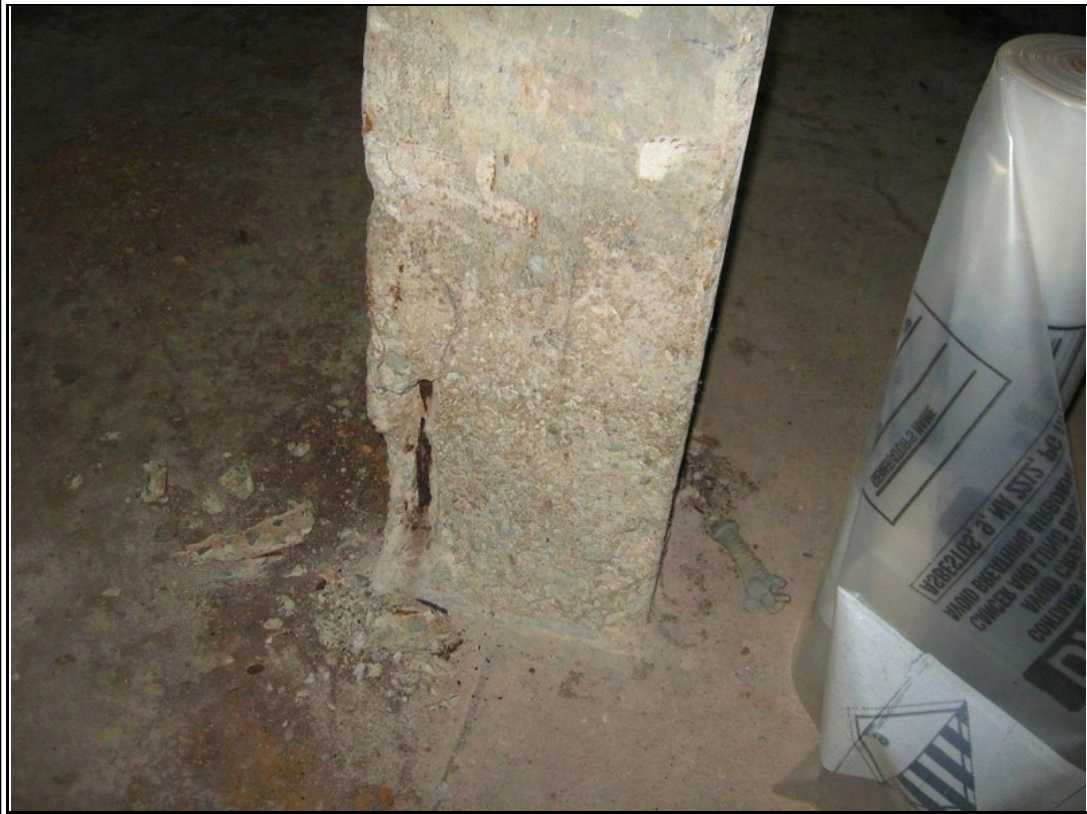
Photograph #: 21

Severely spalled mezzanine concrete column

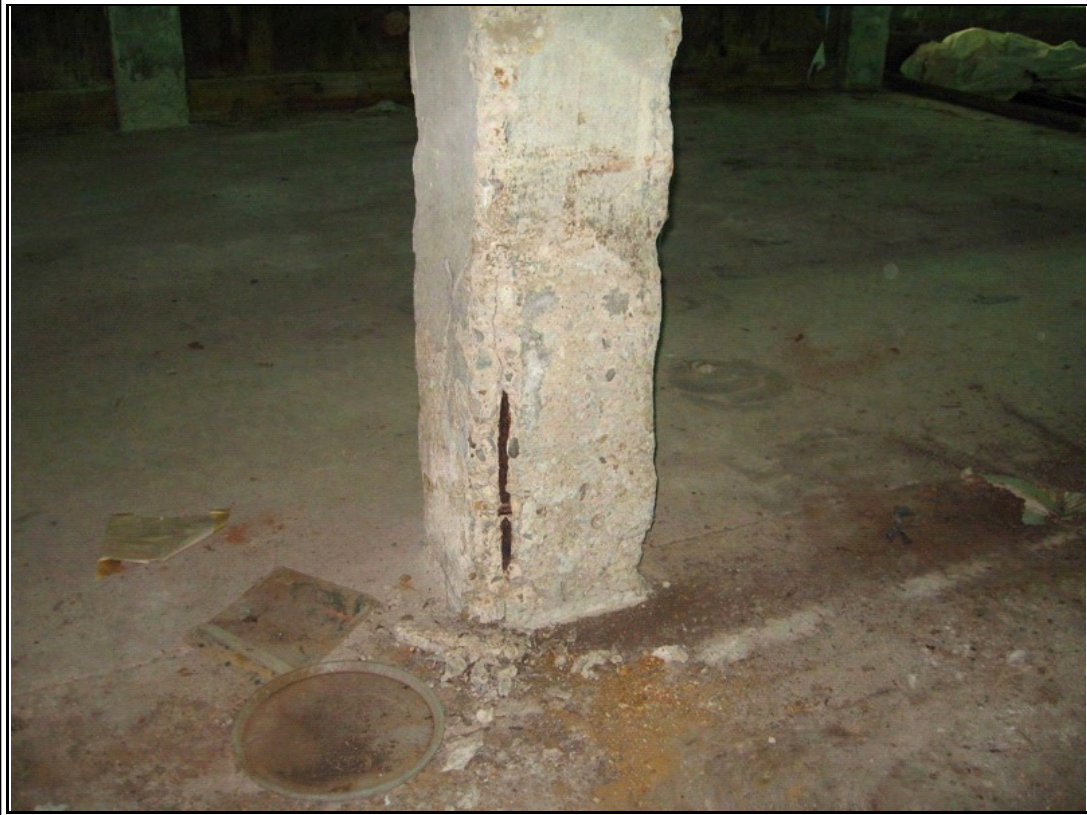
Photograph #: 22

Severely spalled mezzanine concrete column
