Structural Assessment

Muscle Shoals Reservation
adaptive re-use study

Conditions/Market/Planning/Implementation

July 31, 2009
Revised August 25, 2009

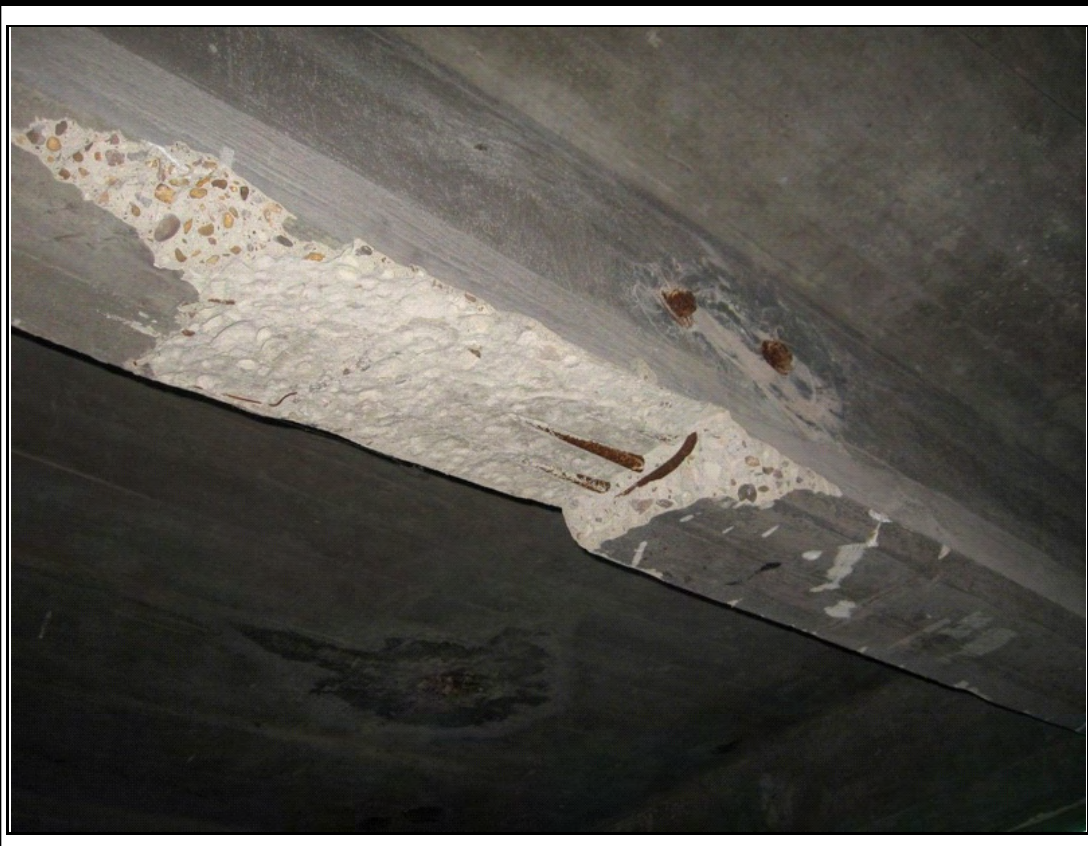
A photograph showing a cross-section of a concrete beam that has been severely damaged. The top portion of the beam is missing, exposing the internal structure. The remaining concrete is light-colored and shows signs of cracking and crumbling. The background is dark and indistinct.	<p>Photograph #: 23</p> <p>Heavily damaged mezzanine concrete beam</p>

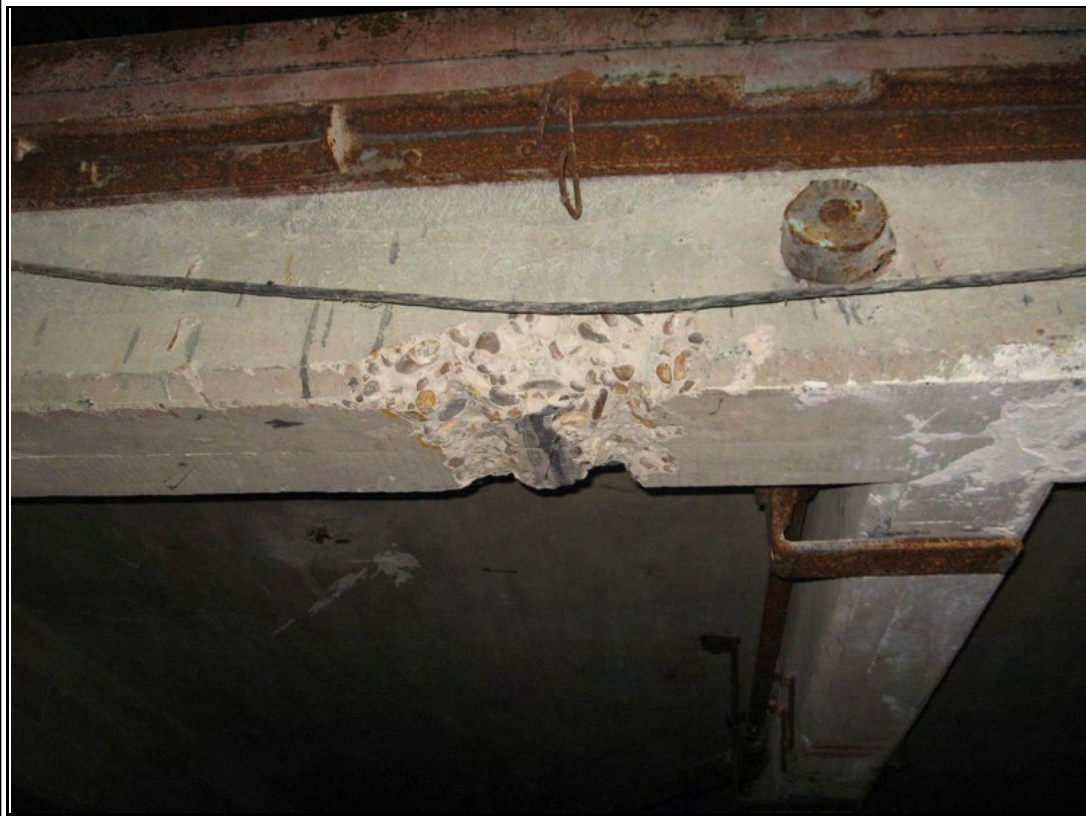
Photograph #: 25

Damaged mezzanine concrete beam

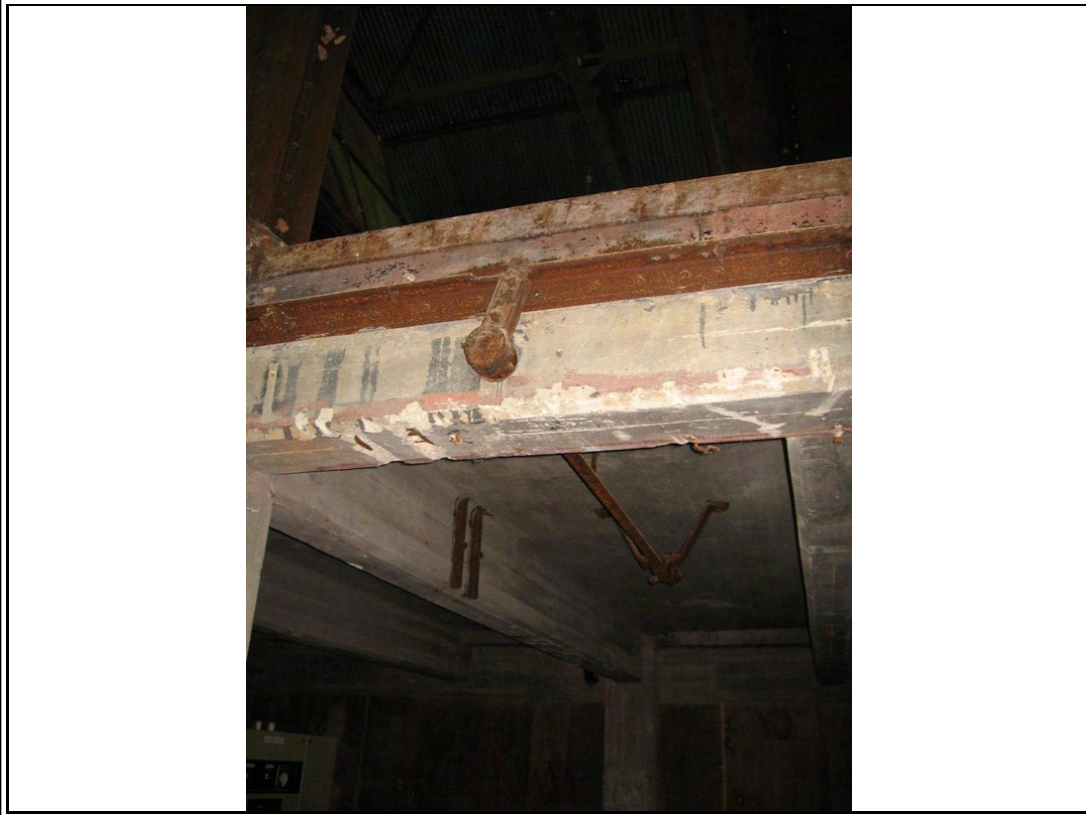
Photograph #: 26

Damaged mezzanine concrete beam

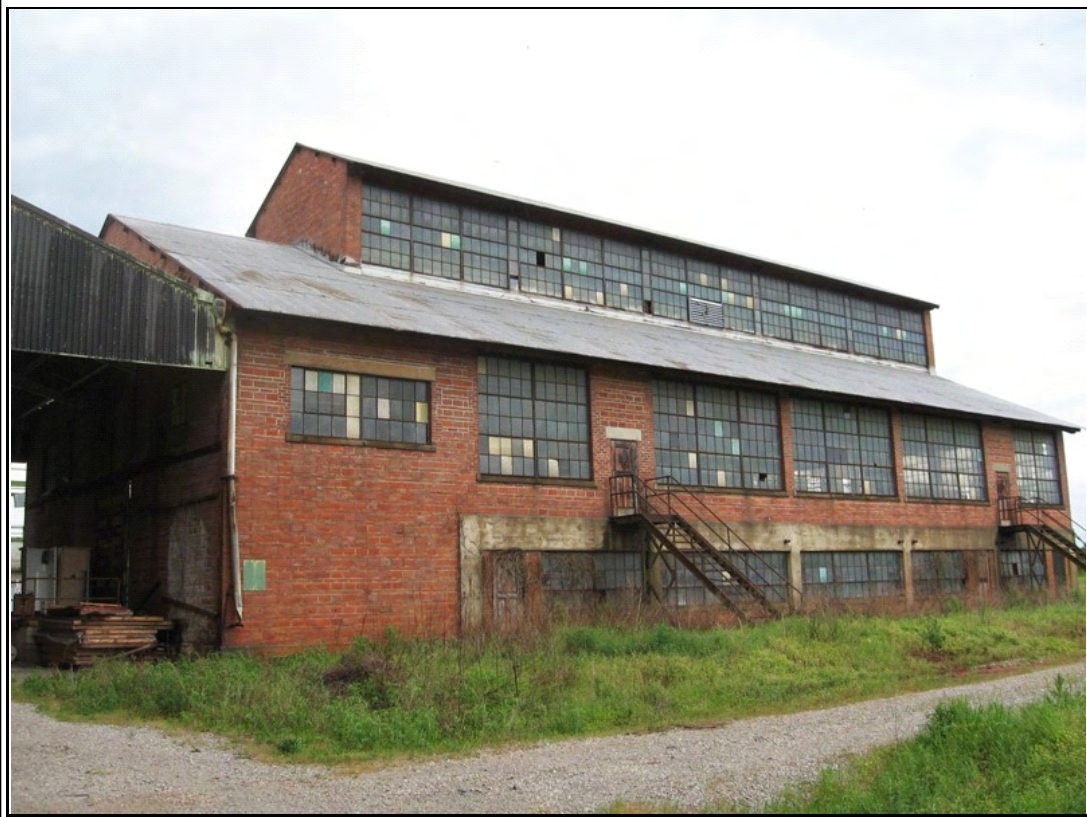
Photograph #: 1

Exterior building looking at west side.

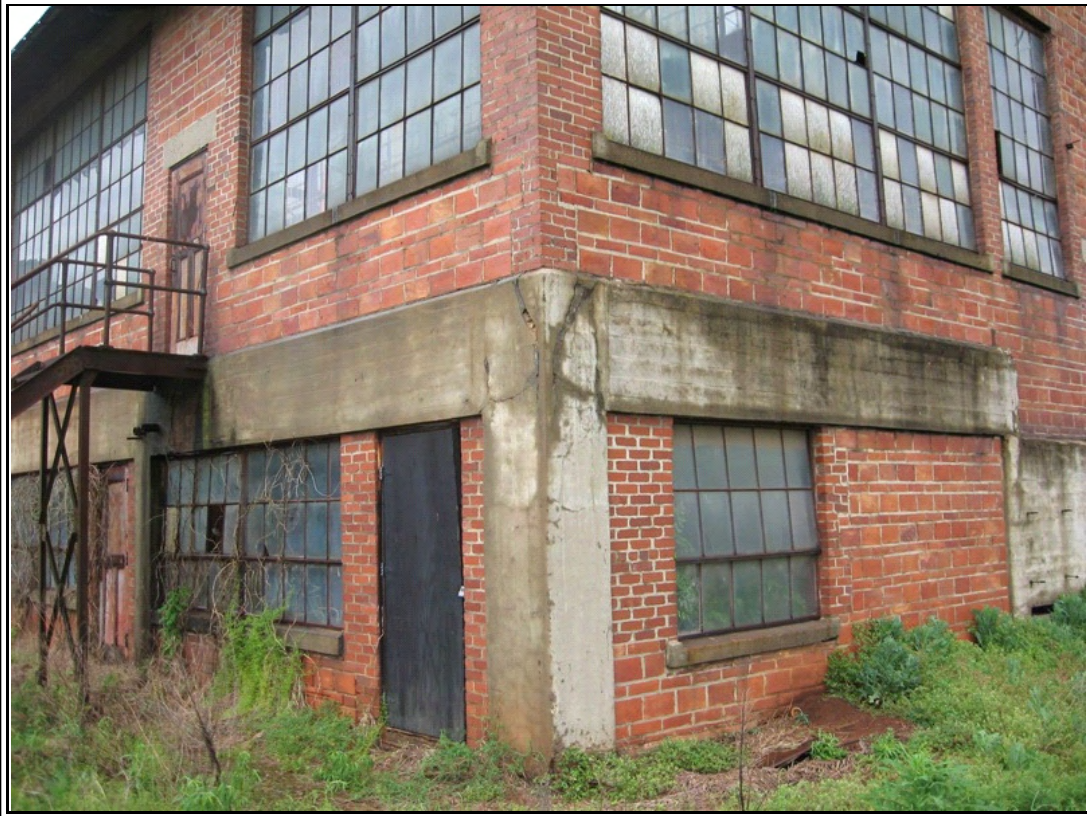
Photograph #: 2

Exterior cracks in concrete mezzanine frame at southwest corner

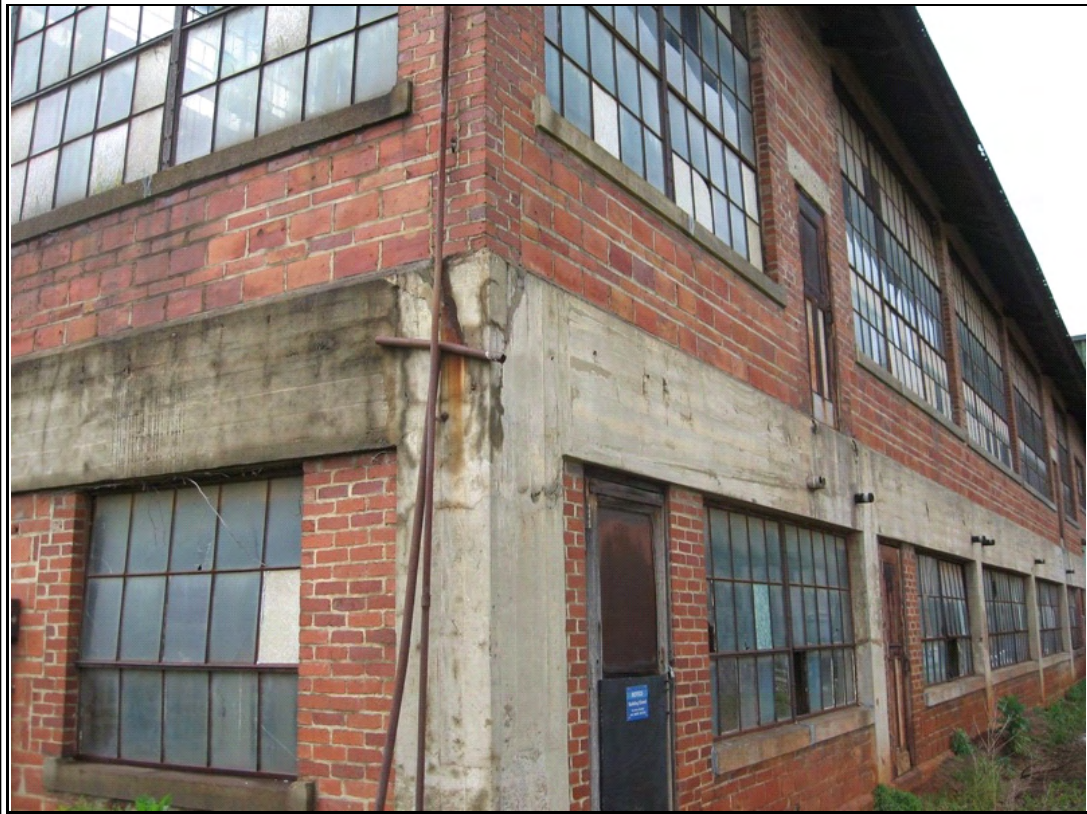
Photograph #: 3

Exterior cracks in concrete mezzanine frame at southeast corner.

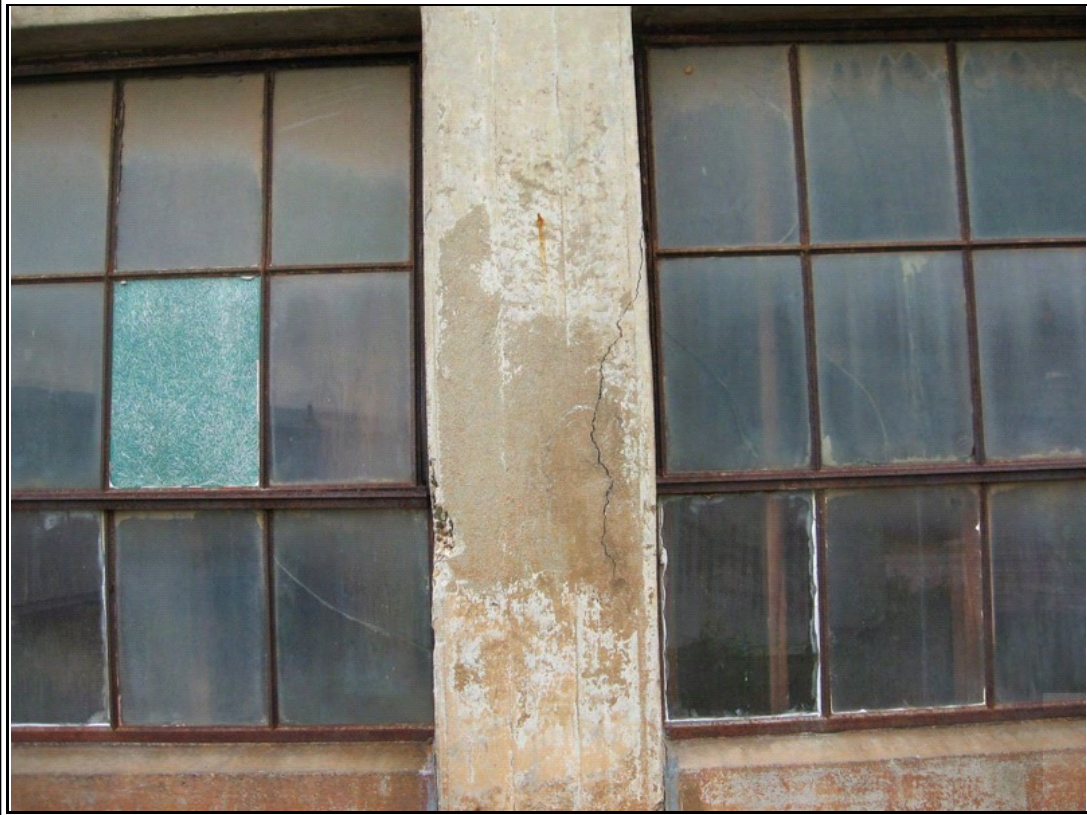
Photograph #: 4

Exterior crack in concrete mezzanine column.

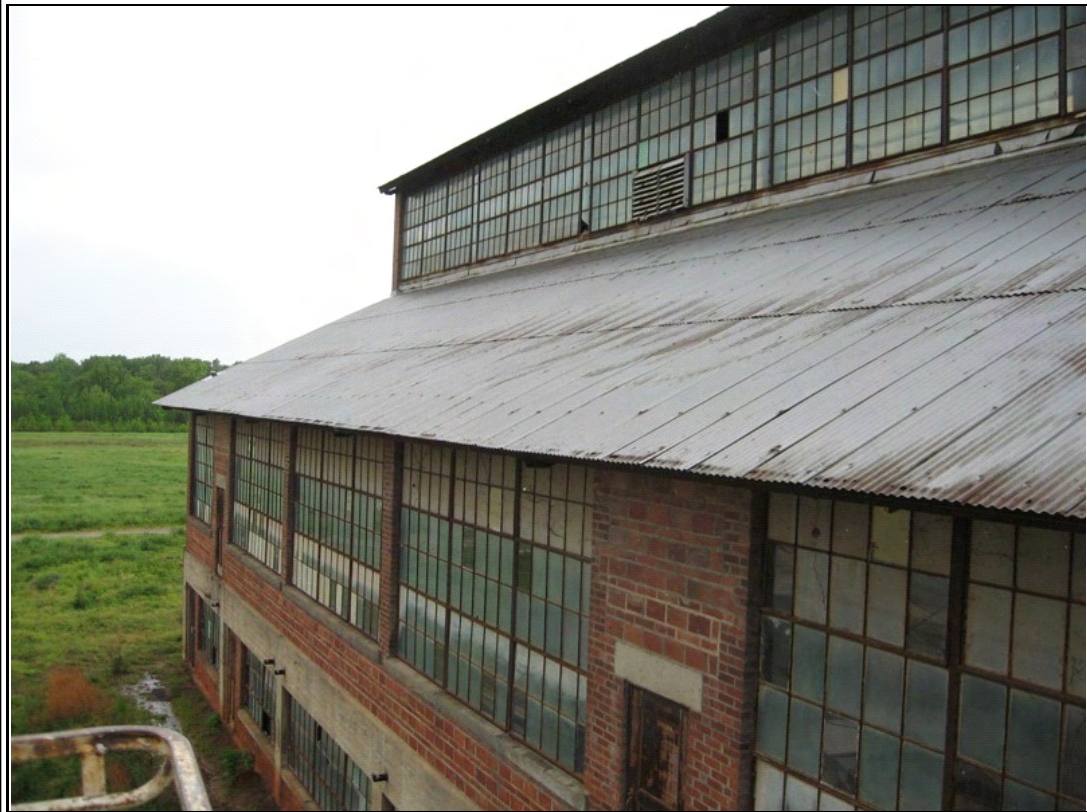
Photograph #: 5

Deteriorated metal roof on east side.

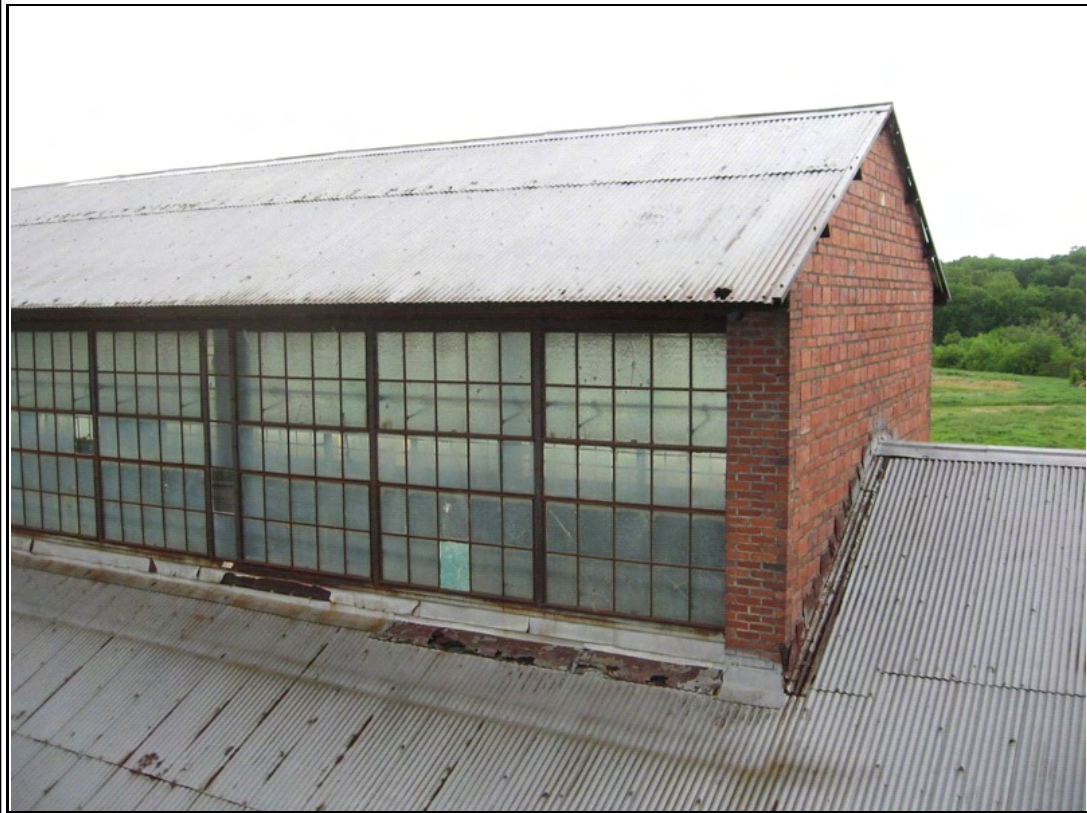
Photograph #: 6

Deteriorated metal roof on east side

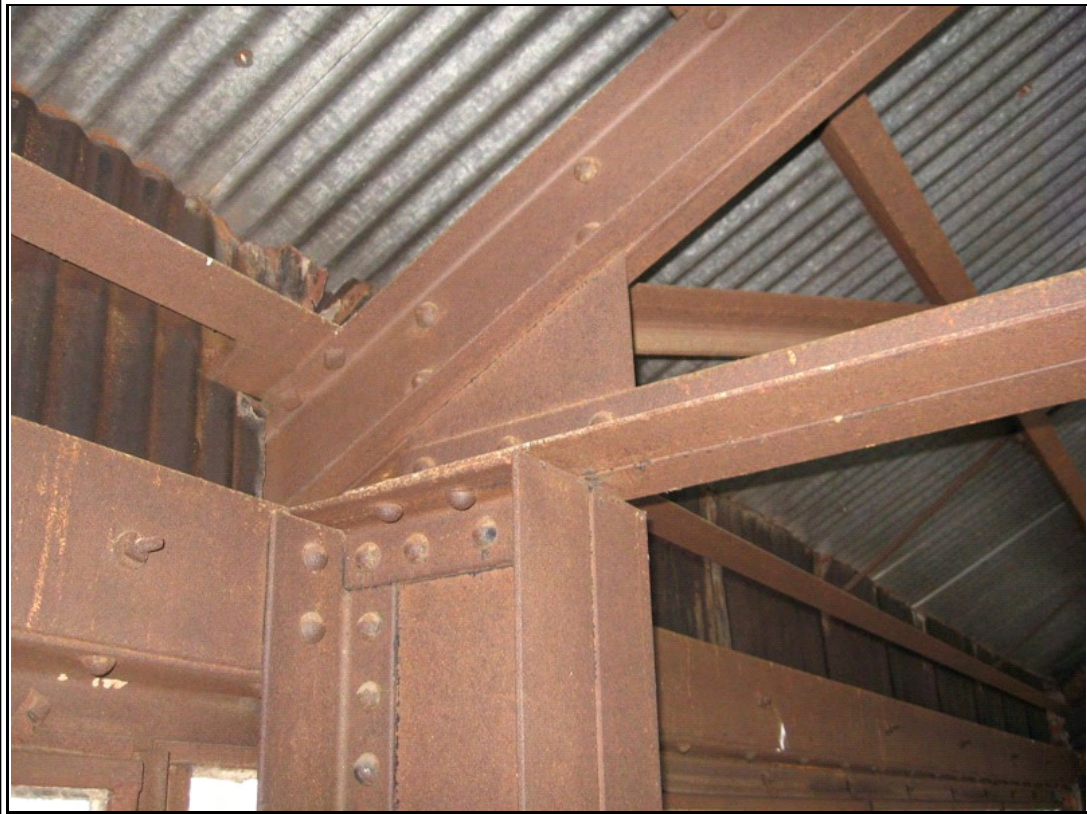
Photograph #: 15

Surface corrosion on steel framing.

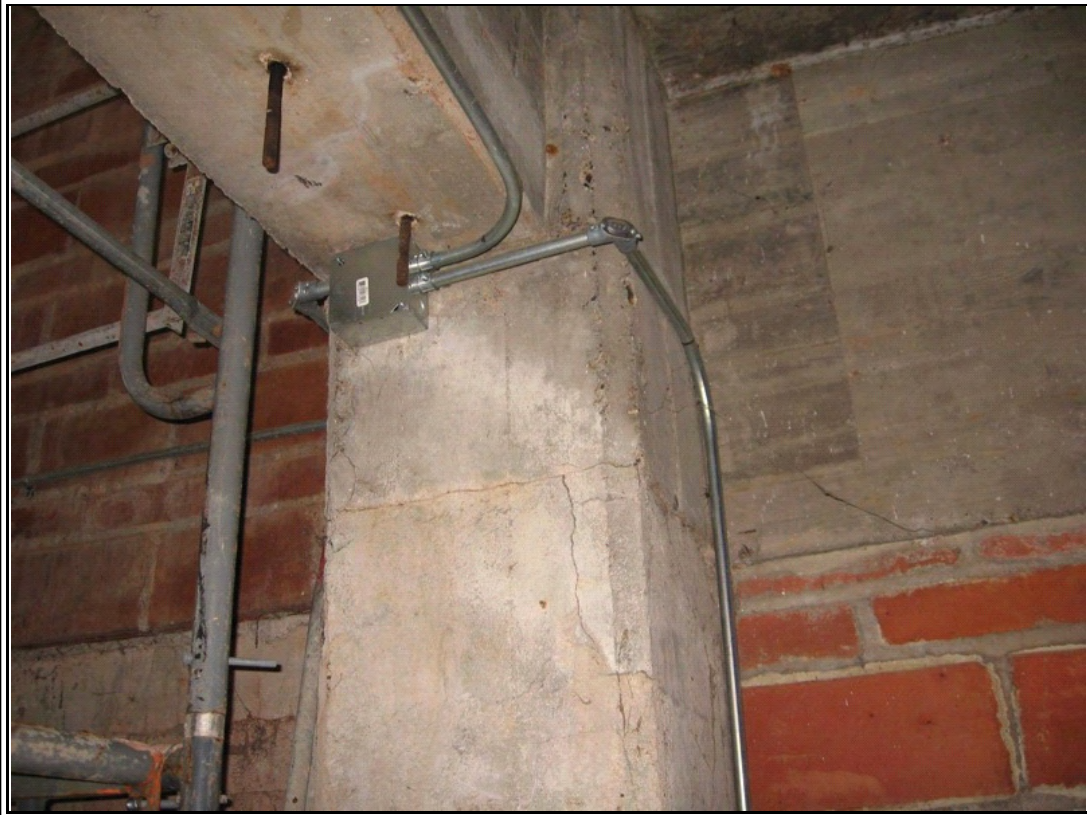
Photograph #: 18

Cracked concrete column at east mezzanine.

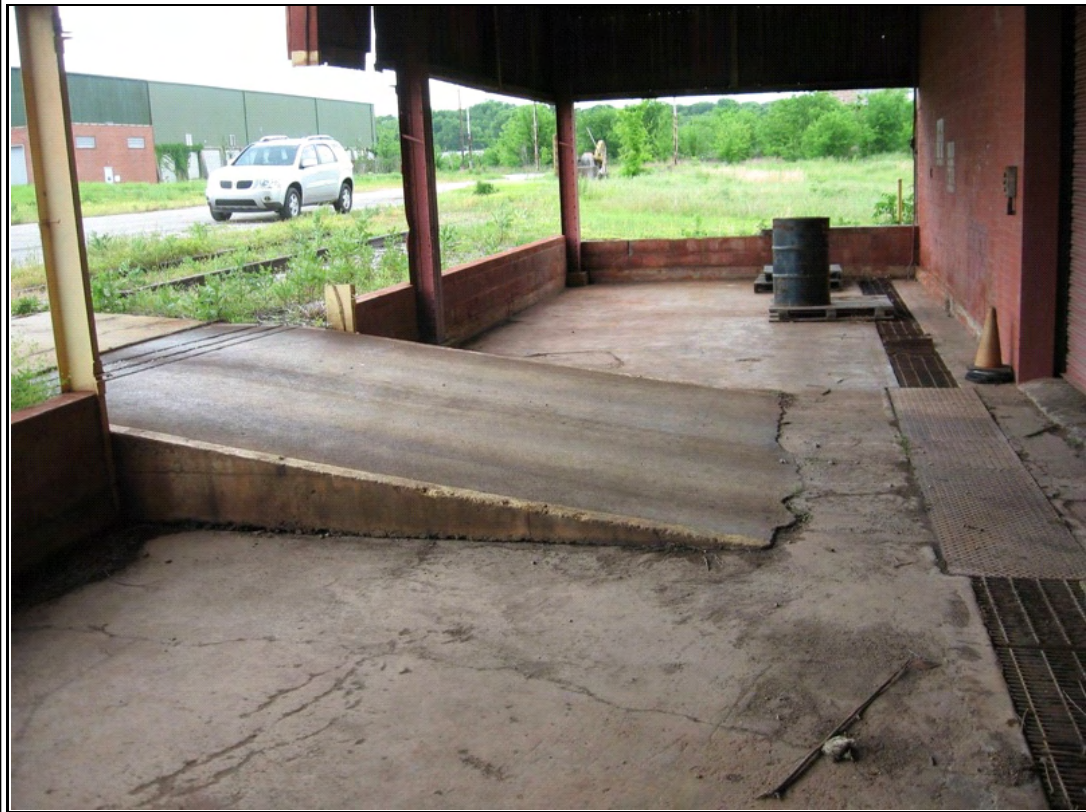
Photograph #: 5

Floor of track shed - note vertical steel framing partially removed adjacent to ramp

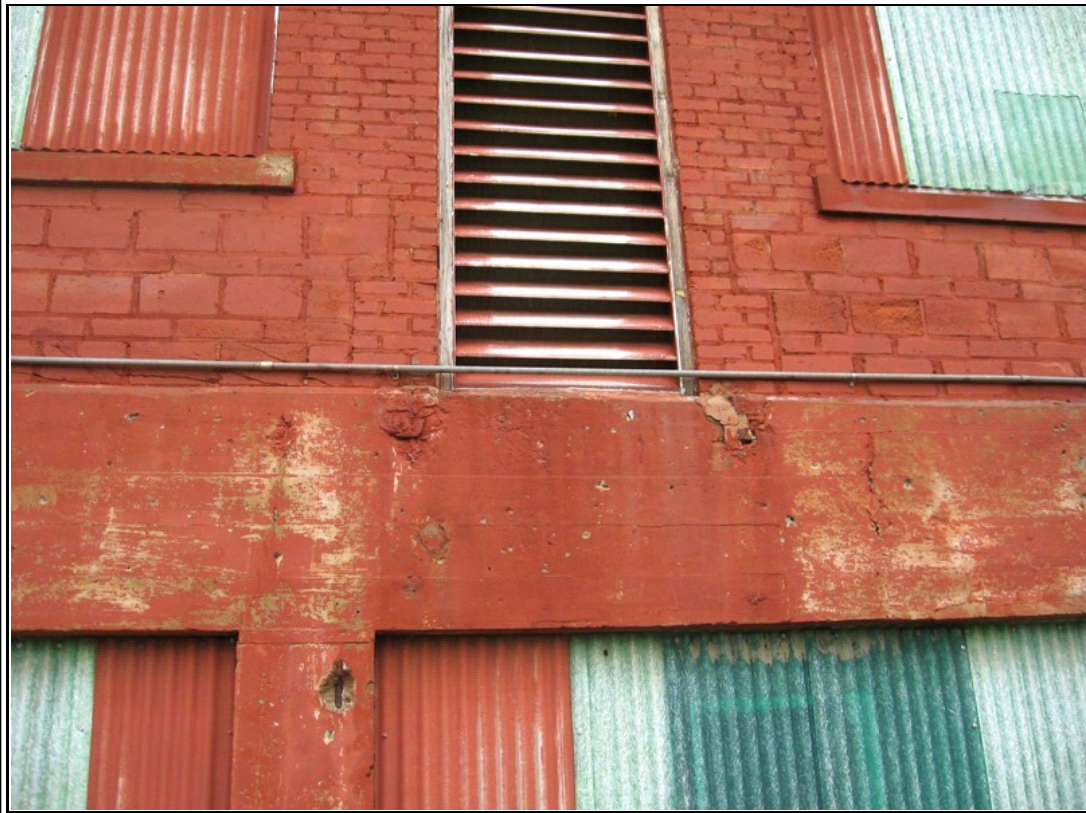
Photograph #: 6

Cracks and spalls in exterior face of concrete mezzanine frame

R-C-1	Route and seal cracks in concrete			
R-C-2	Inject sealant to seal cracks in concrete			
R-C-3	Remove unsound concrete, remediate corroded reinforcing steel (if applicable) and repair spalls with appropriate filler			
R-S-1	Sandblast, prime, and paint structural steel

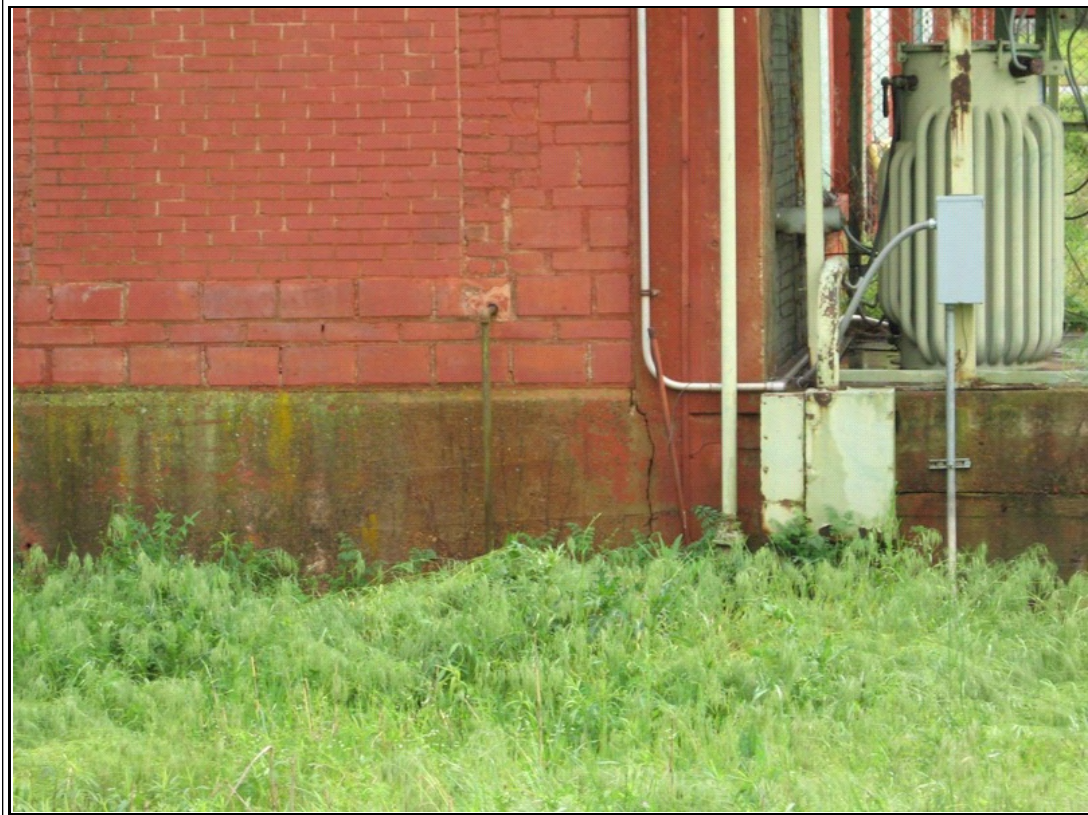
Photograph #: 8

Crack in turned-down slab at northwest corner

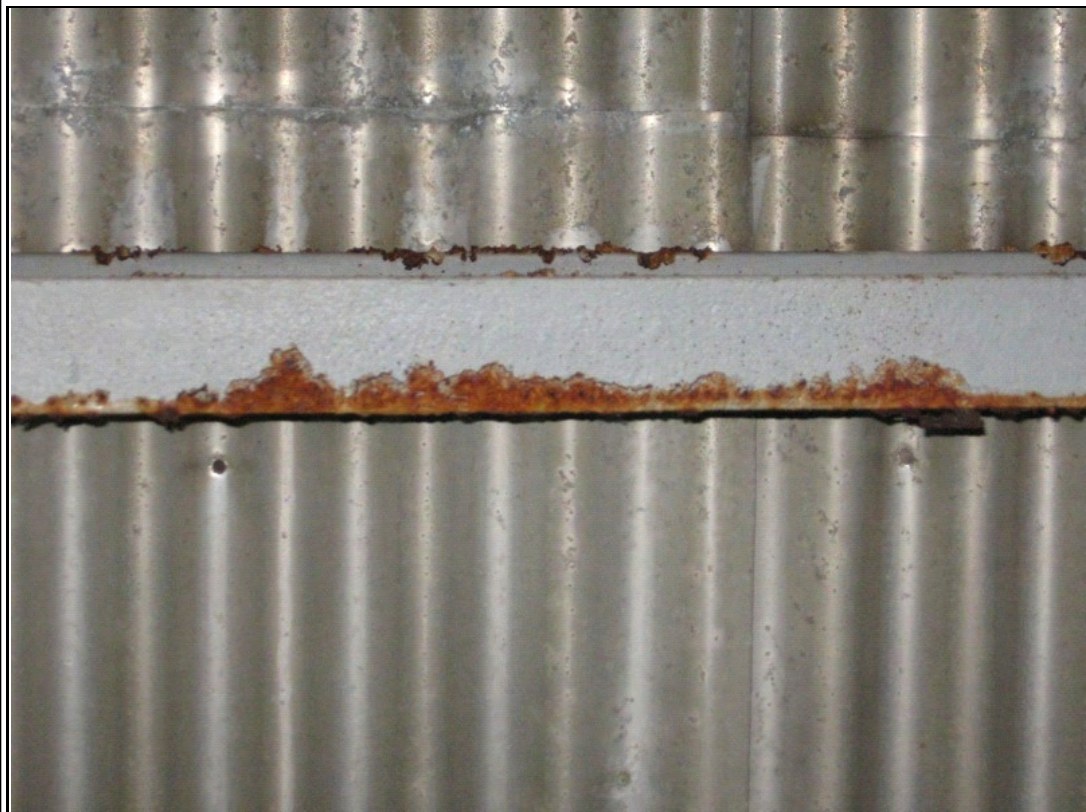
Photograph #: 12

Corrosion on painted steel
framing below new metal
roof

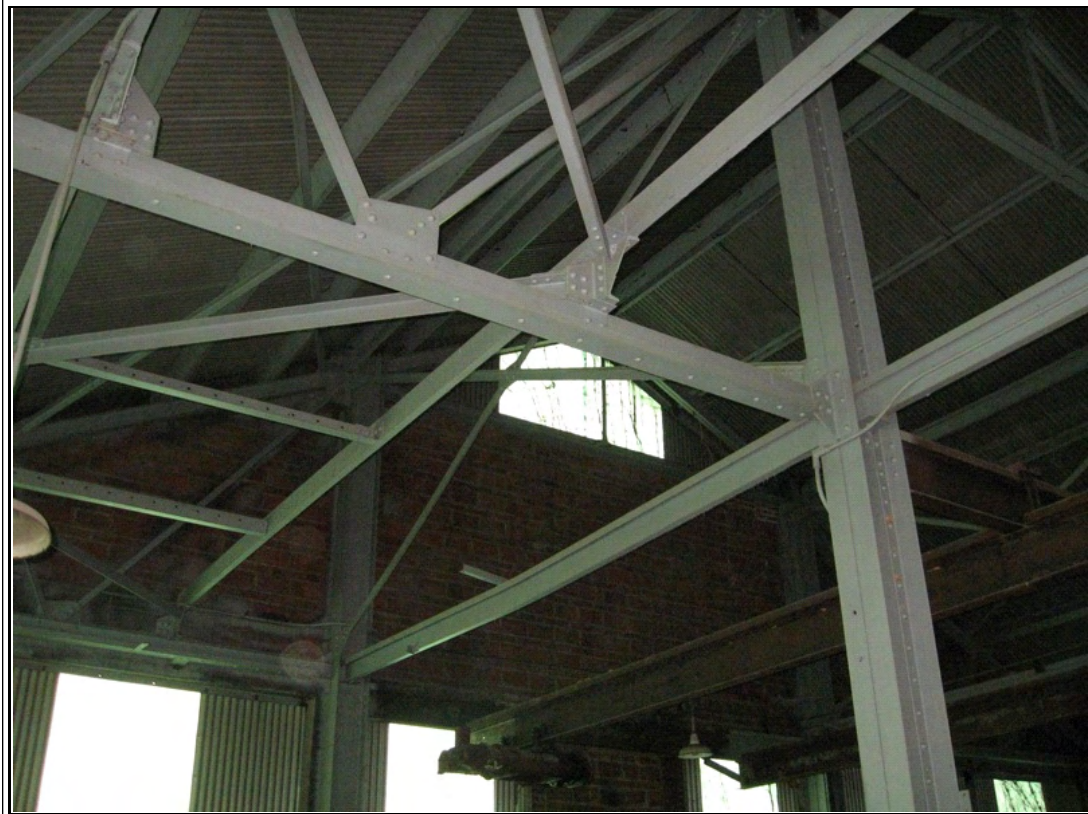
Photograph #: 13

Painted steel framing in good condition

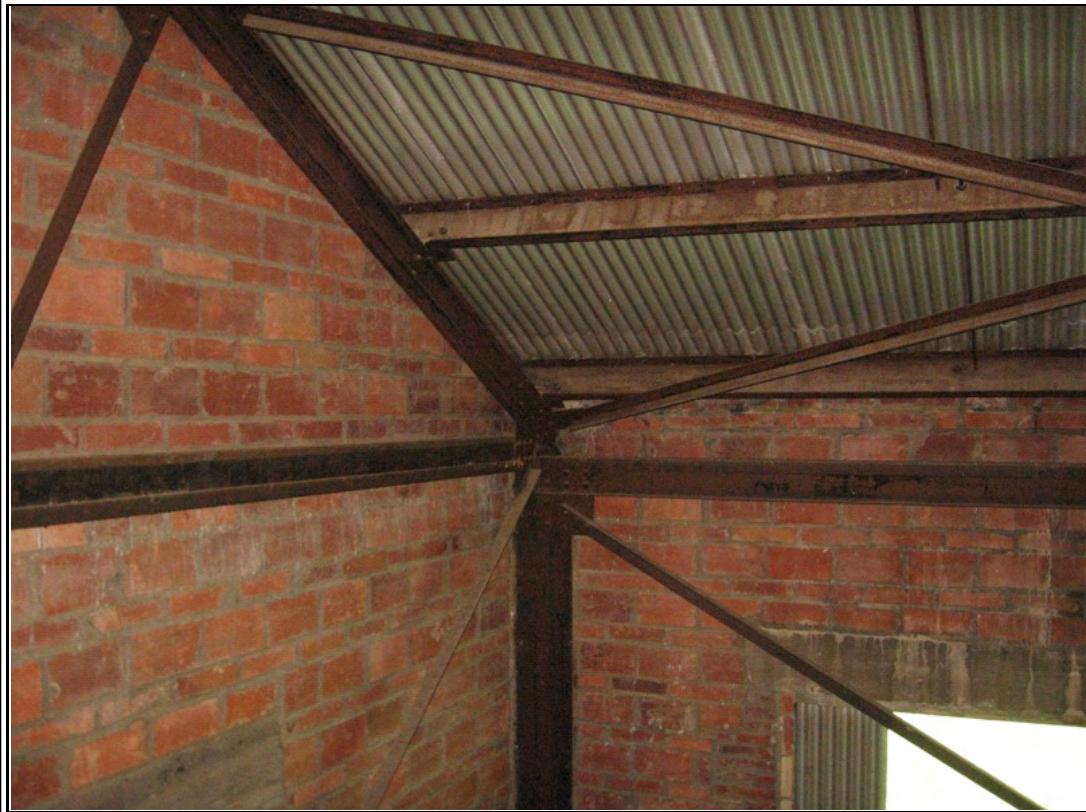
Photograph #: 15

Unpainted corroded steel framing below new metal roof deck

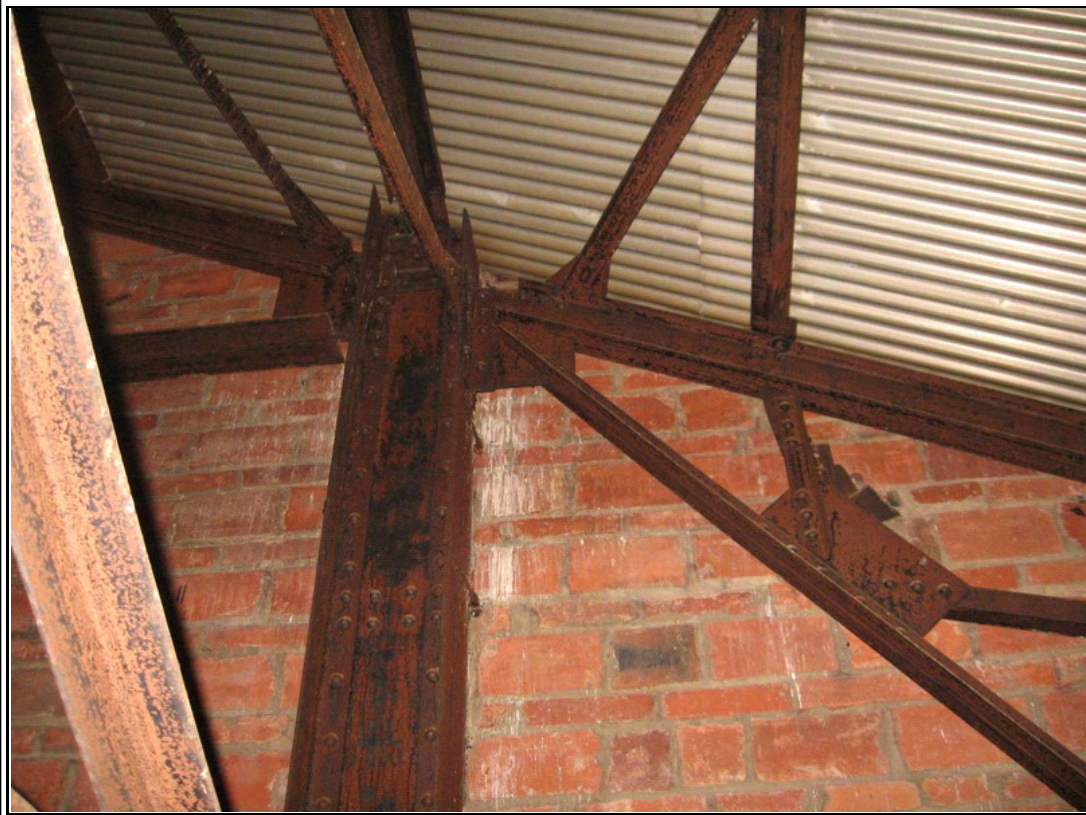
Photograph #: 16

Unpainted corroded steel framing under new metal roof deck

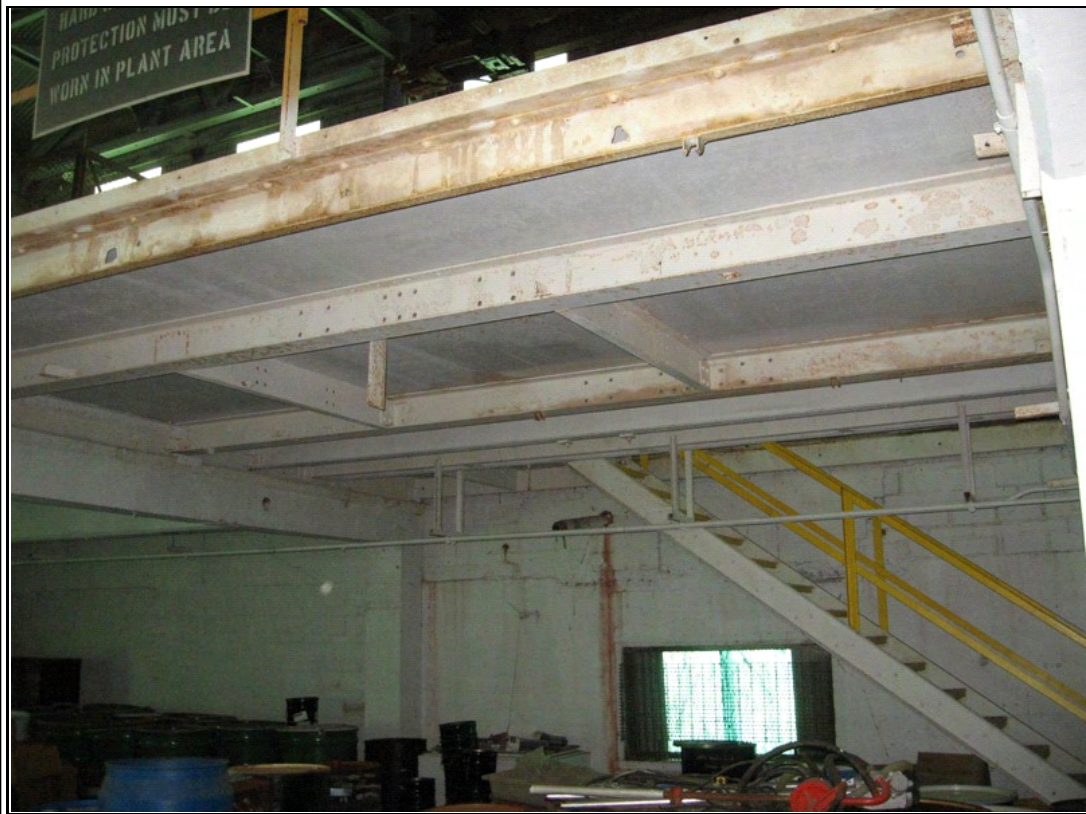
Photograph #: 17

Mezzanine slab on steel beams at center bay of building

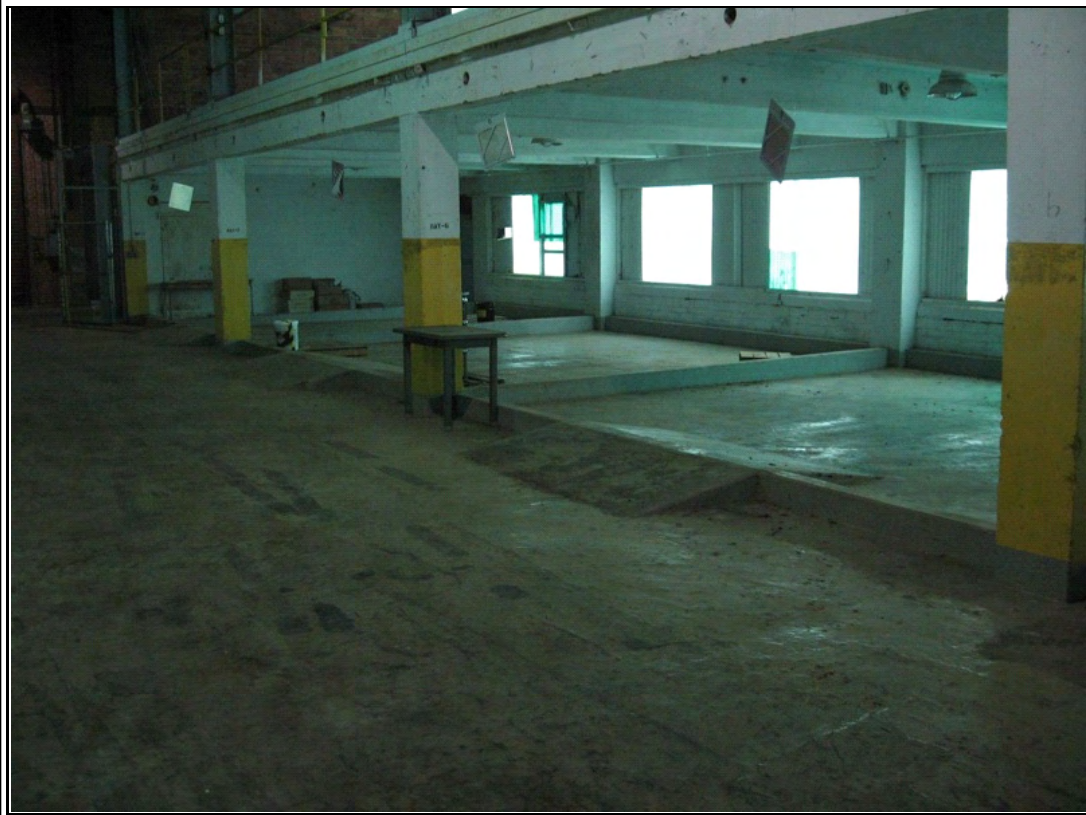
Photograph #: 18

Mezzanine slab on concrete beams at side bay of building

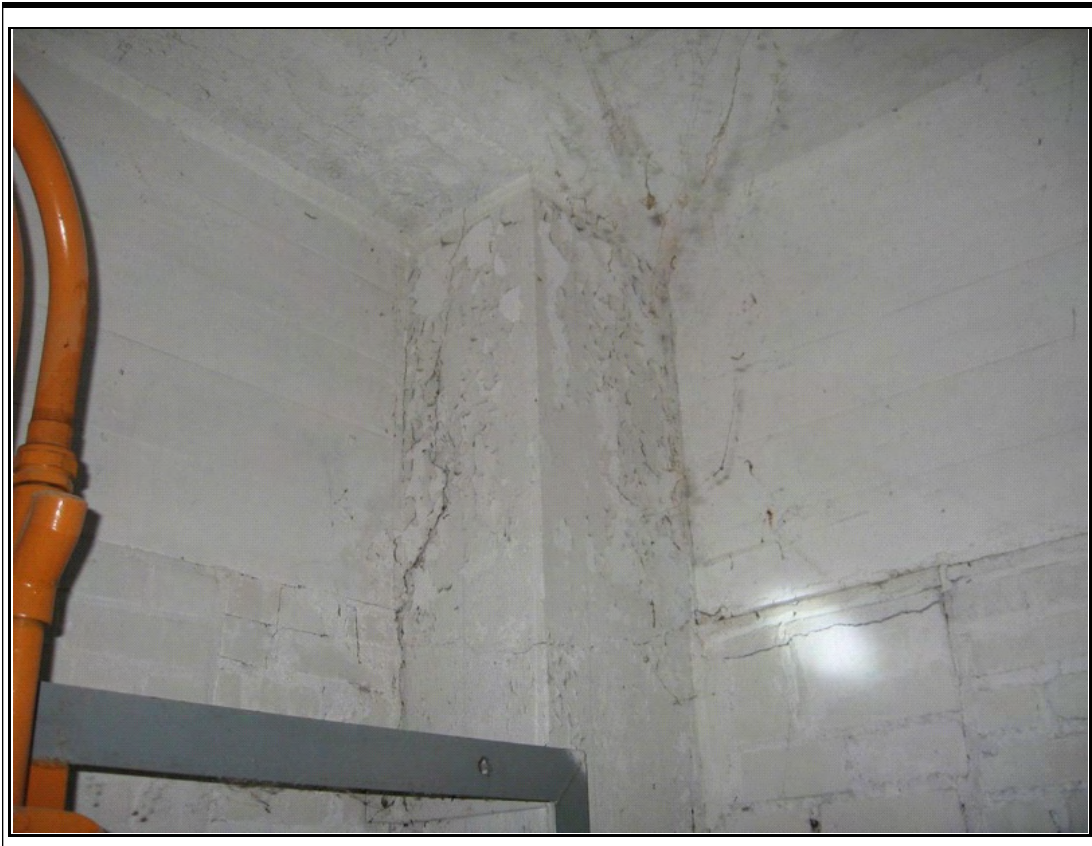
<p>Photograph #: 19</p> <p>Cracks in concrete frame and masonry infill below on mezzanine</p>

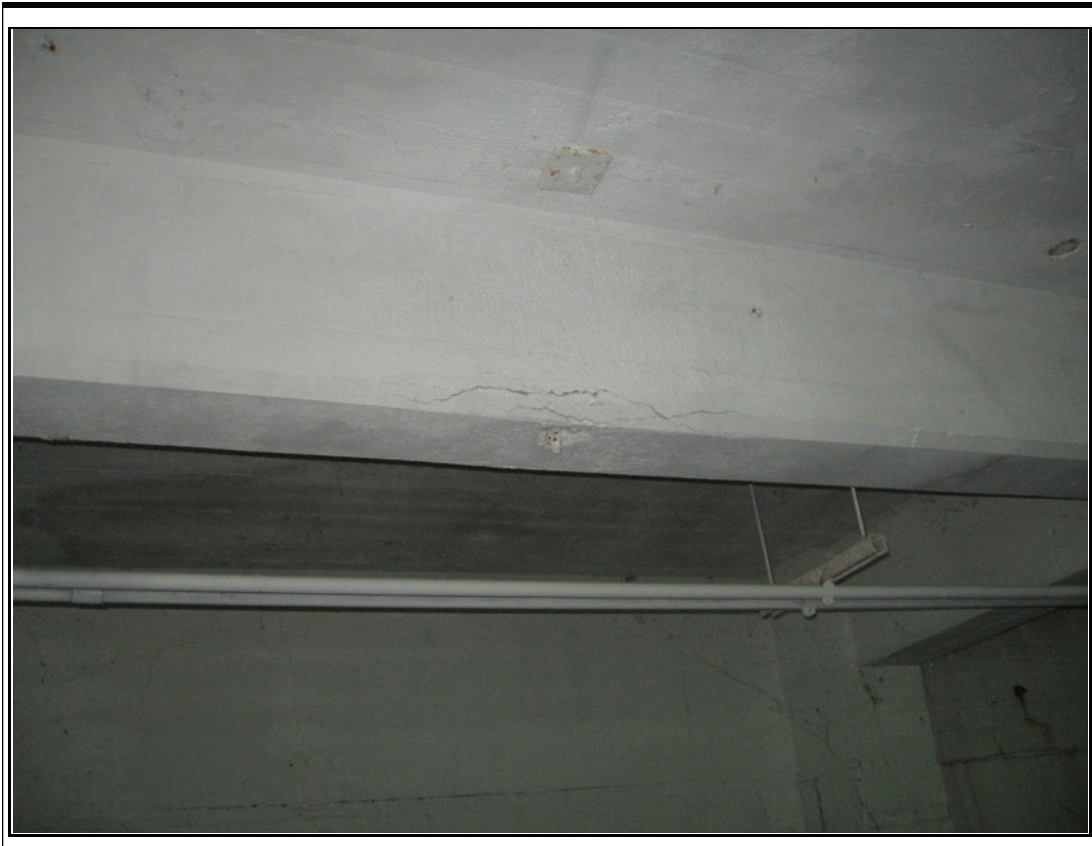
<p>Photograph #: 21</p> <p>Crack and potential spall in concrete beam below mezzanine</p>

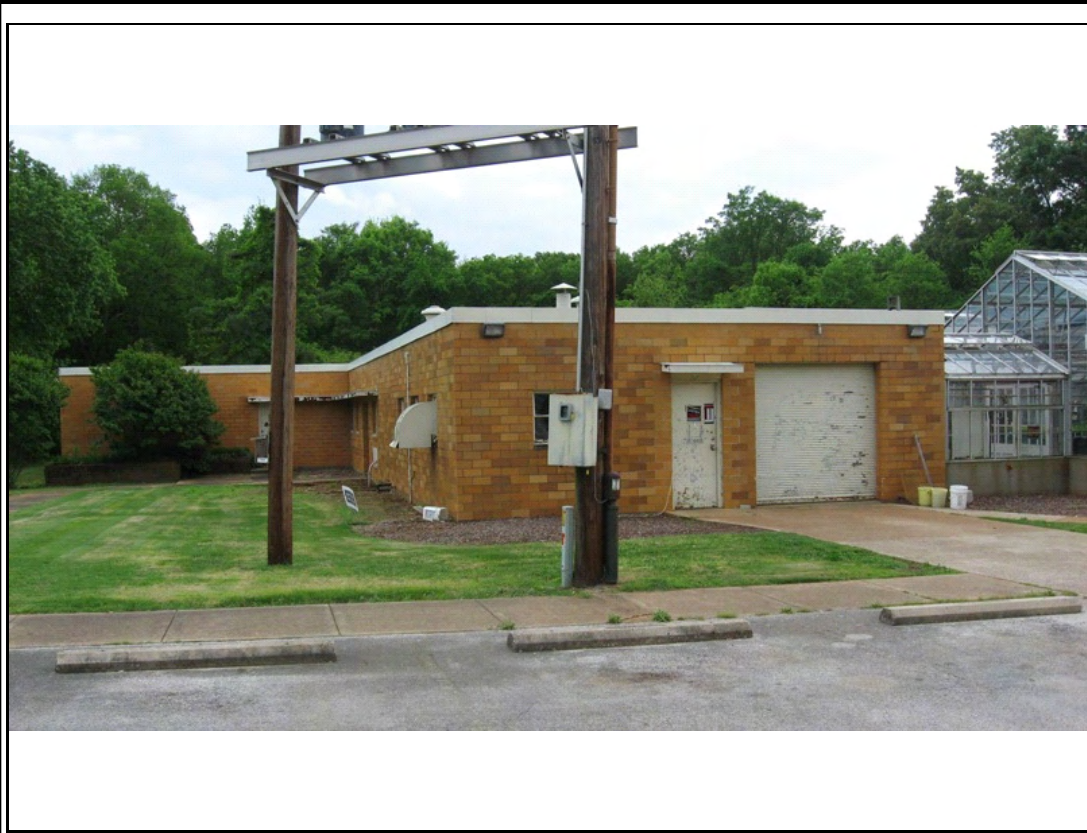
Photograph #: 1

Exterior view of lab building

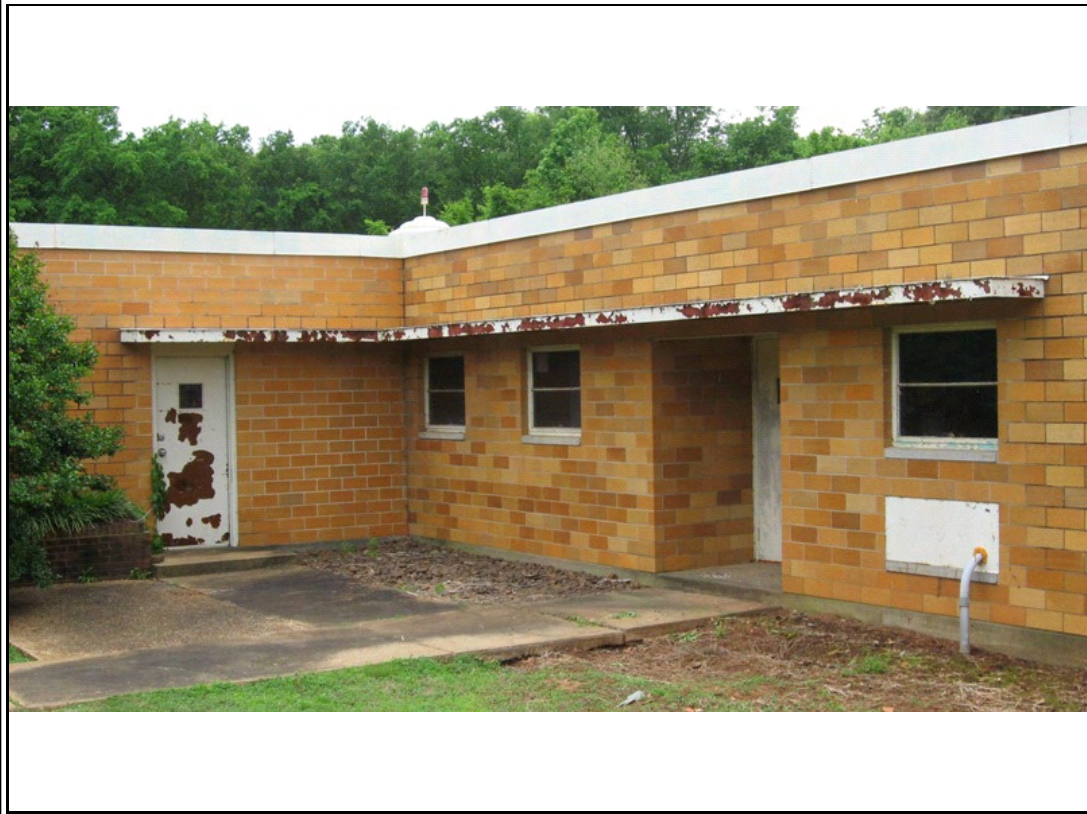
Photograph #: 2

Eroded awning at lab building

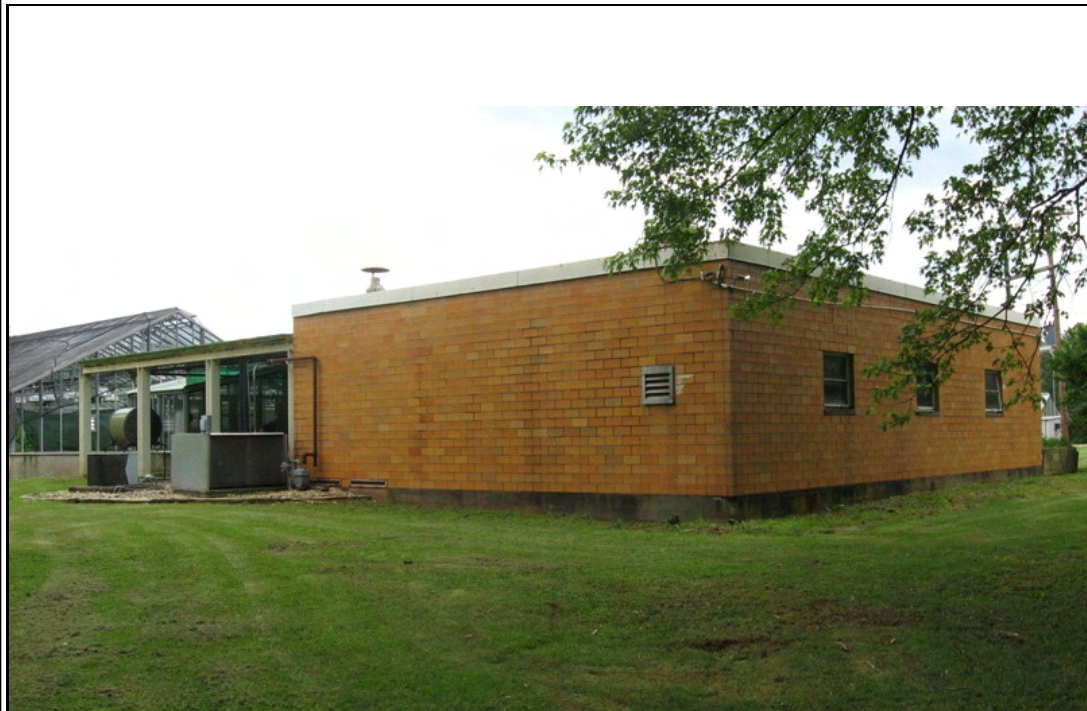
Photograph #: 3

Exterior view of lab building and attached open covered storage area
