Structural Assessment

Muscle Shoals Reservation
adaptive re-use study

Conditions/Market/Planning/Implementation

July 31, 2009
Revised August 25, 2009

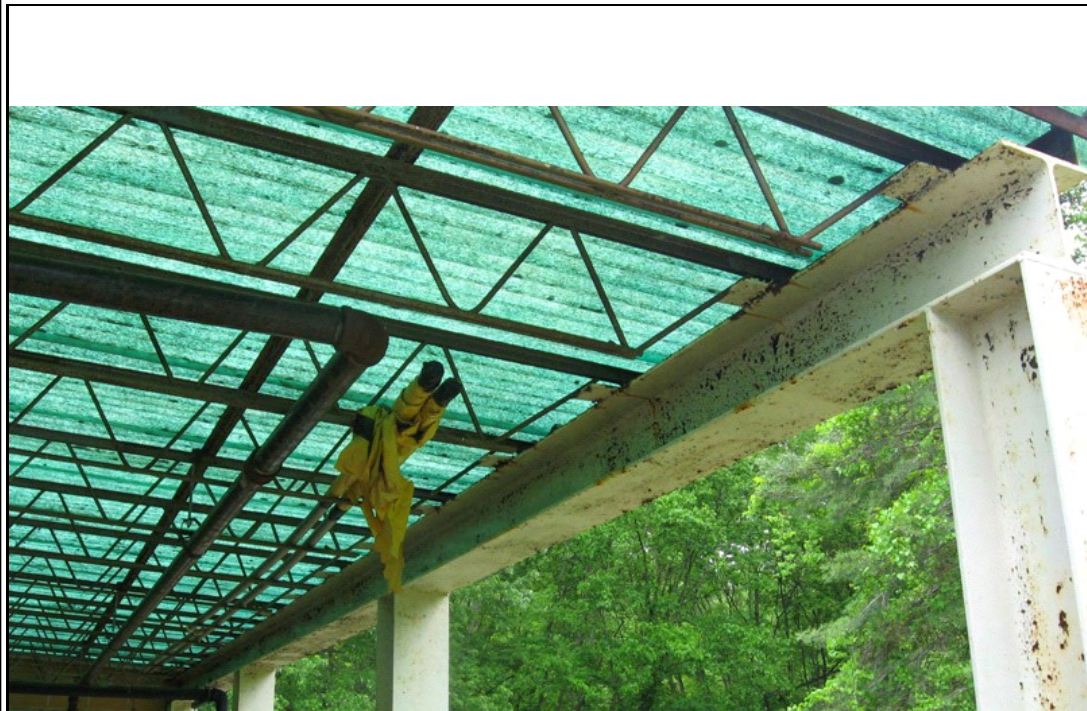
Photograph #: 4

Mildly to moderately corroded steel at open covered storage area

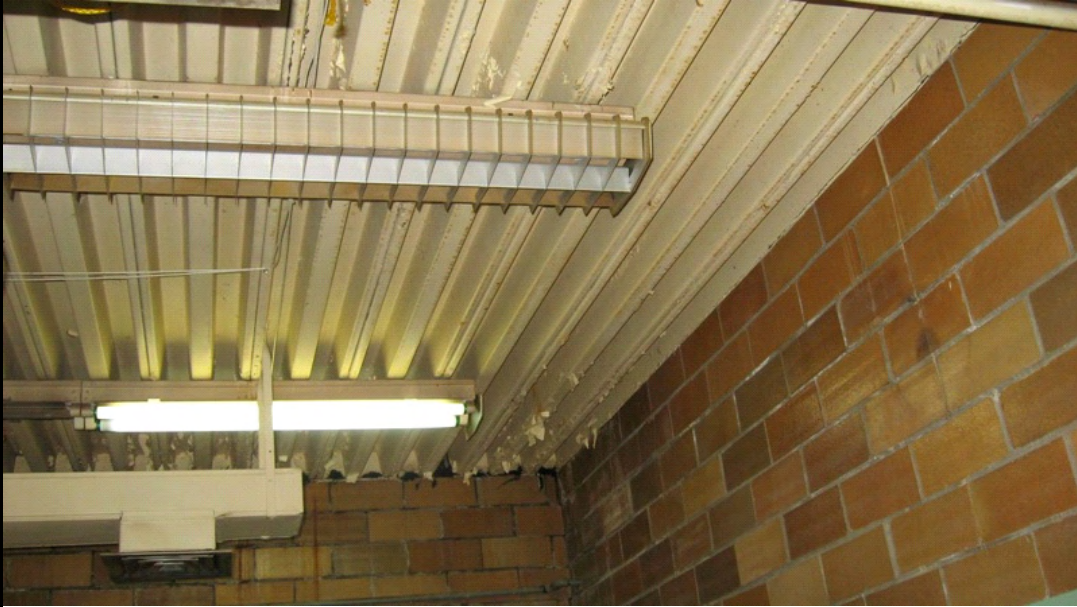
<p>Photograph #: 5</p> <p>Interior evidence of moisture intrusion at lab building roof</p>

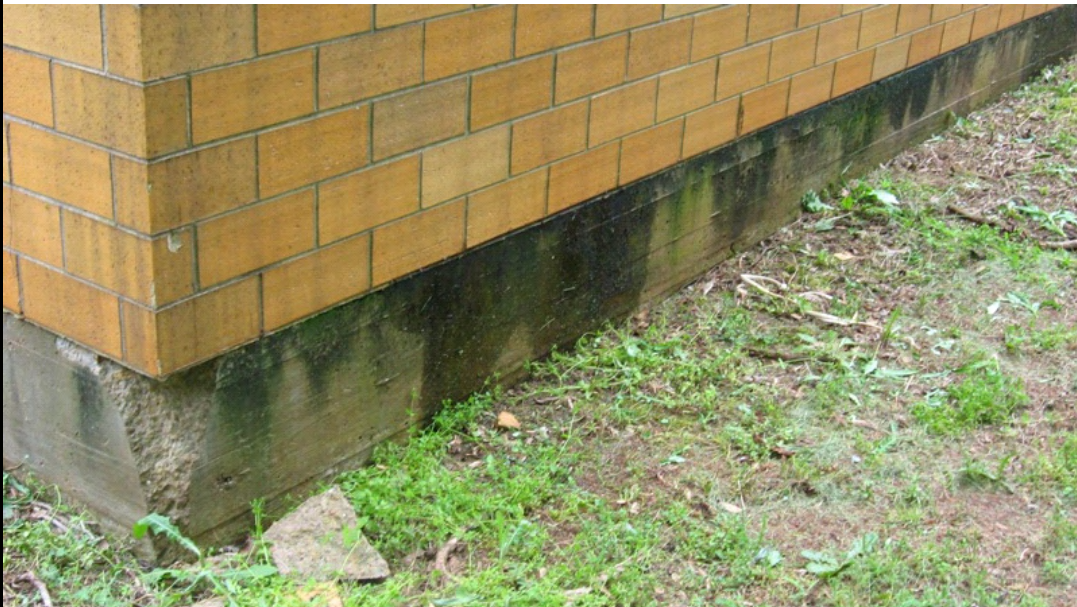
<p>Photograph #: 6</p> <p>Spalled foundation wall and exterior evidence of interior water intrusion</p>

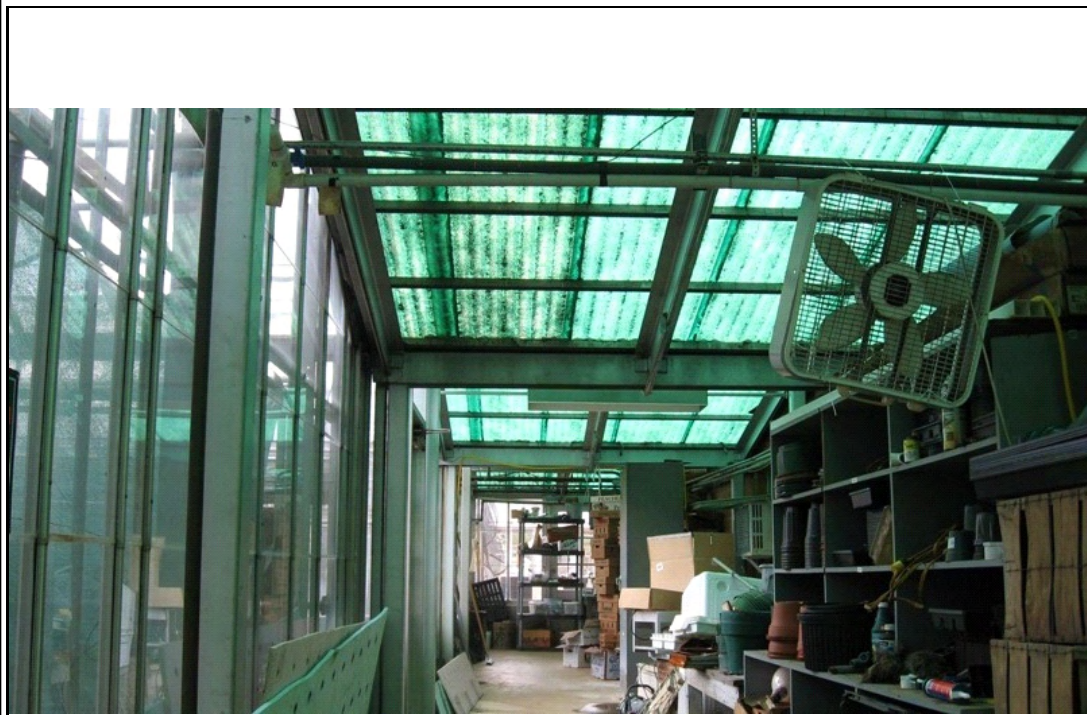
Photograph #: 9

Steel frame enclosure
between lab building and
greenhouses

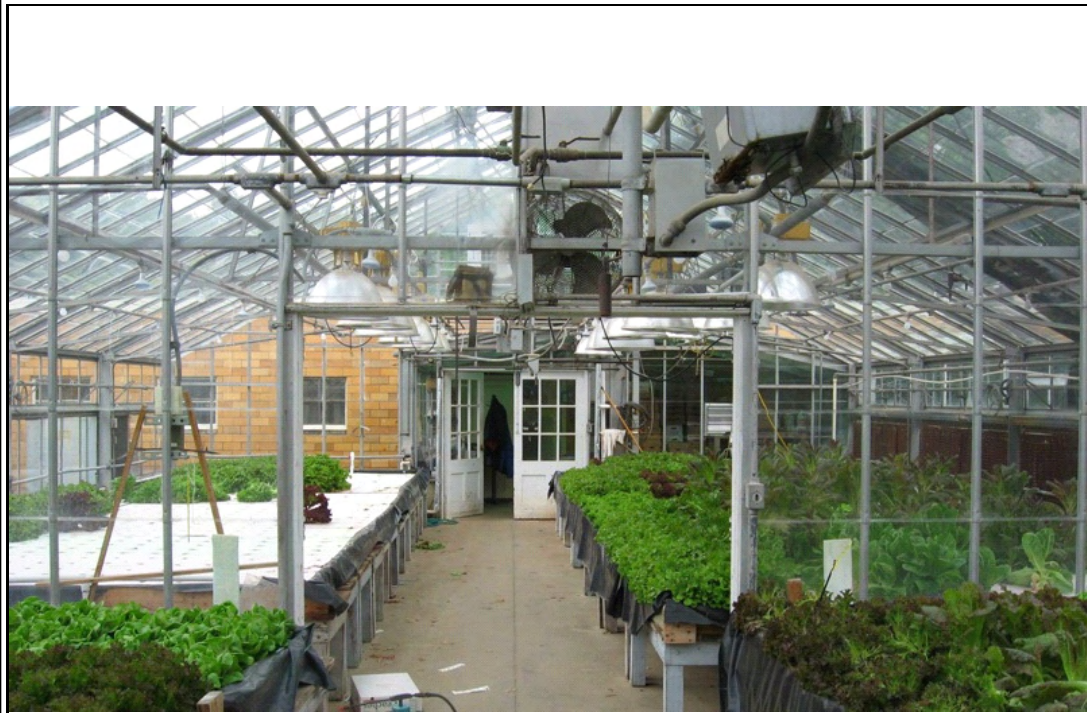
Photograph #: 10

Interior of greenhouse 2
looking at lab building

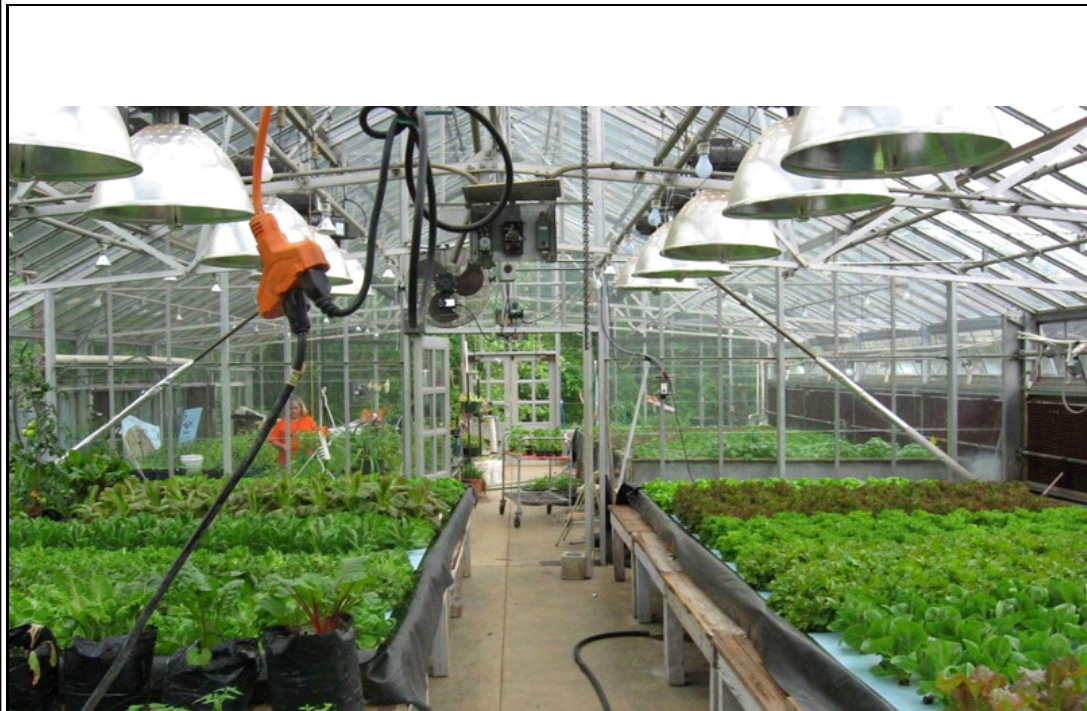
Photograph #: 11

Interior view of greenhouse 3

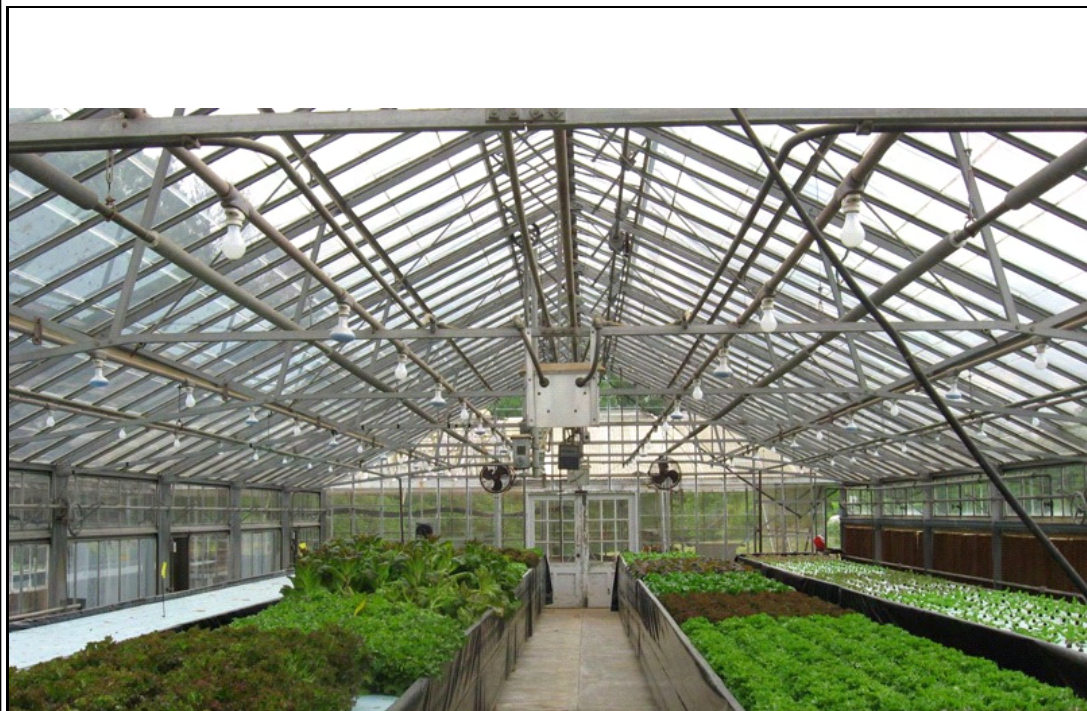
Photograph #: 12

Interior of greenhouse 1

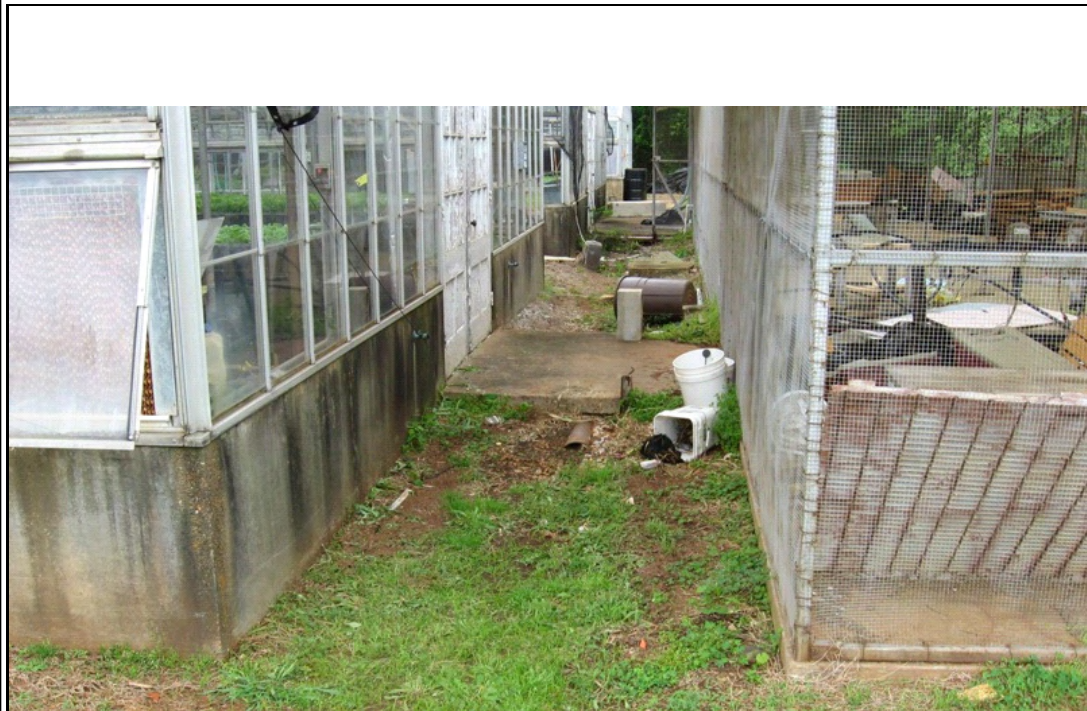
Photograph #: 13

Foundation walls at greenhouses

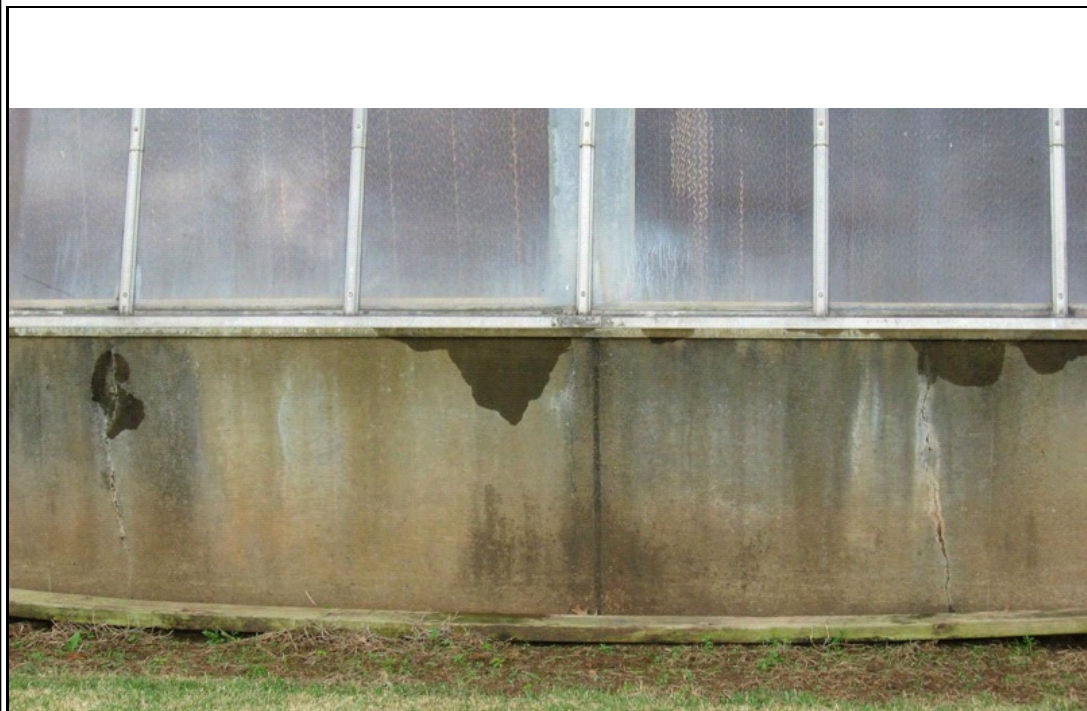
Photograph #: 14

Cracks in foundation wall at greenhouse 1

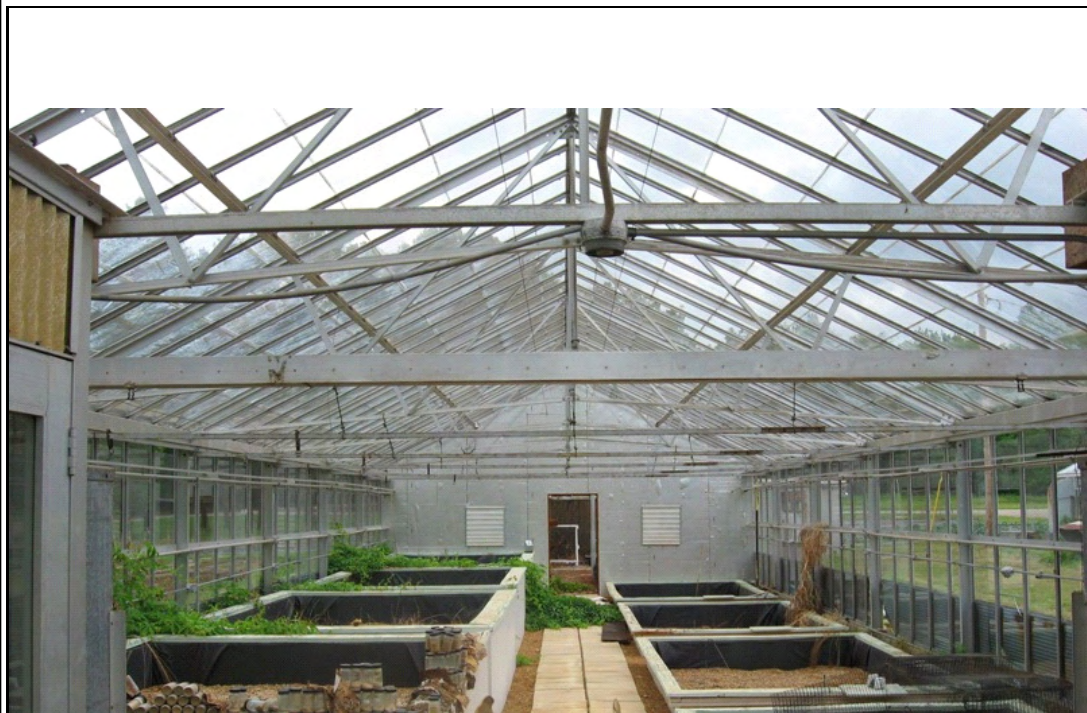
Photograph #: 15

Interior view of exp. Greenhouse

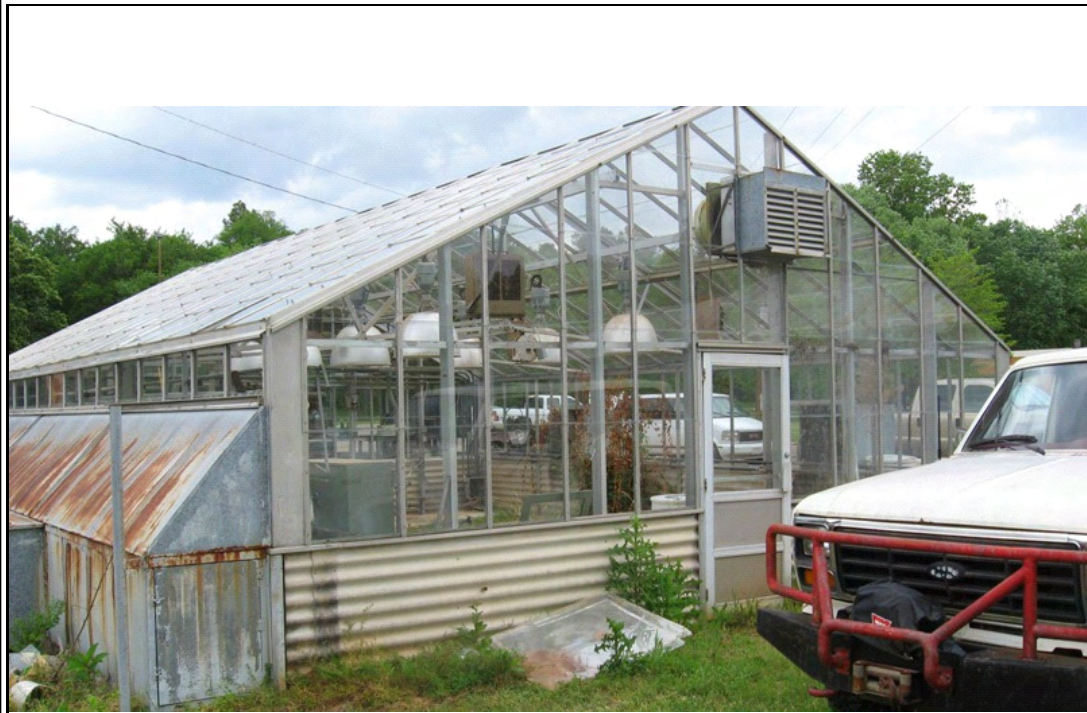
Photograph #: 16

Exterior view of Env. Greenhouse

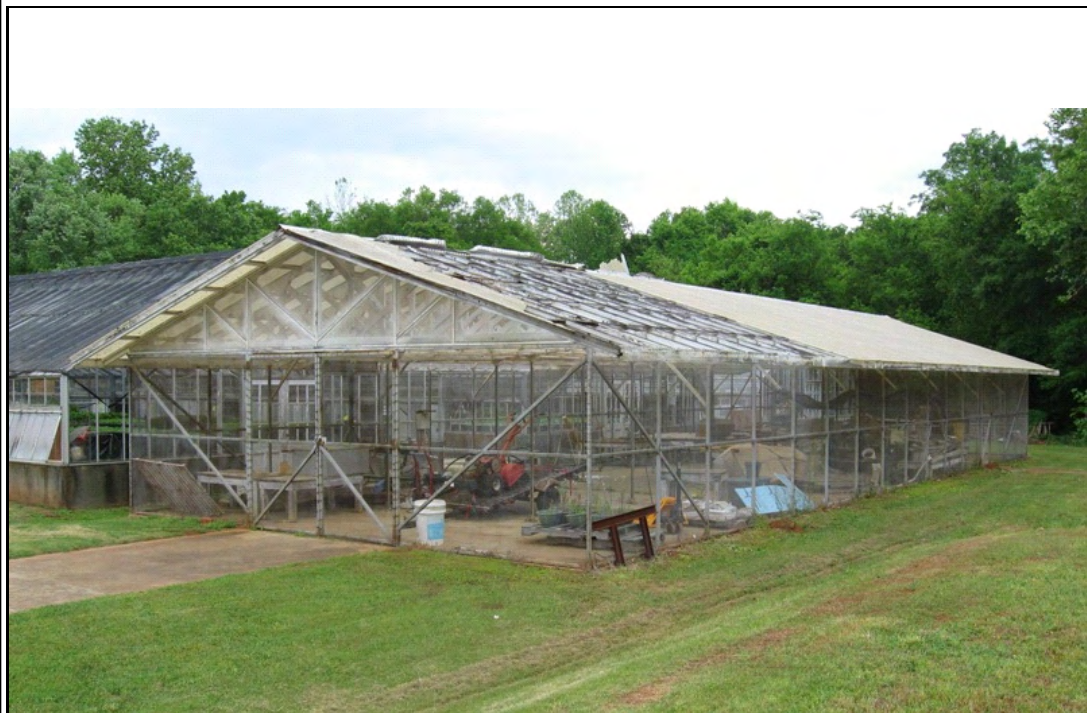
Photograph #: 17

Exterior view of screened porch with damage roof covering

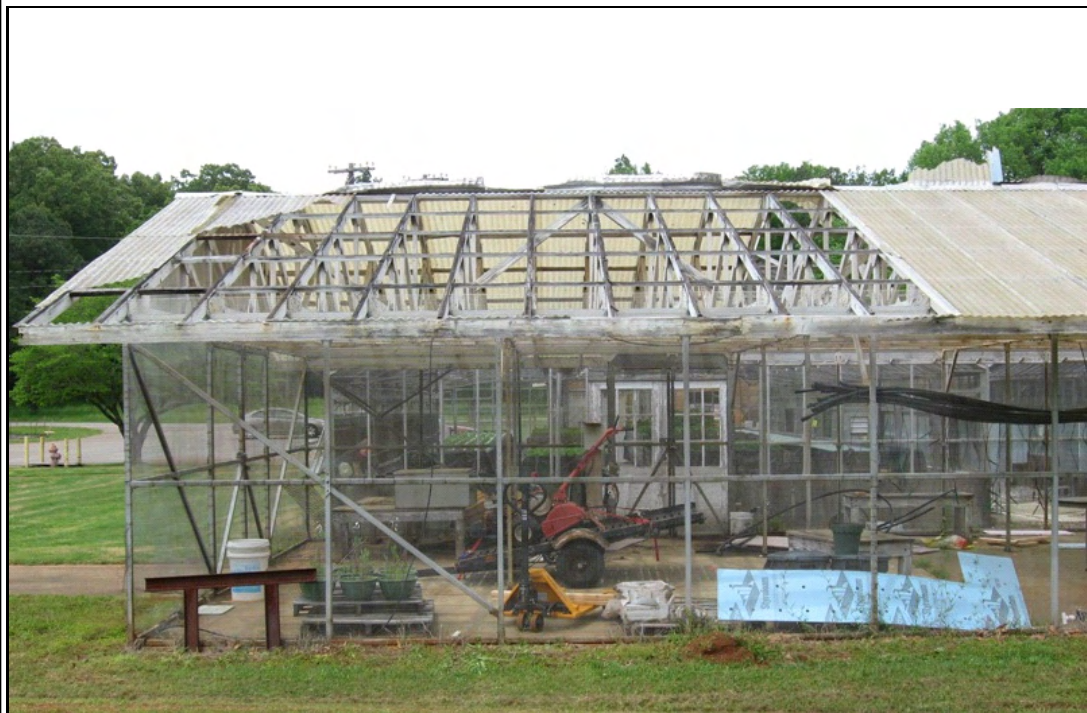
Photograph #: 18

Damaged roof covering at screened porch

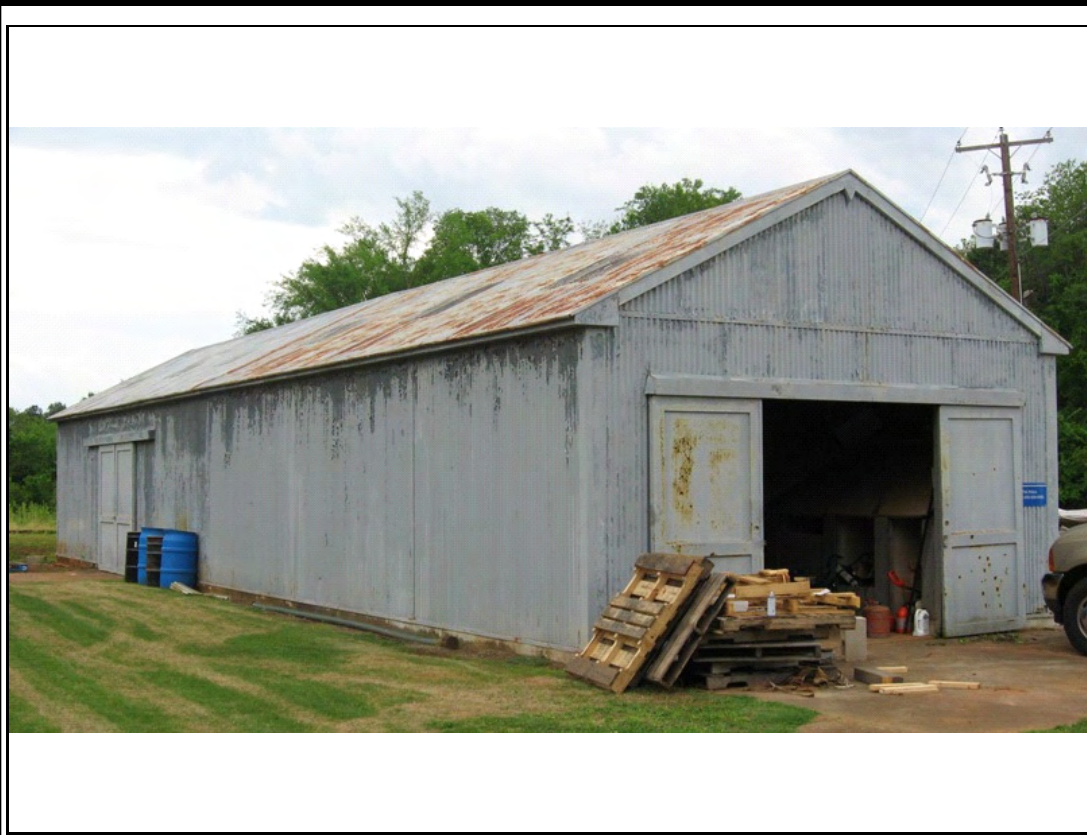
Photograph #: 19

Exterior view of metal storage building with surface corrosion at roof

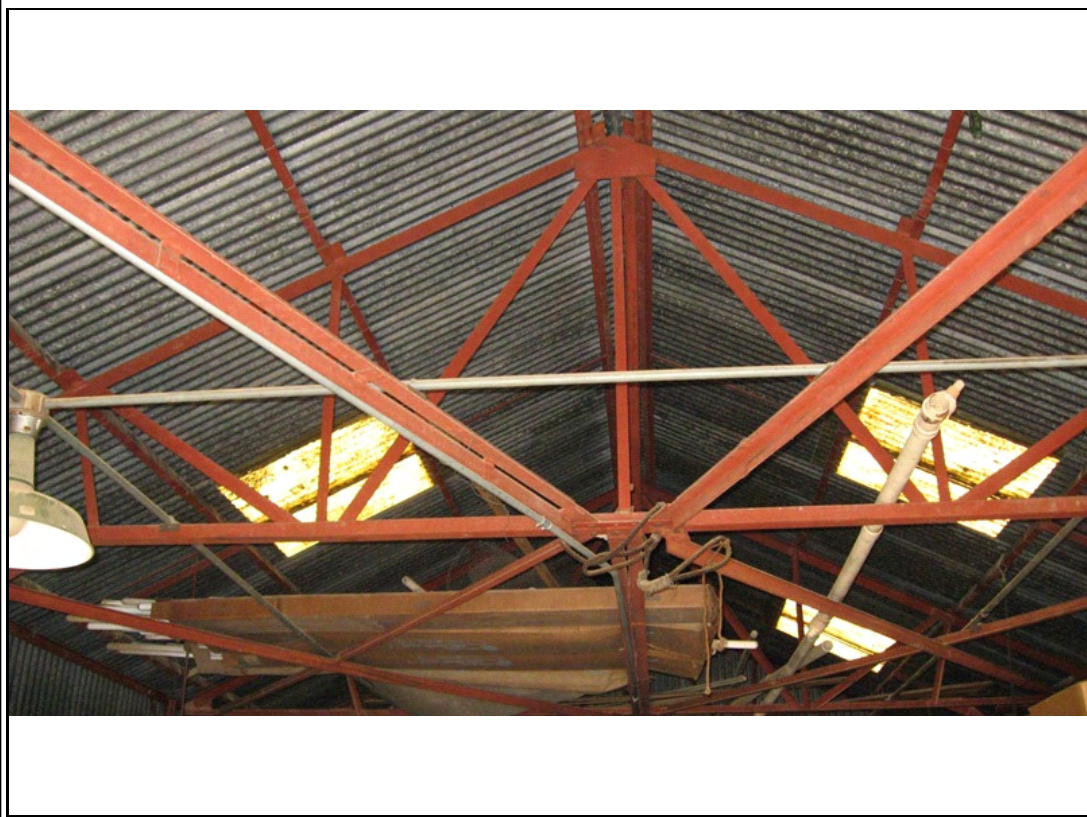
Photograph #: 20

Interior view of metal storage building in generally good condition

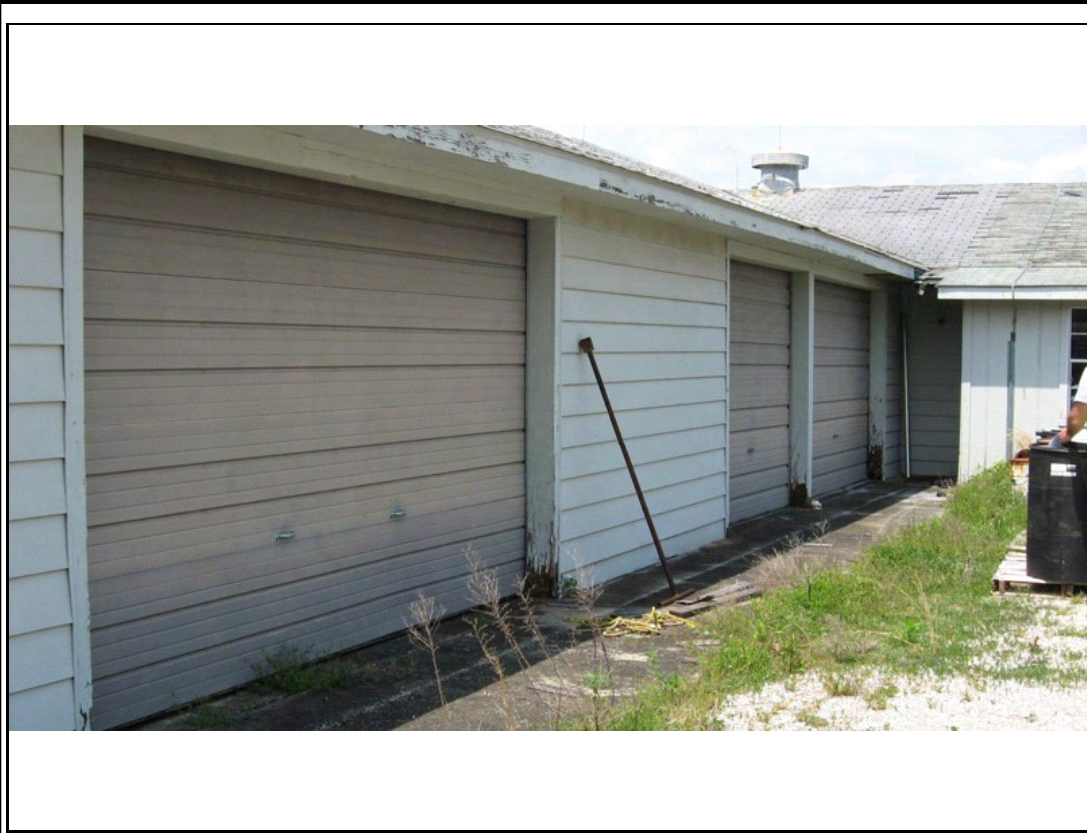
Photograph #: 1

Deteriorated structural supports between overhead doors at south courtyard.

Summary of Recommended Structural Repairs:	Defective framing and finishes at the canopy roofs and overhead doors must be replaced. Architectural features including roofing, fascias, and soffits are in need of repair and/or replacement.
Additional Recommendations:	A detailed investigation of the deteriorated wood construction that was observed in the central structure should be performed to determine the extent and severity of the defective materials. A comprehensive evaluation of the total building roof condition is also needed to determine if defective portions of the roof structure may exist in areas where they could not be observed.

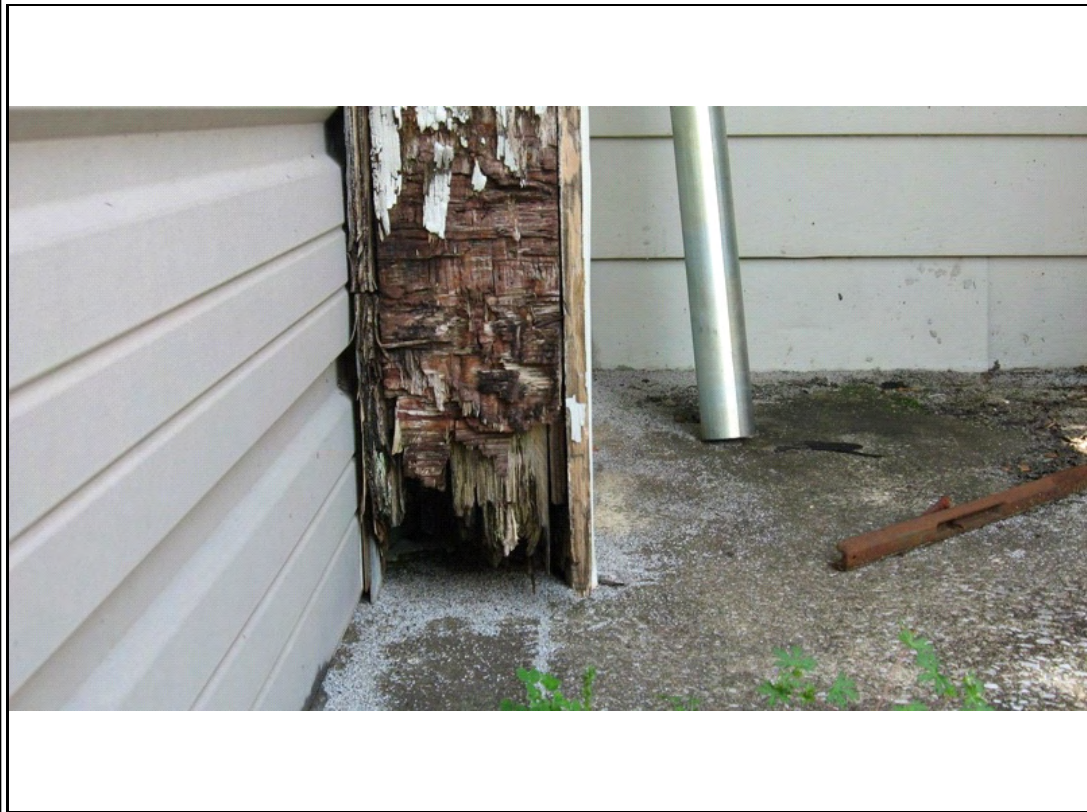
Photograph #: 2

Deteriorated structural supports at overhead door at south courtyard.

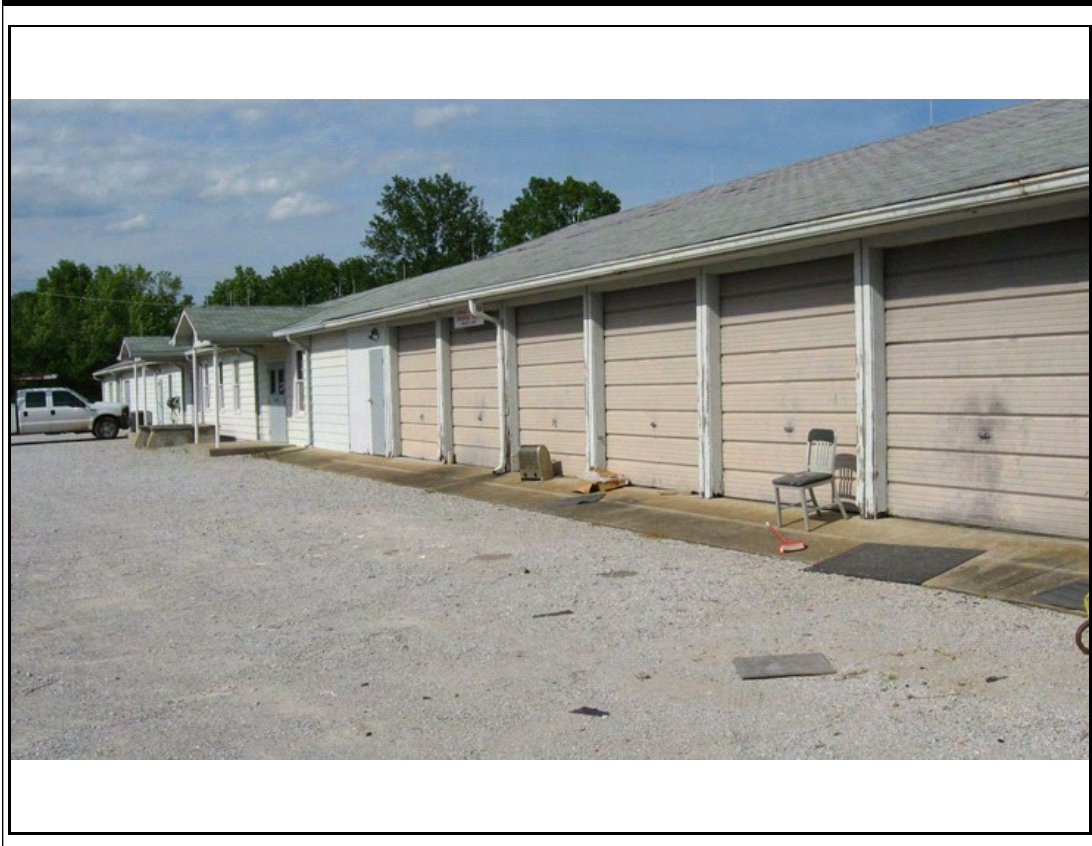
<p>Photograph #: 3</p> <p>Overhead doors on west side of west wing.</p>

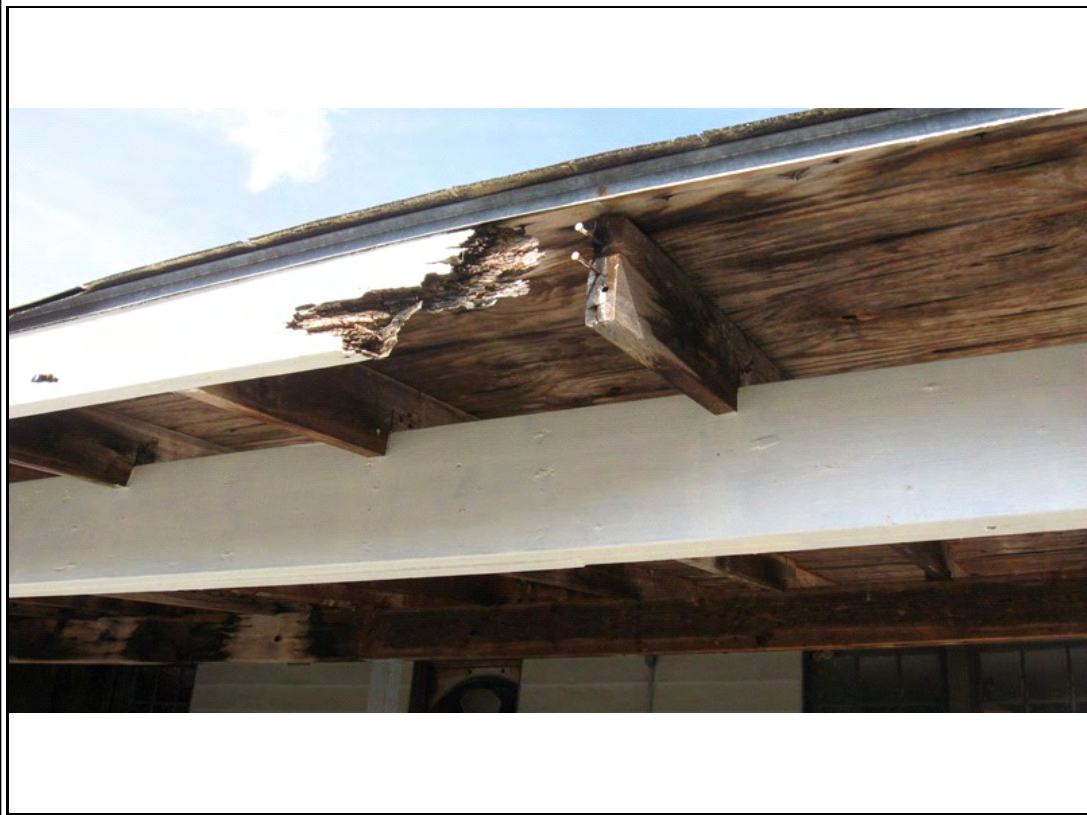
Photograph #: 6

Deteriorated wood canopy
at north courtyard.

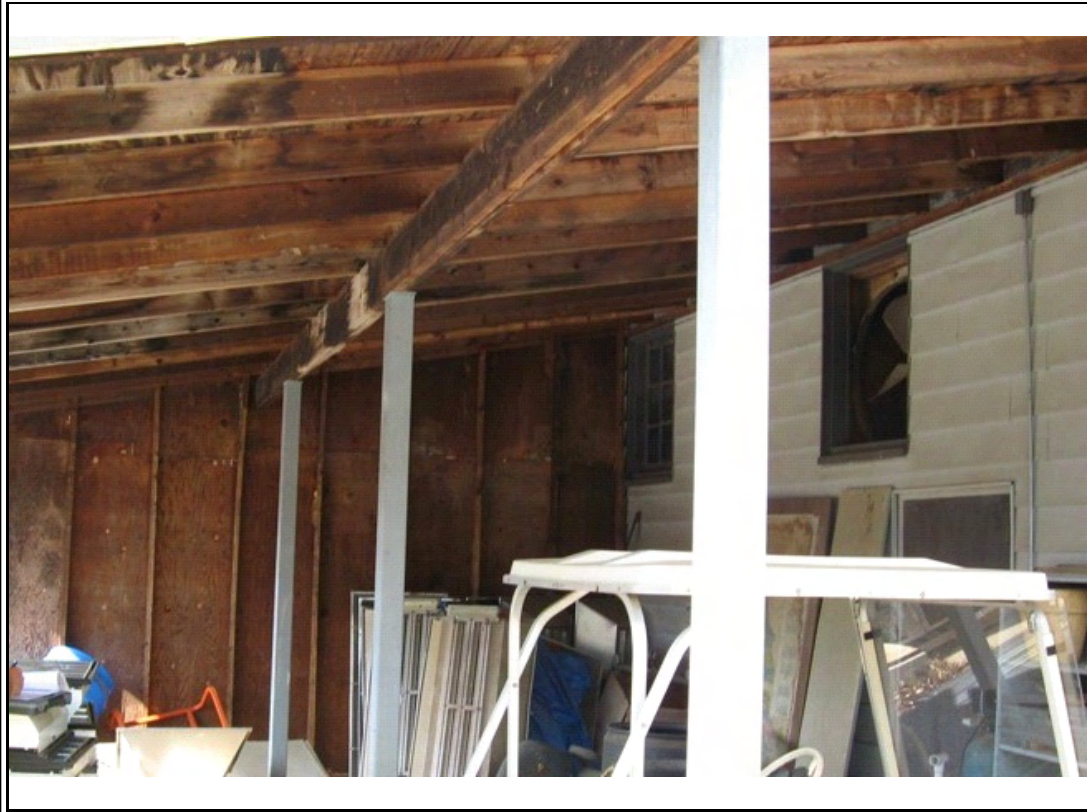
Photograph #: 7

Deteriorated wood canopy
at north courtyard.

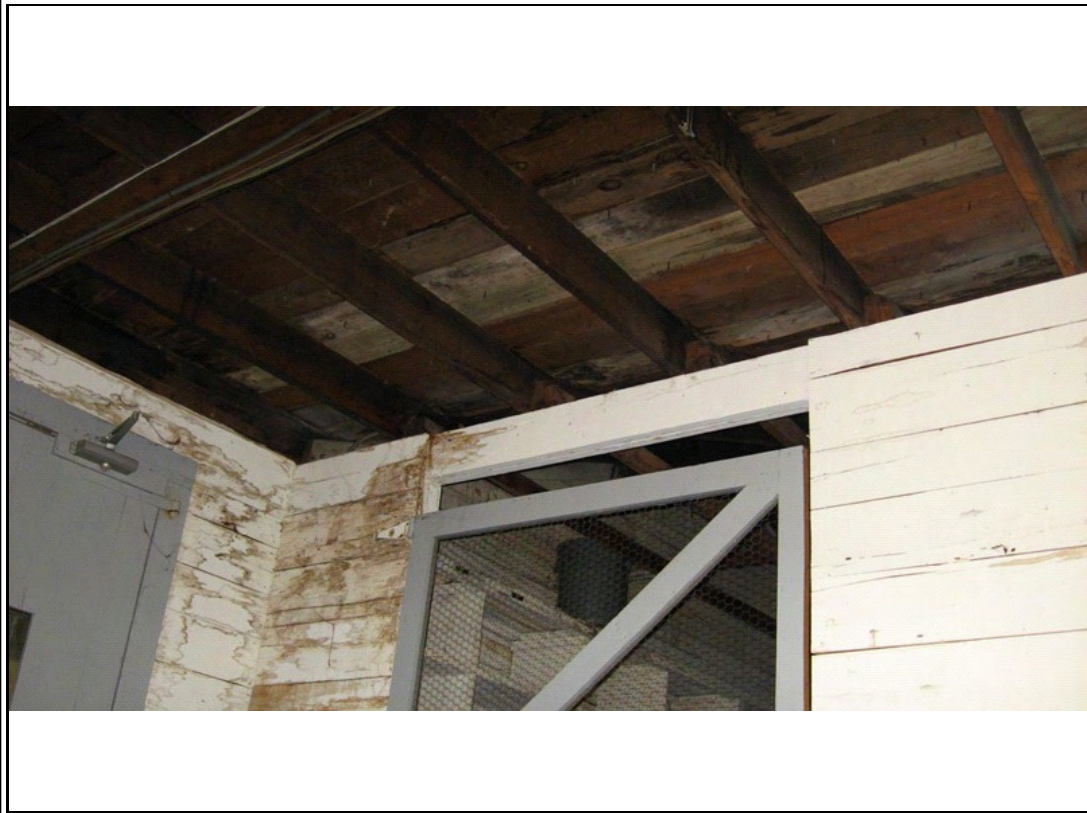
Photograph #: 8

Deteriorated wood framing
and planking at central
structure near east wing
