Tennessee Valley Authority

Cyclic Assessment Report
TVA Muscle Shoals, Alabama
September 16, 2013

Executive Summary

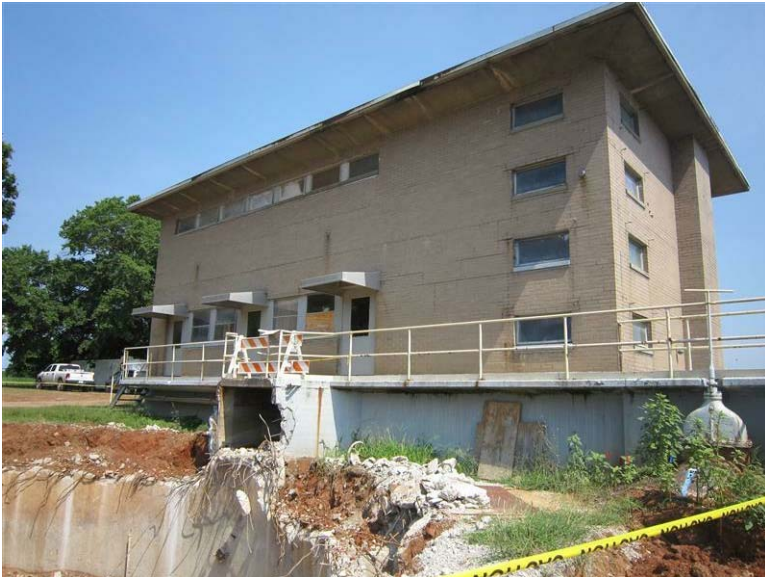
Building 01A - Chemical Feed House: There is a large, deep hole in the ground south of the building that could potentially affect the building's foundation.

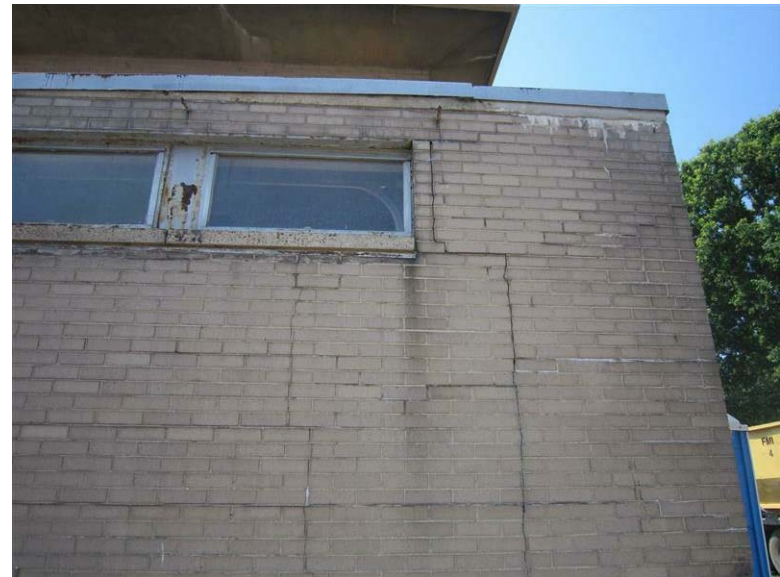
Building 01A - Chemical Feed House: Horizontal cracking is visible on the south facade adjacent to the large hole in ground.

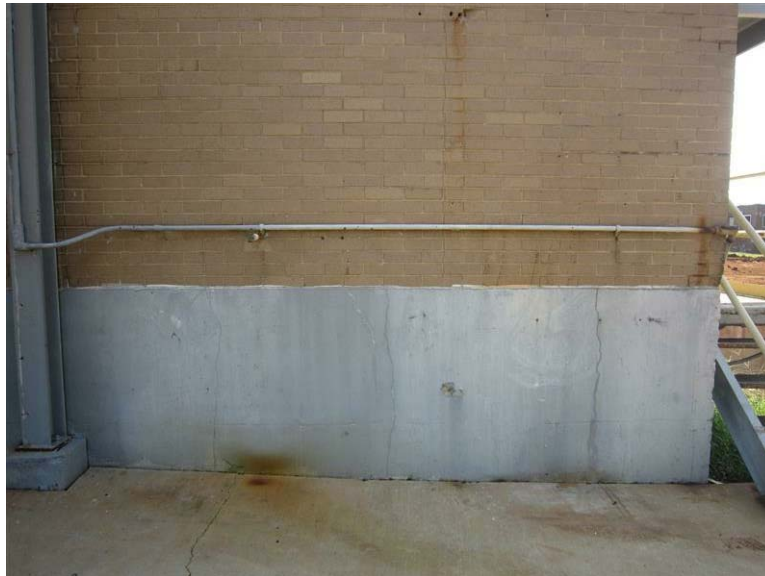
Building 01A - Chemical Feed House: Horizontal cracking is visible in the concrete at the lower wall.

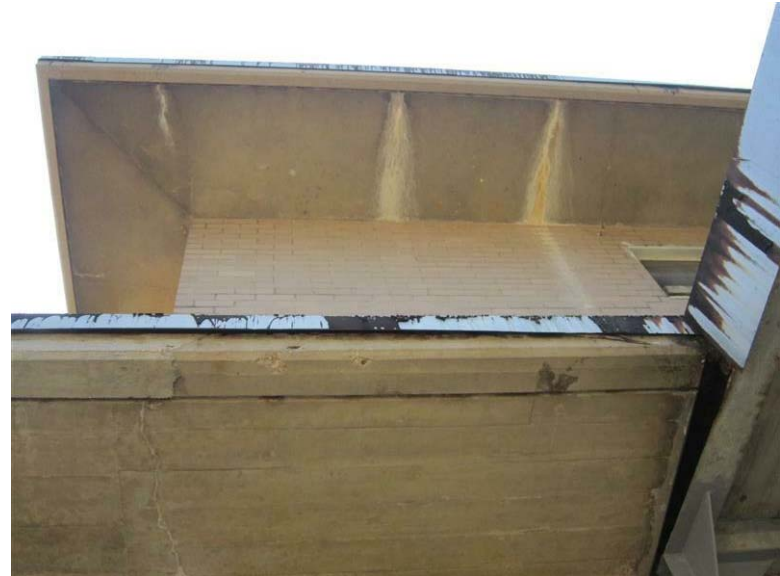
Building 01A - Chemical Feed House: The metal copings have failed and are rusted. There is cracking and staining at the concrete overhangs.

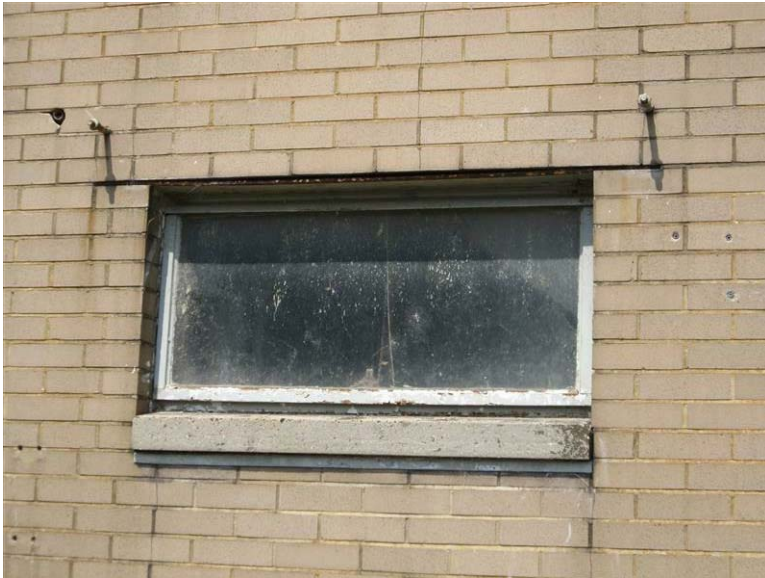
Building 01A - Chemical Feed House: Localized rusting of the steel lintels and metal windows are present.

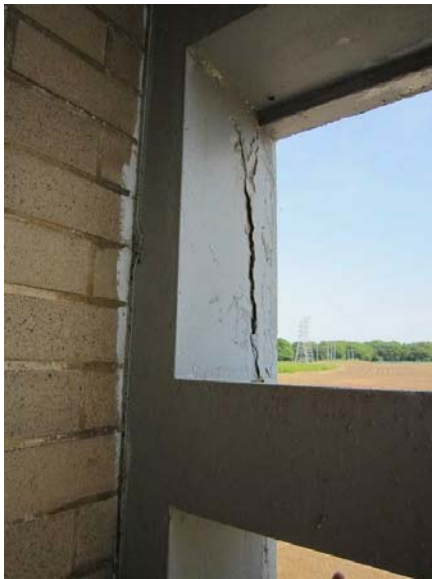
Building 01A - Chemical Feed House: A large vertical crack is visible in the concrete screen at the north entry.

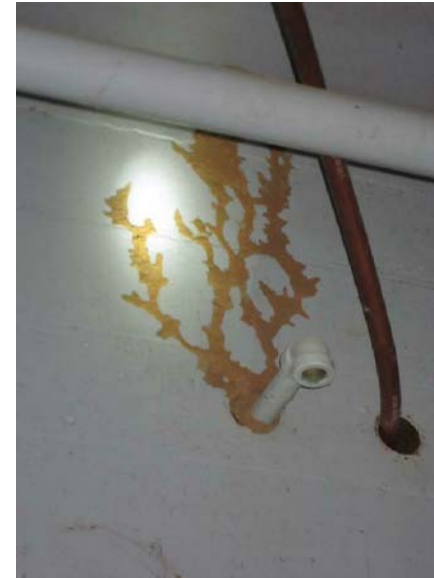
Building 01A - Chemical Feed House: Termites have left a trail along the wall at the pipe penetration.

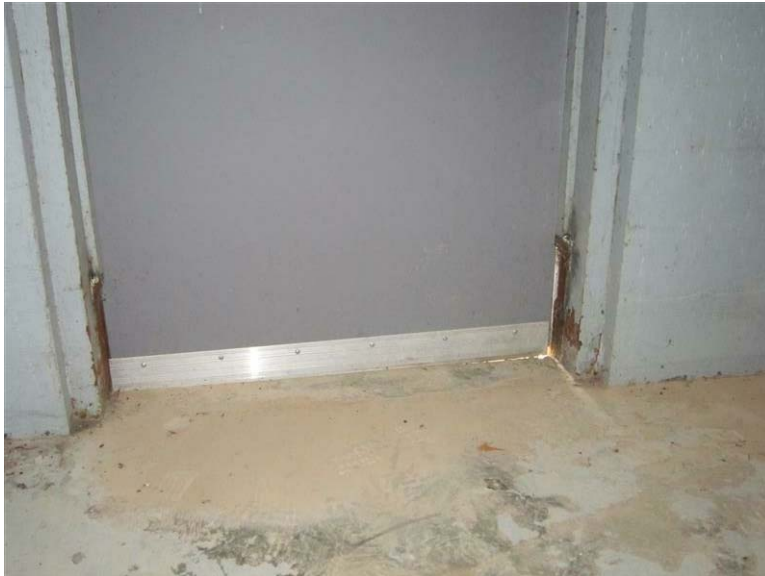
Building 01A - Chemical Feed House: The jambs of the exterior door are badly rusted.

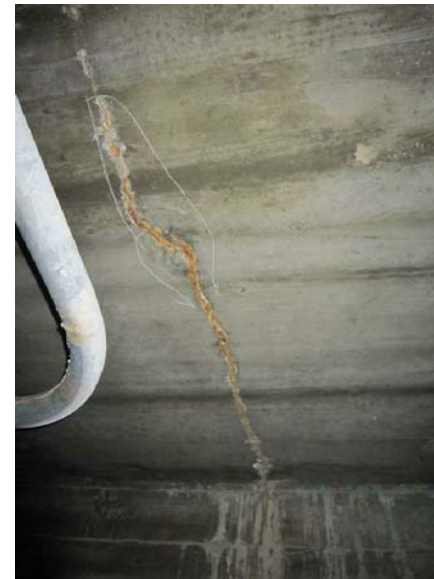
Building 01A - Chemical Feed House: There is a crack at the concrete beam of the second floor stair.

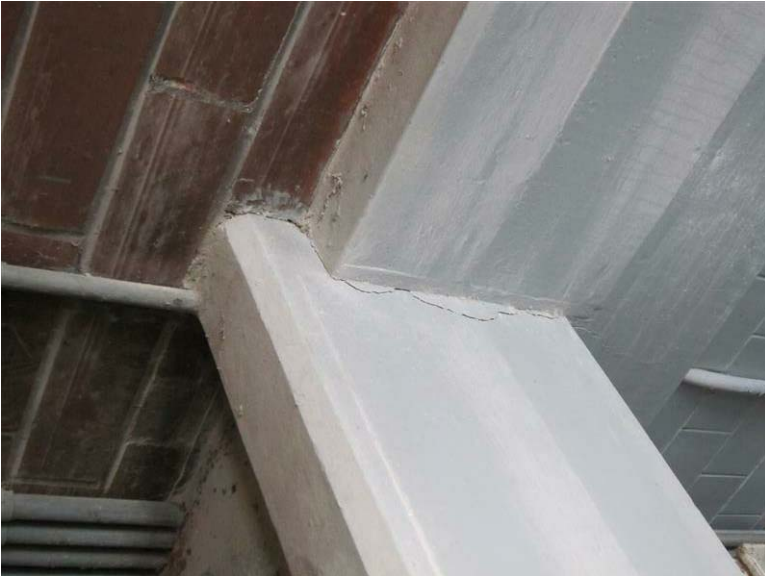
Building 01A - Chemical Feed House: There is a crack at the concrete beam of the second floor stair.

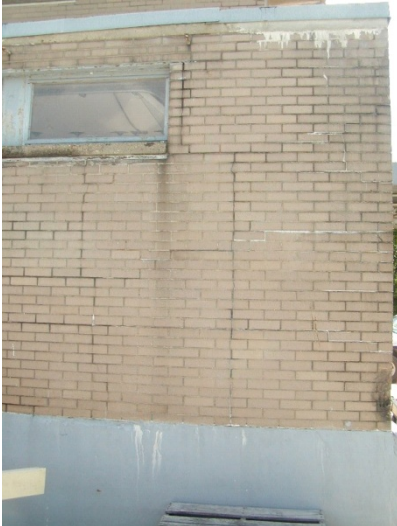
2009 Photo #3: Cracks in masonry on North side

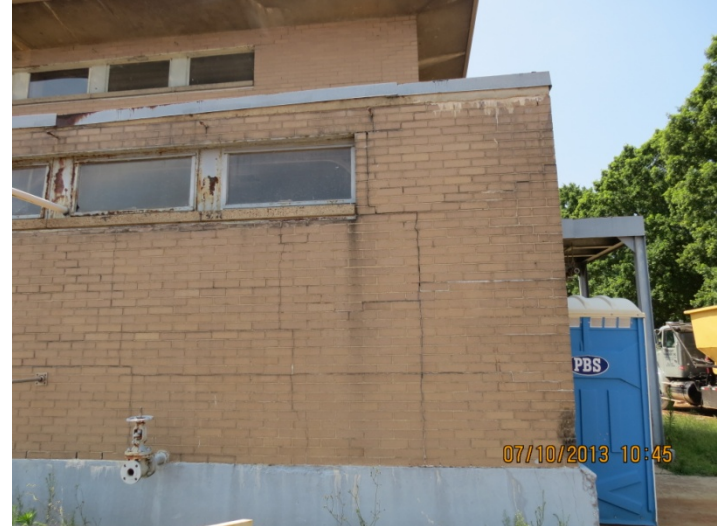
2013 Photo #3: Cracks in masonry on North side. Corrosion evident to the steel framing around windows and roof edging

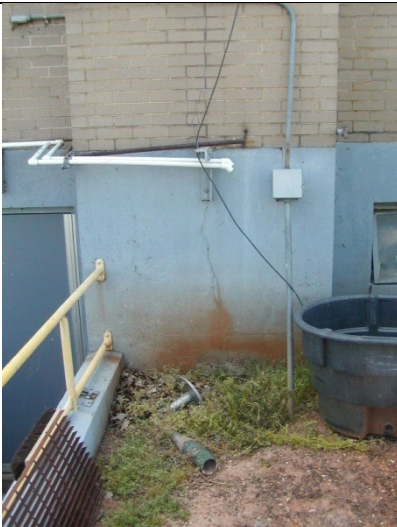
2009 Photo #4: Cracks in masonry and foundation wall on East side

2013 Photo #4: No change observed.

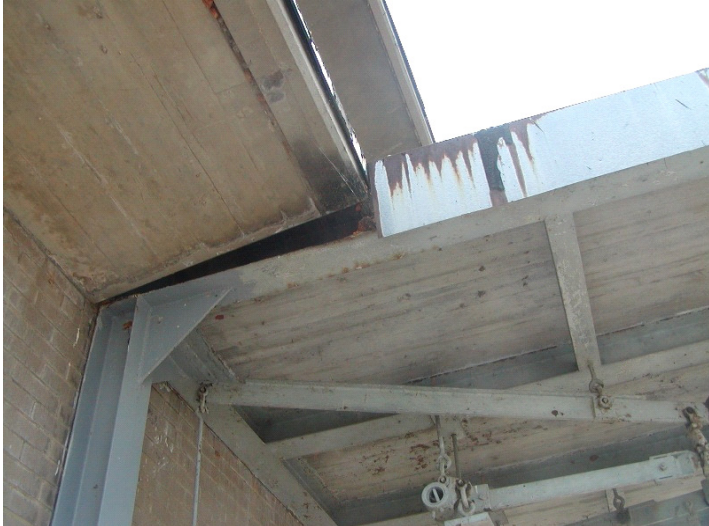
2009 Photo #5: Corroded steel framing and flashing at West canopy

2013 Photo #5: No change observed.

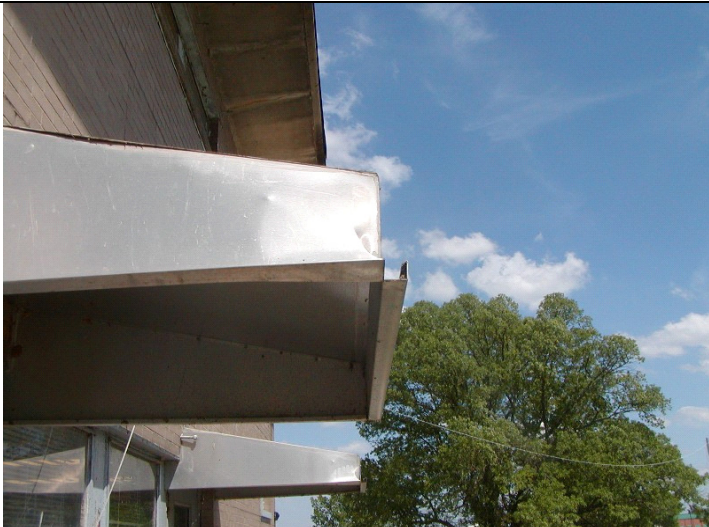
2009 Photo #6: Dented metal awning on South side.

2013 Photo #6: No change observed.

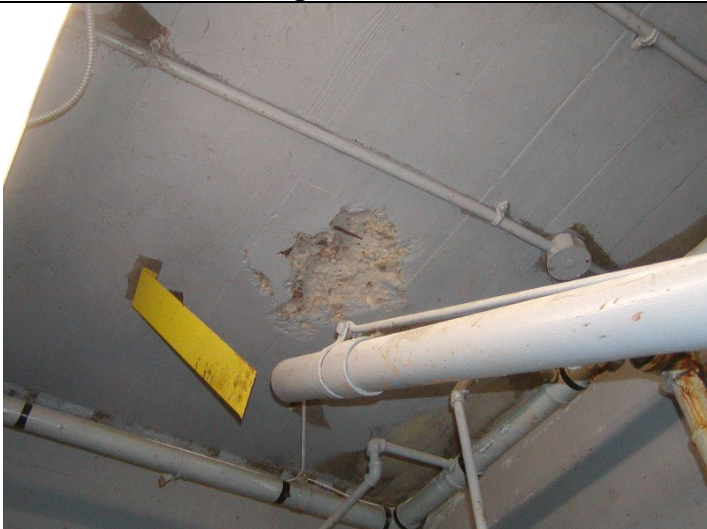
2009 Photo #7: Spall in soffit of floor slab above basement.

2013 Photo #7: No change observed.

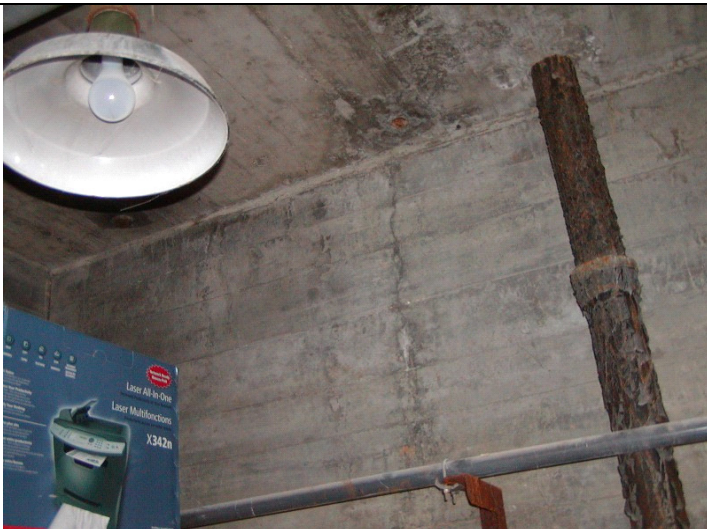
2009 Photo #8: Evidence of water intrusion at basement wall and ceiling.

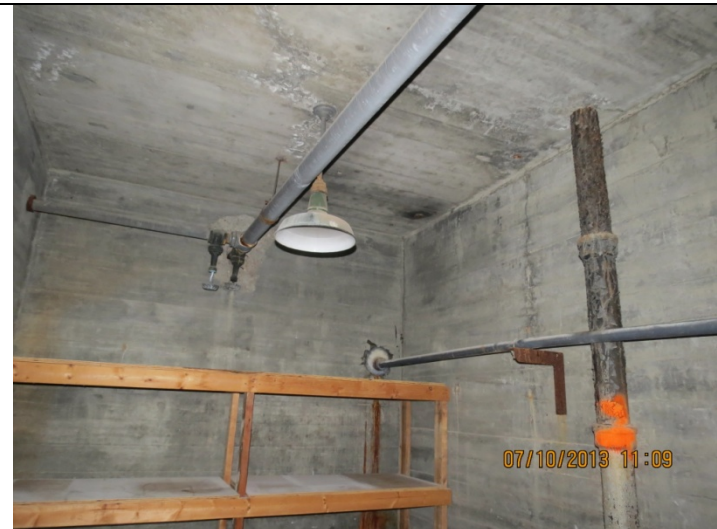
2013 Photo #8: Evidence of water intrusion at basement wall and ceiling. Intrusion appears to be worse than previously reported.

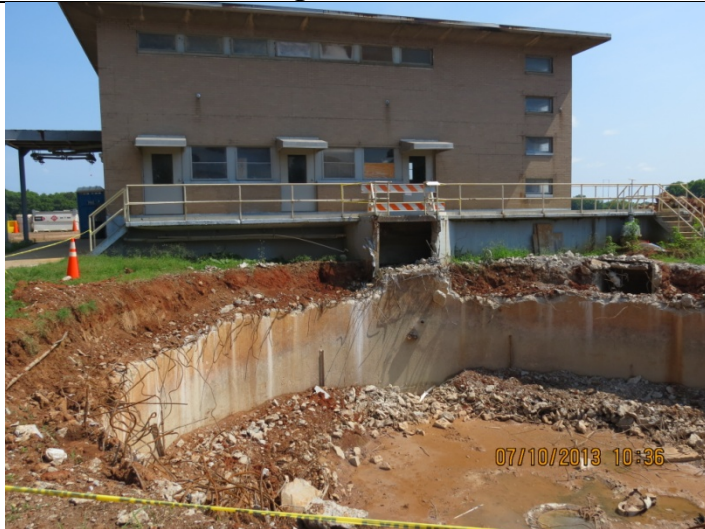
2013 Photo #9: South Side – Previous water treatment pool demolished

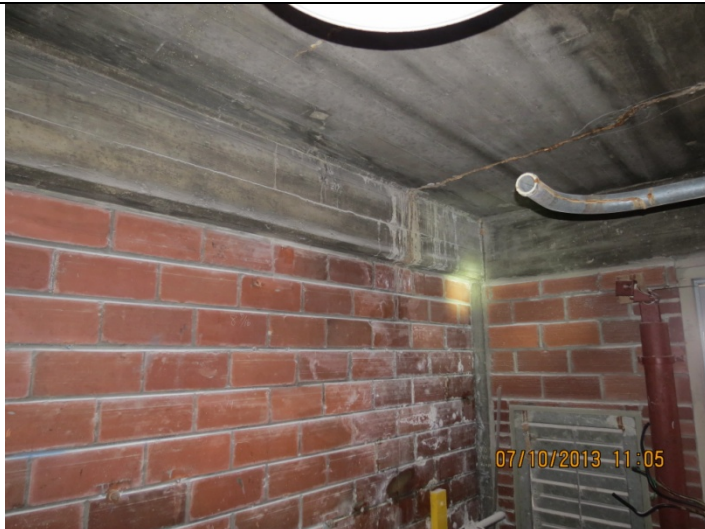
2013 Photo #11: Crack in roof slab runs across entire width of room; Efflorescence present; horizontal beam cracked

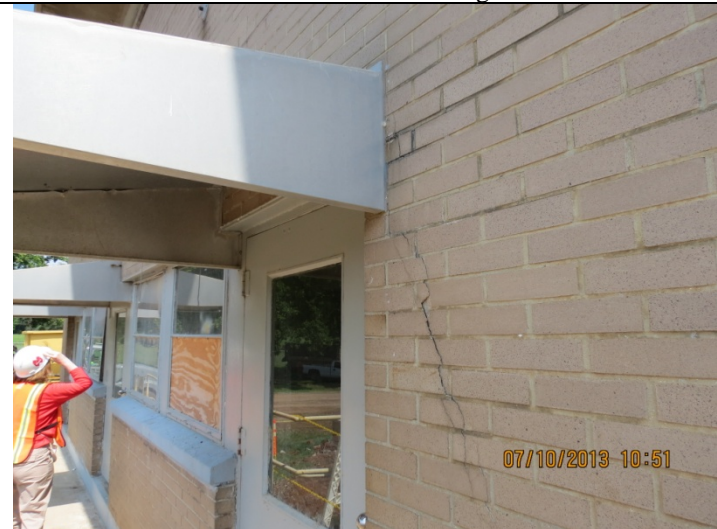
2013 Photo #12: Crack in exterior masonry at awnings on South side of building.

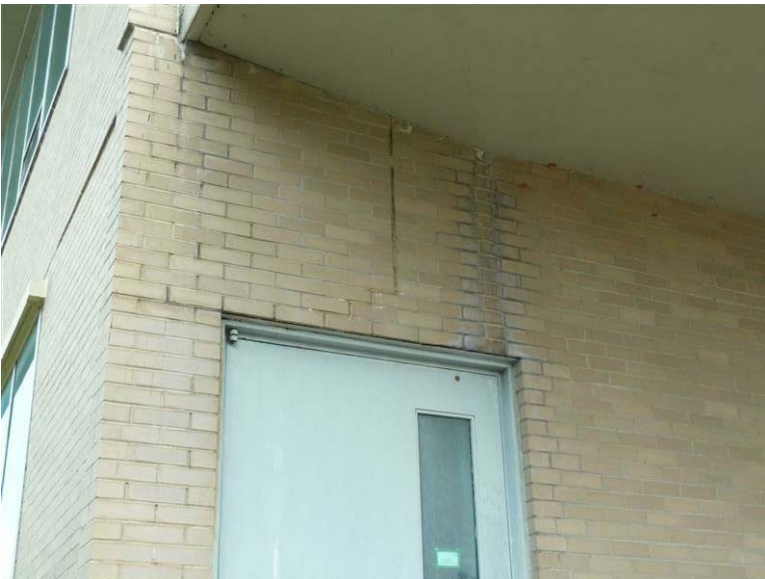
Building 17A - Environmental Research Center : The brick facade has shifted where the awning connects to the building at the southeast corner of this wing.

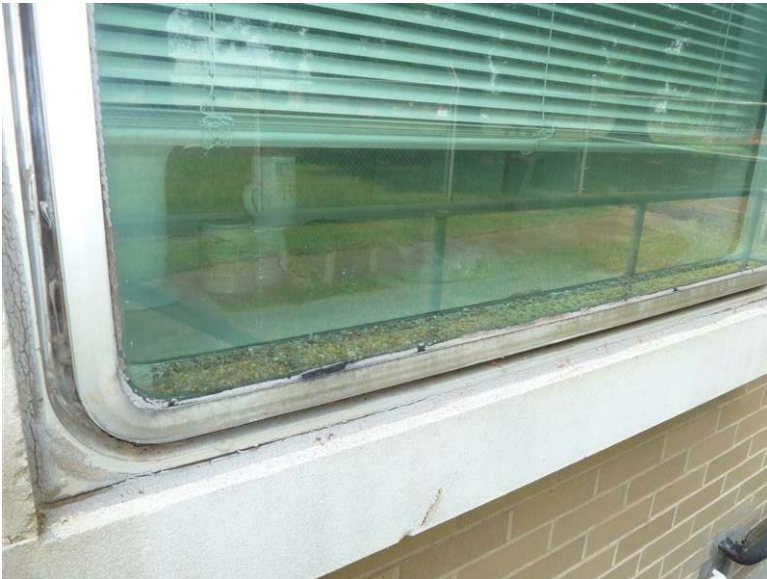
Building 17A - Environmental Research Center: Ladybugs have entered the window cavity indicating the joint/sealant is broken.

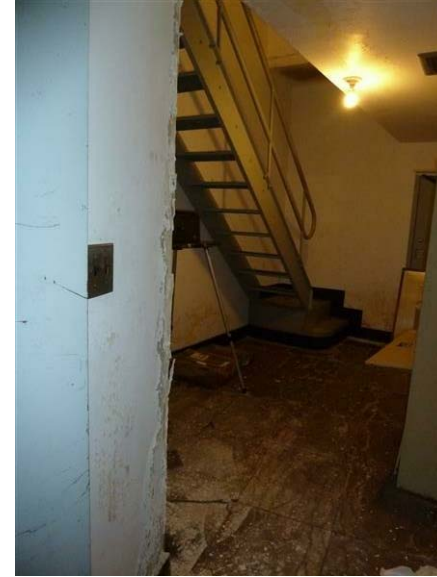
Building 17A - Environmental Research Center: A burst pipe has damaged the plaster wall, ceiling and floor tiles in the room at the rear of the auditorium.

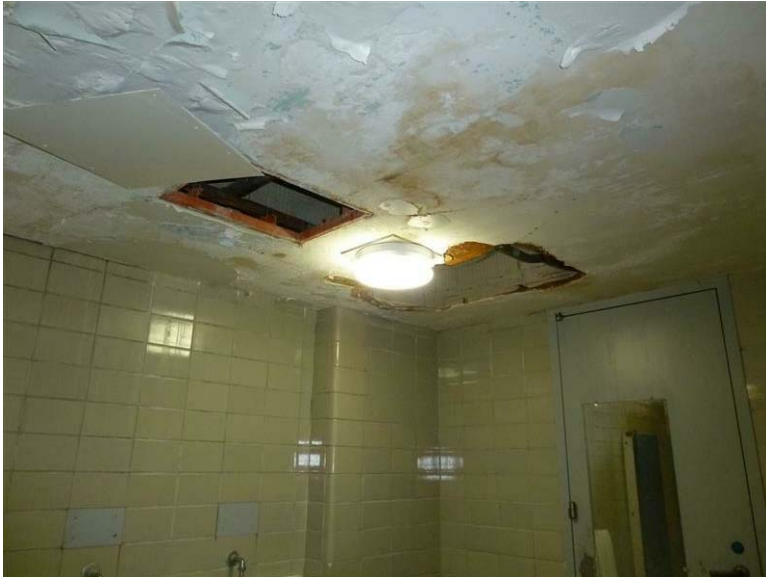
Building 17A - Environmental Research Center: A burst pipe has damaged the plaster ceiling in this lower level restroom.

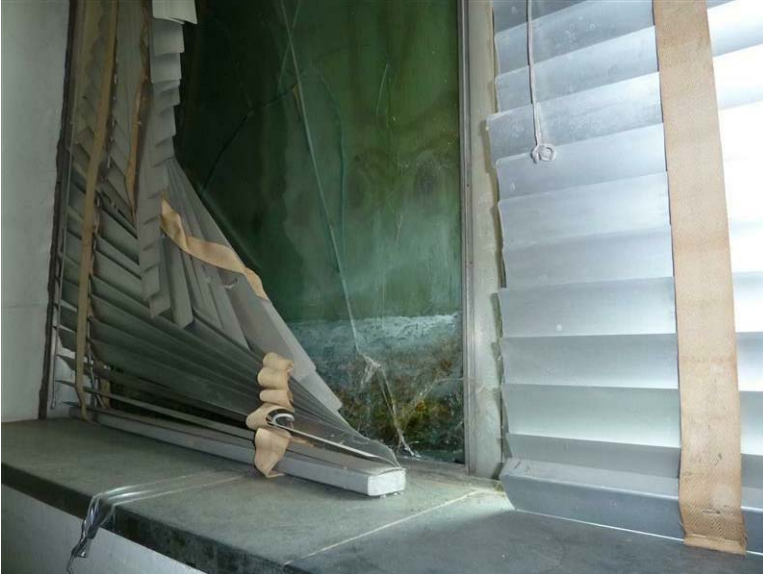
Building 17A - Environmental Research Center: This window has cracked on the east facade.

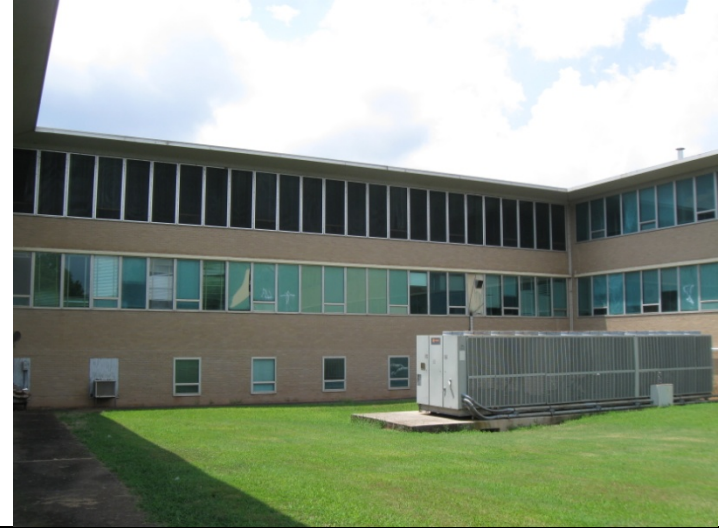
2013 Photo #1: East side of building. Broken windows observed.

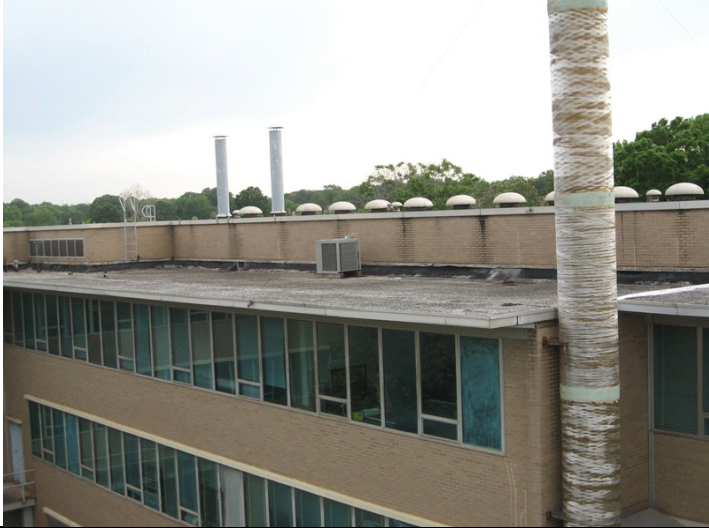
2009 Photo #3: Exterior building in good condition

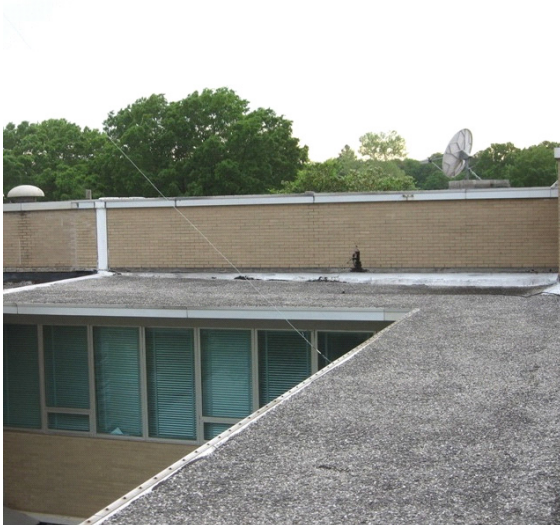
2009 Photo #4: Exterior building in good condition

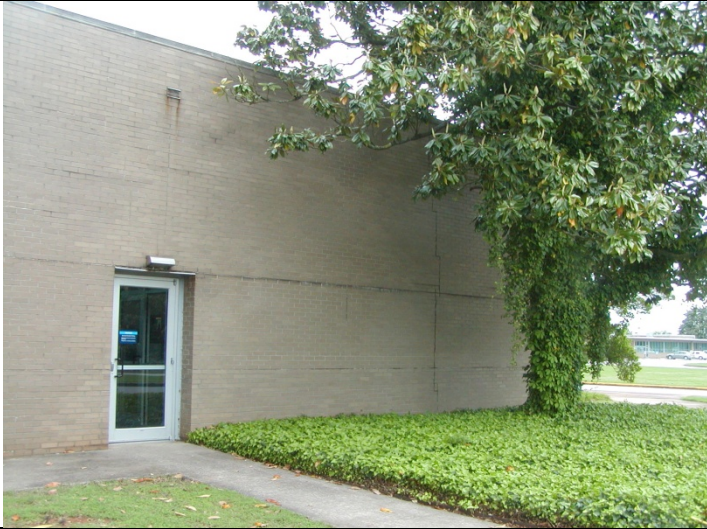
2009 Photo #5: Vertical crack in exterior wall

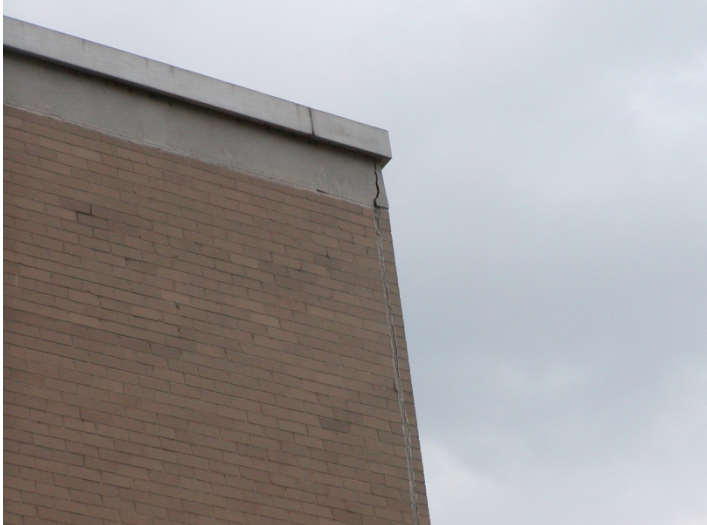
2009 Photo #6: Crack in corner at top of auditorium wall

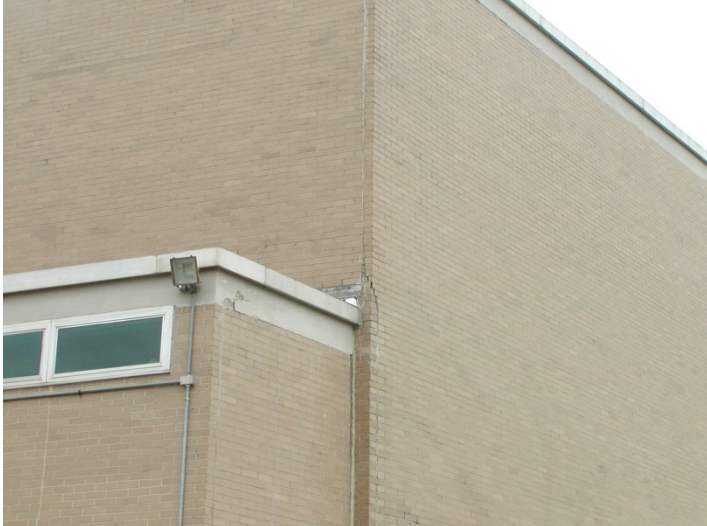
2009 Photo #7: Crack at corner of auditorium wall

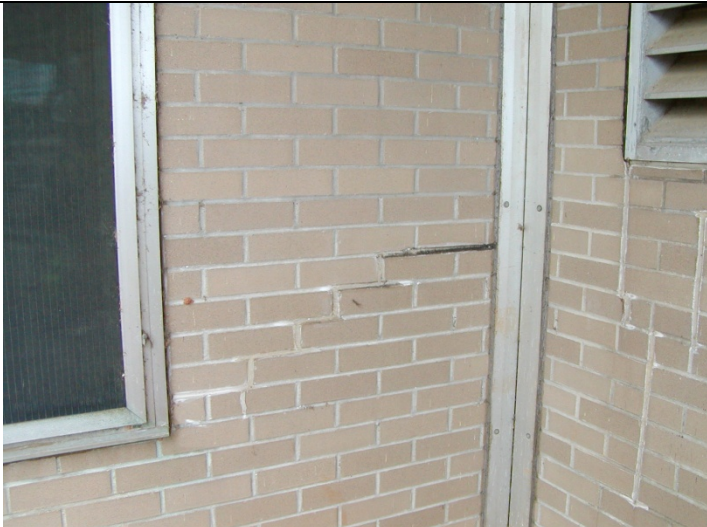
2009 Photo #8: Crack in wall near building entrance

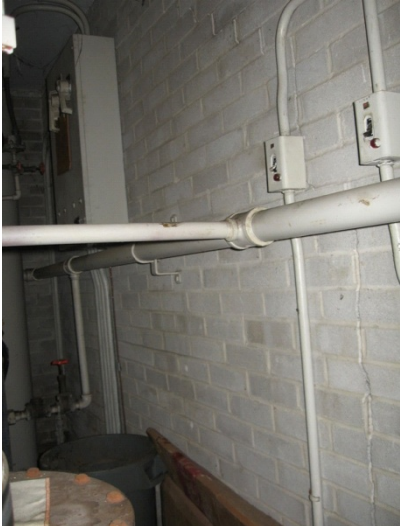
2009 Photo #9: Minor crack in interior brick wall

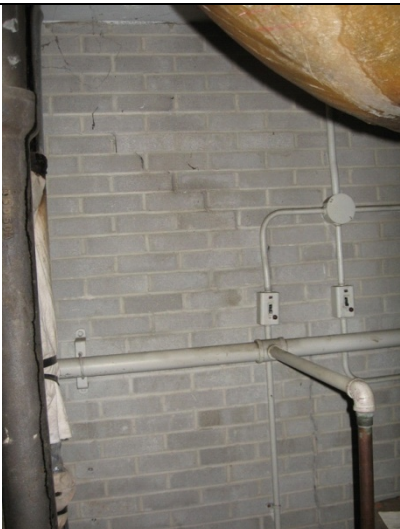
2009 Photo #10: Minor crack in interior brick wall

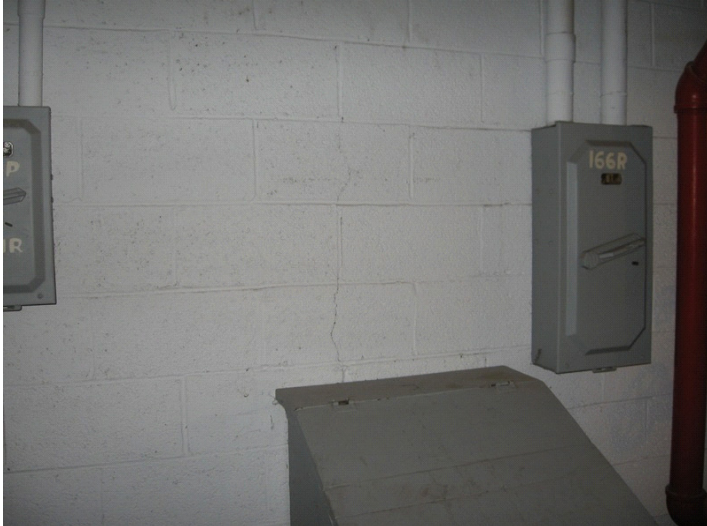
2009 Photo #11: Minor crack in interior concrete masonry wall

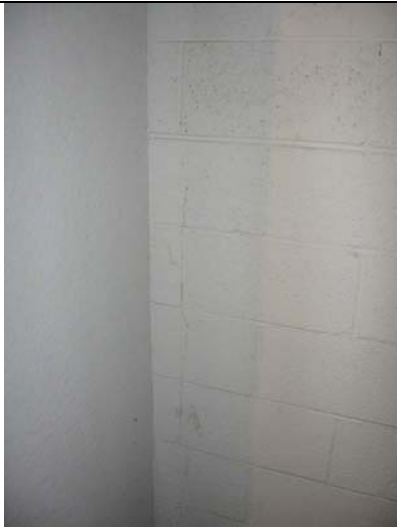
2009 Photo #12: Minor crack in interior concrete masonry wall

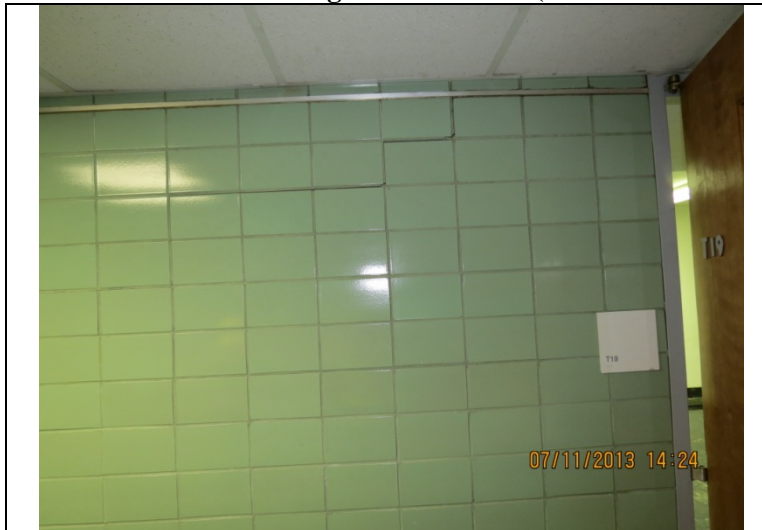
2013 Photo #13: Outside room T19 (Unoccupied): Stair step crack observed at interior wall.

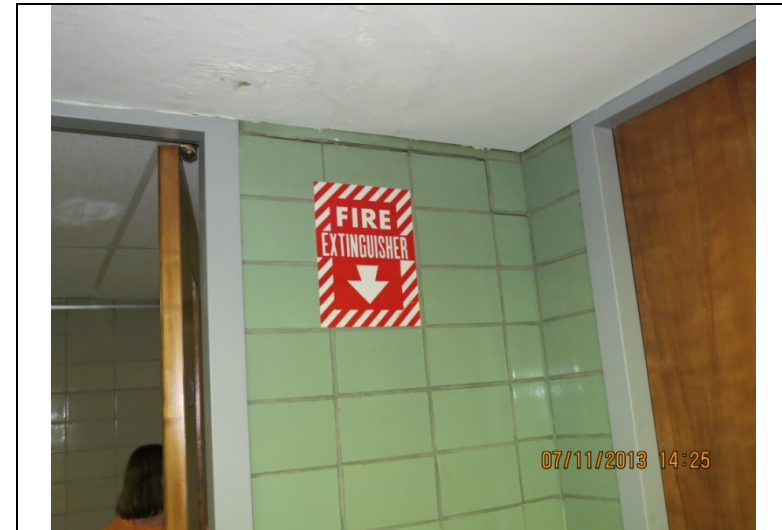
2013 Photo #14: Unoccupied: Photo #13 from other side.

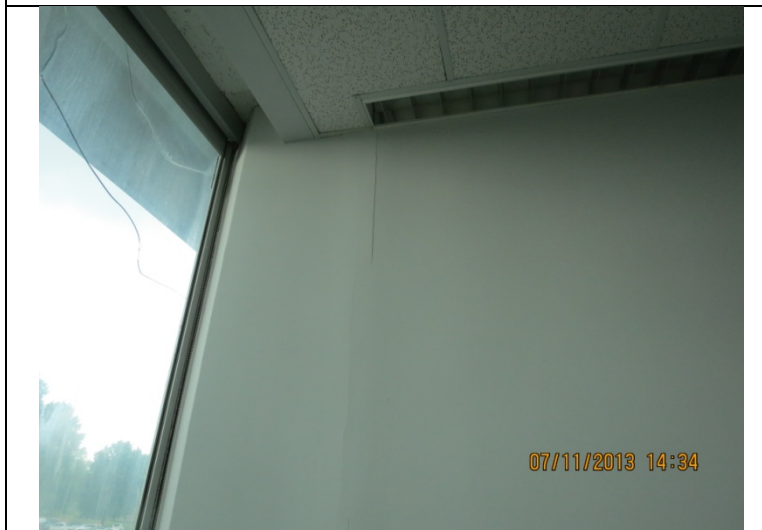
2013 Photo #15: Unoccupied: Crack and ripple in interior finish. (Left) Broken window.

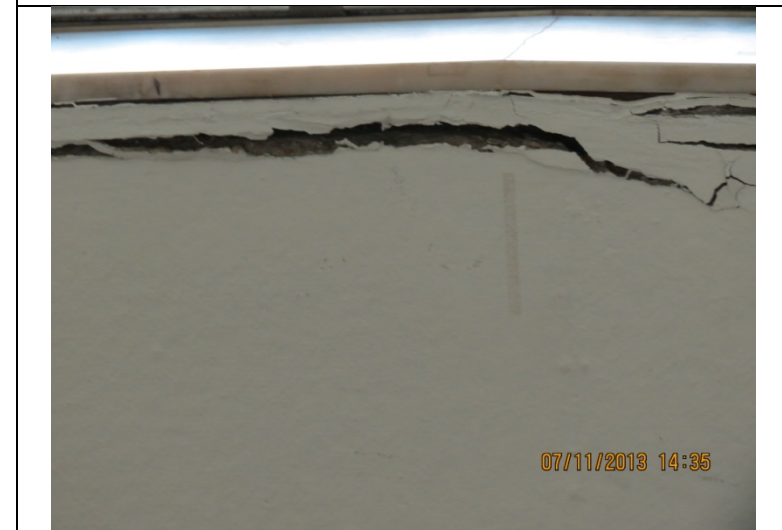
2013 Photo #16: Unoccupied: Broken marble window sill and large crack in wall finish below window

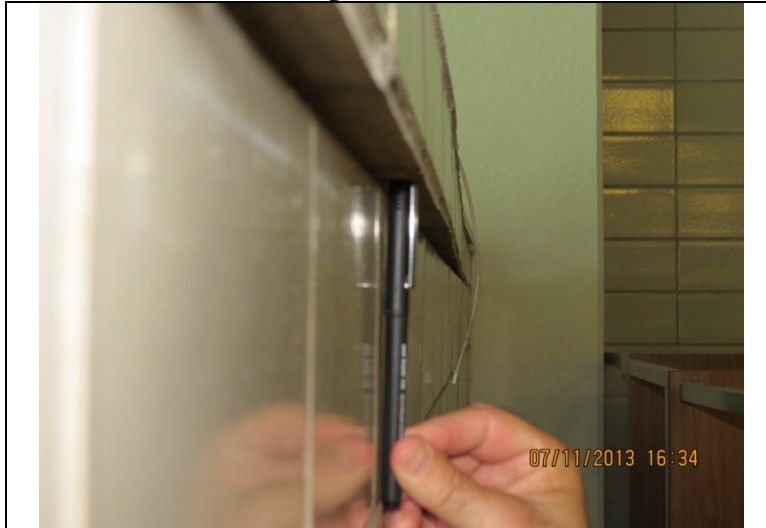
2013 Photo #17: Unoccupied: Inside design center, lateral movement at marble window sill.

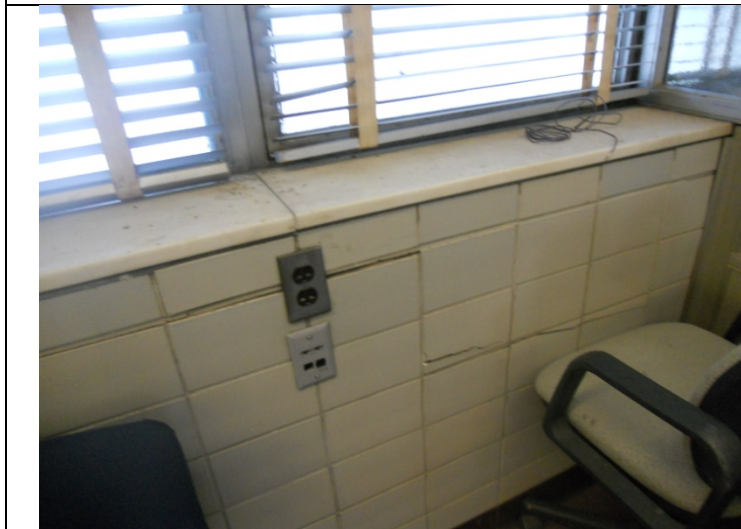
2013 Photo #19: Unoccupied: Stair step cracking in wall finish below marble window sill.

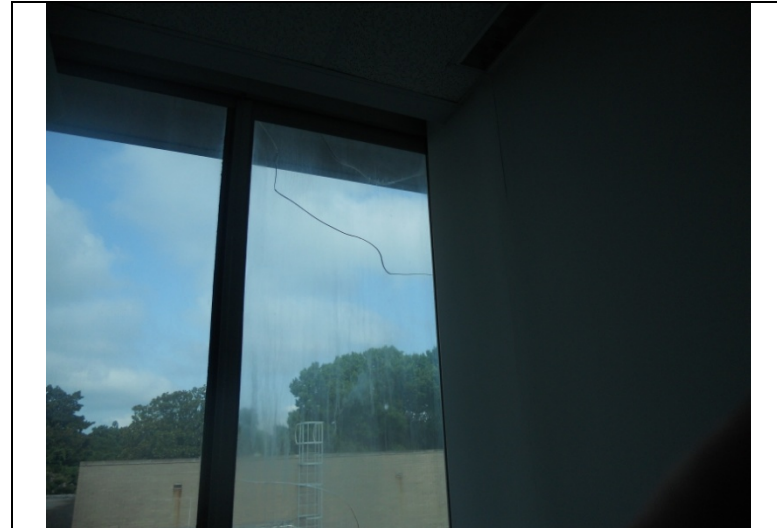
2013 Photo #18: Cracked window in unoccupied space.

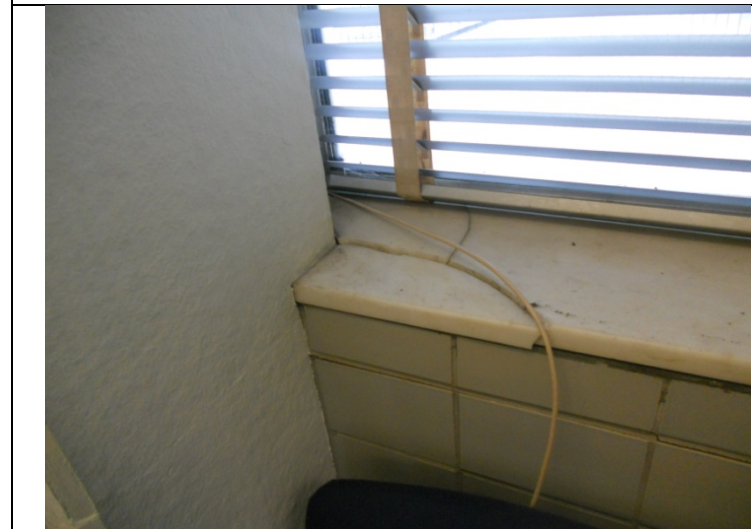
2013 Photo #20: Unoccupied: Broken marble window sill apparently caused by thermal expansion

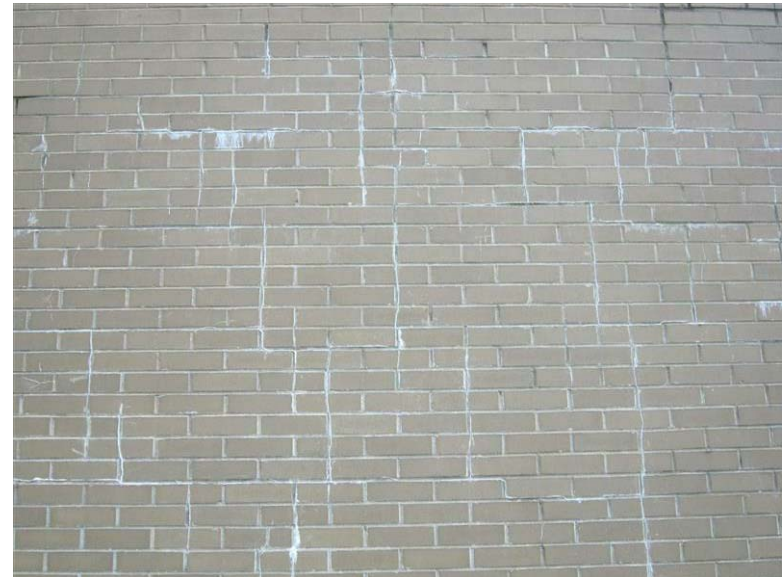
17B - Service Building: Significant thermal cracking and efflorescence is visible on the sawtooth walls.

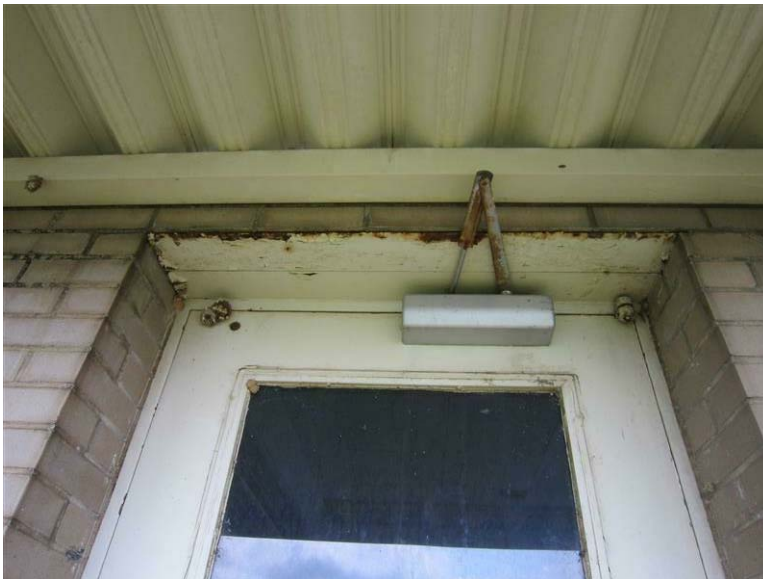
17B - Service Building: Rusting of exterior exposed structural steel.

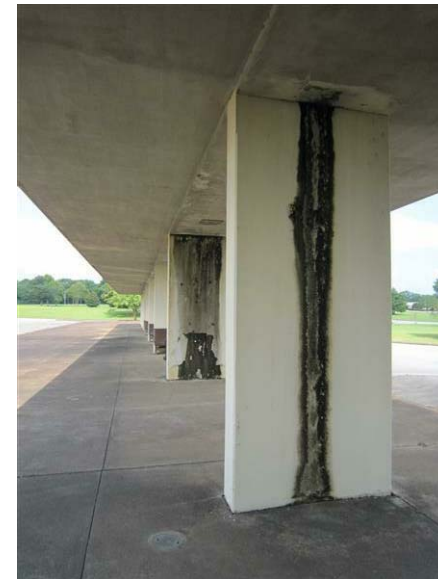
17B - Service Building: Water damage at the concrete canopy has accelerated since the previous assessment.

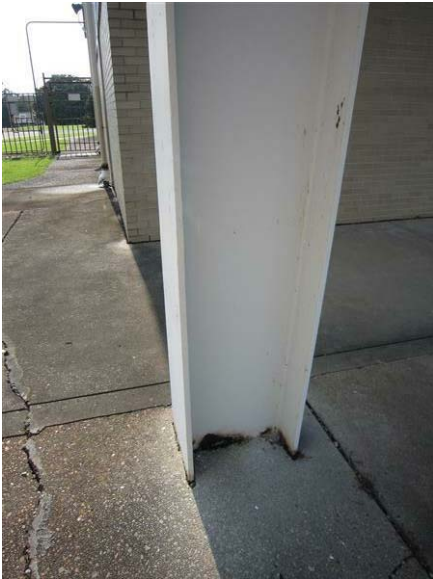
17B - Service Building: The base of the steel columns is rusting adjacent to the concrete.

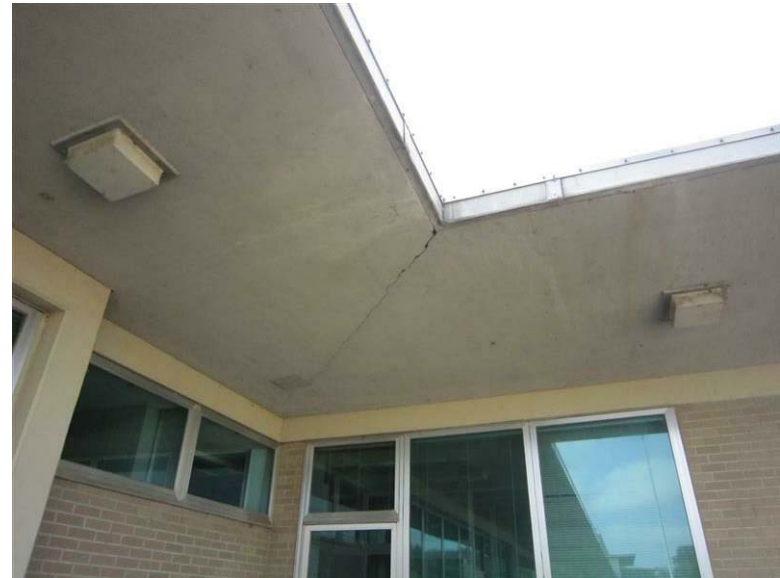
17B - Service Building: The concrete overhang is cracked at the interior corner.

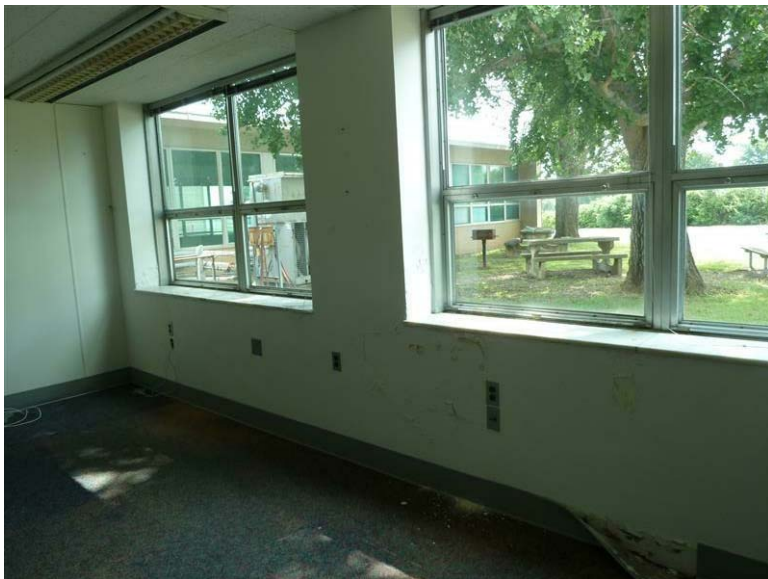
17B - Service Building: Damage to interior finishes due to moisture in the space.

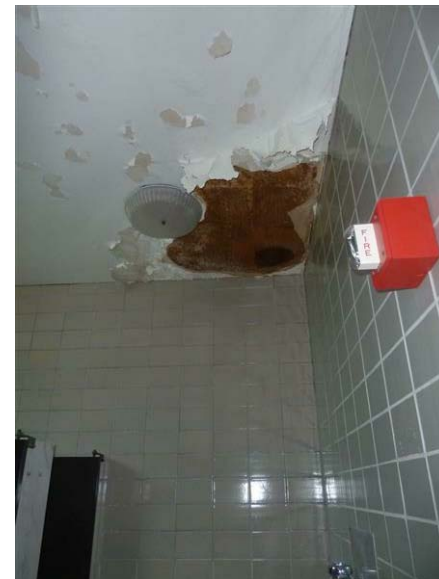
17B - Service Building: Water damage at the restroom ceiling.

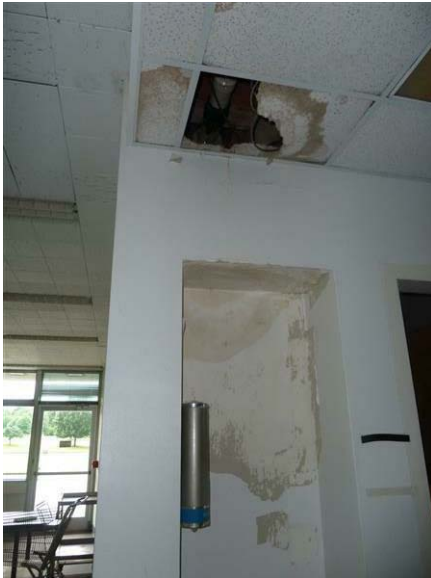
17B - Service Building: The ceiling and wall are damaged from water infiltration adjacent to the water fountain.

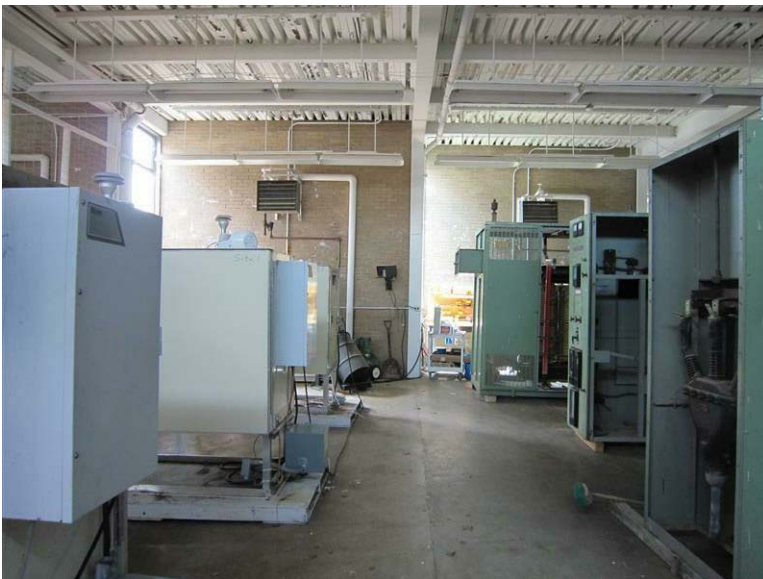
17B - Service Building: Paint is flaking at the metal ceiling.

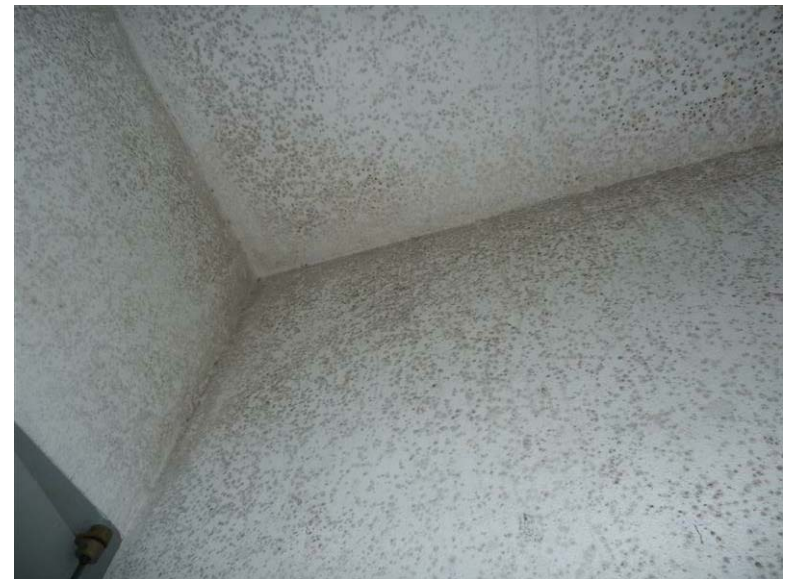
17B - Service Building: Mold and mildew are prevalent in the basement.

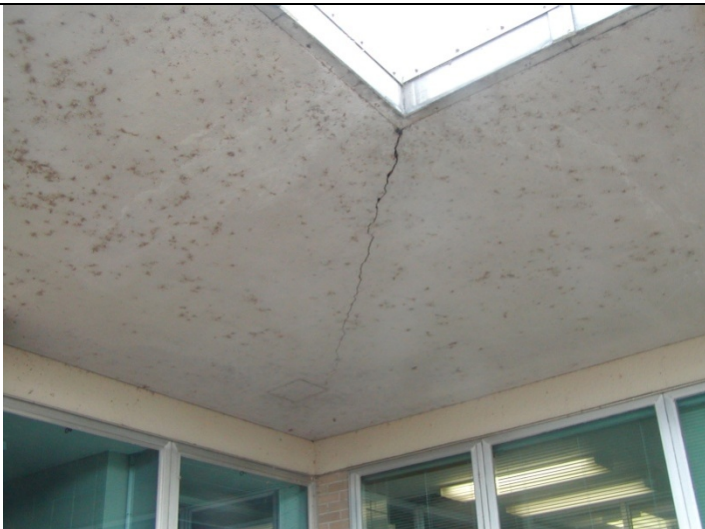
2009 Photo #2:Crack in concrete soffit near main entrance

2013 Photo #2: No change observed.

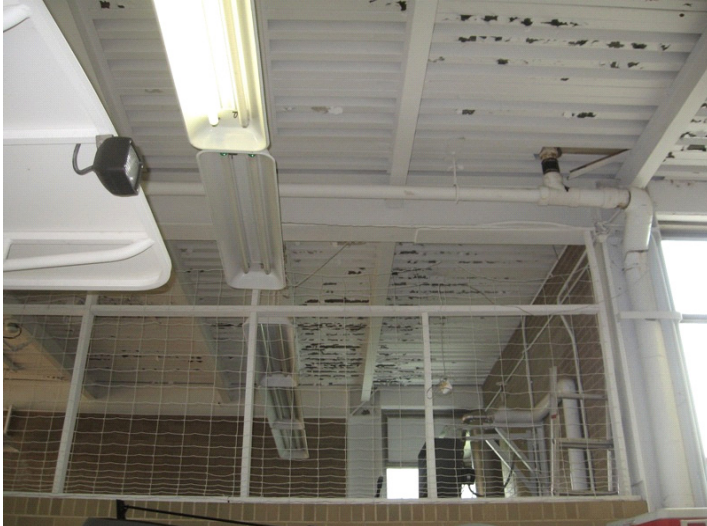
2009 Photo #3: Flaking paint at metal deck in vehicle storage area

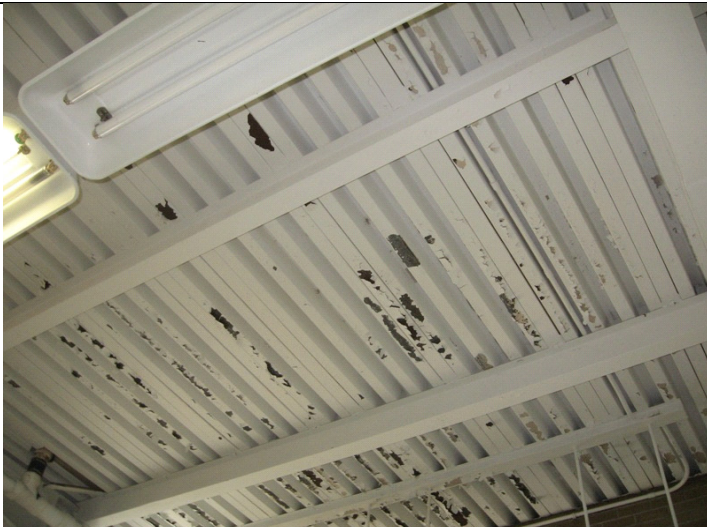
2009 Photo #4: Flaking paint at metal roof deck in vehicle storage area

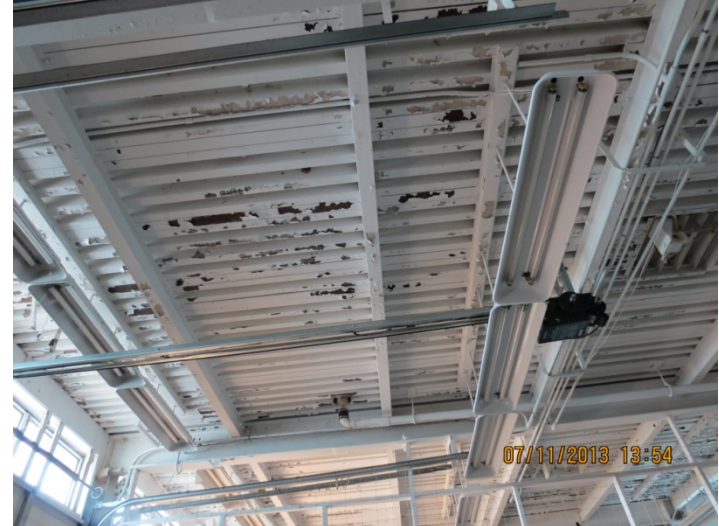
2013 Photo #3: Increased amount of flaking paint and corroded steel decking at vehicle storage area.
