Tennessee Valley Authority

Cyclic Assessment Report
TVA Muscle Shoals, Alabama
September 16, 2013

Executive Summary

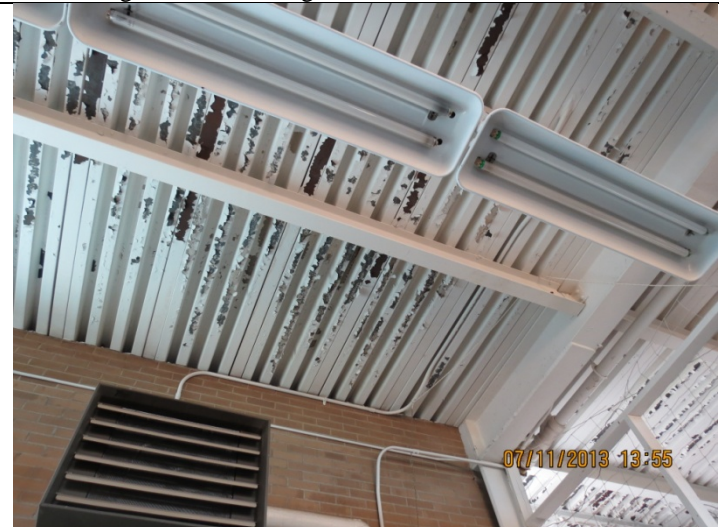
2013 Photo #4: Increased amount of flaking paint and corroded steel decking at vehicle storage area.

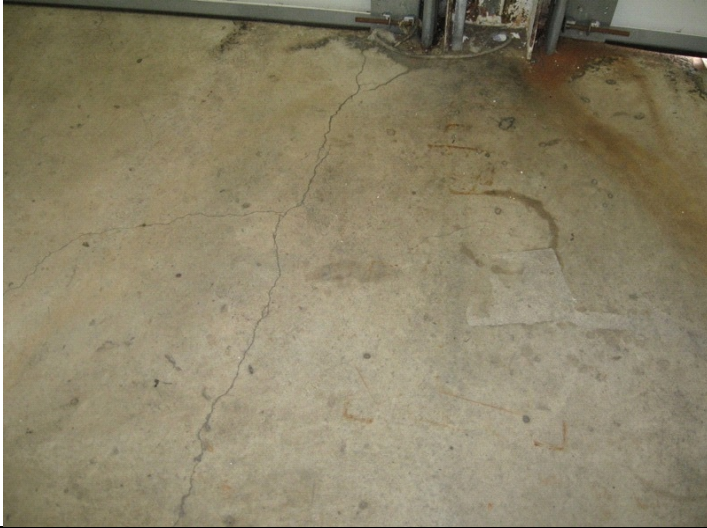
2009 Photo #7: Cracks in slab at vehicle storage area

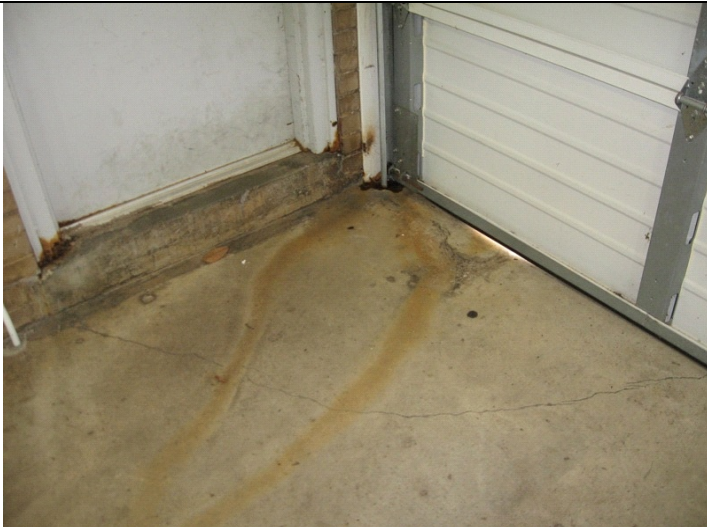
2009 Photo #8: Crack in slab at vehicle storage area

2013 Photo #8: No change observed.

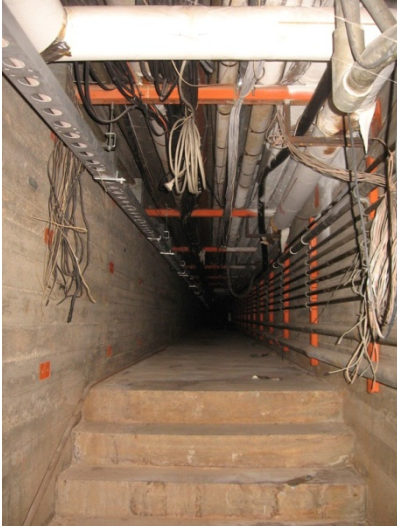
2009 Photo #9: Concrete service tunnel looking toward ERC Building (Building 17a)

2013 Photo #9: No change observed.

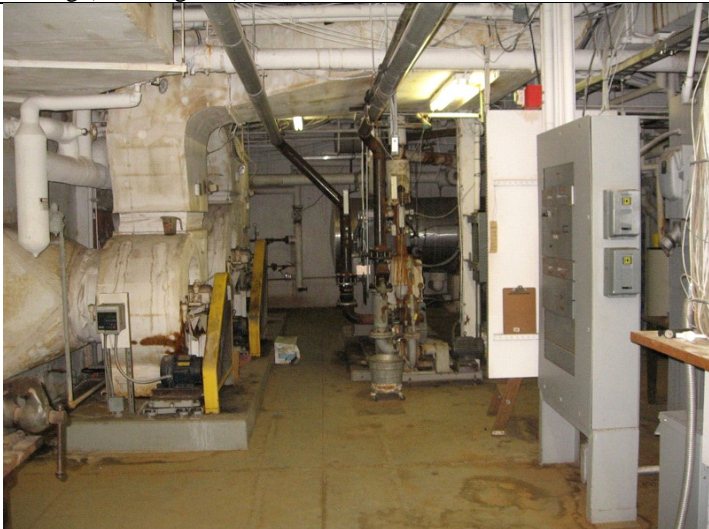
2009 Photo #10: Mechanical equipment in basement.

2013 Photo #10: No change observed.

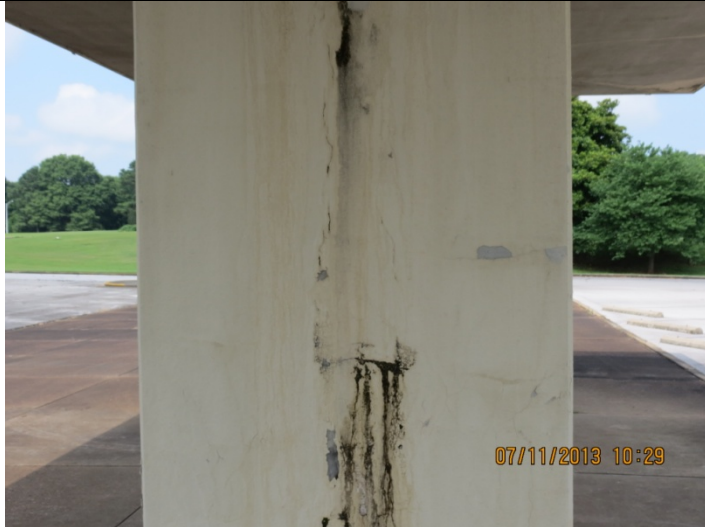
2013 Photo #11: Columns at canopy exhibit mold growth due to leaking interior drains.

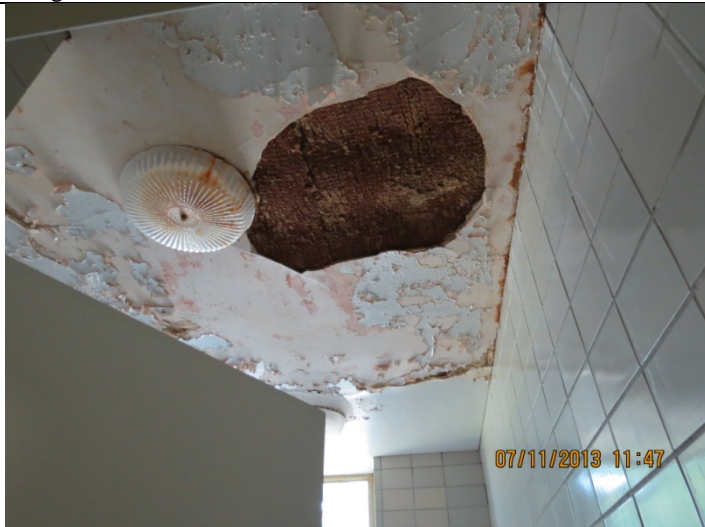
2013 Photo #13: Women's bathroom ceiling. Plaster spalling and rusting steel lath from water infiltration observed.

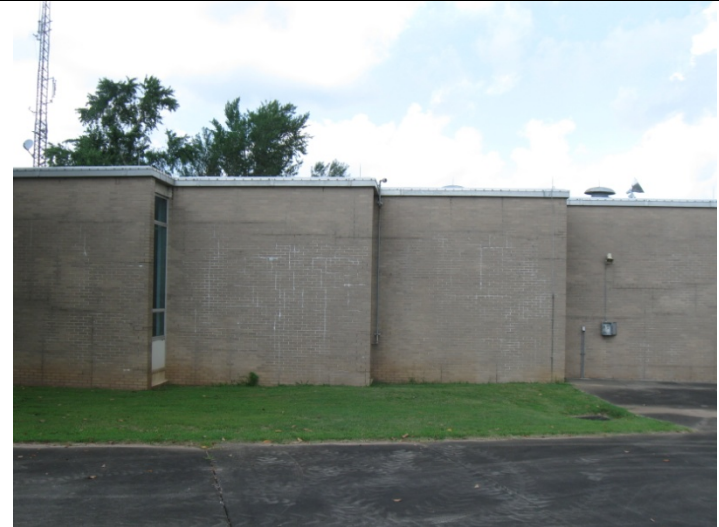
2013 Photo #12: Efflorescence not previously documented at the exterior south masonry wall was observed.

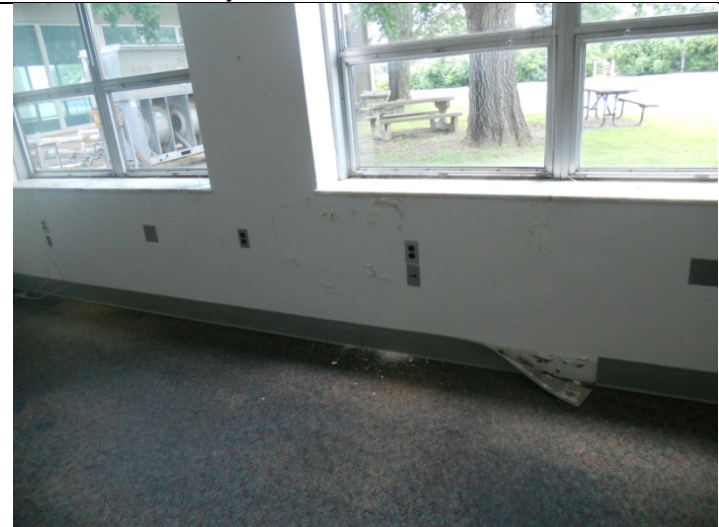
2013 Photo #14: Deterioration of interior finishes observed at several locations.

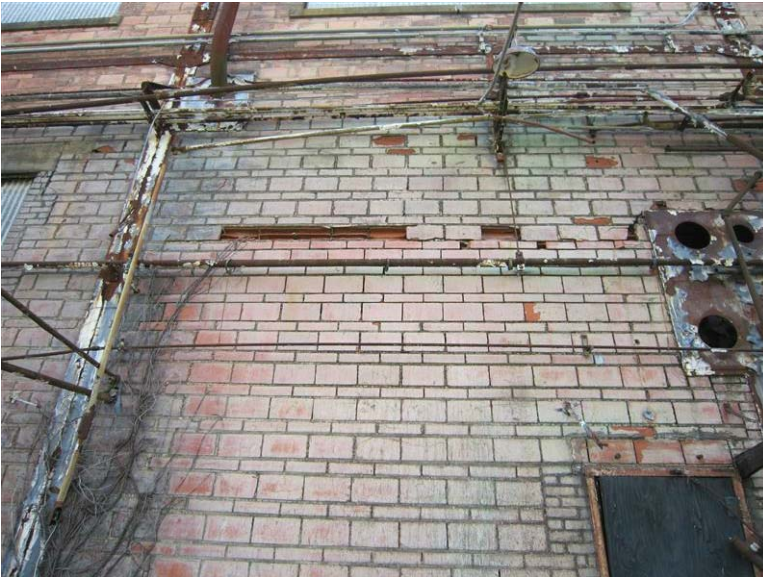
Building 22, 23 – L / N Building: Localized spalled and broken hollow clay tile and rusted steel are prevalent.

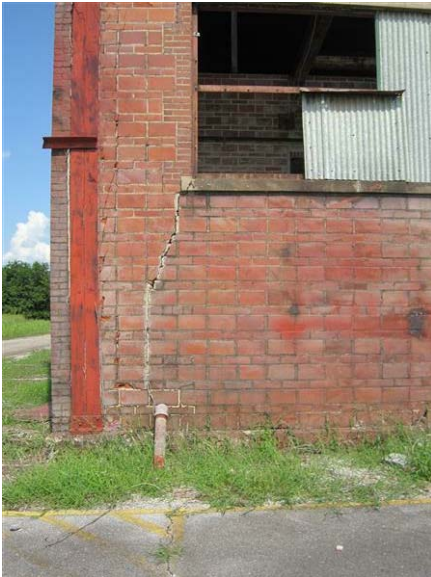
Building 22, 23 – L / N Building: Localized cracking is visible at this window sill.

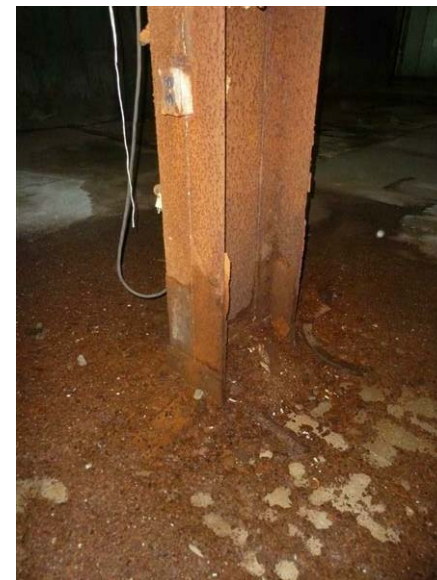
Building 22, 23 – L / N Building: Severe rusting and deterioration are present at this column.

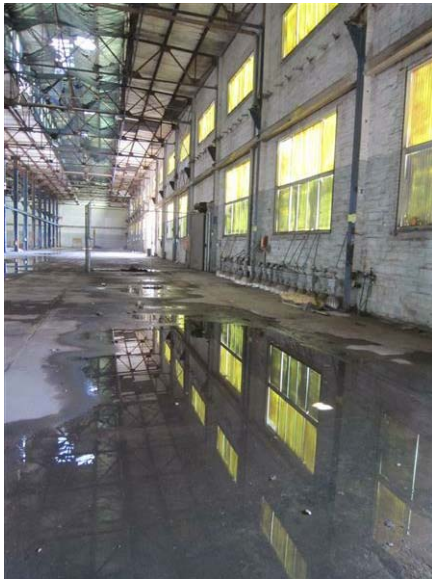
Building 22, 23 – L / N Building: Standing water is present in the building.

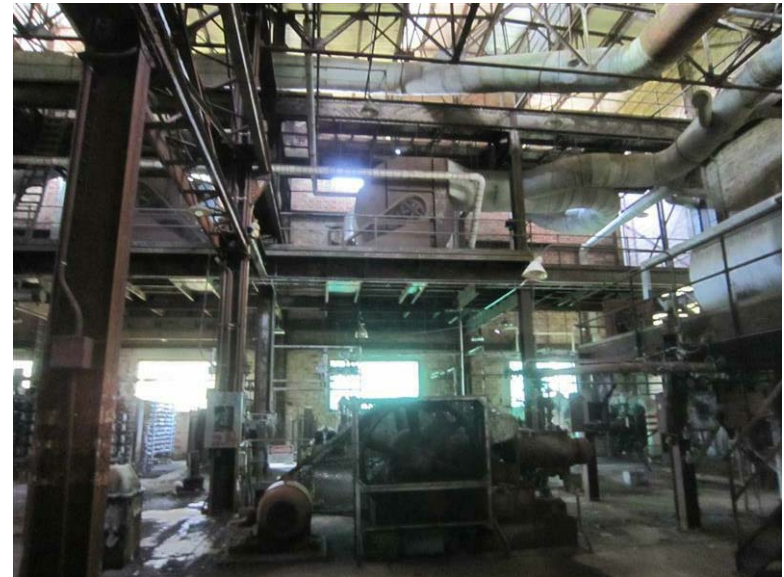
Building 22, 23 – L / N Building: Probable asbestos pipe wrap is present in the building.

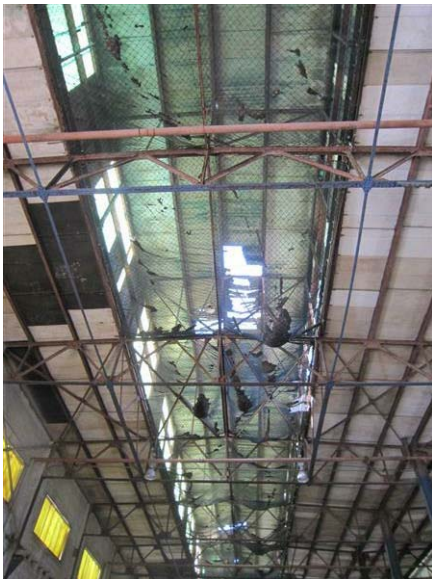
Building 22 / 23 → N					
General Comments:					
The condition of this building remains similar to its condition when it was assessed in 2009, with the exception of the roof and ceiling. The roof and ceiling exhibit severe deterioration and failure to address water infiltration will result in accelerated damage to the interior of the building.

Building 22, 23 – L / N Building: Ceiling panels have deteriorated since the previous assessment.

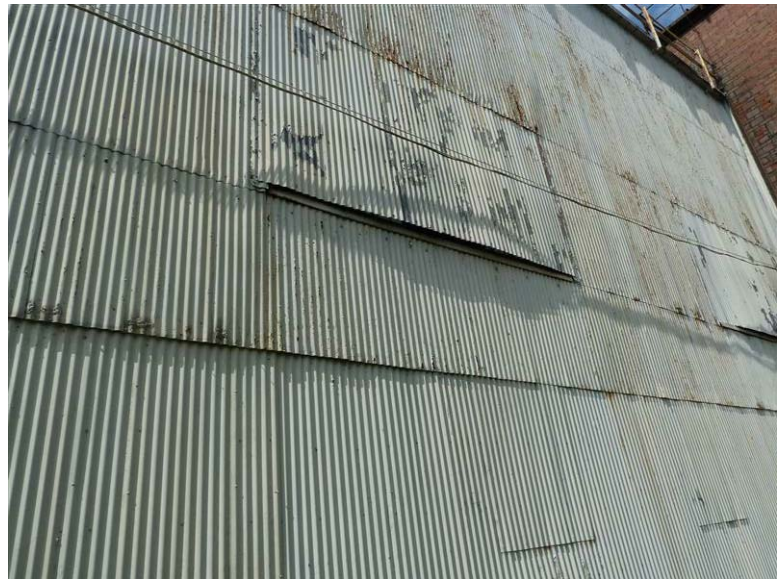
Building 24 – Warehouse No. 4: The openings are covered with corrugated metal panels.

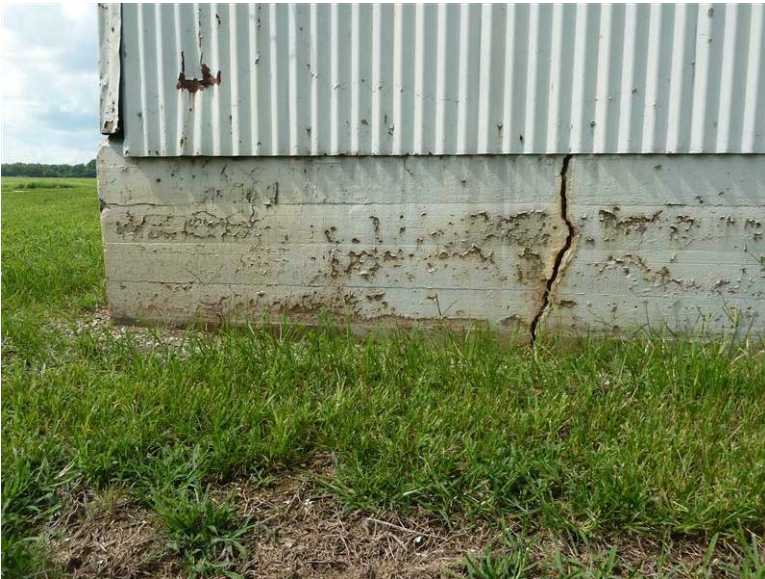
Building 24 – Warehouse No. 4: There is a large crack in the concrete foundation.

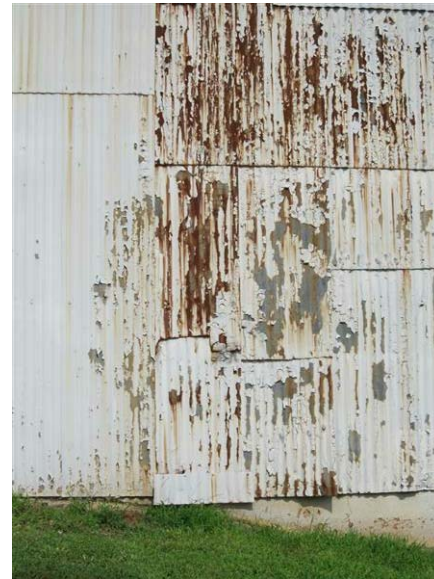
- Metal wall panels rusting in numerous locations
- Metal fascia and railing at roof severely deteriorated
- Louvers at clerestory significantly deteriorated and missing in locations

Building 24 – Warehouse No. 4: Rusting occurs and the paint is flaking from the corrugated metal panels.

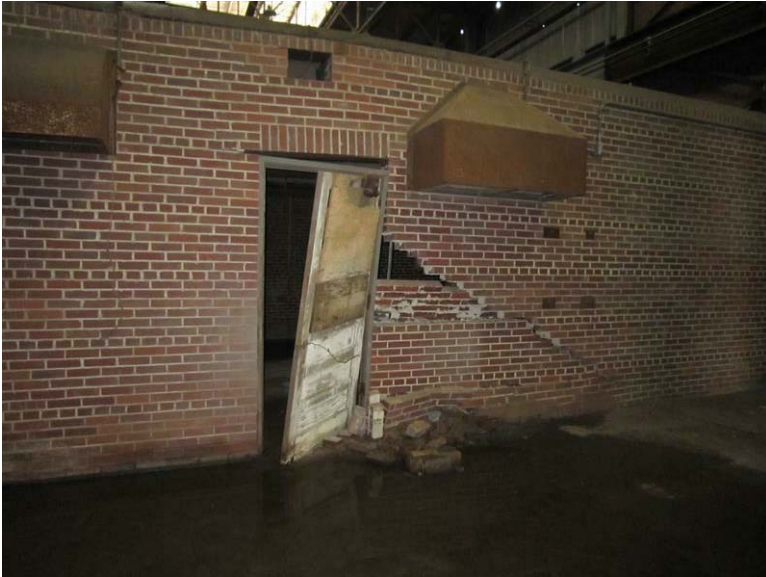
Building 24 – Warehouse No. 4: The brick demising wall has failed and the floor has settled where the water has accumulated.

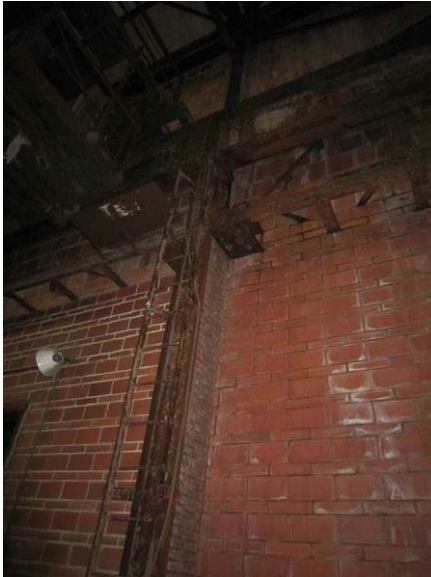
Building 24 – Warehouse No. 4: Water is dripping down the face of the north masonry wall.

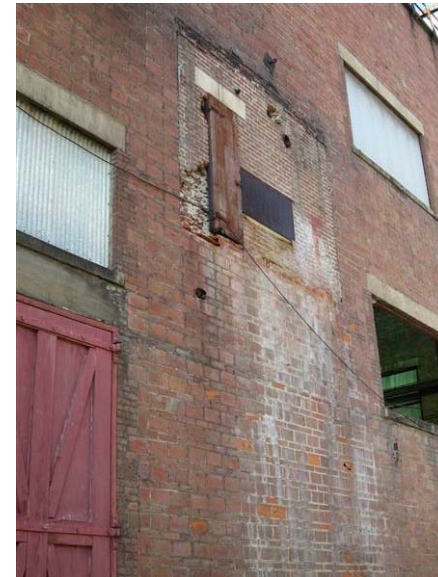
Building 26 – L / N Building Grounds Maintenance Shop: Efflorescence, spalling masonry and eroded mortar joints where water is flowing down the face of the building.

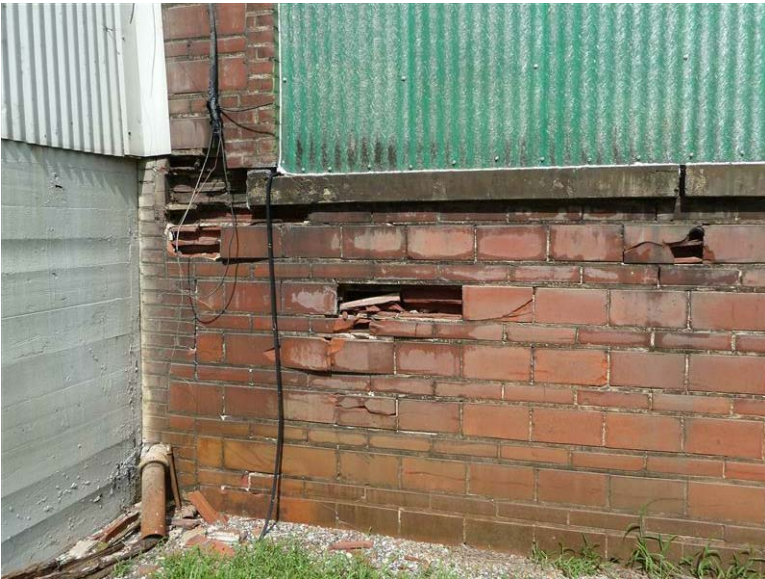
Building 26 – L / N Building Grounds Maintenance Shop: Spalling masonry and eroded mortar joints where water is flowing down the face of the building.

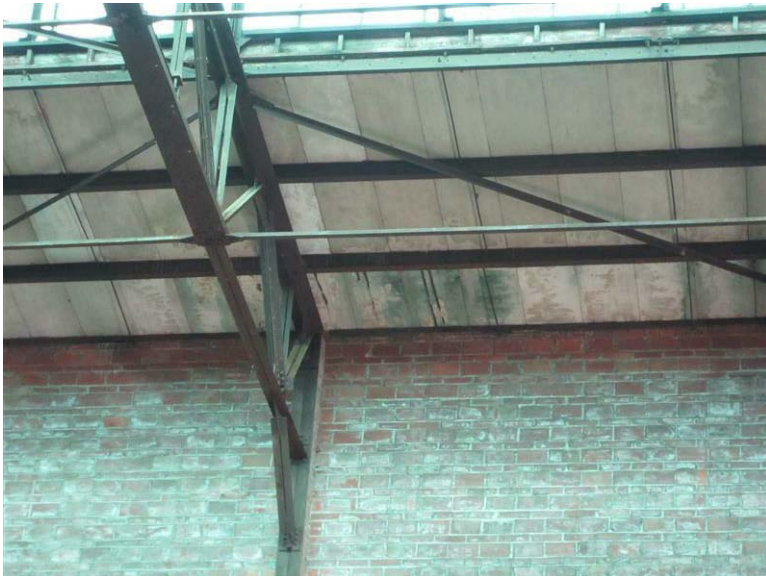
</div> <div>New Comments</div> <ul style="list-style-type: none">Ceiling panels are deteriorated and rebar is exposedLocalized cracking of masonry wallsSecondary space - considerable water damage; mold growth; possible asbestos - containing floor tiles - friable <div>

Building 26 – L / N Building Grounds Maintenance Shop: Rebar is exposed where spalling has occurred on the concrete ceiling panels.

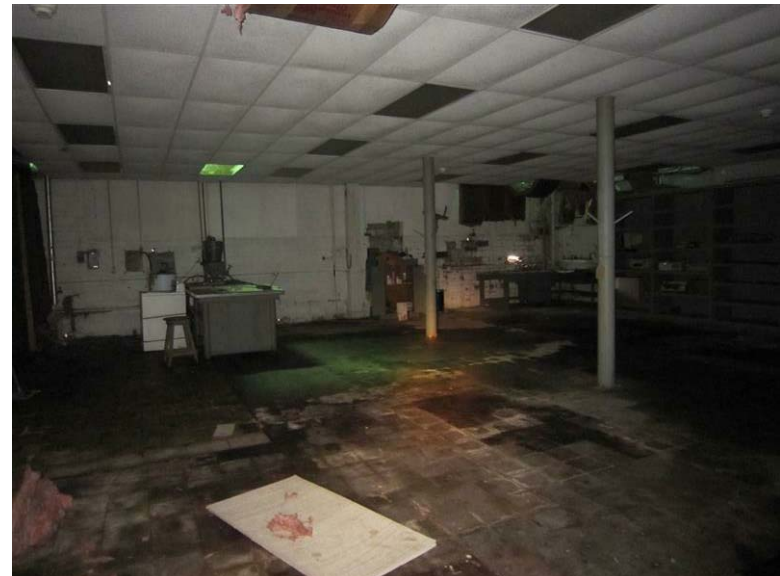
Building 26 – L / N Building Grounds Maintenance Shop: Considerable water damage, mold growth and possible asbestos containing floor tiles are present in the secondary space.

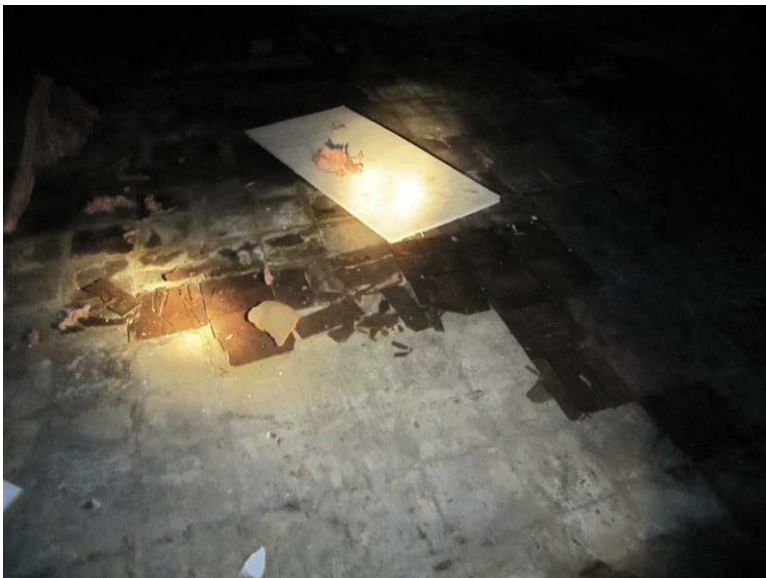
Building 26 – L / N Building Grounds Maintenance Shop: Several possible asbestos containing floor tiles are missing and deteriorated.

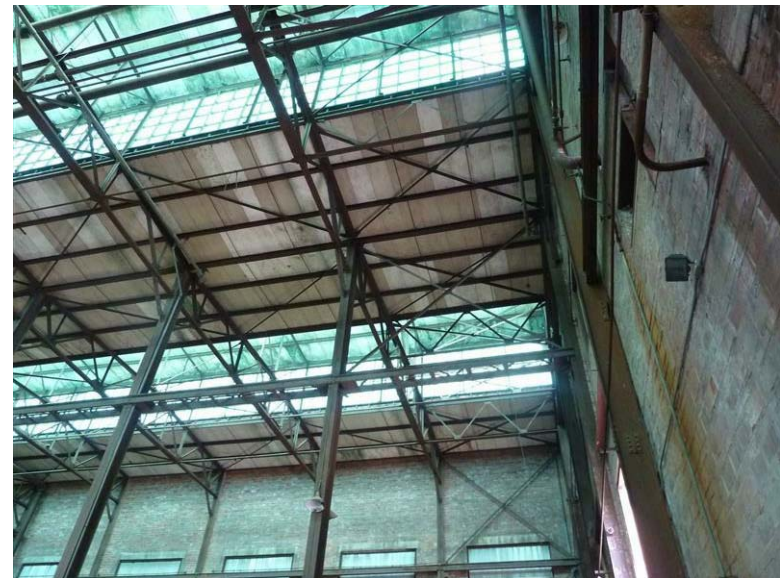
Building 26 – L / N Building Grounds Maintenance Shop: Staining on the north wall adjacent to the pipe.

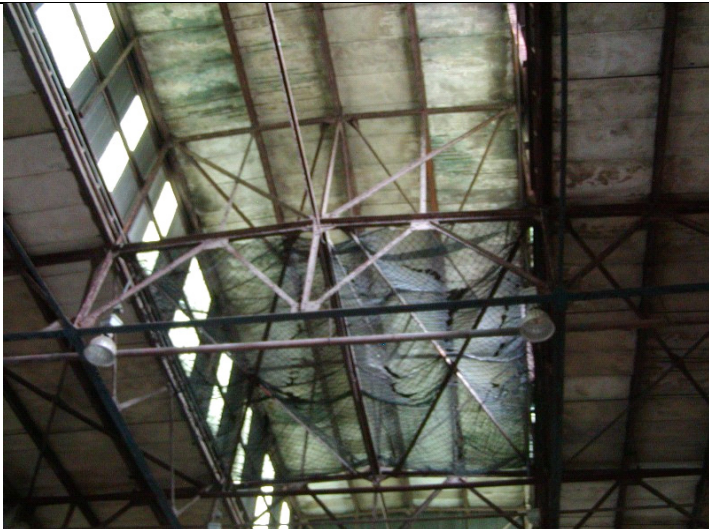
2009 Photo #4: Deteriorated concrete plank roof deck

2013 Photo #4: No change observed.

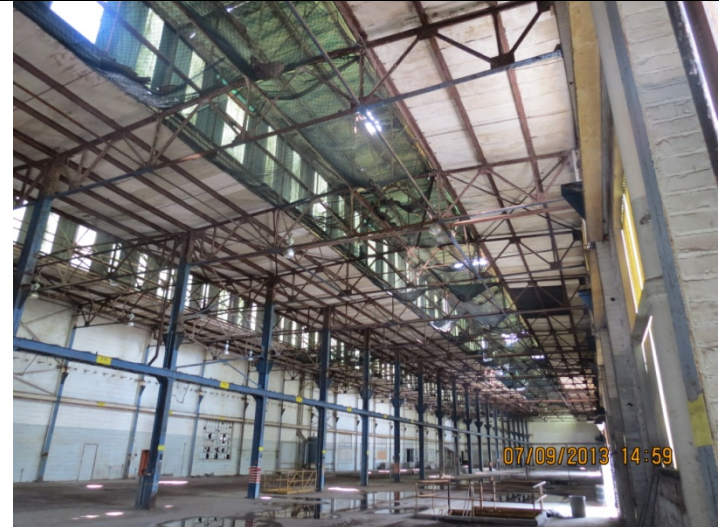
2013 Photo #3: Interior building looking South. Continued concrete roof plank deterioration evident.

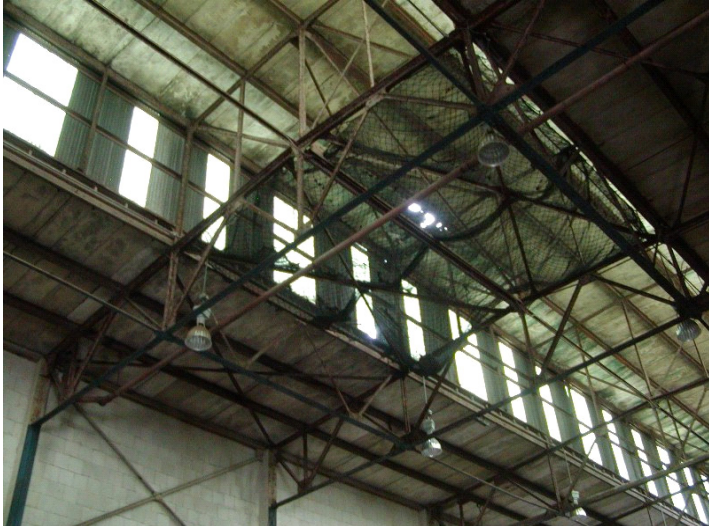
2009 Photo #5: Holes in deteriorated concrete plank roof deck

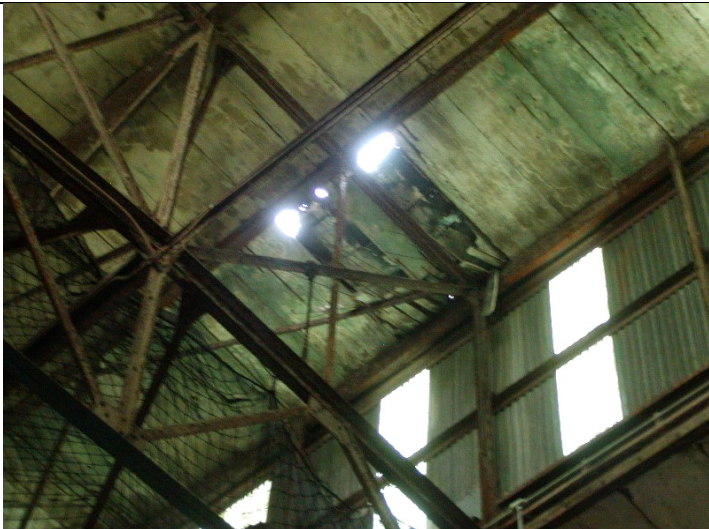
2009 Photo #6: Areas of ruined concrete plank roof deck

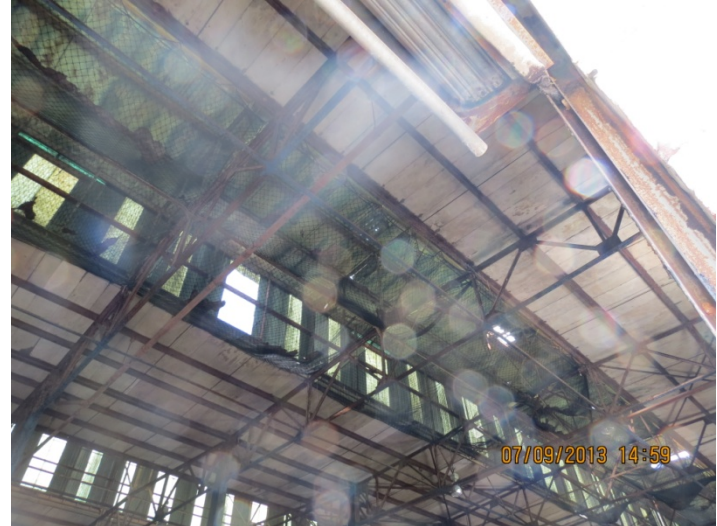
2013 Photo #5: Holes in deteriorated concrete plank roof deck. Condition has continued to decline and may be accelerating.

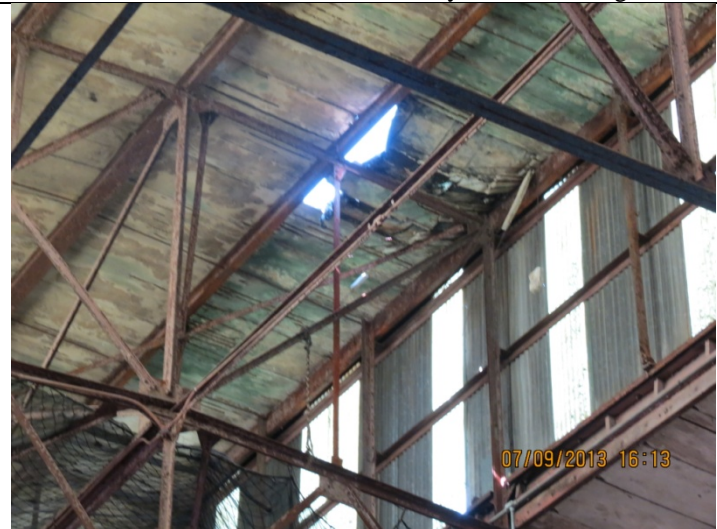
2013 Photo #6: Areas of ruined concrete plank roof deck. Continued deterioration evident.

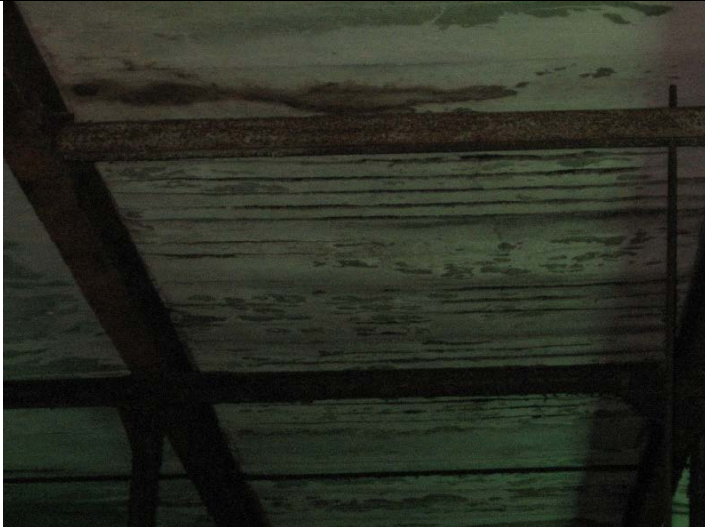
2009 Photo #7: Ruined concrete roof planks

2013 Photo #7: No change observed.

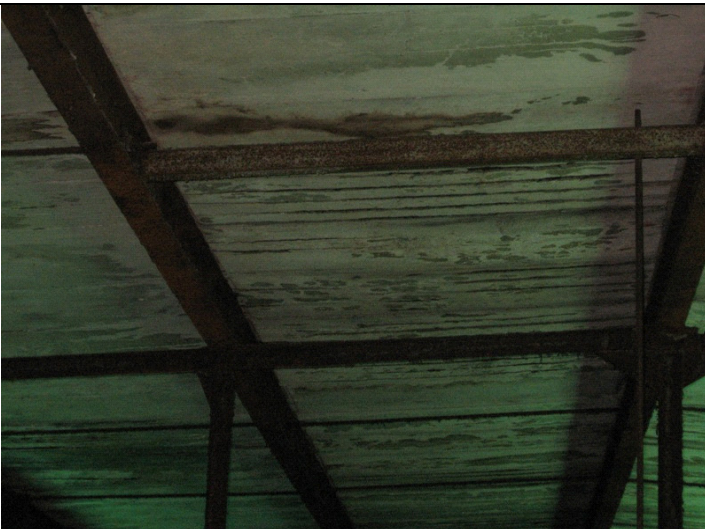
2009 Photo #8: Ruined concrete roof planks

2013 Photo #8: No change observed.

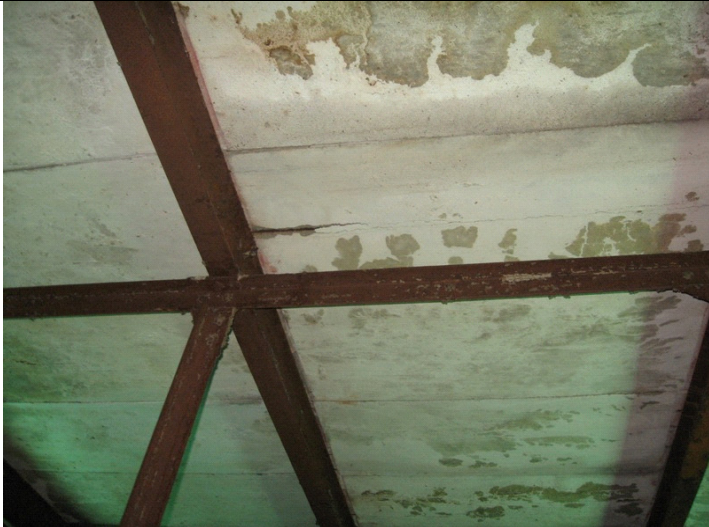
2009 Photo #9: Deteriorated concrete roof planks

2013 Photo #9: No change observed.

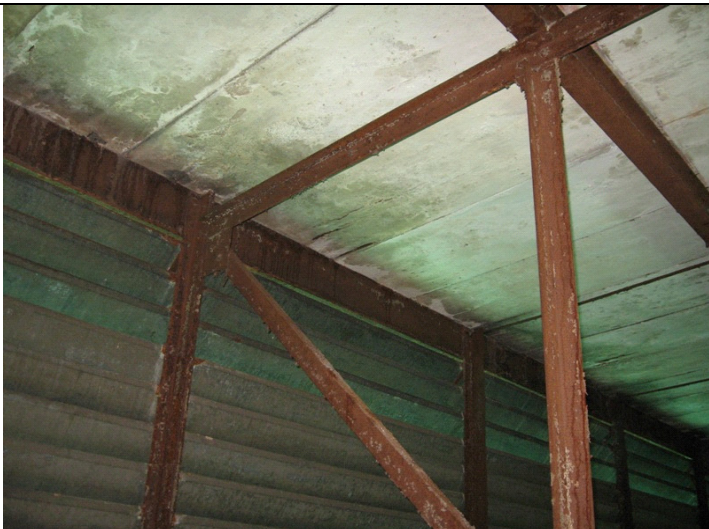
2009 Photo #10: Deteriorated concrete roof planks

2013 Photo #10: No change observed.

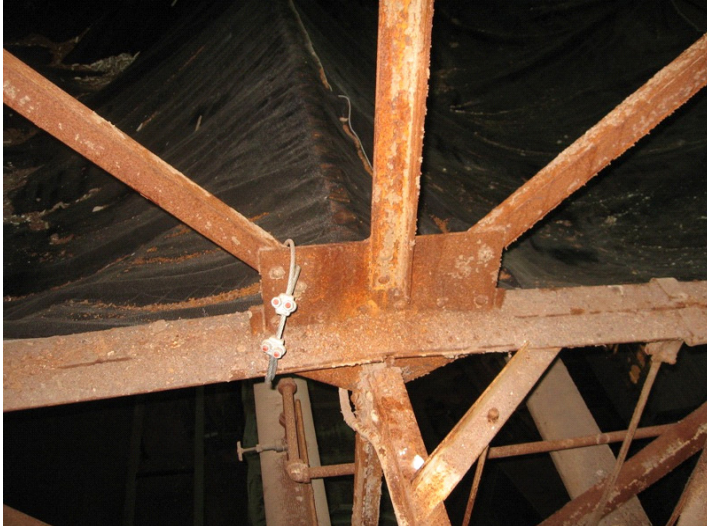
2009 Photo #11: Severely corroded structural steel

2013 Photo #11: No change observed.

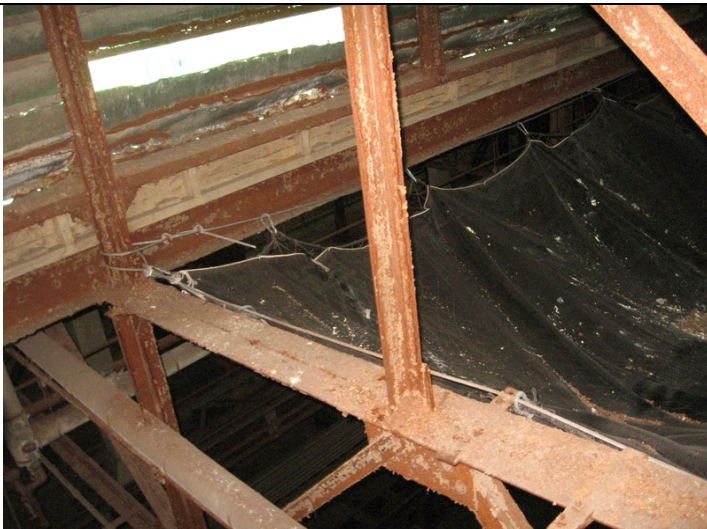
2009 Photo #12: Severely corroded structural steel

2013 Photo #12: No change observed.

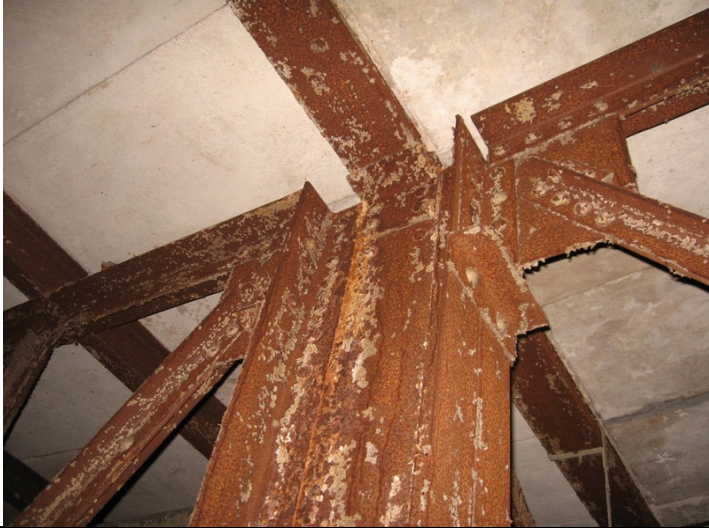
2009 Photo #13: Severely corroded structural steel

2013 Photo #13: No change observed.

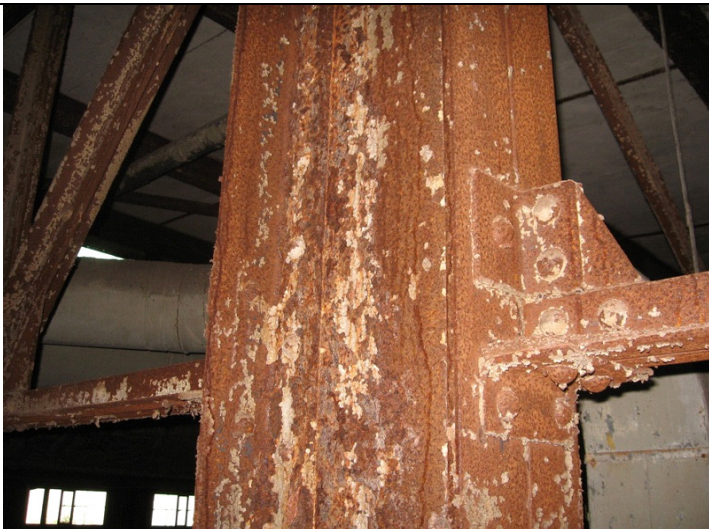
2009 Photo #14: Severely corroded structural steel

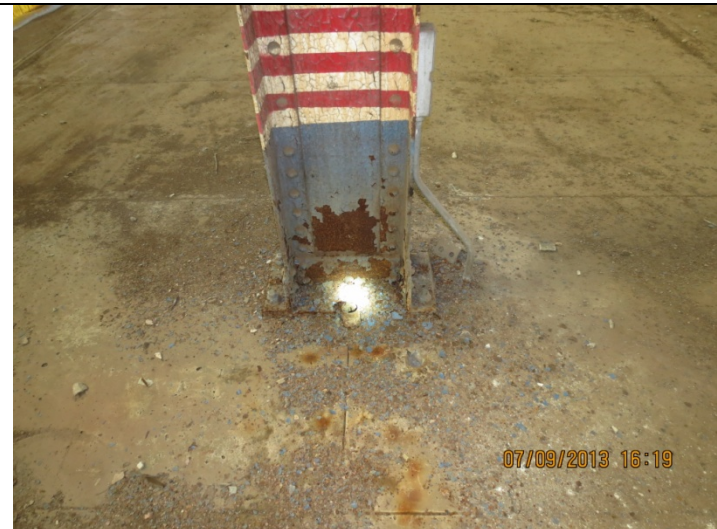
2013 Photo #14: Corroded steel column. Paint flakes have fallen from above as corrosion has worsened. Different location than 2009.

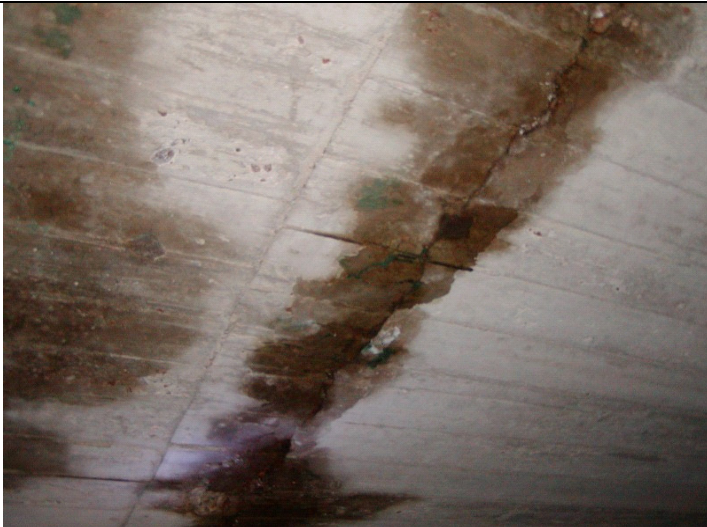
2009 Photo #16: Defective concrete at basement ceiling

2013 Photo #16: No change observed.

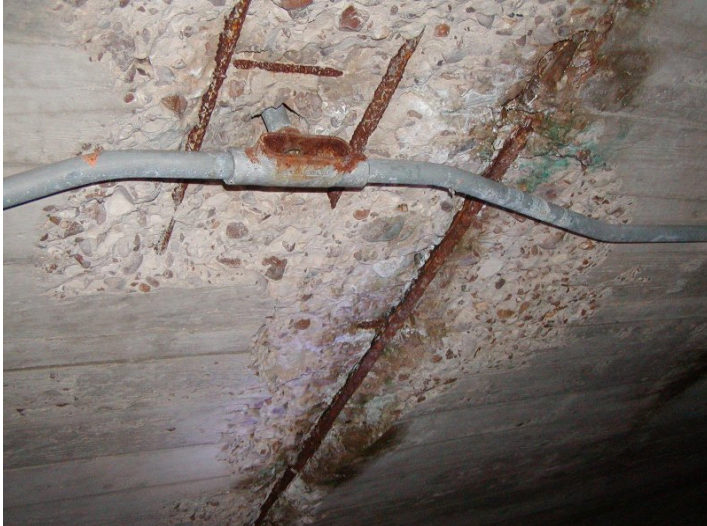
2009 Photo #17: Severely spalled concrete at basement ceiling

2013 Photo #17: No change observed.

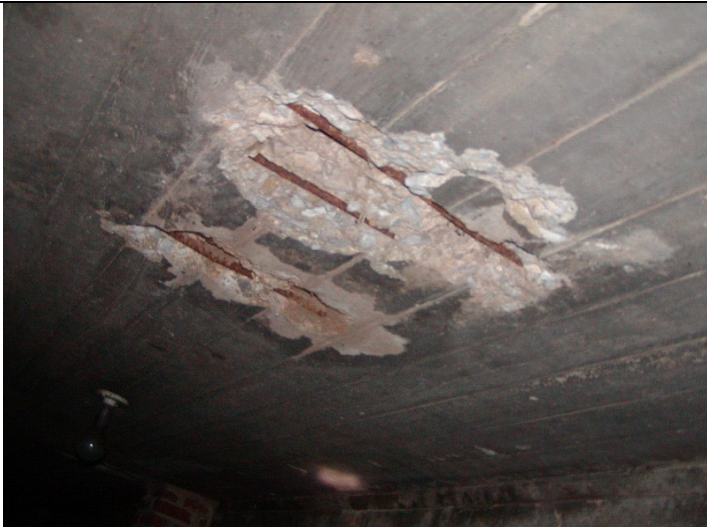
2009 Photo #18: Severely spalled concrete at basement ceiling

2013 Photo #18: No change observed.

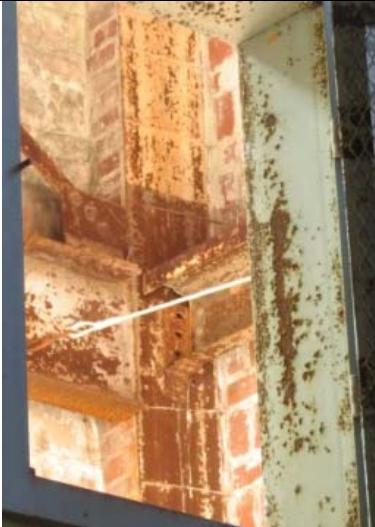
2013 Photo #19: Severely corroded steel and failed connection at Northwest corner of building.

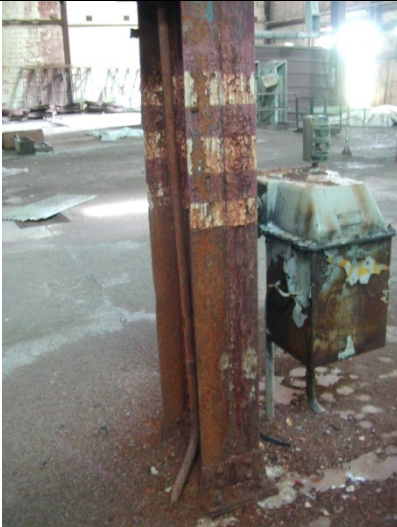
2009 Photo #5: Severely corroded steel column

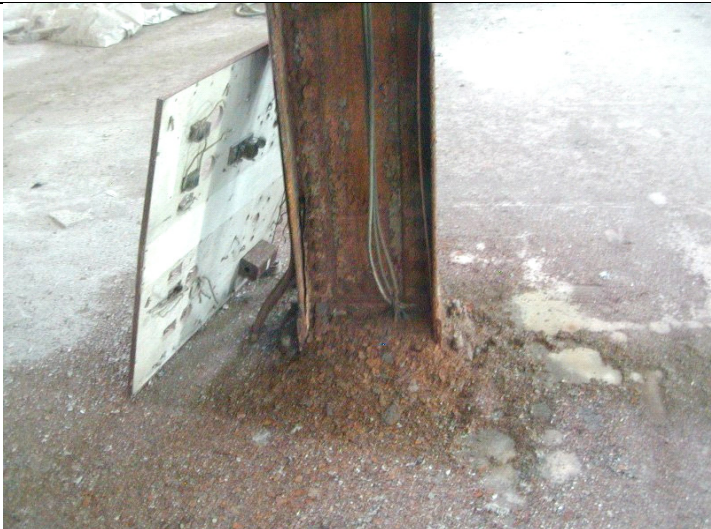
2009 Photo #6: Severely corroded steel column

2013 Photo #6: No change observed.

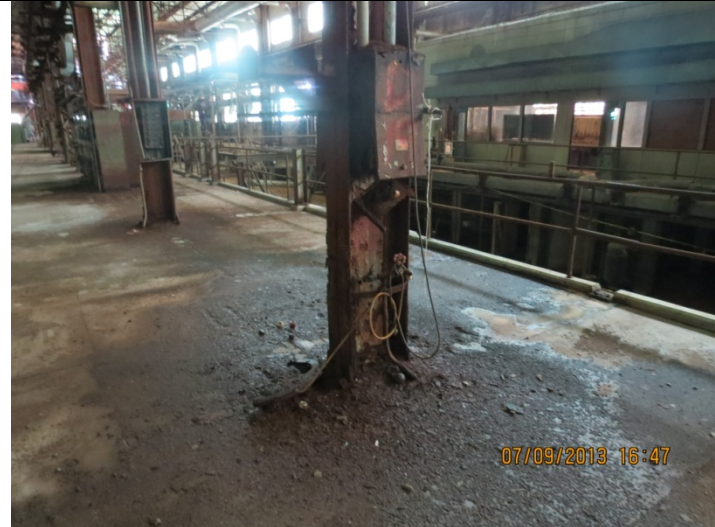
2013 Photo #5: Severely corroded steel column. Above is disconnected roof drain that empties water into the building.

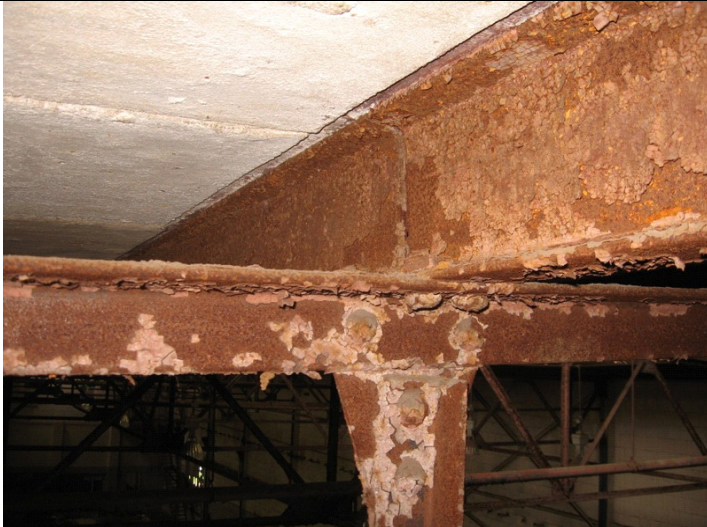
2009 Photo #7: Severely corroded steel framing

2013 Photo #7: No change observed.

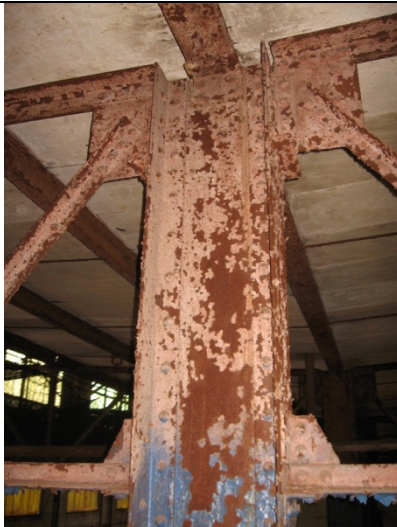
2009 Photo #8: Severely corroded steel framing

2013 Photo #8: No change observed.

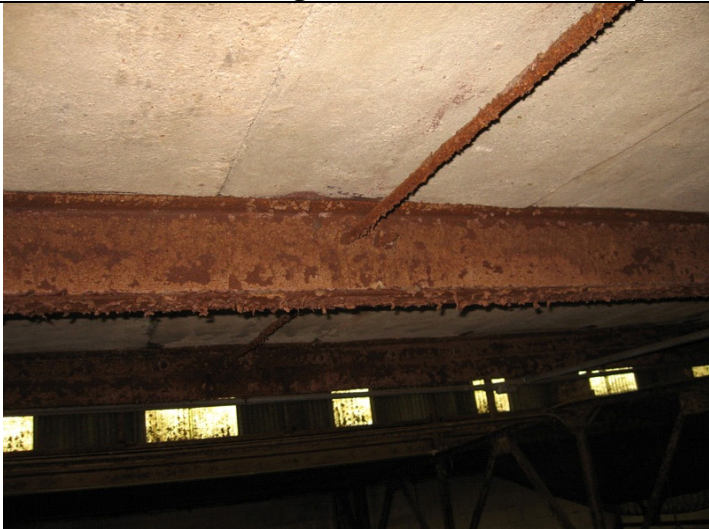
2009 Photo #9: Severely corroded steel framing

2013 Photo #9: No change observed.

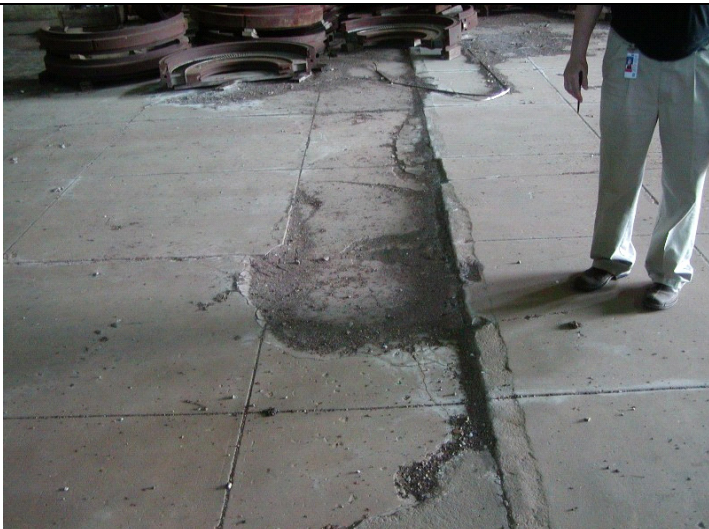
2009 Photo #10: Defective area of elevated slab above basement

2013 Photo #10: No change observed.

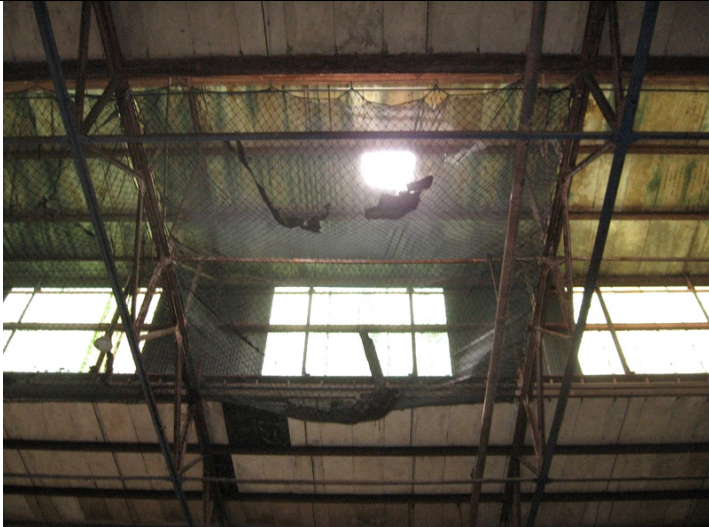
2009 Photo #11: Large holes in deteriorated concrete plank roof deck

2013 Photo #11: No change observed

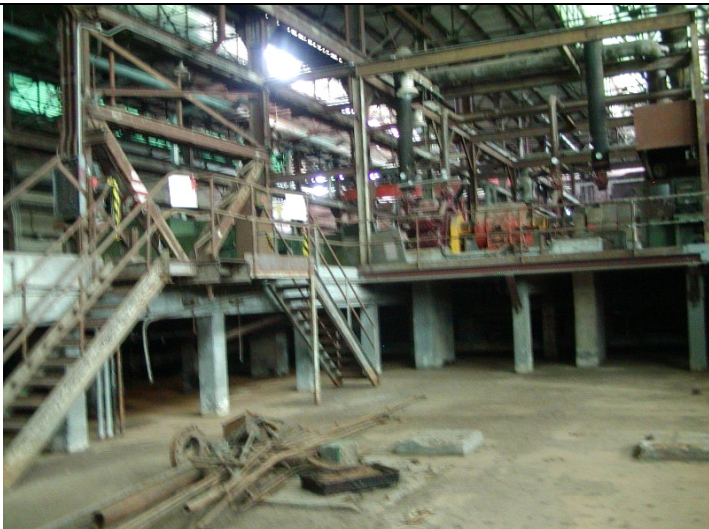
2009 Photo #16: View of open area at basement level

2013 Photo #16: No change observed.

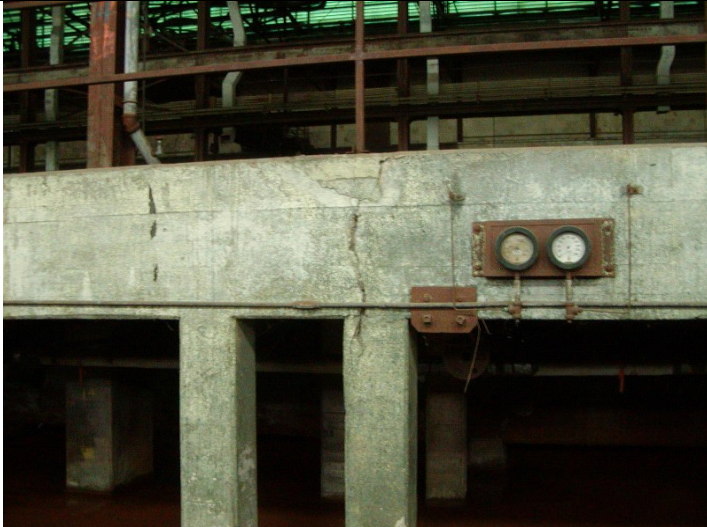
2009 Photo #17: Cracks at edge of elevated slab above basement

2013 Photo #17: No change observed.

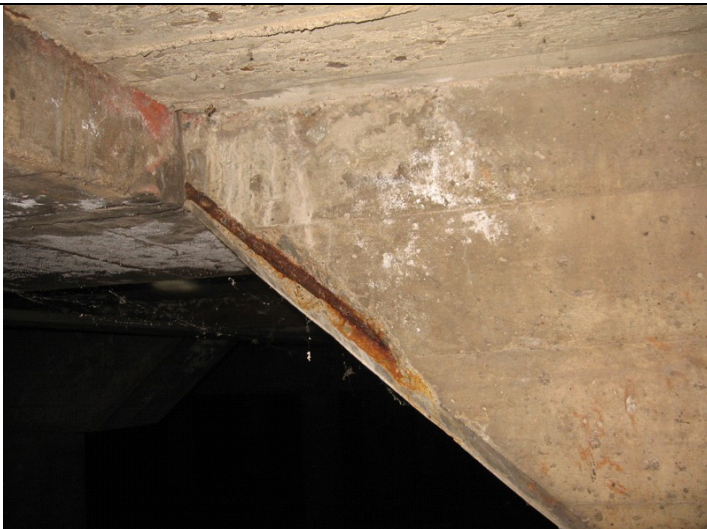
2009 Photo #18: Spalled concrete at basement structure

2013 Photo #18: No change observed.

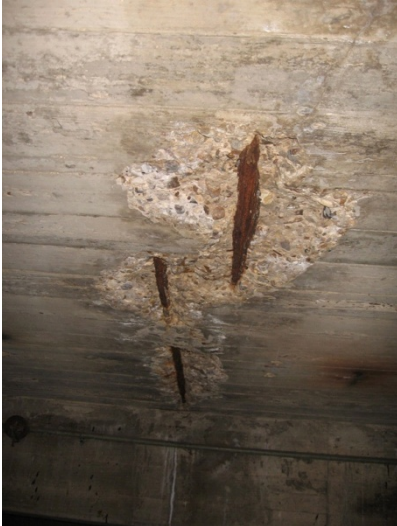
2009 Photo #19: Spalled concrete at basement structure

2013 Photo #19: No change observed.

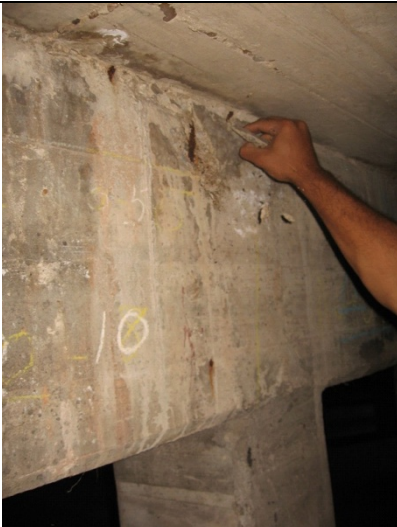
2009 Photo #20: Spalled concrete at basement structure

2013 Photo #20: No change observed.

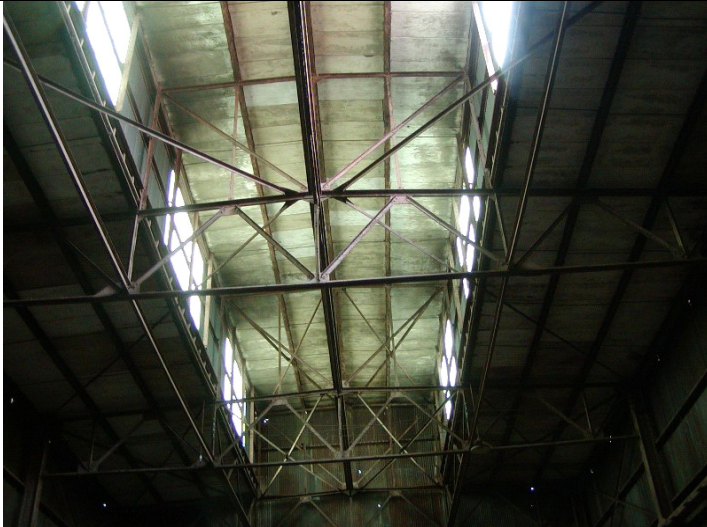
2009 Photo #5: Deteriorated concrete plank roof deck

2013 Photo #5: No change observed.

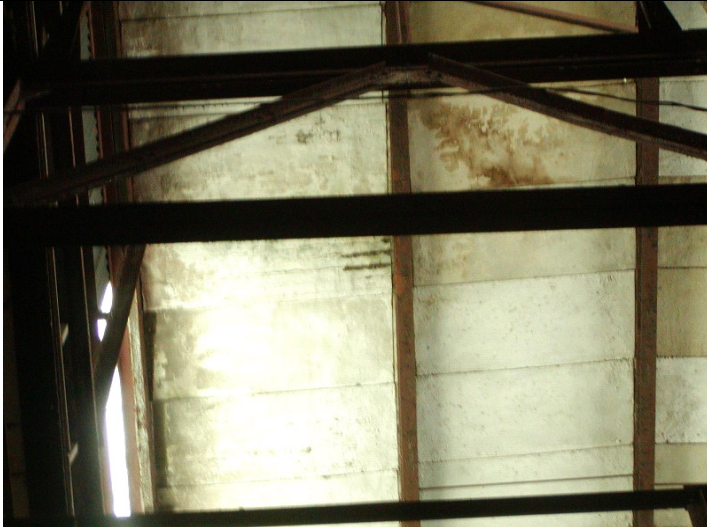
2009 Photo #7: Structurally deficient concrete roof plank

2013 Photo #7: No change observed.
