Tennessee Valley Authority

Cyclic Assessment Report
TVA Muscle Shoals, Alabama
September 16, 2013

Executive Summary

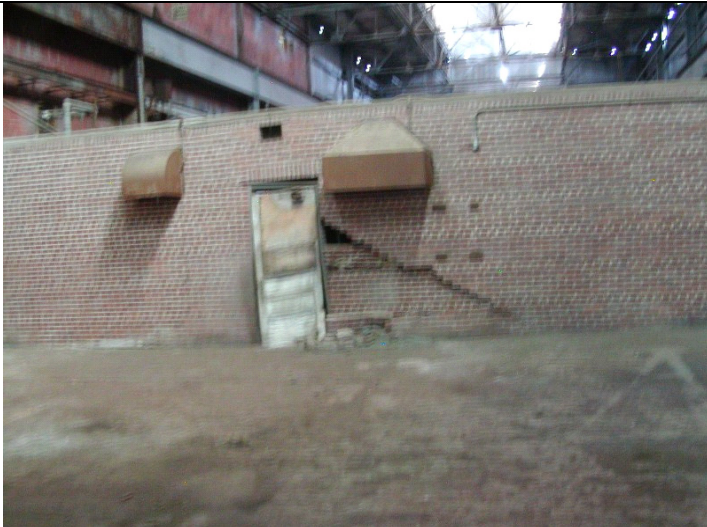
2009 Photo #8: Partially collapsed interior masonry partition

2013 Photo #8: No change observed.

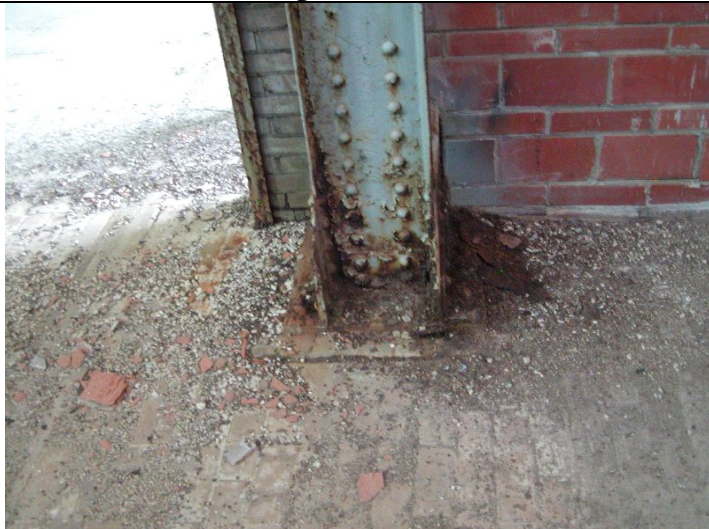
2009 Photo #9: Severe corrosion at column base plate attachment

2013 Photo #9: No change observed.

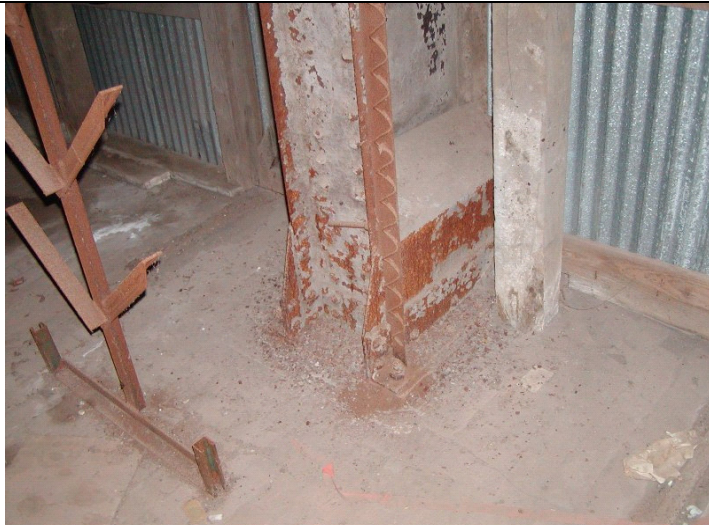
2009 Photo #10: Severely corroded steel column

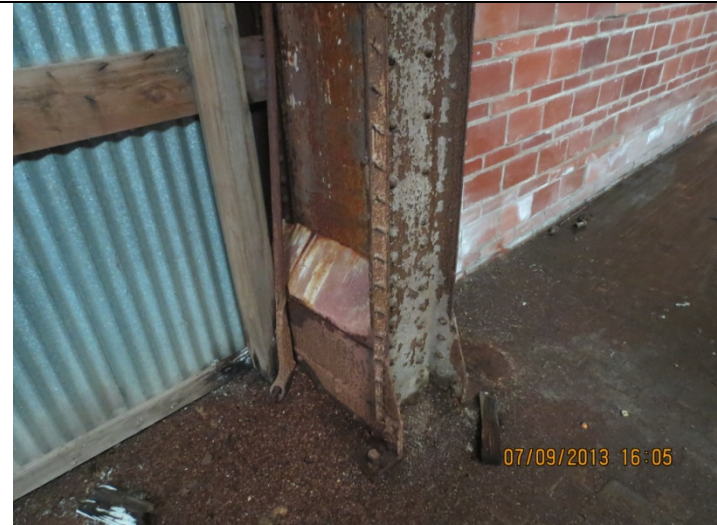
2013 Photo #10: Severely corroded steel column. Continued corrosion evident.

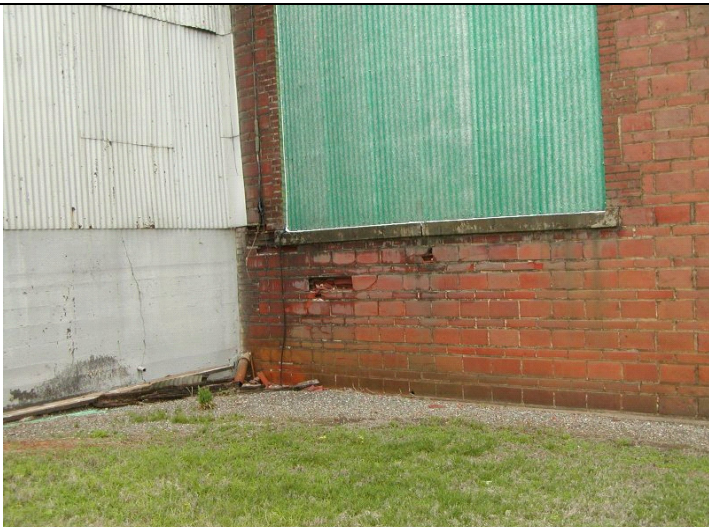
2009 Photo #4: Spalled masonry on West side at intersection with Building 24

2013 Photo #4: No change observed

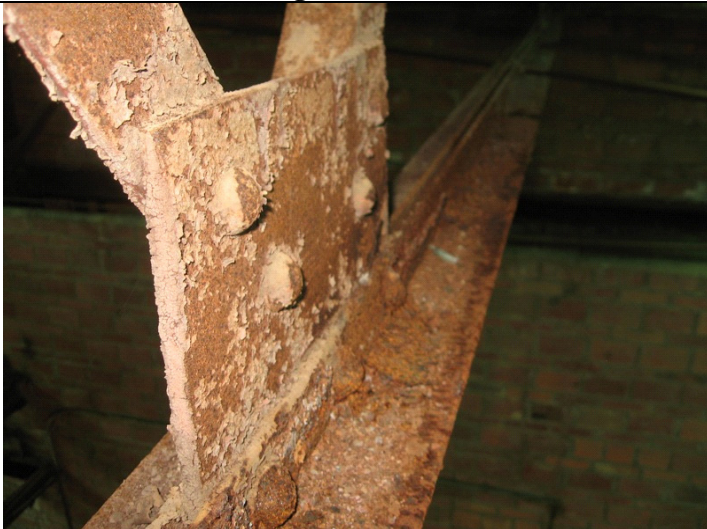
2009 Photo #5: Severely corroded steel framing

2013 Photo #5: No change observed.

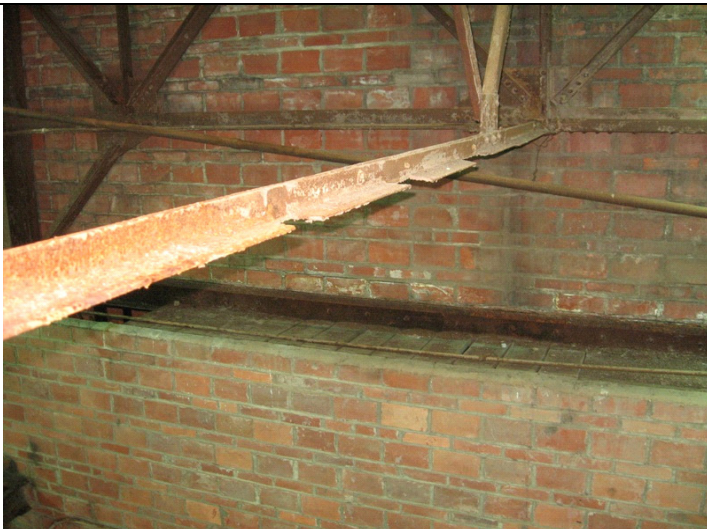
2009 Photo #6: Severely deteriorated steel framing

2013 Photo #6: No change observed.

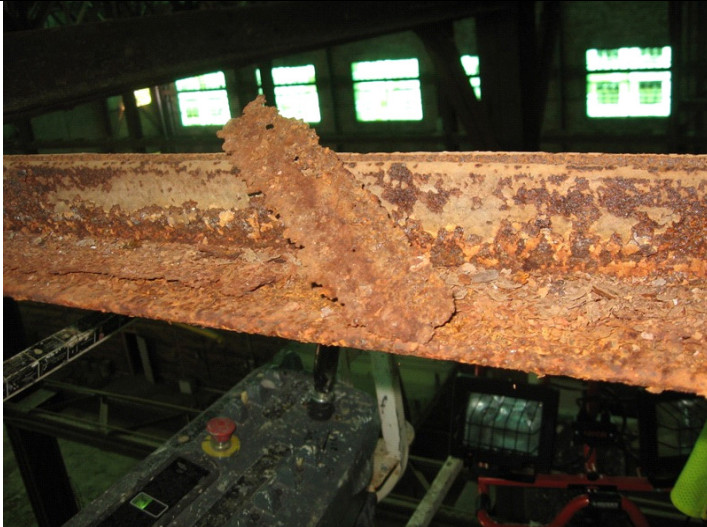
2009 Photo #7: Severely corroded steel framing

2013 Photo #7: No change observed.

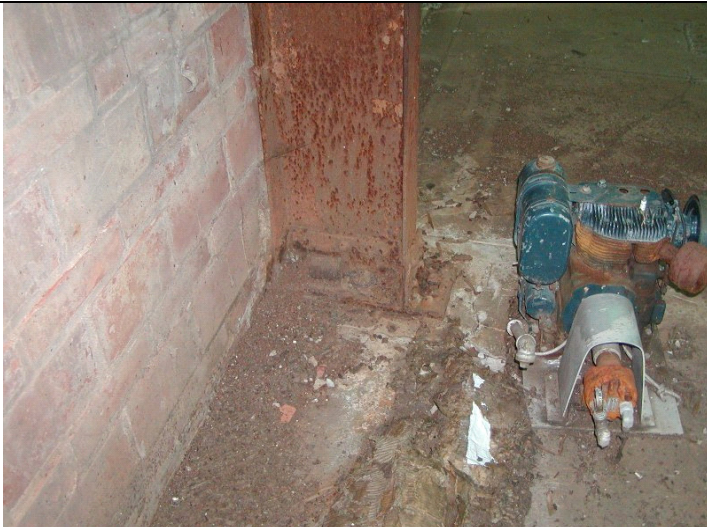
2009 Photo #8: Severely corroded steel framing

2013 Photo #8: No change observed.

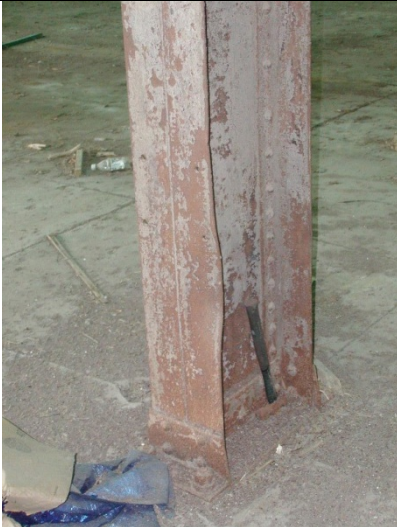
2009 Photo #9: Moderately corroded steel column with impact damage

2013 Photo #9: No change observed.

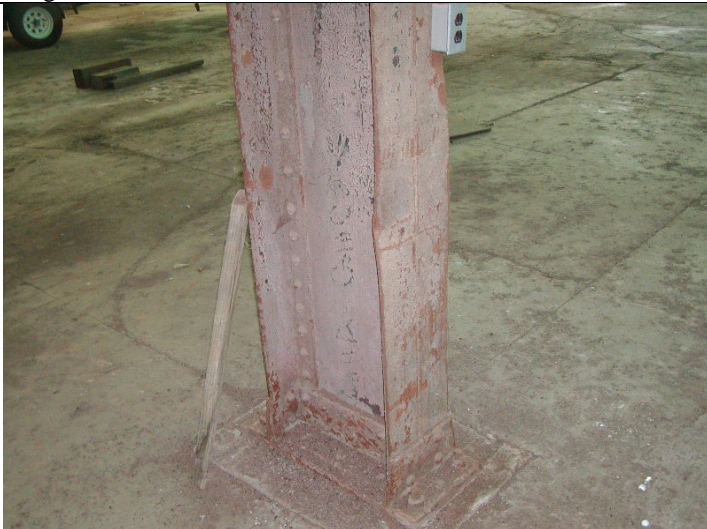
2009 Photo #10: Moderately corroded steel column with impact damage

2013 Photo #10: No change observed.

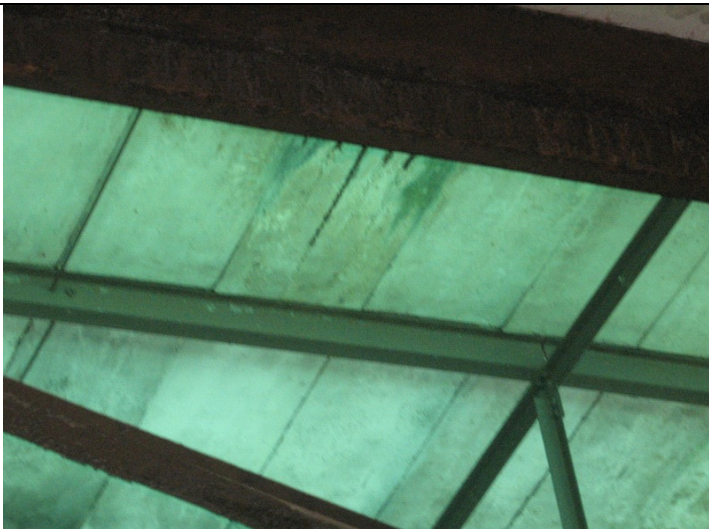
2009 Photo #12: Structurally deficient concrete roof planks

2013 Photo #12: No change observed.

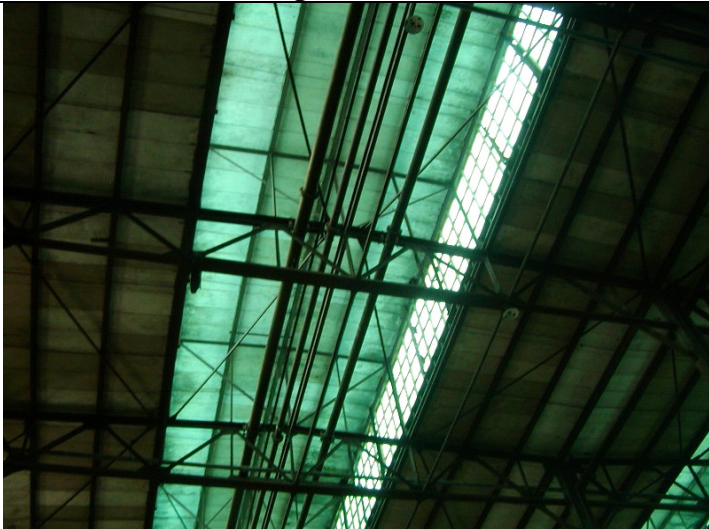
2009 Photo #15: Deteriorated concrete roof planks

2013 Photo #15: No change observed.

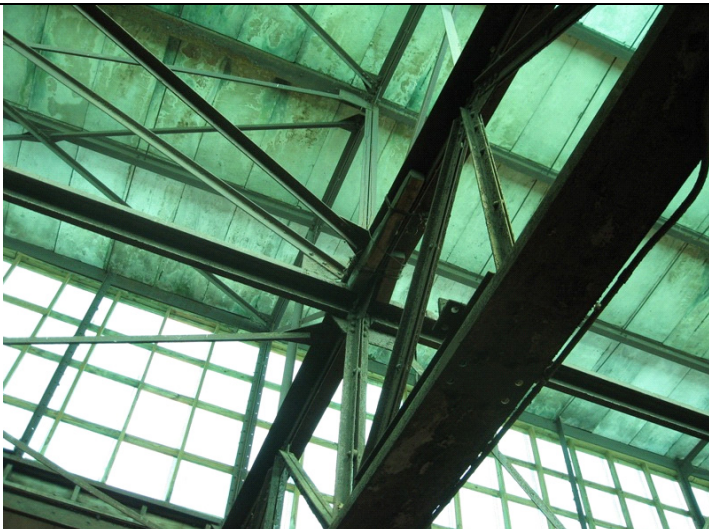
2009 Photo #16: Deteriorated concrete roof planks

2013 Photo #16: No change observed.

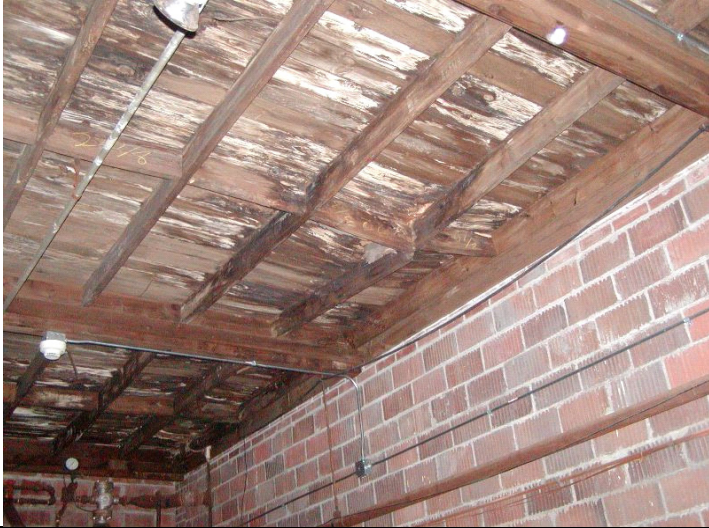
2009 Photo #19: Ruined roof deck of interior enclosure

2013 Photo #19: No change observed.

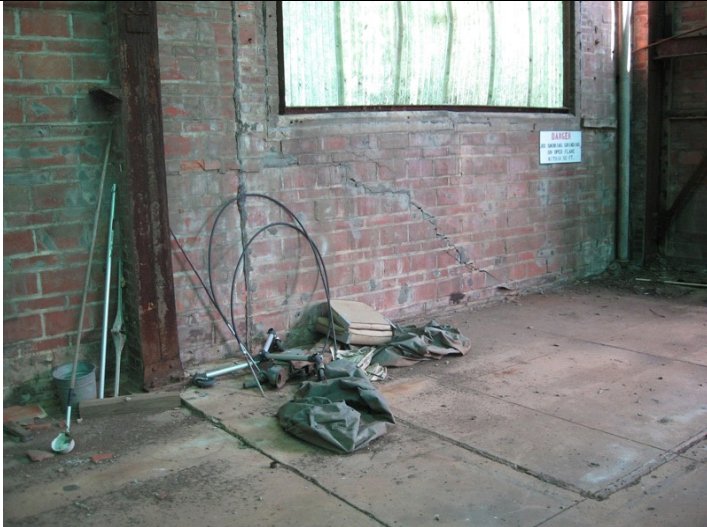
2009 Photo #21: Cracked masonry at outside wall

2013 Photo #21: No change observed.

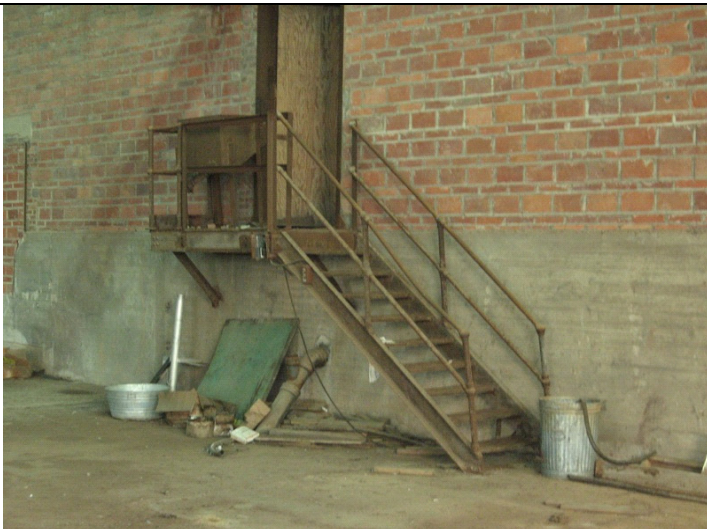
2009 Photo #22: Deteriorated steel stair going up to Building 24

2013 Photo #22: No change observed.

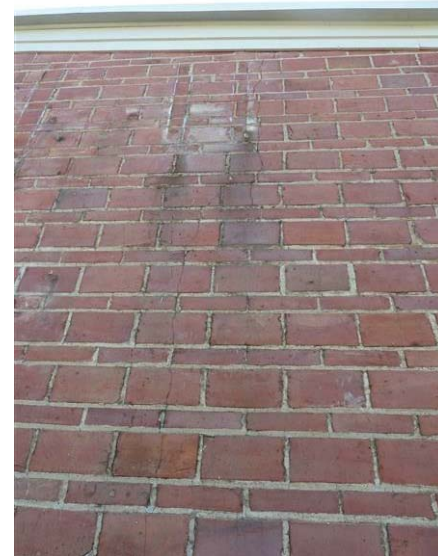
Building 25 – L / N Warehouse Z: Localized staining and efflorescence are visible on the wall.

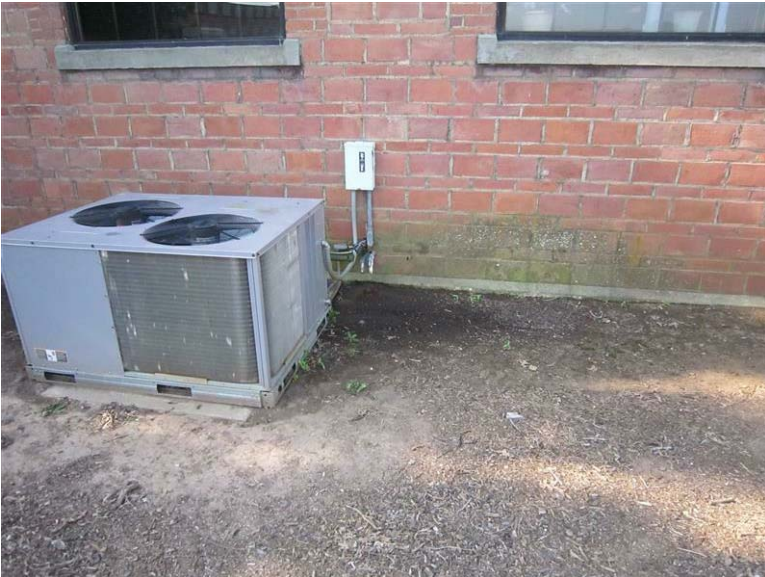
Building 25 – L / N Warehouse Z: There is evidence of water ponding by the HVAC units on the north wall.

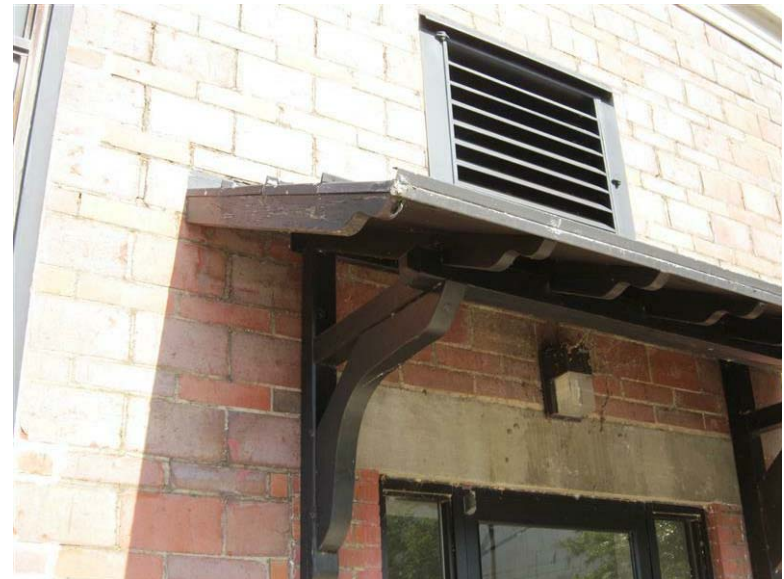
Building 25 – L / N Warehouse Z: The east canopy needs painting.

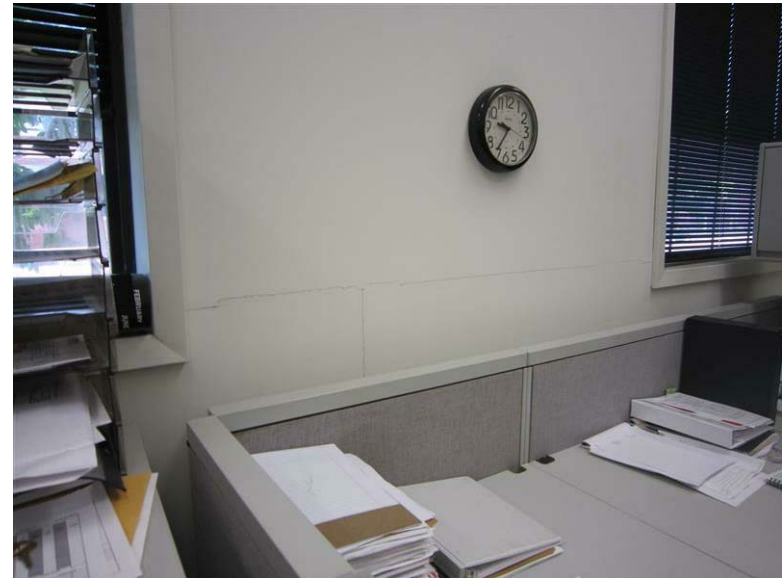
New Comments	
<ul style="list-style-type: none"> Crack in drywall at west end of south room - exterior walls south and west Minor staining of ceiling tile Slight soiling of carpet

Building 25 – L / N Warehouse Z: Horizontal cracking is visible in the gypsum wallboard at the west end of the south room.

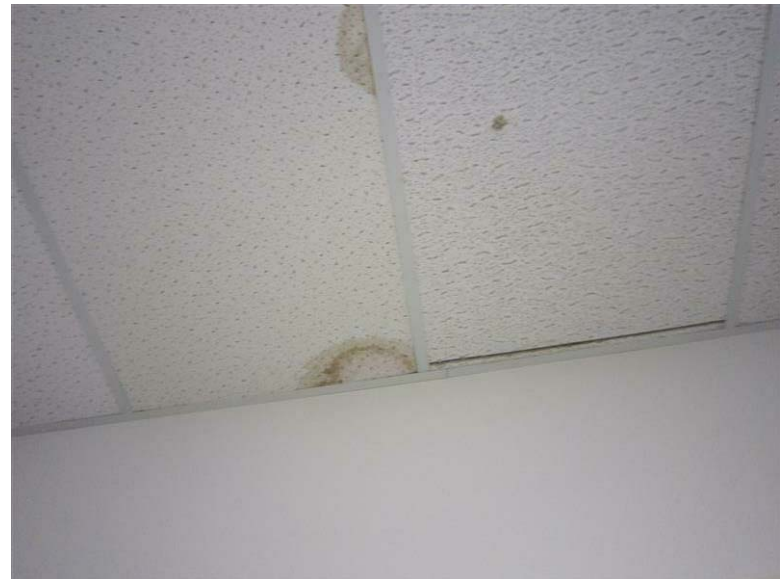
Building 25 – L / N Warehouse Z: Evidence of water infiltration is visible on the acoustical ceiling tiles.

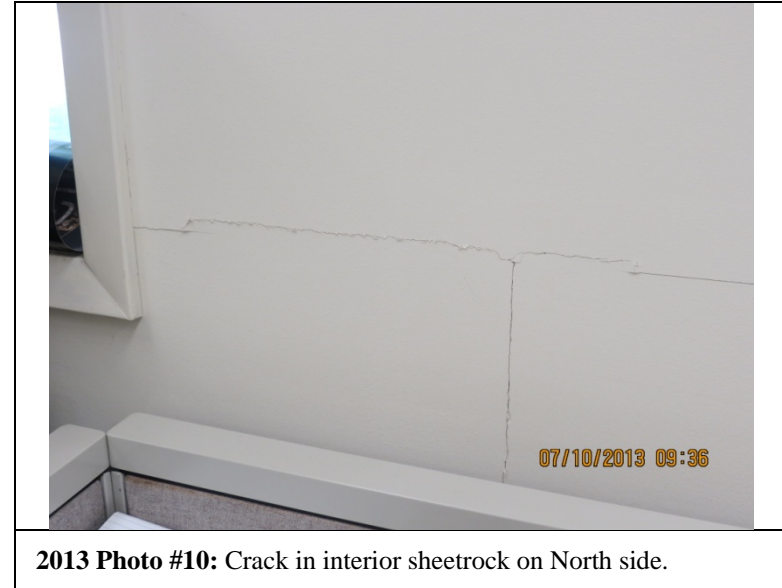
PHOTOLOG: Building No. 25 Project Operations Office Building (New Items Observed in 2013)

Summary of Observations Regarding Present General Building Structural Condition (2013):	2009 observations still apply. Cracks in sheetrock have formed at the exterior walls on the North and South sides toward the West end of the building. These cracks appear to be directly across from one another with the cracking on the South side perpetuating to the ceiling.
Summary of Recommended Structural Repairs (2009):	Minor defects at the exterior walls and awnings need to be repaired.
Additional Recommendations (2009):	Not applicable

Defect Item No.	Defect Description (2009)	2013 Assessment of 2009 Itemized Defects (plus description of new defects where noted)	Photo Log Reference Nos.	
			From 2009 Report	2013
1	Cracks in masonry at west wall	Change in condition was not observed	5,6	
2	Crack in foundation wall at southwest corner	Change in condition was not observed		
3 (new)	N/A	New Defect: Crack in sheetrock at North and South interior walls toward West end of building		9,10

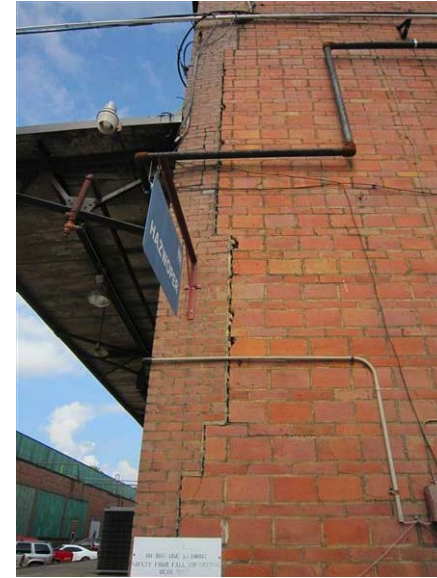
Building 33, 34, 35, 36 – Chemical Plant Warehouse: Severe cracking at the brick quoins at the corners of the building.

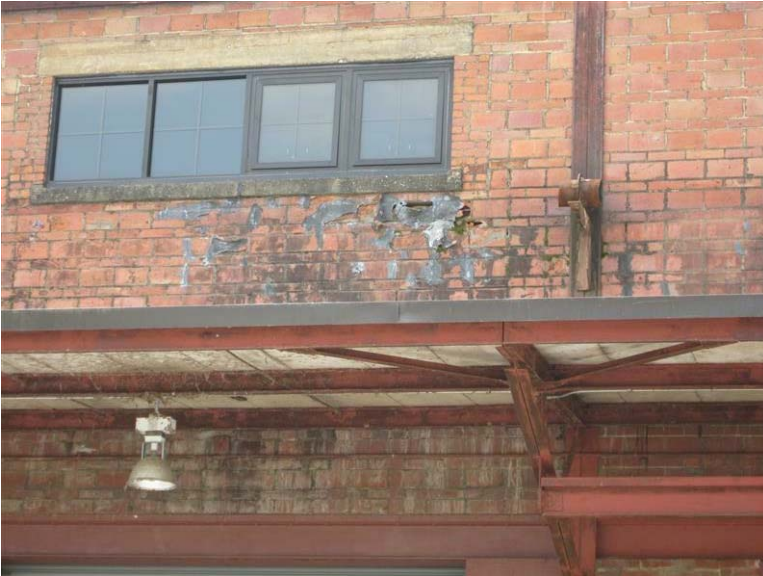
Building 33, 34, 35, 36 – Chemical Plant Warehouse: Most historic windows have recently been replaced with aluminum units

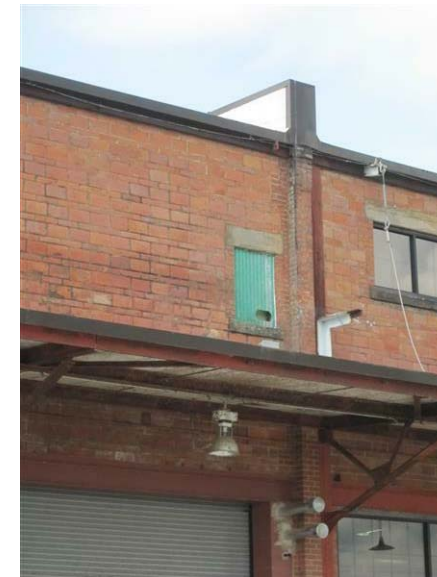
Building 33, 34, 35, 36 – Chemical Plant Warehouse: Tops of the brick buttresses are failing.

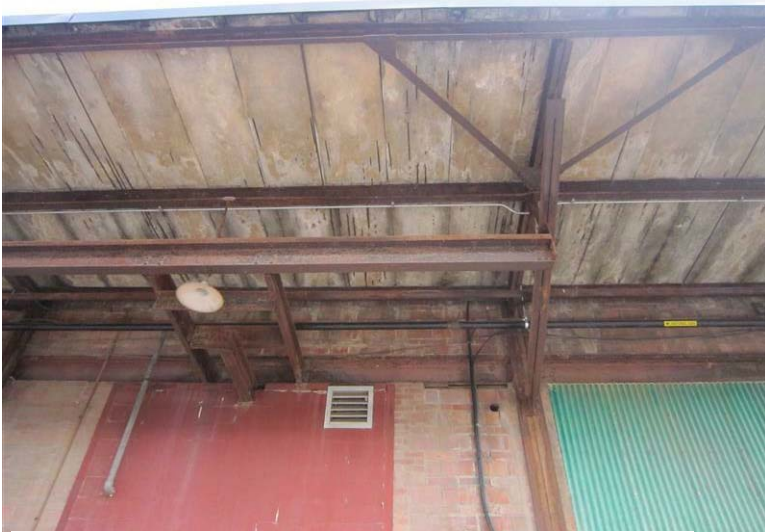
Building 33, 34, 35, 36 – Chemical Plant Warehouse: Concrete panels are spalling exposing the rebar at the north canopy.

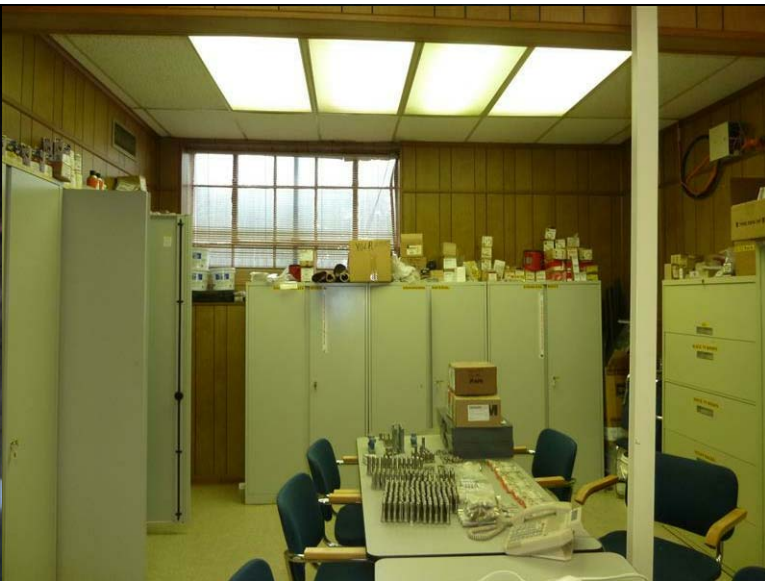
Building 33 – Chemical Plant Warehouse - Shipping and Receiving Office: One of the historic steel windows remains in this office space, but the walls have been clad in paneling.

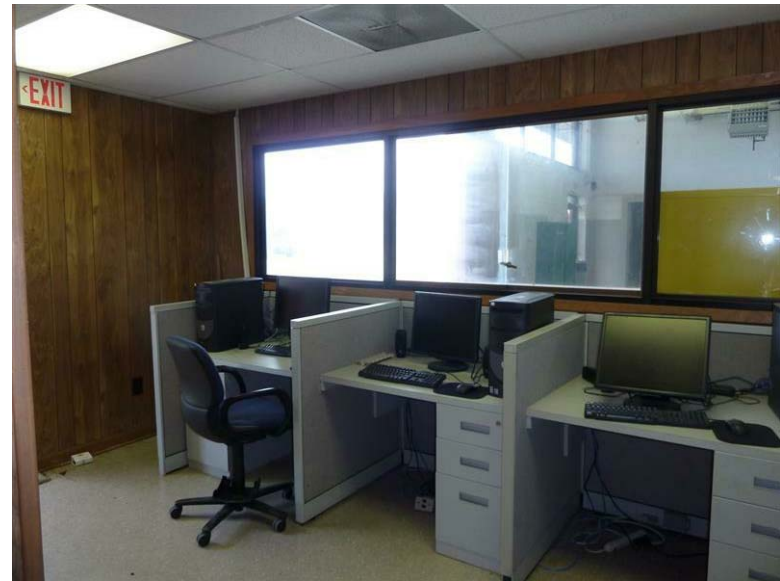
Building 33 – Chemical Plant Warehouse - Shipping and Receiving Office: The historic steel windows in this office have been replaced with aluminum windows.

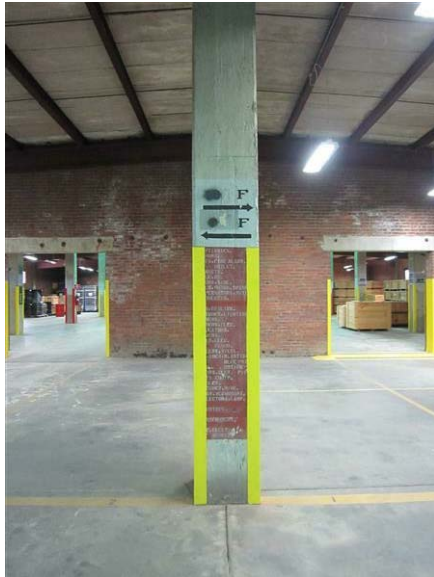
Building 33 – Chemical Plant Warehouse - Shipping and Receiving Office: Some interior modifications have been made to the shipping and receiving space.

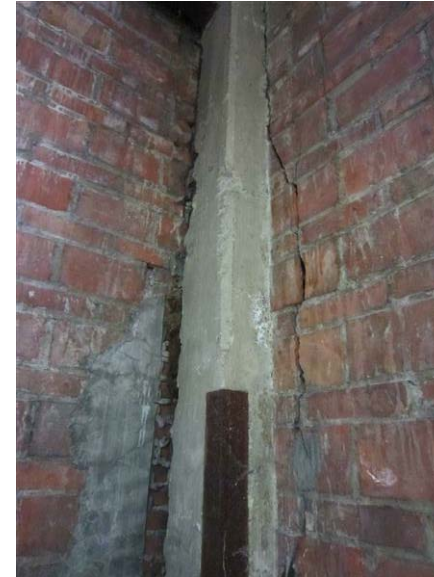
Building 33 – Chemical Plant Warehouse - Shipping and Receiving Office: Severe cracking is visible along exterior corners.

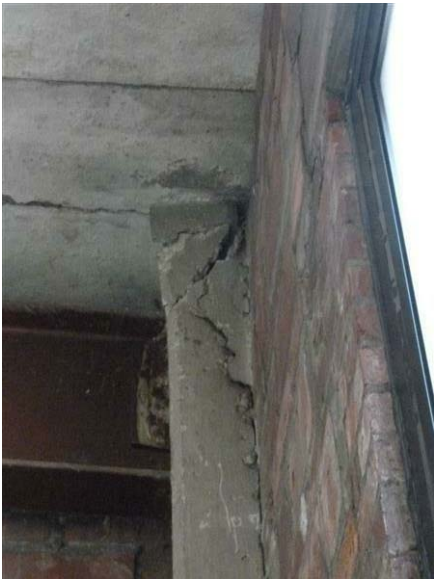
Building 33 – Chemical Plant Warehouse - Shipping and Receiving Office: The concrete columns are severely damaged.

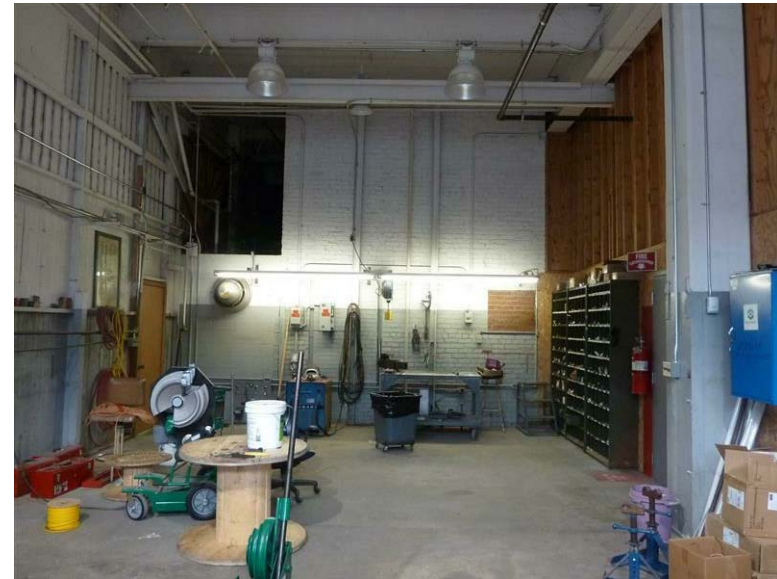
Building 34 – Chemical Plant Warehouse - Instrumentation / Electric Shop: Overall view of the interior

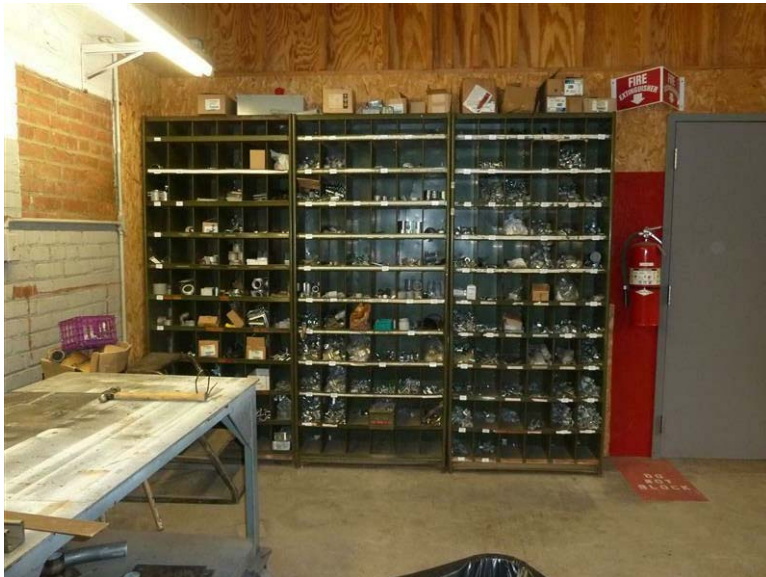
Building 34 – Chemical Plant Warehouse - Instrumentation / Electric Shop: An unfinished wood stud and plywood partition wall was built to enclose the space.

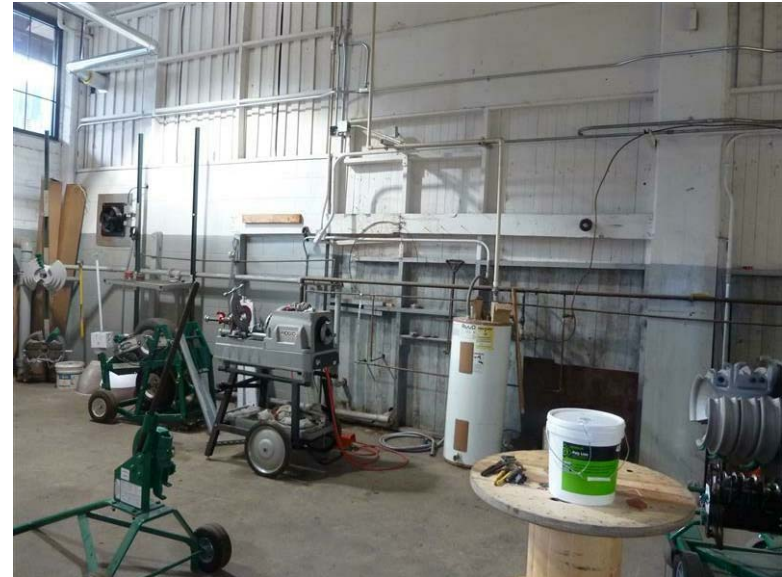
Building 34 – Chemical Plant Warehouse - Instrumentation / Electric Shop: A painted wood stud wall clad in vertical wood boards encloses this space.

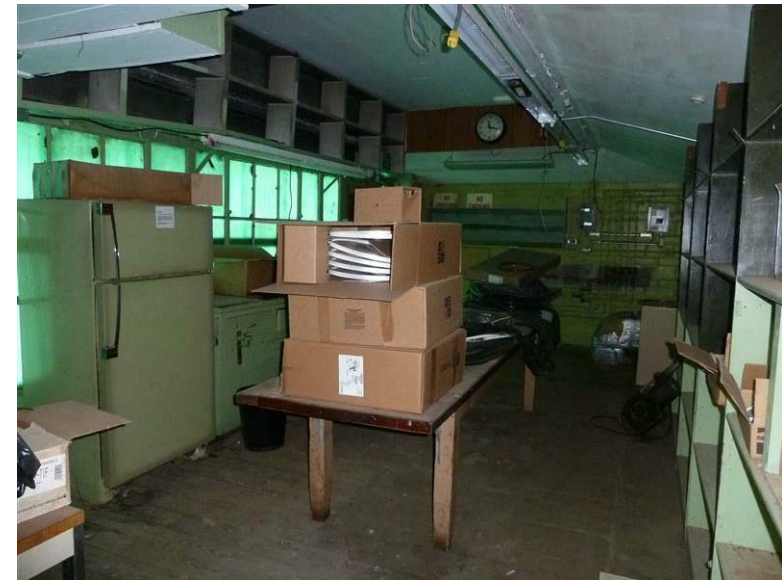
Building 34 – Chemical Plant Warehouse - Instrumentation / Electric Shop: The second floor space has a wood floor and partially sloped ceiling.

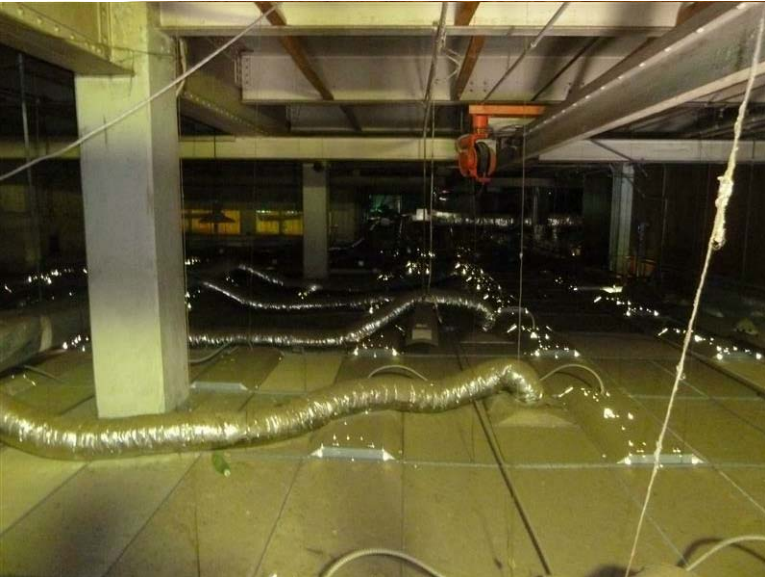
Building 34 – Chemical Plant Warehouse - Instrumentation / Electric Shop: Acoustical ceiling tiles have installed, lowering the ceiling height.

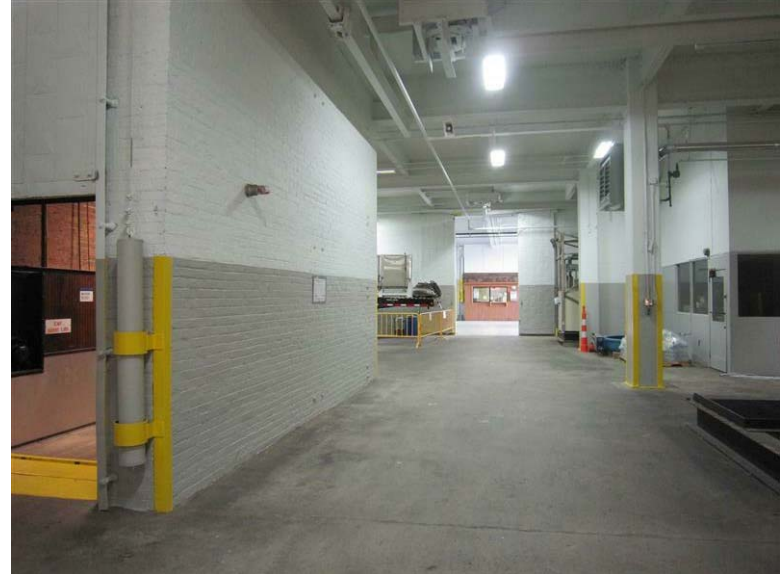
Building 35 – Chemical Plant Warehouse: Recent modifications have been made in this space.

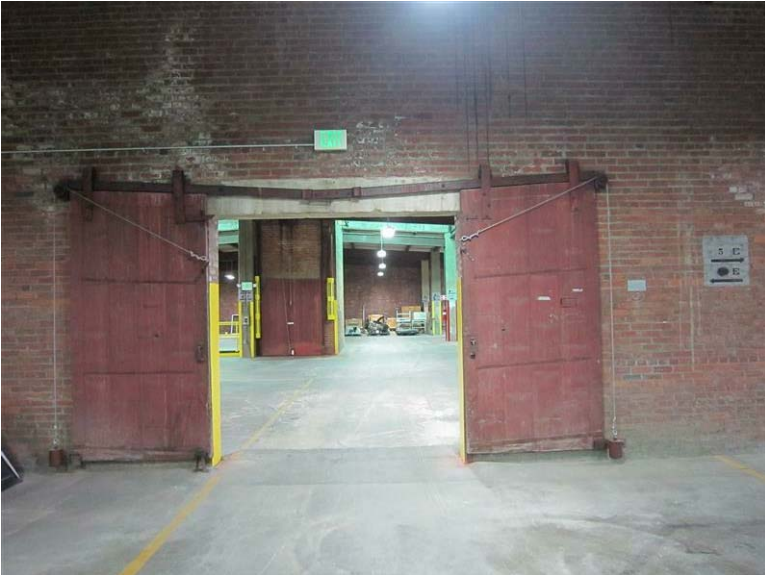
Building 36 – Chemical Plant Warehouse: The historic sliding doors remain intact.

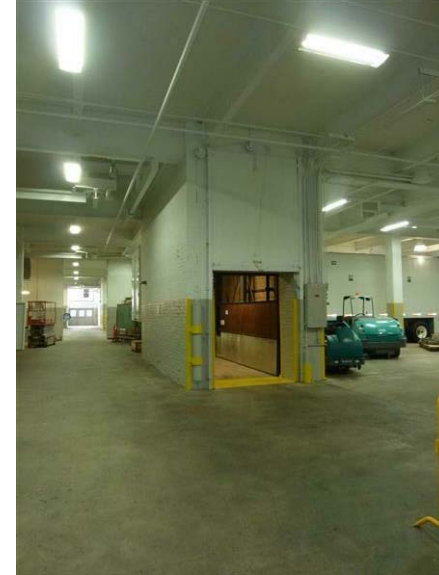
Building 35 – Chemical Plant Warehouse: Recent modifications have been made to this space.

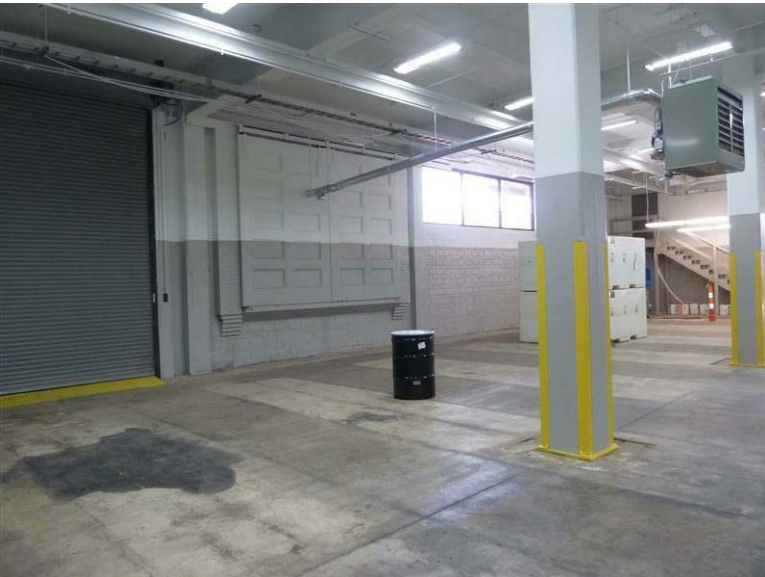
Building 35 – Chemical Plant Warehouse: Recent modifications have been made to this space. A pipe penetrates the historic door.

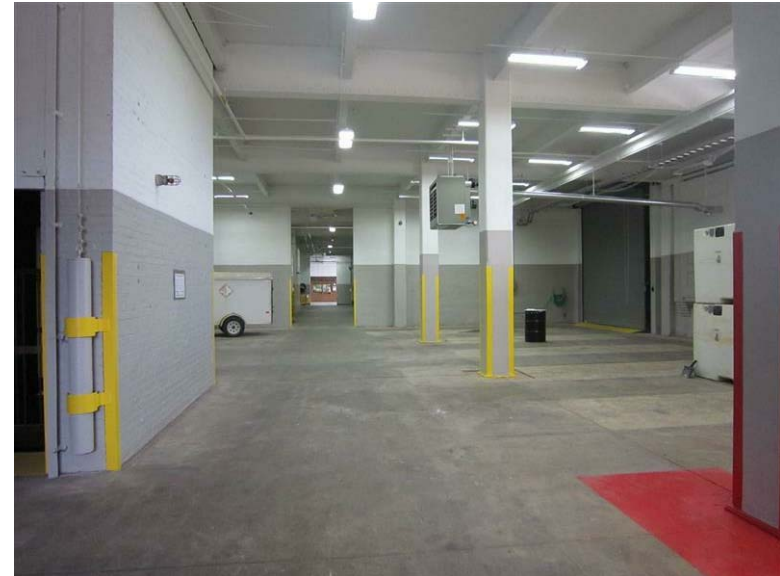
Building 36 – Chemical Plant Warehouse - Projects Operations Storage Warehouse: Recent modifications have been made to this space.

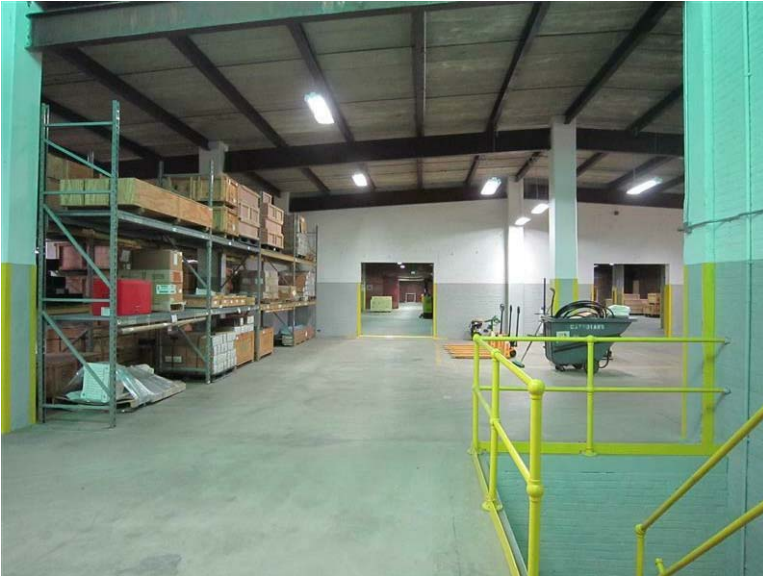
Building 36 – Chemical Plant Warehouse - Projects Operations Storage Warehouse: Recent modifications have been made to this space.

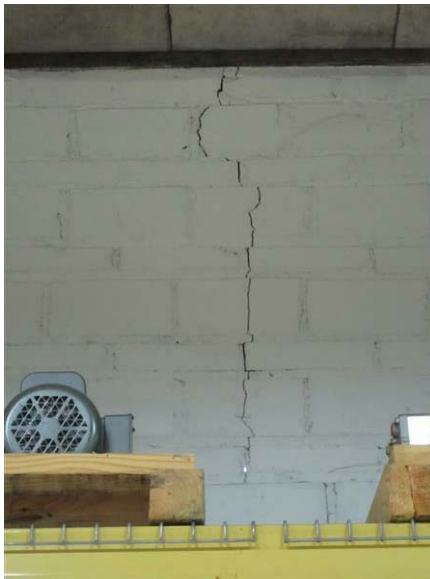
Building 36 – Chemical Plant Warehouse - Projects Operations Storage Warehouse: A large horizontal crack penetrates the hollow clay tile.

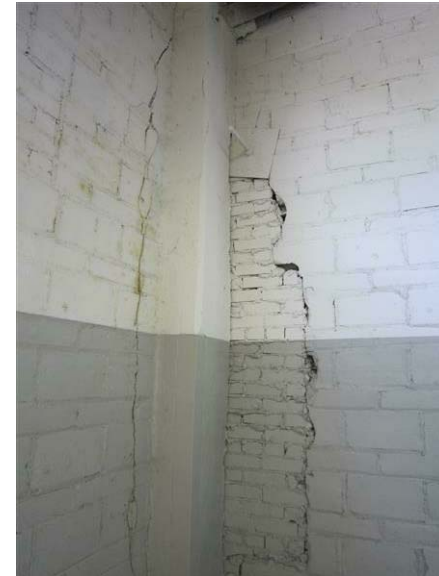
Building 36 – Chemical Plant Warehouse - Projects Operations Storage Warehouse: Severe cracking is visible at the exterior corners of the building.

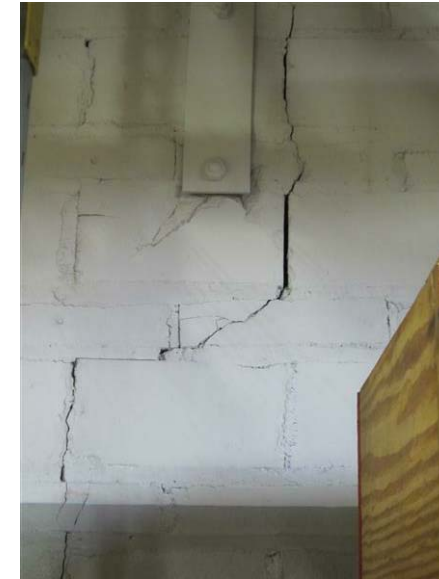
Building 36 – Chemical Plant Warehouse - Projects Operations Storage Warehouse: Severe cracking is separating the wall adjacent to this anchor.

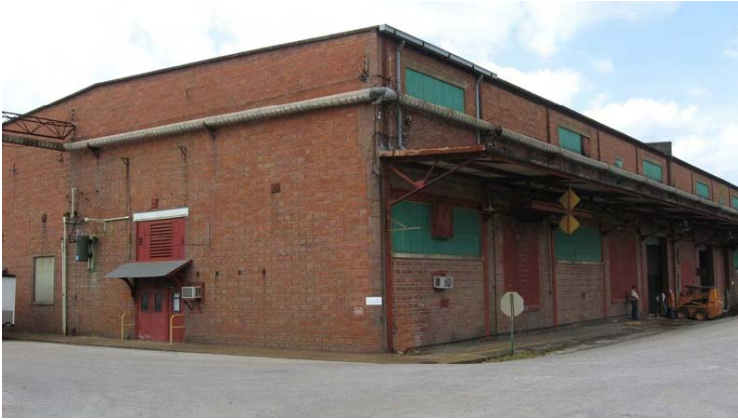
2009 Photo #1: Exterior building looking at Northeast corner.

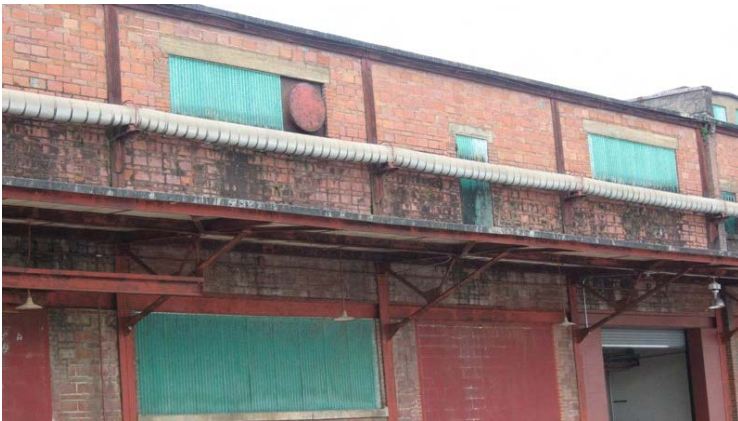
2009 Photo #2: Exterior building looking at North side.

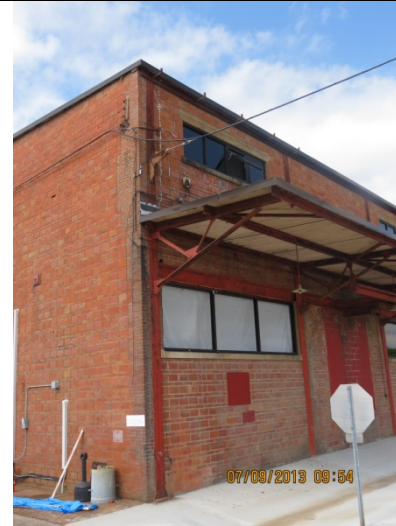
2013 Photo #1: Exterior building looking at Northeast corner.

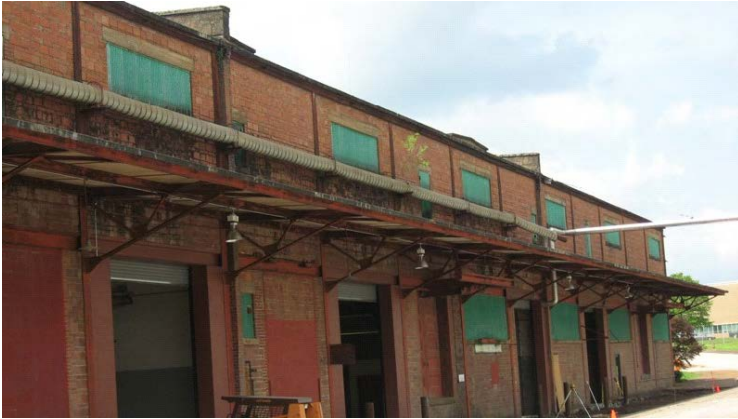
2009 Photo #3: Exterior building looking at North side toward West end.

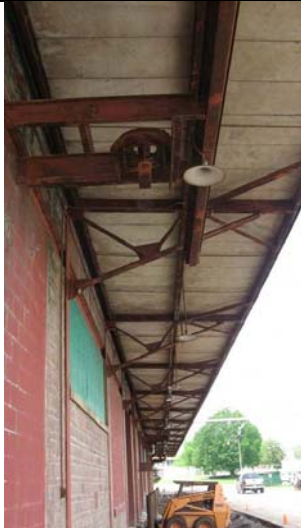
2009 Photo #4: Underside of North canopy.

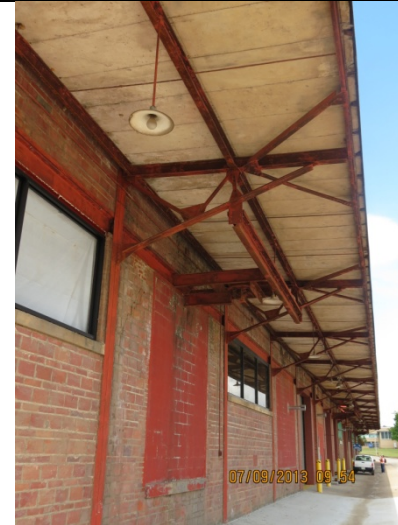
2013 Photo #4: Underside of North canopy.

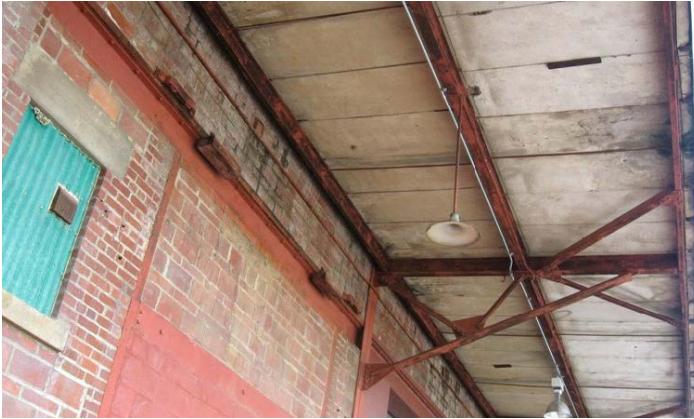
2009 Photo #5: Deteriorated concrete roof planks at North canopy.

2013 Photo #5: No change observed.

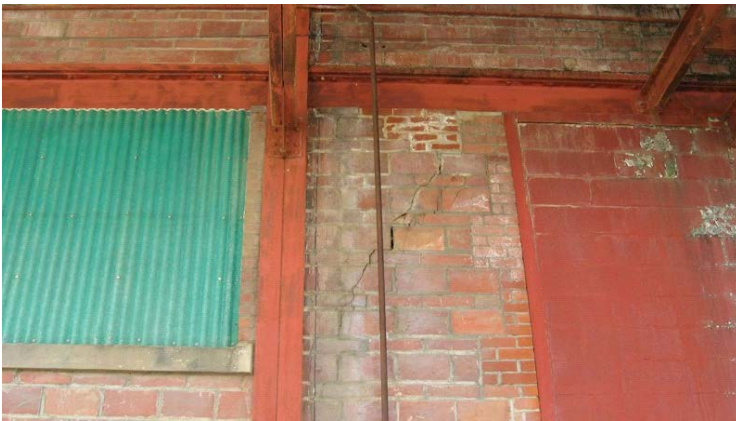
2009 Photo #6: Crack in exterior masonry below North canopy.

2013 Photo #6: No change observed.

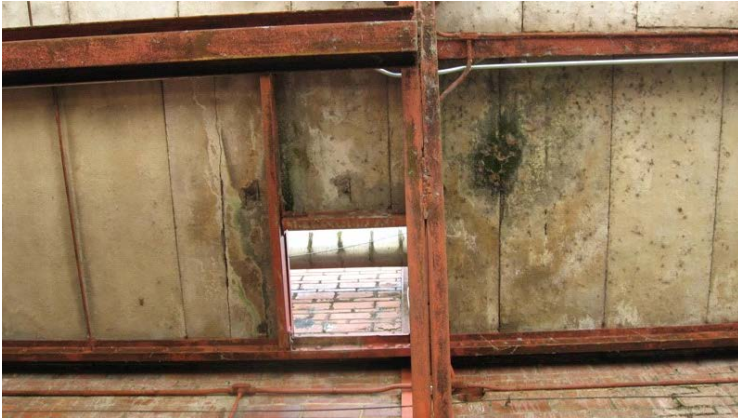
2009 Photo #7: Deteriorated concrete roof planks at North canopy.

2013 Photo #7: No change observed.

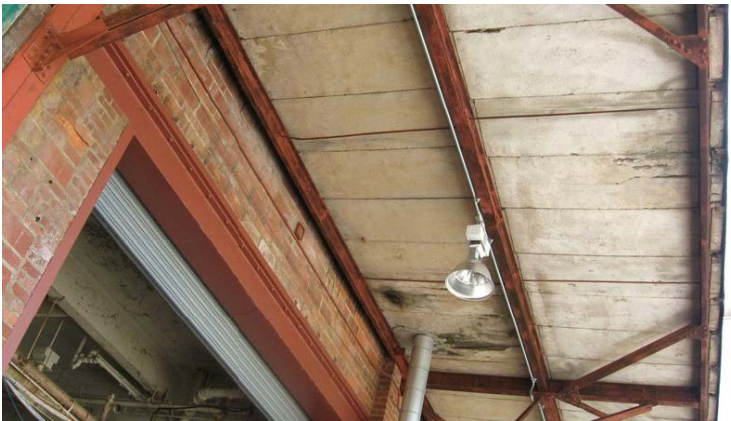
2009 Photo #8: Deteriorated concrete roof plants at North canopy.

2013 Photo #8: No change observed.

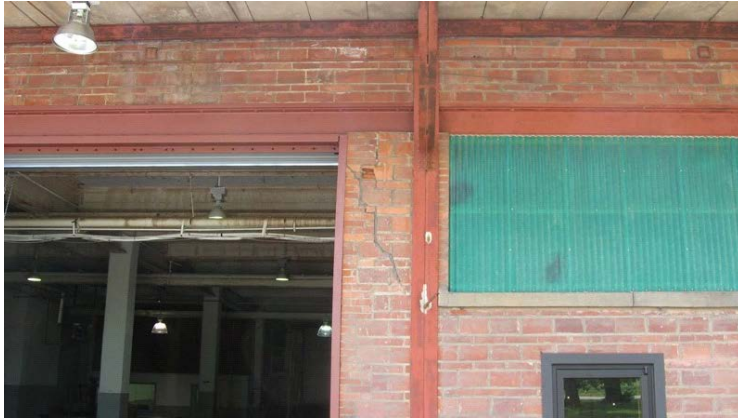
2009 Photo #9: Cracks in exterior masonry below North canopy.

2013 Photo #9: No change observed.

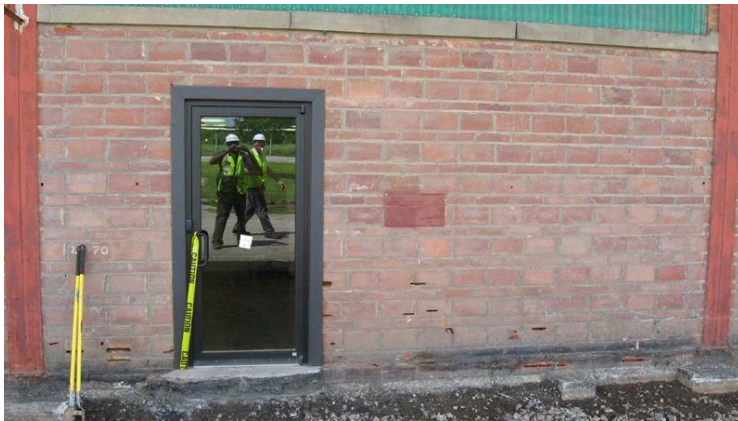
2009 Photo #10: Voids and spalls in exterior masonry at North wall.

2013 Photo #10: No change observed.

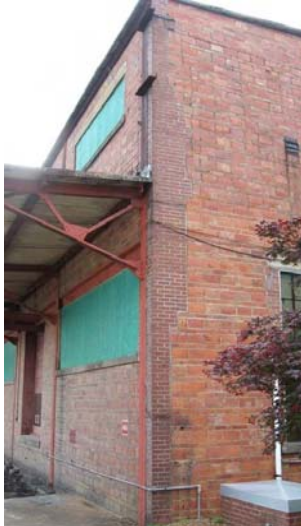
2009 Photo #11: Exterior building looking at Northwest corner.

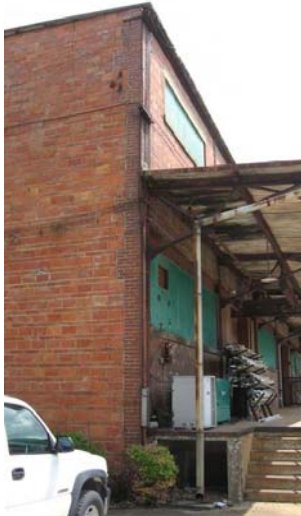
2009 Photo #12: Exterior building looking at Southwest corner.

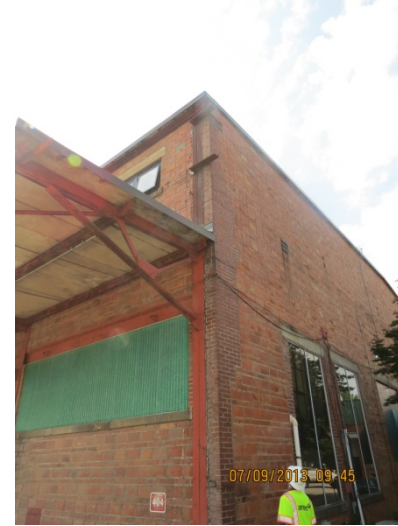
2013 Photo #11: Exterior building looking at Northwest corner.
