Tennessee Valley Authority

Cyclic Assessment Report
TVA Muscle Shoals, Alabama
September 16, 2013

Executive Summary

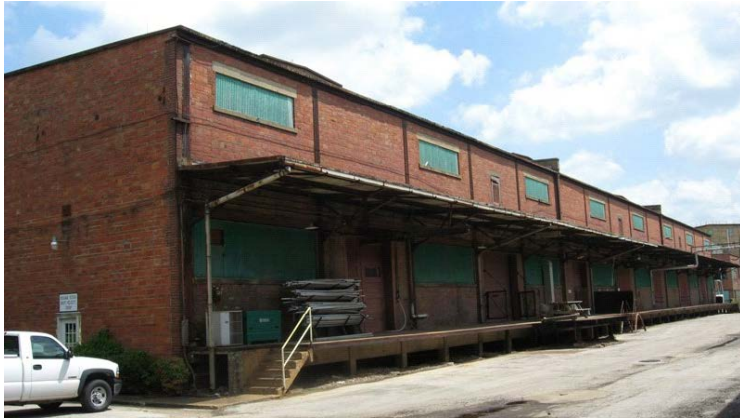
2009 Photo #13: Exterior building looking at Southwest corner.

2013 Photo #13: No change observed.

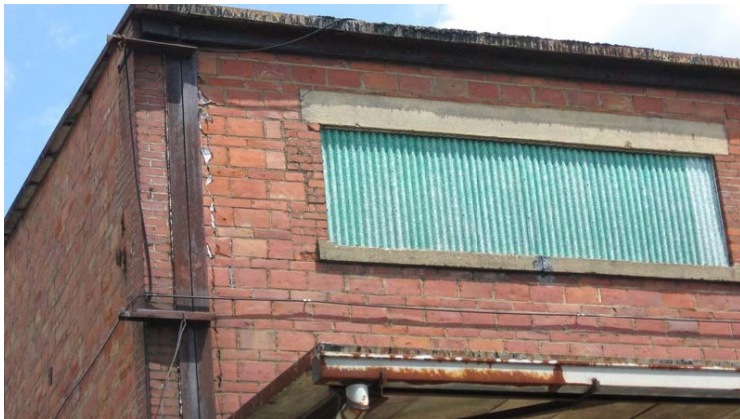
2009 Photo #14: Cracks in exterior masonry on South side Southwest corner.

2013 Photo #14: No change observed.

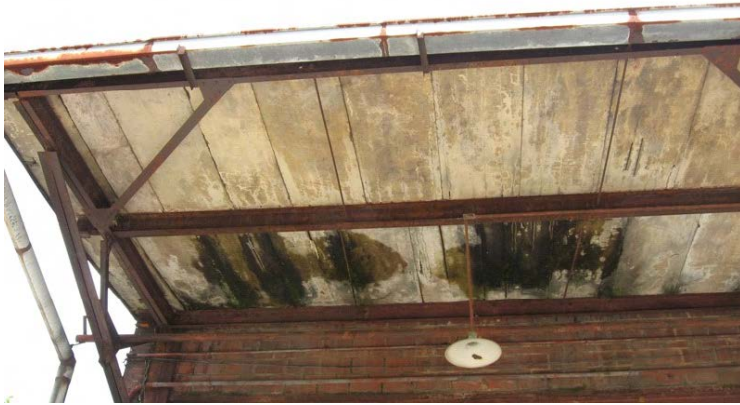
2009 Photo #15: Deteriorated concrete roof planks at West end of South canopy.

2013 Photo #15: No change observed.

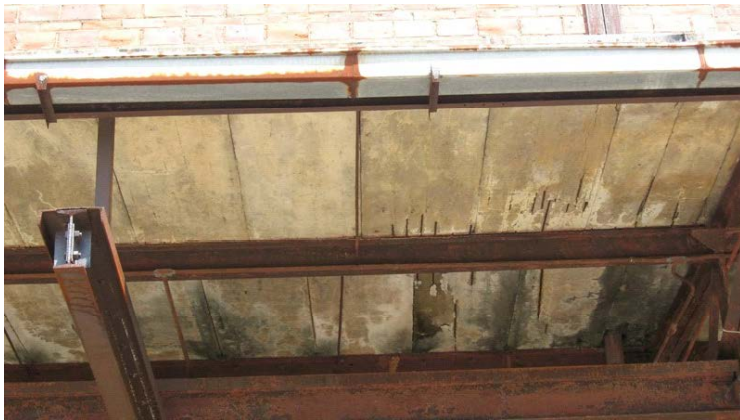
2009 Photo #16: Ruined concrete roof planks at South canopy.

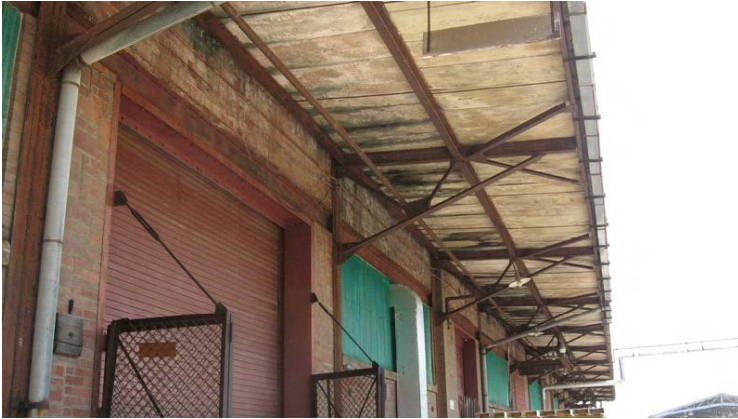
2009 Photo #17: Deteriorated concrete roof planks at South canopy.

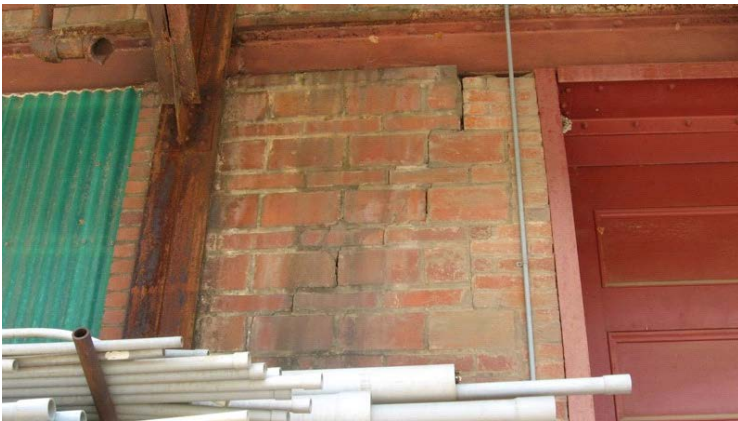
2009 Photo #18: Crack in exterior masonry below South canopy.

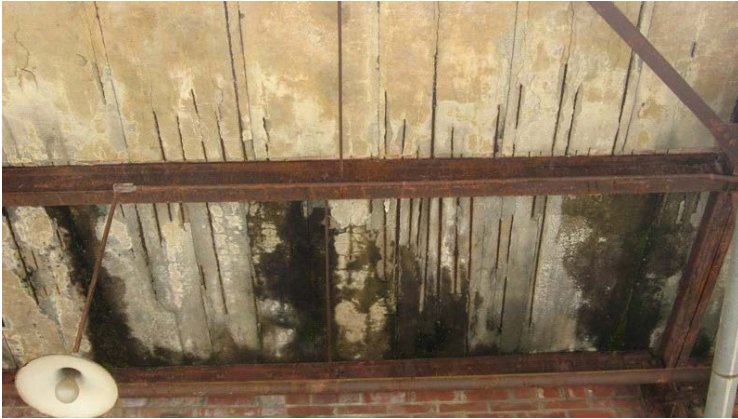
2009 Photo #19: Ruined concrete roof planks at South canopy.

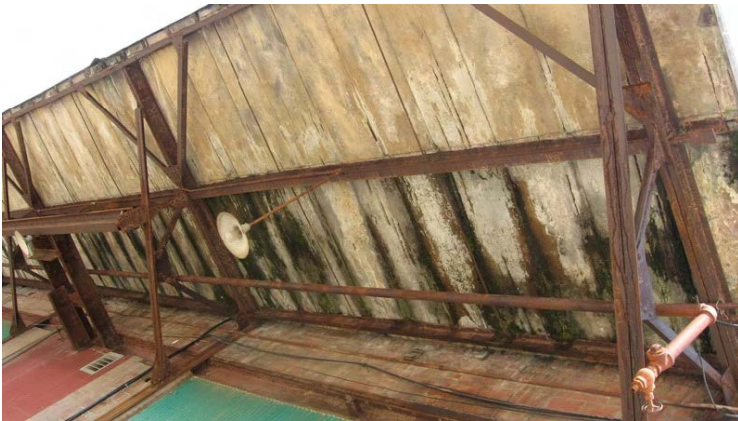
2009 Photo #20: Deteriorated and ruined concrete roof planks at South canopy.

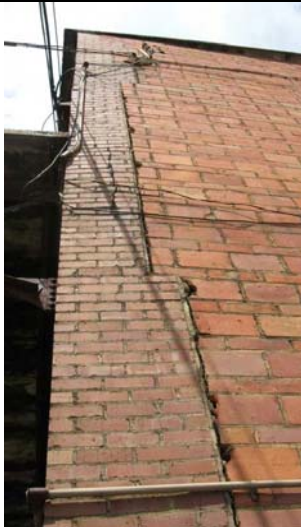
2009 Photo #22: Vertical crack in masonry on East side of Southeast corner.

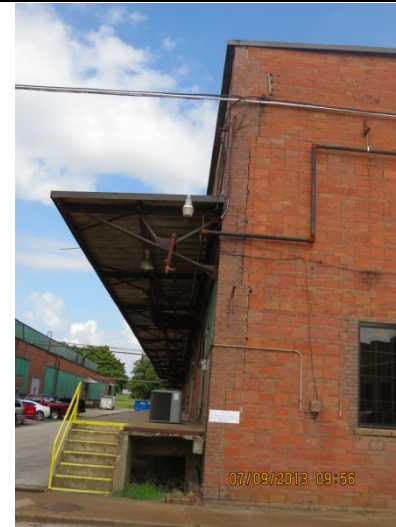
2013 Photo #22: Vertical crack in masonry on East side of Southeast corner. Additional movement observed.

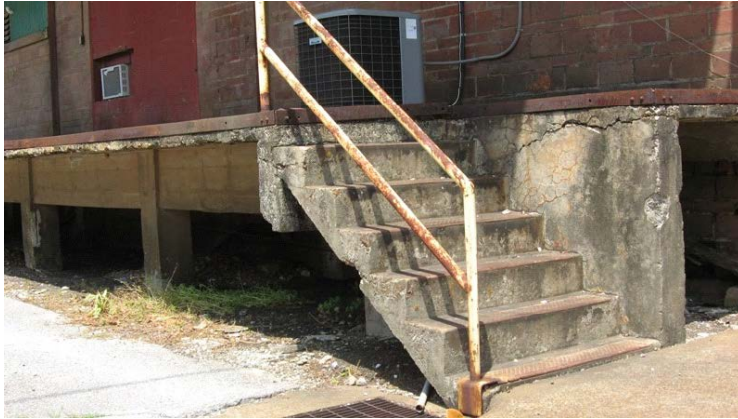
2009 Photo #23: Deteriorated concrete steps and support at East and South loading dock.

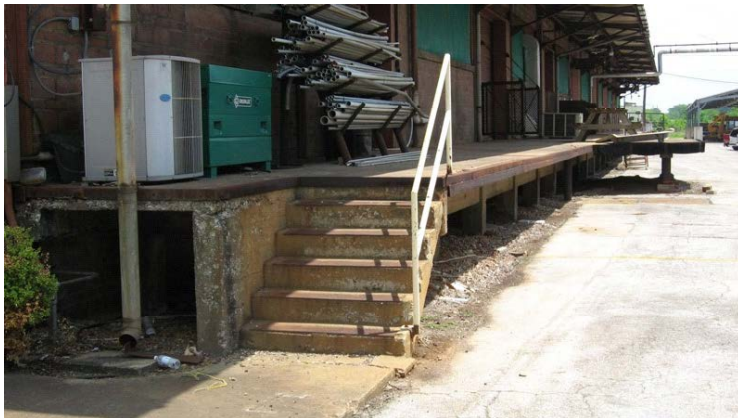
2009 Photo #24: Deteriorated concrete steps and support at West and South loading dock.

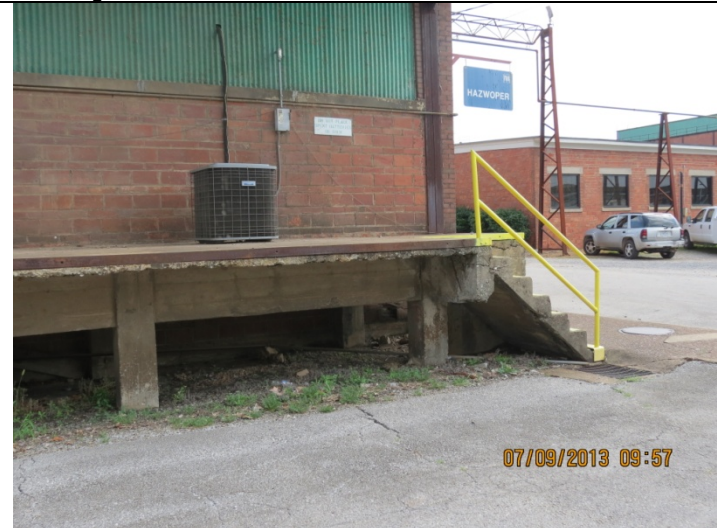
2013 Photo #23: Deteriorated concrete steps and support at East and South loading dock. Elevated slab deterioration evident.

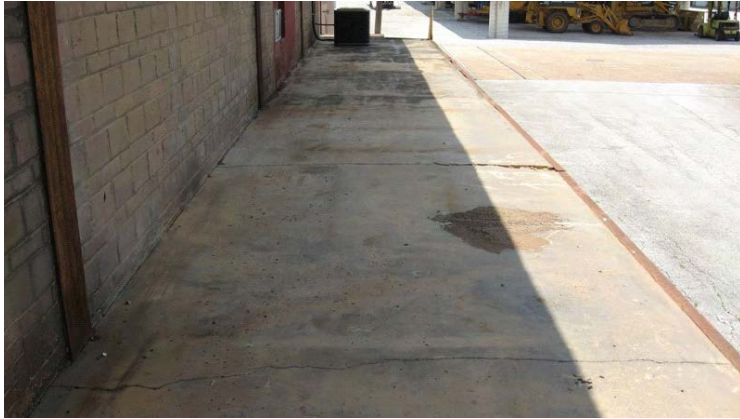
2009 Photo #25: Cracks in South loading deck slab.

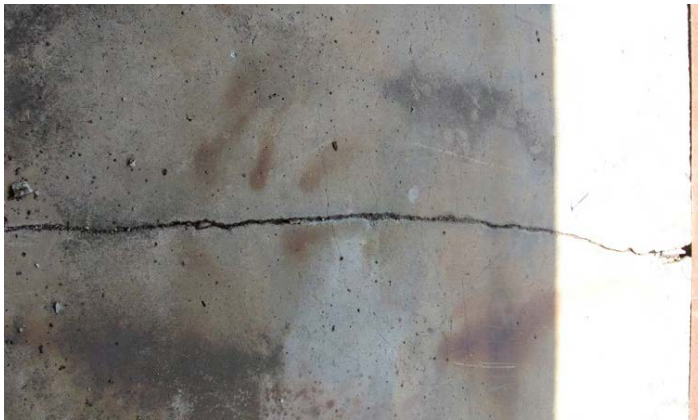
2009 Photo #26: Crack in South loading dock slab.

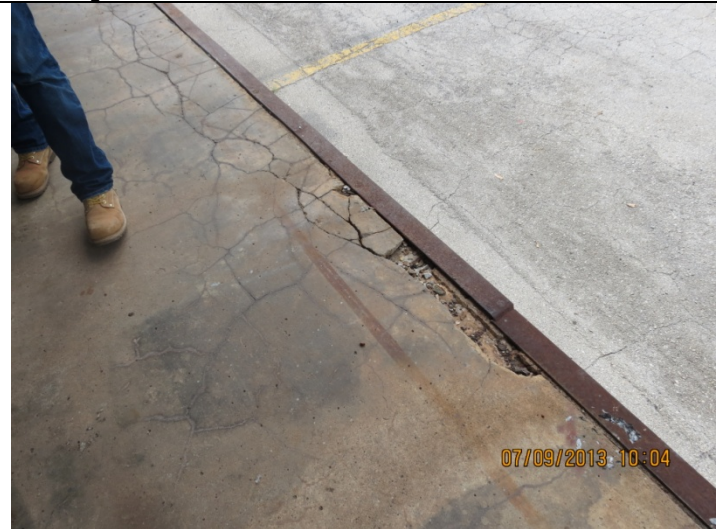
2013 Photo #25: Cracks in South loading deck slab. Different location than 2009 photo.

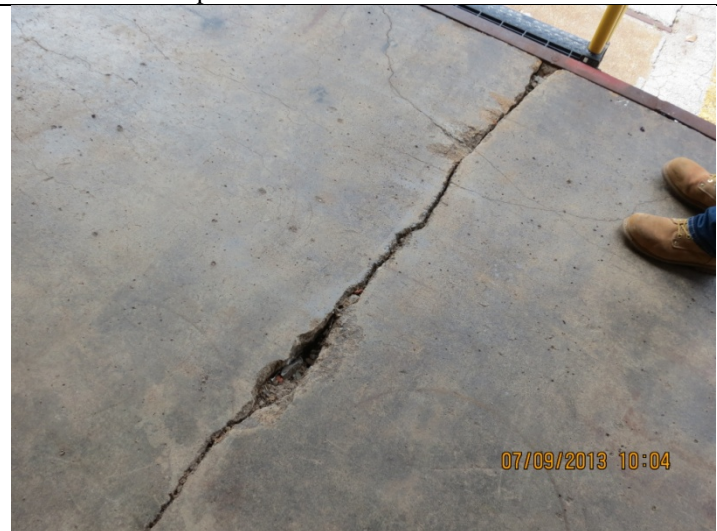
2013 Photo #26: Crack in South loading dock slab. Different location than 2009 photo.

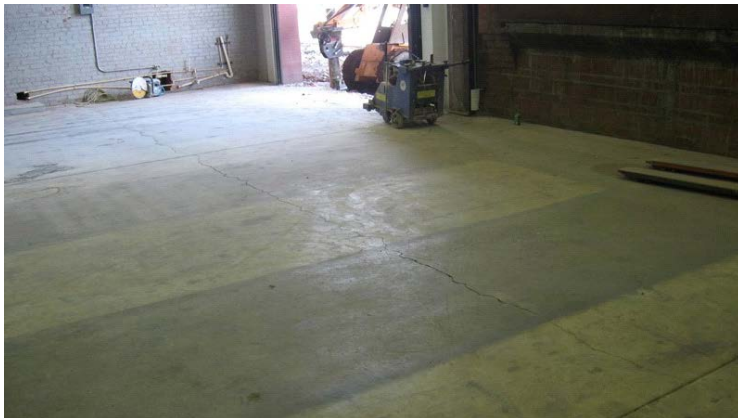
2009 Photo #28: Crack in floor in Northwest area of first level.

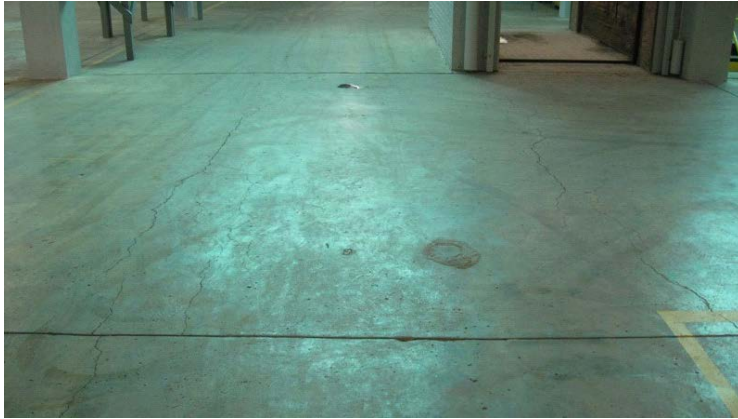
2009 Photo #31: Cracks in East area of second floor slab.

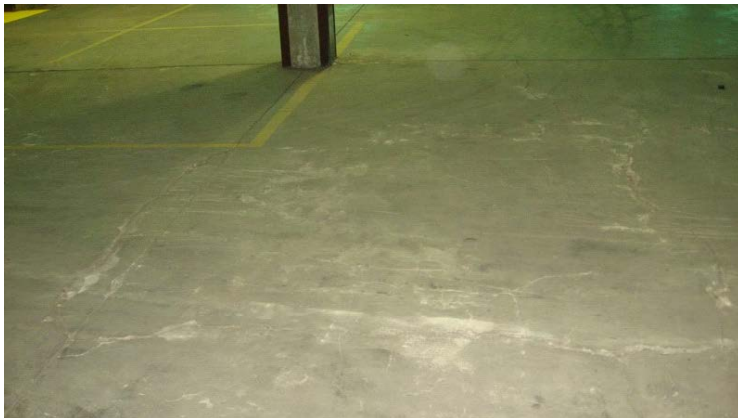
2009 Photo #32: Cracks in West area of second floor slab.

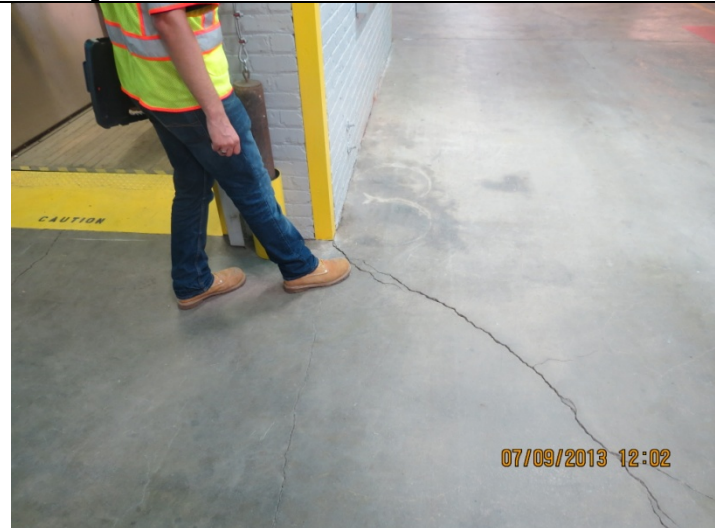
2013 Photo #31: Cracks in second floor slab at Northeast corner of East elevator. Different location than 2009 photo.

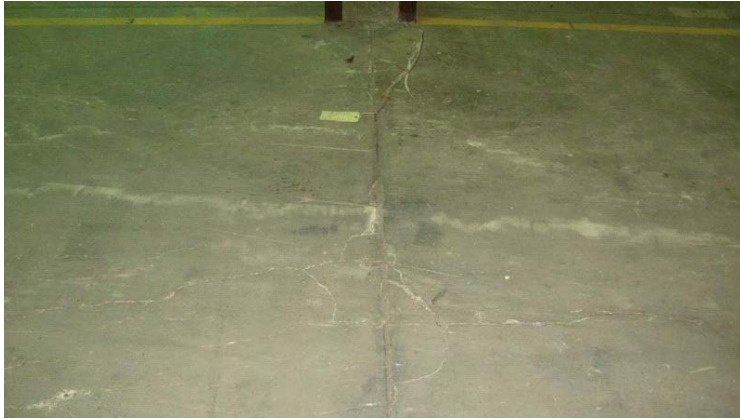
2009 Photo #33: Cracks in West area of second floor slab.

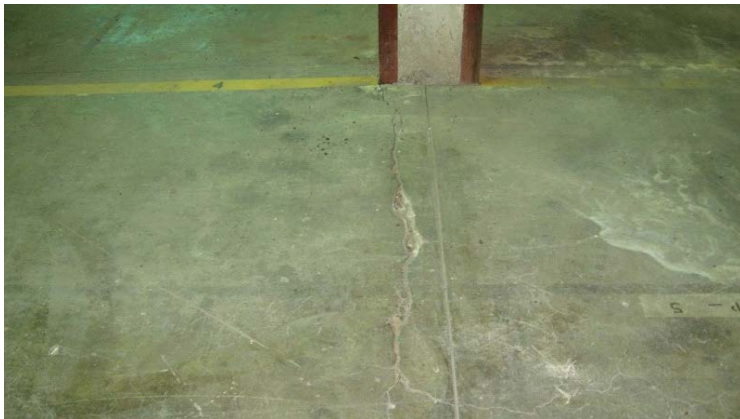
2009 Photo #34: Cracks in West area of second floor slab.

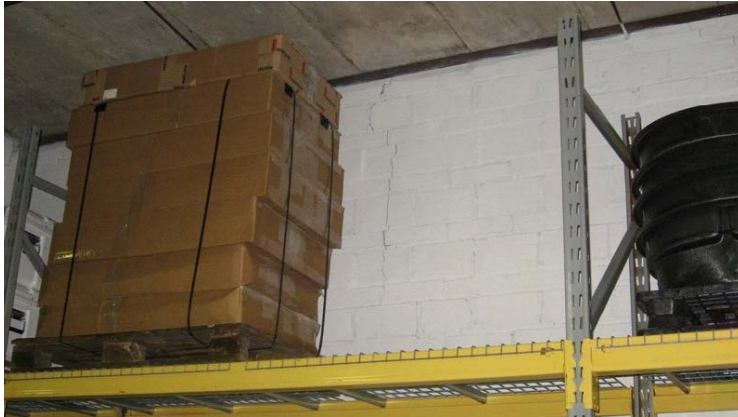
2009 Photo #35: Interior crack in South masonry wall near East end.

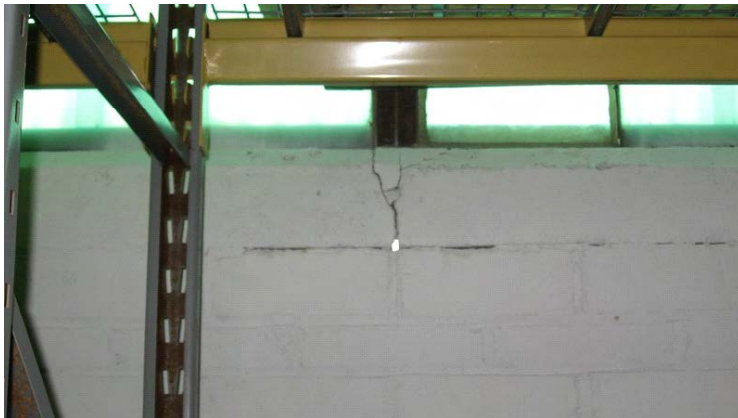
2009 Photo #36: Interior crack/void at window sill on South side near East end.

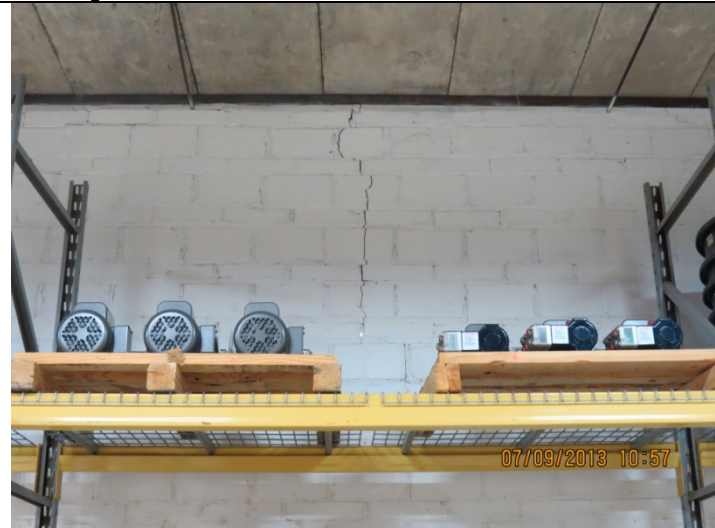
2013 Photo #35: Interior crack in South masonry wall near East end. Daylight seen through crack due to continued settlement.

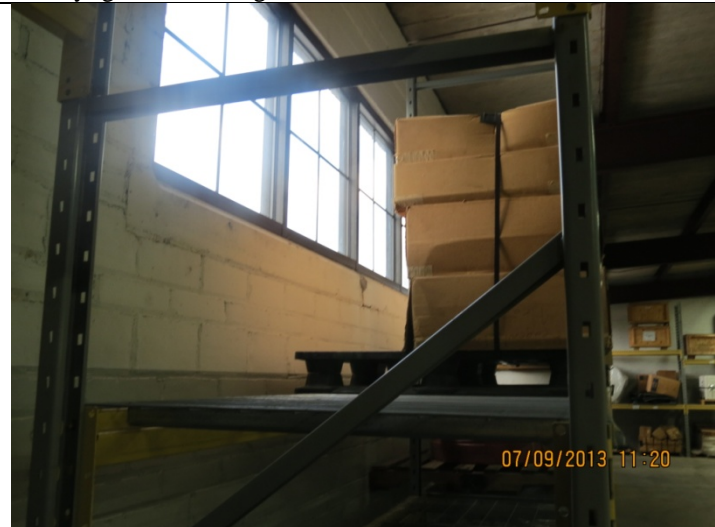
2013 Photo #36: Interior crack/void at window sill on South side near East end has been infilled with grout.

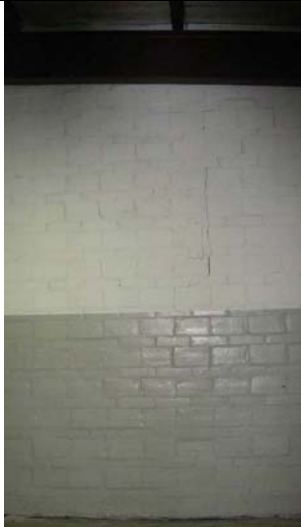
2009 Photo #37: Interior crack in East wall.

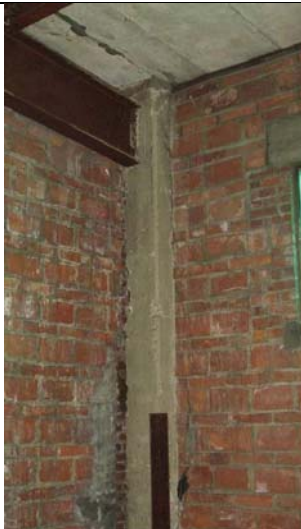
2009 Photo #38: Interior crack/void at column and wall at Northwest corner.

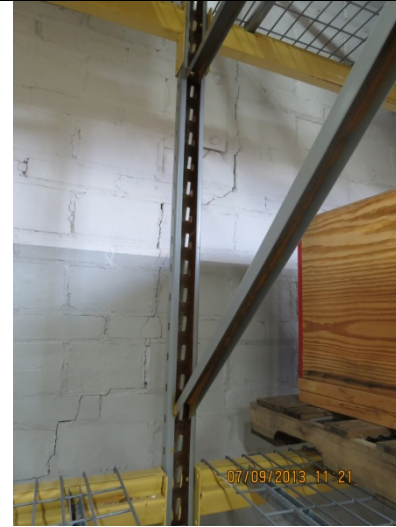
2013 Photo #37: Interior crack in East wall. Crack continues to perpetuate since 2009.

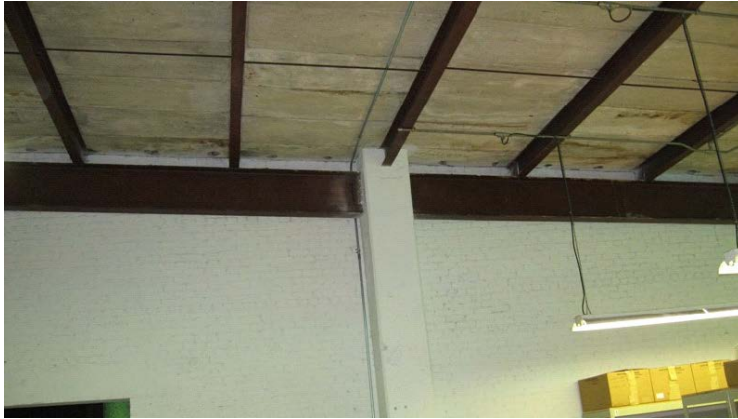
2009 Photo #39: Spalls and surface deterioration at concrete roof planks at interior wall.

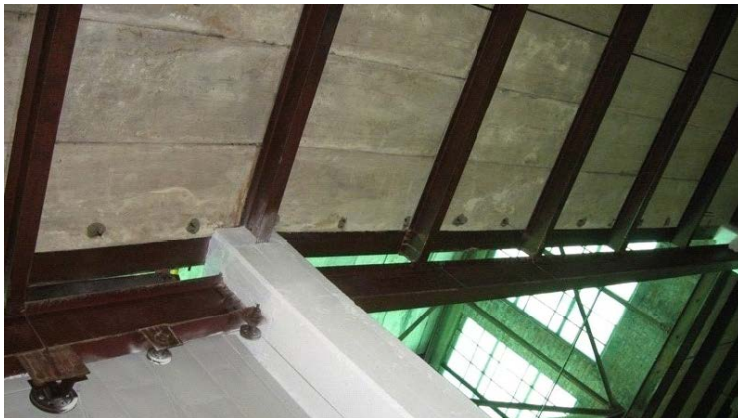
2009 Photo #40: Spalls at concrete roof planks adjacent to clerestory monitor.

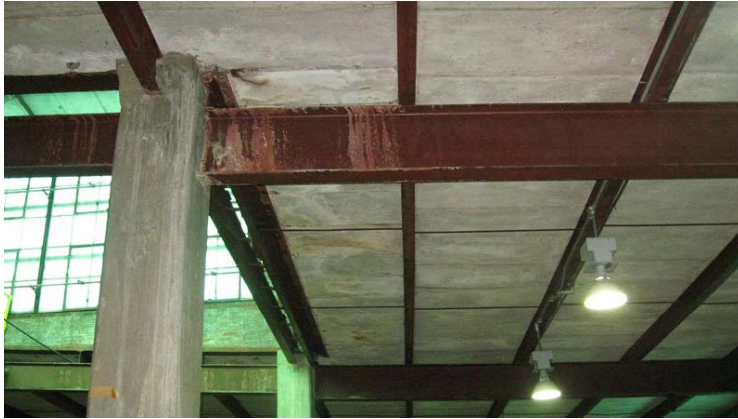
2009 Photo #41: Water intrusion damage at concrete roof planks, steel beams, and concrete column.

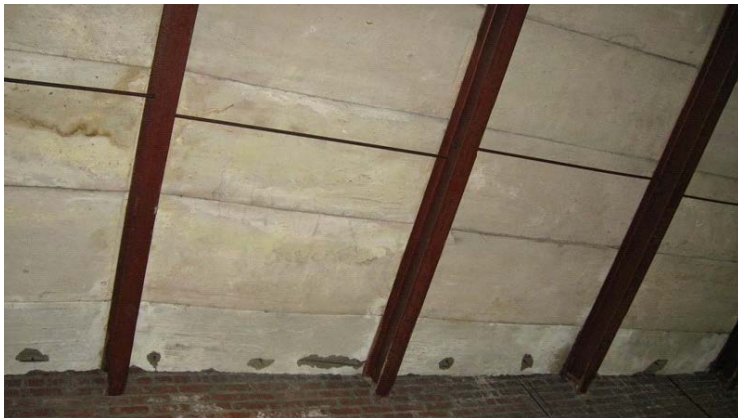
2009 Photo #42: Spalls and surface deterioration at concrete roof planks at interior wall.

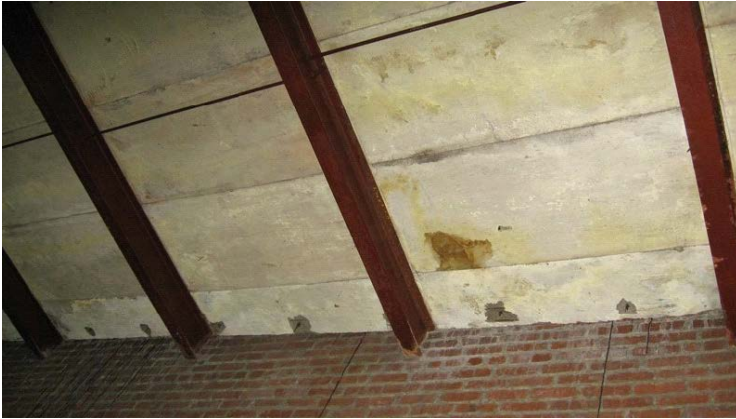
2009 Photo #43: Spalls and surface deterioration at concrete roof planks at interior walls.

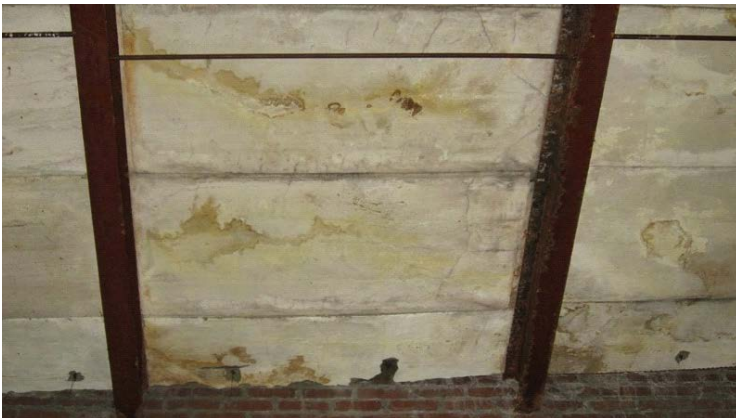
2009 Photo #44: Deteriorated concrete roof plank at interior wall.

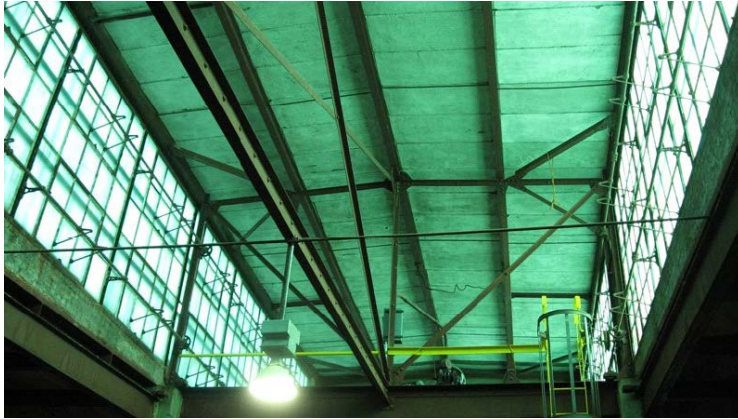
2009 Photo #45: Concrete roof planks at clerestory monitor.

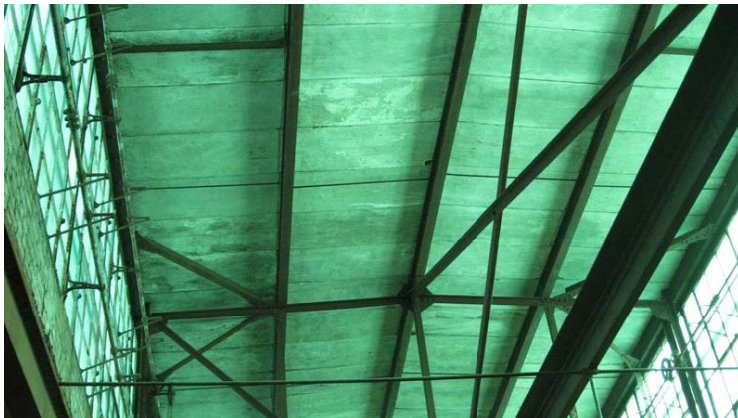
2009 Photo #46: Concrete roof planks with surface deterioration at clerestory monitor.

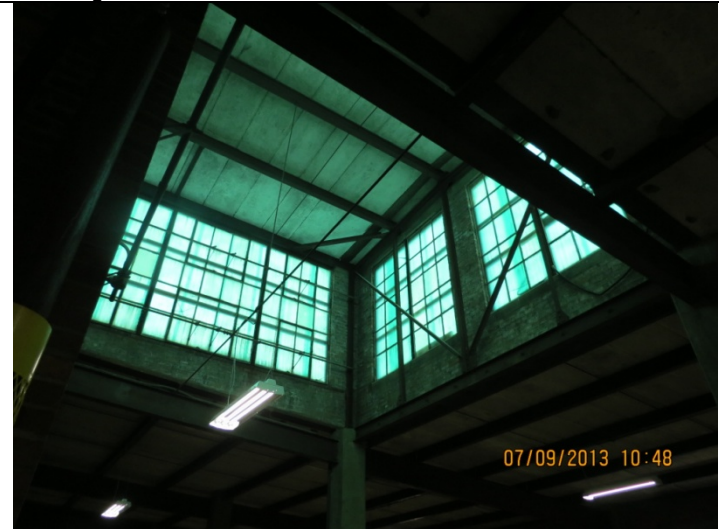
2013 Photo #45: Concrete roof planks at clerestory monitor.
Different location than 2009 photo.

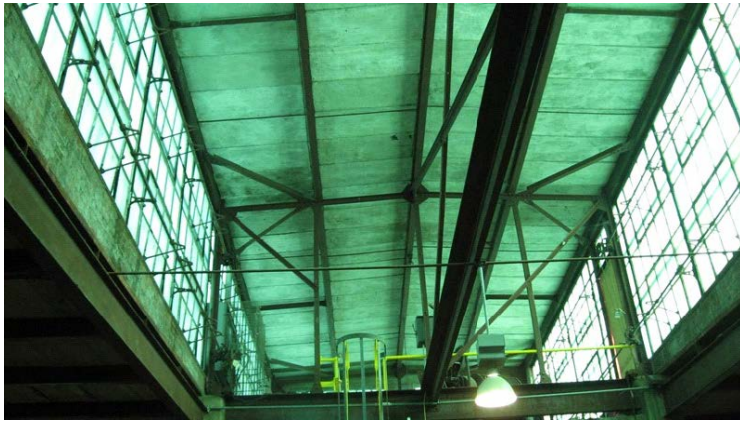
2009 Photo #47: Concrete roof planks with surface deterioration at clerestory monitor.

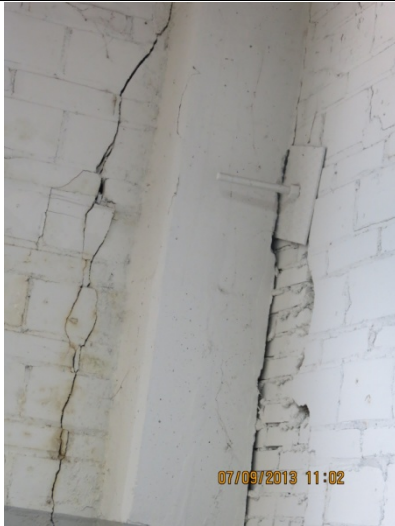
2013 Photo #49: Northeast corner column, Severe cracking of brick finishes observed. Post installed tie back installed.

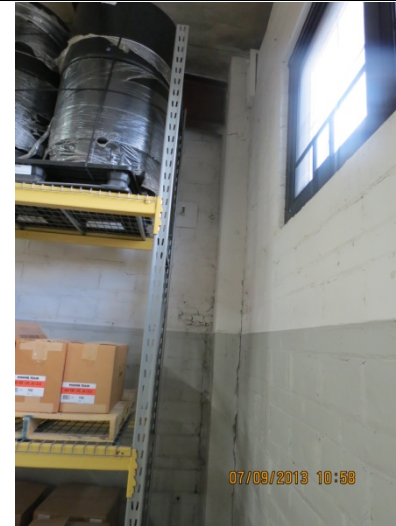
2013 Photo #50: Southeast corner column. Severe cracking of brick observed. Post installed tie back installed.

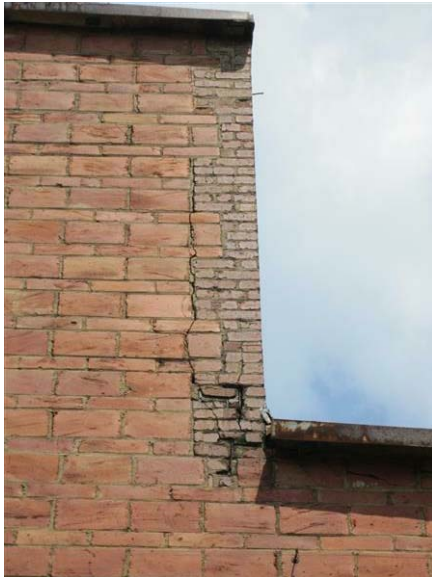
Building 37, 38 – Machine Shop: Cracking in the brick quoins the corners of the building.

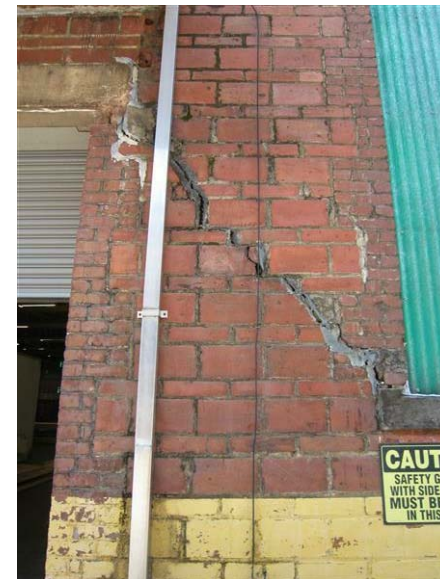
Building 37, 38 – Machine Shop: Although this crack was patched previously, it has continued to separate.

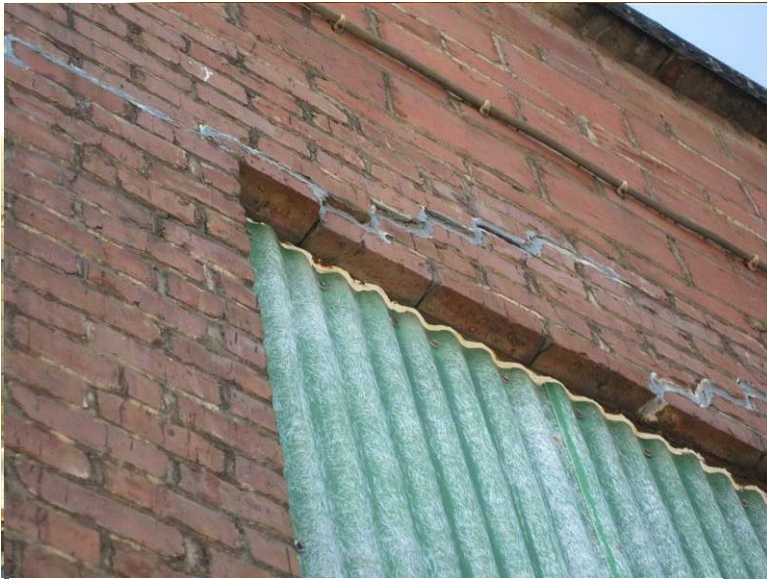
Building 37, 38 – Machine Shop: Several cracks occur in the brick surround, which has begun to shift above the window.

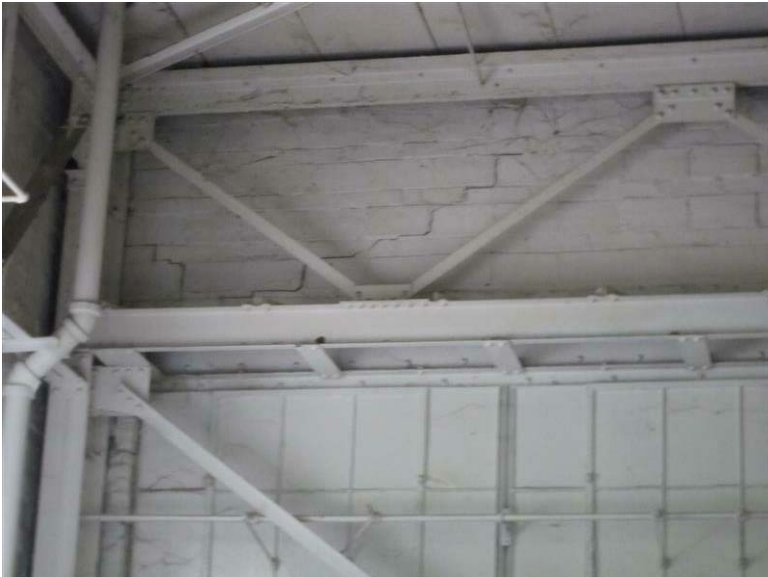
Building 37 – Machine Shop: Diagonal cracking along the upper portion of the wall above the window.

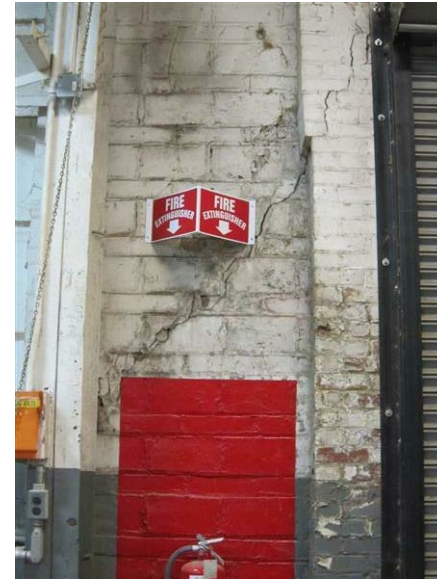
Building 37 – Machine Shop: Severe cracking between the door and window openings.

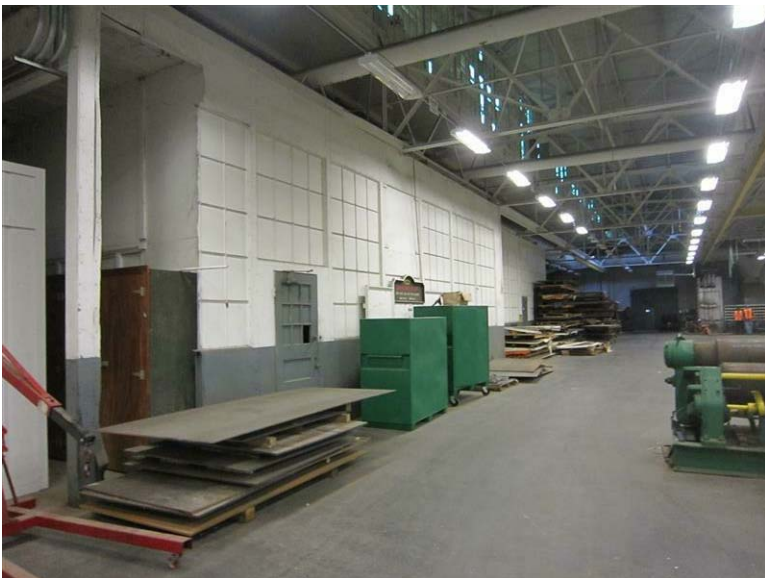
Building 37 – Machine Shop: The glass pane is broken on the wood door leading to the office space.

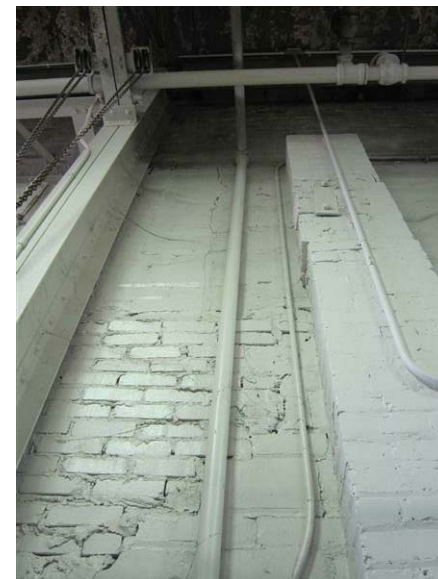
Building 38 – Machine Shop - Gas and Diesel Repair Shop: Although covered with paint, cracking is visible along the hollow clay tile wall.

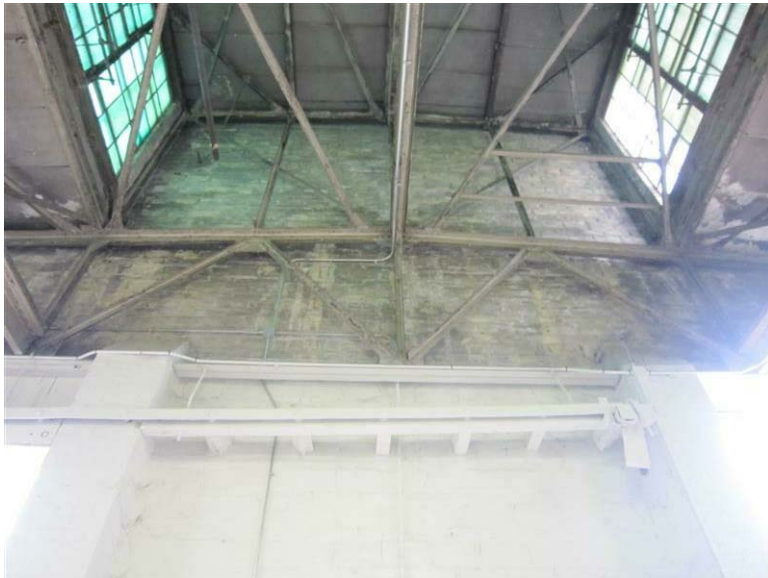
Building 38 – Machine Shop - Gas and Diesel Repair Shop: The hollow clay tile walls leading to the clerestory are stained.

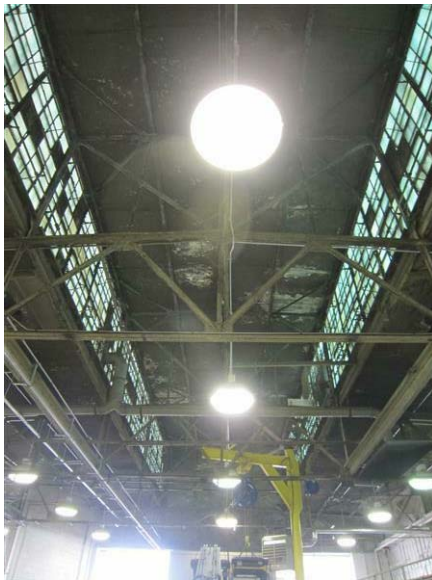
Building 38 – Machine Shop - Gas and Diesel Repair Shop: A majority of the concrete ceiling panels are damaged.

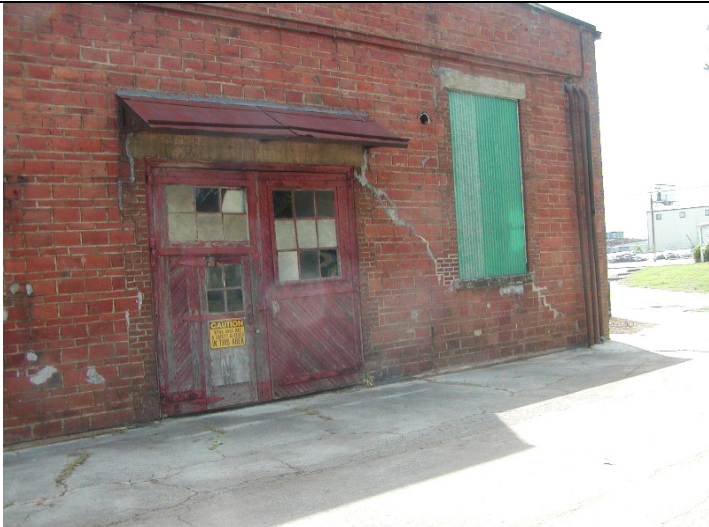
2009 Photo #4: Cracks in masonry South end of West wall

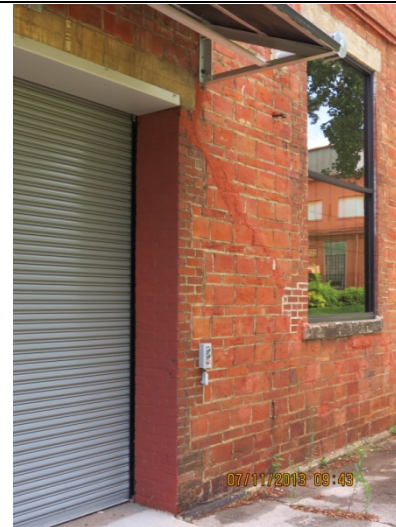
2013 Photo #4: Repairs to cracks in masonry South end of West wall observed.

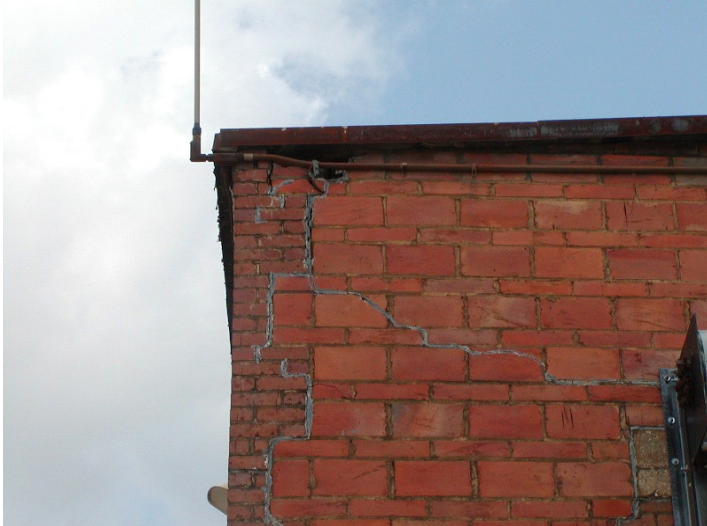
2009 Photo #5: Cracks in masonry at Southeast corner

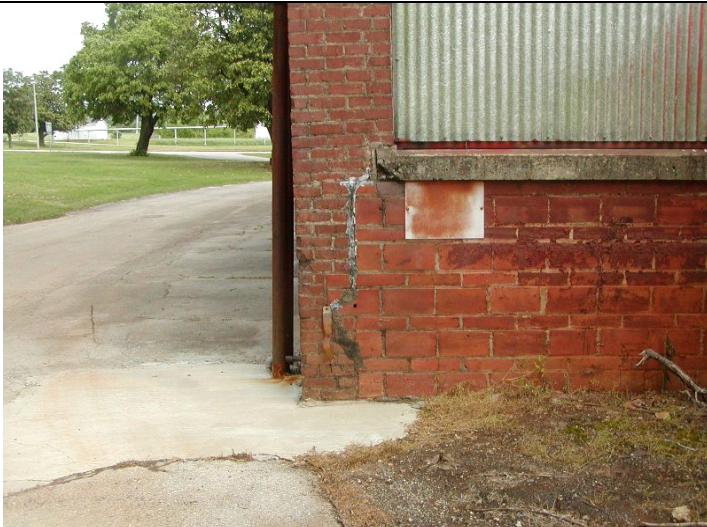
2009 Photo #6: Cracks in masonry at Southwest corner

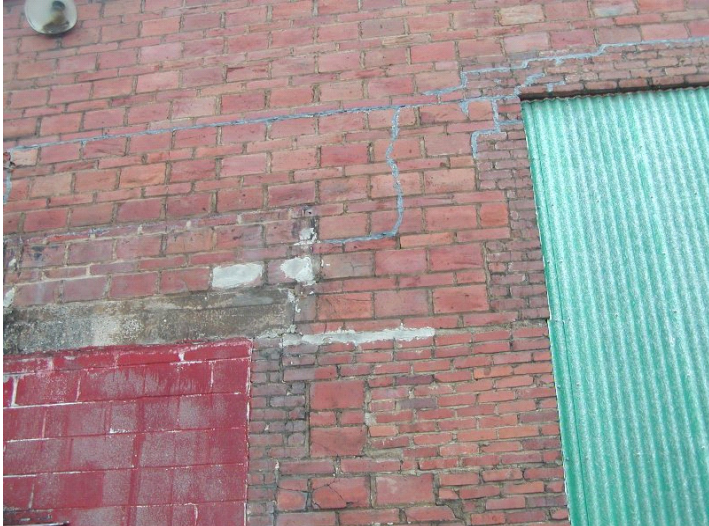
2009 Photo #7: Cracks in masonry in South wall

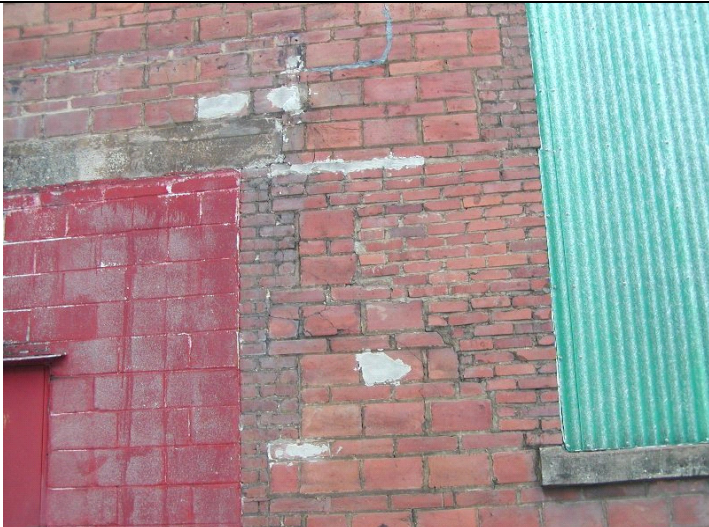
2009 Photo #8: Cracks in masonry (Same locations as Photo No. 7)

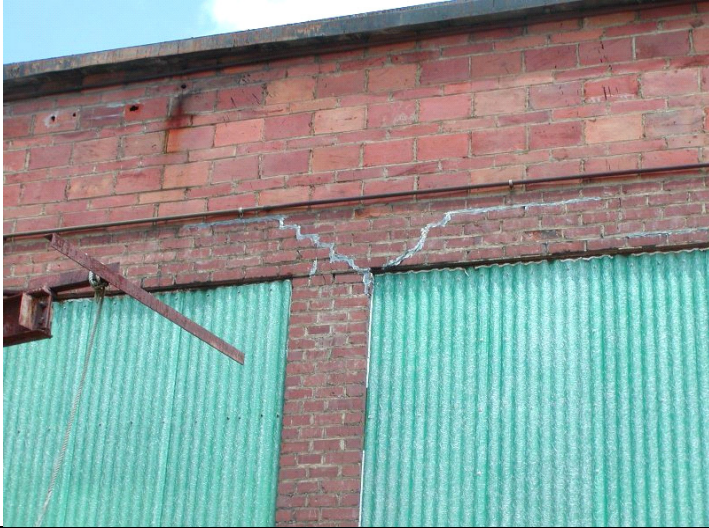
2009 Photo #9: Cracks in masonry lintels at South wall

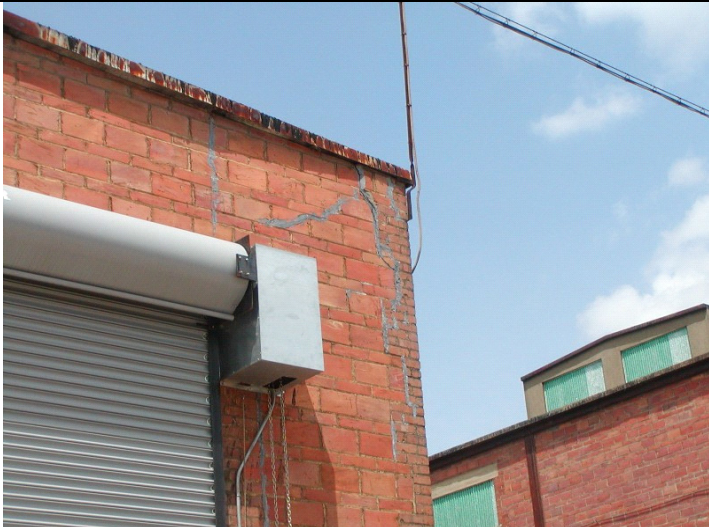
2009 Photo #10: Cracks in masonry North end of East wall

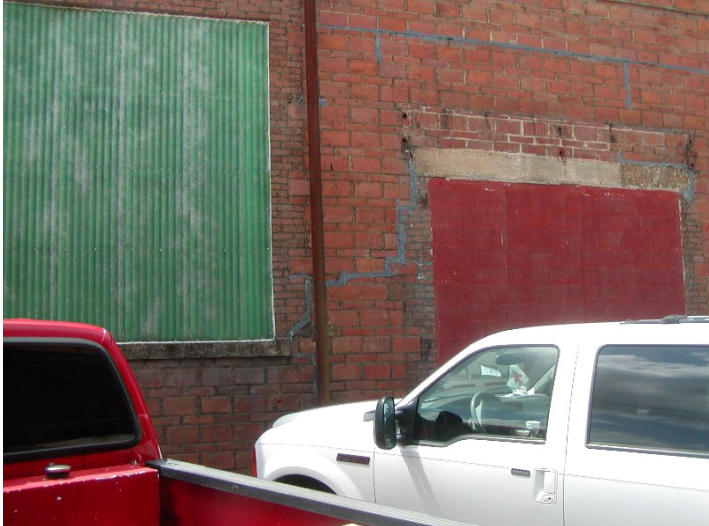
2009 Photo #11: Cracks in masonry at North wall

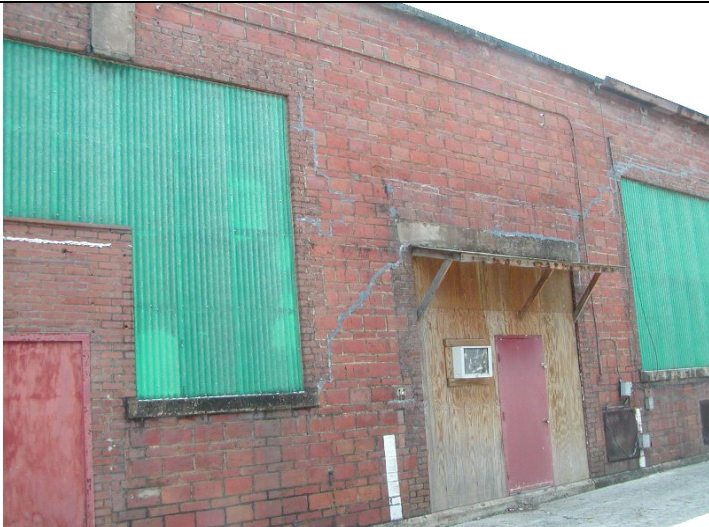
2009 Photo #12: Cracks in masonry at North wall

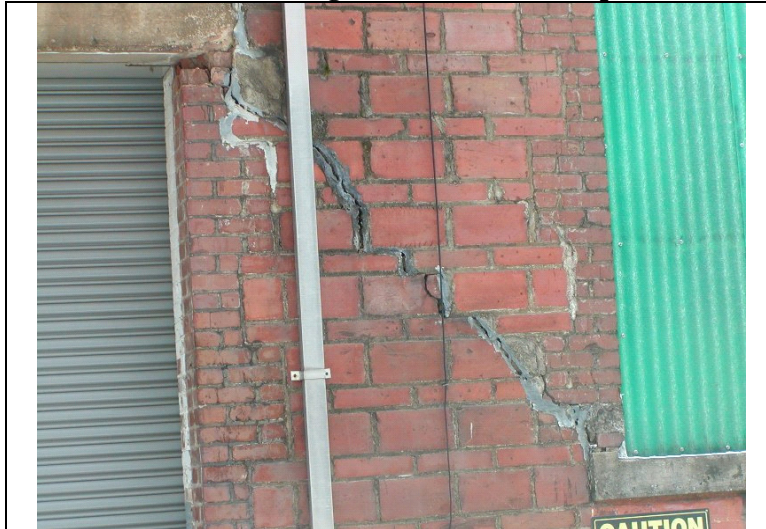
2009 Photo #13: Cracks in masonry at North wall

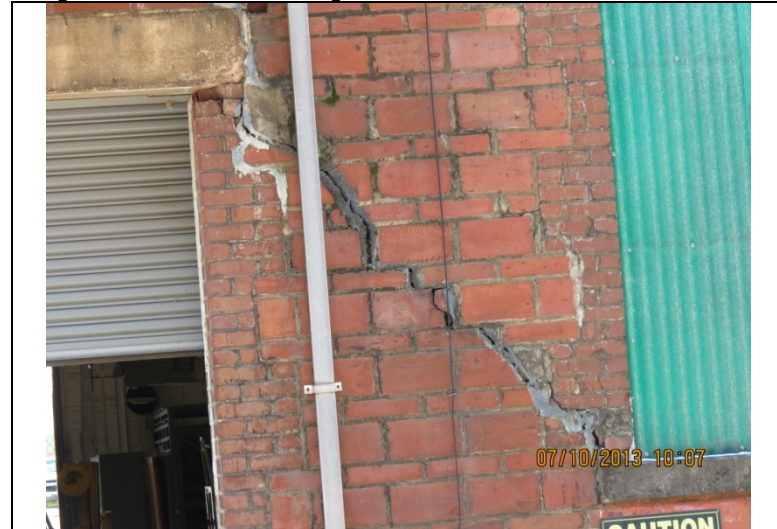
2013 Photo #13: Cracks in masonry at North wall. Additional movement observed.

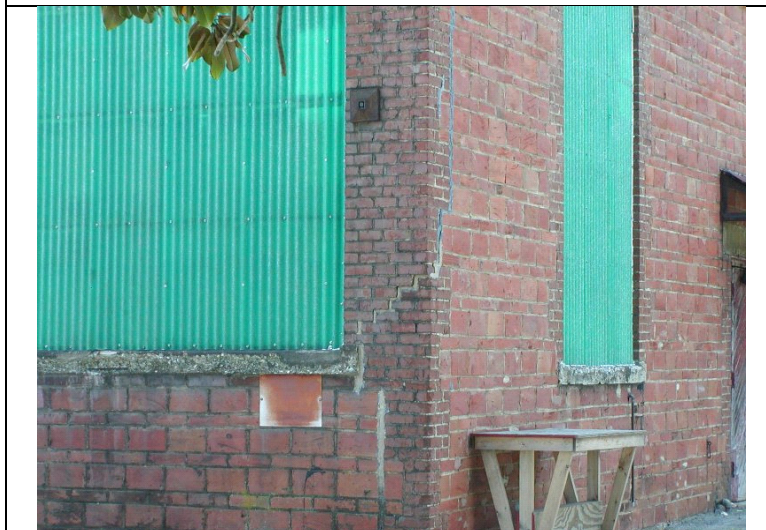
2009 Photo #14: Cracks in masonry at Northwest corner

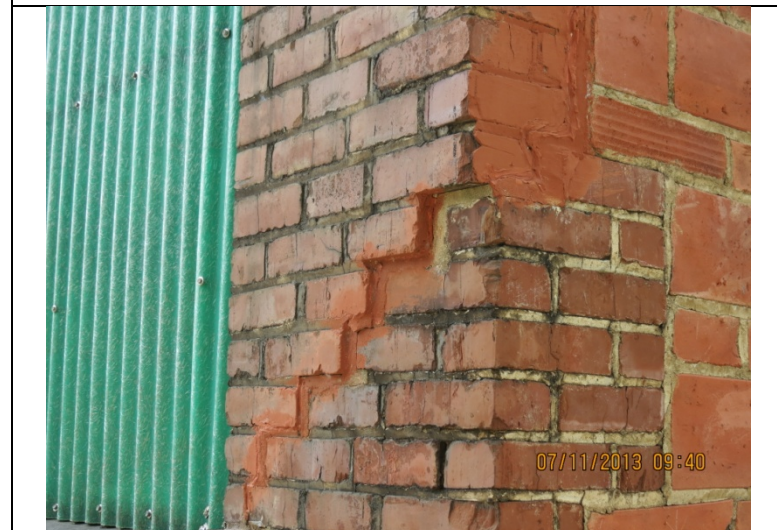
2013 Photo #14: Repaired cracks in masonry at Northwest corner.

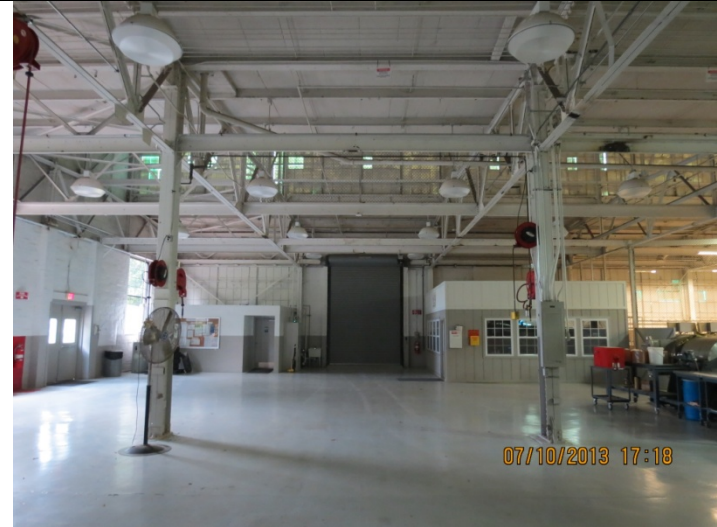
2013 Photo #15: Interior building at the West end has been refinished.

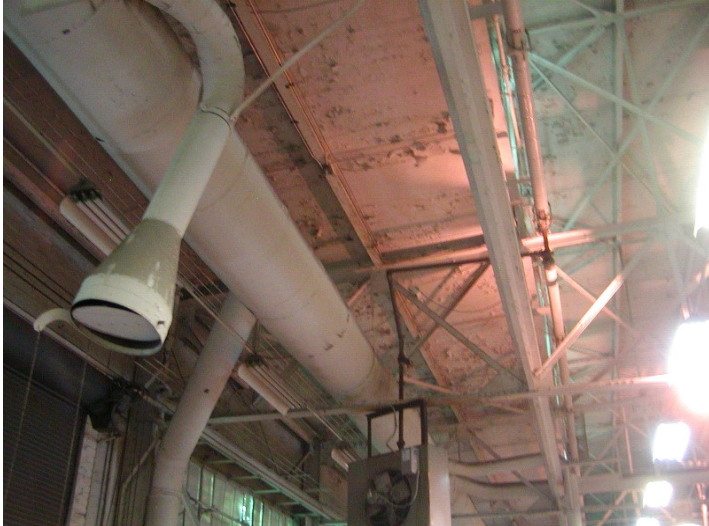
2009 Photo #17: Surface deterioration at concrete plank deck
