Tennessee Valley Authority

Cyclic Assessment Report
TVA Muscle Shoals, Alabama
September 16, 2013

Executive Summary

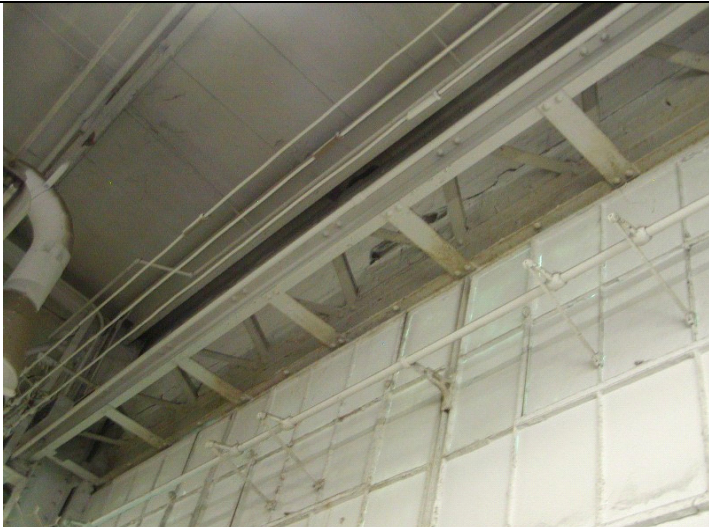
2009 Photo #18: Crack and spall in concrete plank roof deck

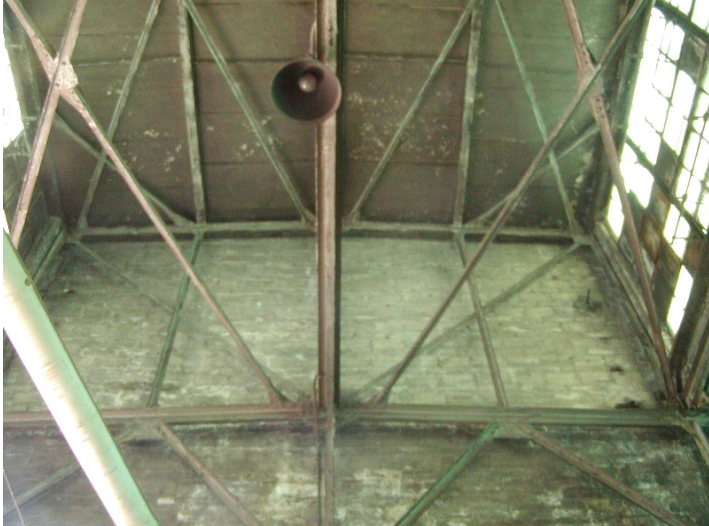
2009 Photo #19: General moderate deterioration of monitor framing, wall, and roof deck

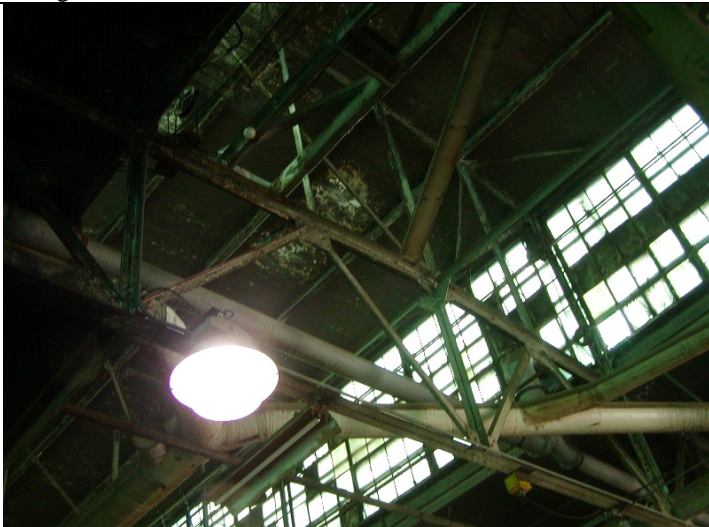
2009 Photo #20: Deteriorated concrete plank roof deck at monitor

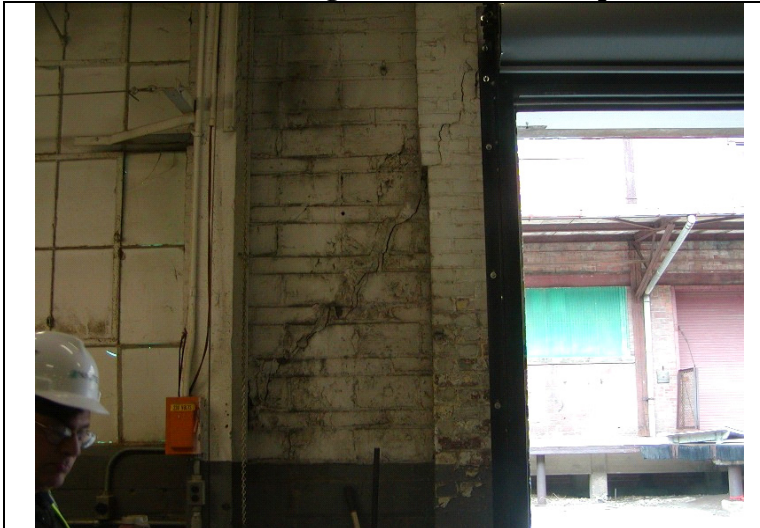
2009 Photo #21: Diagonal crack in masonry at North wall

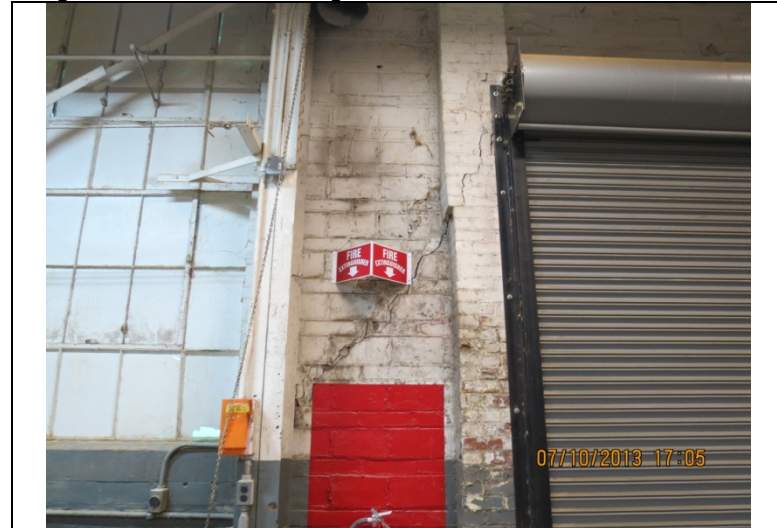
2013 Photo #21: Diagonal crack in masonry at North wall

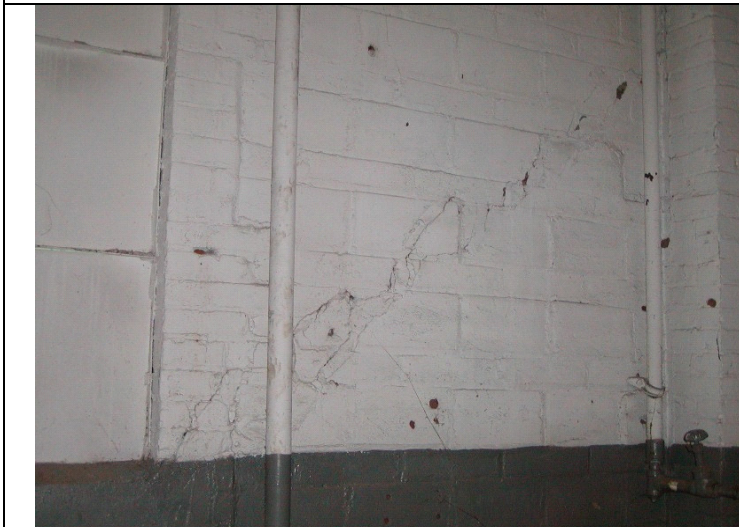
2009 Photo #22: Diagonal crack in masonry at West wall

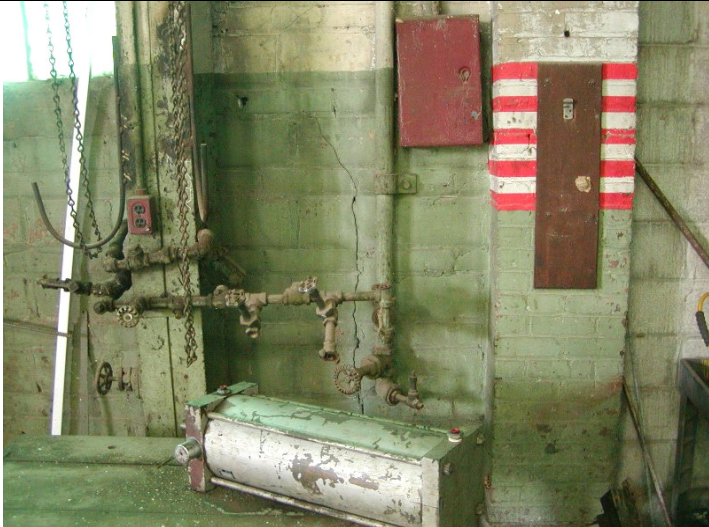
2009 Photo #23: Vertical crack in masonry at South wall

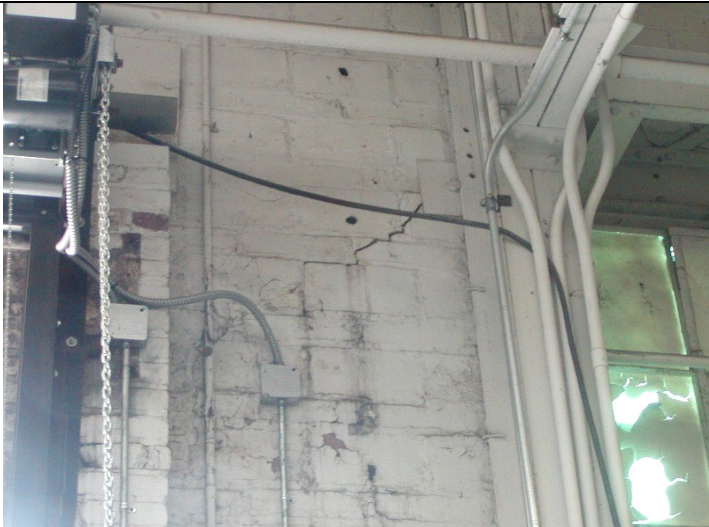
2009 Photo #24: Diagonal crack in masonry at South wall

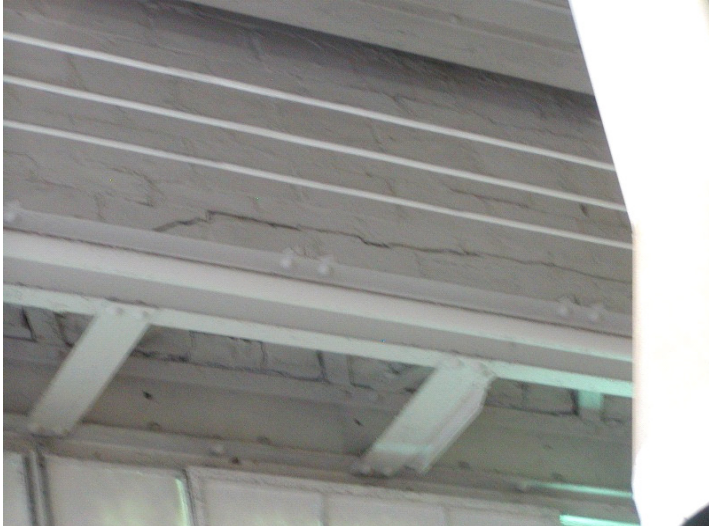
2009 Photo #25: Horizontal crack in masonry at South wall

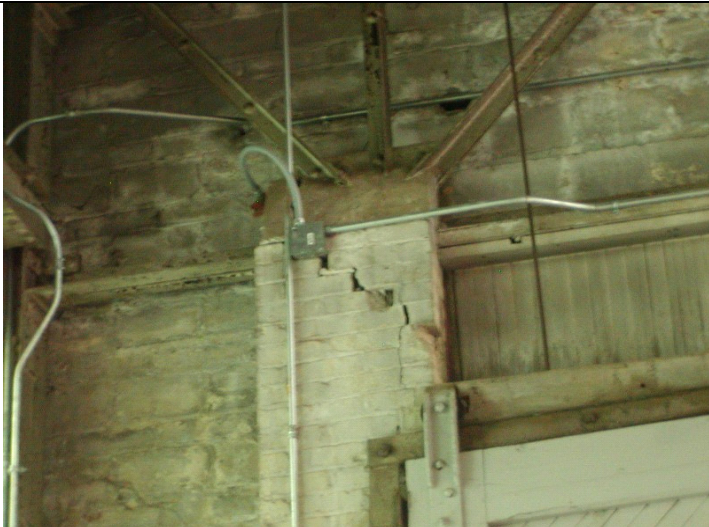
2009 Photo #26: Cracked and partially dislodged masonry at Northeast corner

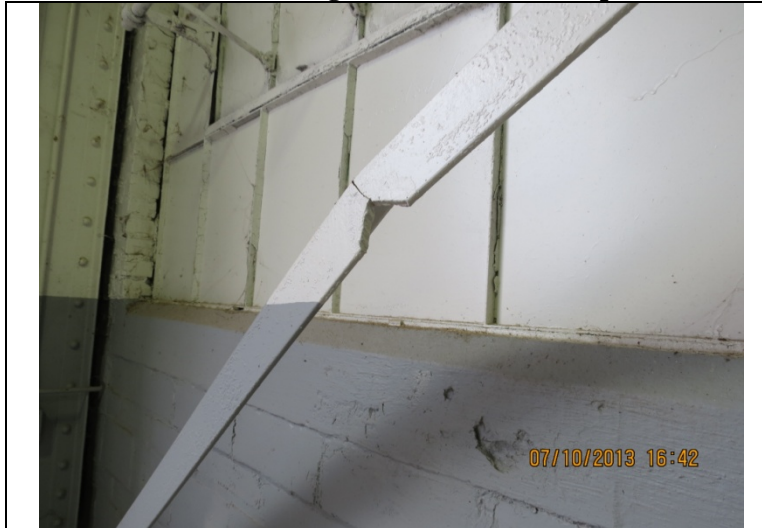
2013 Photo #27: Failed cross-bracing at the South face at the East end of the building.

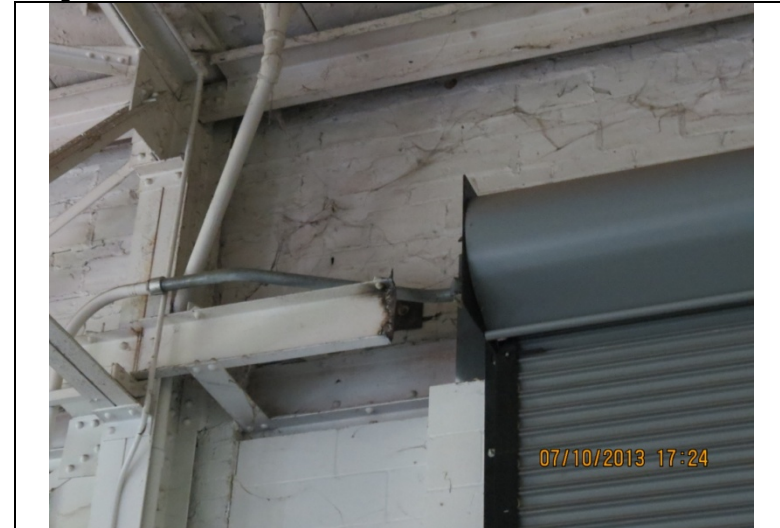
2013 Photo #28: Brace cut to facilitate installation of roll-up door.

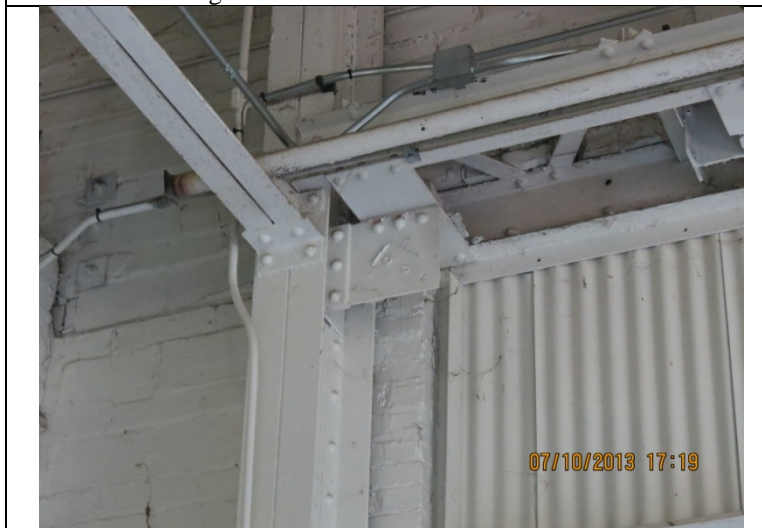
2009 Photo #29: Cross-bracing removed at Southwest corner.

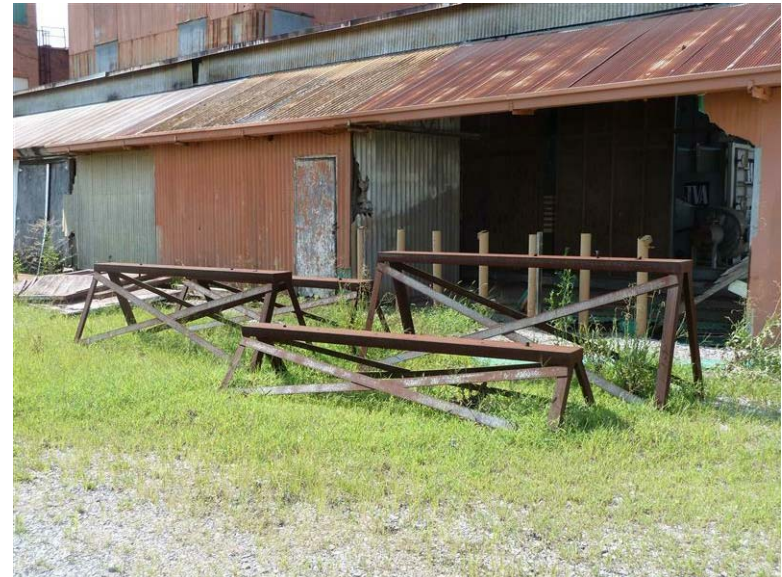
Building 39 – Engineering Lab: Rusty metal outside shed addition.

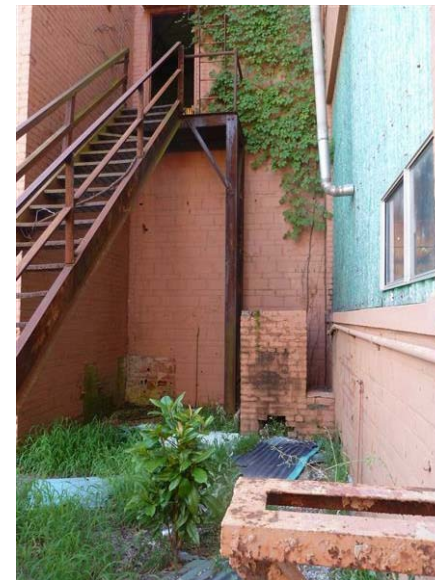
Building 39 – Engineering Lab: This exterior metal stair is severely rusted.

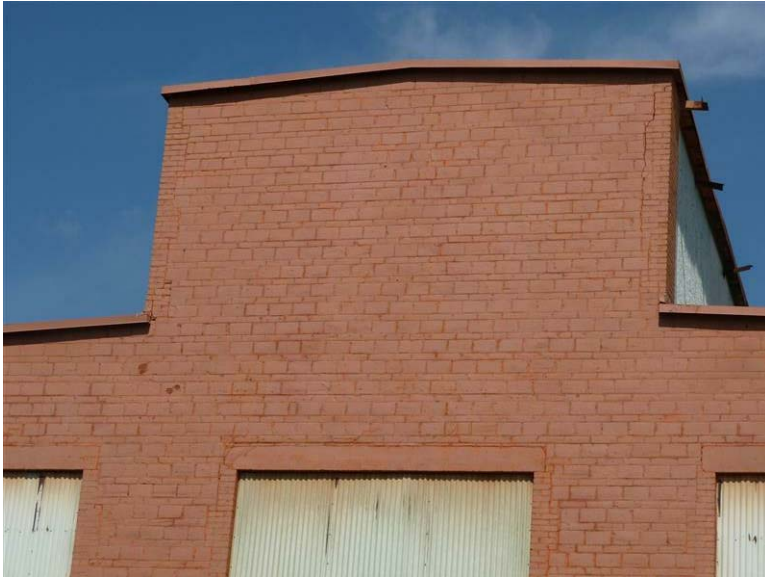
Building 39 – Engineering Lab: Cracking is visible at the hollow clay tile and brick quoins on the upper wall.

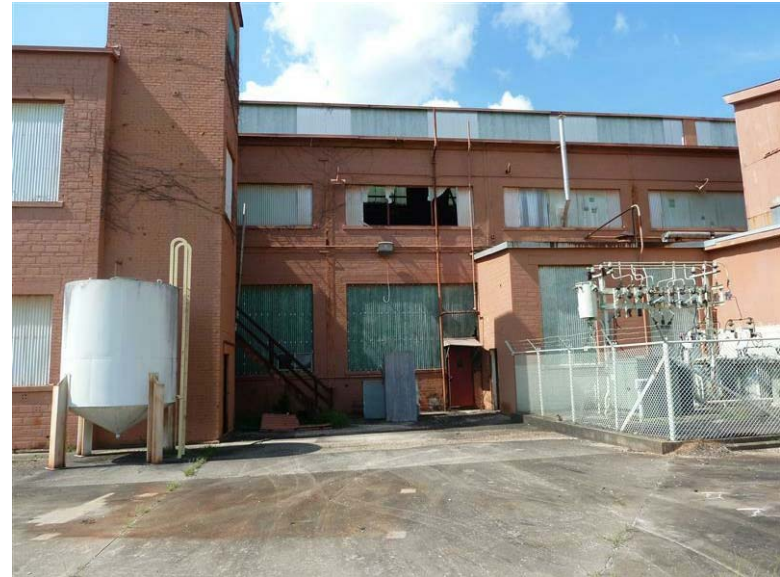
Building 39 – Engineering Lab: The fiberglass panels covering the windows are torn and missing in some areas, exposing the interior to moisture.

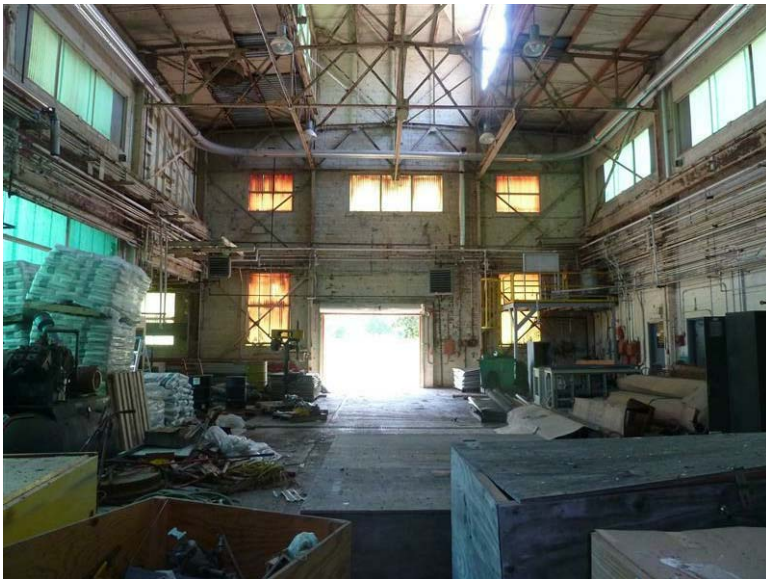
Comments
Severe water damage to majority of concrete ceiling panels; metal deck used for repair in areas Interior wall of hollow clay tile dividing building into two areas Entire interior painted, including steel structure, concrete ceiling panels, and hollow clay tile Concrete floor has trench drains in several areas Steel showing signs of rust from extensive water intrusion Large wood doors and original steel windows in hollow clay tile wall between spaces intact

Building 39 – Engineering Lab: This portion of the building is a double height space. Several concrete ceiling panels have been replaced with metal panels.

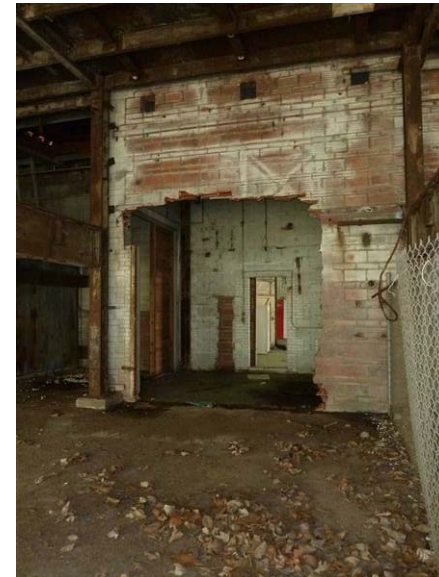
Building 39 – Engineering Lab: The lintel is missing where an opening was made in the hollow clay tile wall adjacent to the south addition.

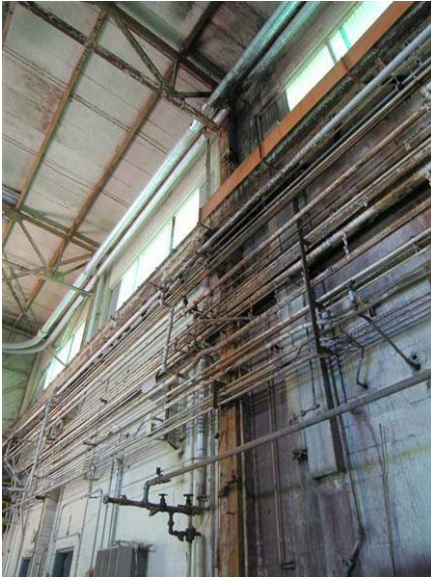
Building 39 – Engineering Lab: Severe water damage has rusted the steel column and stained the wall.

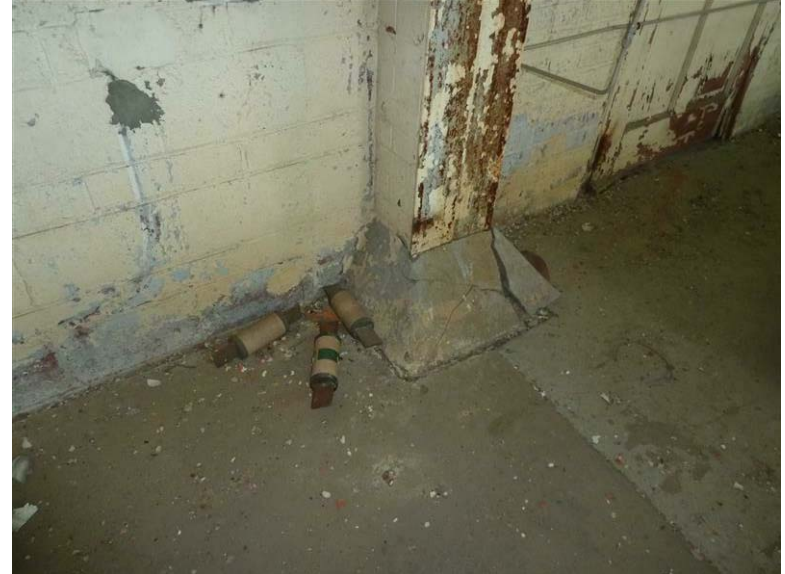
Building 39 – Engineering Lab: The concrete footing at this column is cracked.

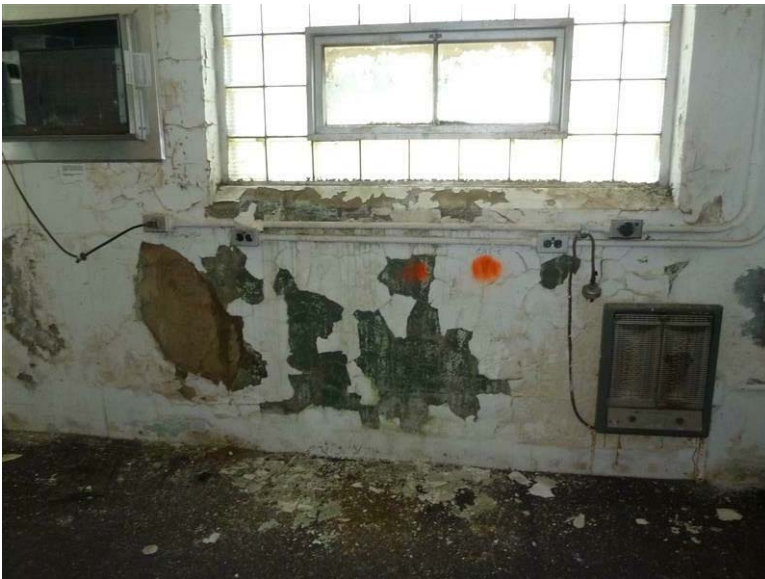
Building 39 – Engineering Lab: Water infiltration has severely damaged this plaster wall on the north facade.

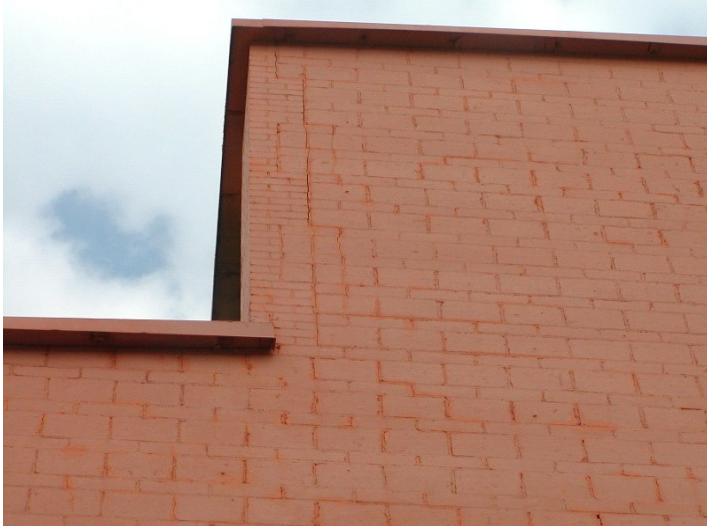
2009 Photo #5: Crack in masonry at end wall East side

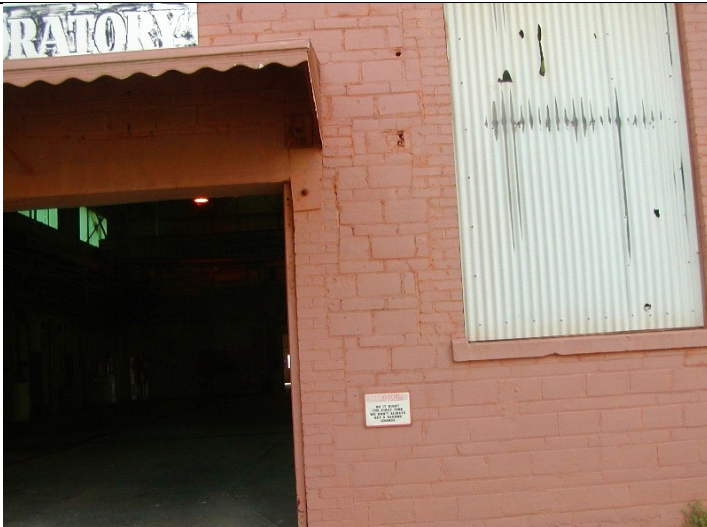
2009 Photo #6: Crack in wall by door opening West end

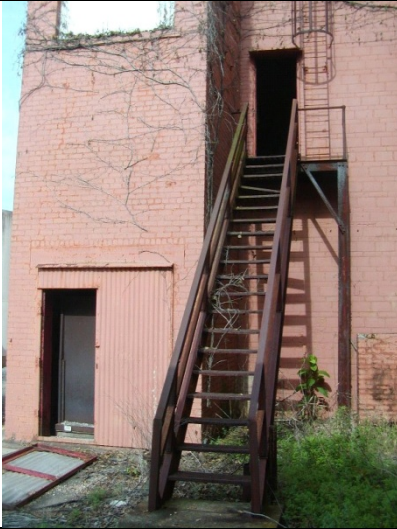
2009 Photo #7: Deteriorated exterior steel stair

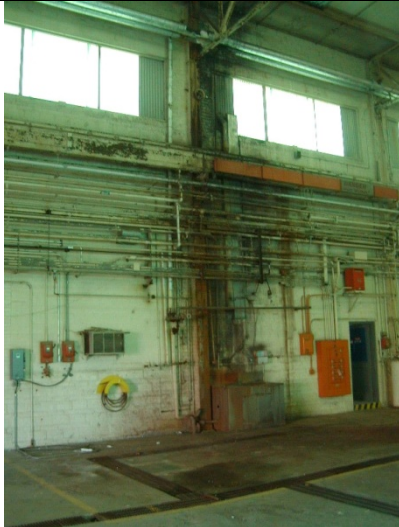
2009 Photo #11: Deteriorated wall construction North side of main building

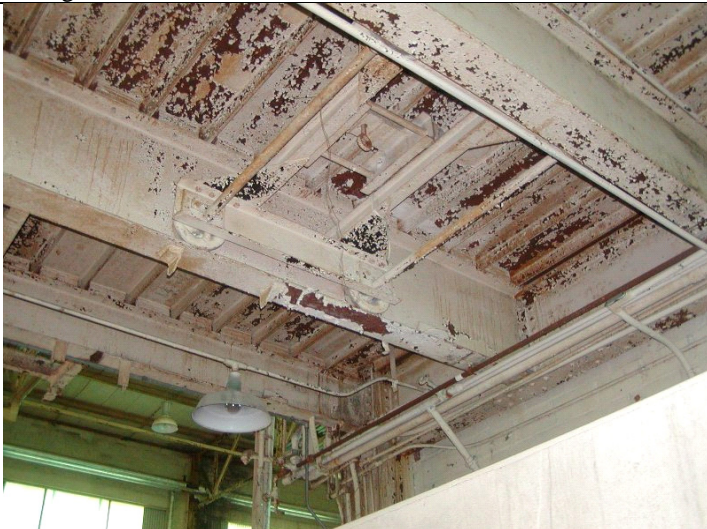
2009 Photo #12: Corroded steel below second floor at Southwest corner

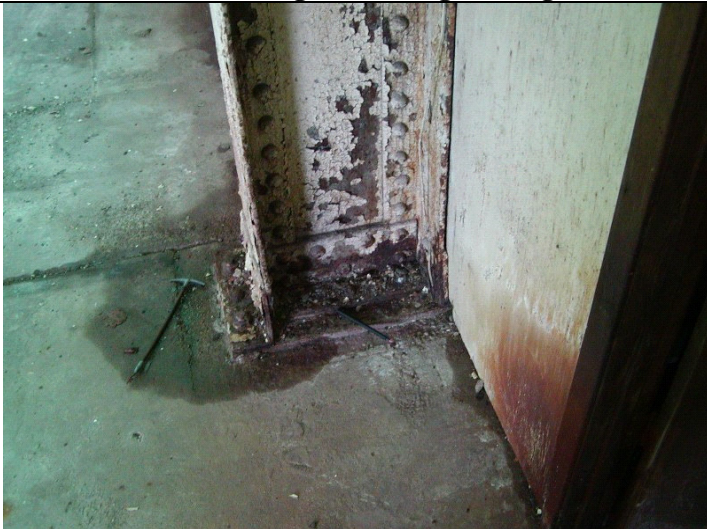
2009 Photo #13: Corroded steel column North side of main building

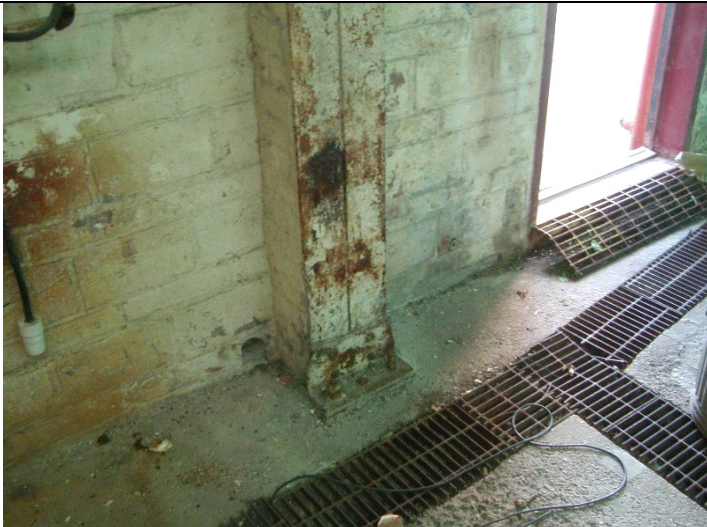
2009 Photo #14: Corroded steel column and deteriorated steel trench grates at South side of main building

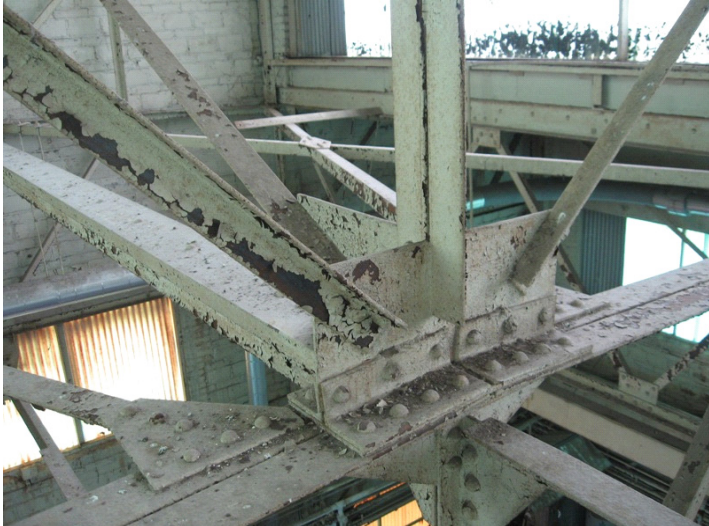
2009 Photo #19: Flaking paint at corroded steel roof framing

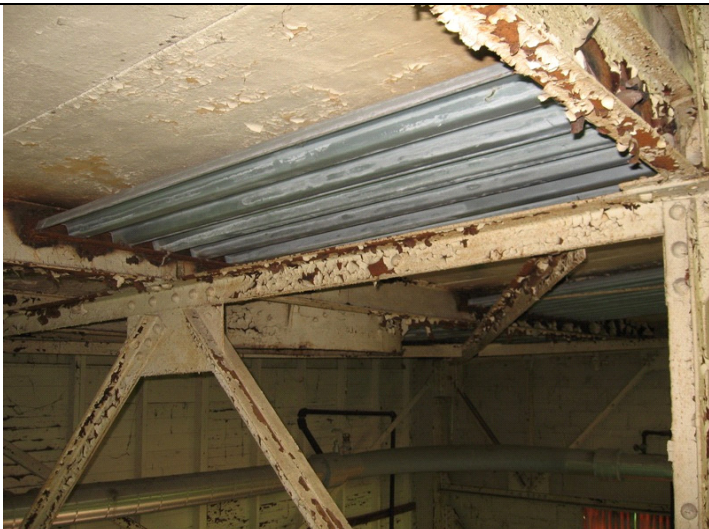
2009 Photo #20: Flaking paint at corroded steel roof framing

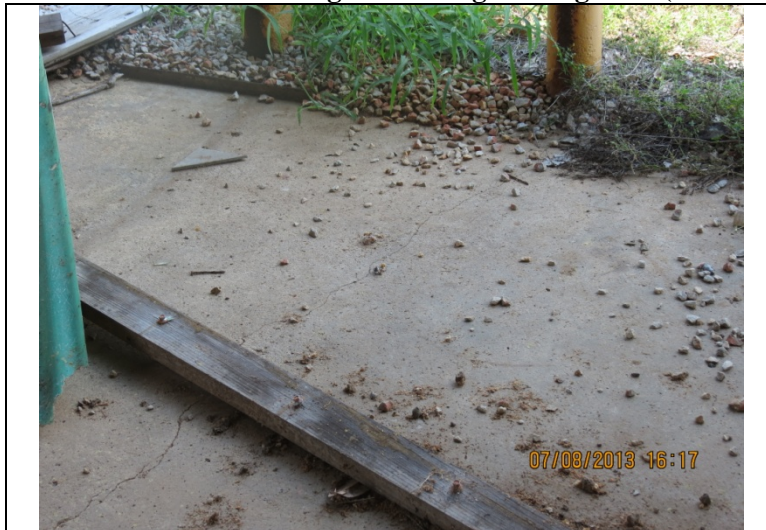
2013 Photo #21: East end of extension, crack in slab on grade perpetuates across entire width of structure.

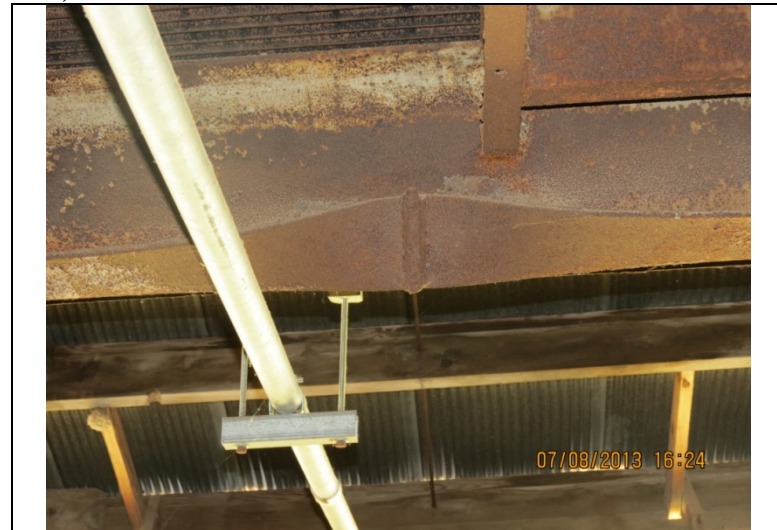
2013 Photo #22: Damaged steel beam due to impact or other unforeseen use of member.

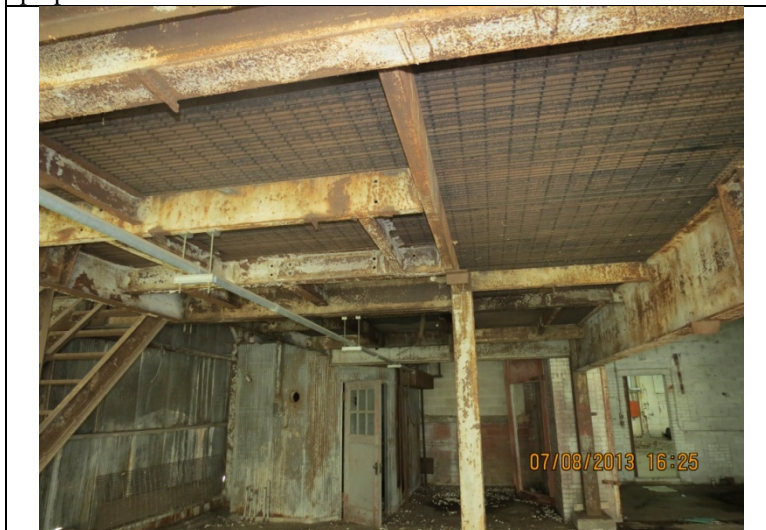
2013 Photo #23: Severely corroded steel framing at west end of structure.

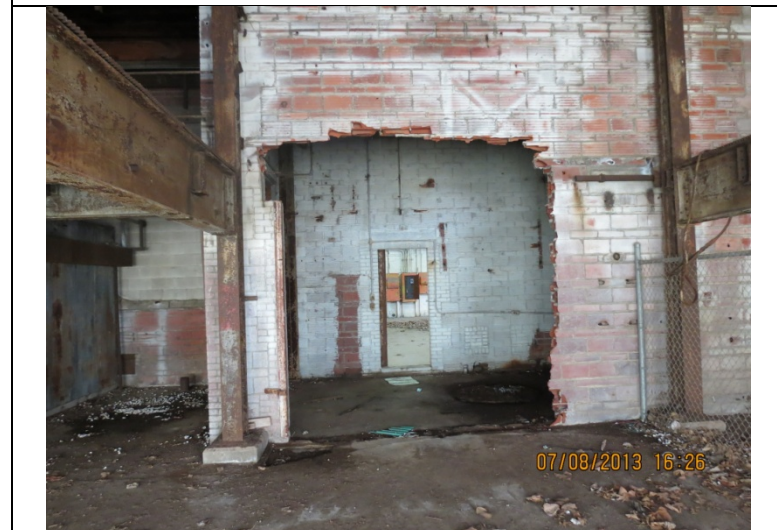
2013 Photo #24: Hole in masonry wall of main section of Building 39. Steel framing has been cut as well.

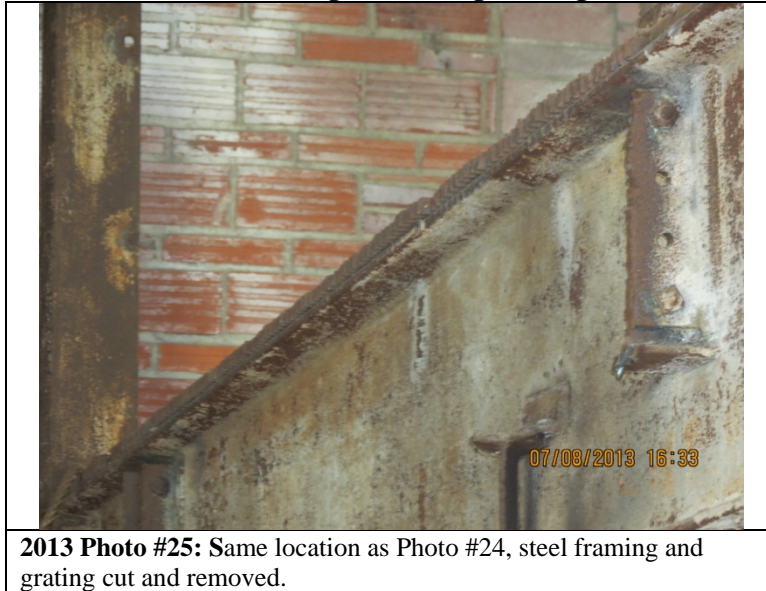
2013 Photo #25: Same location as Photo #24, steel framing and grating cut and removed.

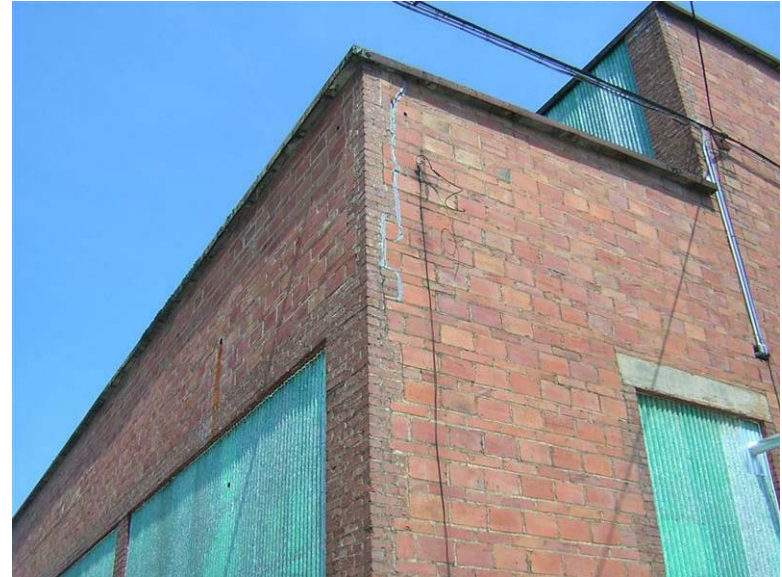
Building 41 – Sheet Metal Shop: Cracking is visible in the hollow clay tile and brick quoins located at the upper corners of the building.

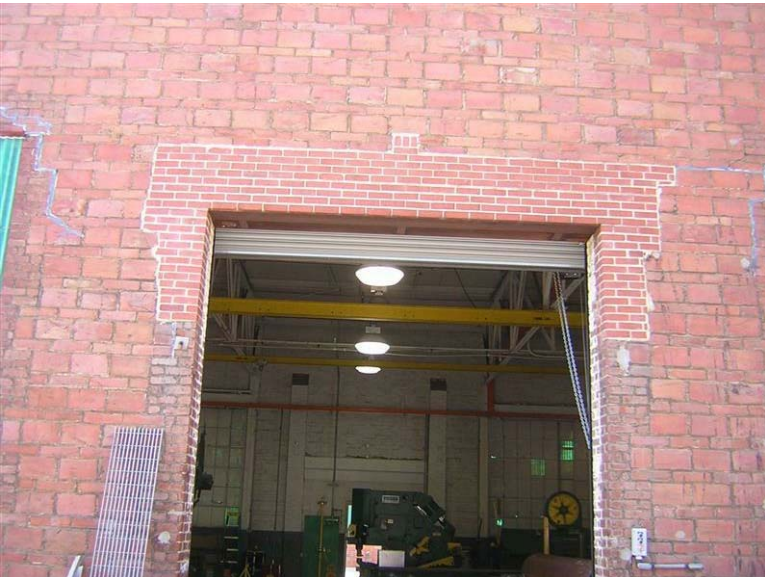
Building 41 – Sheet Metal Shop: The brick door surround has been replaced with incompatible brick in a non-historic pattern.

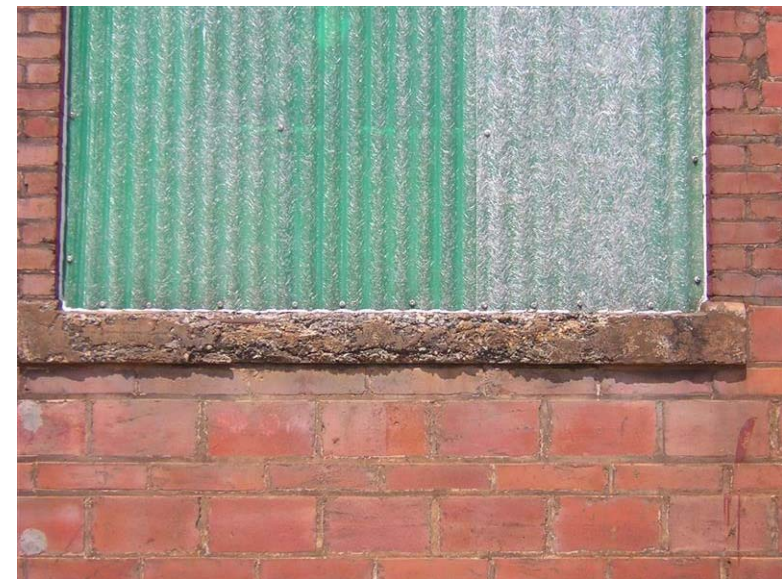
Building 41 – Sheet Metal Shop: Localized spalling of concrete sills is prevalent.

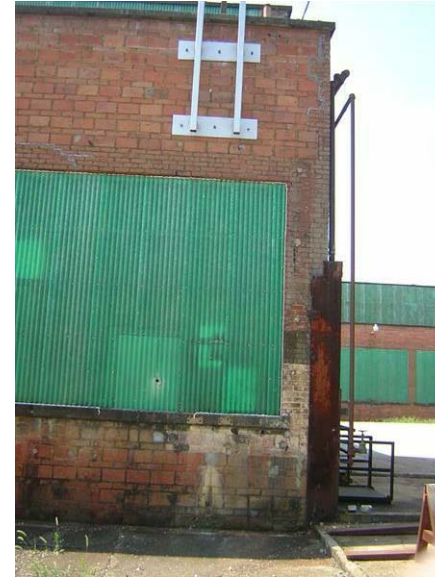
Building 41 – Sheet Metal Shop: Water staining and efflorescence are visible on the west side of the north wall.

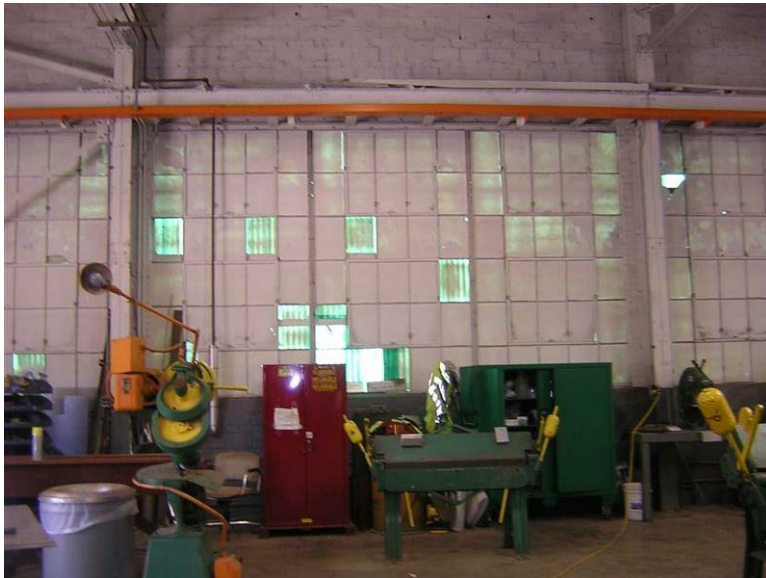
Building 41 – Sheet Metal Shop: Glass panes are missing in many windows. The exterior of the windows are covered with fiberglass panels.

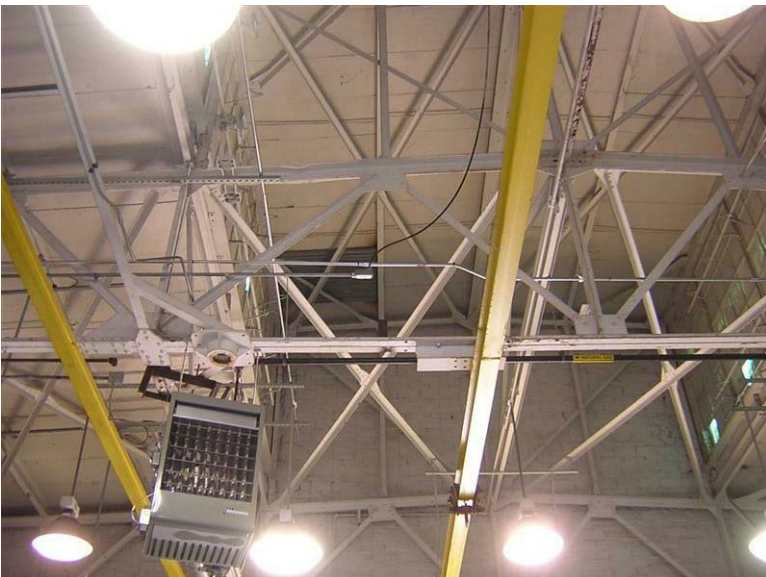
Building 41 – Sheet Metal Shop: Although the steel truss system is painted, rusting occurs and paint is flaking.

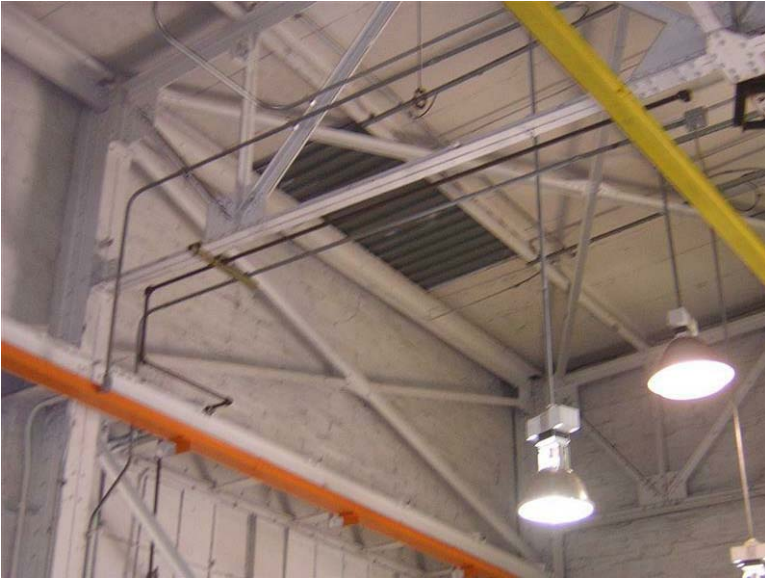
Building 41 – Sheet Metal Shop: Some of the concrete ceiling panels have been replaced with metal panels.

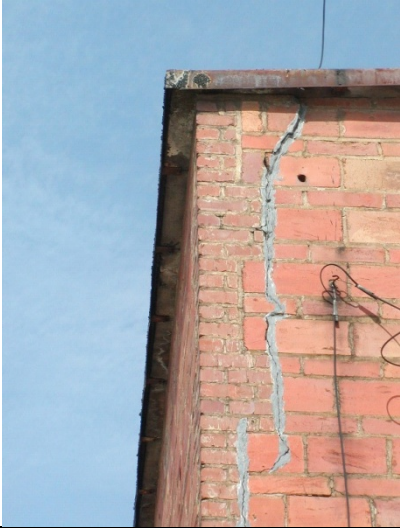
2009 Photo #5: Cracked and partially dislodged masonry at Southeast corner

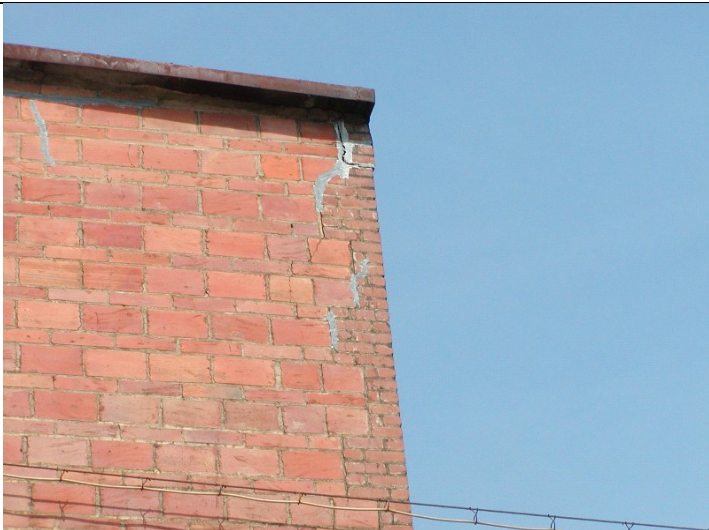
2009 Photo #6: Cracks in masonry at Northeast corner

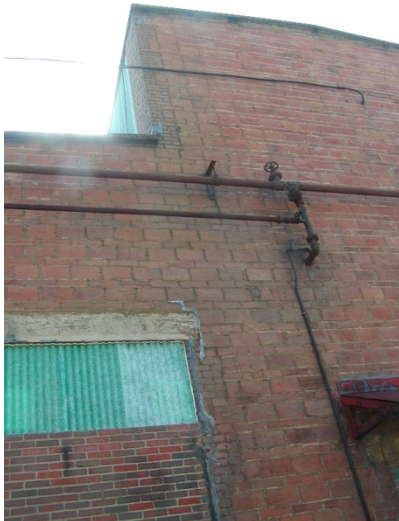
2009 Photo #7: Surface deterioration and cracks in exterior masonry at West wall

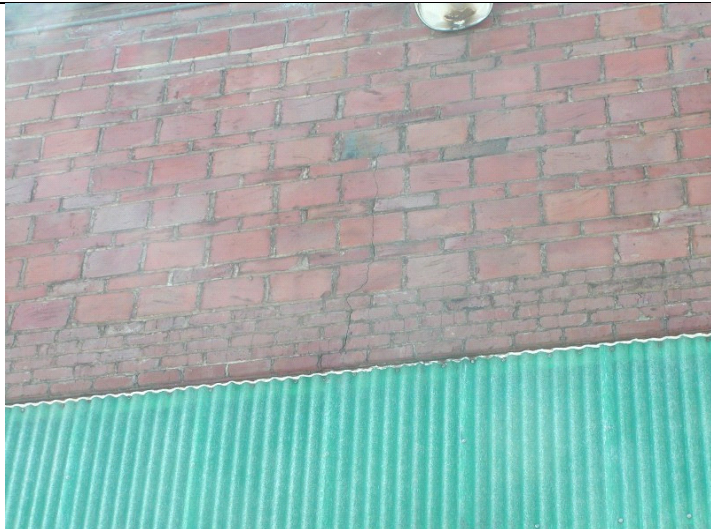
2009 Photo #8: Crack above window opening on North side

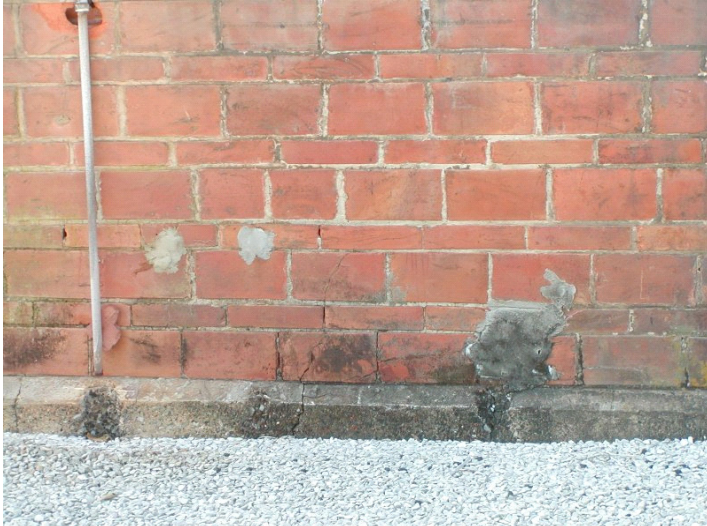
2009 Photo #9: Cracks in masonry and exposed slab edge on North side

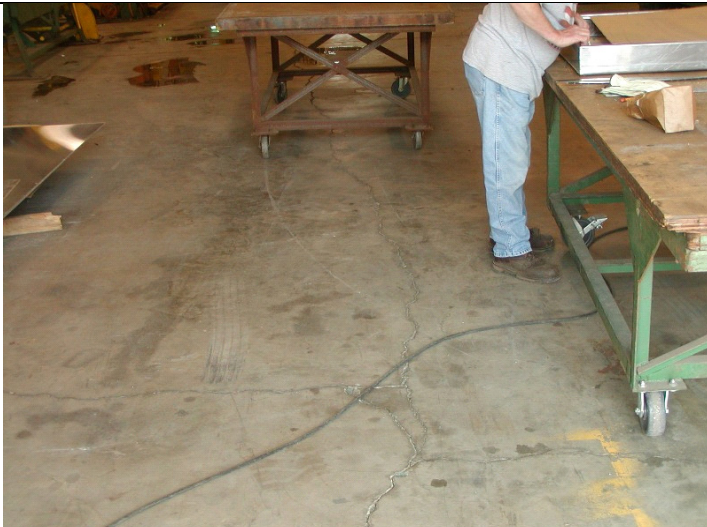
2009 Photo #10: Large cracks in concrete floor slab

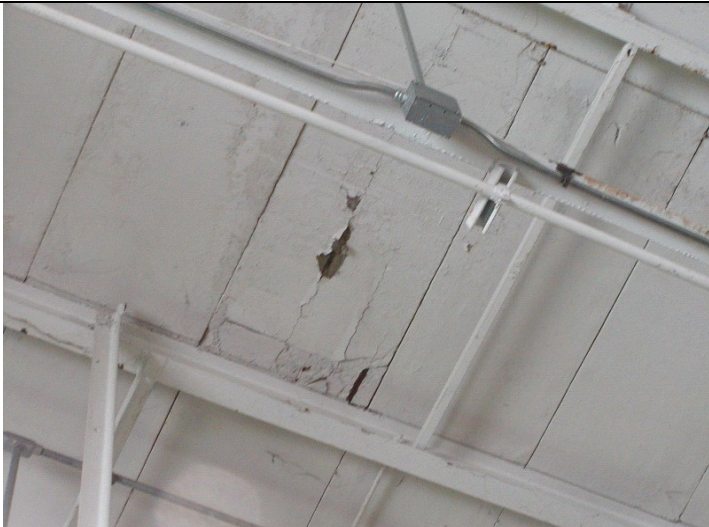
2009 Photo #12: Structurally defective concrete roof deck panel

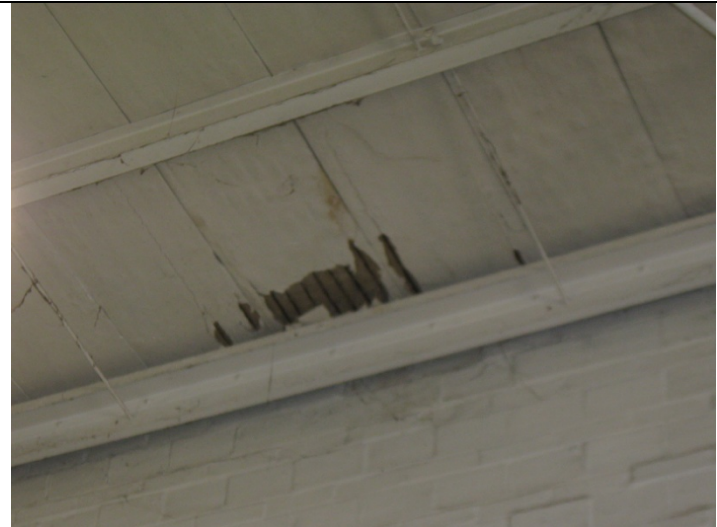
2013 Photo #12: Additional structurally defective concrete roof deck panels – condition in 2009 was not documented

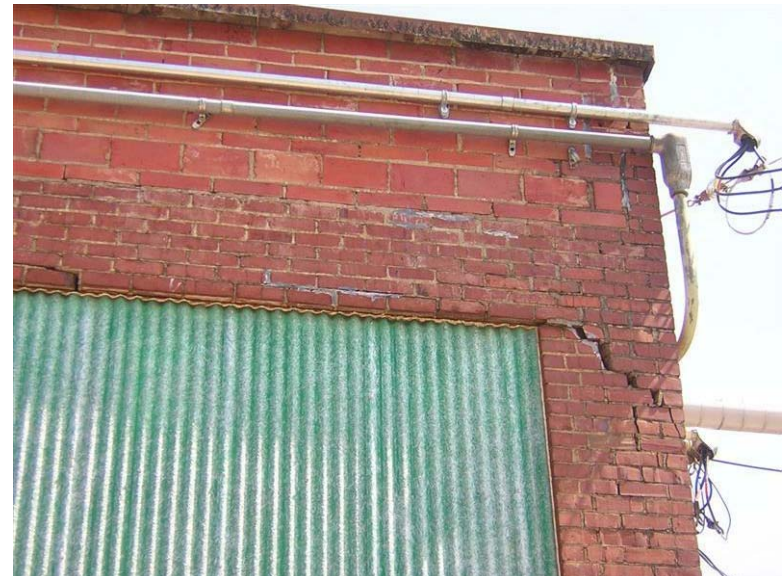
Building 42 – Pipe Shop: There is severe cracking of the brick at the southeast corner of the building.

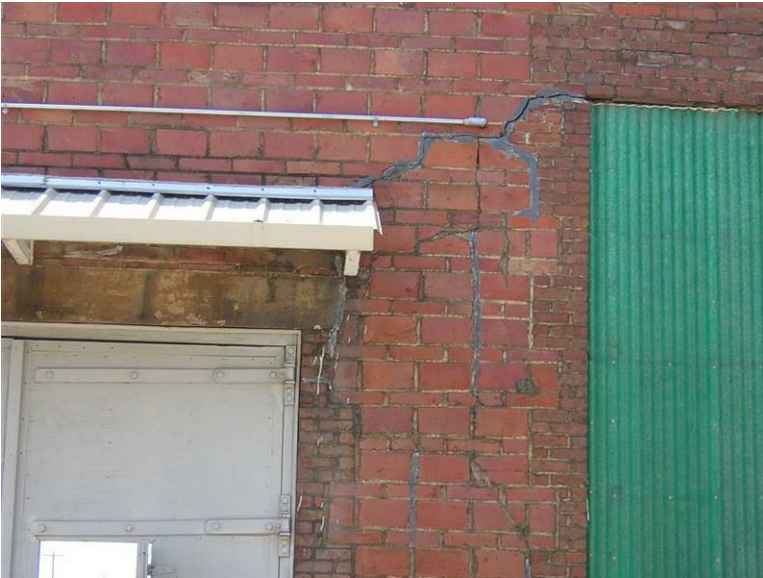
Building 42 – Pipe Shop: Severe cracking is visible on the south wall especially above windows and between openings. Some cracks have been sealed with a material incompatible with the mortar.

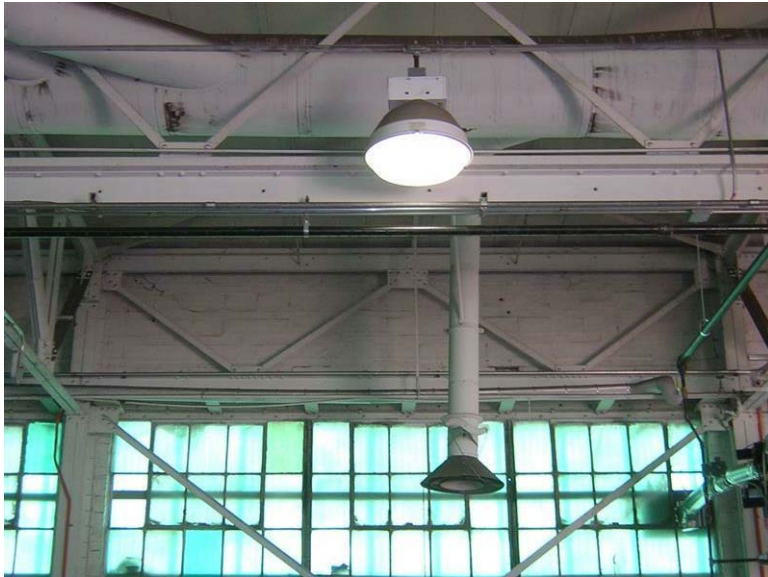
Building 42 – Pipe Shop: The upper hollow clay tile wall is cracked.

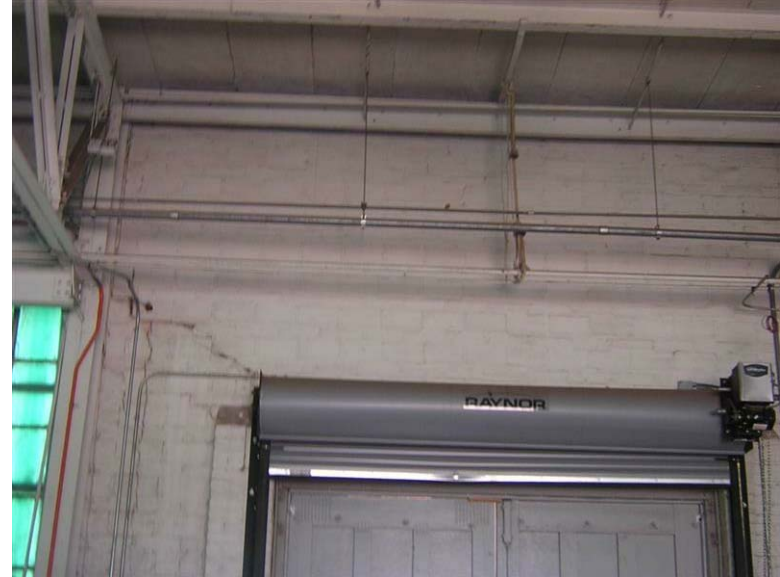
Building 42 – Pipe Shop: Diagonal cracking in the hollow clay tile is prevalent between window and door openings.

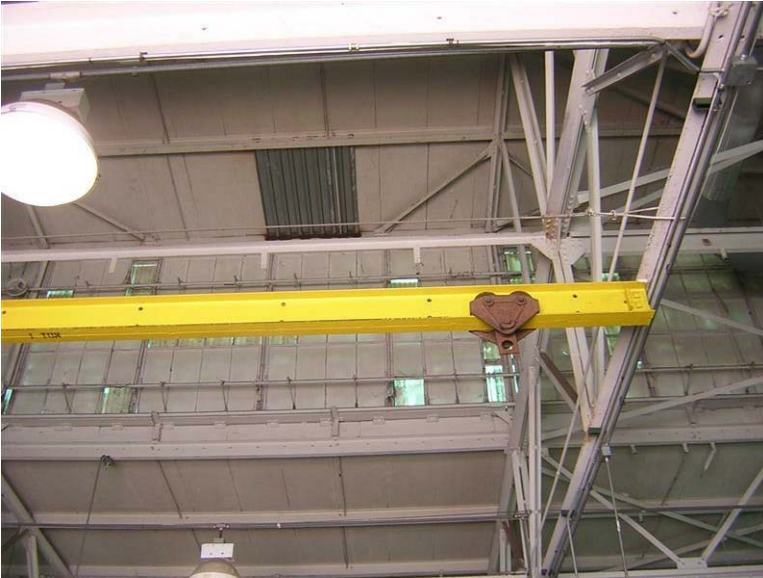
Building 42 – Pipe Shop: Some concrete ceiling panels have been replaced with metal panels.
