Tennessee Valley Authority

Cyclic Assessment Report
TVA Muscle Shoals, Alabama
September 16, 2013

Executive Summary

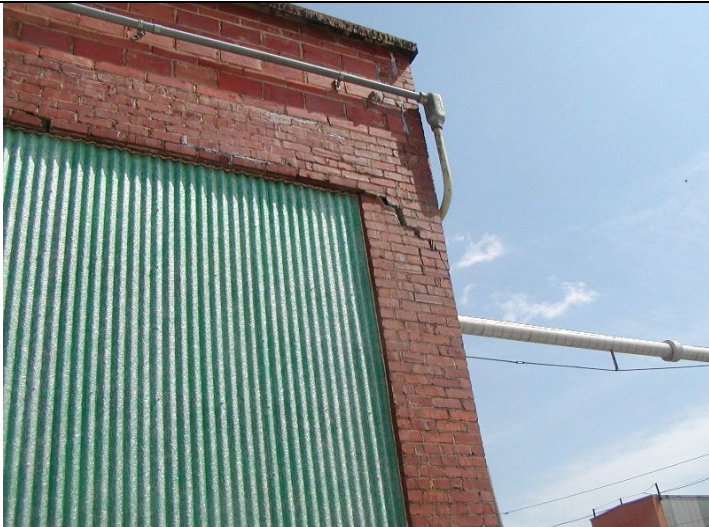
2009 Photo #4: Crack and partially dislodged masonry at Southeast corner

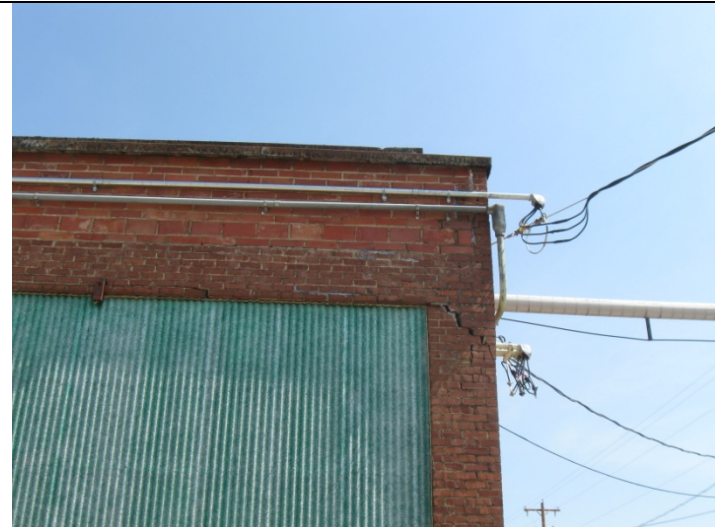
2013 Photo #4: Crack and partially dislodged masonry at Southeast corner exhibits minor progressive deterioration

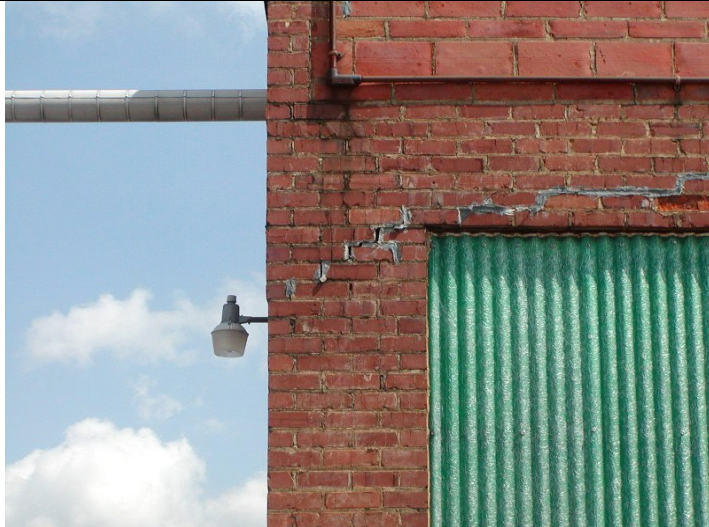
2009 Photo #5: Horizontal crack in masonry at Southwest corner

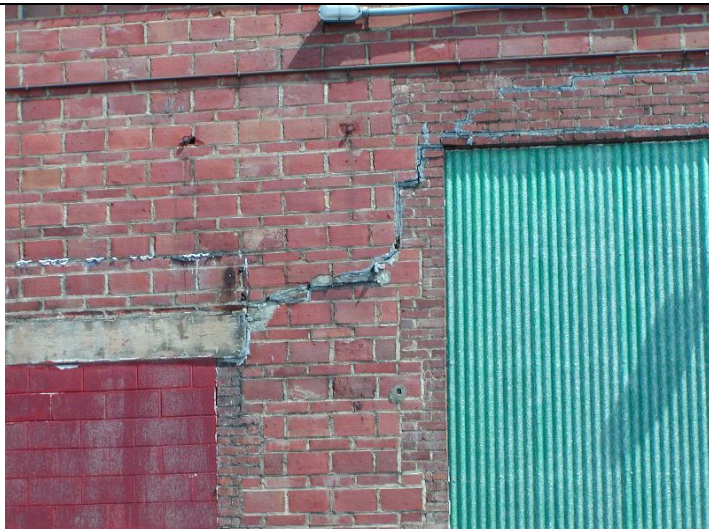
2009 Photo #6: Cracks in masonry on South side

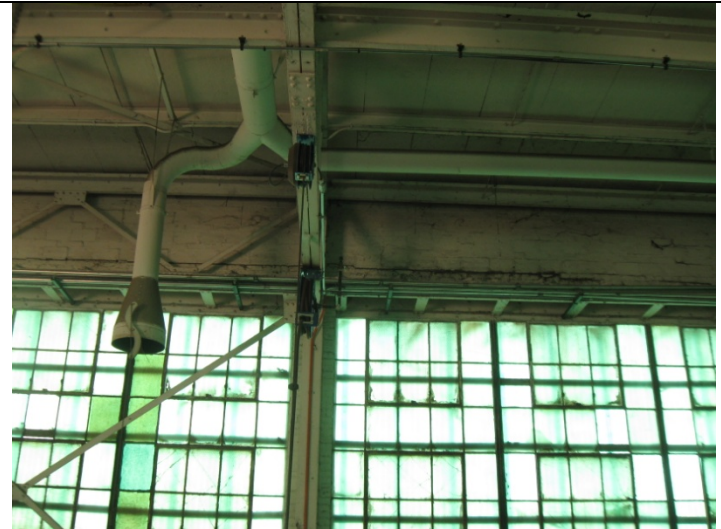
2013 Photo #7: Minor progressive deterioration of masonry above windows was observed

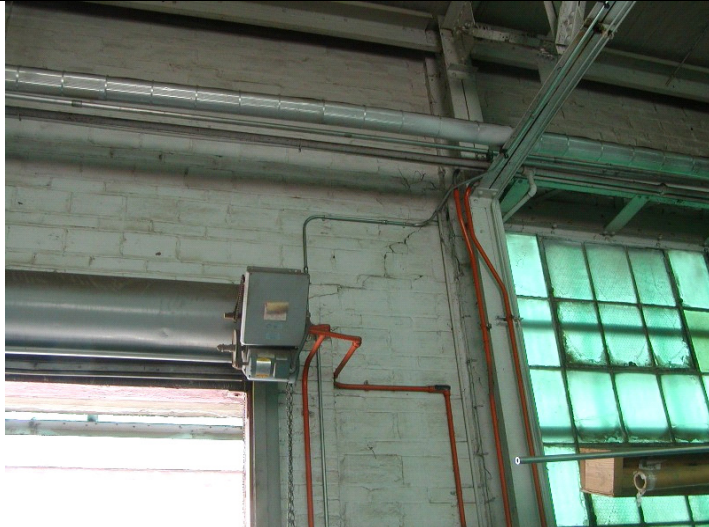
2009 Photo #9: Example of diagonal crack in masonry at overhead doors

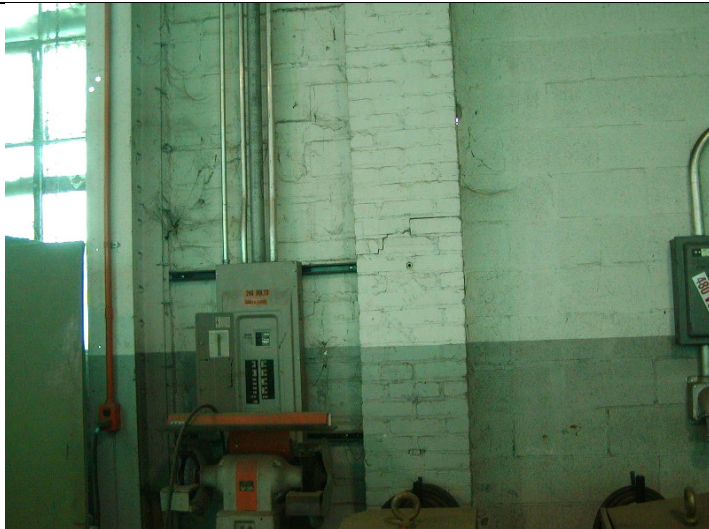
2009 Photo #10: Horizontal crack in brick pier

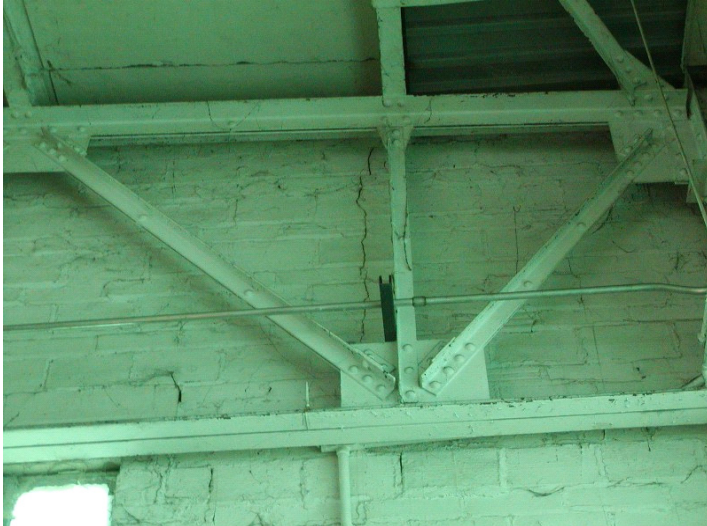
2009 Photo #11: Crack in masonry at end wall

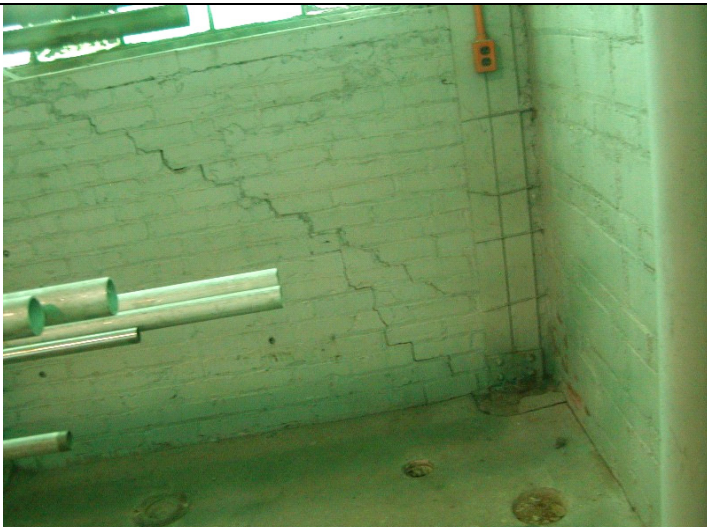
2009 Photo #12: Diagonal crack in masonry at corner of building below window

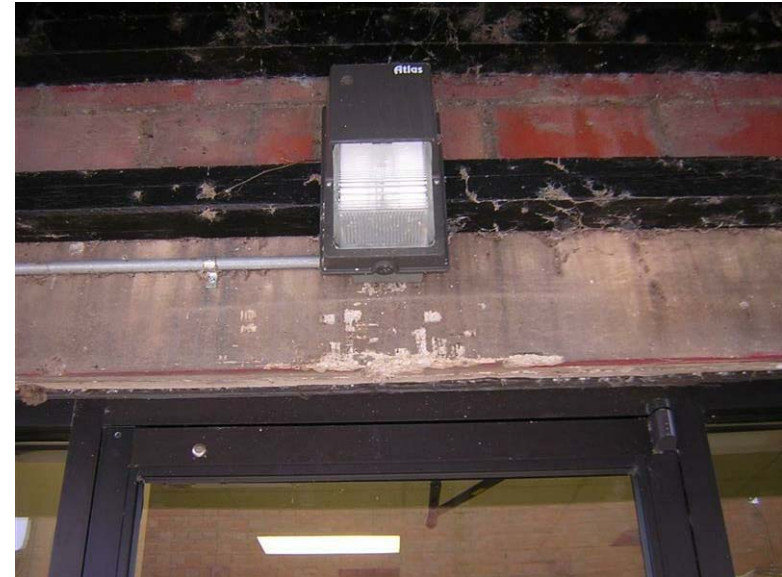
Building 44 – Project Operations Bath House: The concrete lintel is chipped at the main entrance on the west facade.

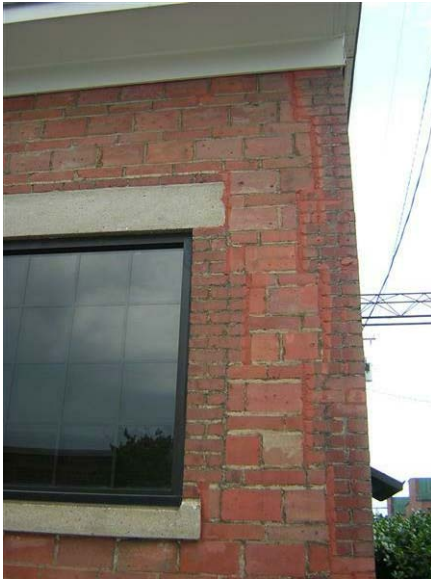
Building 44 – Project Operations Bath House: The cracks along the quoins have been infilled with red mortar.

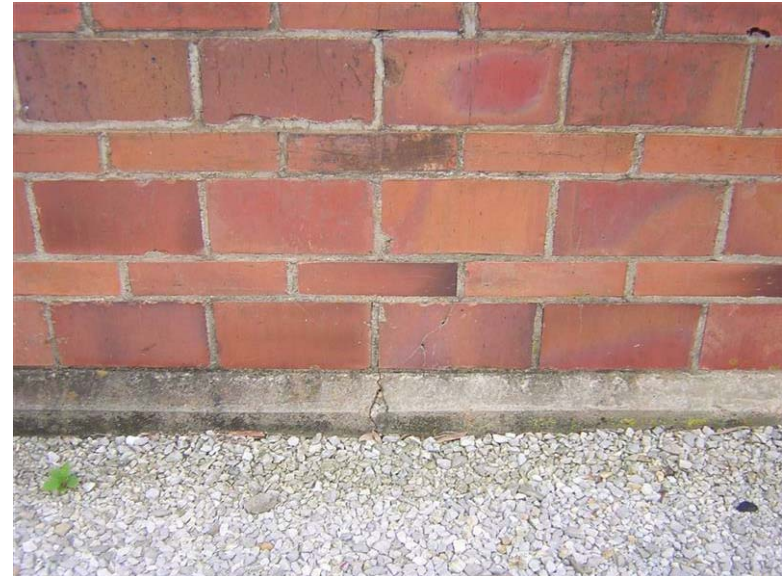
Building 44 – Project Operations Bath House: The concrete foundation is cracked in several areas.

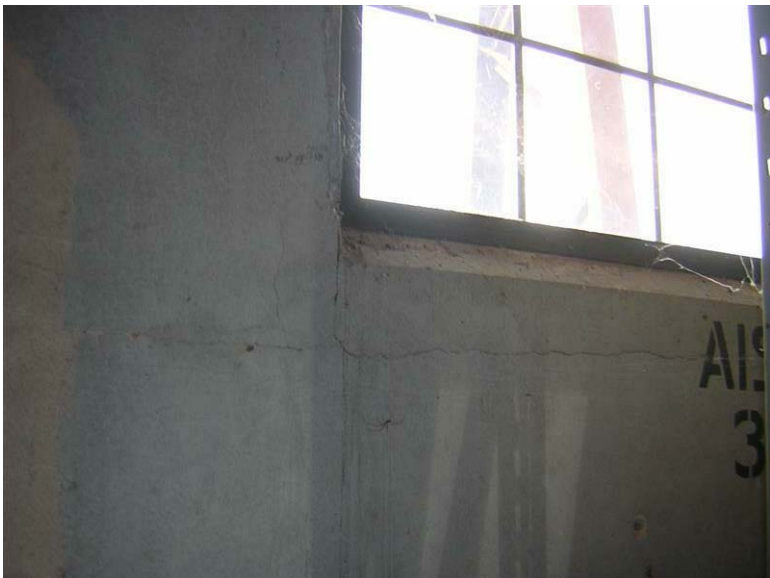
Building 44 – Project Operations Bath House: A horizontal crack is visible on the south wall beneath the sill in the storage area.

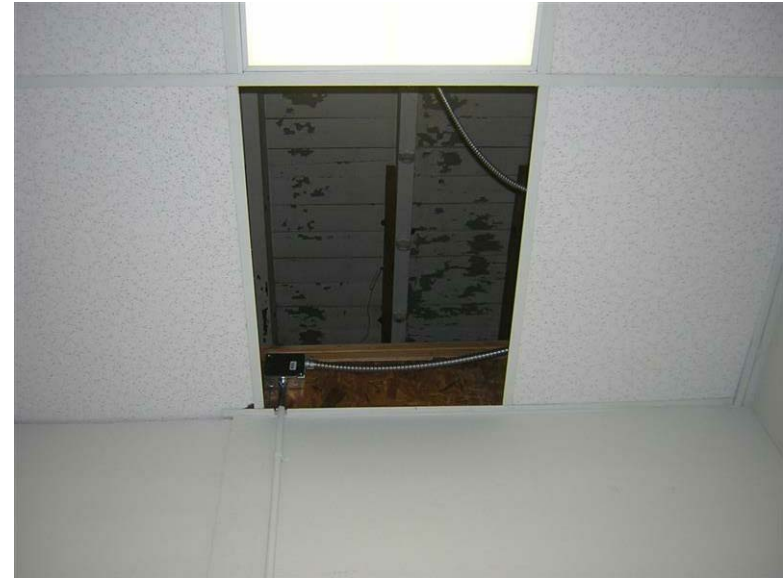
Building 44 – Project Operations Bath House: Wood roof decking and plywood is visible above the acoustical ceiling tiles.

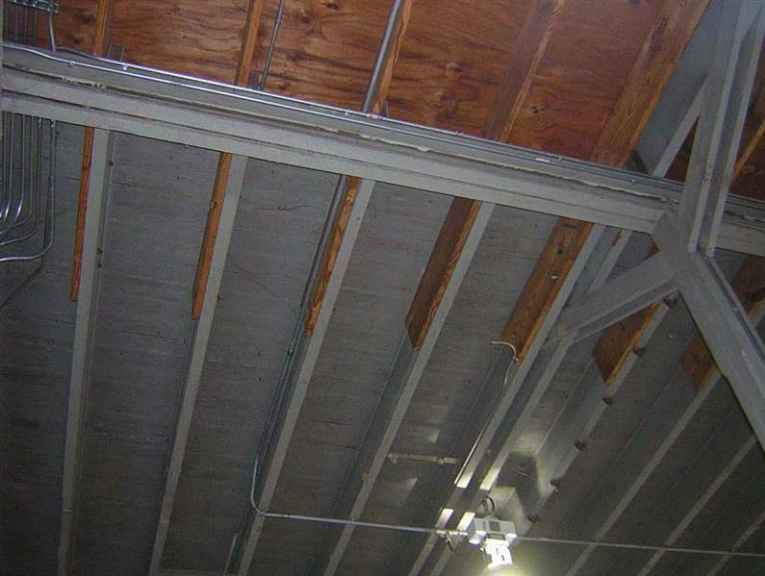
Building 44 – Project Operations Bath House: The wood decking has been partially replaced with plywood in the storage area. New wood structural members have been installed in portions of the roof.

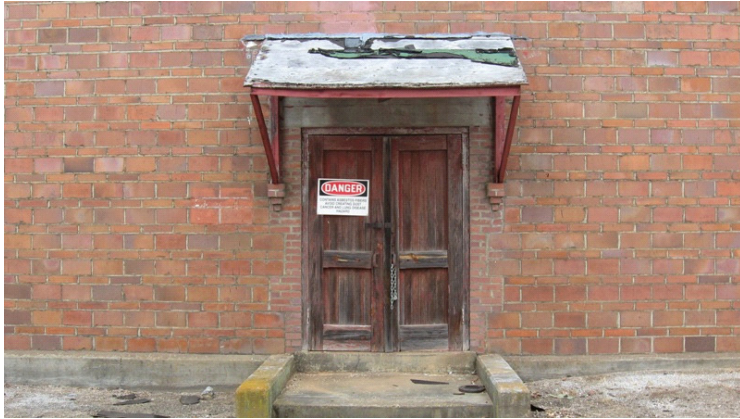
2009 Photo #3: Wood frame exterior awning at East end

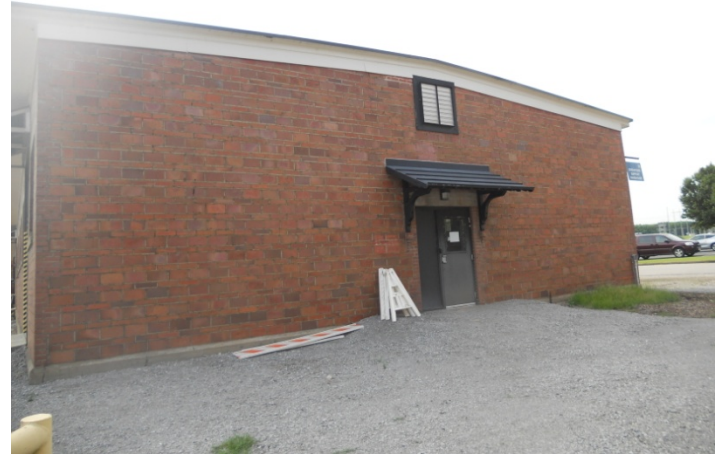
2013 Photo #3: Exterior awnings have been replaced

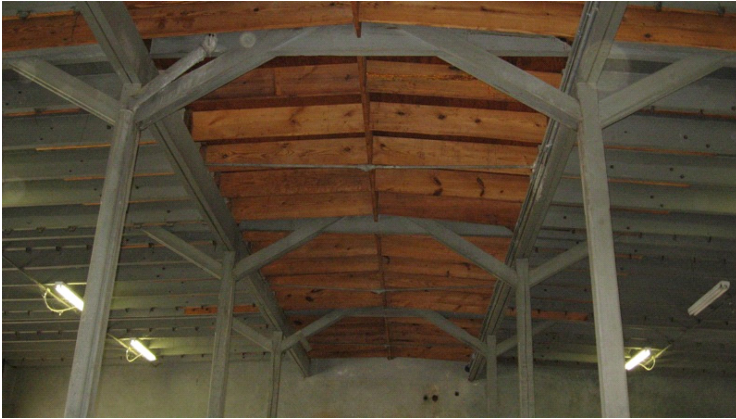
2009 Photo #5: Partially reconstructed wood frame roof structure

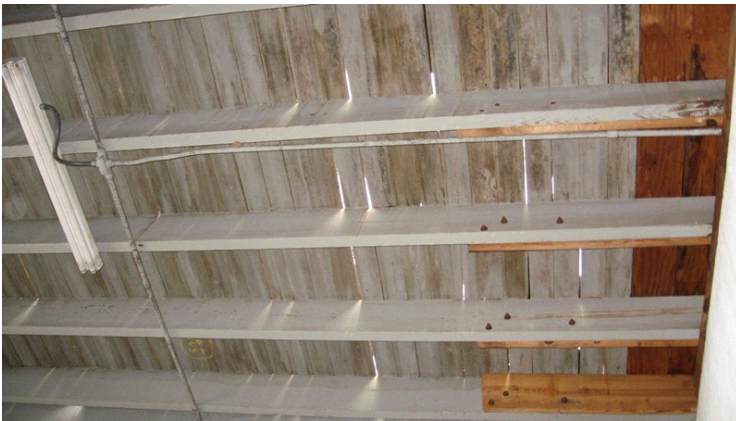
2009 Photo #6: Existing wood plank roof with no roof covering
(Bright spots are daylight visible through roof deck)

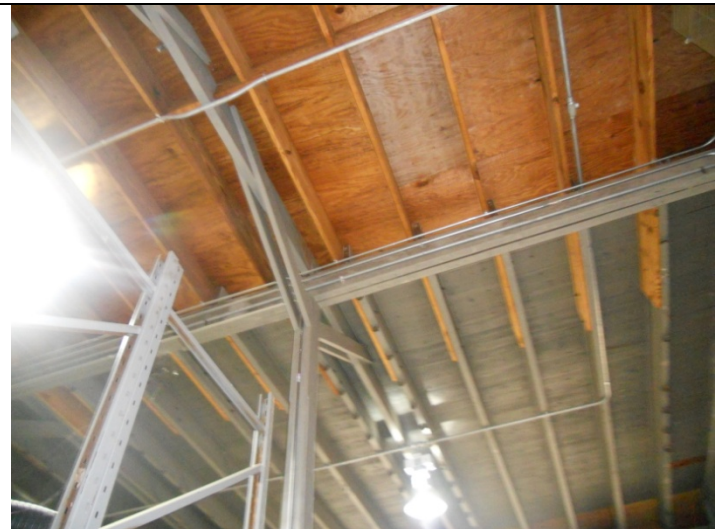
2013 Photo #6: Wood roof framing has been repaired and
deteriorated portions of wood roof deck have been replaced

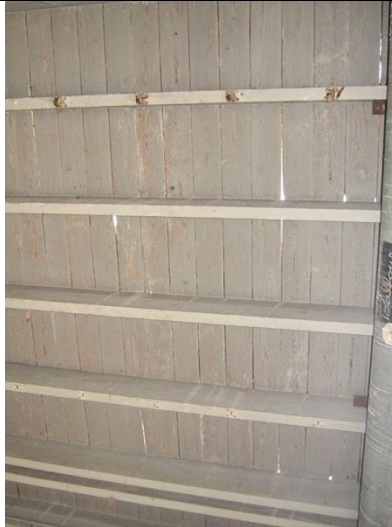
2009 Photo #7: Existing wood plank roof deck with no roof covering (Bright spots are daylight visible through roof deck)

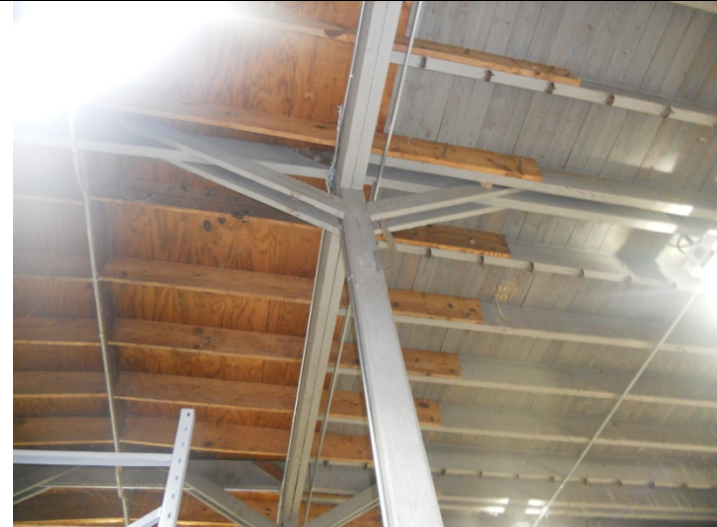
2013 Photo #7: Wood roof framing has been repaired and deteriorated portions of wood roof deck have been replaced

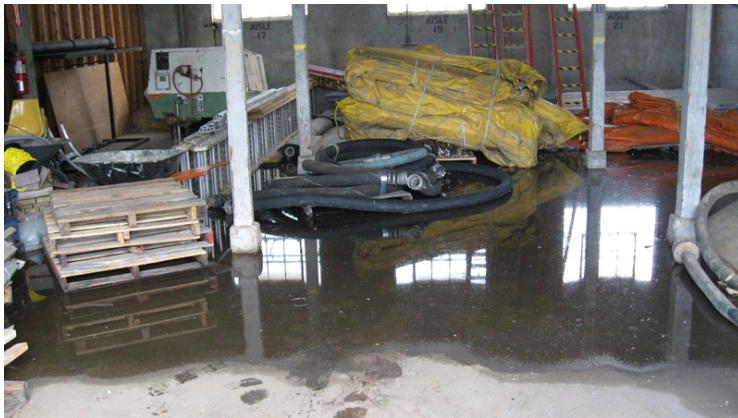
2009 Photo #8: Standing water on floor in one area of uncovered roof deck

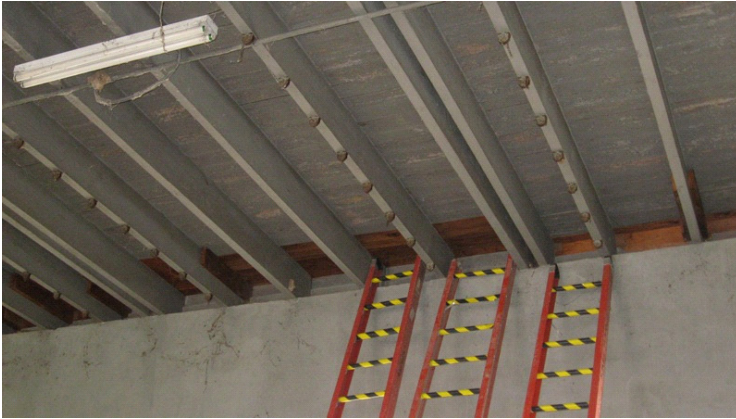
2009 Photo #9: Partially replaced wood roof deck

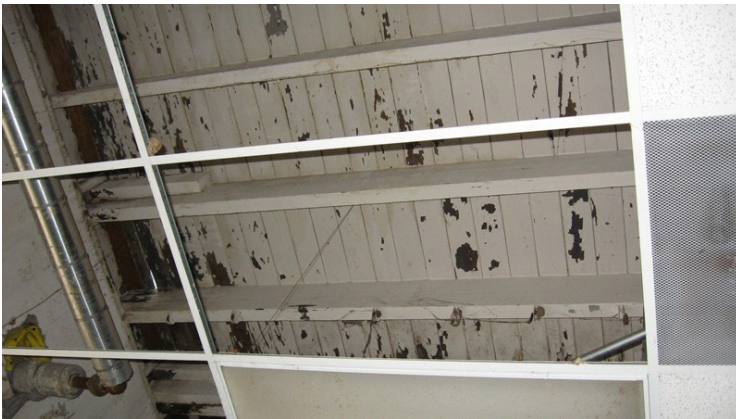
2009 Photo #10: Moisture damage at wood plank roof deck above partially removed lay-in ceiling

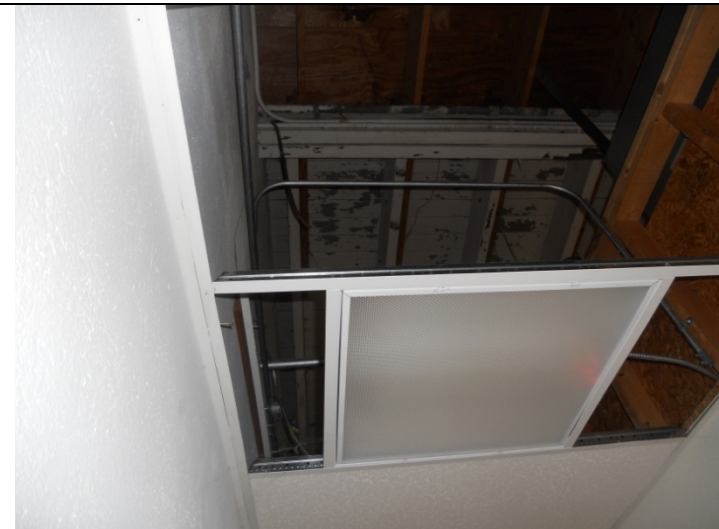
2013 Photo #10: Repairs to roof deck visible above partially removed lay-in ceiling

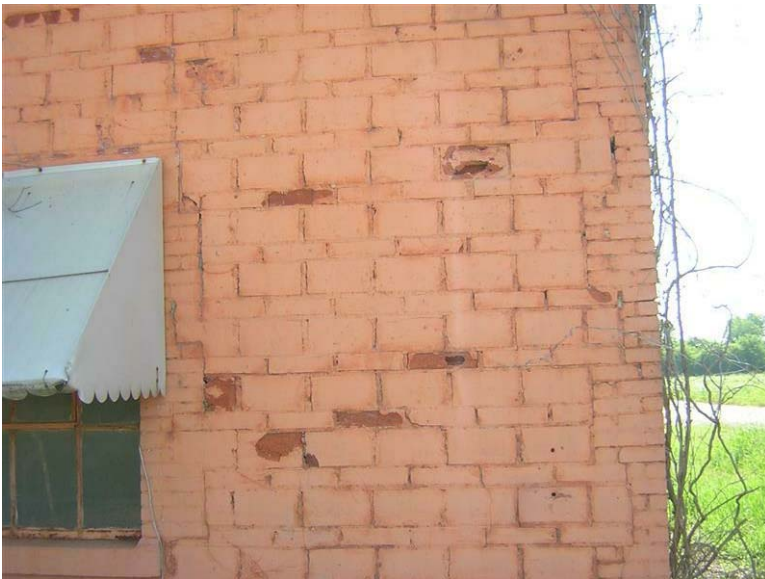
Building 53 – Tin Shop: The hollow clay tile is spalling on the west facade.

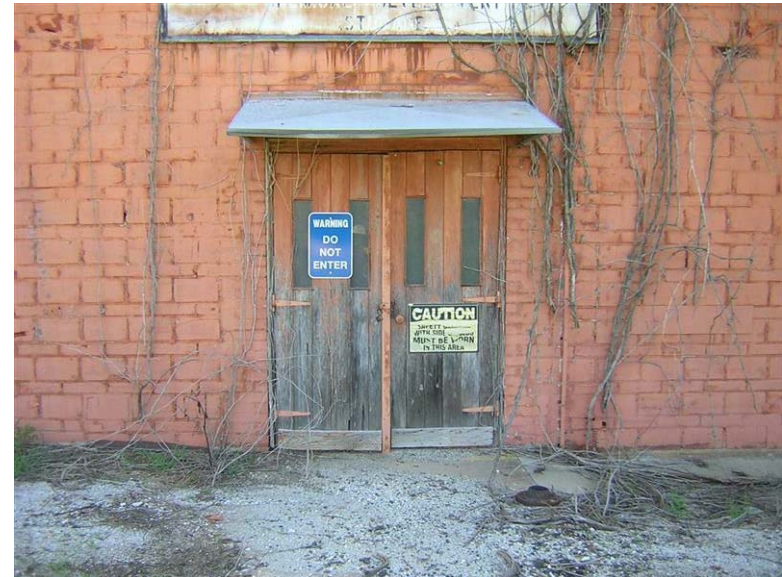
Building 53 – Tin Shop: Paint is flaking from the wooden doors.

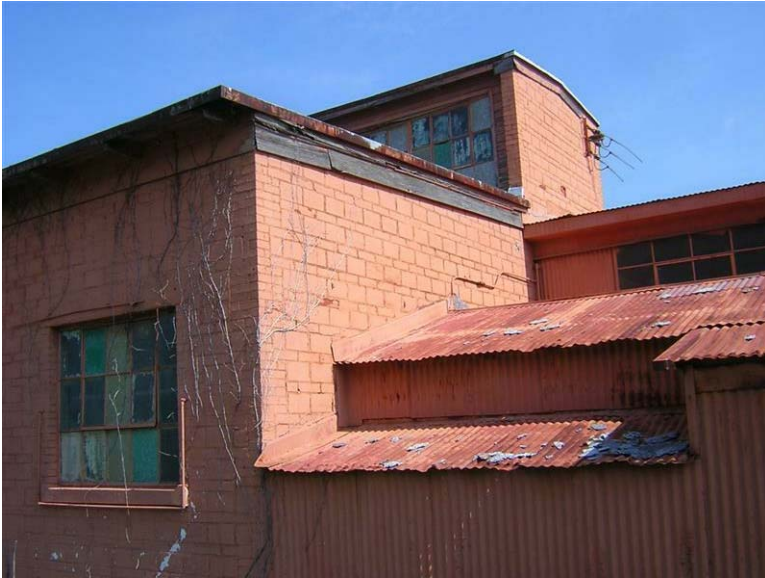
Building 53 – Tin Shop: The wood fascia board is in poor condition and the metal roof is rusted.

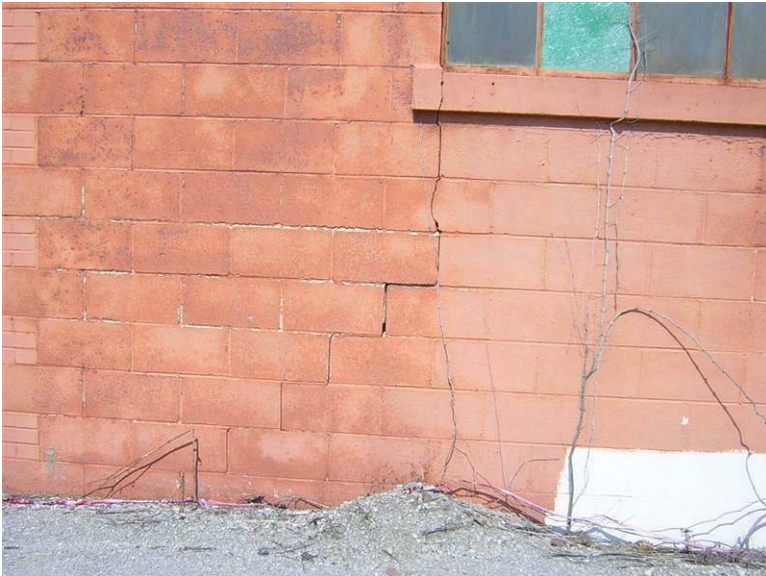
Building 53 – Tin Shop: Diagonal cracking is located beneath this window on the south facade.

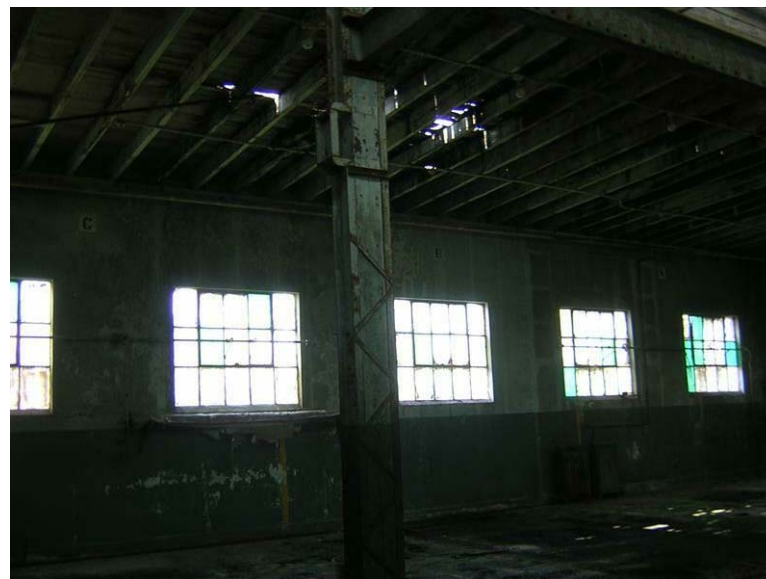
Building 53 – Tin Shop: Daylight is shining through holes in the roof decking.

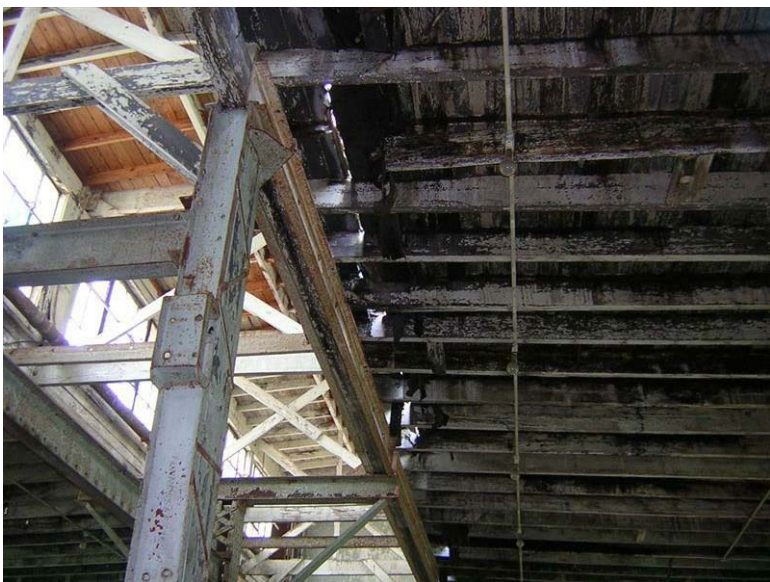
Building 53 – Tin Shop: The roof is stained from water damage.

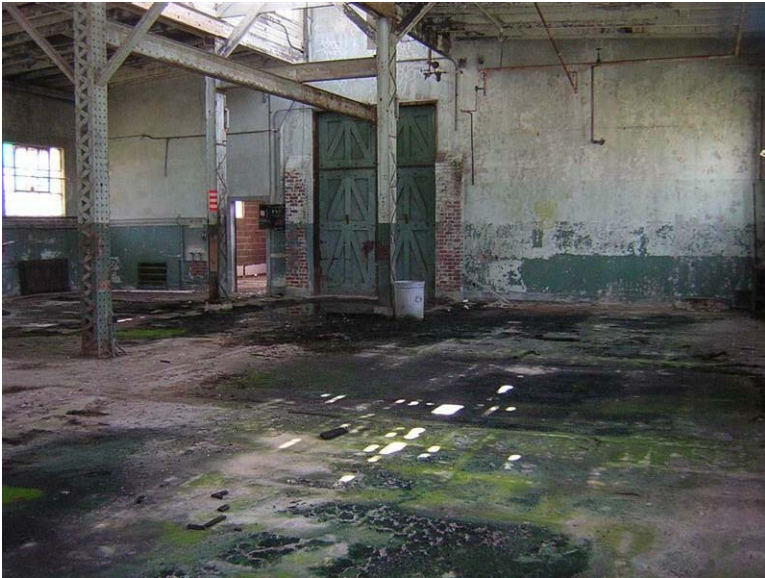
Building 53 – Tin Shop: Standing water has collected on the concrete floor in the primary space.

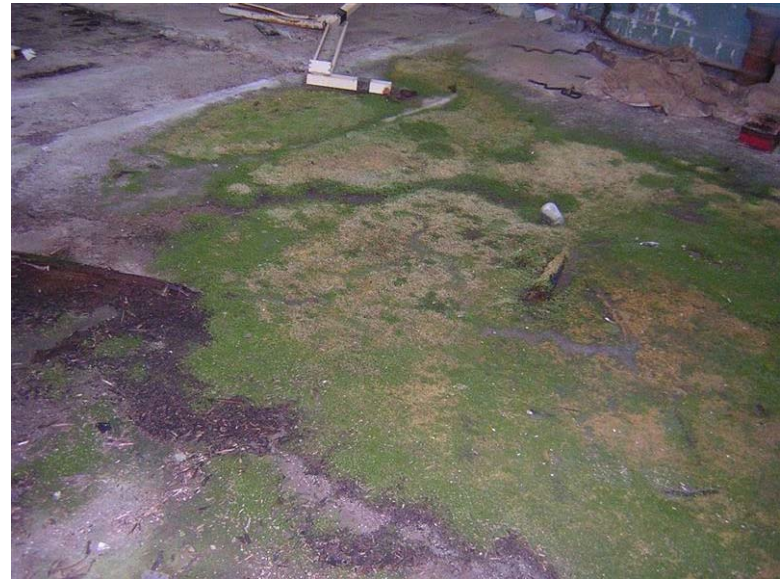
Building 53 – Tin Shop: Moss growth is prevalent on the concrete floor in the primary space.

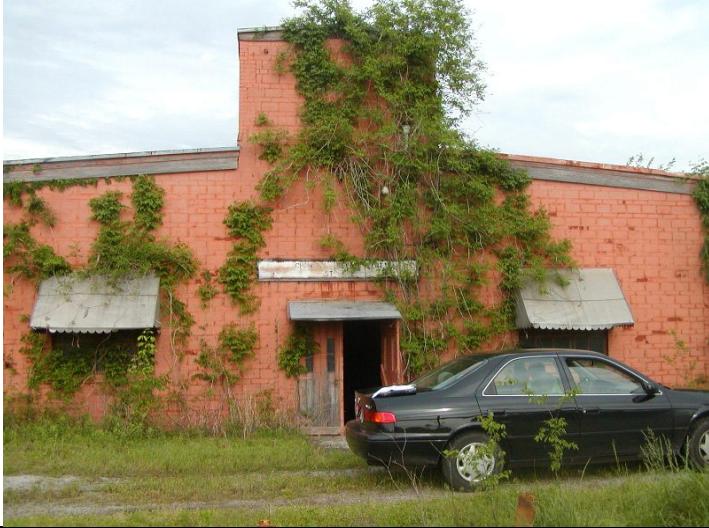
2009 Photo #1: Exterior building, looking at west elevation

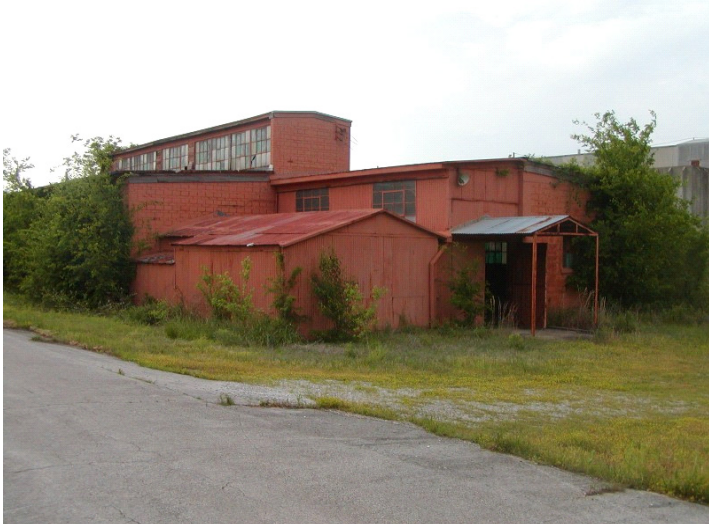
2009 Photo #2: Exterior building looking at additions on east end

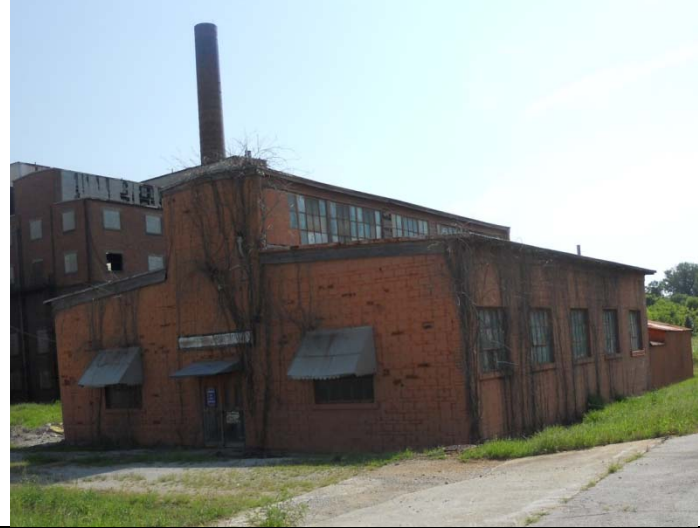
2013 Photo #1: Exterior building, west and south sides

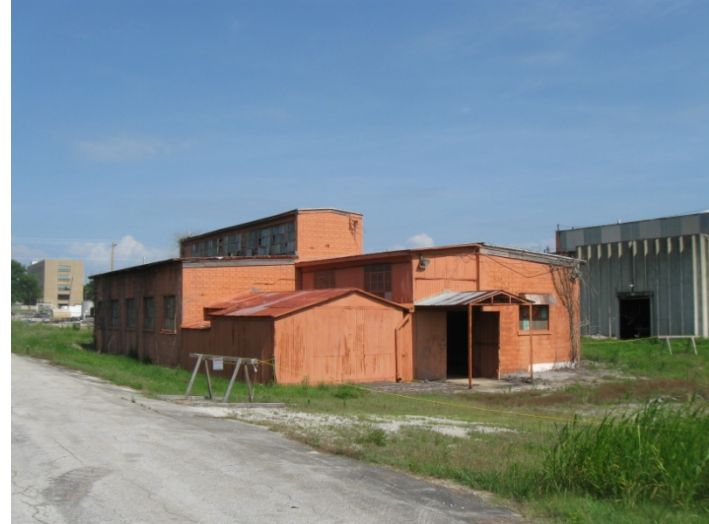
2013 Photo #2: Exterior building looking at additions on east end

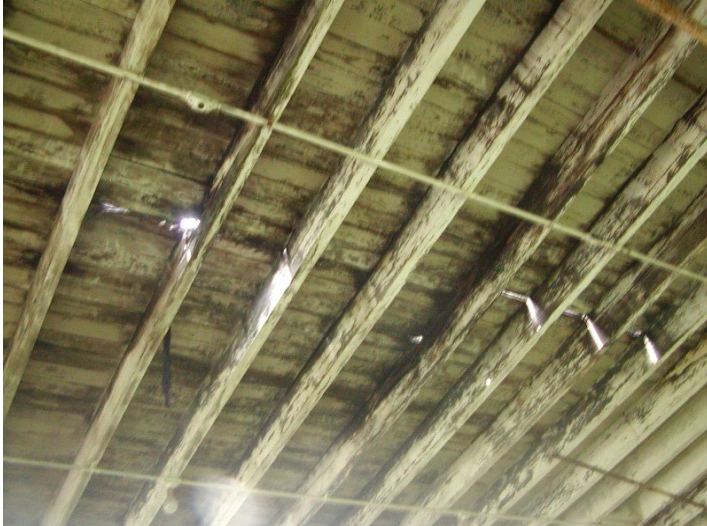
2009 Photo #3: Severely decayed wood roof structure with daylight visible through voids in wood plank deck

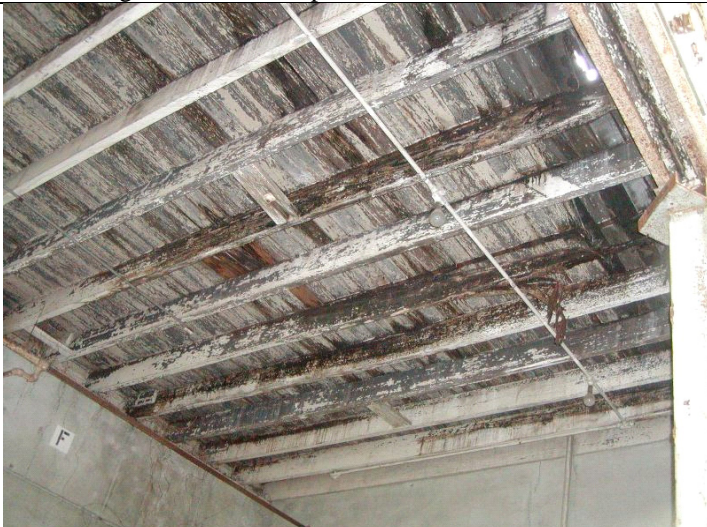
2009 Photo #4: Severely deteriorated wood roof structure

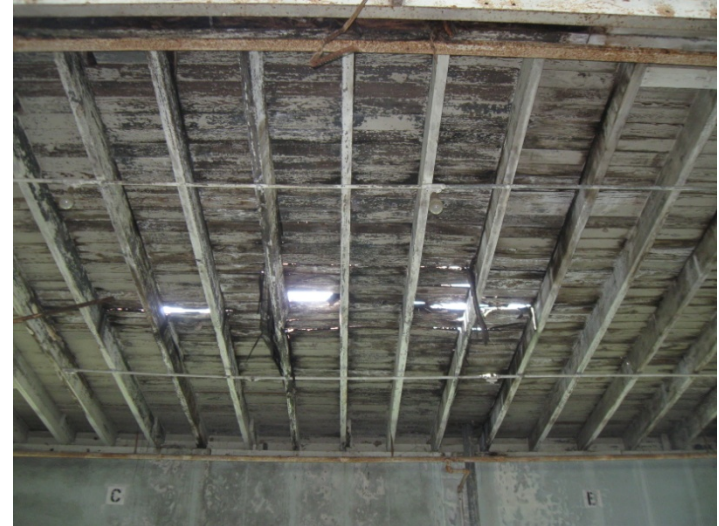
2013 Photo #3: More severely decayed wood roof structure with more daylight visible through voids in wood plank deck

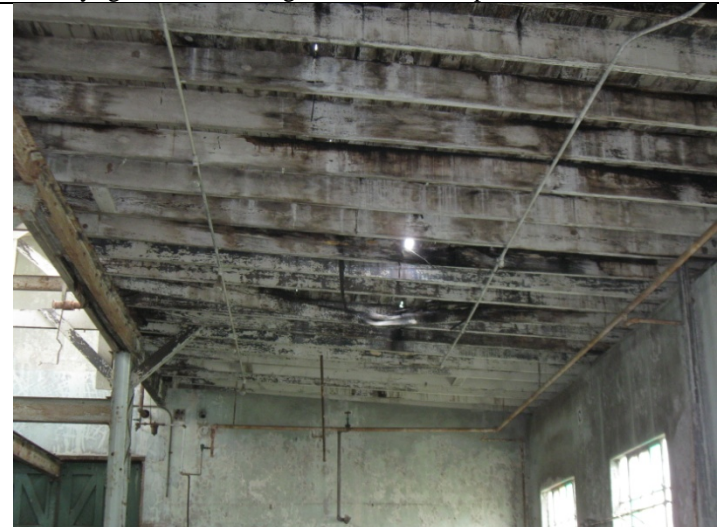
2013 Photo #4: Failure of framing members has begun to occur.

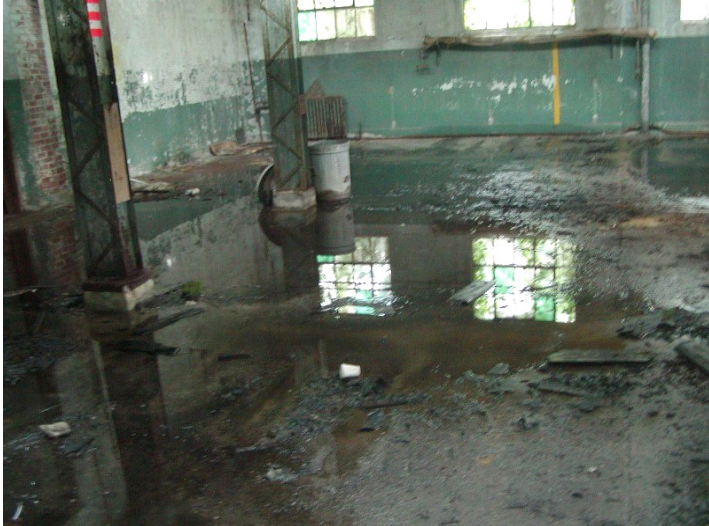
2009 Photo #5: Standing water on floor inside building; corroded steel columns

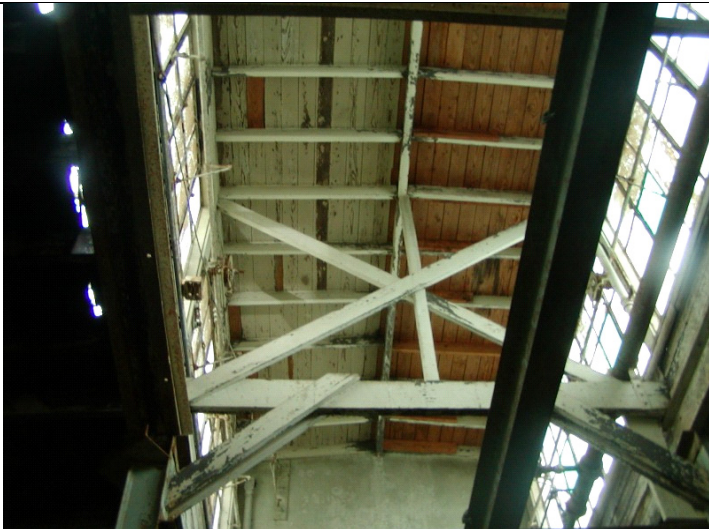
2009 Photo #6: Partially repaired roof deck at clerestory monitor

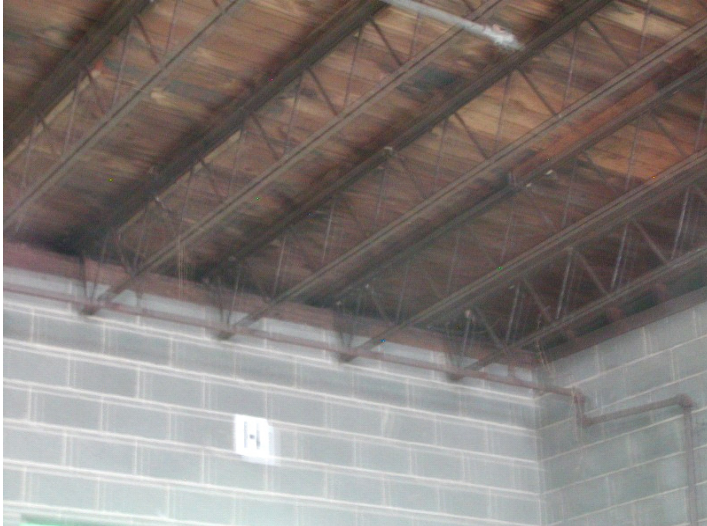
2009 Photo #7: Wood plank roof deck at East addition is damaged by water intrusion

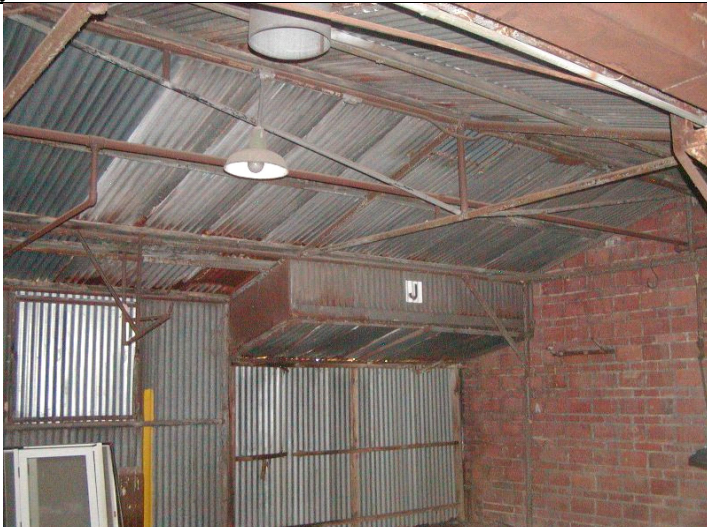
2009 Photo #8: Corroded metal roof deck and steel framing at East addition

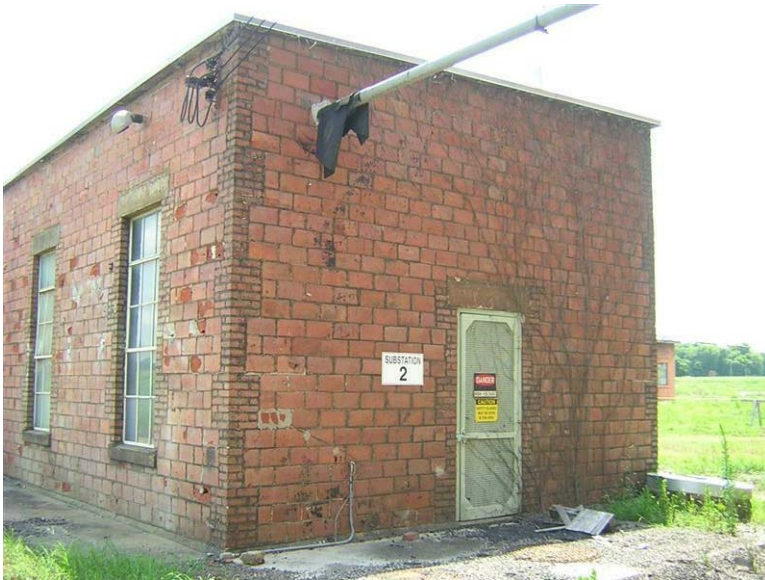
Building 57 – Substation No. 2: Overall view at the northeast corner of the building

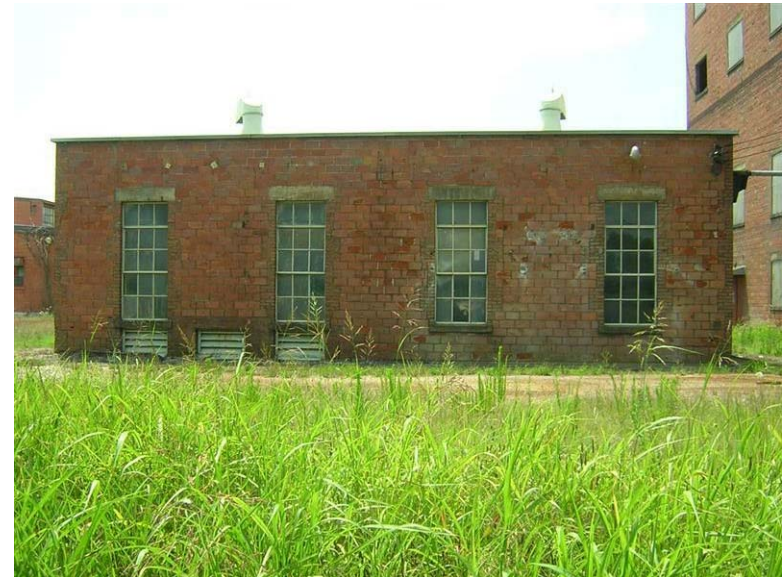
Building 57 – Substation No. 2: Overall view of the east facade

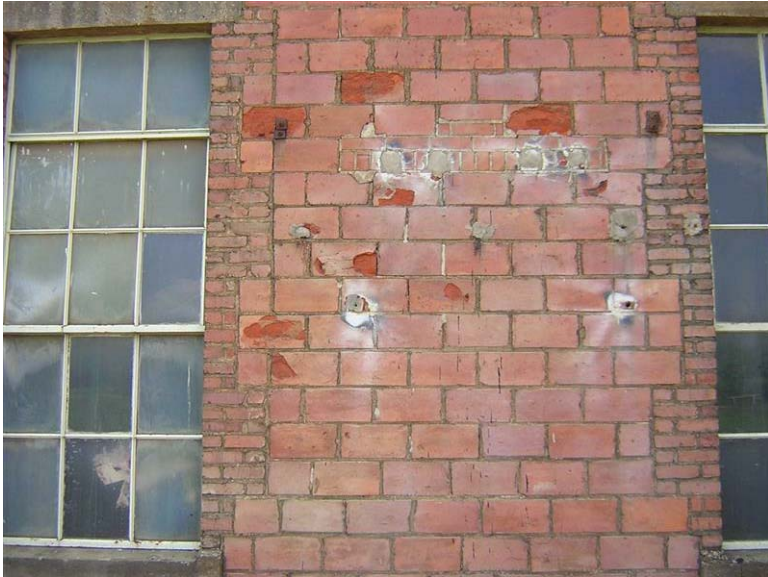
Building 57 – Substation No. 2: Some of the holes in the hollow clay tile have been parged with concrete.

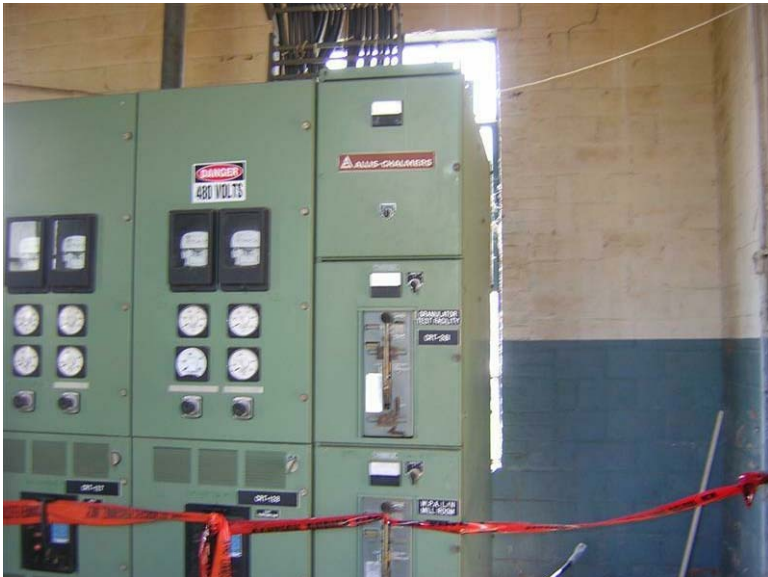
Building 57 – Substation No. 2: The wall is cracked adjacent to the window in the background.

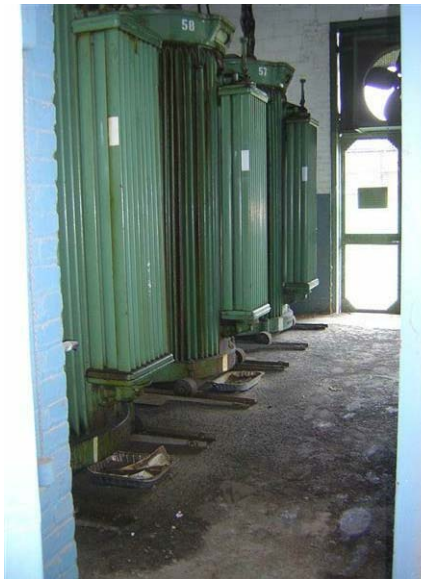
Building 57 – Substation No. 2: Moisture is visible on the concrete slab.

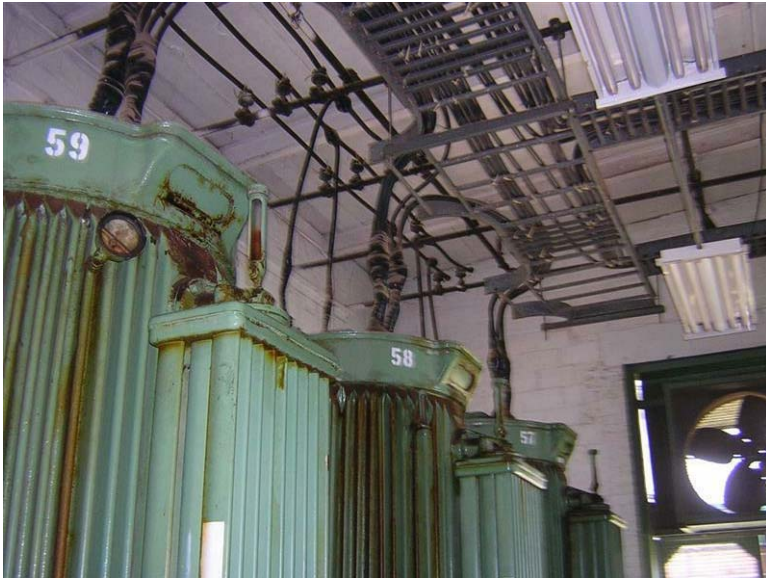
Building 57 – Substation No. 2: Interior view of the ceiling and raceways for electrical conduits overhead.

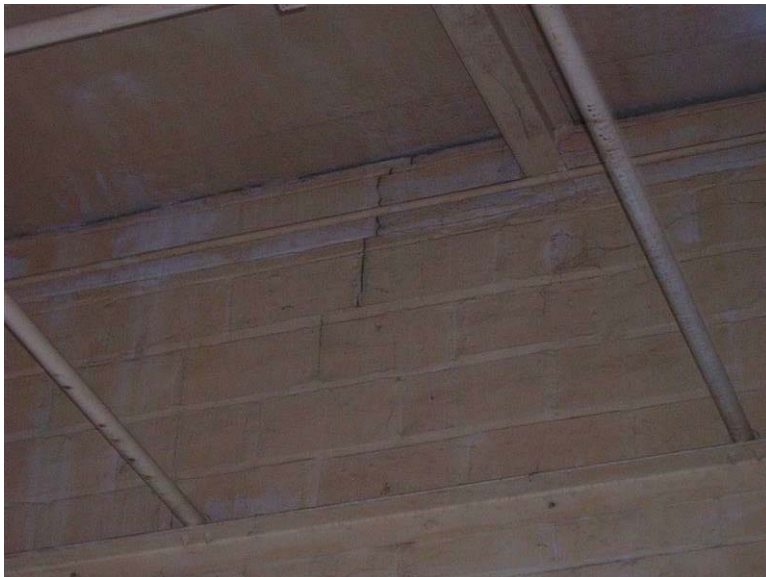
Building 57 – Substation No. 2: Diagonal cracks are visible at the upper walls.

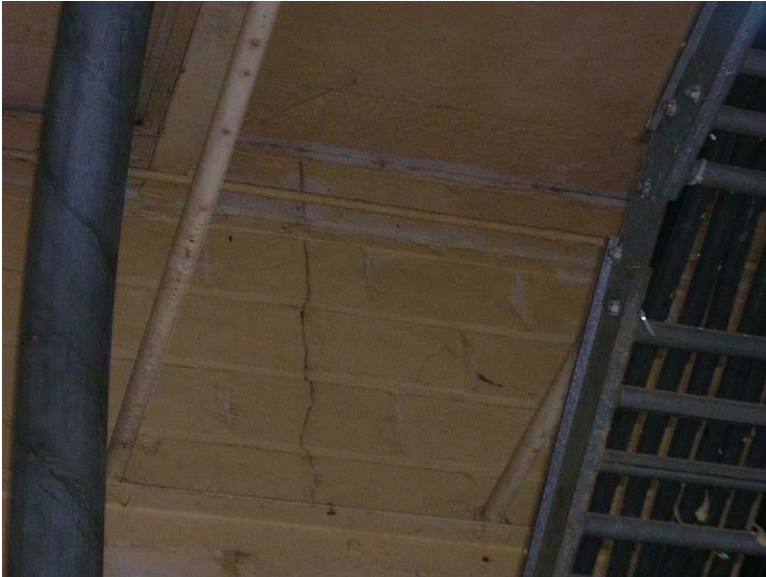
Building 57 – Substation No. 2: Horizontal cracking was visible in the upper wall.

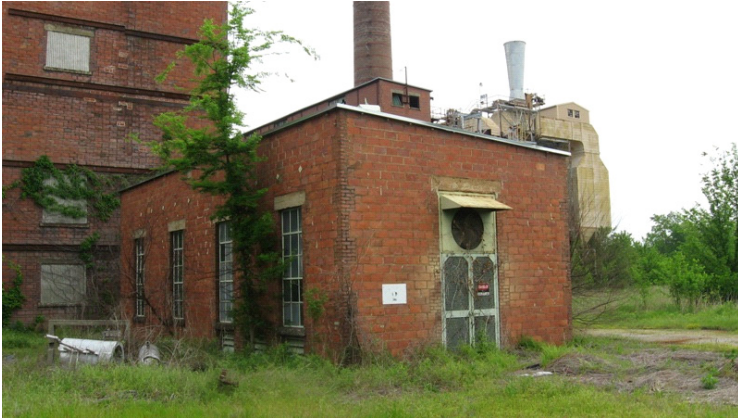
2009 Photo #1: Exterior building looking at Southwest corner

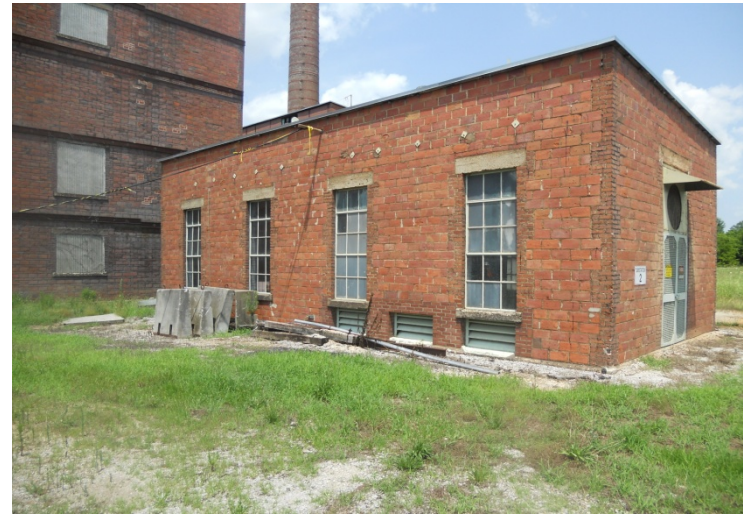
2013 Photo #1: Exterior building looking at Southwest corner

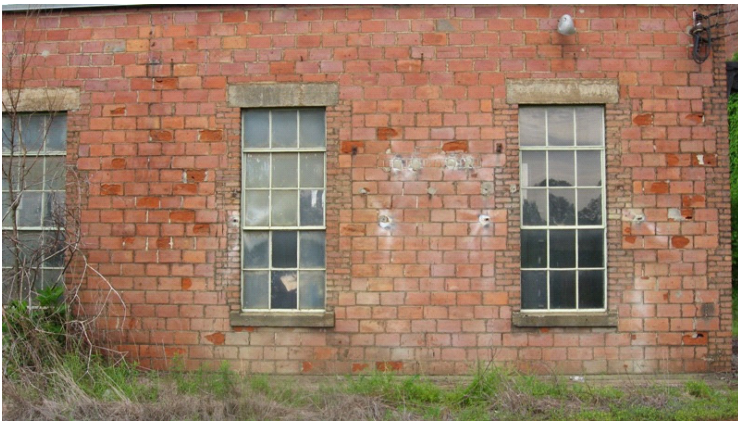
2009 Photo #2: Multiple surface spalls in exterior masonry – East side
