Tennessee Valley Authority

Cyclic Assessment Report
TVA Muscle Shoals, Alabama
September 16, 2013

Executive Summary

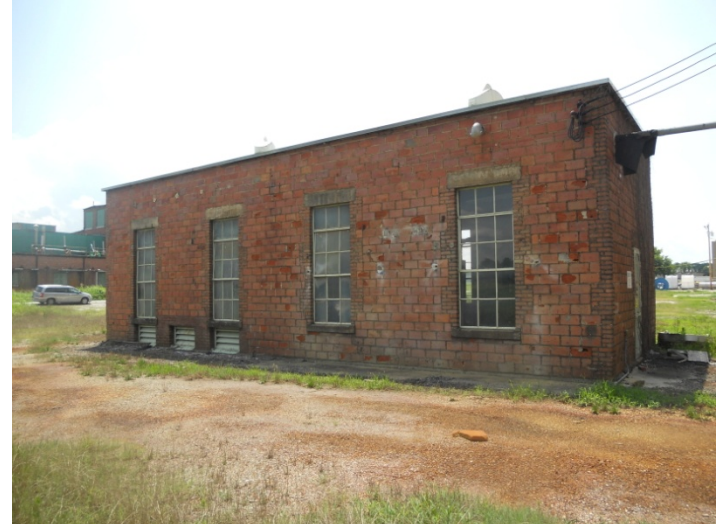
2013 Photo #2: Minor progressive deterioration of exterior masonry

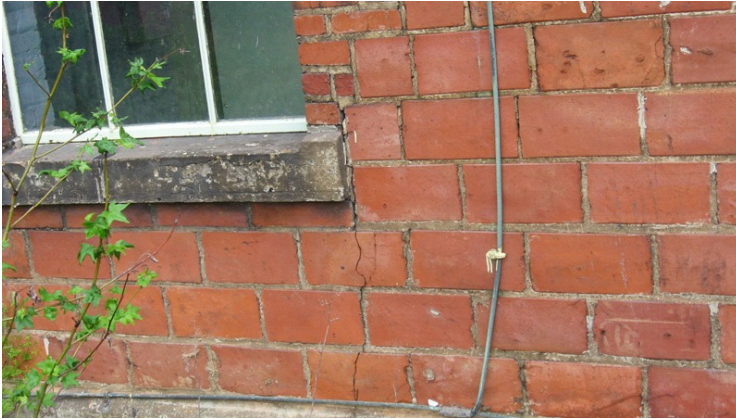
2009 Photo #3: Vertical cracks in masonry – West side

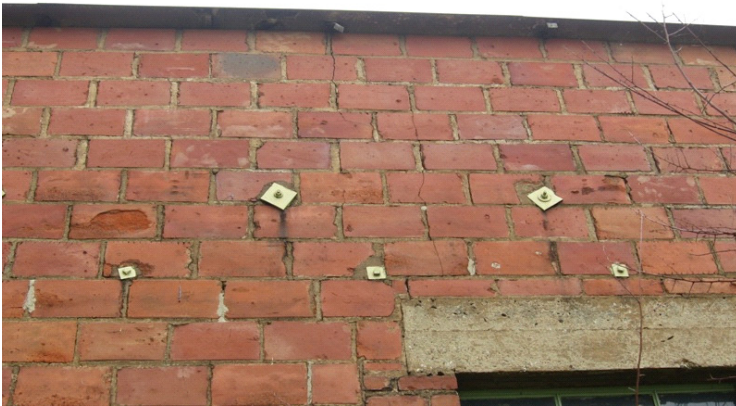
2009 Photo #4: Vertical cracks in masonry – West side

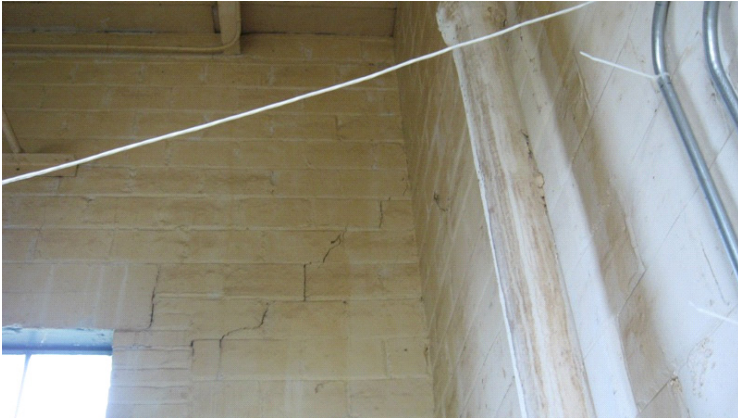
2009 Photo #5: Cracks in masonry – West wall

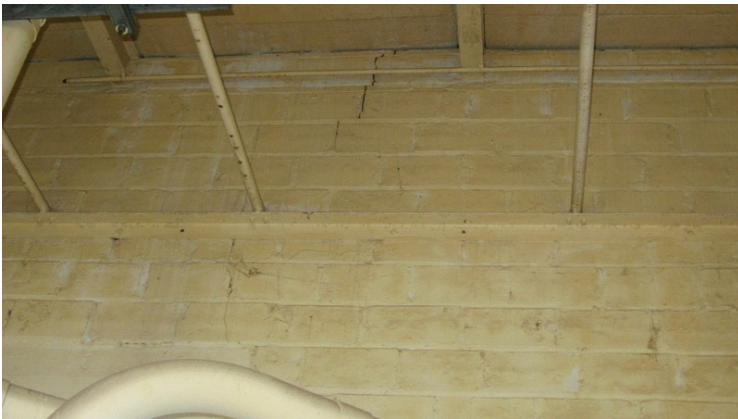
2009 Photo #6: Cracks in masonry – West wall

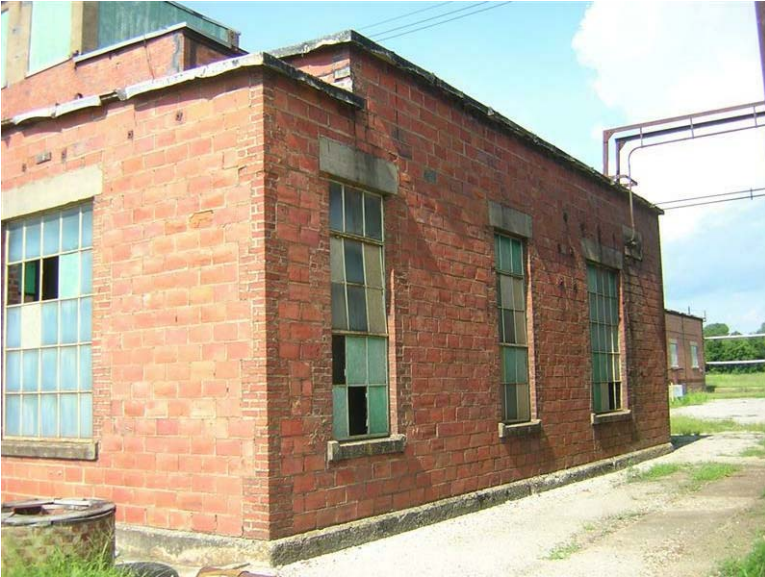
Building 68 – Substation No. 4: Overall view of the south facade

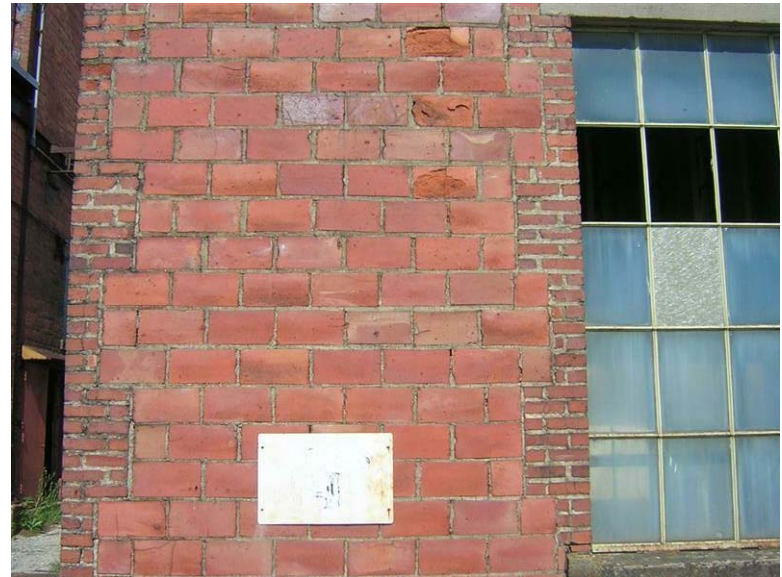
Building 68 – Substation No. 4: Hollow clay tile is spalling on the west facade. Several window panes are broken.

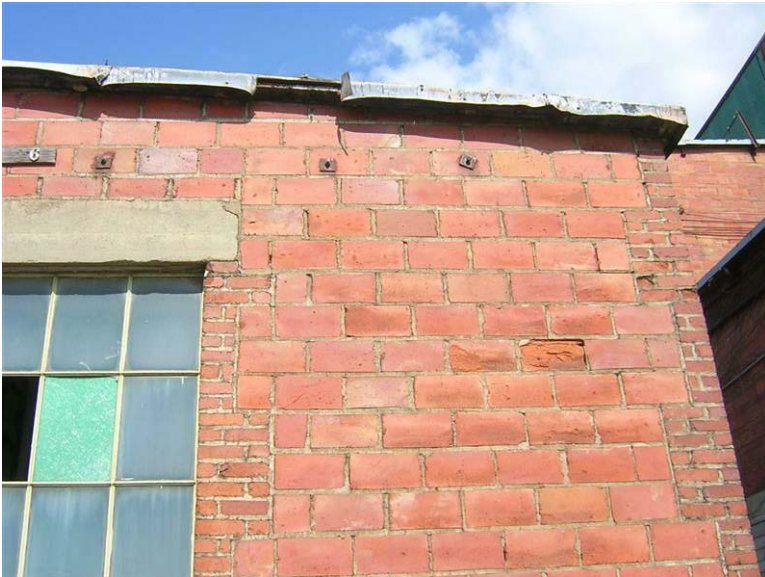
Building 68 – Substation No. 4: Hollow clay tile is spalling on the west facade and the metal coping is damaged.

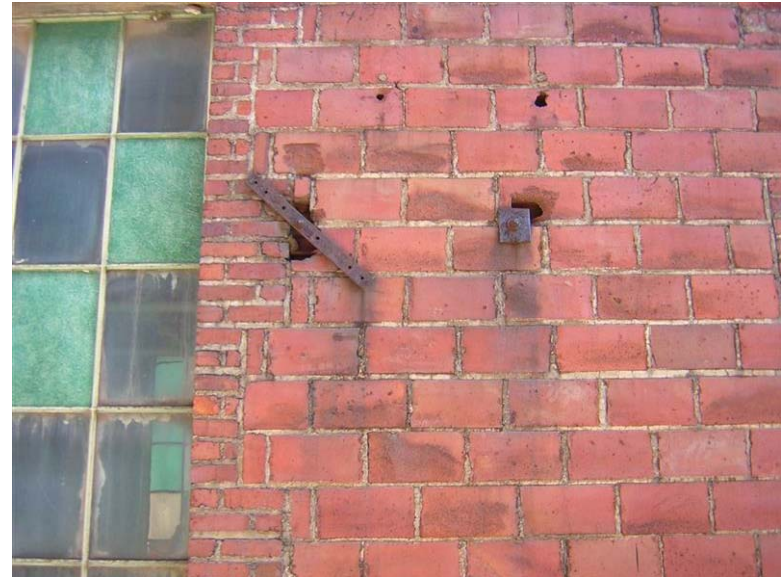
Building 68 – Substation No. 4: Portions of the hollow clay tile are damaged where through-wall ties are located on the south façade.

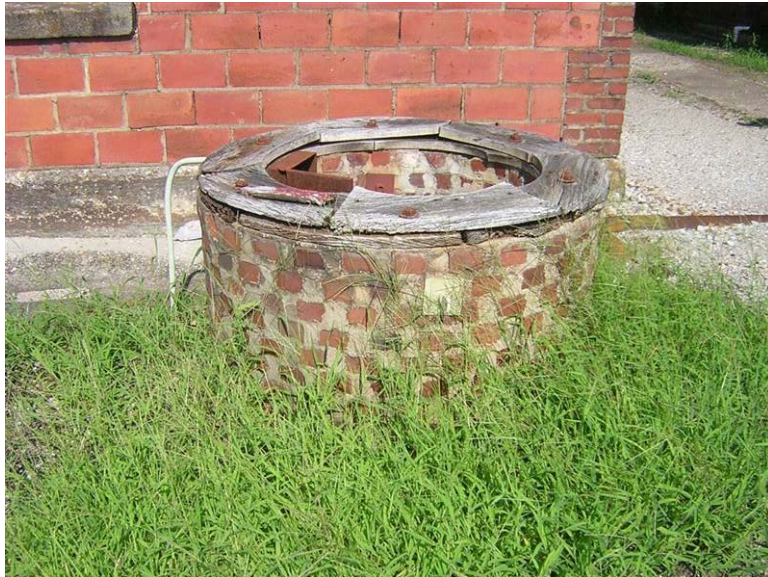
Building 68 – Substation No. 4: The wood is warped and damaged on top of this well structure.

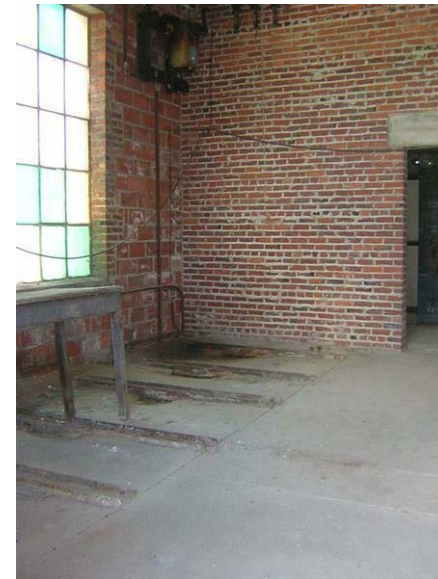
Building 68 – Substation No. 4: Interior view of the building

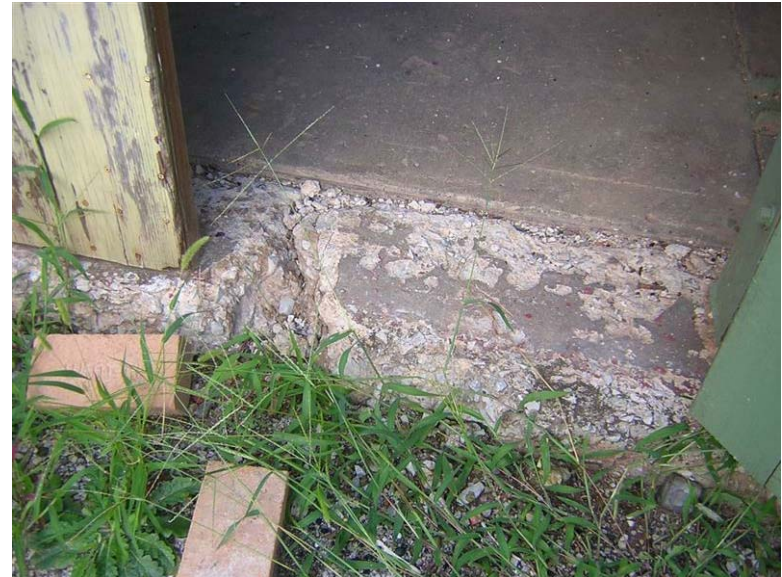
Building 68 – Substation No. 4: The concrete slab is broken at the door opening.

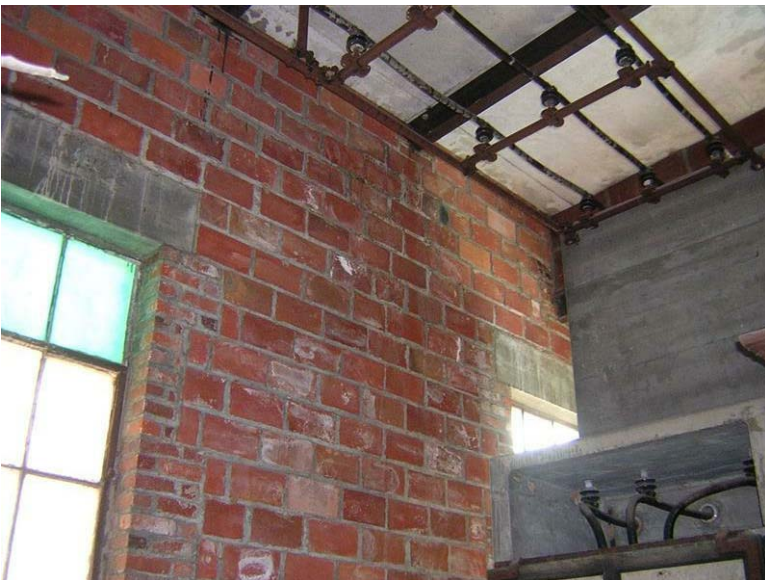
Building 68 – Substation No. 4: The steel structure is rusted and efflorescence is visible on the wall.

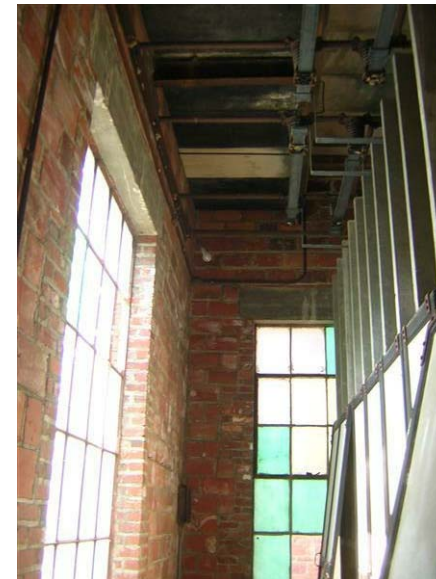
Building 68 – Substation No. 4: A row of concrete panels along the west wall are blackened from moisture

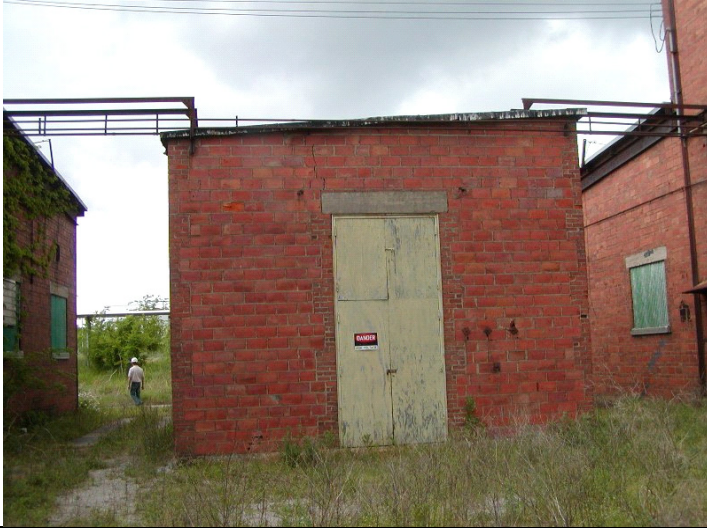
2009 Photo #1: East wall of substation

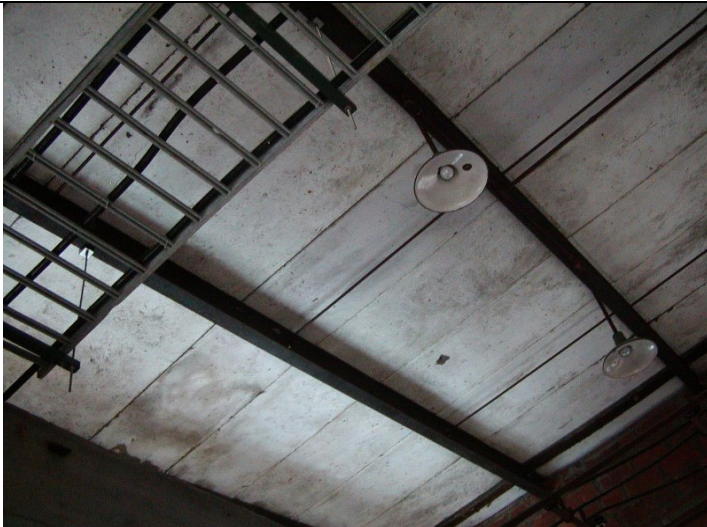
2009 Photo #2: Roof deck at substation

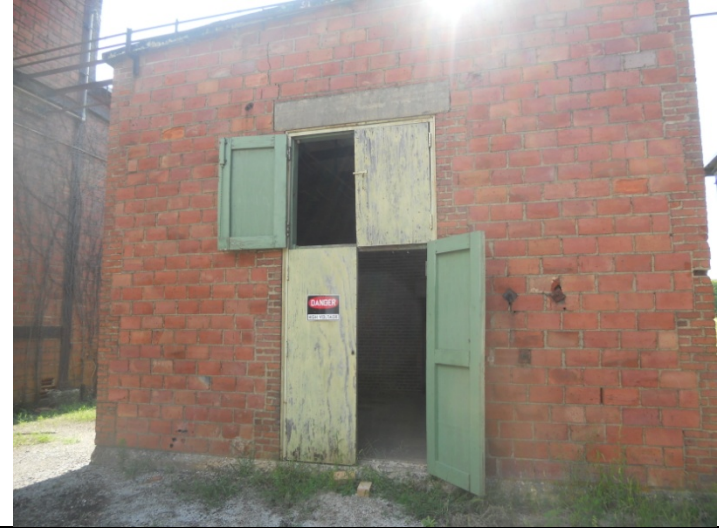
2013 Photo #1: East wall of substation

**No change
observed**

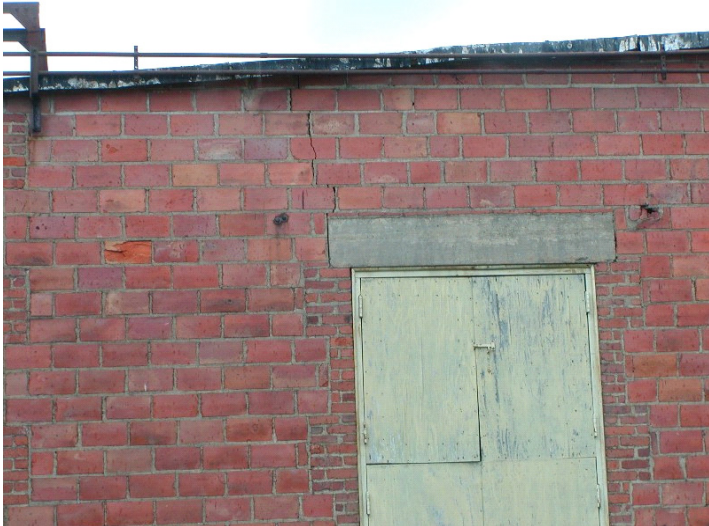
2009 Photo #3: Cracked and spalled masonry at substation

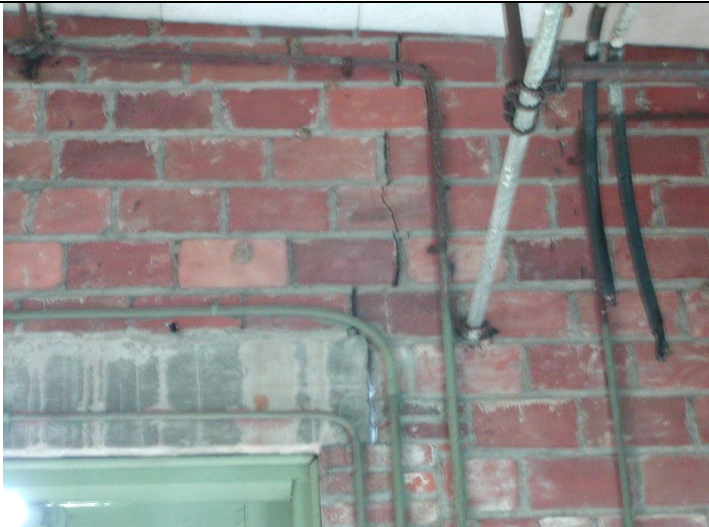
2009 Photo #4: Cracked masonry at substation lintel

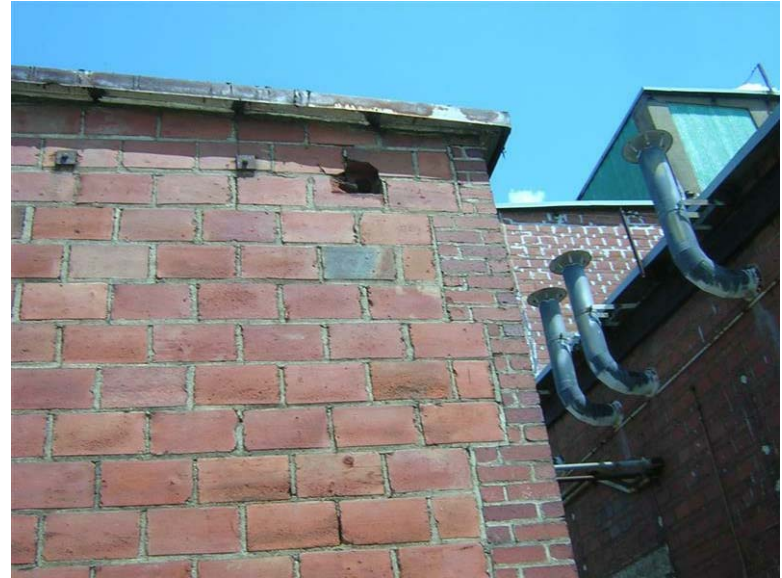
Building 68a – Substation No. 5: Holes penetrate the upper west facade.

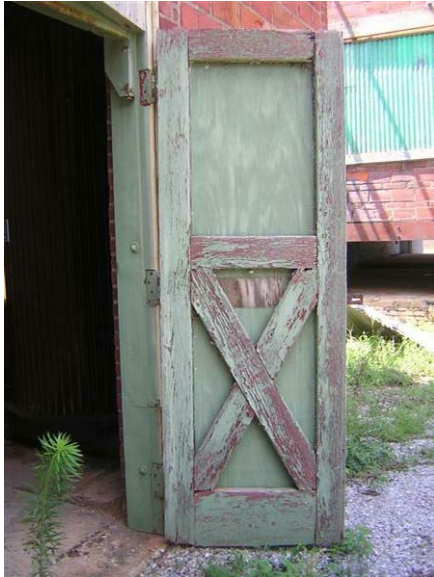
Building 68a – Substation No. 5: Paint is flaking from the wood doors on the east facade.

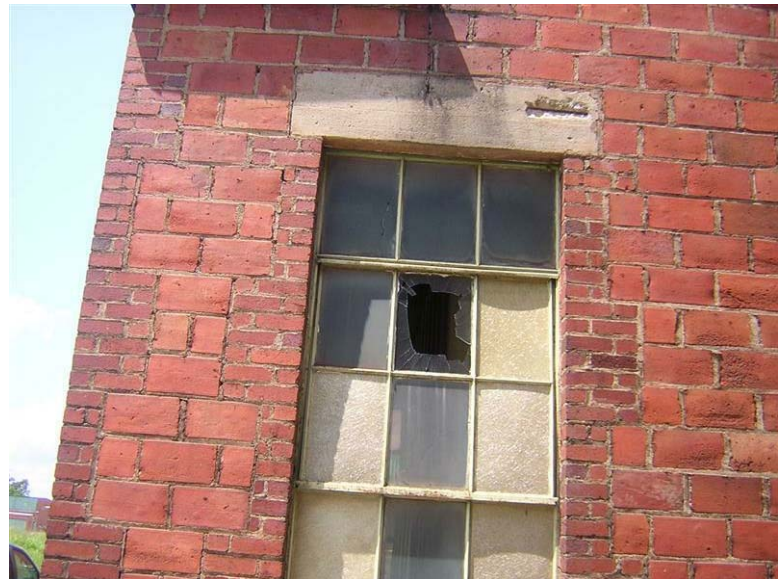
Building 68a – Substation No. 5: Rebar is exposed on the concrete lintel.

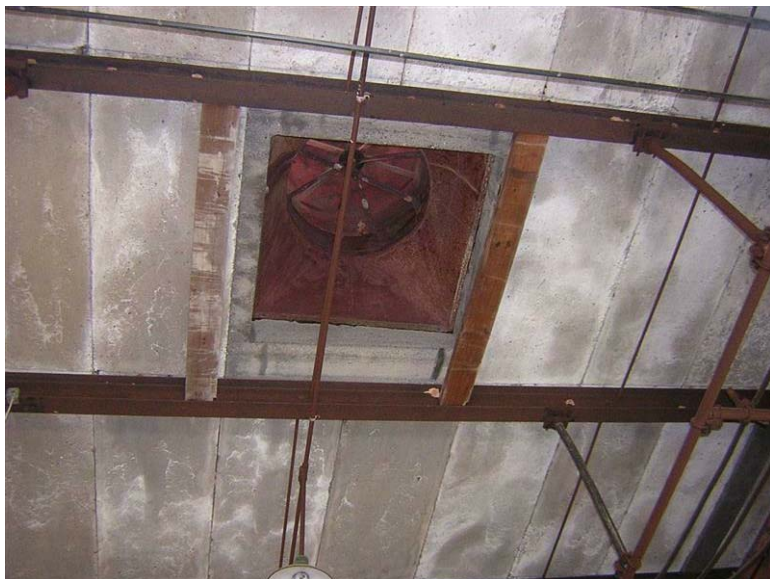
Building 68a – Substation No. 5: The steel structure is rusted.

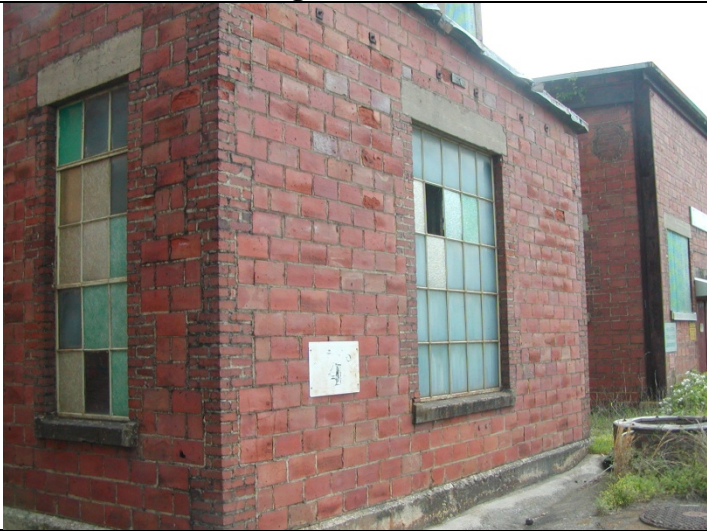
2009 Photo #1: West wall of substation in generally good condition

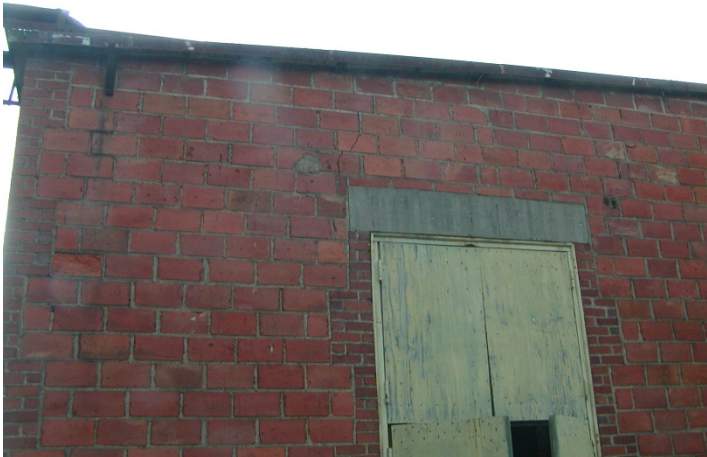
2009 Photo #2: Minor cracks in masonry at East wall of substation

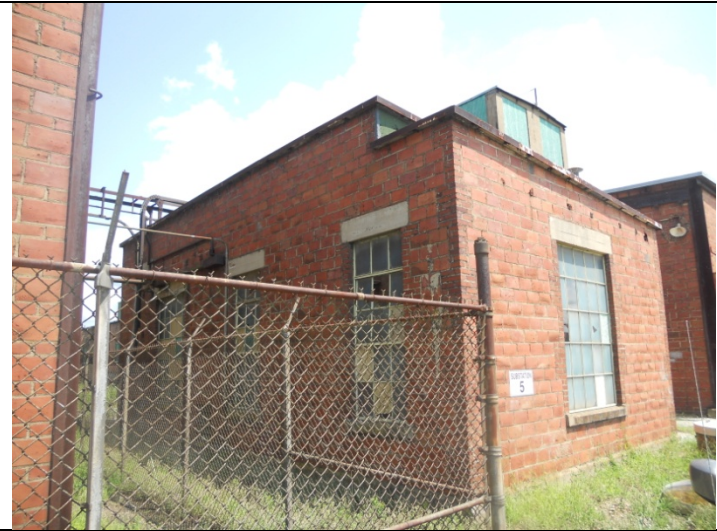
2013 Photo #1: West wall of substation in generally good condition

**No change
observed**

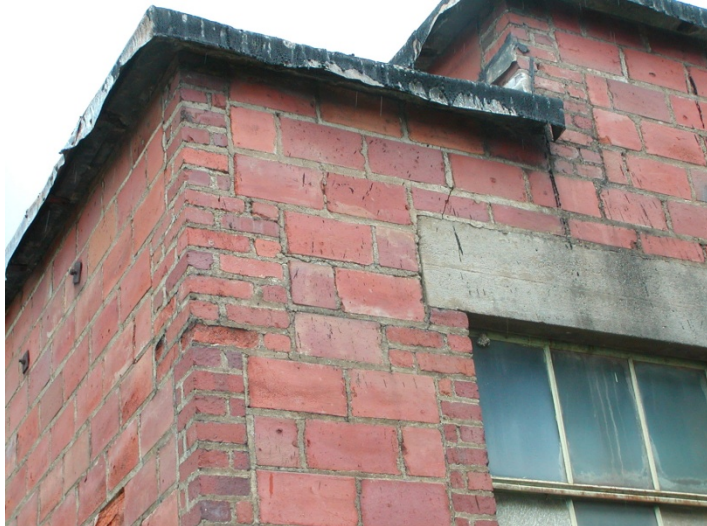
2009 Photo #3: Minor spalls in exterior masonry

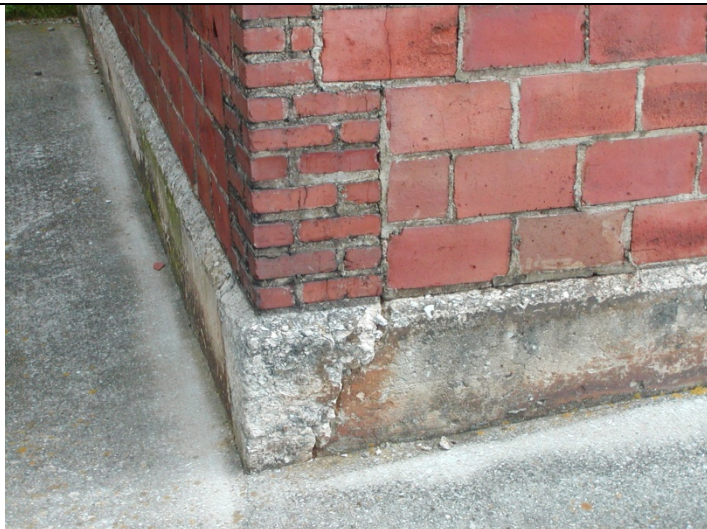
2009 Photo #4: Minor crack on turned down slab

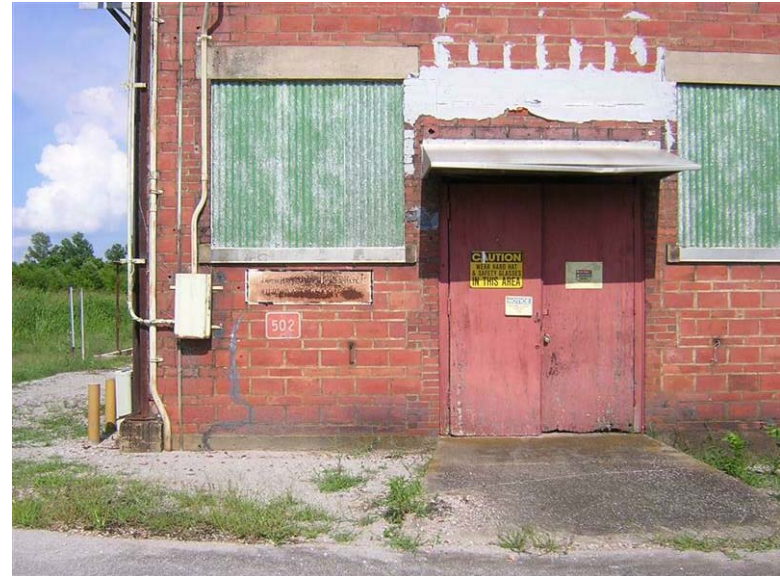
Building 69 – Catalyzer Building No. 1: The historic awning has been replaced and the flush wood doors are damaged.

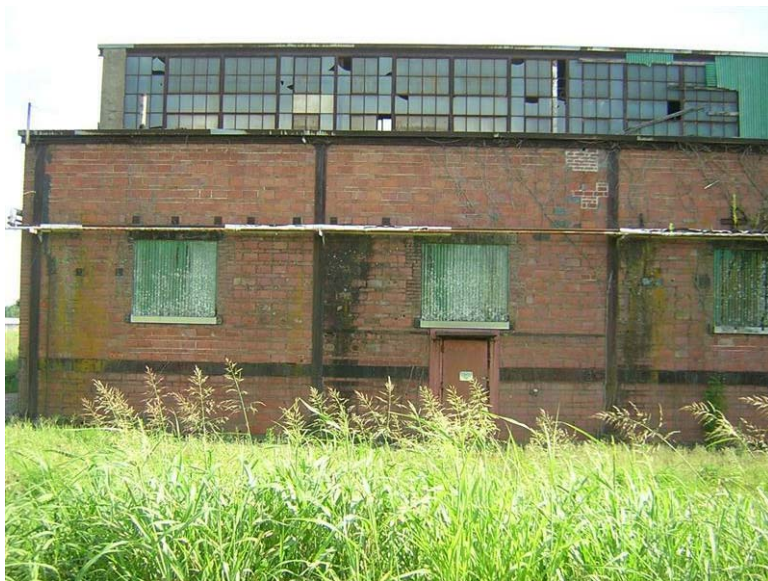
Building 69 – Catalyzer Building No. 1: Extant clerestory windows have several broken panes and the lower windows are covered with fiberglass.

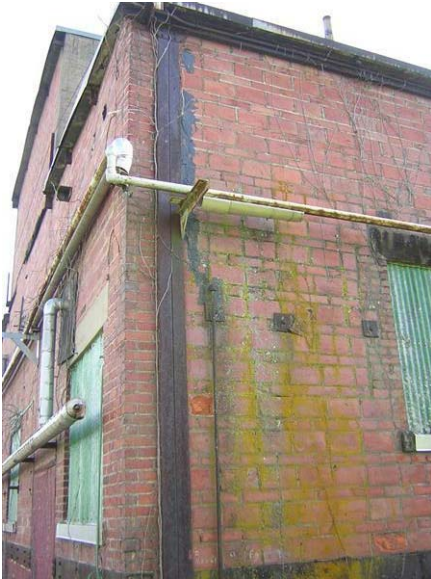
Building 69 – Catalyzer Building No. 1: Staining and mold growth are visible on the north facade.

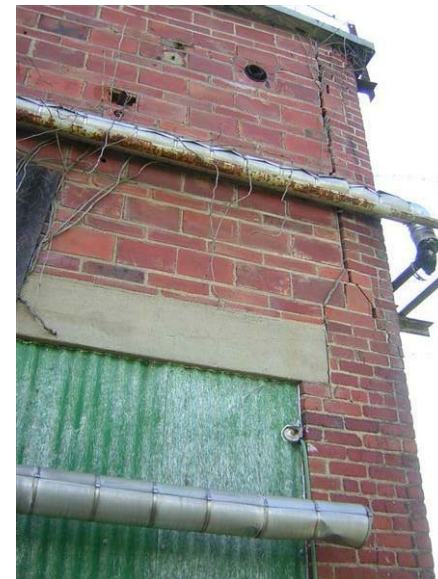
Building 69 – Catalyzer Building No. 1: Visual separation of the corner at the east wall.

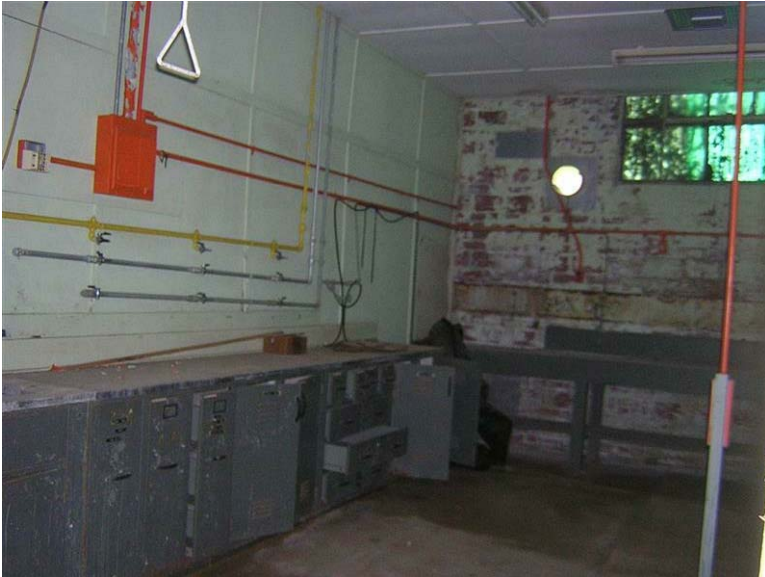
Building 69 – Catalyzer Building No. 1: Paint is flaking from the hollow clay tile walls in the laboratory space.

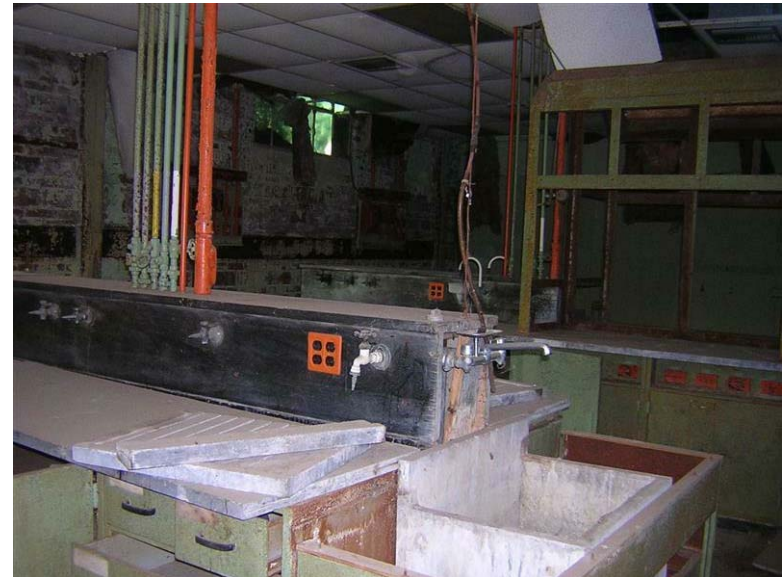
Building 69 – Catalyzer Building No. 1: Acoustical ceiling tiles are missing.

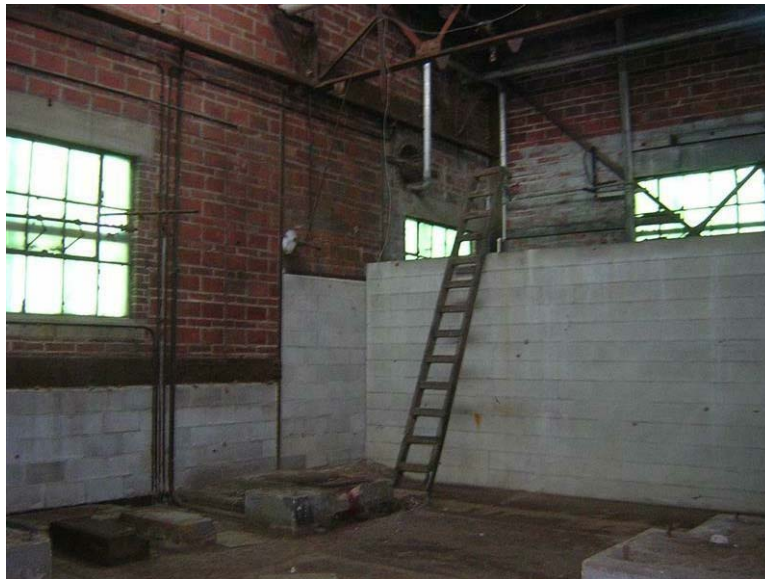
Building 69 – Catalyzer Building No. 1: CMU infill has replaced the wood louvers at the rear of the building.

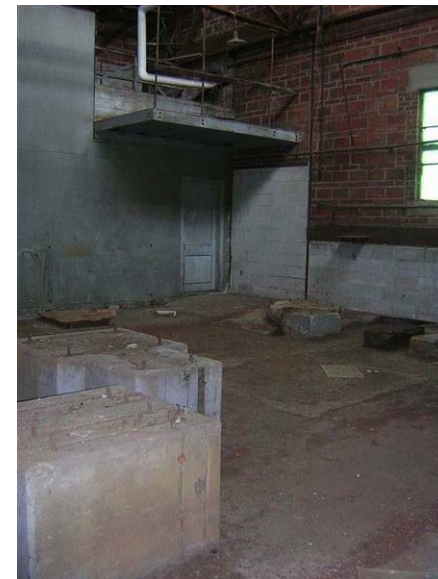
Building 69 – Catalyzer Building No. 1: The steel supporting the mezzanine is rusted.

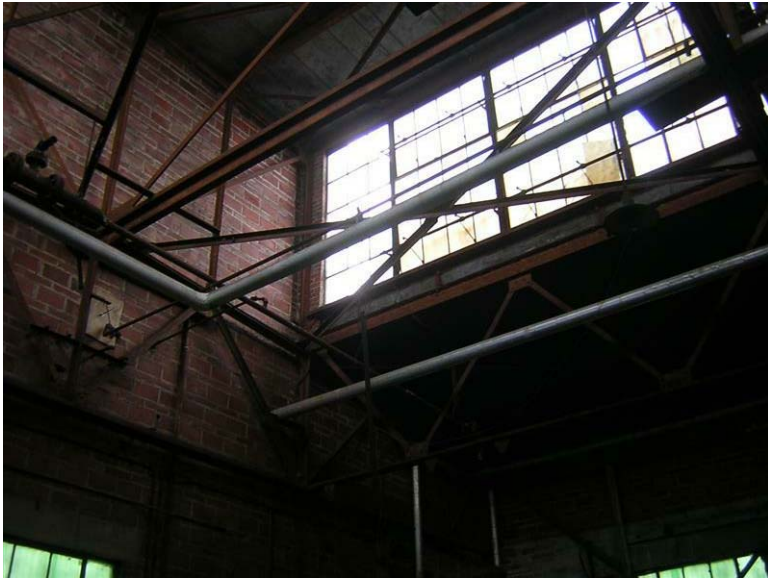
Building 69 – Catalyzer Building No. 1: The steel structure is rusted.

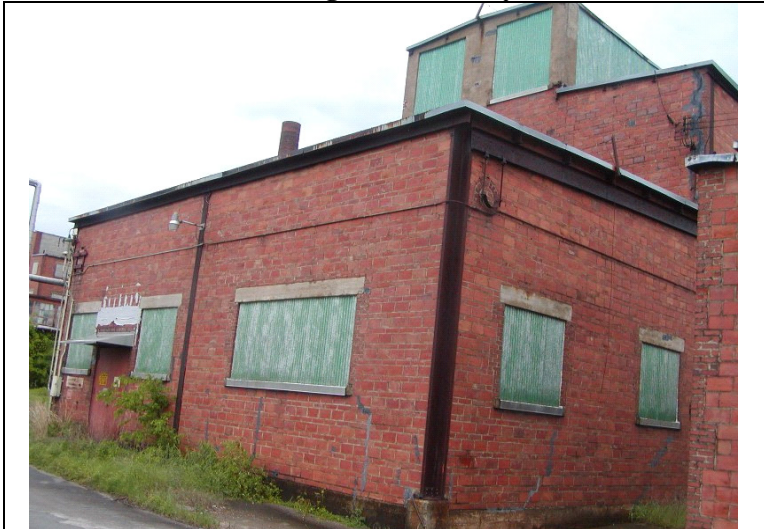
2009 Photo #1: Exterior building looking at Southwest corner – note multiple cracks in masonry

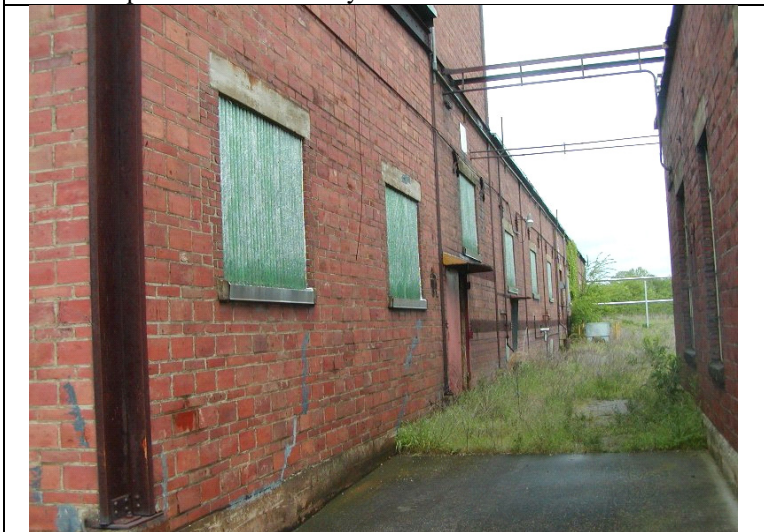
2009 Photo #2: Exterior building looking at South wall – note cracks in masonry above foundation wall

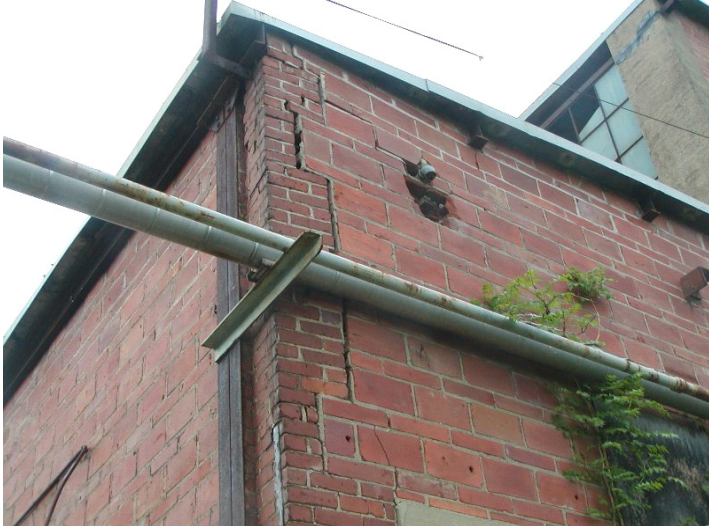
2009 Photo #3: Cracked and partially dislodged masonry at Southeast corner

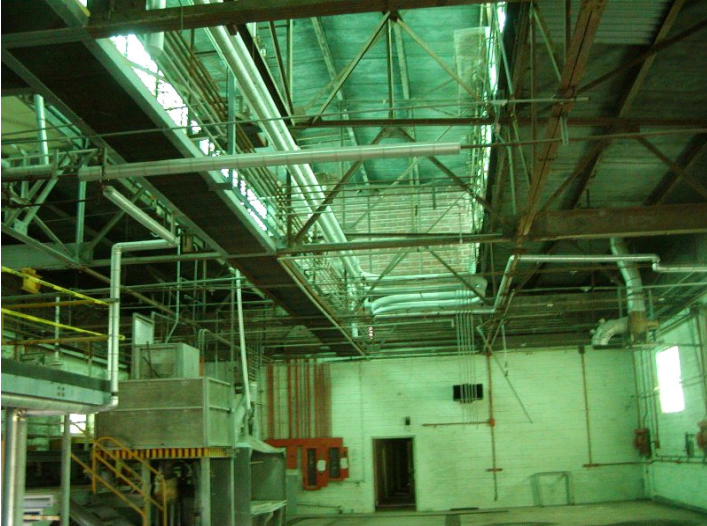
2009 Photo #5: Interior building looking East

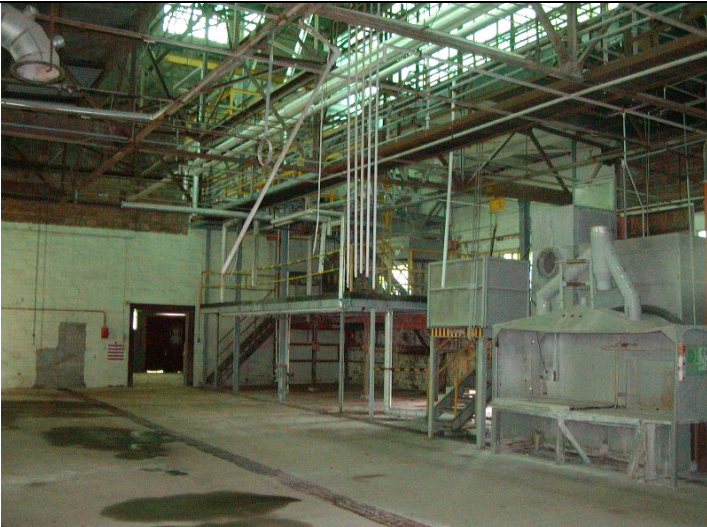
2009 Photo #6: Interior building looking West

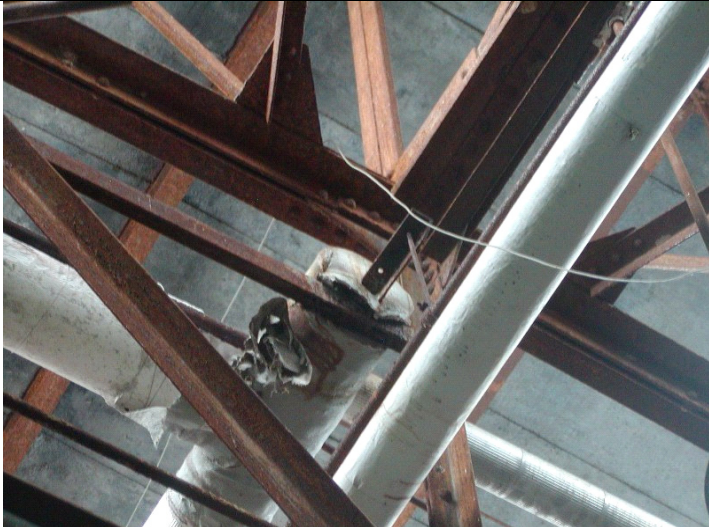
2009 Photo #7: Moderately corroded steel roof framing

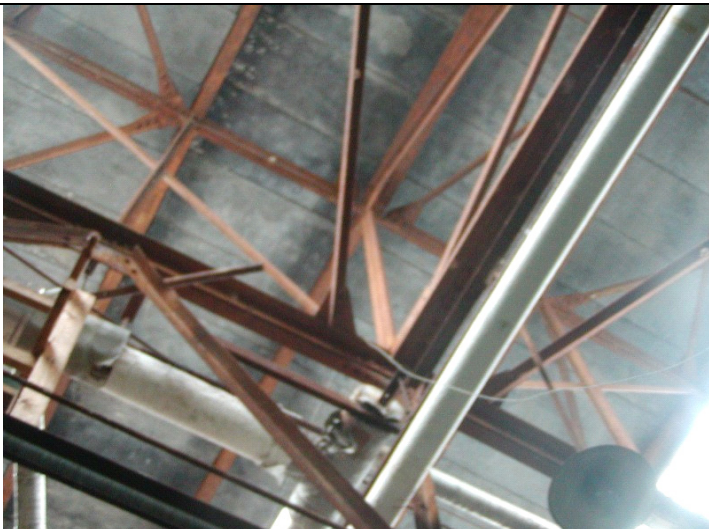
2009 Photo #8: Moderately corroded steel roof framing and surface deterioration on concrete plank roof deck

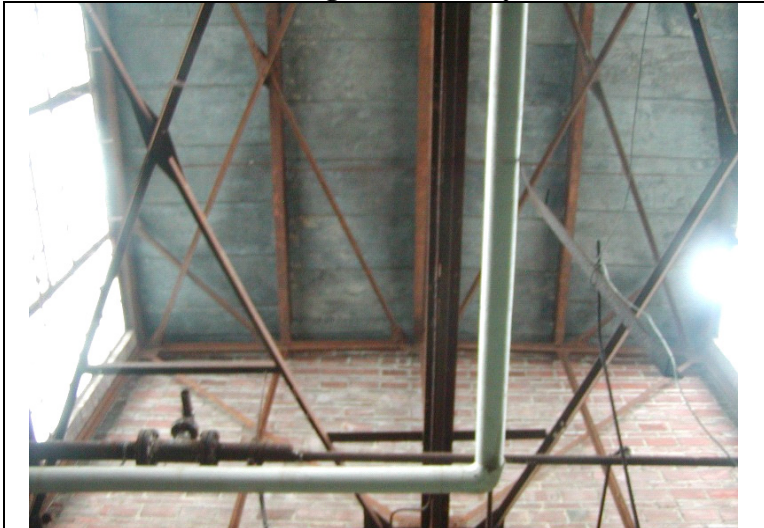
2009 Photo #9: Monitor roof with corroded steel framing and surface deterioration on concrete plank roof deck

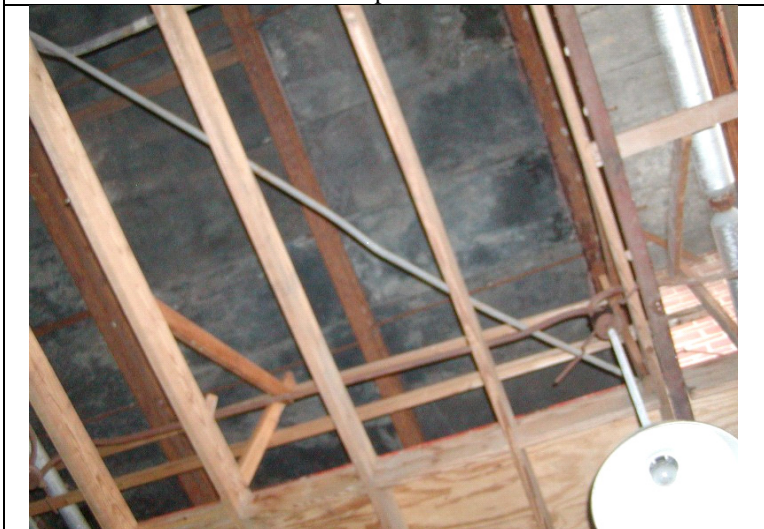
2009 Photo #10: Corroded steel framing and deteriorated roof deck at low roof

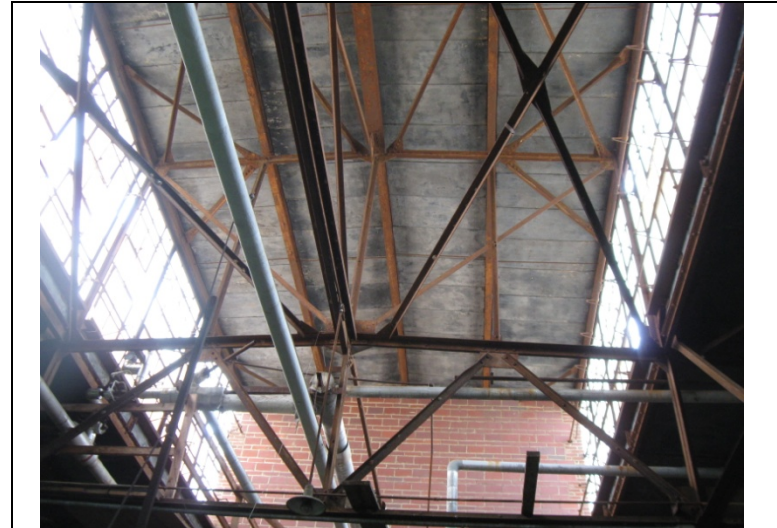
2013 Photo #9: Minor progressive deterioration of steel framing and concrete plank roof deck appears to be evident

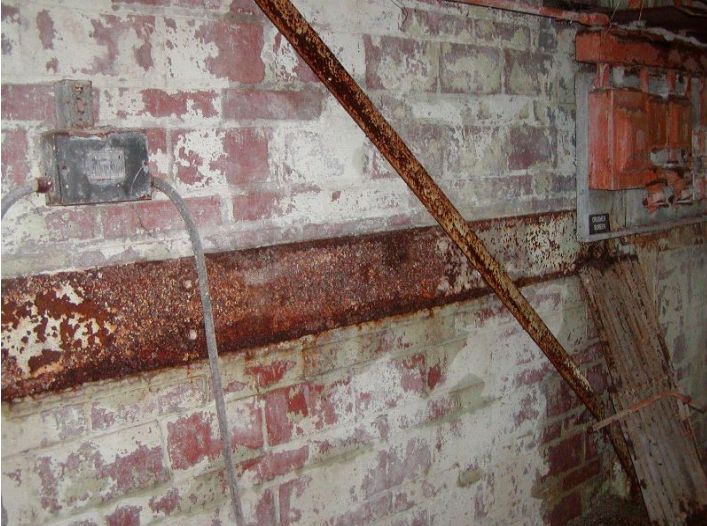
2009 Photo #11: Heavily corroded steel framing at North wall

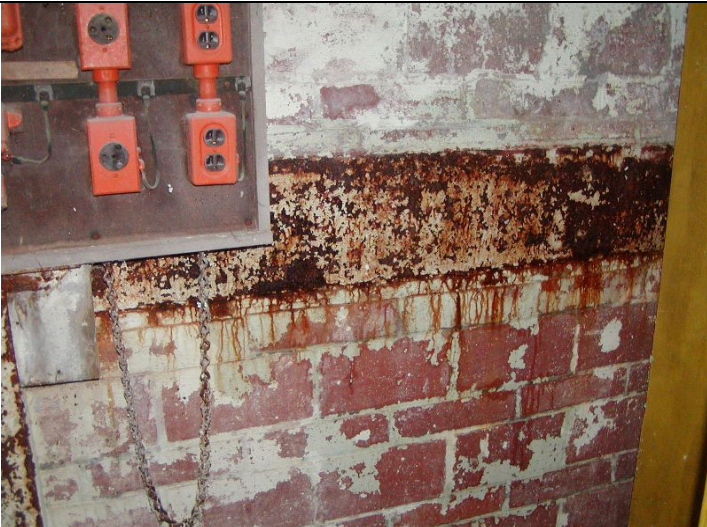
2009 Photo #12: Heavily corroded steel framing at North wall

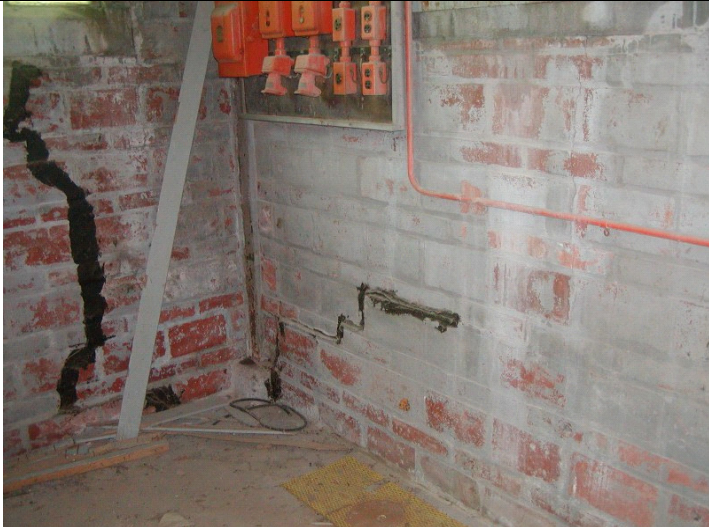
2009 Photo #13: Previously repaired cracks in wall at Northwest corner

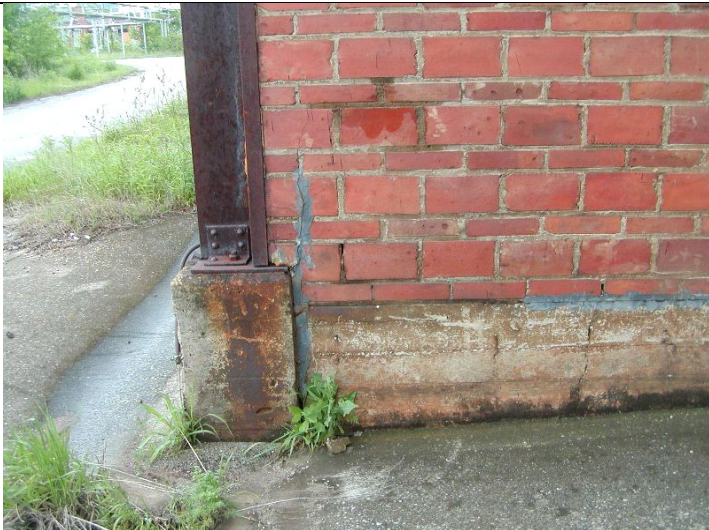
2009 Photo #14: Cracks in masonry and foundation wall at Southwest corner

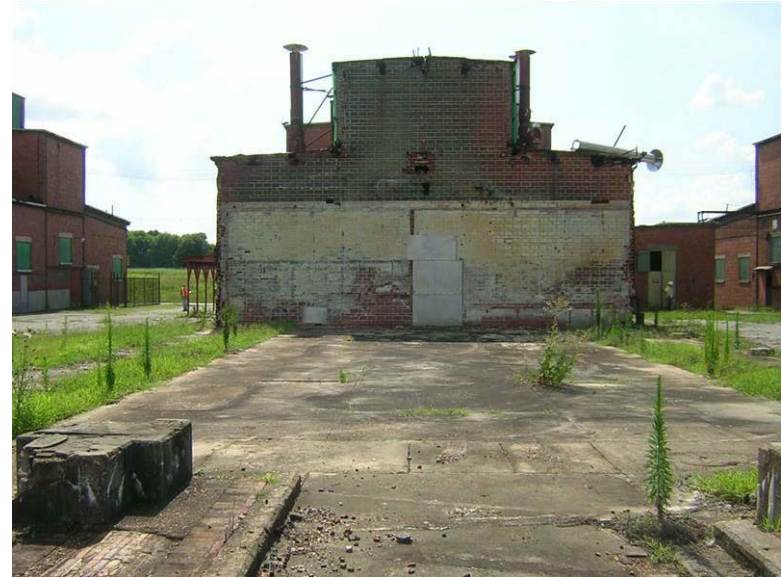
Building 70 – Catalyzer Building No. 2: The rear of the building was damaged in a fire and has been demolished.

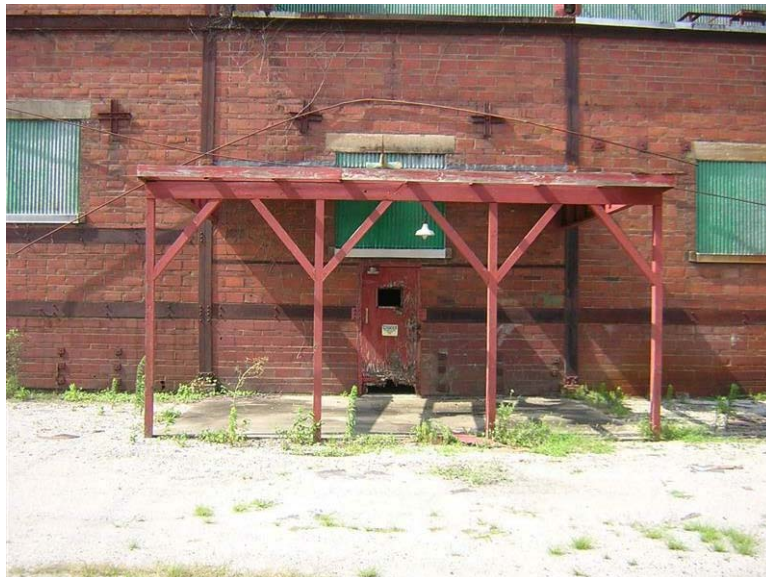
Building 70 – Catalyzer Building No. 2: The wood door and awning are damaged.

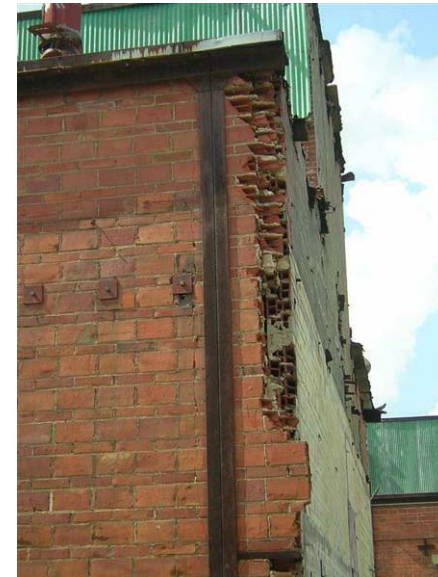
Building 70 – Catalyzer Building No. 2: The hollow clay tile is broken at the corner where the adjacent portion of the building has been demolished.

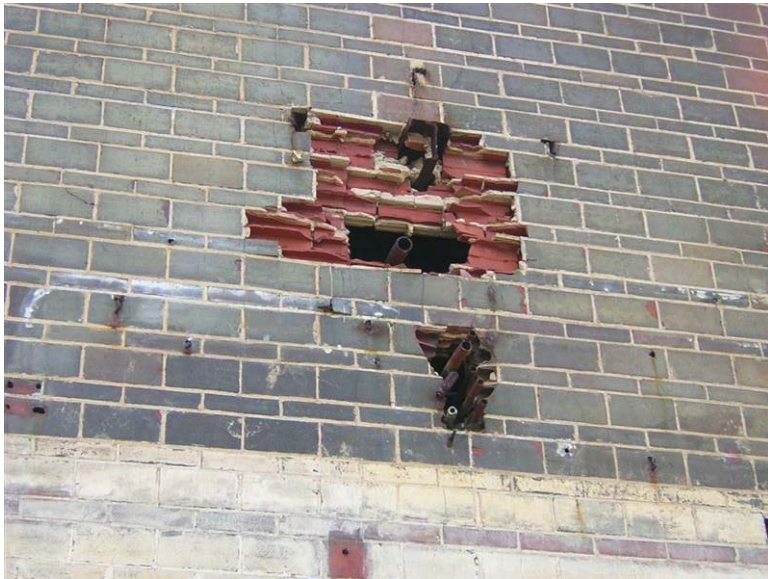
Building 70 – Catalyzer Building No. 2: There is a hole in the wall at the rear of the building.

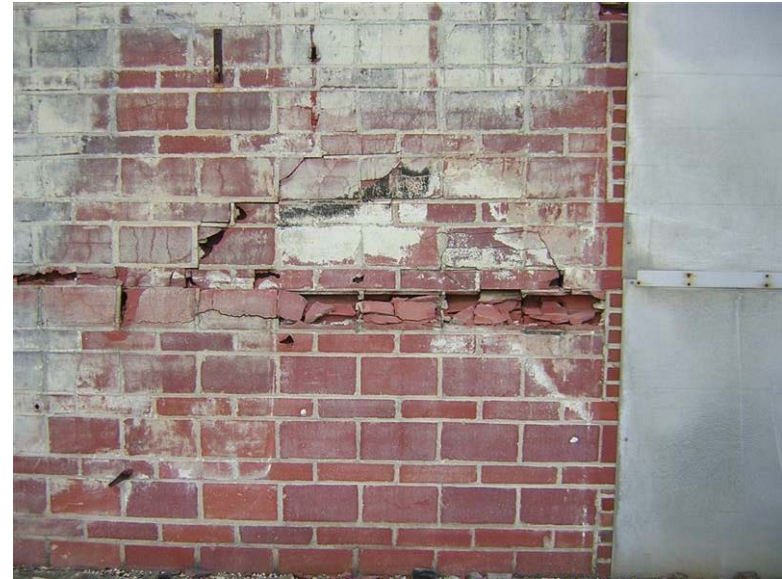
Building 70 – Catalyzer Building No. 2: The wall is caving in at the rear of the building.

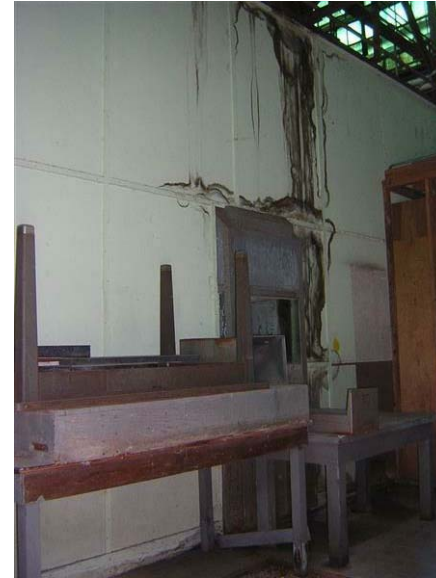
Building 70 – Catalyzer Building No. 2: Water infiltration has stained this interior partition.
