Tennessee Valley Authority

Cyclic Assessment Report
TVA Muscle Shoals, Alabama
September 16, 2013

Executive Summary

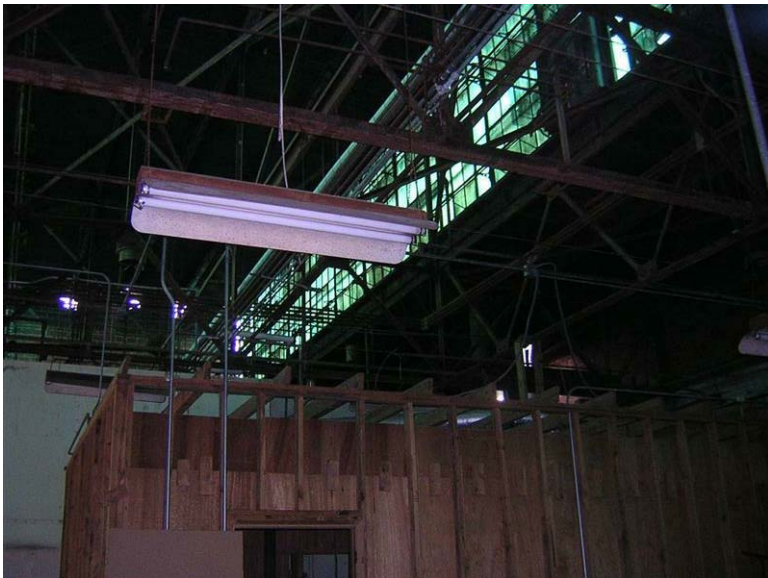
Building 70 – Catalyzer Building No. 2: This infill is unfinished with exposed wood members.

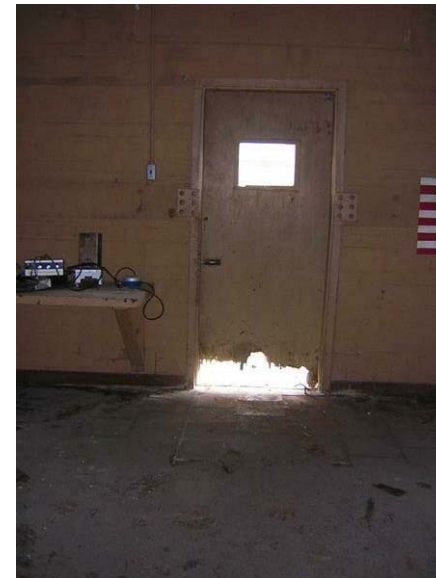
Building 70 – Catalyzer Building No. 2: This door leading to the exterior has worsened in condition.

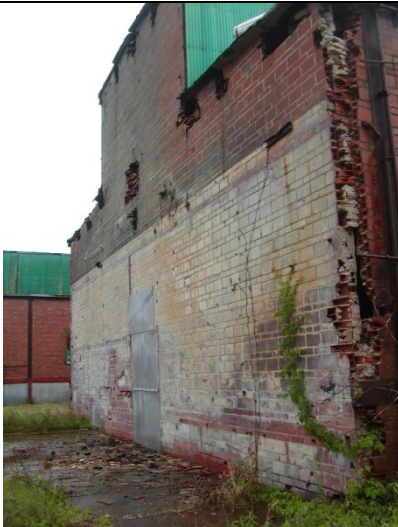
2009 Photo #4: East end of building – end wall is former interior wall

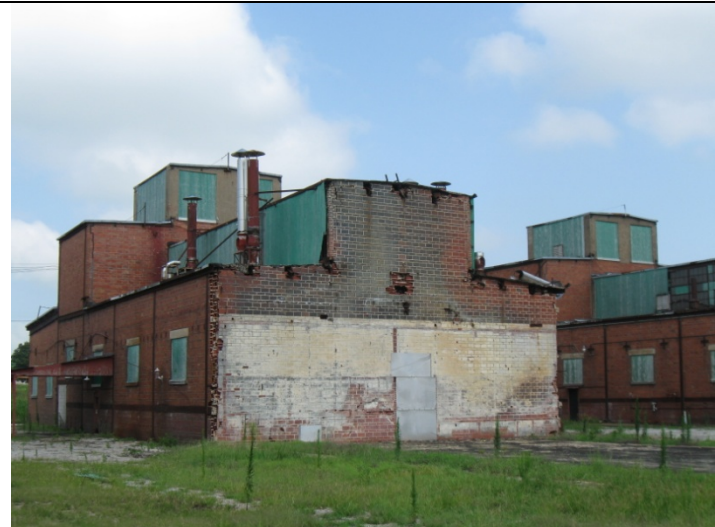
2013 Photo #4: East end of building – end wall is former interior wall – significant changes were not observed

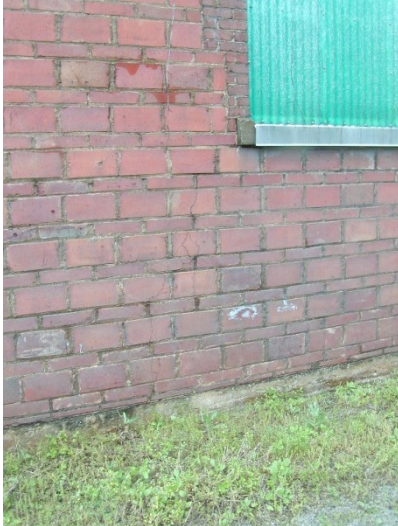
2009 Photo #5: Crack in South exterior wall

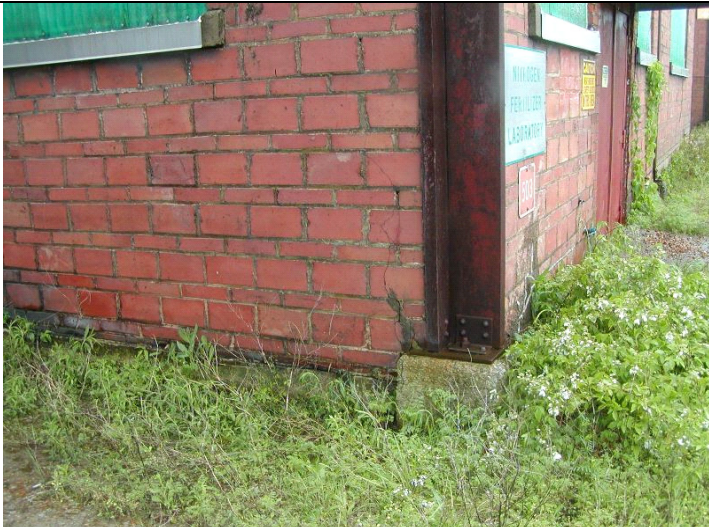
2009 Photo #6: Crack in wall at Northwest corner

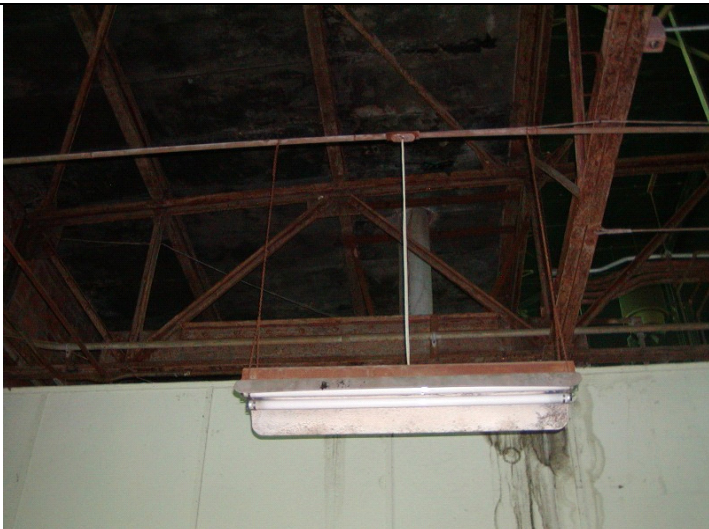
2009 Photo #10: Corroded steel framing and deteriorated roof deck

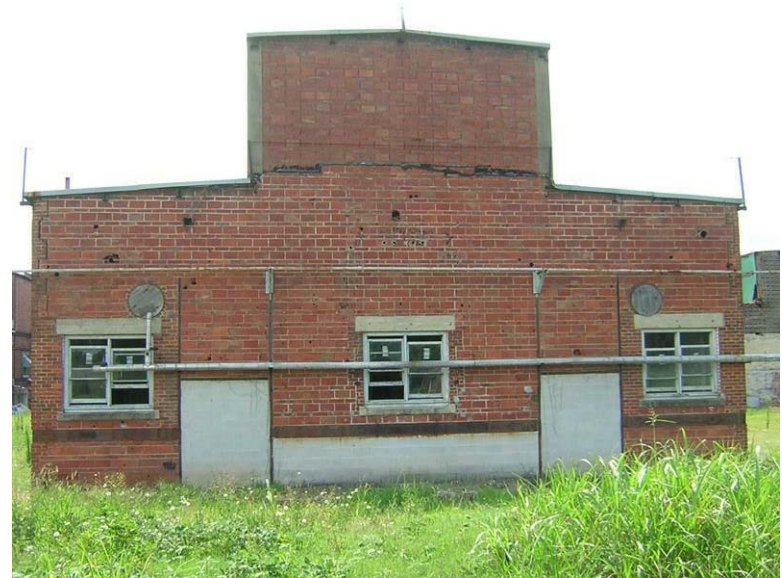
Building 71 – Catalyzer Building No. 3: The original steel windows have been replaced with aluminum windows.

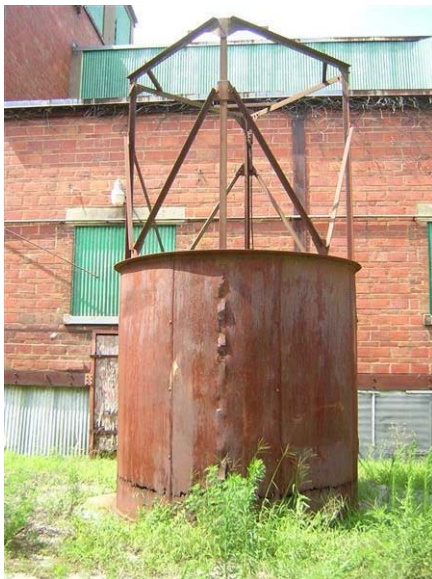
Building 71 – Catalyzer Building No. 3: The cylindrical metal structure adjacent to the building is rusted.

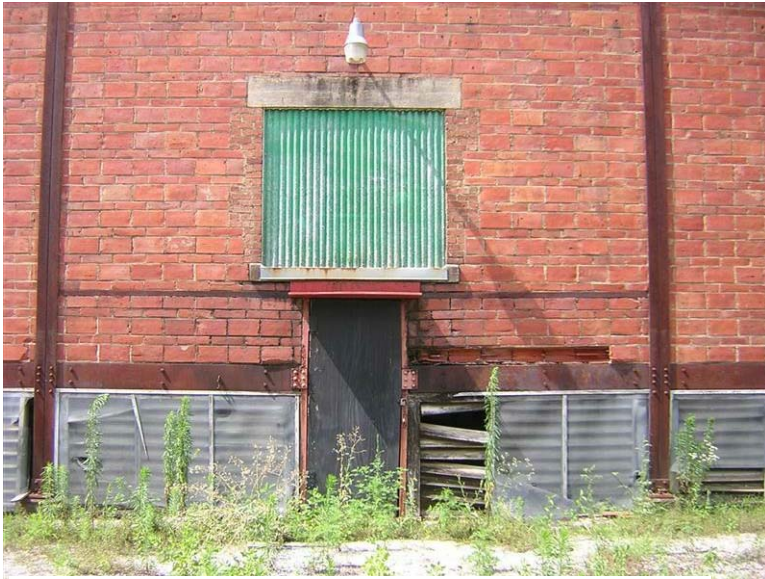
Building 71 – Catalyzer Building No. 3: Several wood louvers are broken and damaged.

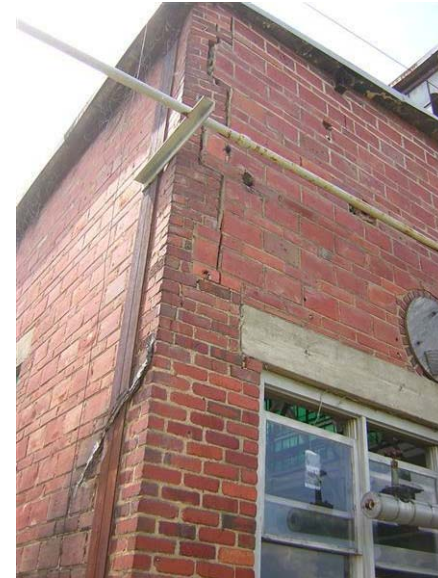
Building 71 – Catalyzer Building No. 3: The quoins are cracked at the rear corners.

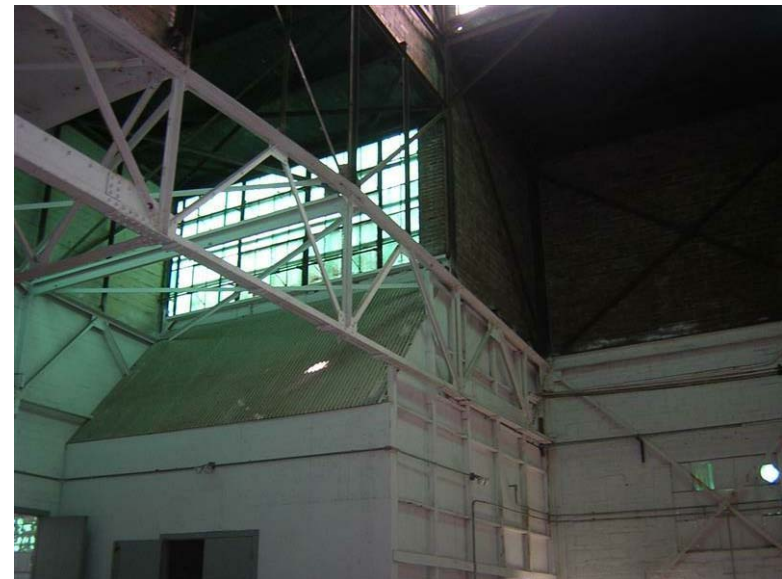
Building 71 – Catalyzer Building No. 3: Metal decking has been placed over this interior infill.

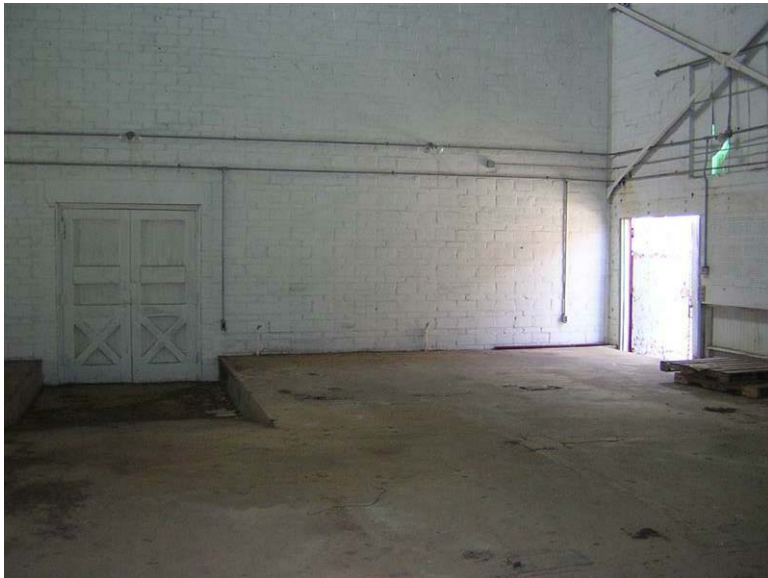
Building 71 – Catalyzer Building No. 3: The doors leading to the vault were locked and the area was gated from the exterior.

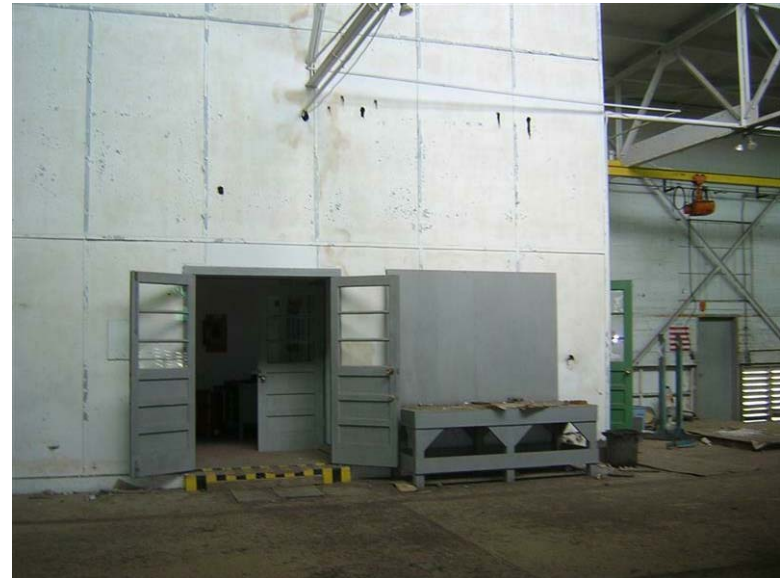
Building 71 – Catalyzer Building No. 3: Paint is flaking from the interior partition wall, which has several holes.

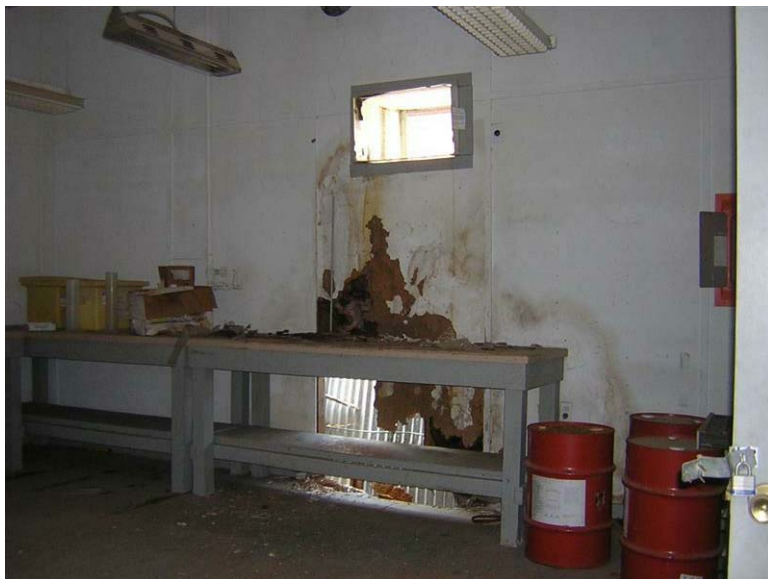
Building 71 – Catalyzer Building No. 3: Water infiltration has severely damaged the wood stud wall.

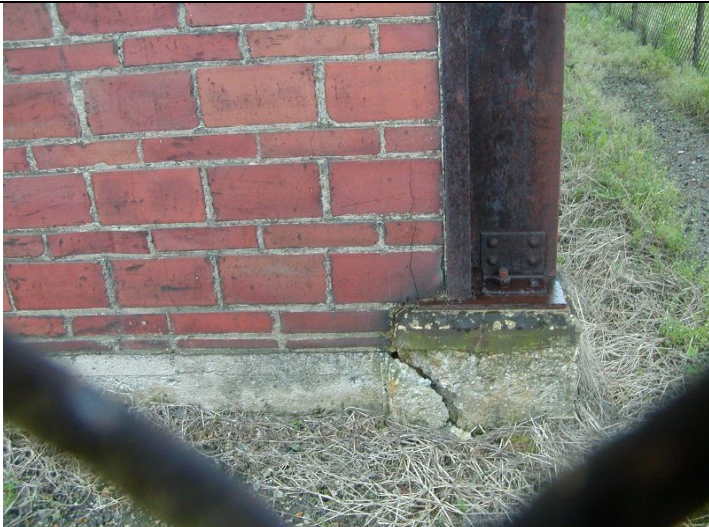
2009 Photo #4: Cracked concrete pier and masonry at Northwest corner

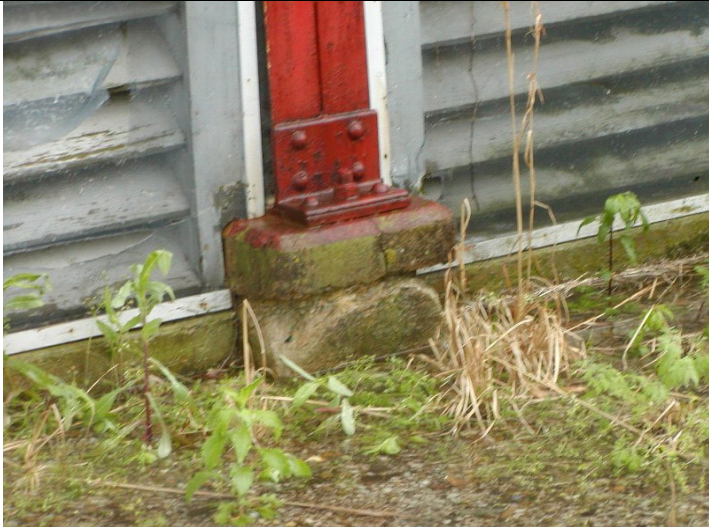
2009 Photo #5: Deteriorated concrete pier at column

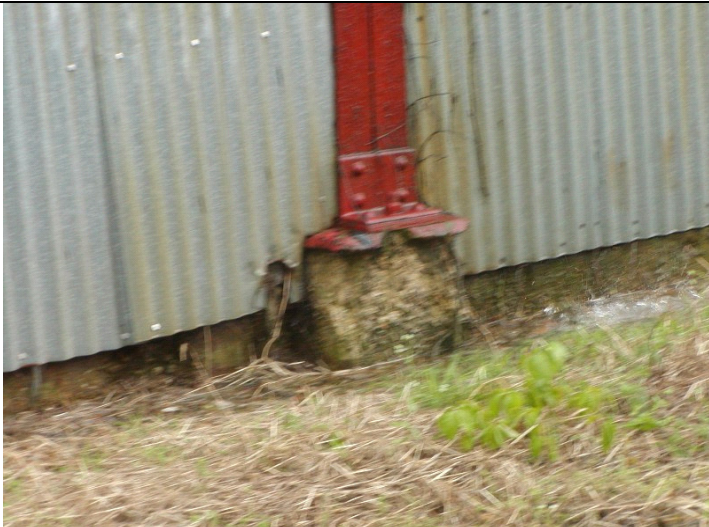
2009 Photo #6: Deteriorated concrete pier at column

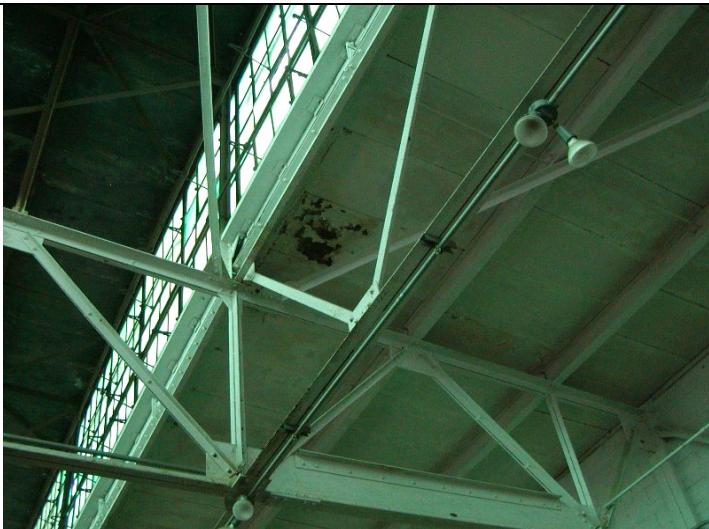
2009 Photo #10: Deteriorated concrete plank at roof deck

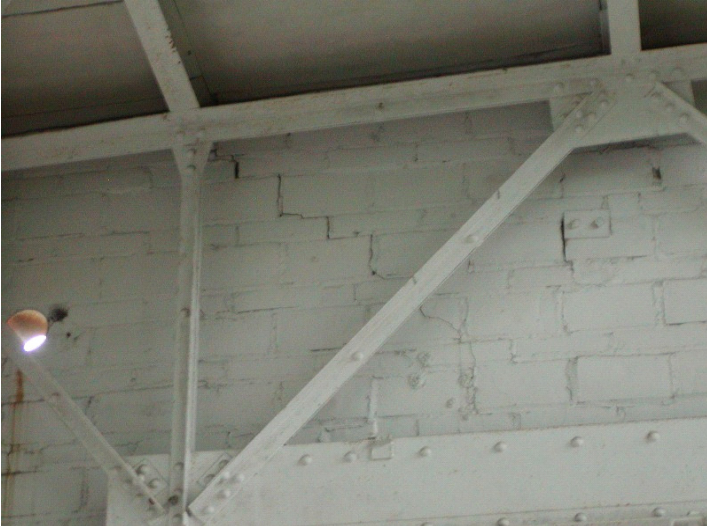
2009 Photo #11: Interior crack in masonry at East wall

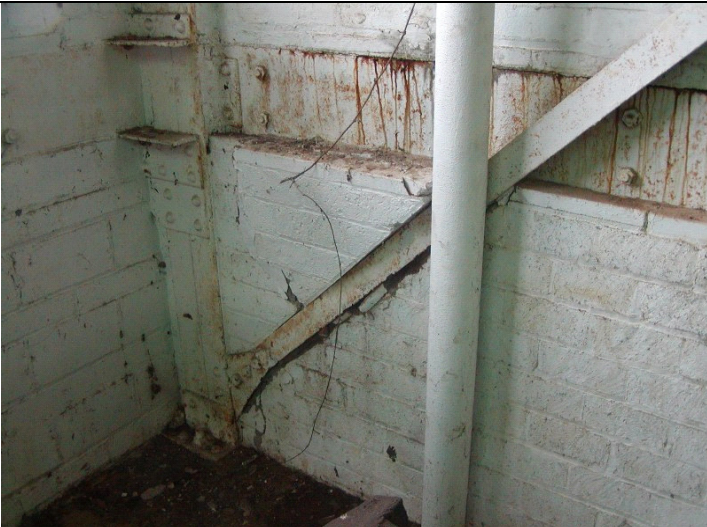
2009 Photo #12: Infill cracking and displacement at Southeast corner

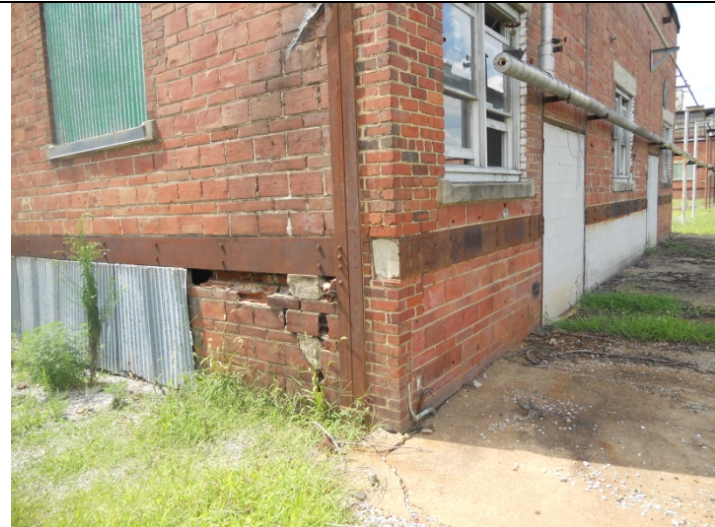
2013 Photo #12: General progressive deterioration was observed

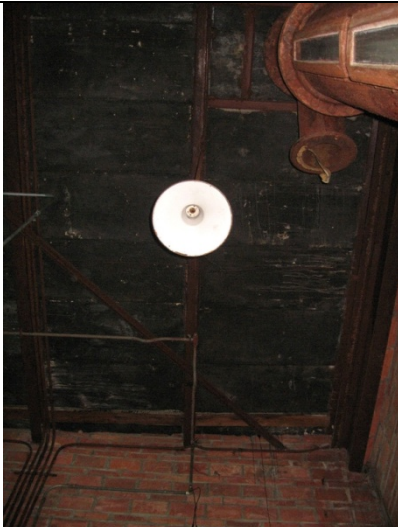
2009 Photo #14: Heavily deteriorated roof deck at West end

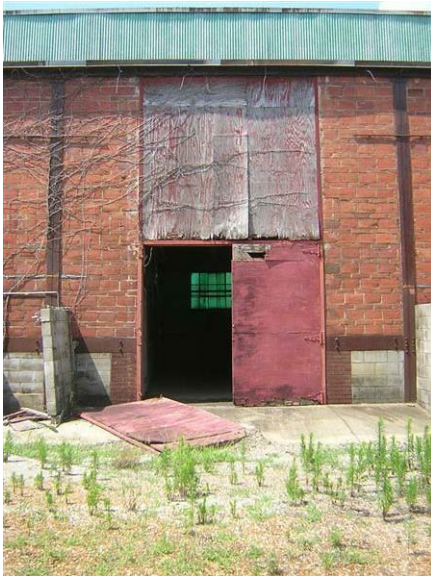
Building 72 – Catalyzer Building No. 4: The doors at this opening are in poor condition. One door is missing from its hinges.

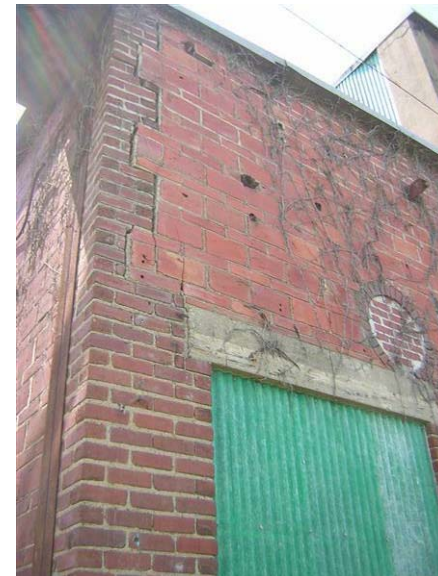
Building 72 – Catalyzer Building No. 4: Cracking has separated the brick quins from the hollow clay tile on the east elevation.

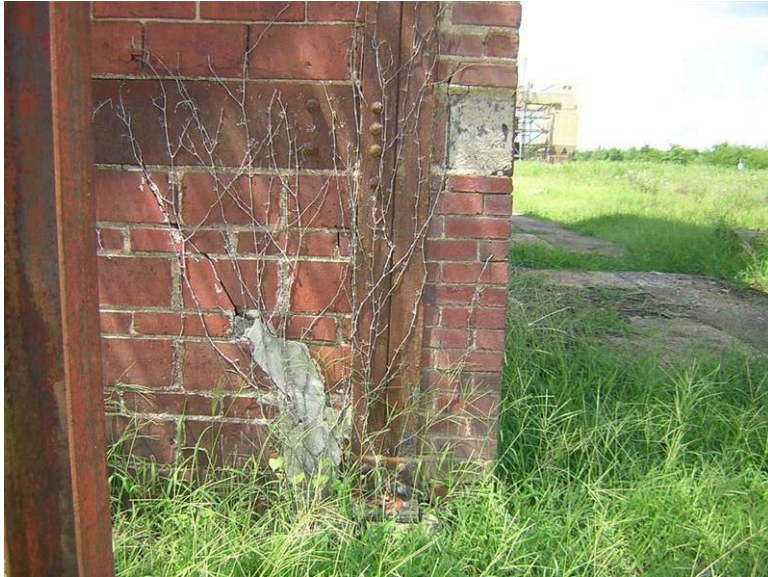
Building 72 – Catalyzer Building No. 4: The crack at the south wall has been partially parged with concrete.

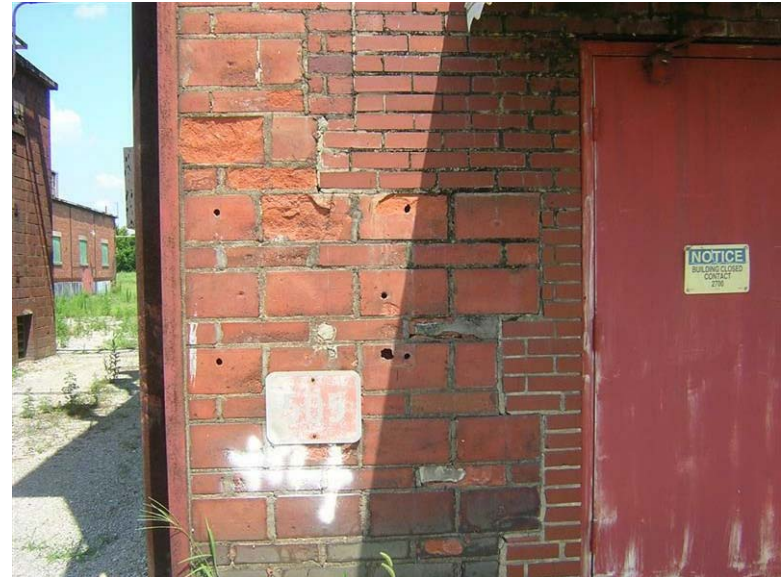
Building 72 – Catalyzer Building No. 4: The hollow clay tile is spalling on the west façade.

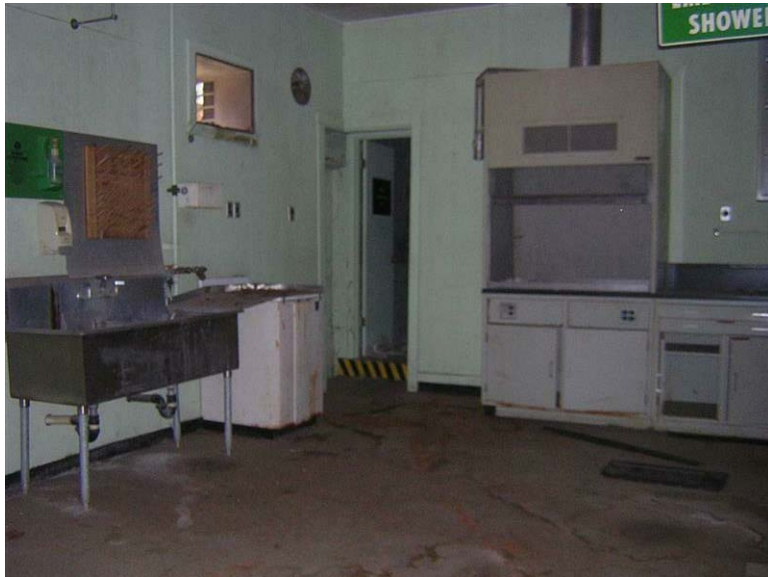
Building 72 – Catalyzer Building No. 4: The floor in the laboratory space is water-stained.

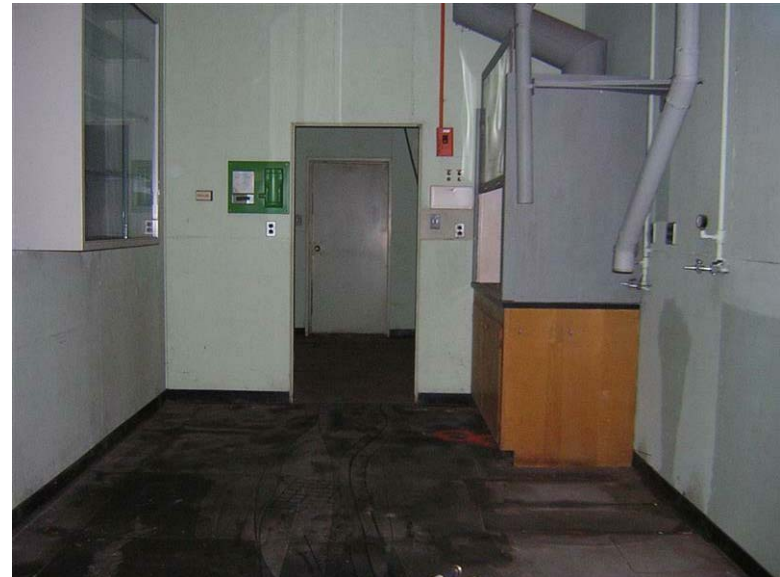
Building 72 – Catalyzer Building No. 4: The floor tiles in the hallway are damaged from moisture.

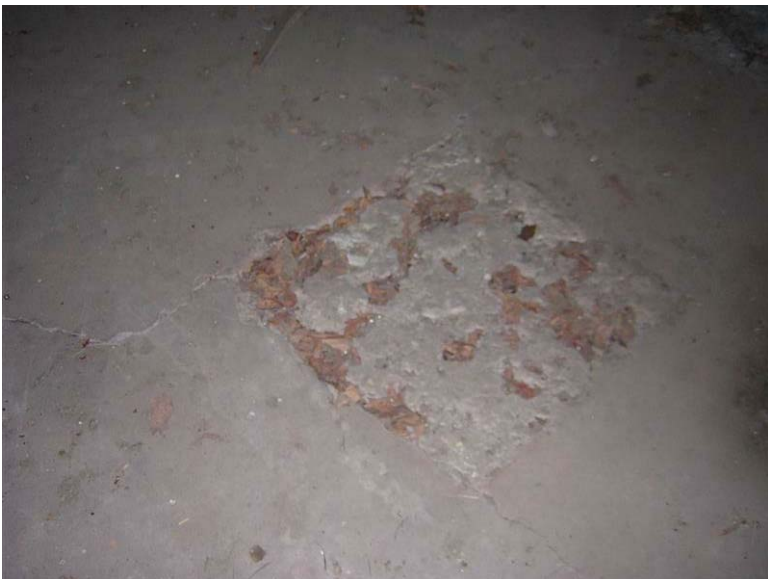
Building 72 – Catalyzer Building No. 4: The concrete floor is cracked and damaged in several areas.

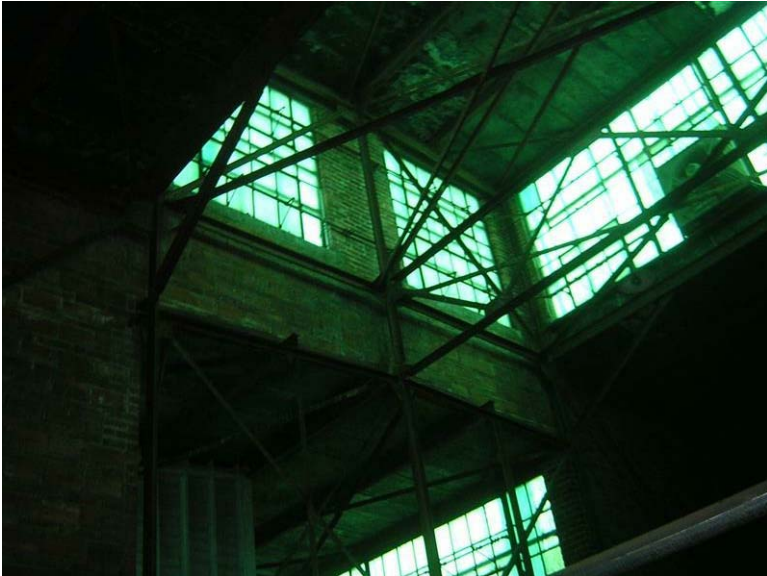
Building 72 – Catalyzer Building No. 4: Several of the concrete panels are damaged from water infiltration.

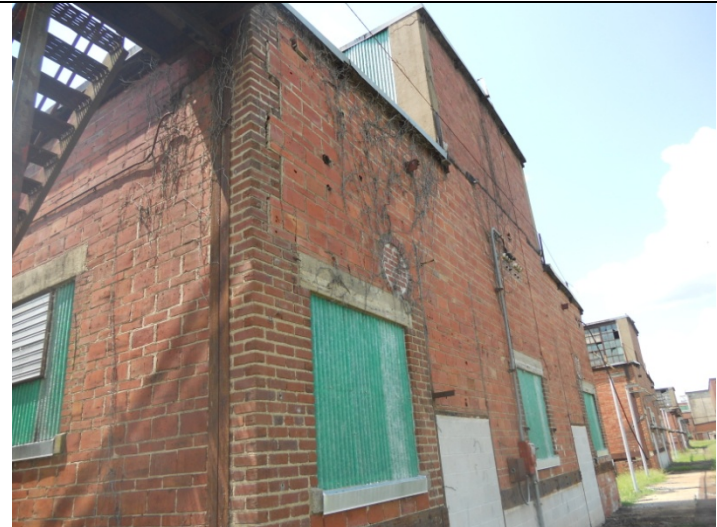
2013 Photo #2: SE corner of building. Vegetation covering portions of exterior walls is now dead, making masonry defects more visible.

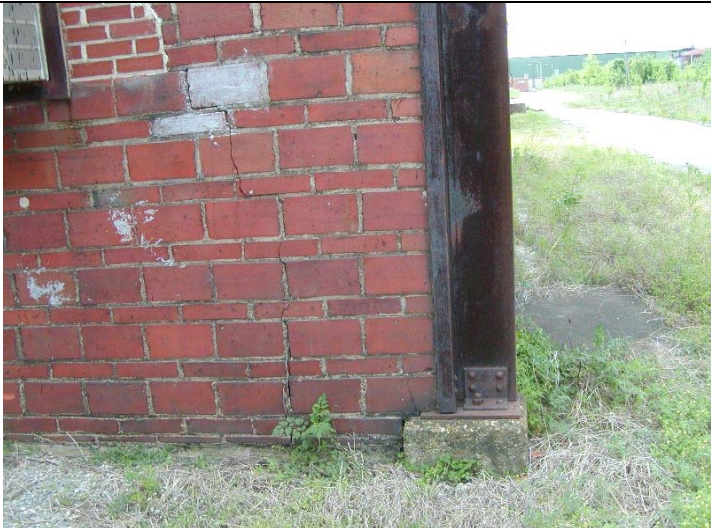
2009 Photo #4: Crack in wall at Northwest corner

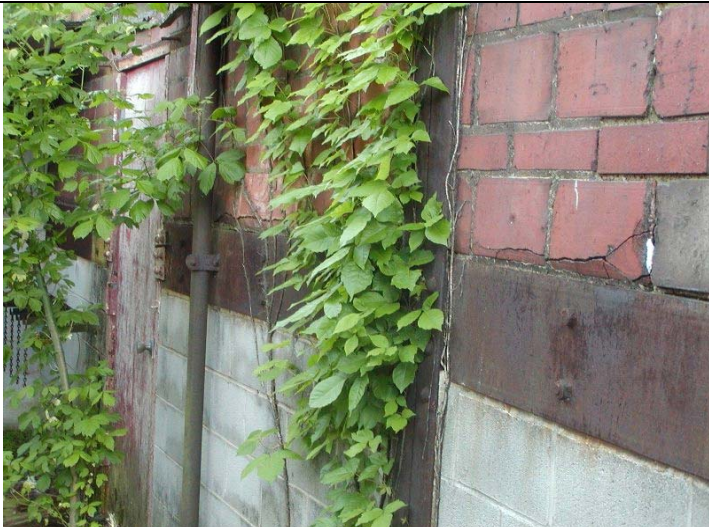
2009 Photo #5: General deterioration on North side of building

2009 Photo #6: Detail view of North side

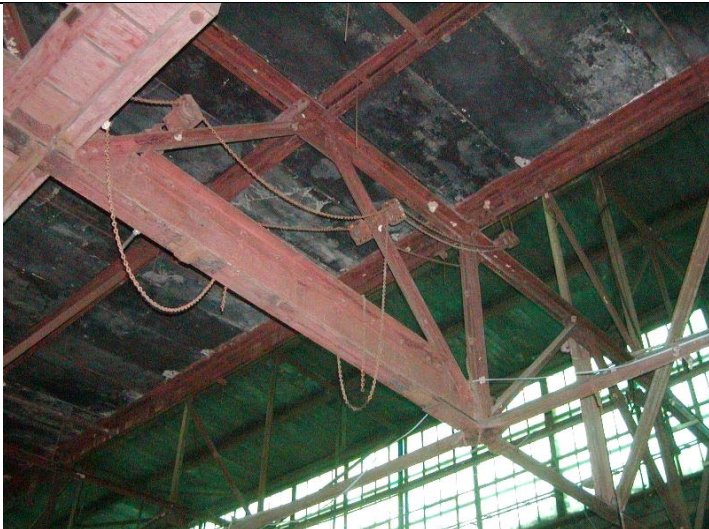
2009 Photo #8: Corroded steel roof framing and deteriorated concrete roof planks

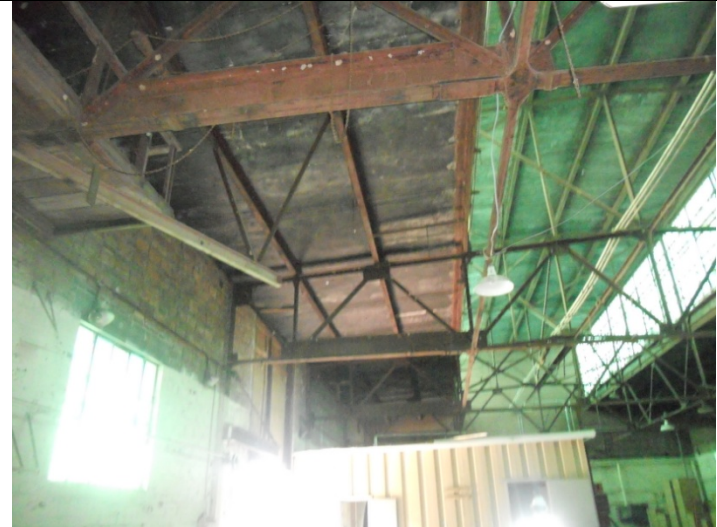
2013 Photo #7: Progressive deterioration of roof framing and deck appears to be evident

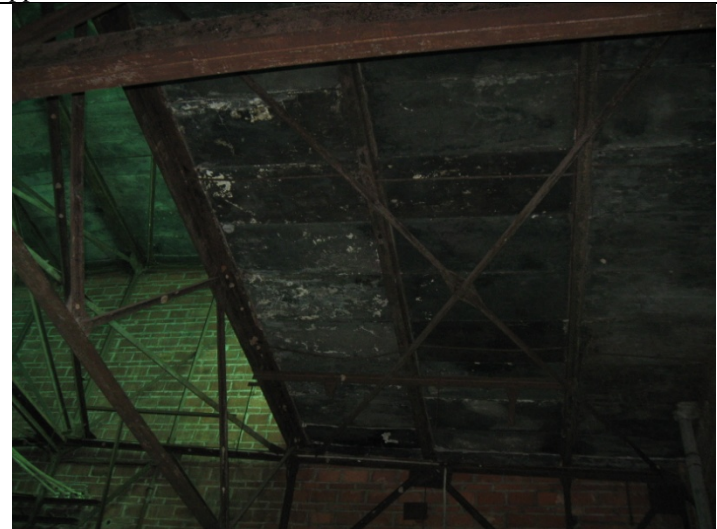
2013 Photo #8: Progressive deterioration of roof framing and deck appears to be evident

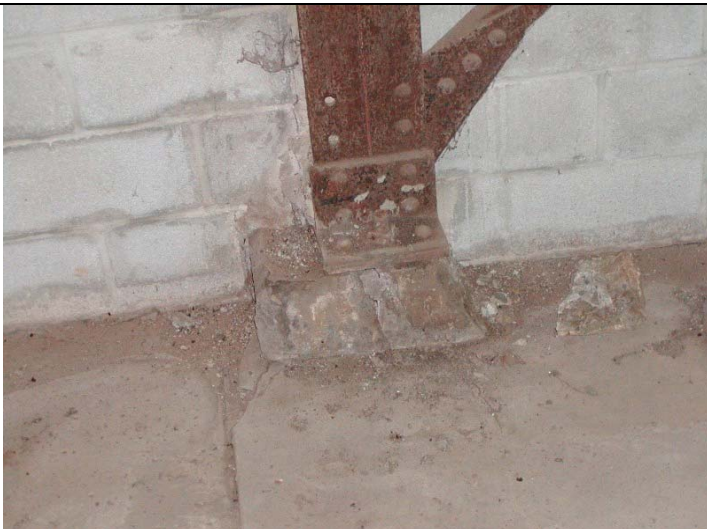
2009 Photo #10: Deteriorated concrete pier at column

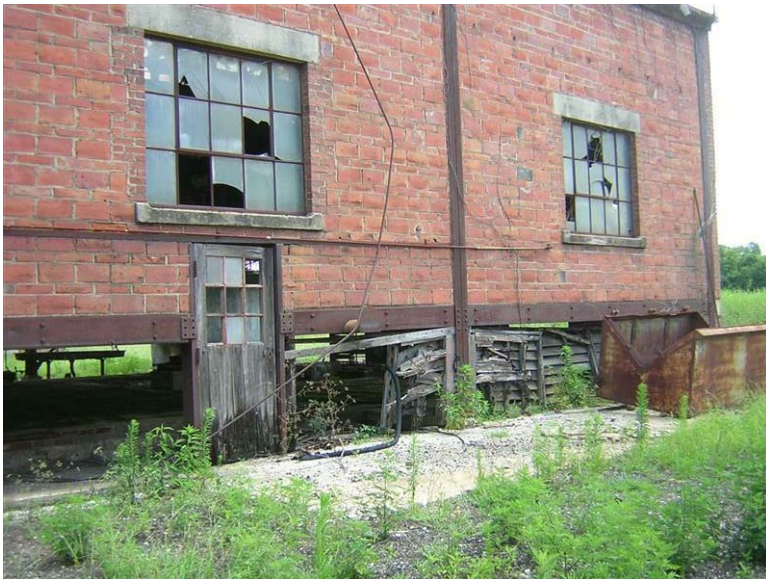
Building 73 – Catalyzer Building No. 5: The wood door is damaged from moisture and the steel windows have several broken panes.

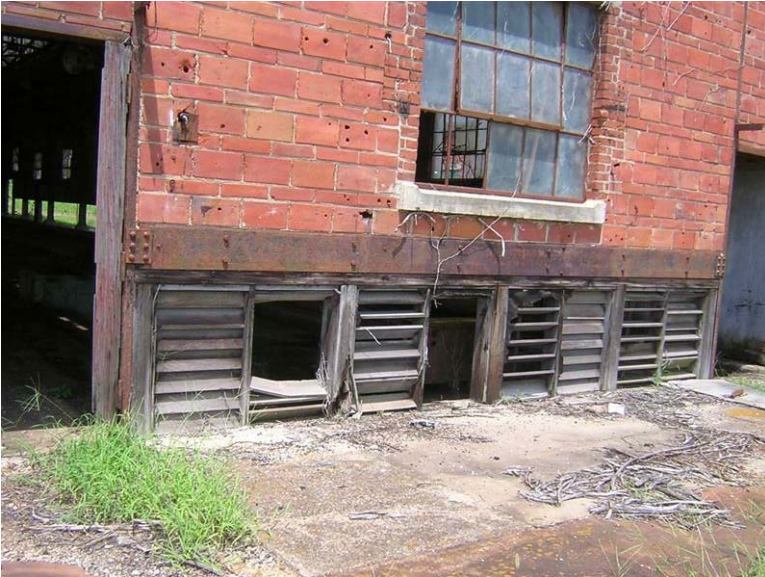
Building 73 – Catalyzer Building No. 5: Several of the wood louvers are broken.

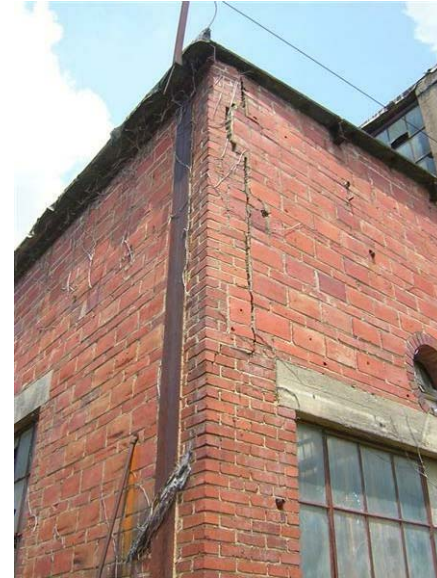
Building 73 – Catalyzer Building No. 5: Visible cracking is located along the quoins at the upper east facade.

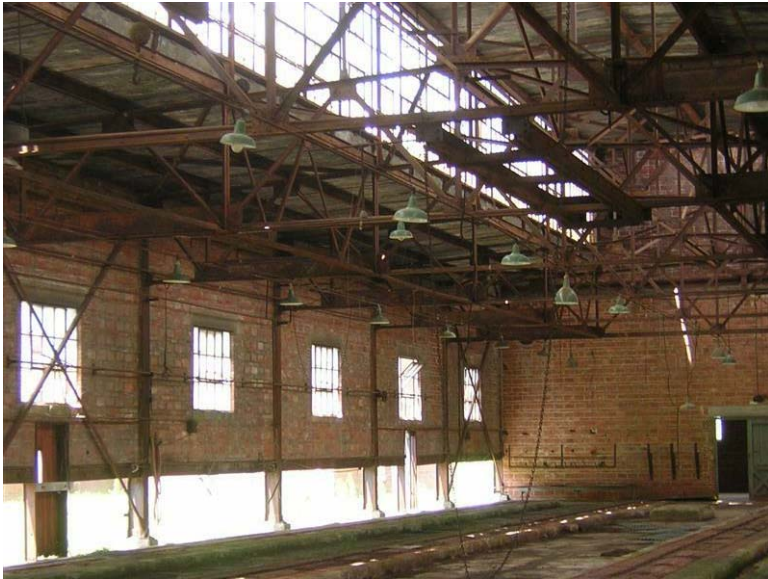
Building 73 – Catalyzer Building No. 5: The steel structure is rusted and several concrete panels are stained from water damage.

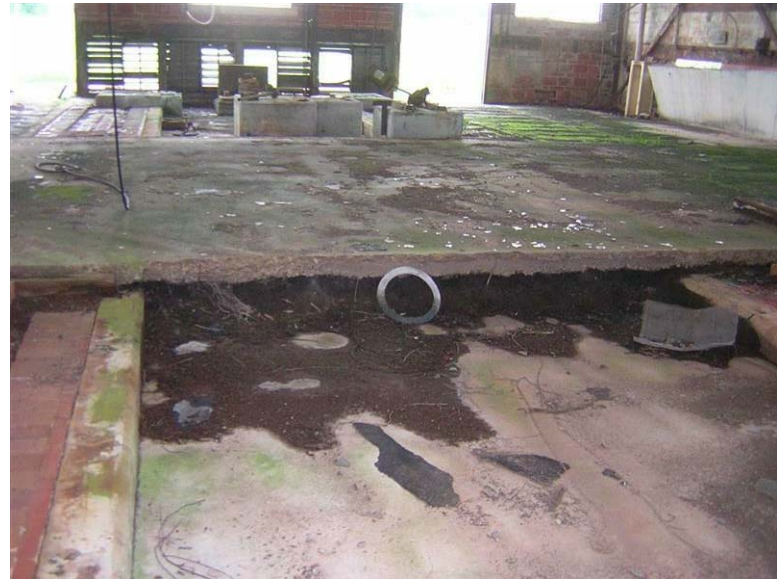
Building 73 – Catalyzer Building No. 5: The concrete floor is cracked in several areas.

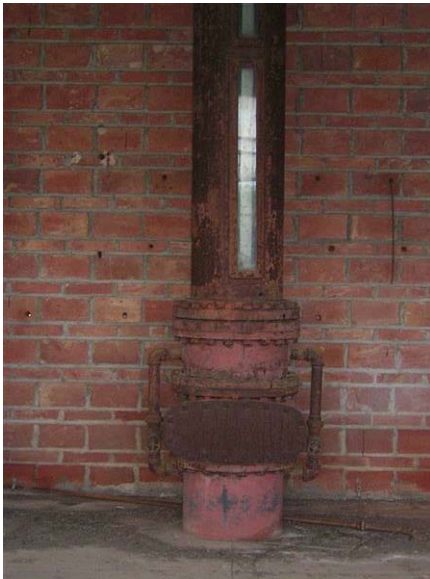
Building 73 – Catalyzer Building No. 5: Some of the equipment used in the catalyzer process is rusted.

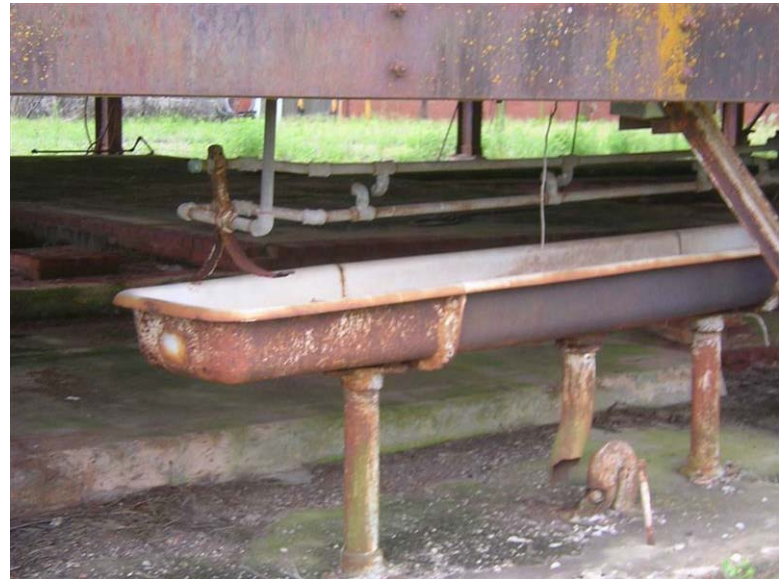
Building 73 – Catalyzer Building No. 5: Some of the equipment used in the catalyzer process is rusted.

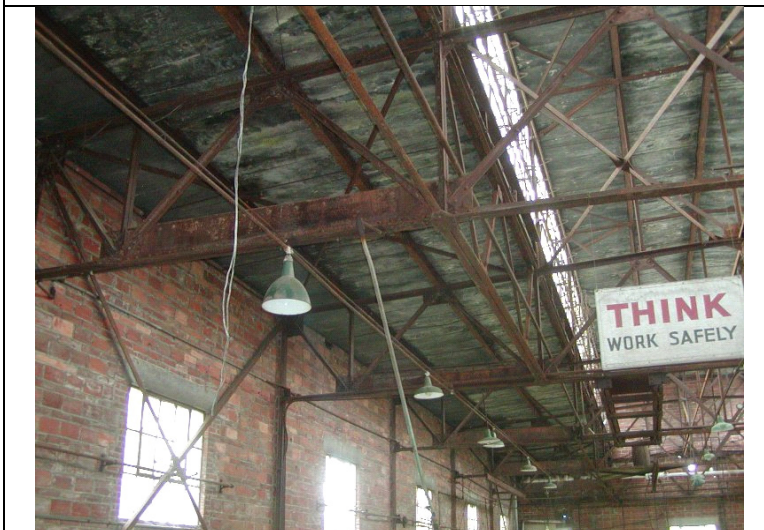
2009 Photo #6: Corroded steel framing and deteriorated concrete plank roof deck

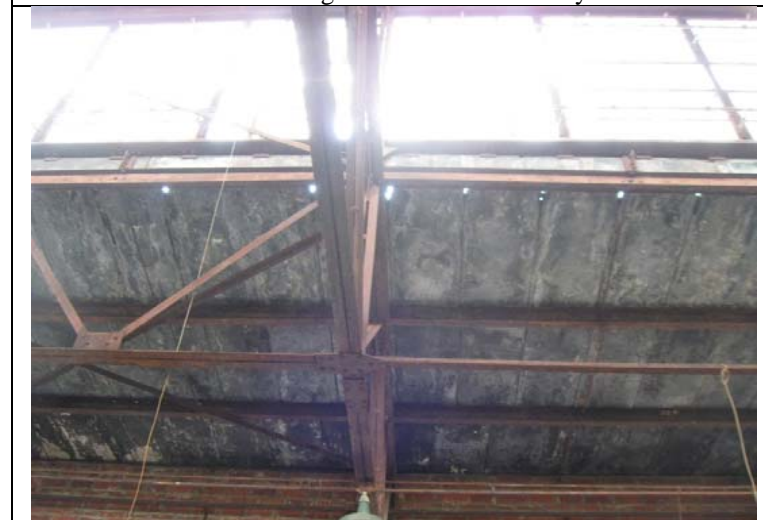
Defect Item No.	Defect Description (2009)	2013 Assessment of 2009 Itemized Defects	Photo Log Reference Nos.	
			From 2009 Report	2013
1	Foundation settlement cracks on northwest corner	Change in condition was not observed	13,14	
2	Foundation settlement cracks on southwest corner	Change in condition was not observed		
3	Foundation settlement cracks on north wall	Change in condition was not observed		
4	Sagging support beam for north wall masonry	Change in condition was not observed	12	
5	Deteriorated masonry at southeast corner	Change in condition was not observed	10	
6	Cracking in exterior masonry at southeast corner.	Change in condition was not observed		
7	Cracking in masonry at northeast corner	Change in condition was not observed		
8	Corrosion of steel framing	Minor progressive deterioration of steel framing appears to be evident	6,7	
9	Spalling and deteriorated concrete roof deck	Progressive deterioration was noted, including more exposed reinforcing steel and holes through concrete planks	6,7,8,9	5,6,7,8

2013 Photo #6: Progressive deterioration of concrete plank roof deck was observed – note holes through deck below clerestory

Additional Recommendations (2009):	A detailed evaluation of the concrete plank roof deck will be required to determine what portion of the original deck can be salvaged and the extent of repairs required. (2013: It appears unlikely that significant portions of the existing concrete roof deck can be salvaged. Full replacement of the roof deck should be anticipated.)

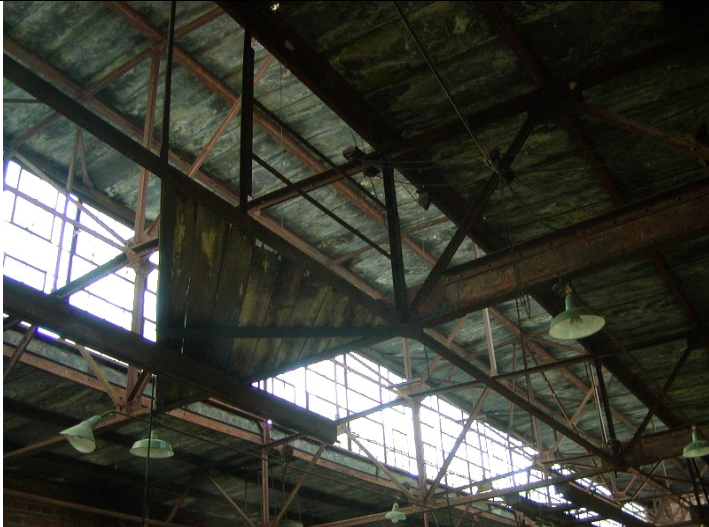
2009 Photo #7: Corroded steel framing and deteriorated concrete plank roof deck

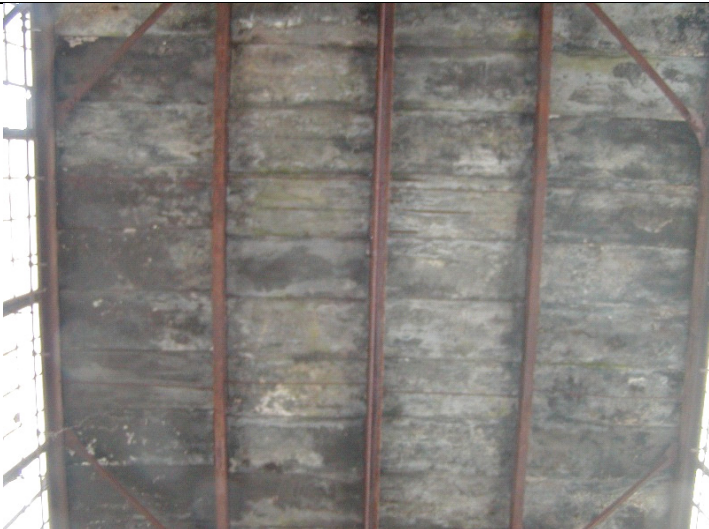
2009 Photo #8: Deteriorated concrete plank roof deck at monitor. Exposed reinforcing steel is visible

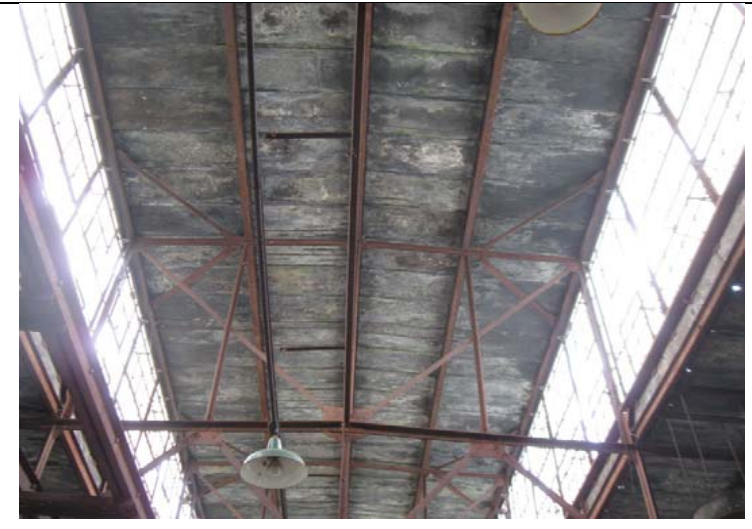
2013 Photo #8: Progressive deterioration of concrete plank roof deck indicates change in condition from (4) "Deteriorated" to (5) "Critical"

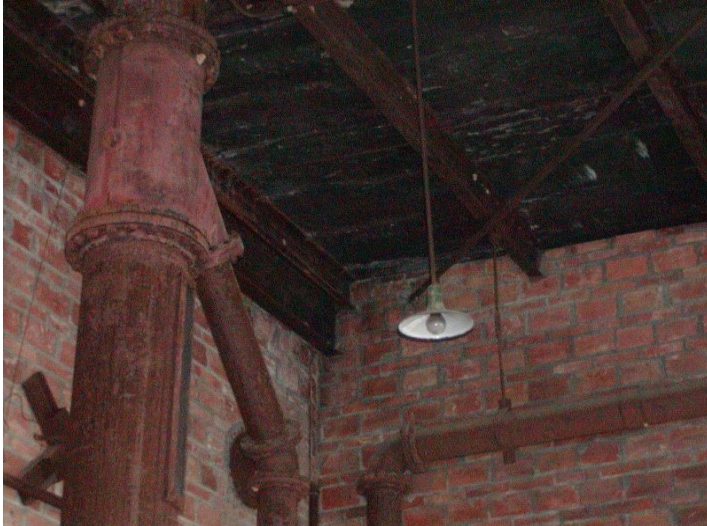
2009 Photo #9: Severely deteriorated roof structure at West end of building

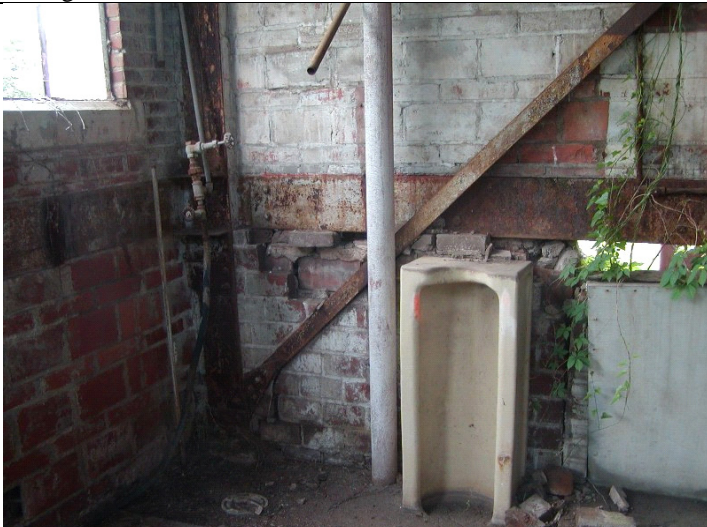
2009 Photo #10: Damaged masonry infill at Southeast corner

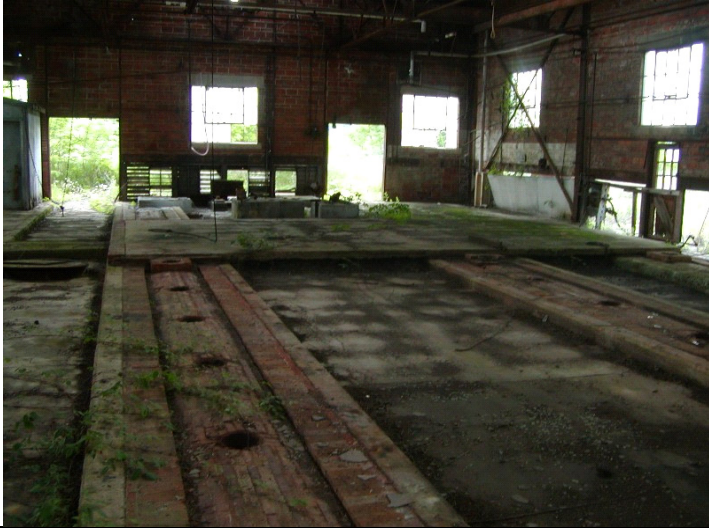
2009 Photo #11: Irregular, deteriorated floor system in main building

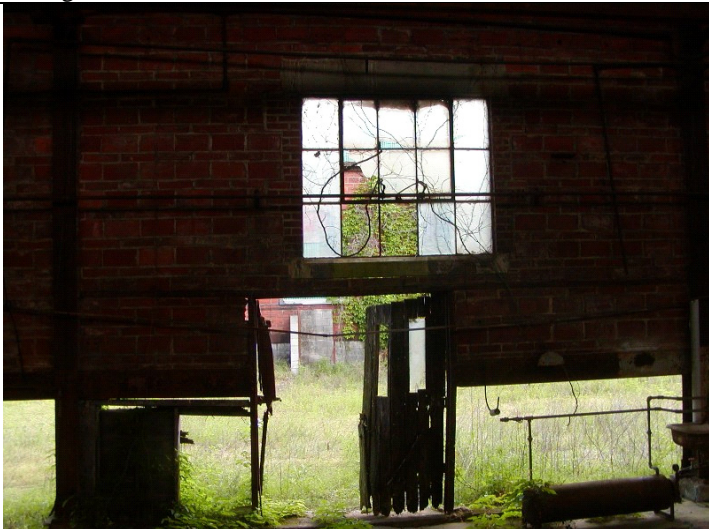
2009 Photo #12: Structurally unstable masonry infill and supporting steel framing

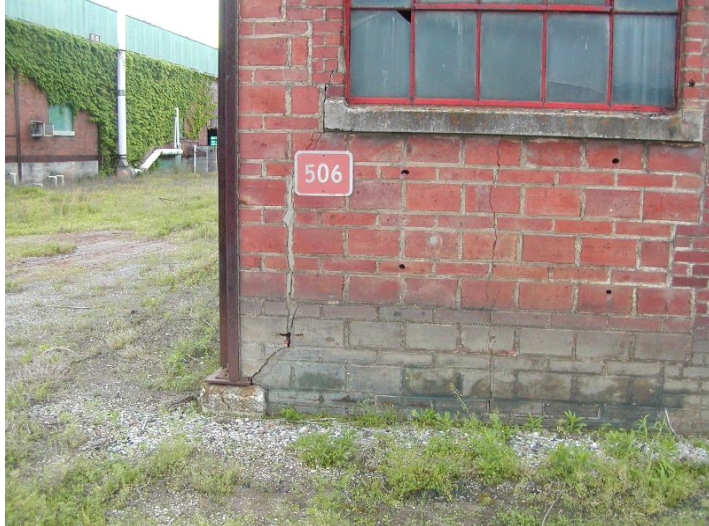
2009 Photo #13: Settlement cracks in masonry at Northwest corner

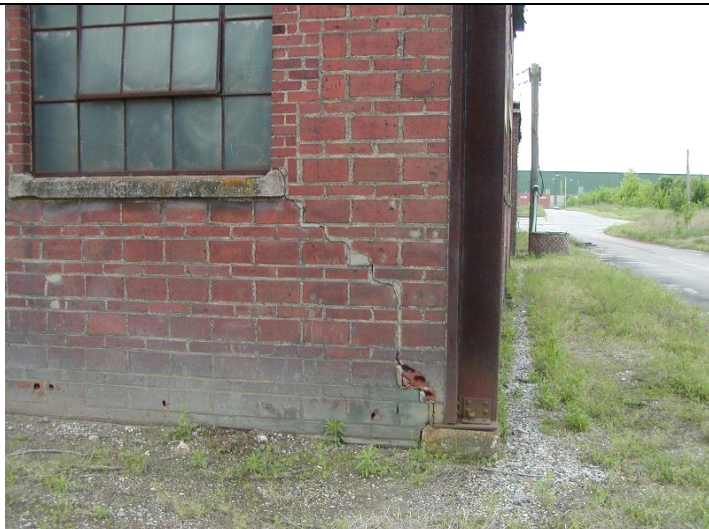
2009 Photo #14: Settlement cracks in masonry at Northwest corner
