Tennessee Valley Authority

Cyclic Assessment Report
TVA Muscle Shoals, Alabama
September 16, 2013

Executive Summary

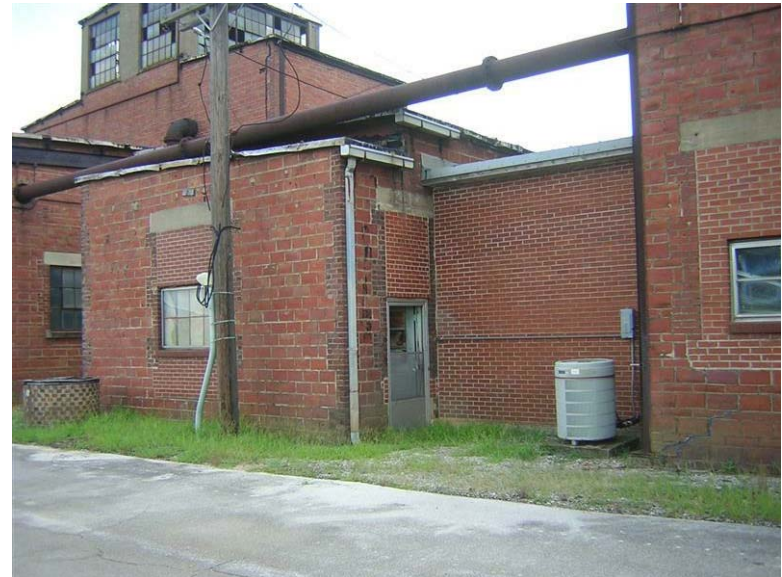
Building 74 – Catalyzer Building No. 6: A flush brick facade connects the substation to the adjacent catalyzer building.

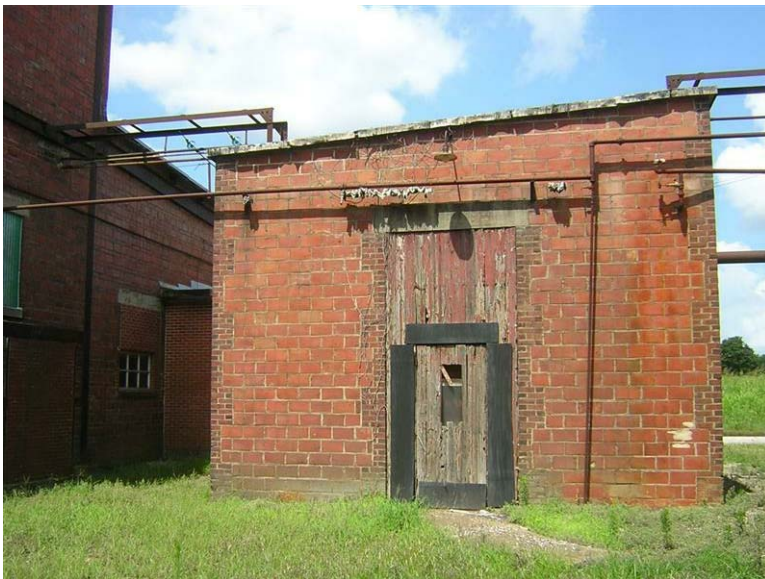
Building 74 – Catalyzer Building No. 6: Paint is flaking and the wood door is damaged at the adjoining substation.

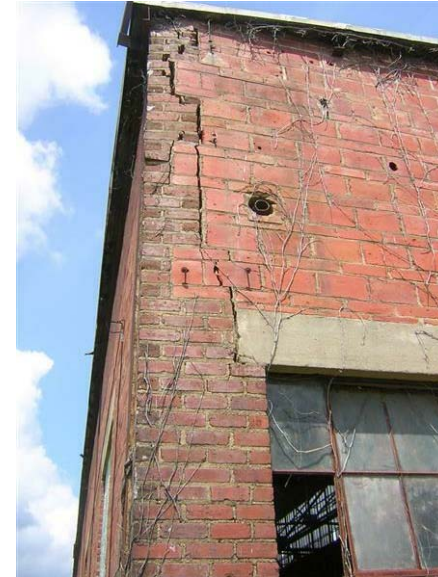
Building 74 – Catalyzer Building No. 6: The wall is cracked along the brick quoins.

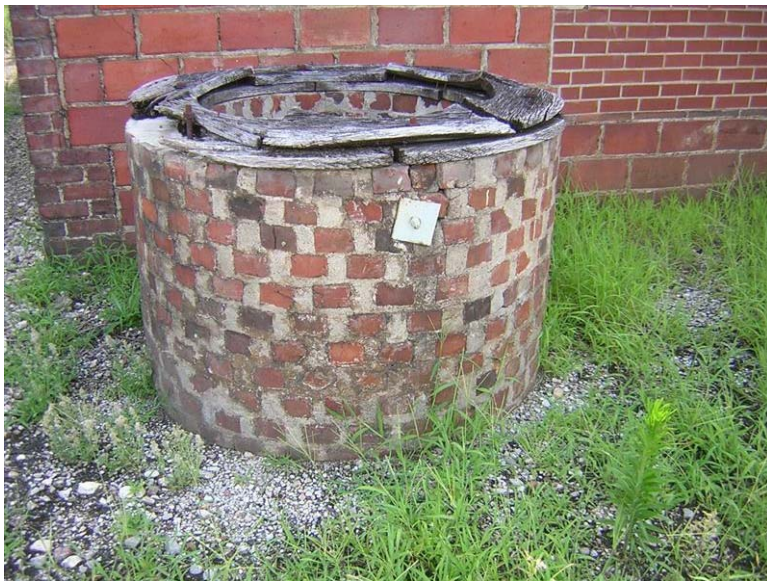
Building 74 – Catalyzer Building No. 6: The wood on top of the brick well / structure is warped and damaged.

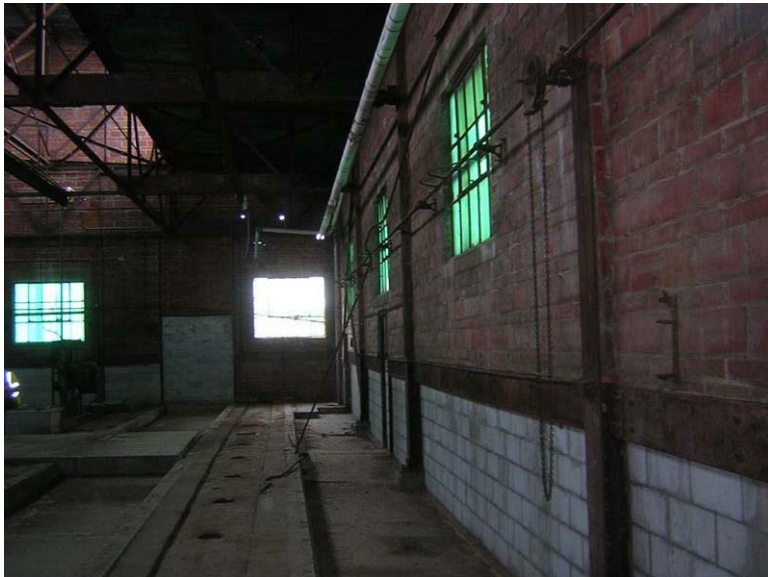
Building 74 – Catalyzer Building No. 6: The exposed steel is rusted.

Summary of Recommended Structural Repairs (2009):	The structural steel framing must be sandblasted and painted. Remediation of the concrete plank roof deck will be required. Cracks and spalls in the exterior masonry walls must be repaired. Remediation of the existing floor system at the east end of the building is not required, but a new floor system in this portion of the building must be constructed in order to reuse this area of the building.
Additional Recommendations (2009):	A detailed evaluation of the concrete plank roof deck will be required to determine the type of remediation and the extent of repairs required.

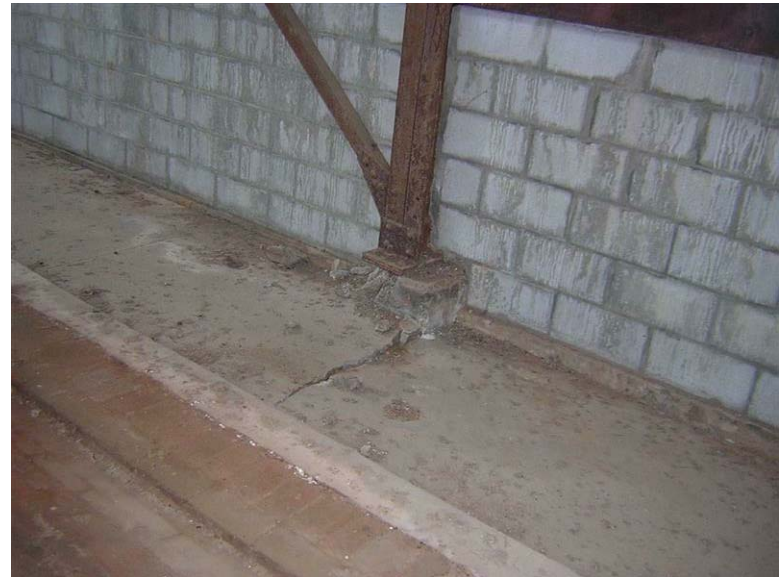
Building 74 – Catalyzer Building No. 6: The concrete footing is broken beneath the steel column.

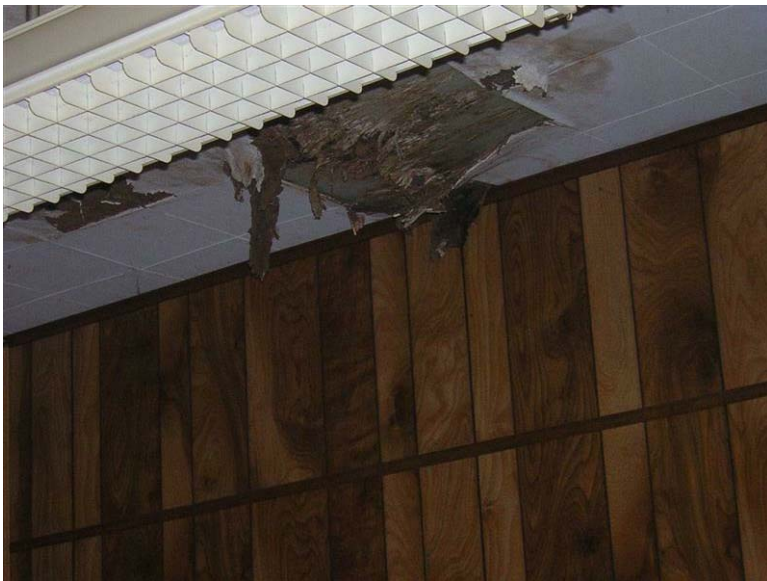
Building 74 – Catalyzer Building No. 6: Water infiltration has damaged the ceiling tiles.

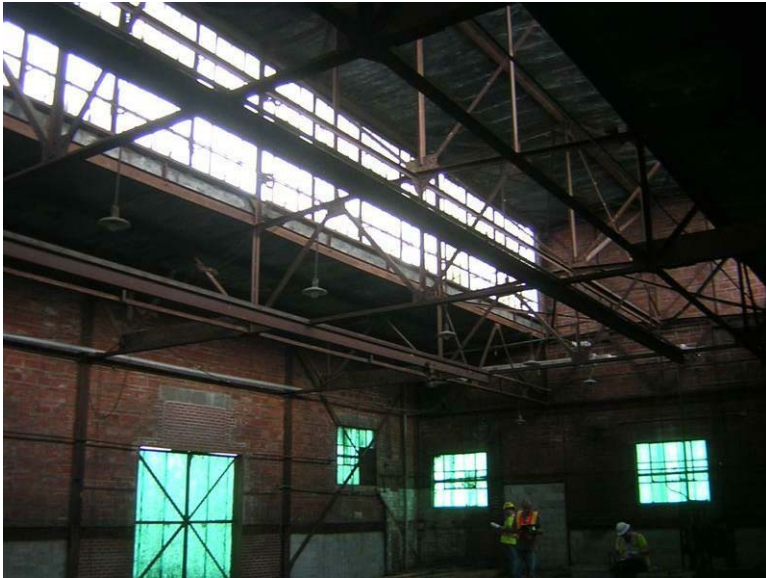
Building 74 – Catalyzer Building No. 6: The steel structure is rusted.

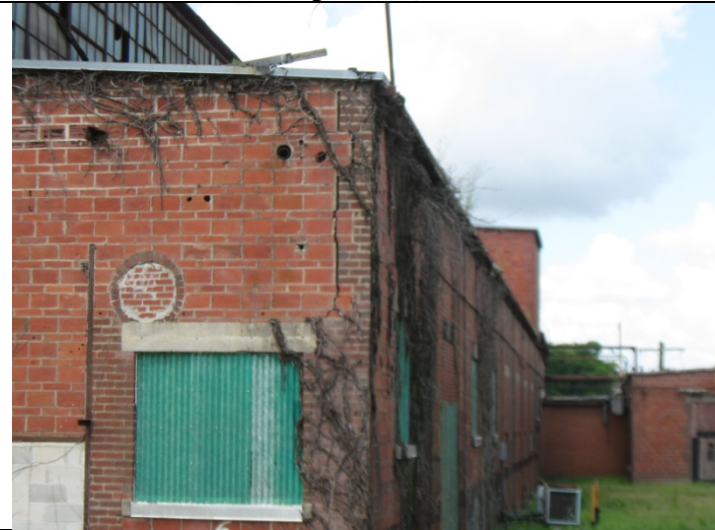
2013 Photo #1: NE corner of building. Vegetation covering portions of exterior walls is now dead, making masonry defects more visible.

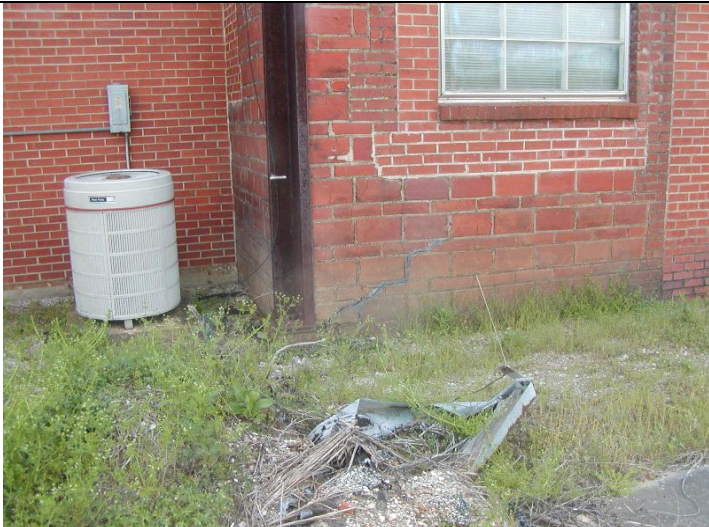
2009 Photo #4: Crack in masonry at Northwest corner where North addition adjoins original building

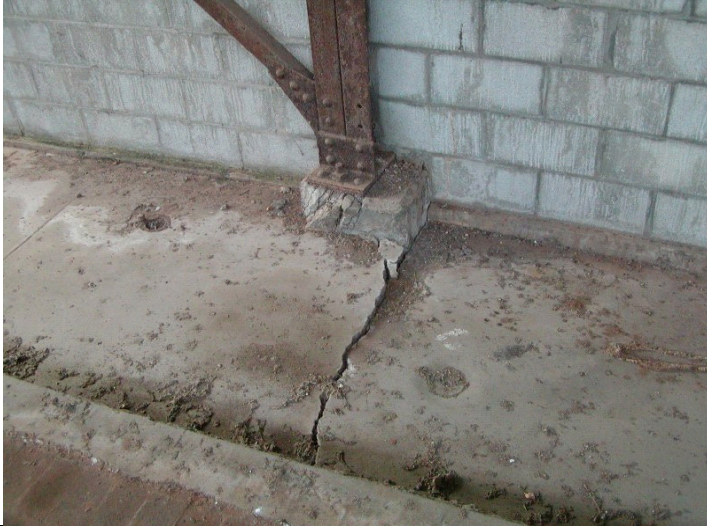
2009 Photo #7: Deteriorated concrete pier and slab at column

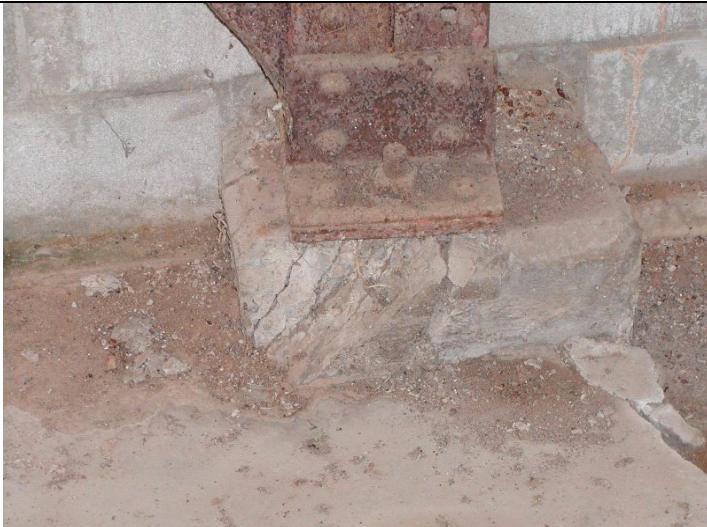
2009 Photo #8: Close-up of deteriorated column attachment at concrete pier

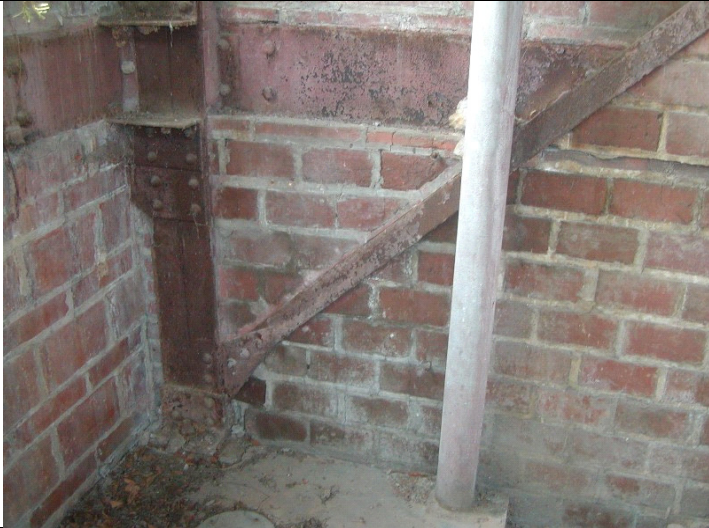
2009 Photo #9: Deteriorated steel column and wall framing

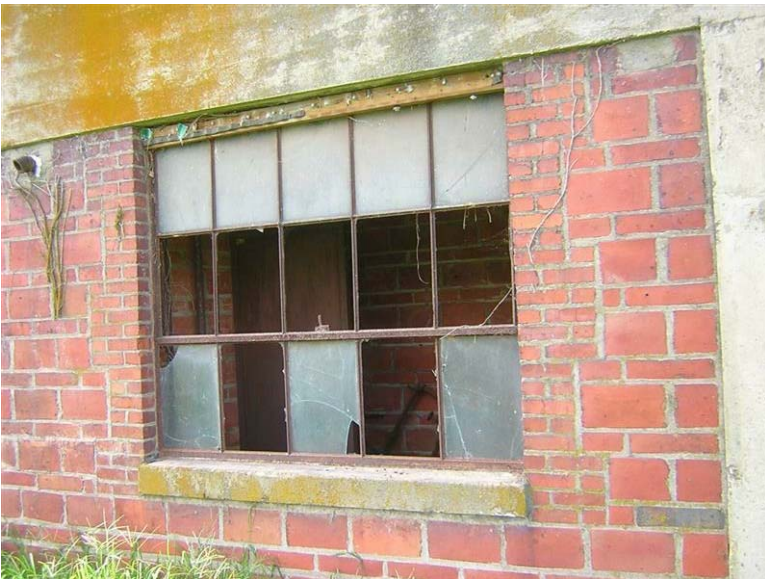
Building 79 – 3A – Nitrate House: Panes are missing and broken in this uncovered window.

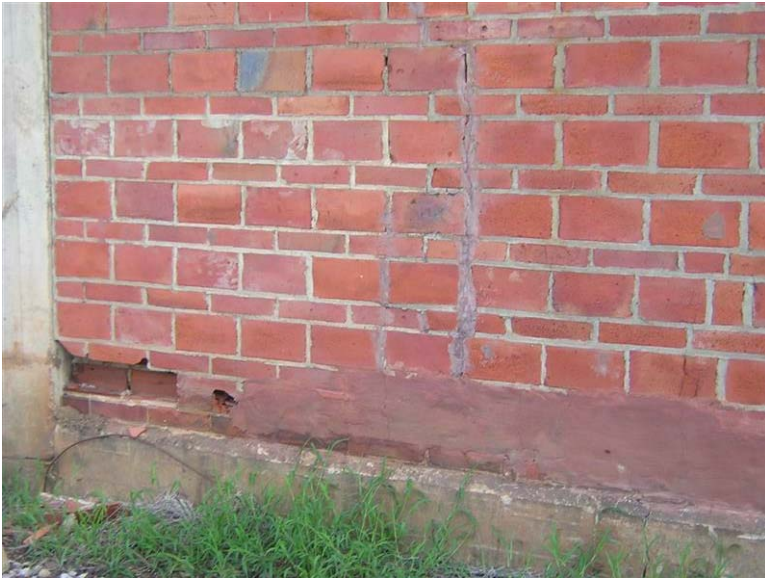
Building 79 – 3A – Nitrate House: Hollow clay tile at the base of this wall has been parged.

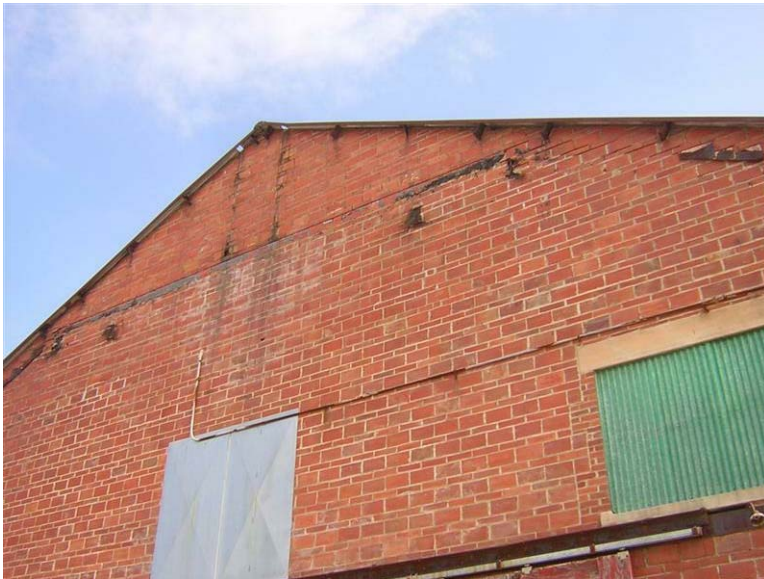
Building 79 – 3A – Nitrate House: There is a large horizontal crack across the gable end.

Summary of Recommended Structural Repairs (2009):	Interior and exterior cracks and spalls in the concrete mezzanine structures must be repaired. The structural steel framing must be sandblasted and painted. Cracks and holes in the exterior masonry walls must be repaired. Defects in the metal roof system must be repaired, and the deteriorated exterior metal roof panels should either be replaced or cleaned, primed, and coated in order to preserve the existing material.
Additional Recommendations (2009):	N/A

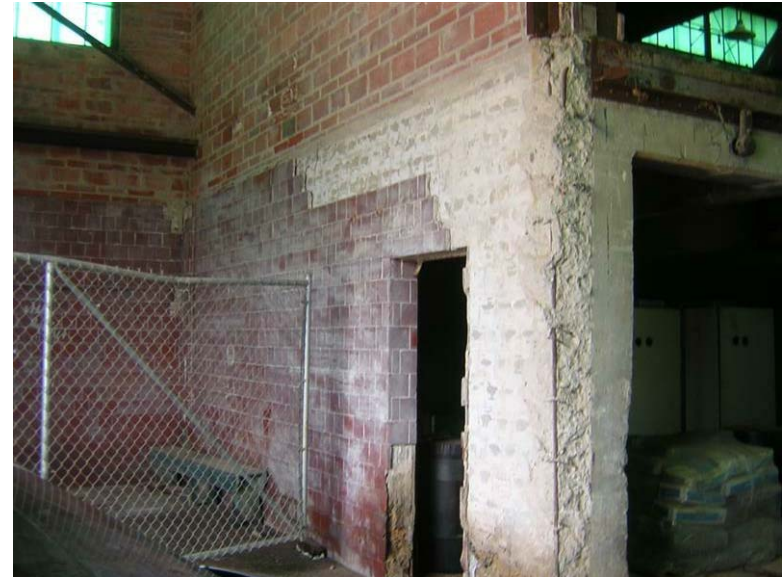
Building 79 – 3A – Nitrate House: Several tiles have detached from the concrete wall and rebar is exposed at the corner.

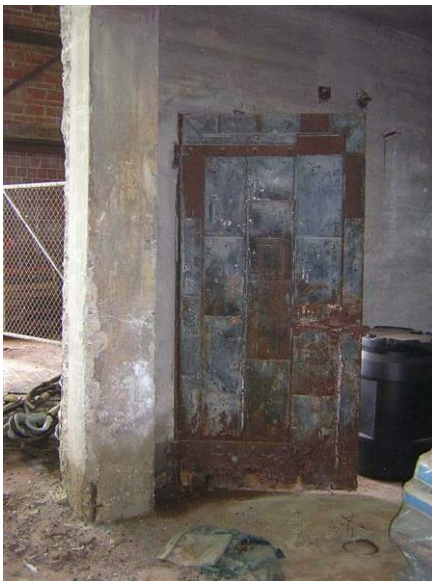
Building 79 – 3A – Nitrate House: The metal door is rusted.

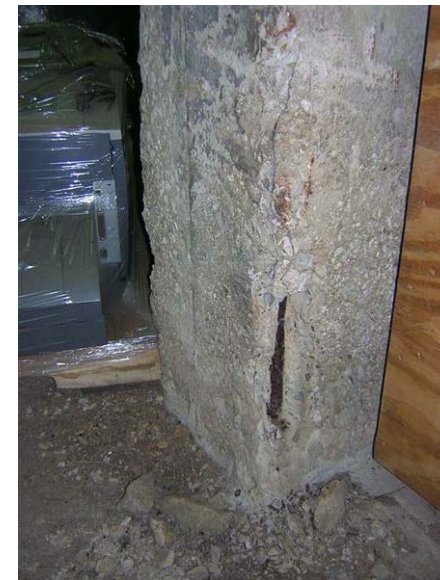
Building 79 – 3A – Nitrate House: Rebar is exposed and the concrete is deteriorating at this column.

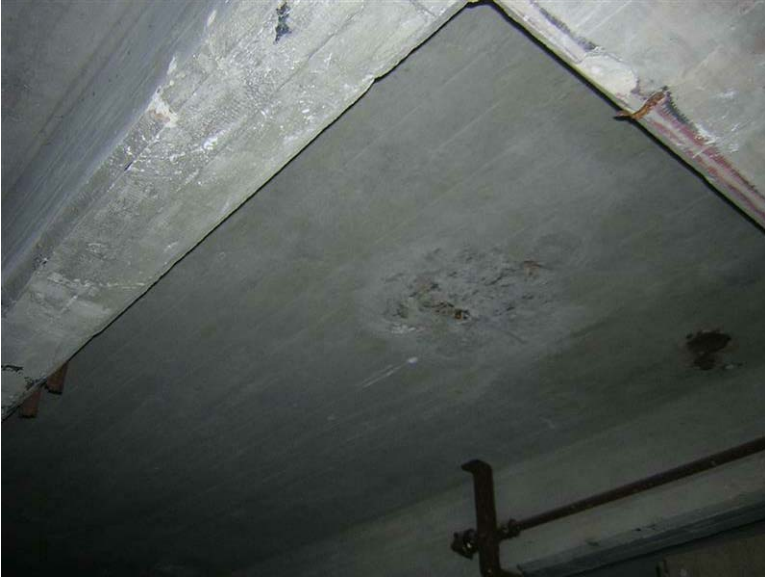
Building 79 – 3A – Nitrate House: Rebar is exposed at the underside of the mezzanine floor.

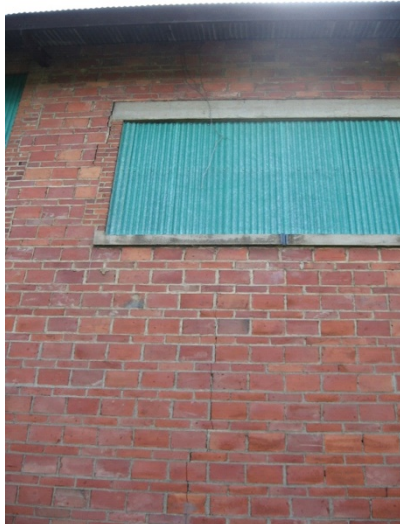
2009 Photo #4: Vertical cracks in masonry

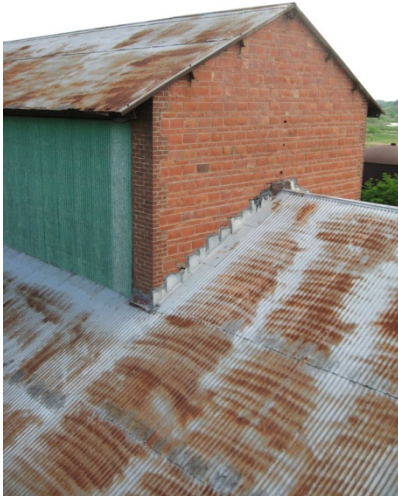
2009 Photo #7: Deteriorated metal roof at South end

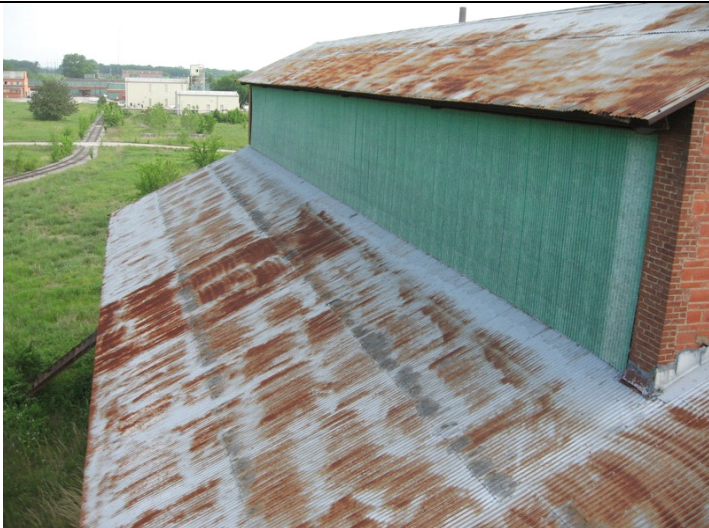
2009 Photo #8: Deteriorated metal roof on West side

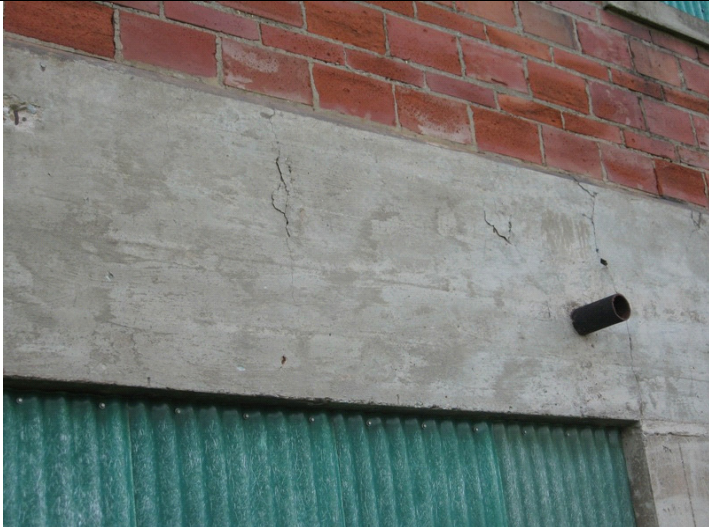
2009 Photo #9: Minor cracks and spalls in exterior face of mezzanine concrete frame

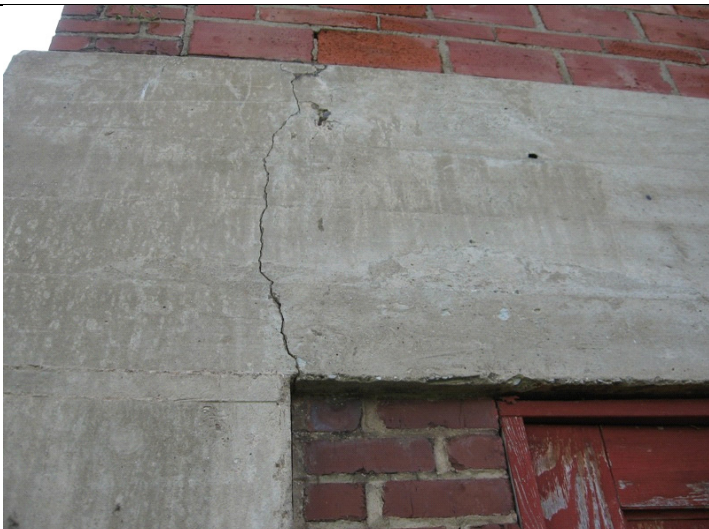
2009 Photo #10: Substantial crack in exterior mezzanine concrete frame

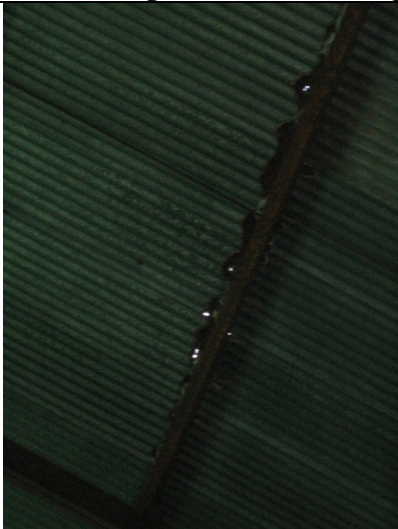
2009 Photo #17: Holes in metal roof deck

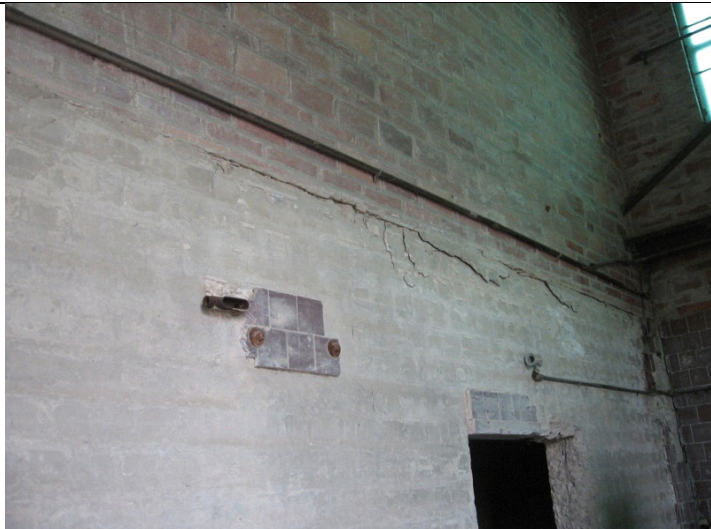
2009 Photo #18: Cracked and spalled concrete at interior wall

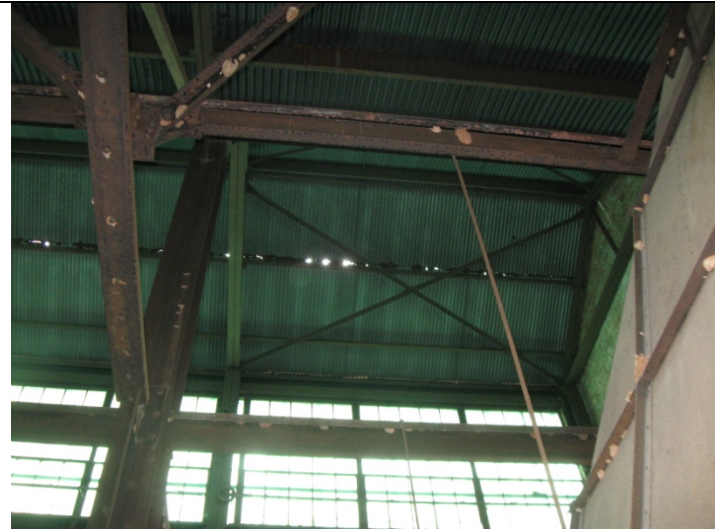
2013 Photo #17: More and larger holes were observed in metal roof deck in 2013

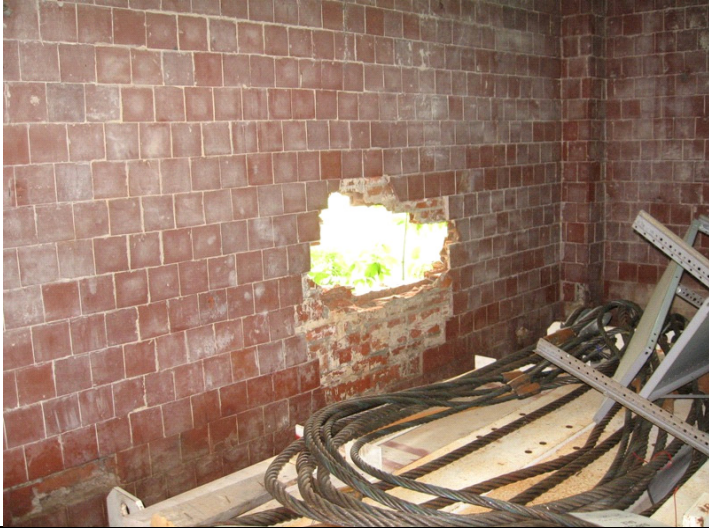
2009 Photo #19: Large hole in exterior masonry wall

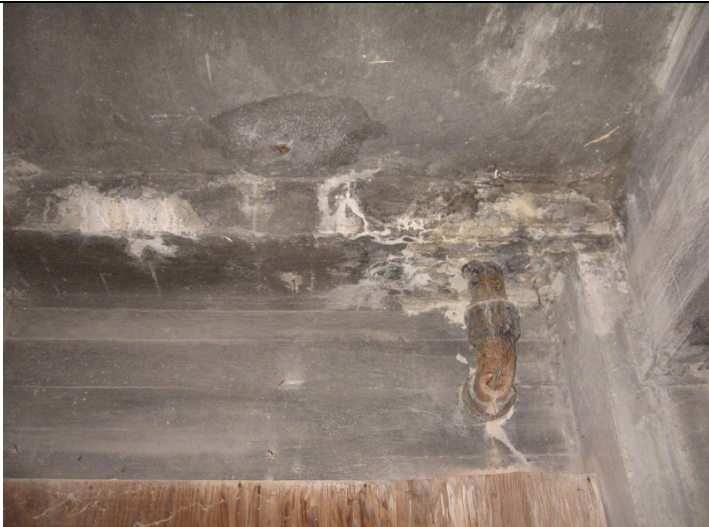
2009 Photo #20: Deterioration from water intrusion at mezzanine concrete frame

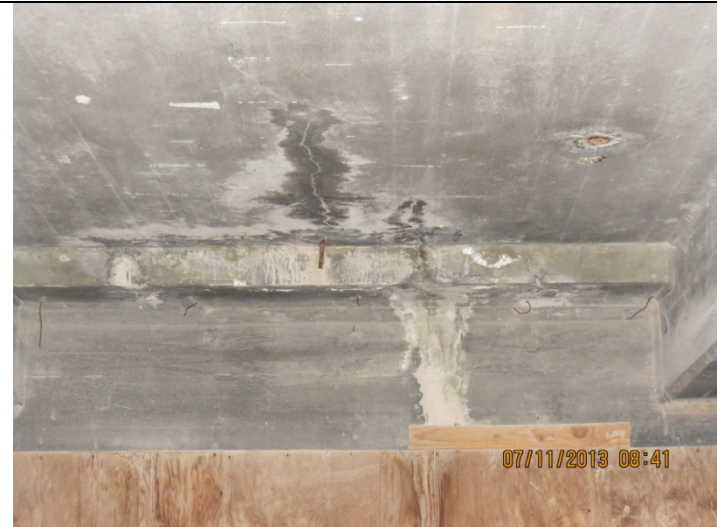
2013 Photo #20: Additional deterioration from water intrusion at mezzanine concrete frame was observed

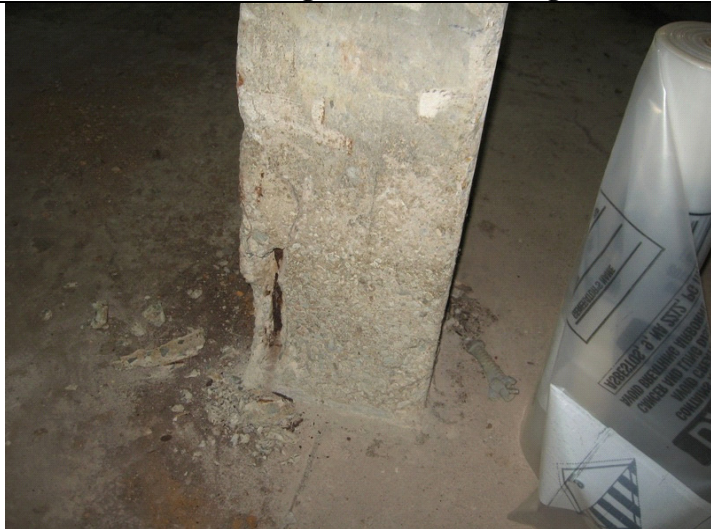
2009 Photo #21: Severely spalled mezzanine concrete column

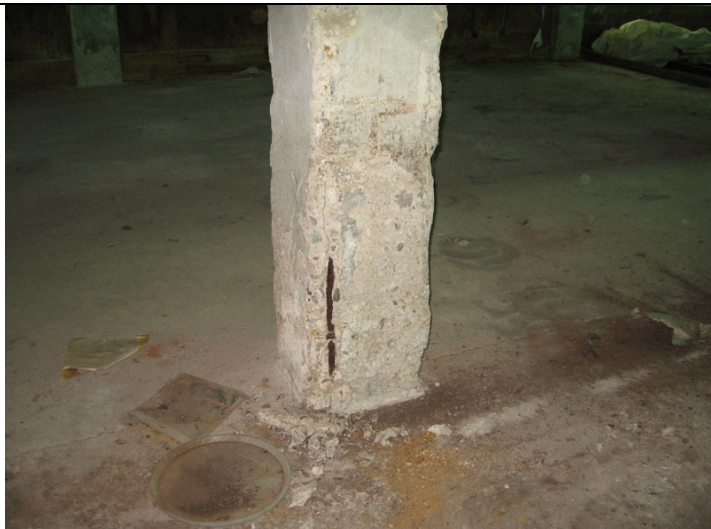
2009 Photo #22: Severely spalled mezzanine concrete column

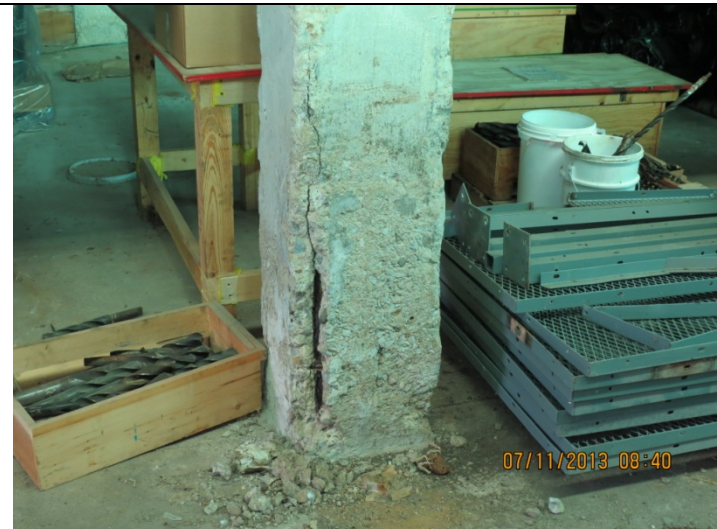
Defect Item No.	Defect Description (2009)	2013 Assessment of 2009 Itemized Defects	Photo Log Reference Nos.	
			From 2009 Report	2013
1	Vertical masonry crack 1 inch wide in southwest corner	Change in condition was not observed	2	
2	Cracks at lintel on west elevation at south window	Change in condition was not observed	4	
3	Vertical cracks at columns on exposed mezzanine concrete frame on west elevation	Change in condition was not observed	10	
4	Spalls in west elevation	Change in condition was not observed		
5	Badly rusted exterior metal stars on west elevation	Change in condition was not observed	3	
6	Masonry exterior wall at north elevation - fair condition	Change in condition was not observed		
7	Crack at columns in exposed mezzanine concrete frame on east elevation	Change in condition was not observed		
8	Surface spalls on east elevation	Change in condition was not observed		
9	Lots of spalls (impact damage) of concrete columns supporting concrete mezzanine	Vertical cracking at damaged corners of columns is significantly expanded	21,22	22

2013 Photo #22: Vertical crack at corner of column is significantly expanded, indicating progressive deterioration of reinforcing steel

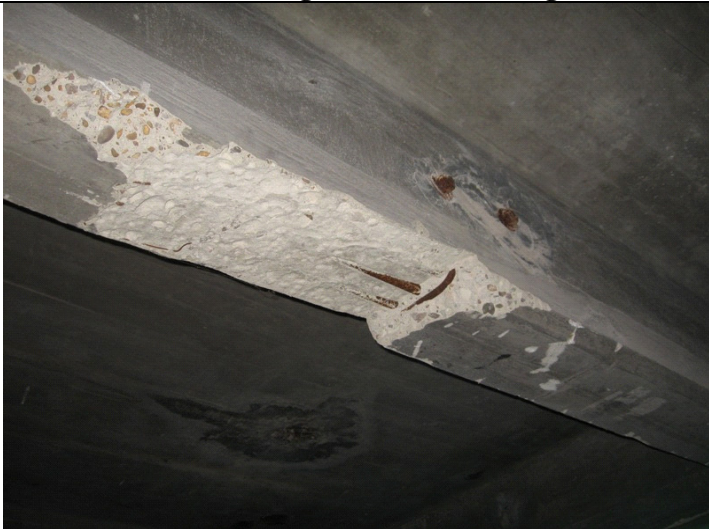
10	Impact damage at concrete mezzanine beams; serious chunk missing in 3 locations	Change in condition was not observed	23,24,25,26	
11	Voids in masonry wall below both mezzanines at closed end	Change in condition was not observed		
12	Roof diaphragm - corrugated metal deck or signs of rusting	More and larger holes were observed in clerestory metal roof deck	7,8,17	17

2009 Photo #23: Heavily damaged mezzanine concrete beam

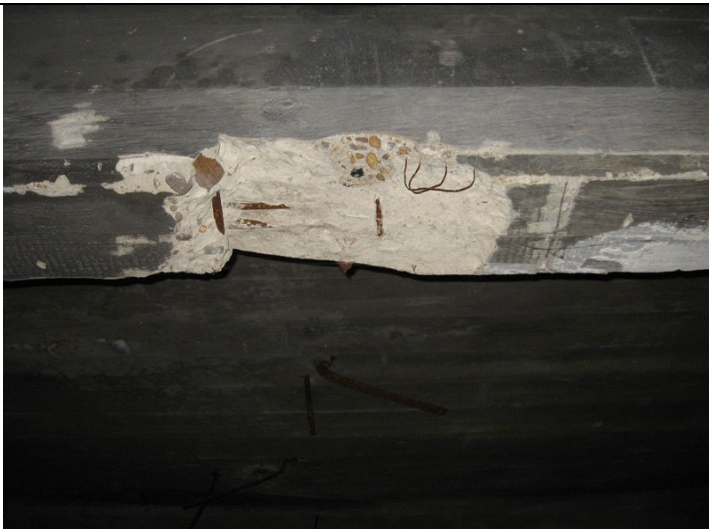
2009 Photo #24: Heavily damaged mezzanine concrete beam

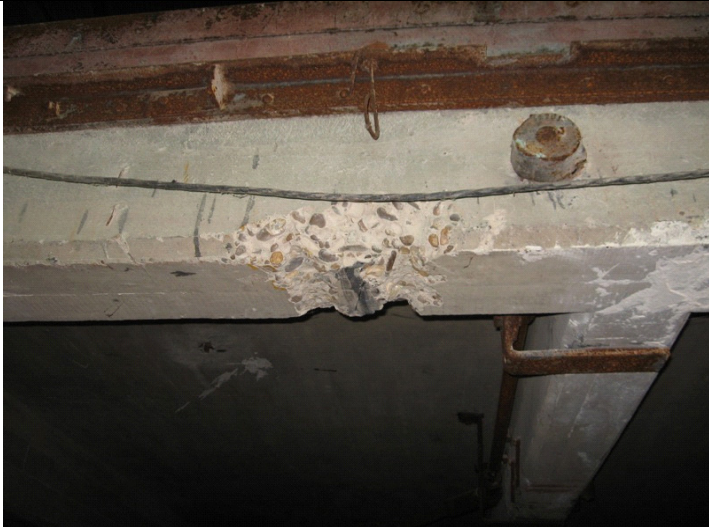
2009 Photo #25: Damaged mezzanine concrete beam

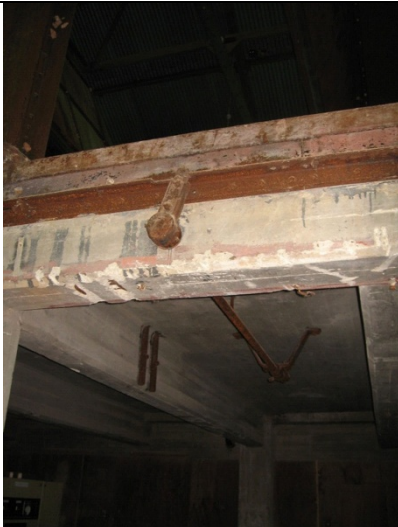
2009 Photo #26: Damaged mezzanine concrete beam

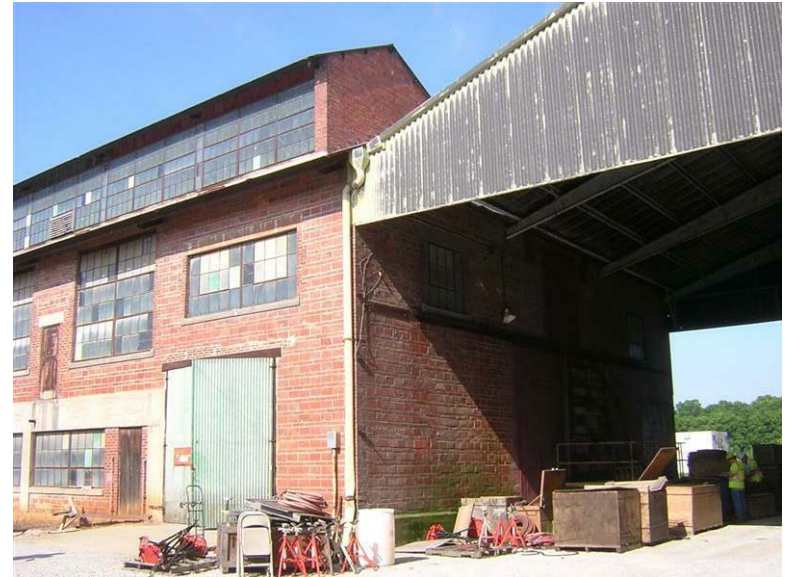
Building 81 – 5A – Nitrate House: Water flows from the attached shed towards the north wall.

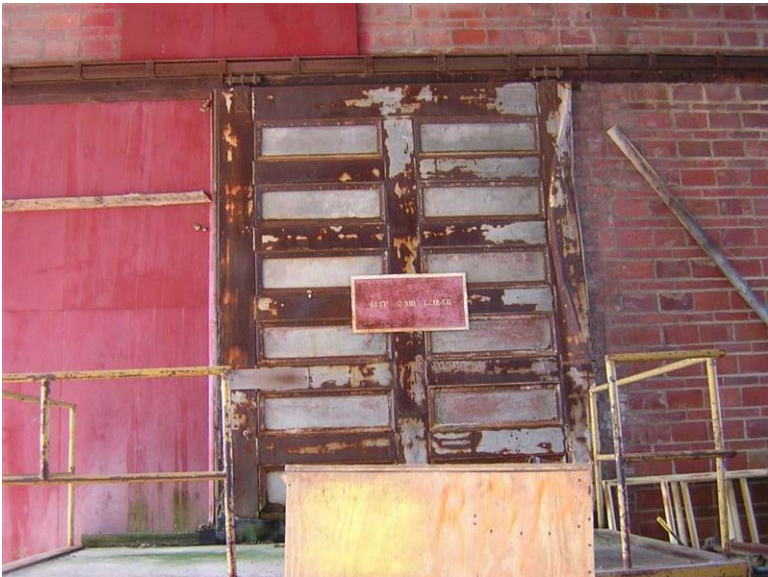
Building 81 – 5A – Nitrate House: The exterior doors are rusted.

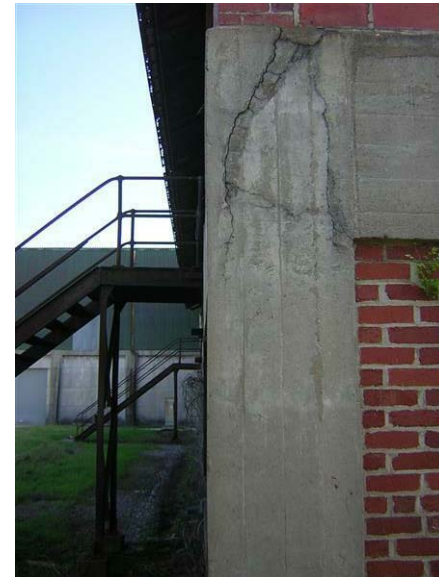
Building 81 – 5A – Nitrate House: Localized cracking is visible in the concrete structure.

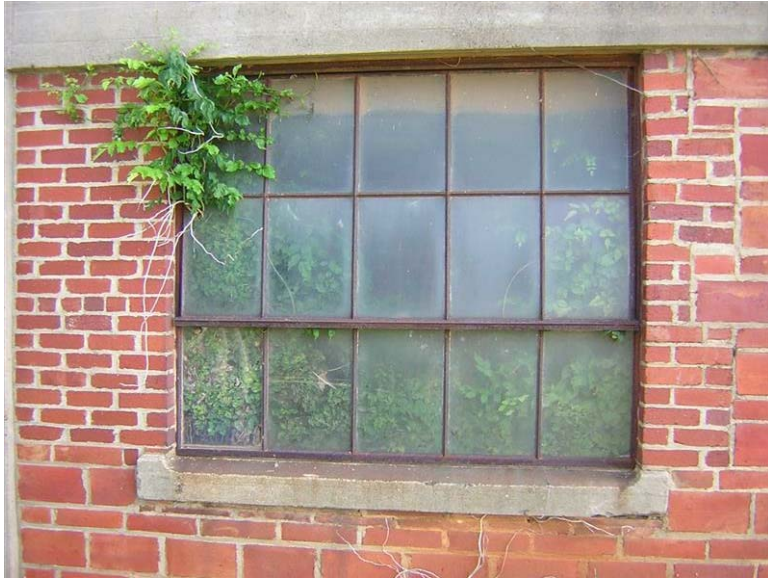
Building 81 – 5A – Nitrate House: Localized plant growth is located in the building.

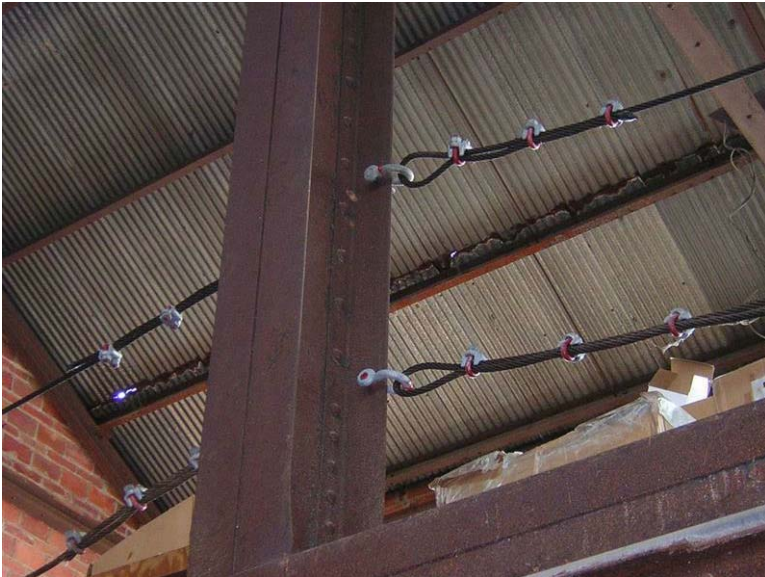
Building 81 – 5A – Nitrate House: Penetrations have been made in the steel columns for railings on the mezzanine.

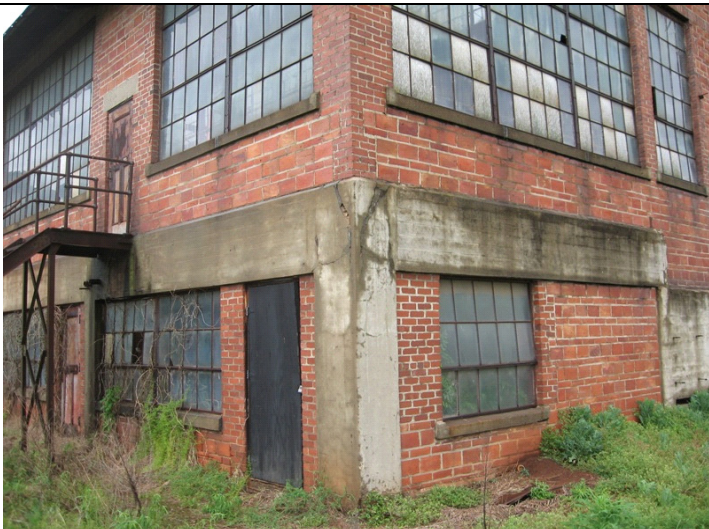
2009 Photo #2: Exterior cracks in concrete mezzanine frame at Southwest corner

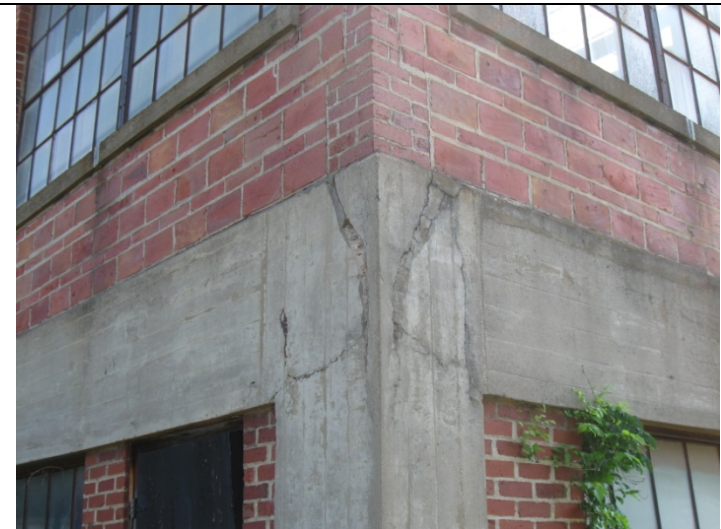
2013 Photo #2: Exterior cracks in concrete mezzanine frame at Southwest corner exhibit progressive deterioration

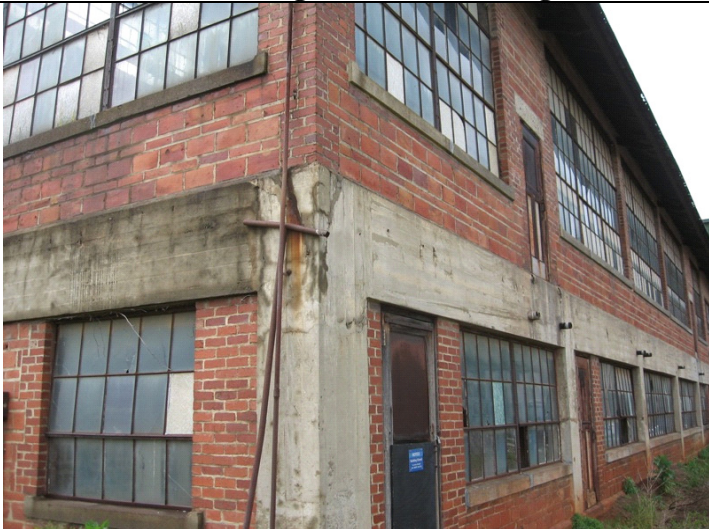
2009 Photo #3: Exterior cracks in concrete mezzanine frame at Southeast corner

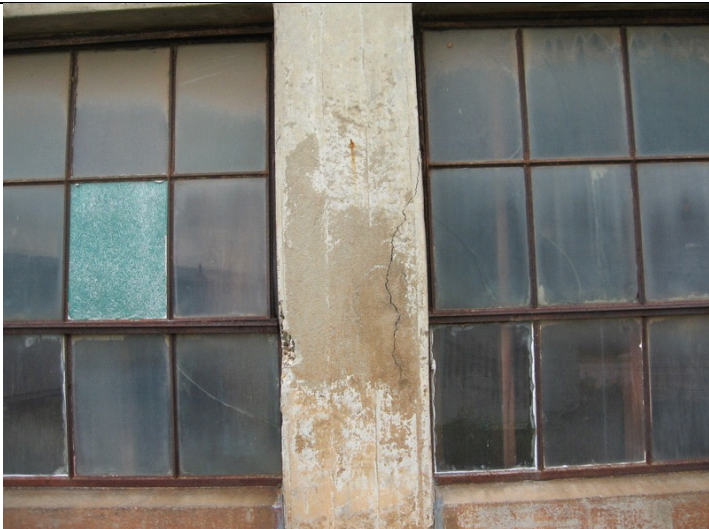
2009 Photo #4: Exterior crack in concrete mezzanine column

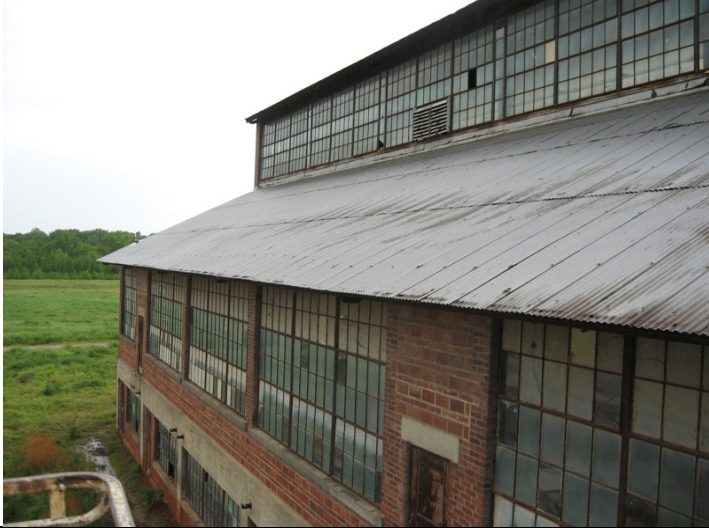
2009 Photo #5: Deteriorated metal roof on East side

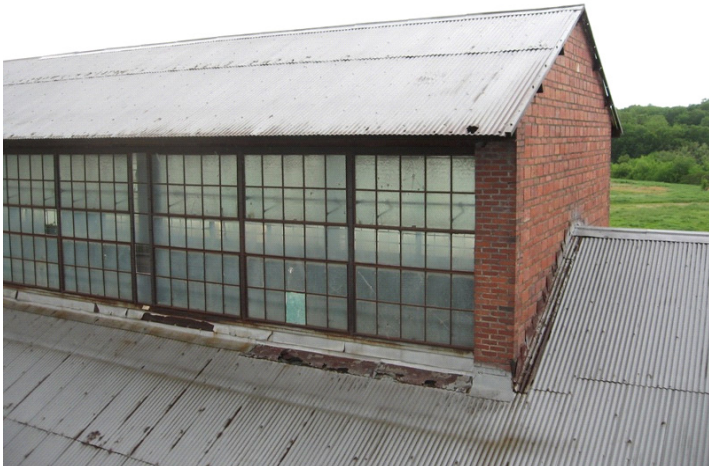
2009 Photo #6: Deteriorated metal roof on East side

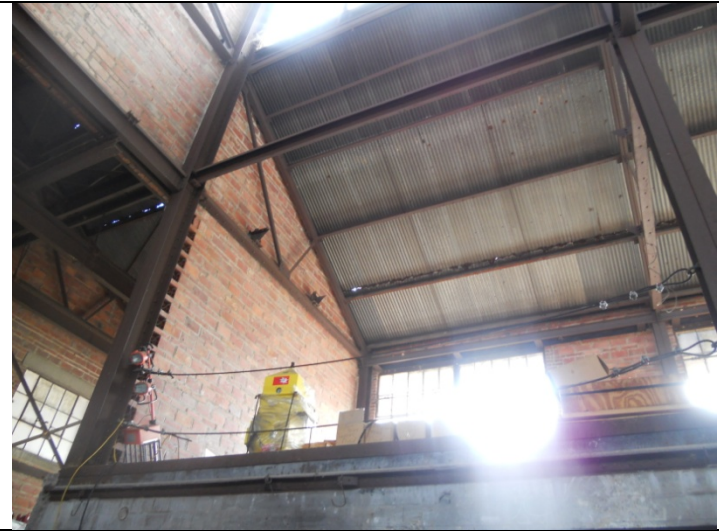
2013 Photo #7: More holes and more corrosion were observed on underside of metal roof deck

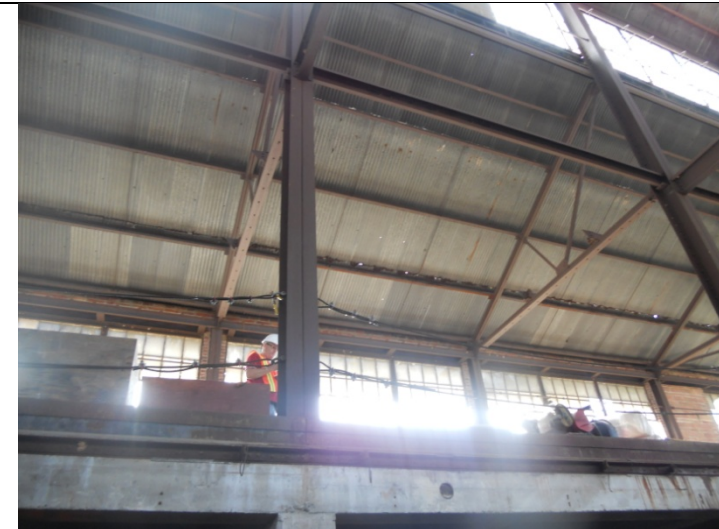
2013 Photo #8: More holes and more corrosion were observed on underside of metal roof deck

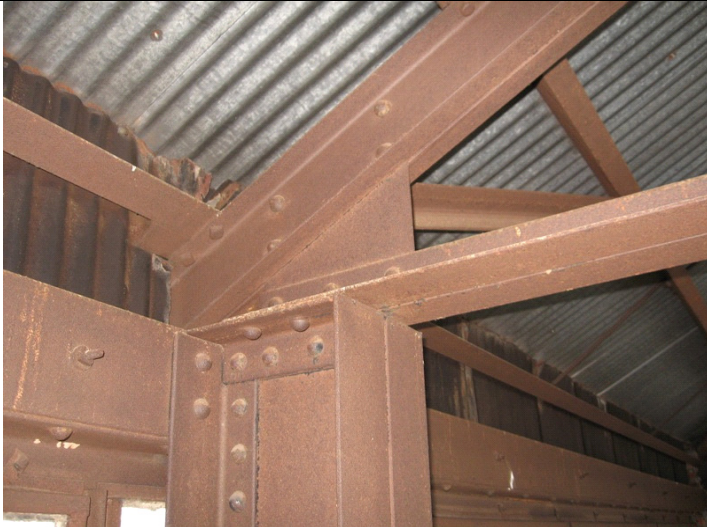
2009 Photo #15: Surface corrosion on steel framing

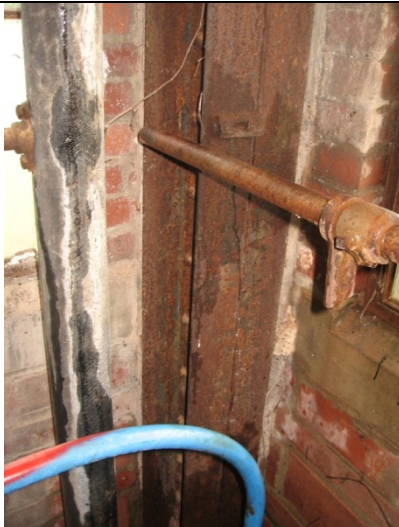
2009 Photo #16: Corroded steel column

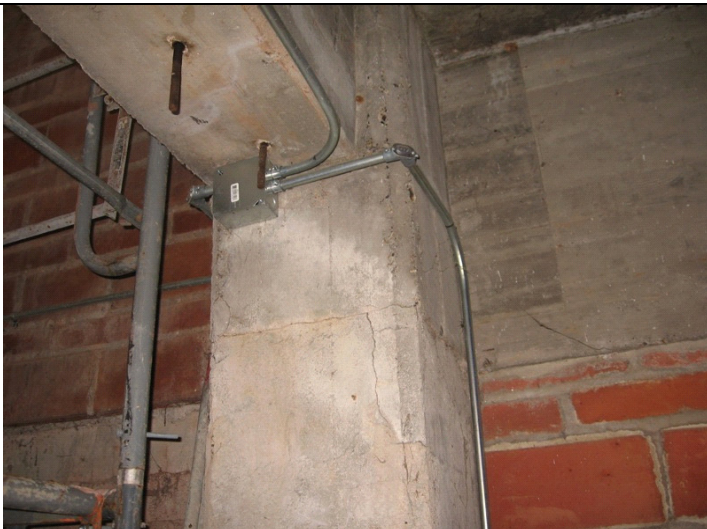
2009 Photo #18: Cracked concrete column at East mezzanine

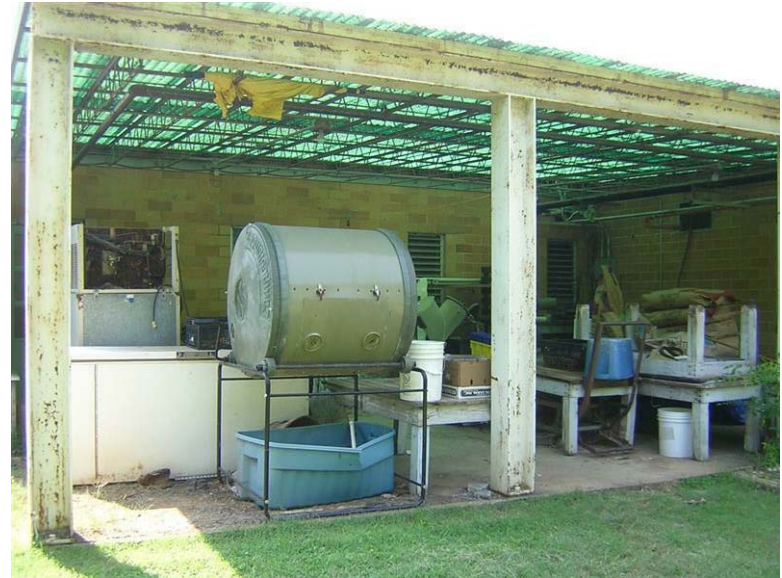
Building 118 – Greenhouse A: Rusting is visible in the steel shed structure at the rear.

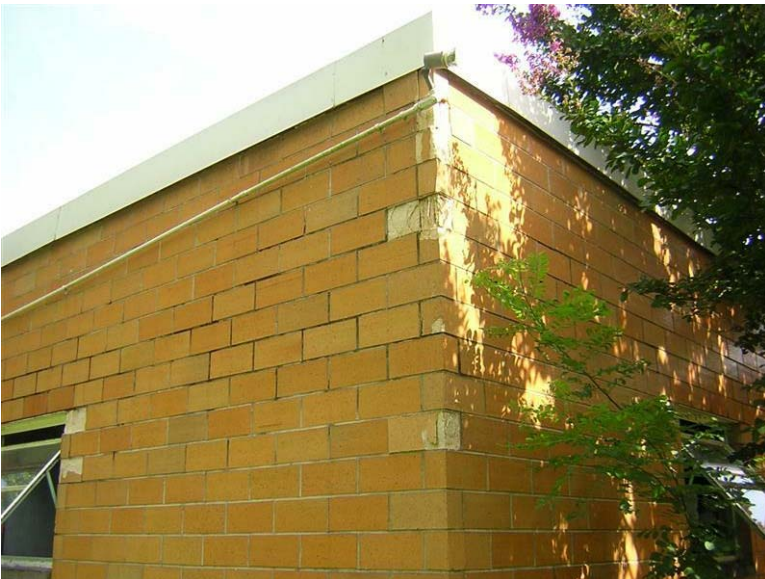
Building 118 – Greenhouse A: Localized spalling has occurred in the tiles at this corner of the building.
