Tennessee Valley Authority

Cyclic Assessment Report
TVA Muscle Shoals, Alabama
September 16, 2013

Executive Summary

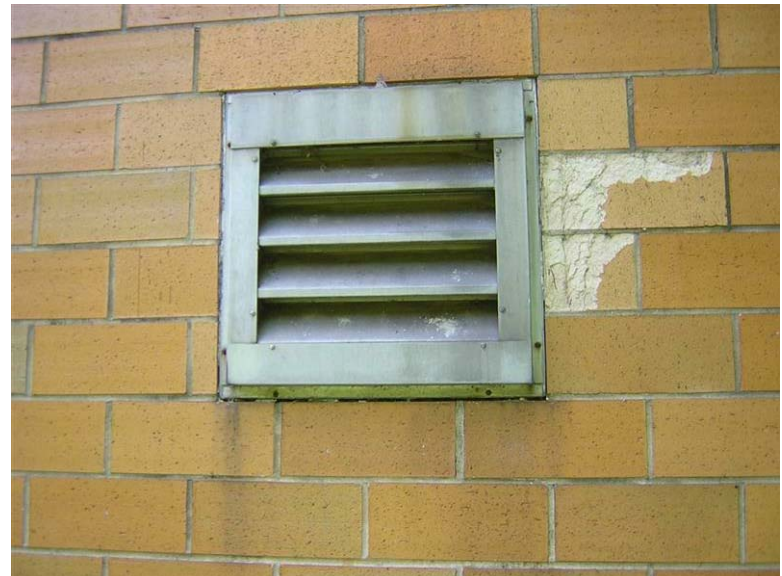
Building 118 – Greenhouse A: The glazed tiles have spalled adjacent to the vent opening.

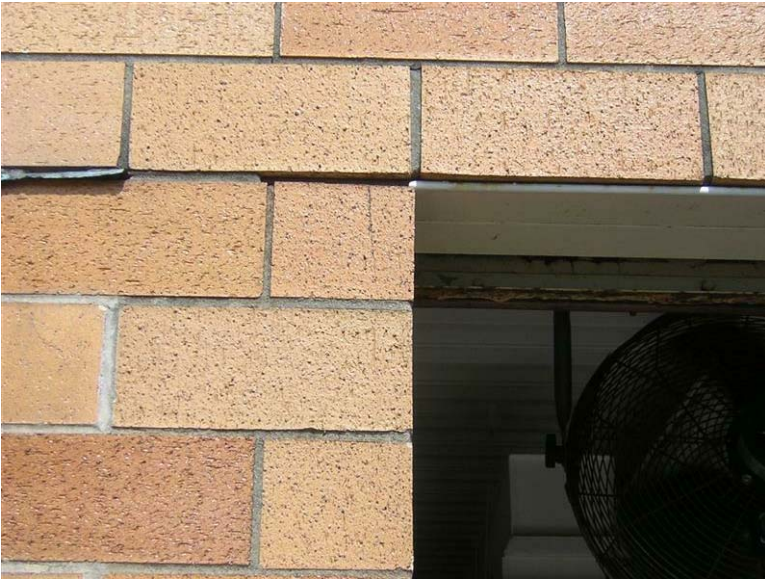
Building 118 – Greenhouse A: The lintels are rusting at the bearing points.

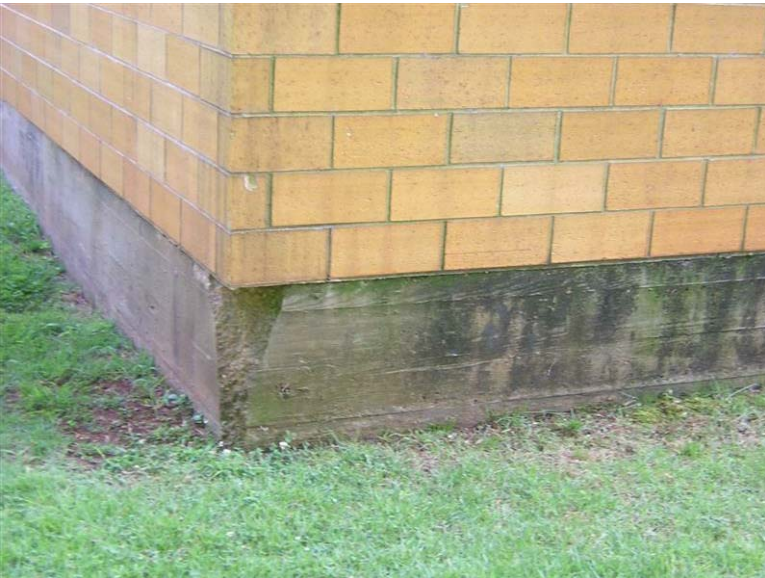
Building 118 – Greenhouse A: Localized damage is visible at the corner of the concrete foundation.

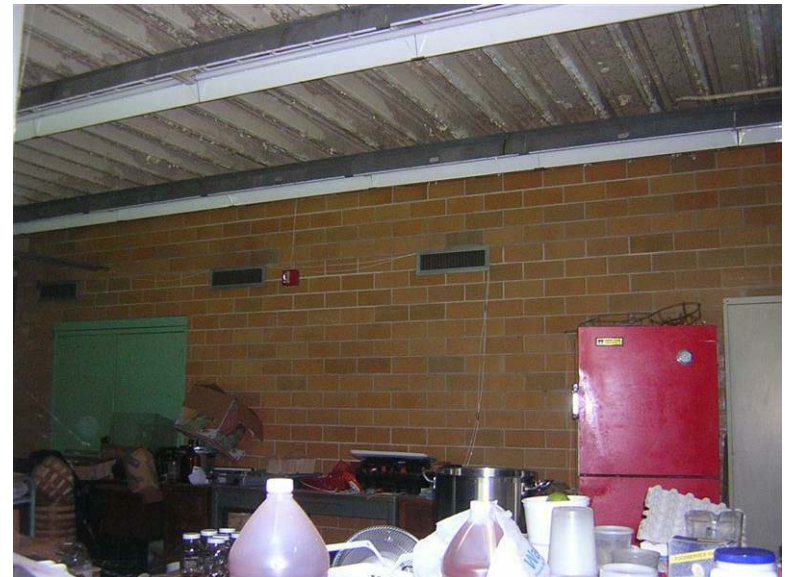
Building 118 – Greenhouse A: Paint is flaking from the metal ceiling.

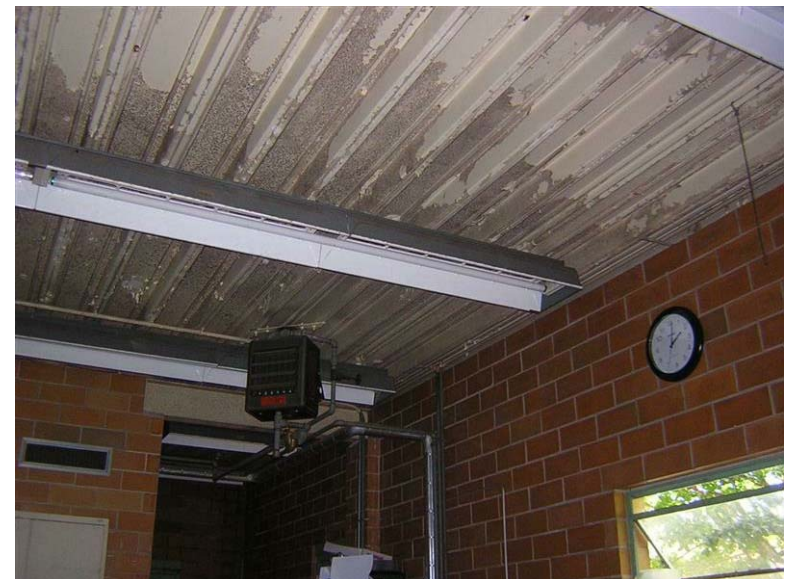
Building 118 – Greenhouse A: Paint is flaking from the metal ceiling.

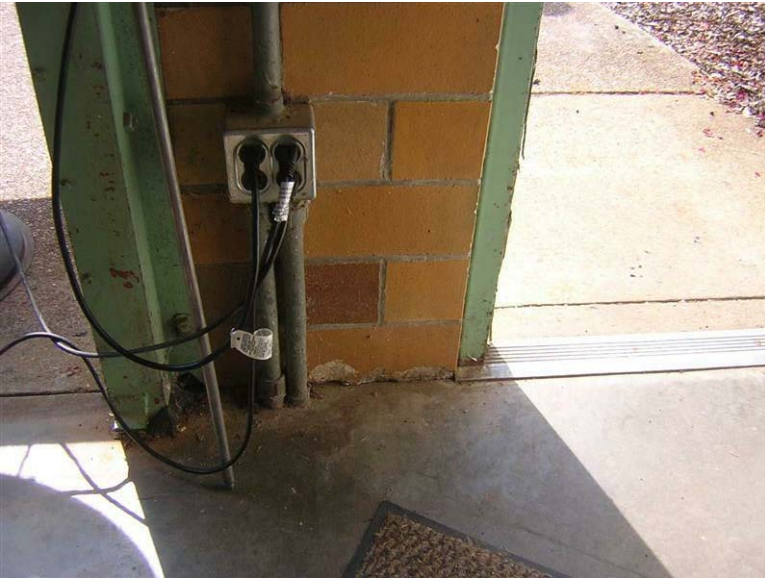
Building 118 – Greenhouse A: The glazed tiles are chipped at the base adjacent to the main entrance.

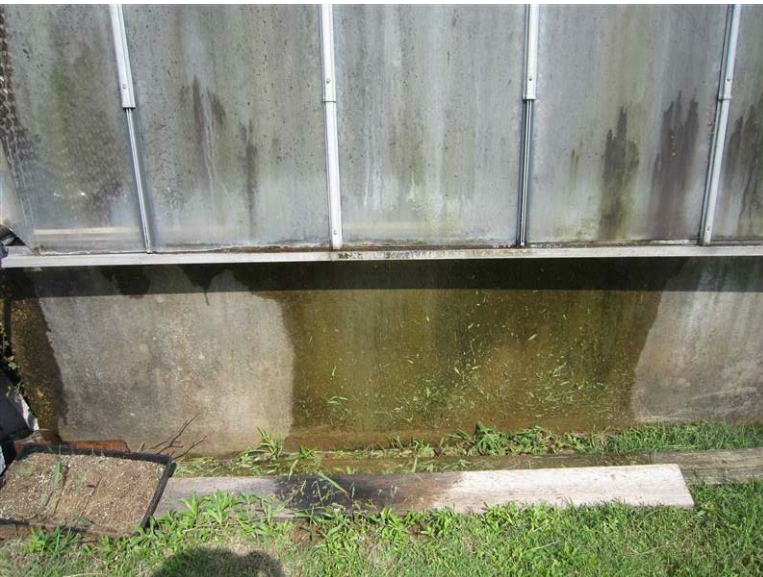
Building 118 – Greenhouse B-D: Staining from moisture and cracking is visible on the lower concrete wall.

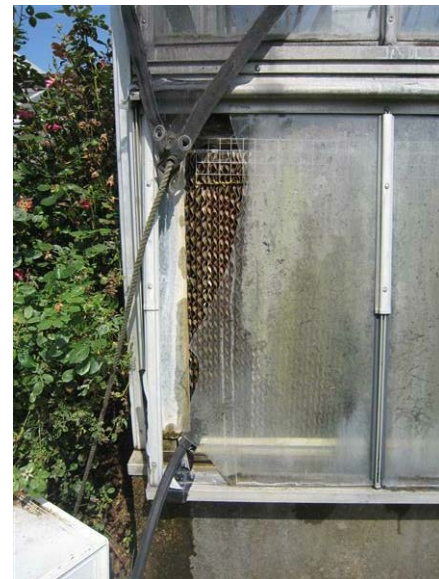
Building 118 – Greenhouse B-D: Localized broken panes occur in the glazed walls.

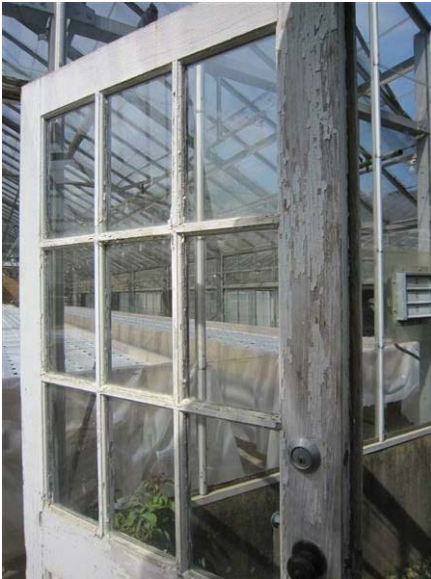
Building 118 – Greenhouse B-D: Although paint is flaking from several of the wooden doors, the wood remains in good condition.

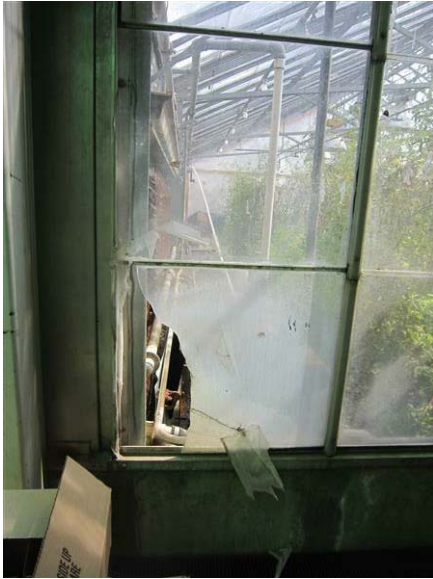
Building 118 – Greenhouse B-D: There are several localized broken panes.

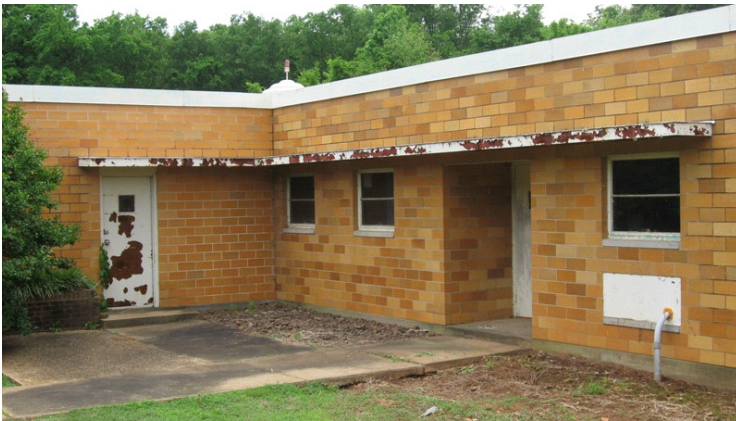
2009 Photo #2: Corroded awning at lab building

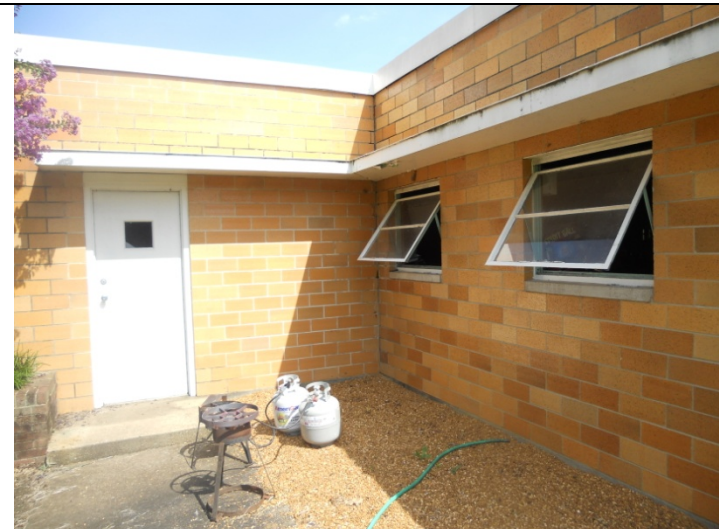
2013 Photo #2: Awning at lab building, steel has been refinished.

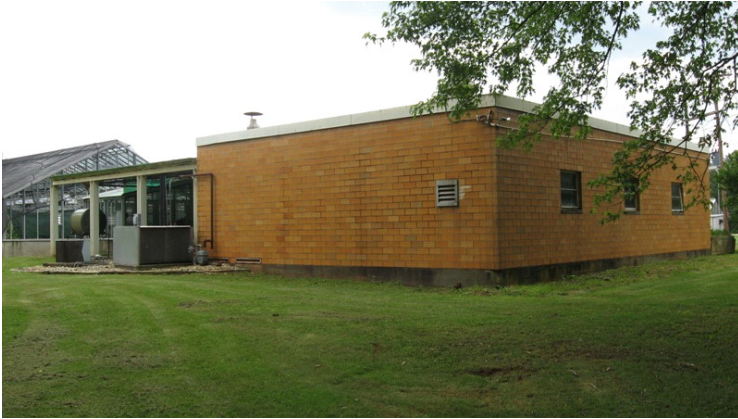
2009 Photo #3: Exterior view of lab building and attached open covered storage area

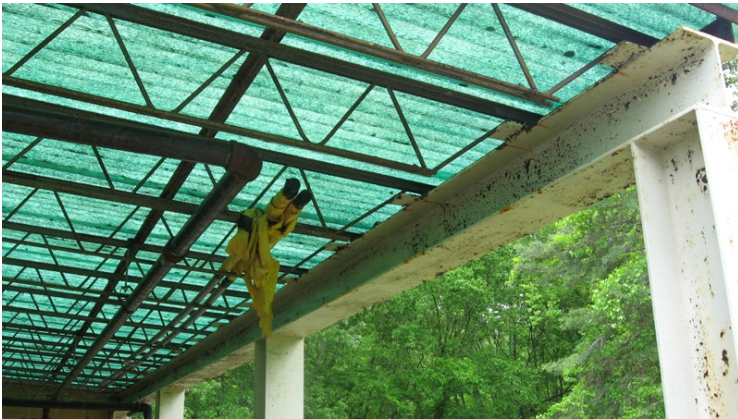
2009 Photo #4: Mildly to moderately corroded steel at open covered storage area

Summary of Recommended Structural Repairs (2009):	The Lab Building roof membrane must be repaired or replaced, and water intrusion damage to the metal roof deck must be repaired. The steel framing at the open covered storage area should be cleaned and painted. Concrete foundation walls should be repaired, including cracks in the greenhouse stem walls and a spalled corner of the turned-down slab at the Lab Building. The metal roof at the Storage Building should be cleaned and coated, and the translucent panel roof at the Screened Porch should be replaced. Deteriorated wood framing at the Screened Porch roof must be replaced or reinforced.
Additional Recommendations (2009):	Not applicable

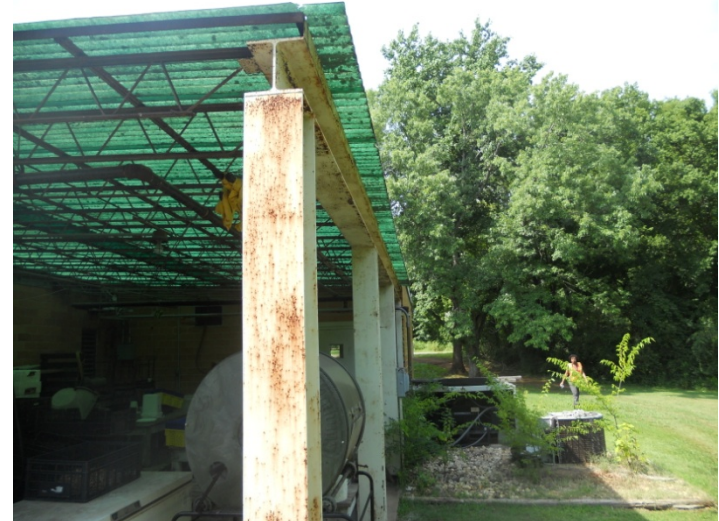
2013 Photo #4: Corroded steel exhibits progressive deterioration.

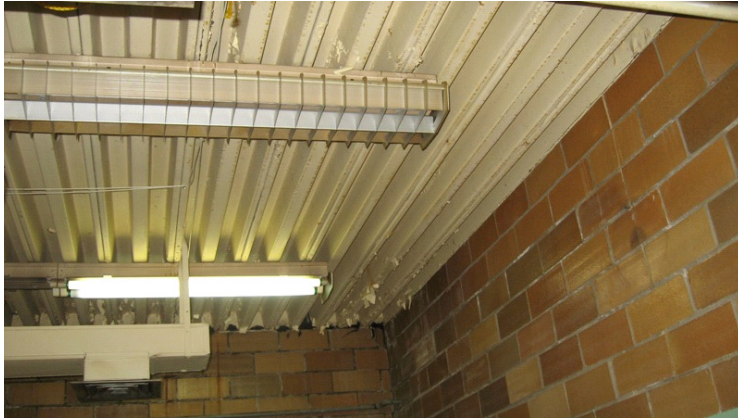
2009 Photo #5: Interior evidence of moisture intrusion at lab building roof

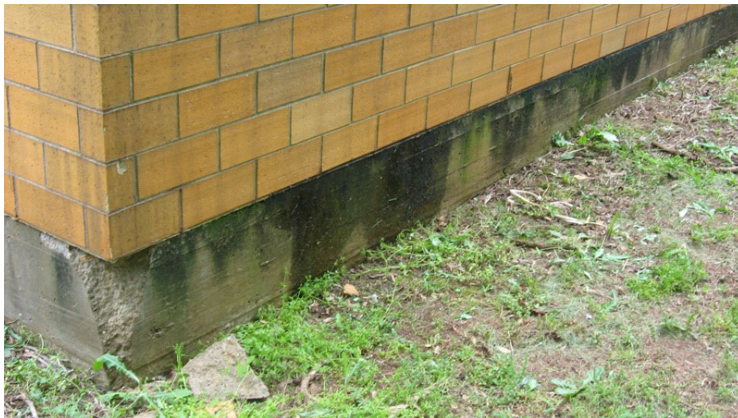
2009 Photo #6: Spalled foundation wall and exterior evidence of interior water intrusion

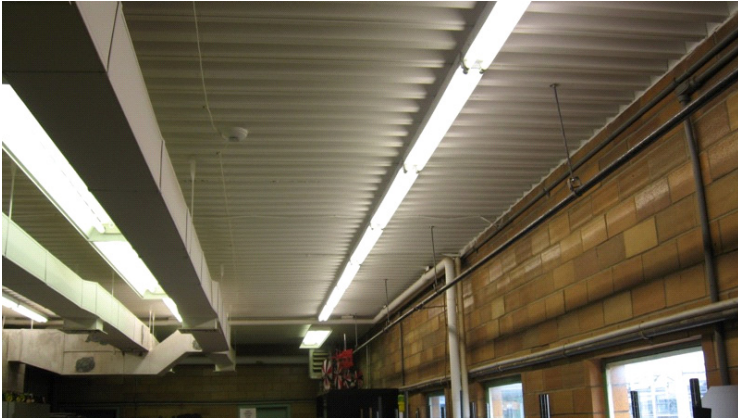
2009 Photo #7: Interior of work room at lab building

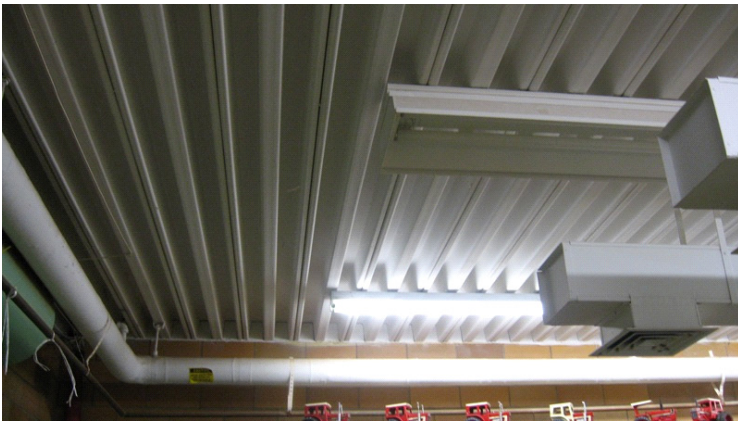
2009 Photo #8: Metal roof deck at lab building in generally good condition

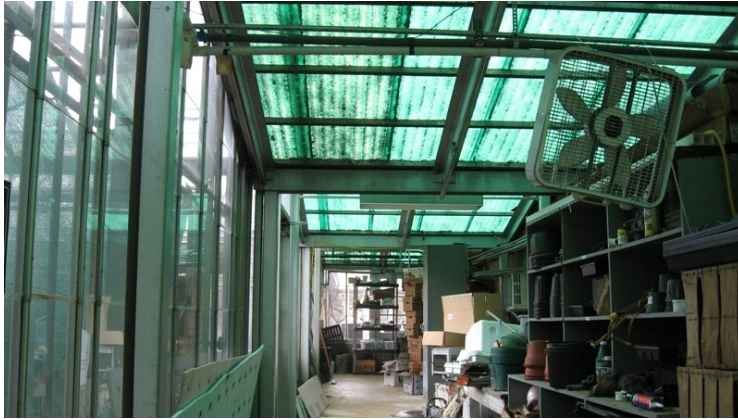
2009 Photo #9: Steel frame enclosure between lab building and greenhouses

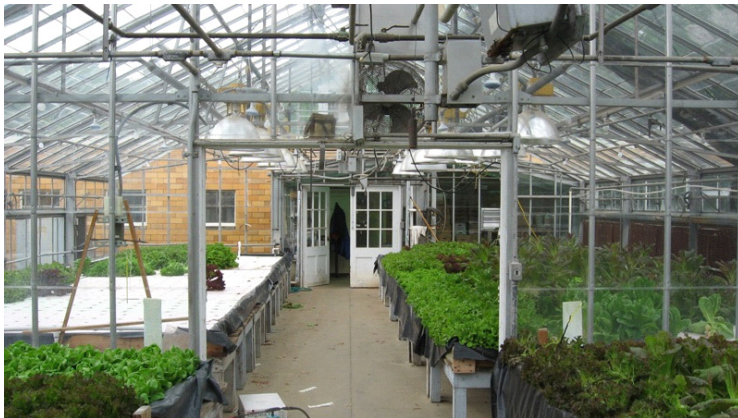
2009 Photo #10: Interior of greenhouse 2 looking at lab building

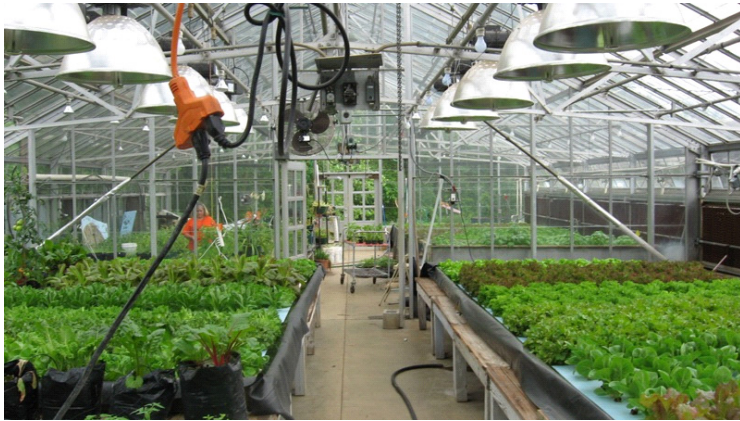
2009 Photo #11: Interior view of greenhouse 3

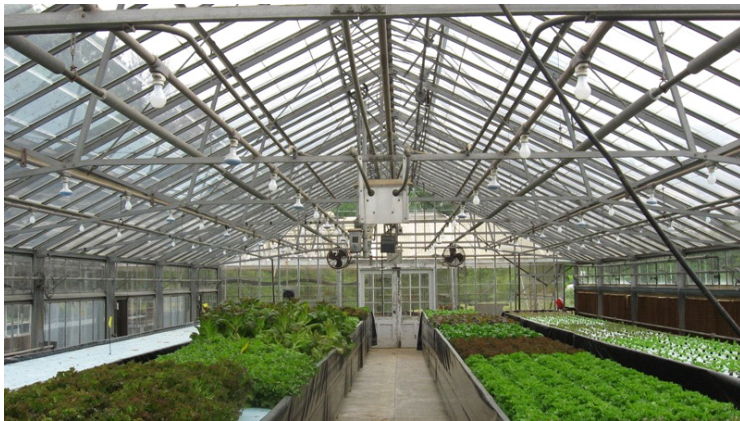
2009 Photo #12: Interior view of greenhouse 1

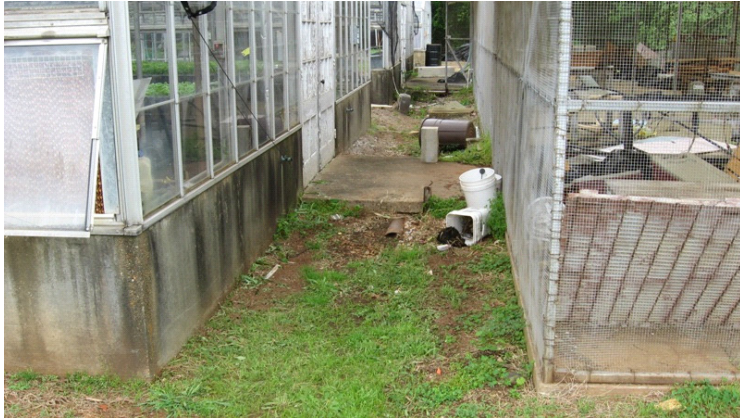
2009 Photo #13: Foundation walls at greenhouses

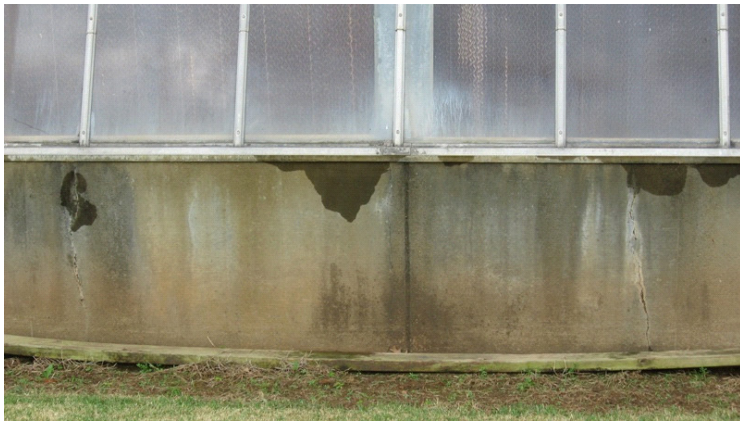
2009 Photo #14: Cracks in foundation wall at greenhouse 1
